PARAGON GEOTECHNICAL
CONSULTING ENGINEERS

May 5, 2008

Re: Geotechnical Evaluation of Pond Seepage
Hidden Lakes Estates North Pond Dam
Hidden Lakes Estates
Granite Bay, California
(Proj. No. 1383-01-07)

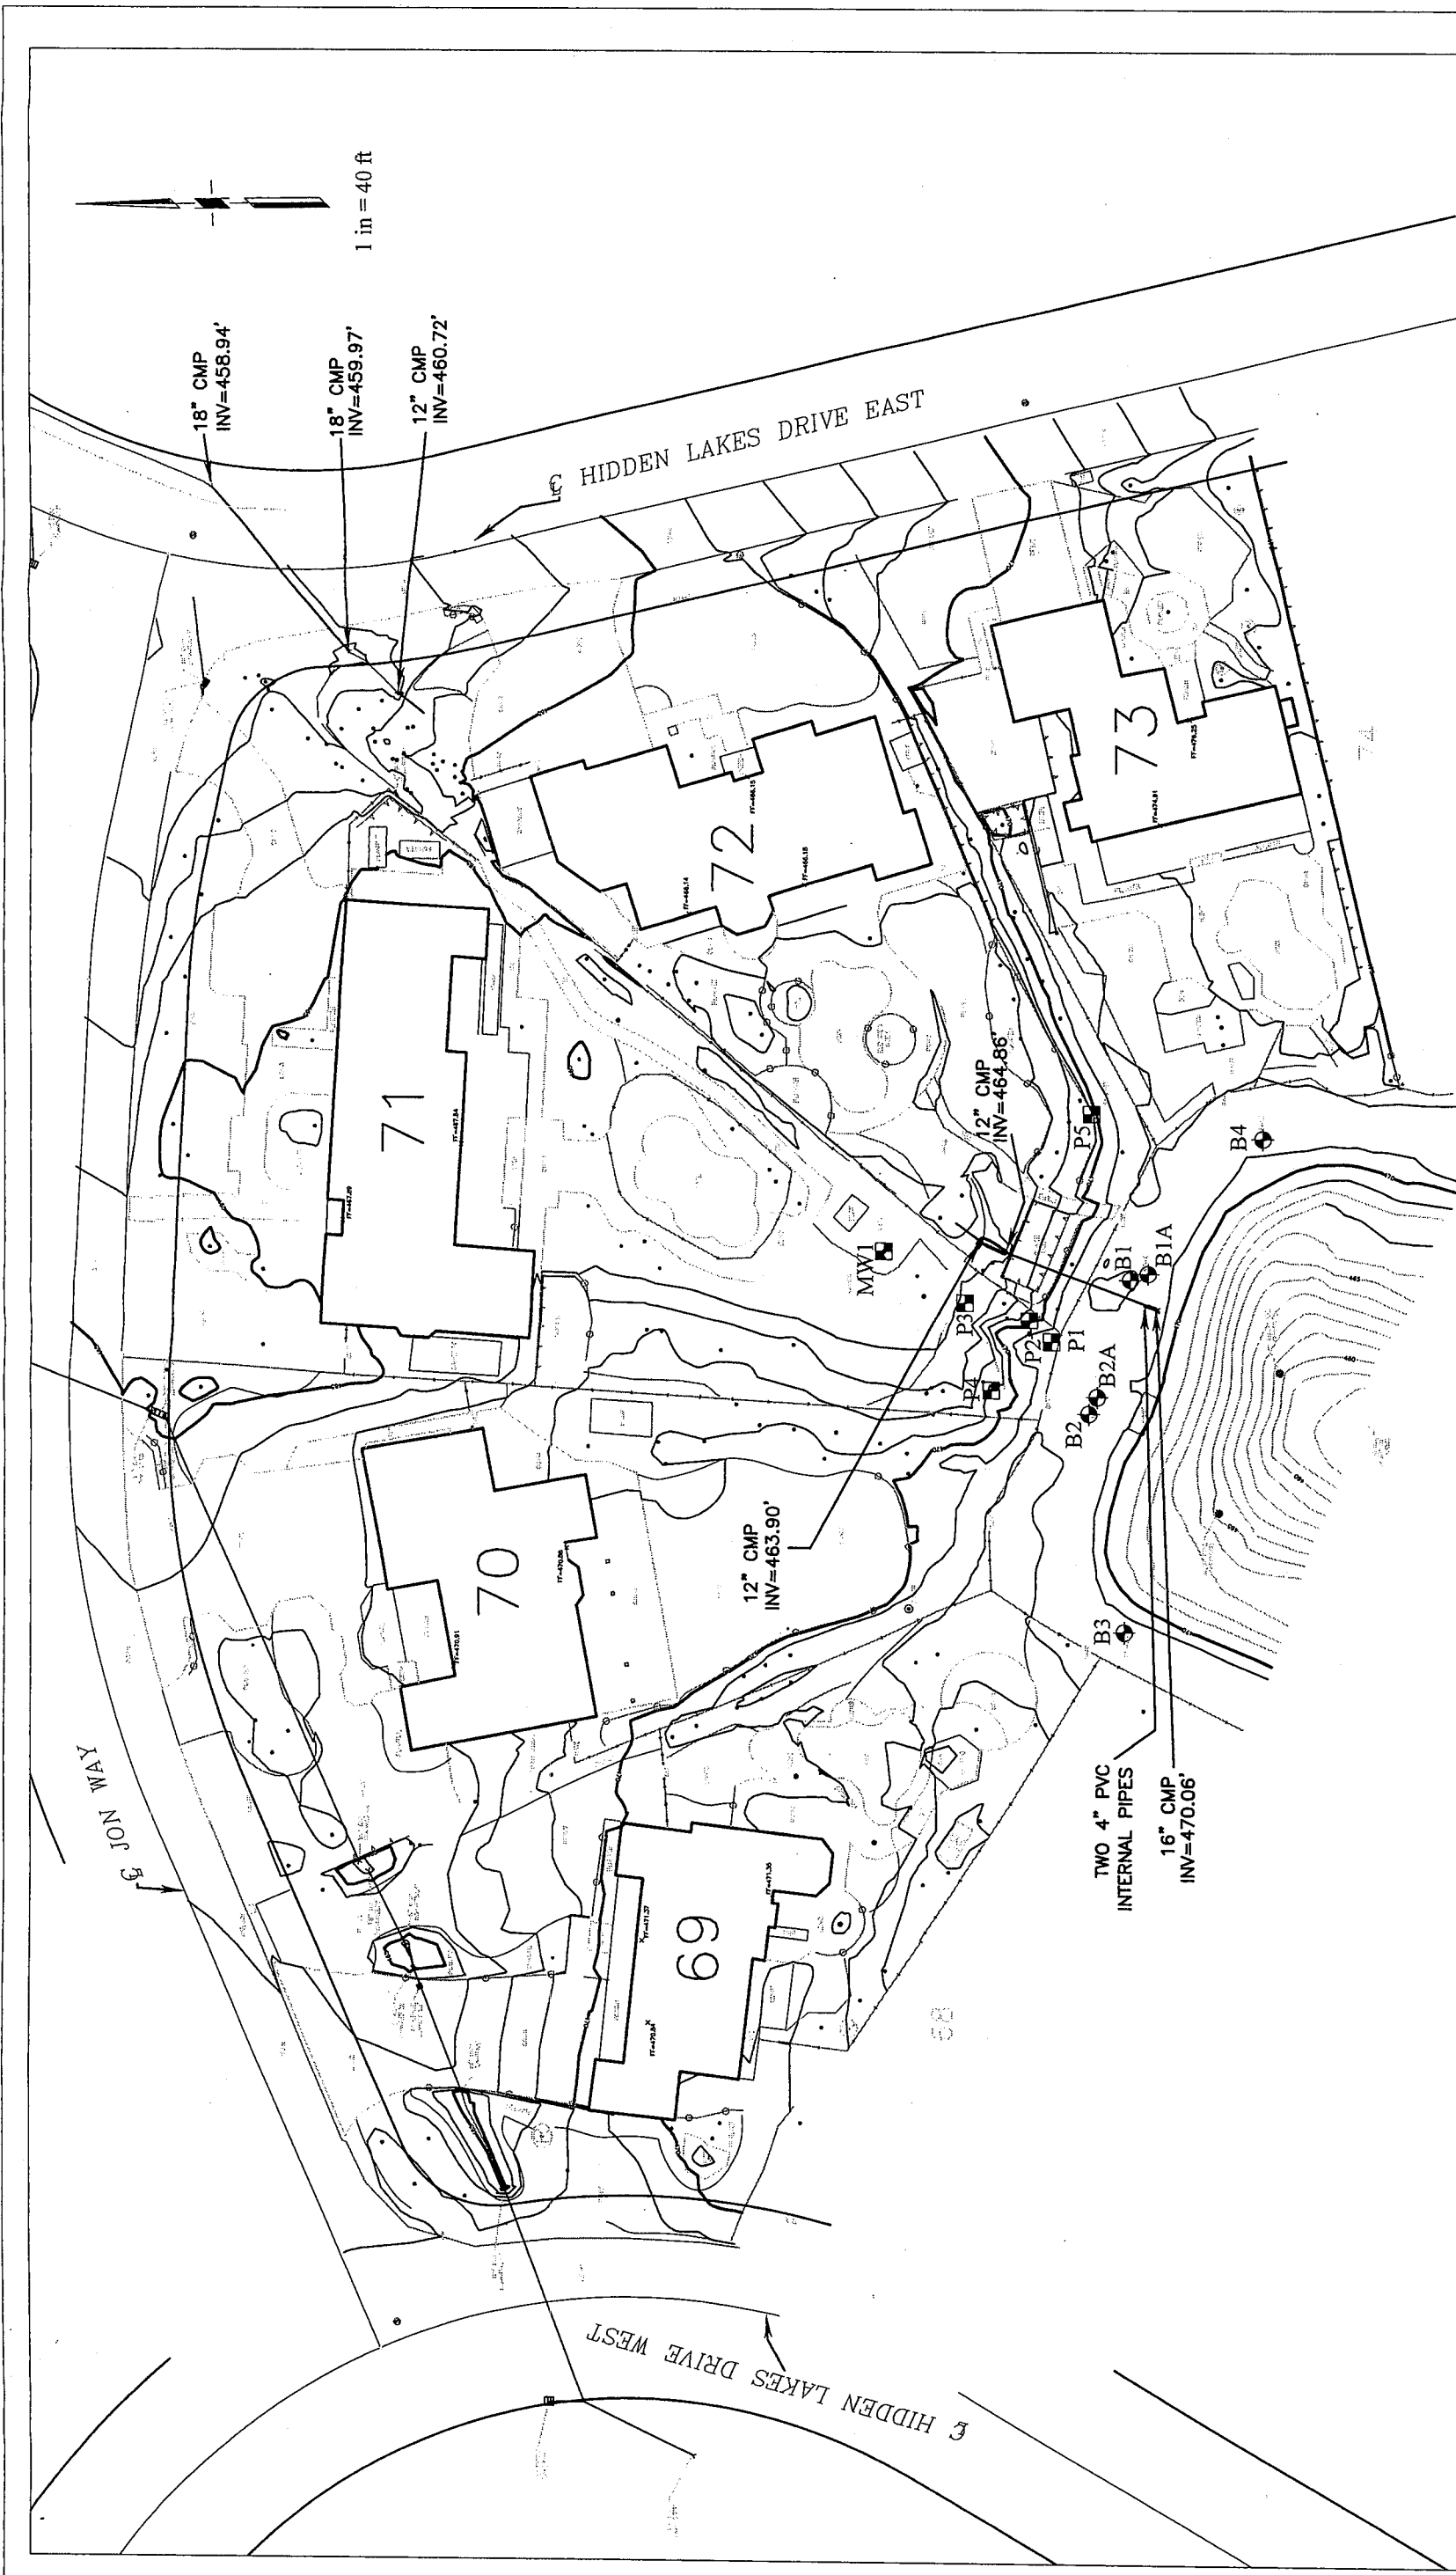
PLATE
1

A relatively detailed topographic survey (performed by others) of the north dam and adjacent residential lots is presented in Plate 2. At the time of our field exploration, the north dam was approximately 5 to 6 feet high, as measured from the downstream toe to the crest of the embankment. The crest of the embankment was about 20 feet wide, and was nearly level. The water level in the pond was located about 1.5 to 2 feet below the crest of the embankment.

Furthermore, as shown on Plate 2 of this report, and on the as-built drawings for the subdivision, both the current and pre-development topography in the vicinity of the north dam and adjacent lots slope toward a low area where lots 71 and 72 are located. The current topography in this area appears to drain portions of lots 69, 70 and 73 towards

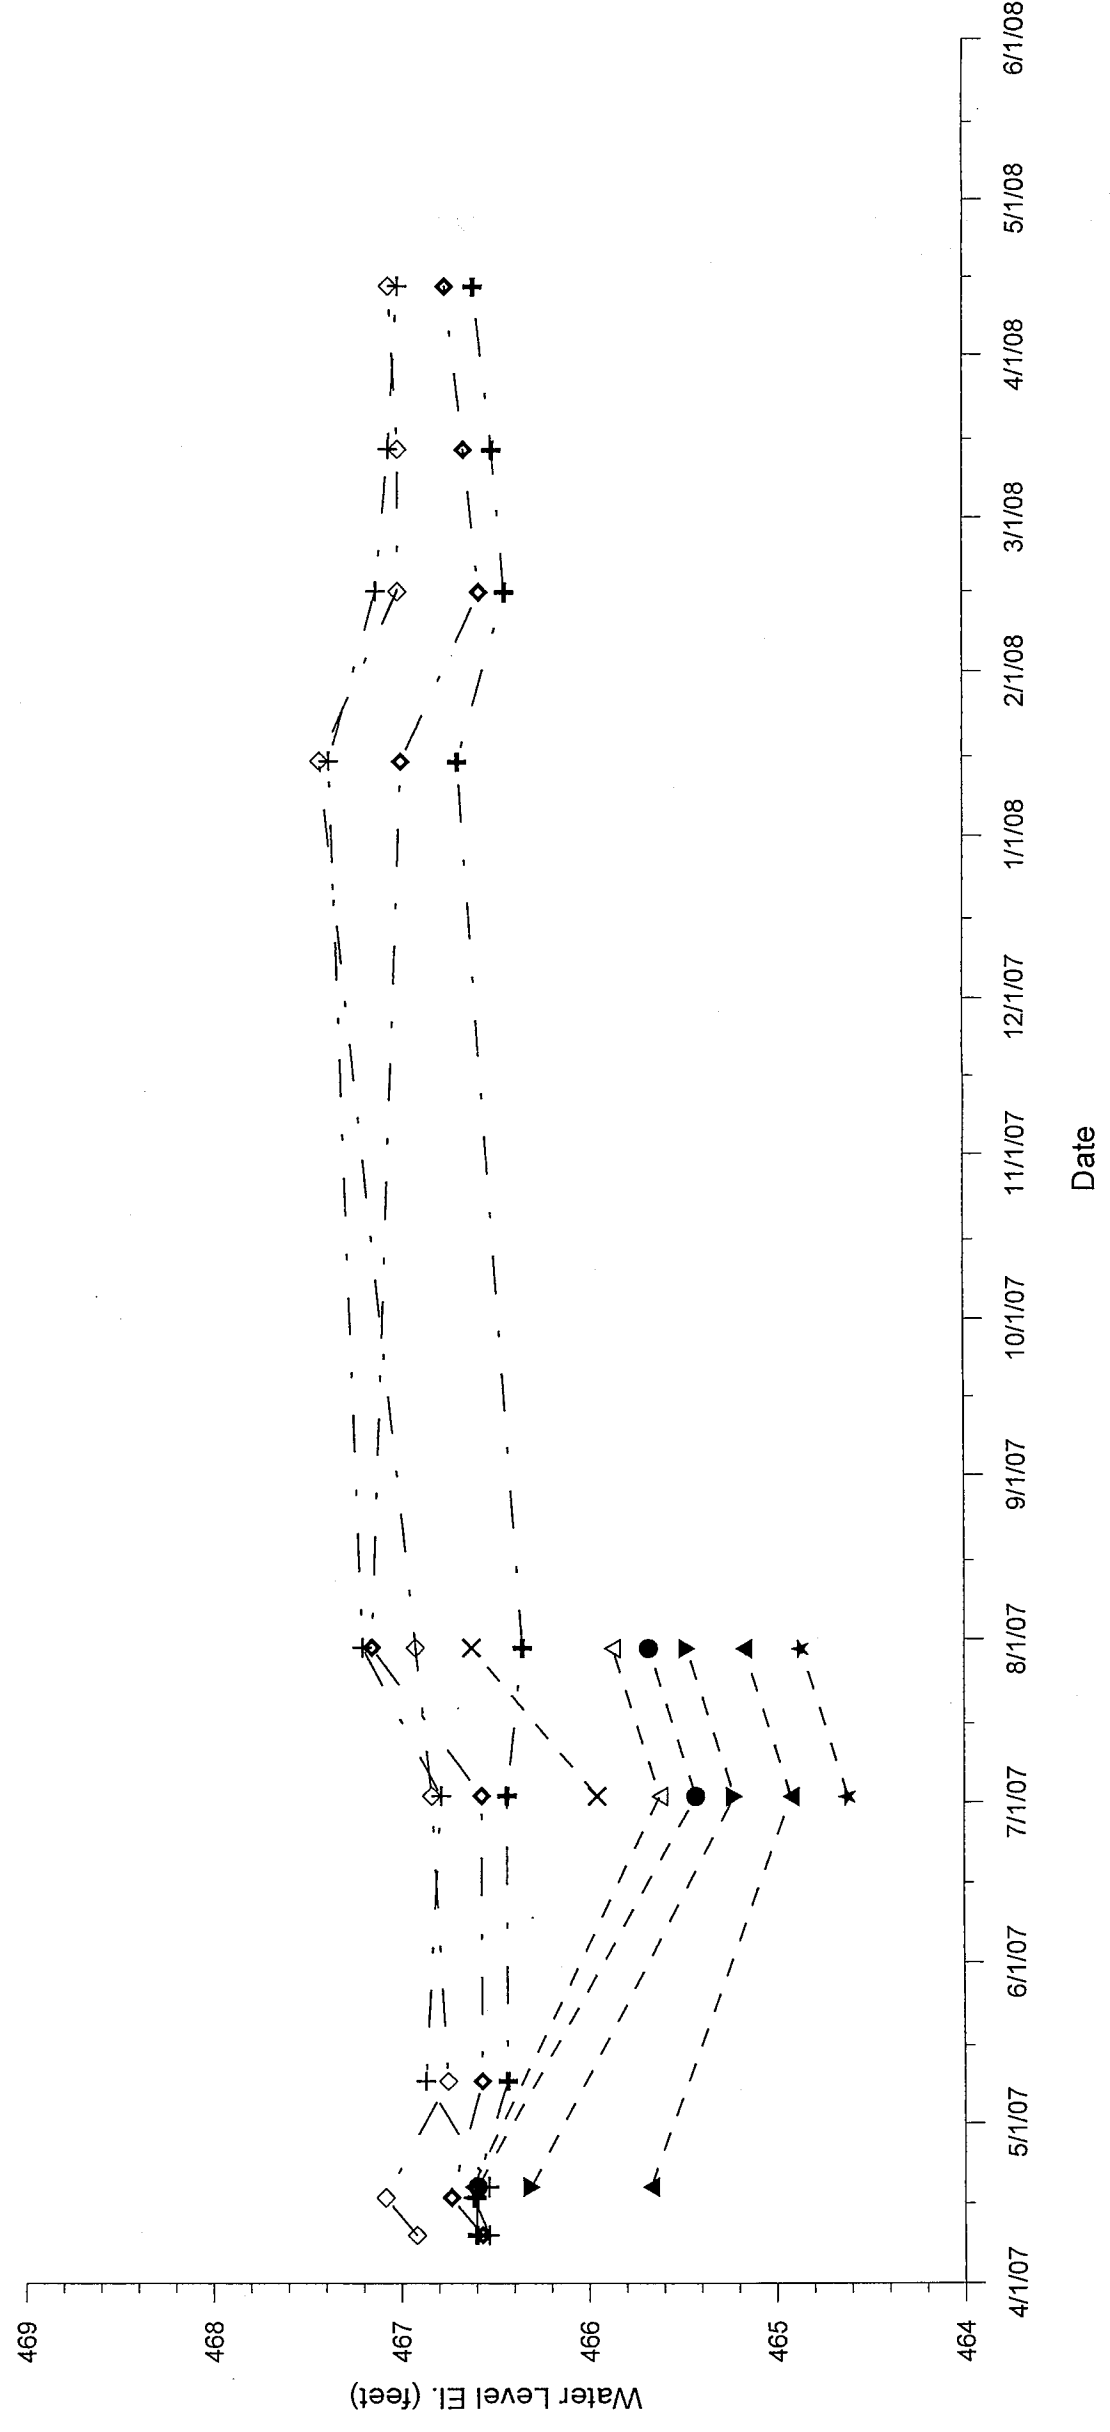
PLATE
16

Due to the relatively large time gap between measurements, it is difficult to identify long-term trends in the data. However, the data does suggest relatively steady-state seepage conditions in the dam, with slight seasonal variations. The data from the piezometers on lot 71 indicate a lowering of the groundwater level of about 9 to 13 inches between April 19 and July 2, 2007 with a slight increase by July 30, 2007.
