YOUNGDAHL CONSULTING GROUP, INC.

18 August, 2003
Project No. 03286

Subject: 7884 JON WAY
Granite Bay, California
*GEOTECHNICAL RECONNAISSANCE RELATED TO SUBSURFACE WATER
CONDITIONS*

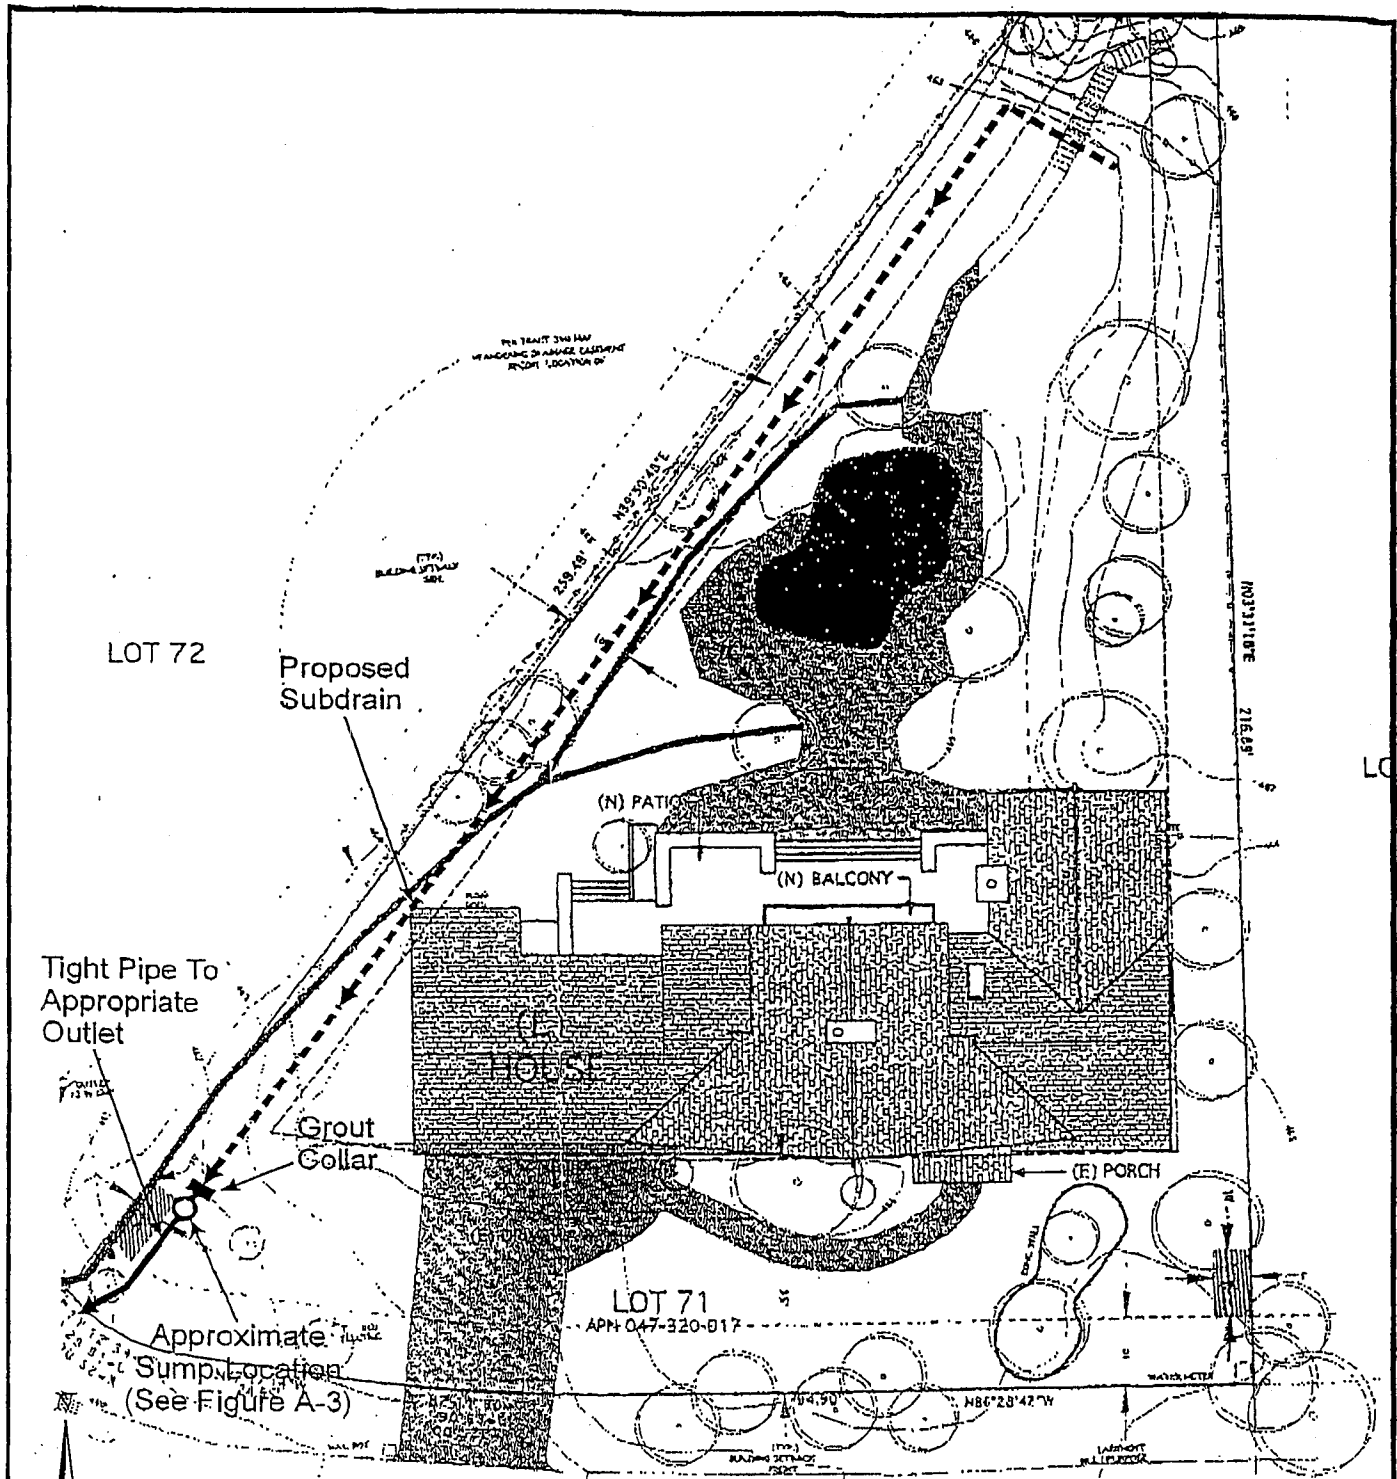
FIGURE
 A-1

SITE PLAN
 Jon Way (7884)
 Granite Bay, California

For immediate relief purposes, we recommend that a new subdrain be installed along the south and east property line to intercept subsurface water flow as shown on Figure 1. The drain should be deepened into bedrock materials a minimum depth of 1 foot to intercept water which may be perched along the soil/bedrock contact. We recommend that the drain be designed as a gravity flow system which discharges into the drain inlet located at the Jon Drive/ Hidden Lakes Drive intersection. Given the elevation of the property and depth to water, a minimum pipe gradient of 0.5 percent should be maintained. A sump should be positioned near the outlet as a precaution should additional dewatering be required due to excess lake seepage, outflow and rainfall. The last 20 foot of the drain line should be a solid "tight" pipe with a grout collar positioned at the junction of the perforated and tight pipe to reduce the potential for water migrating from the line back to the home.
