SAN DIEGO REGIONAL
WATER QUALITY
CONTROL BOARD

Re: Facility Inspection report 05C-041

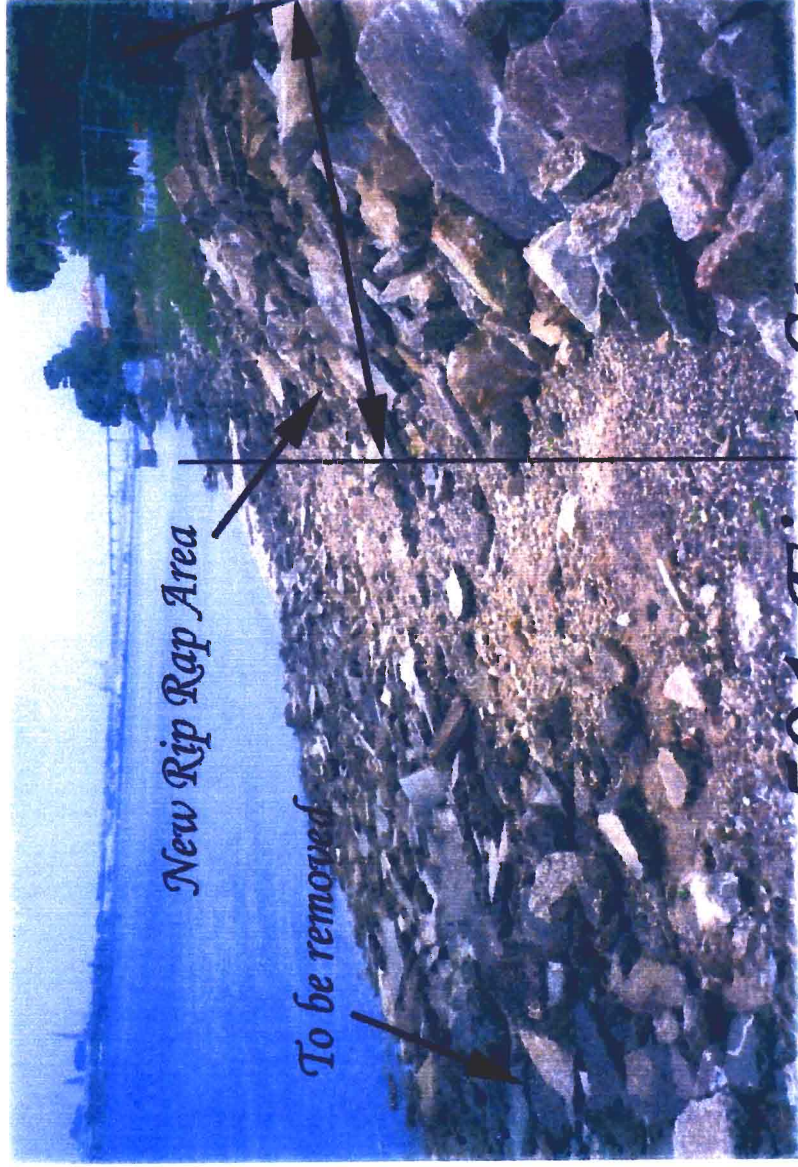
Attached are photographs of the site before, during and after the work. The first photograph taken from 501 looking past 505 was submitted with the permit applications for 501. You will notice that the replacement riprap was not going to cover the entire rubble area. The native sediment would be exposed by the permitted work. The second photograph is taken from 505 looking toward 501 and the park. Please note the native beach existing prior to start of work. Also note the eelgrass and sea lettuce wrack on the

Photograph submitted with 501 First St permit applications. Note proposed rip rap replacement results in more exposed sand (beach)

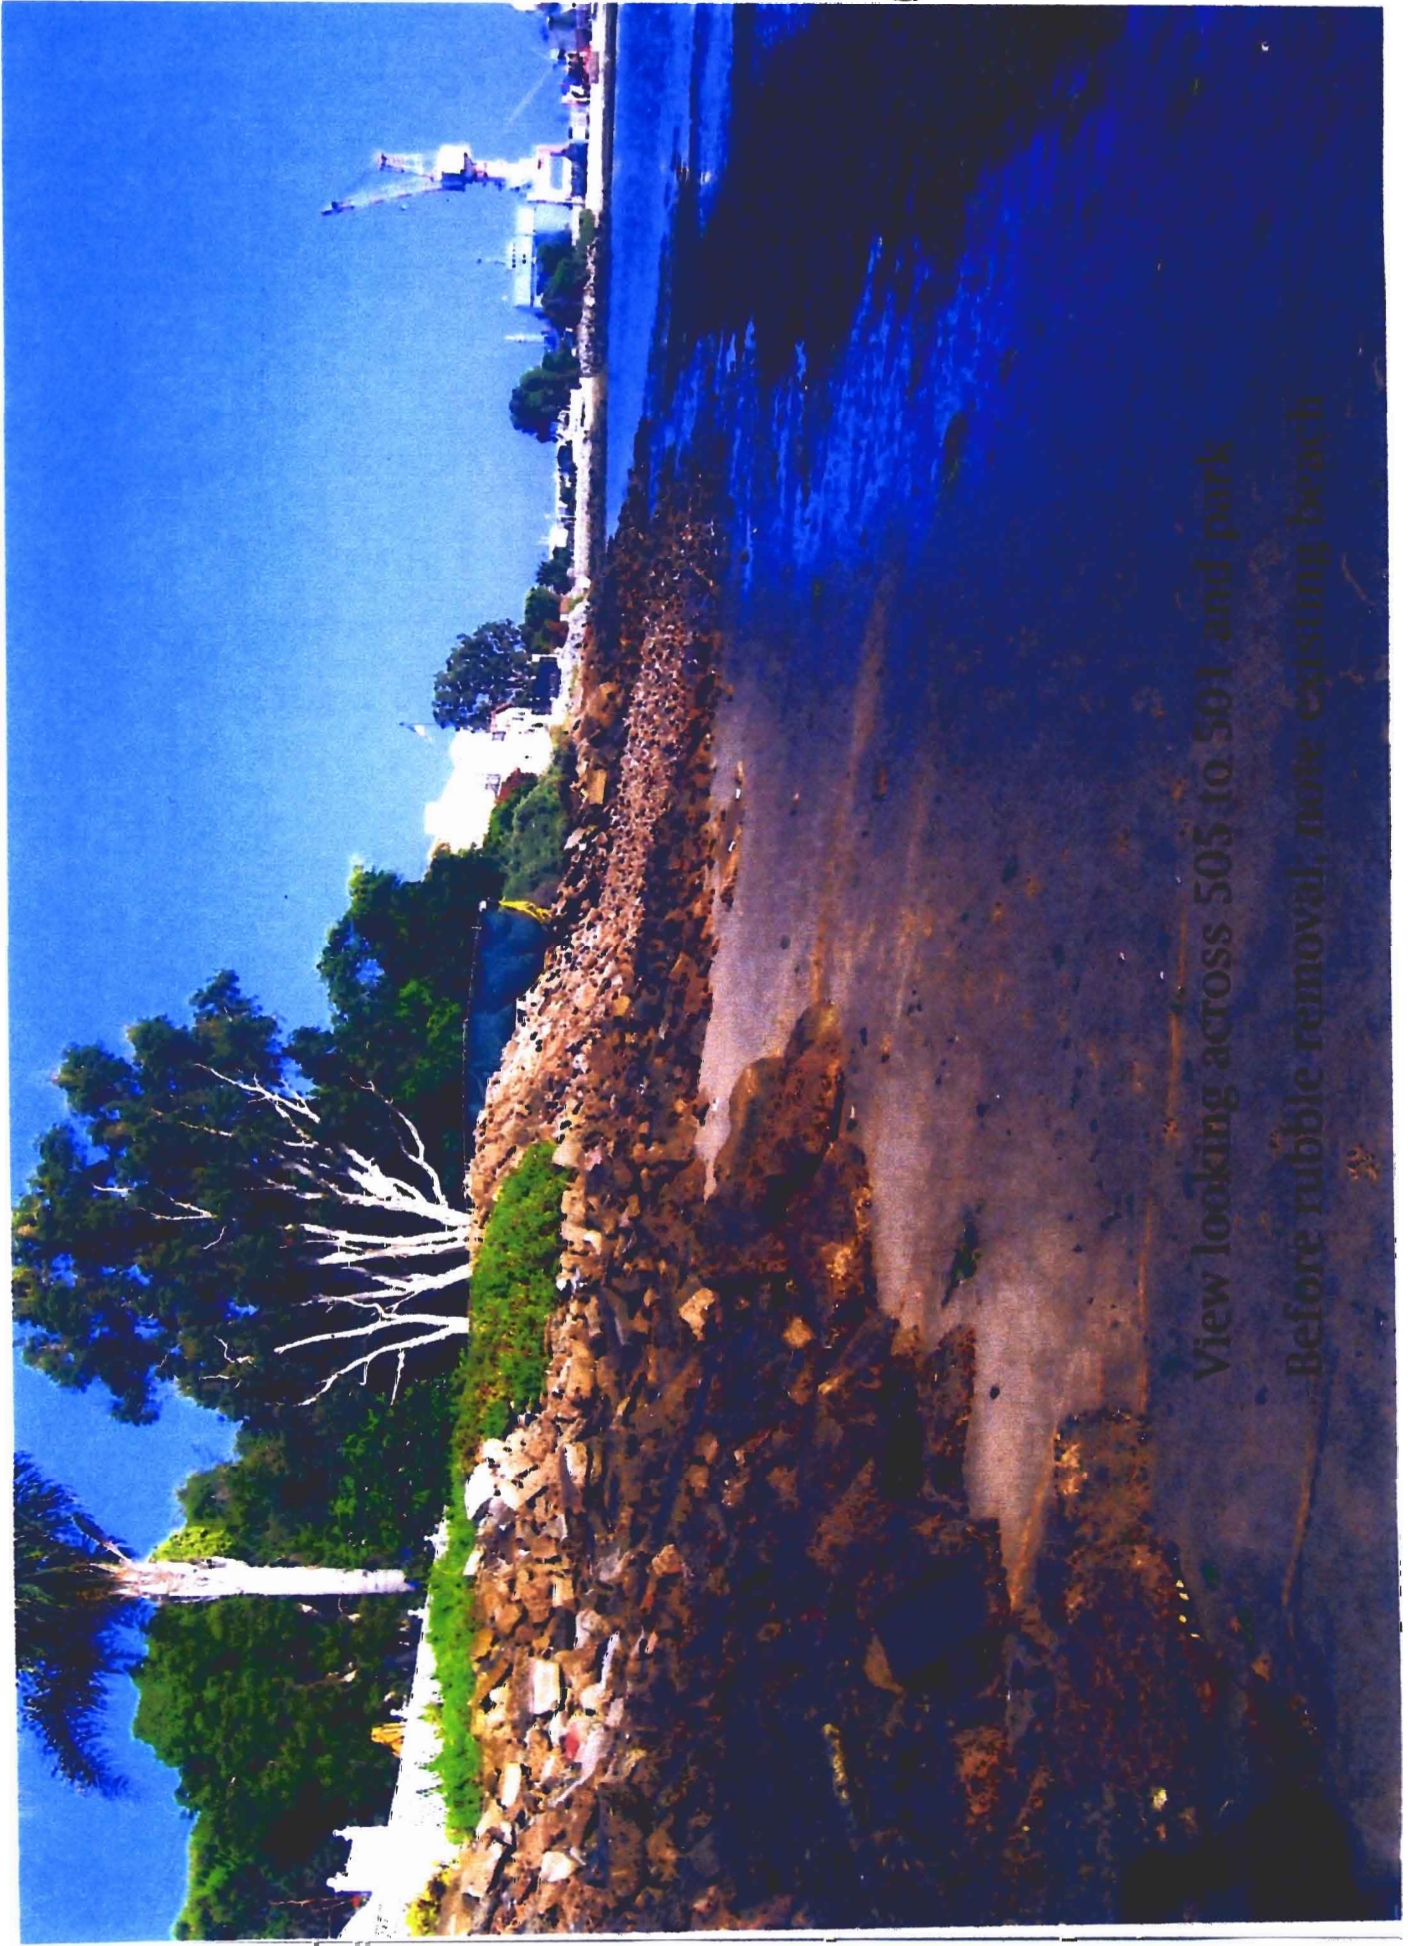
501 First St.

View looking across 505 to 501 and park
Before rubble removal, now existing beach

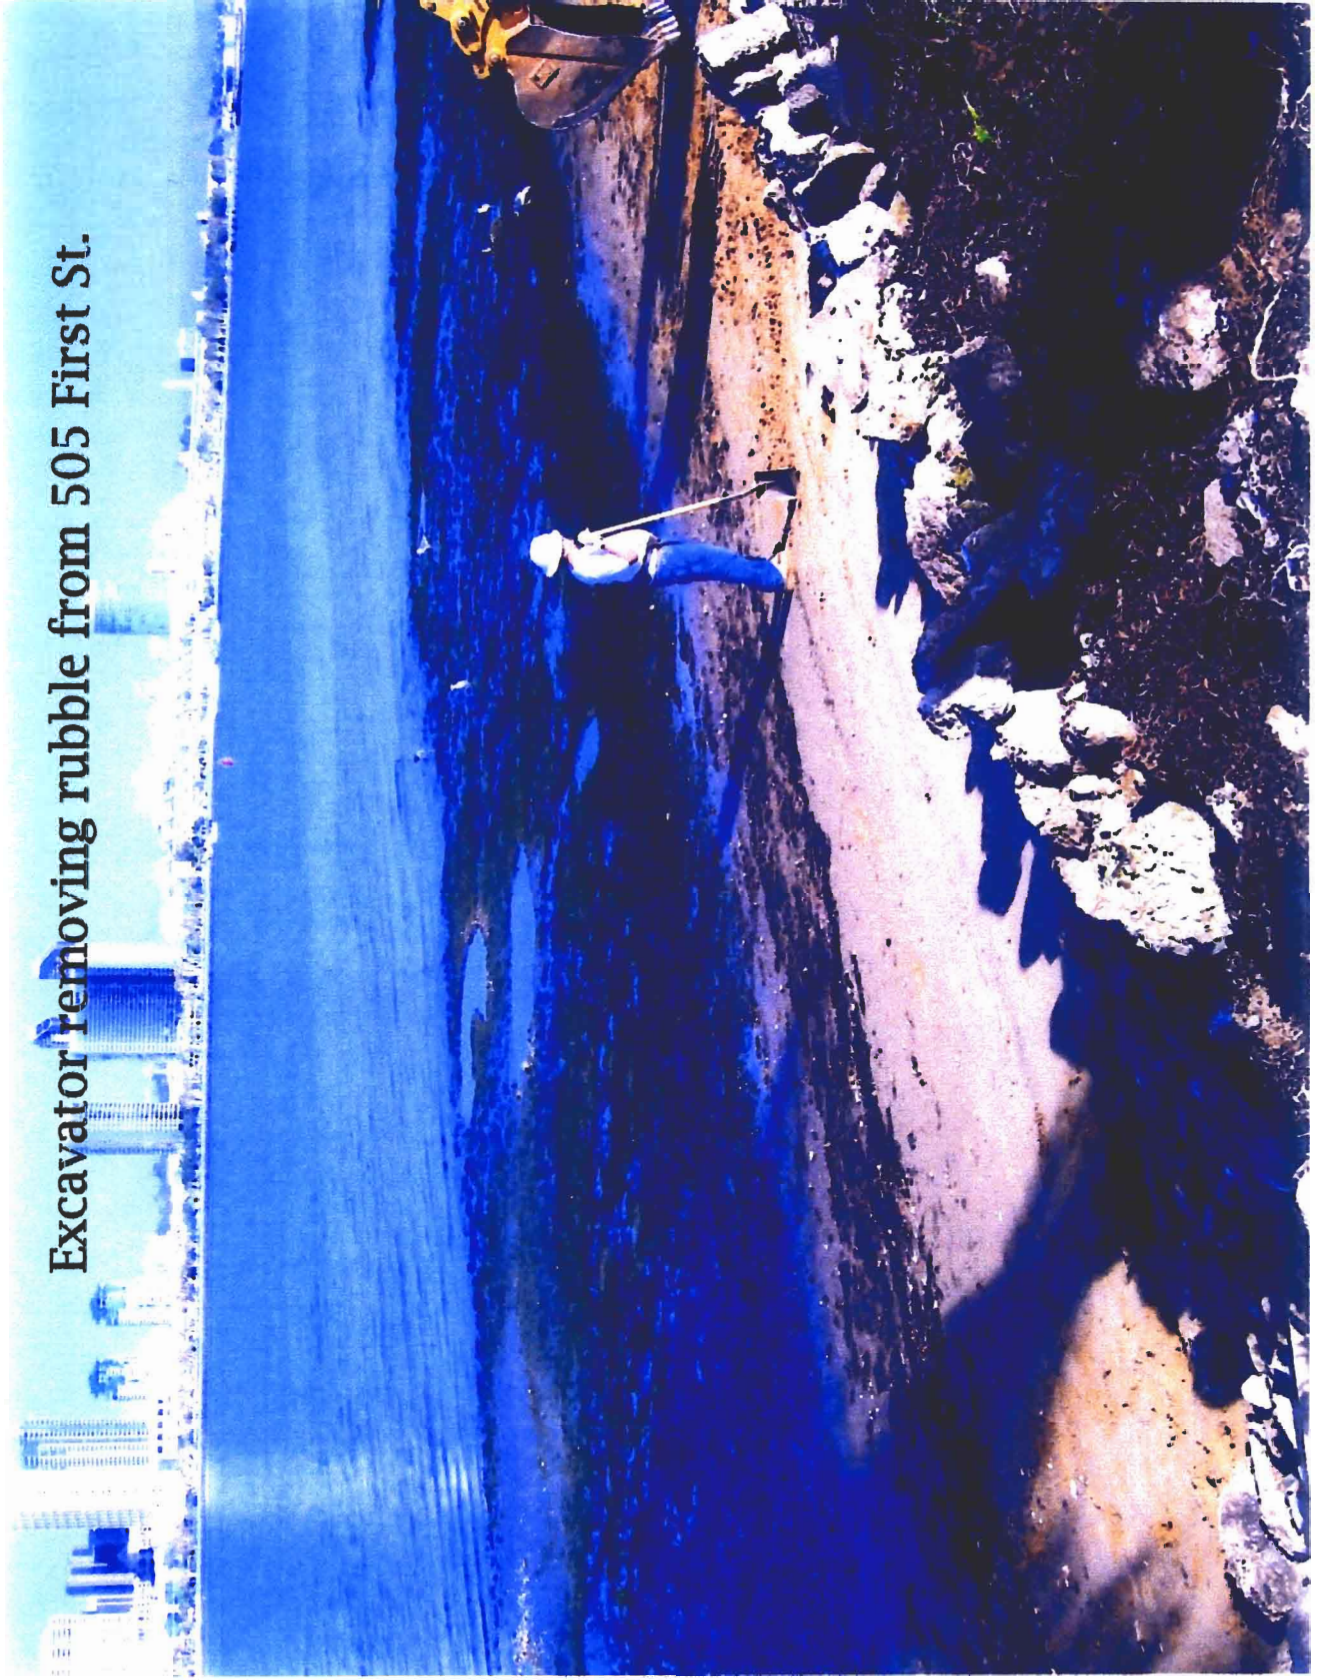
The second photograph shows the excavator operating the first day. Note the entire work area is dry and the excavator can lift the rubble with minimal disturbance of the underlying material. We installed a yellow tape barrier to make delineate the limits of where the worker could walk on the shore. The third and fourth photographs show this barrier along with the cover we placed over the work site at the conclusion of each work day to prevent any stormwater runoff. In addition straw waddle was placed around the project and a brow ditch constructed to ensure no water run-off. Mr. Robert Smith, of the Port of San Diego, regularly inspected the work progress. Mr. Smith was pleased with our efforts to protect the bay during the work.

Excavator removing rubble from 505 First St.

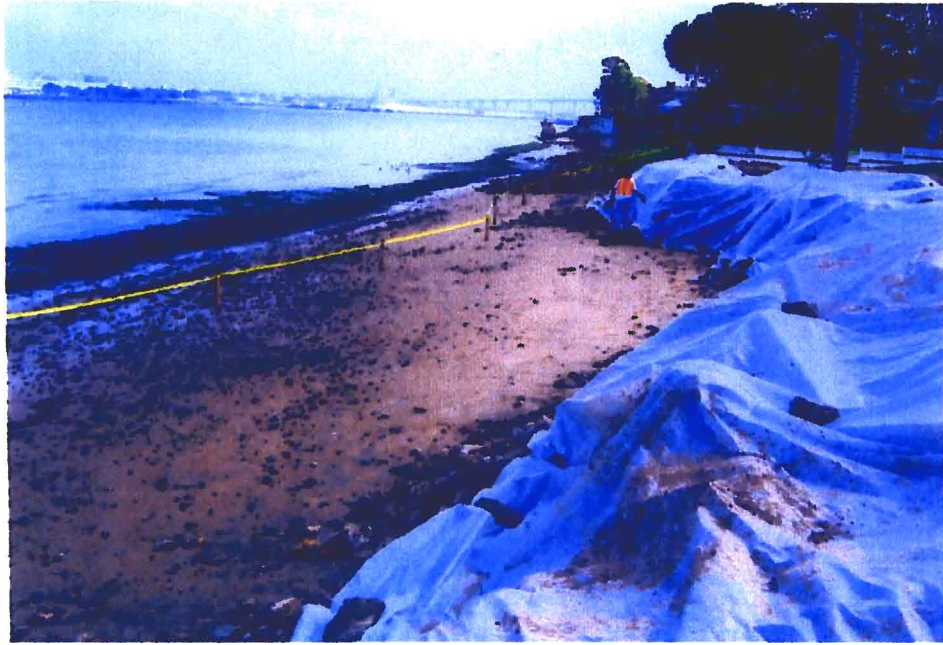
Shows end of day shore protection during rubble removal

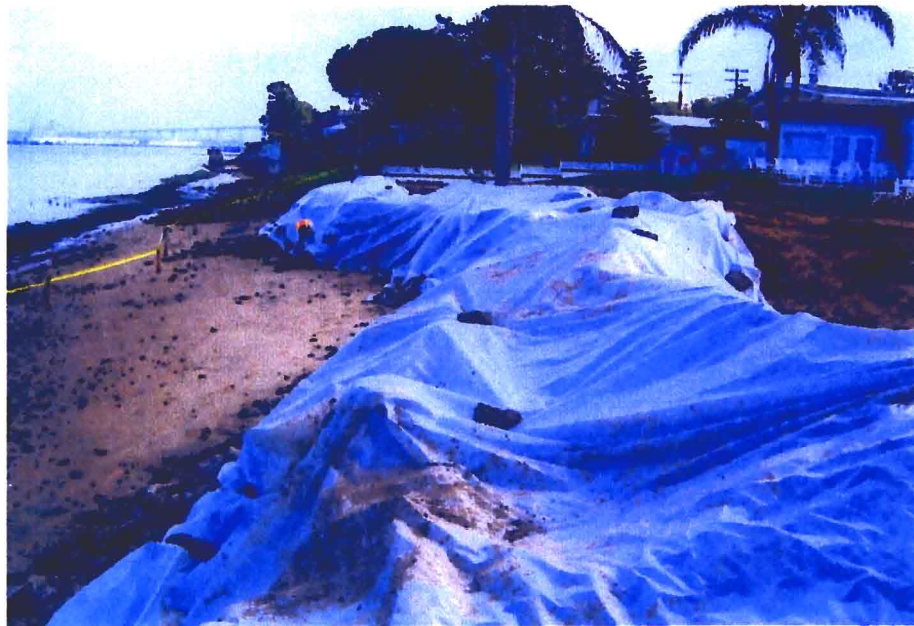
Yellow tape barrier used to prevent entry to eelgrass bed

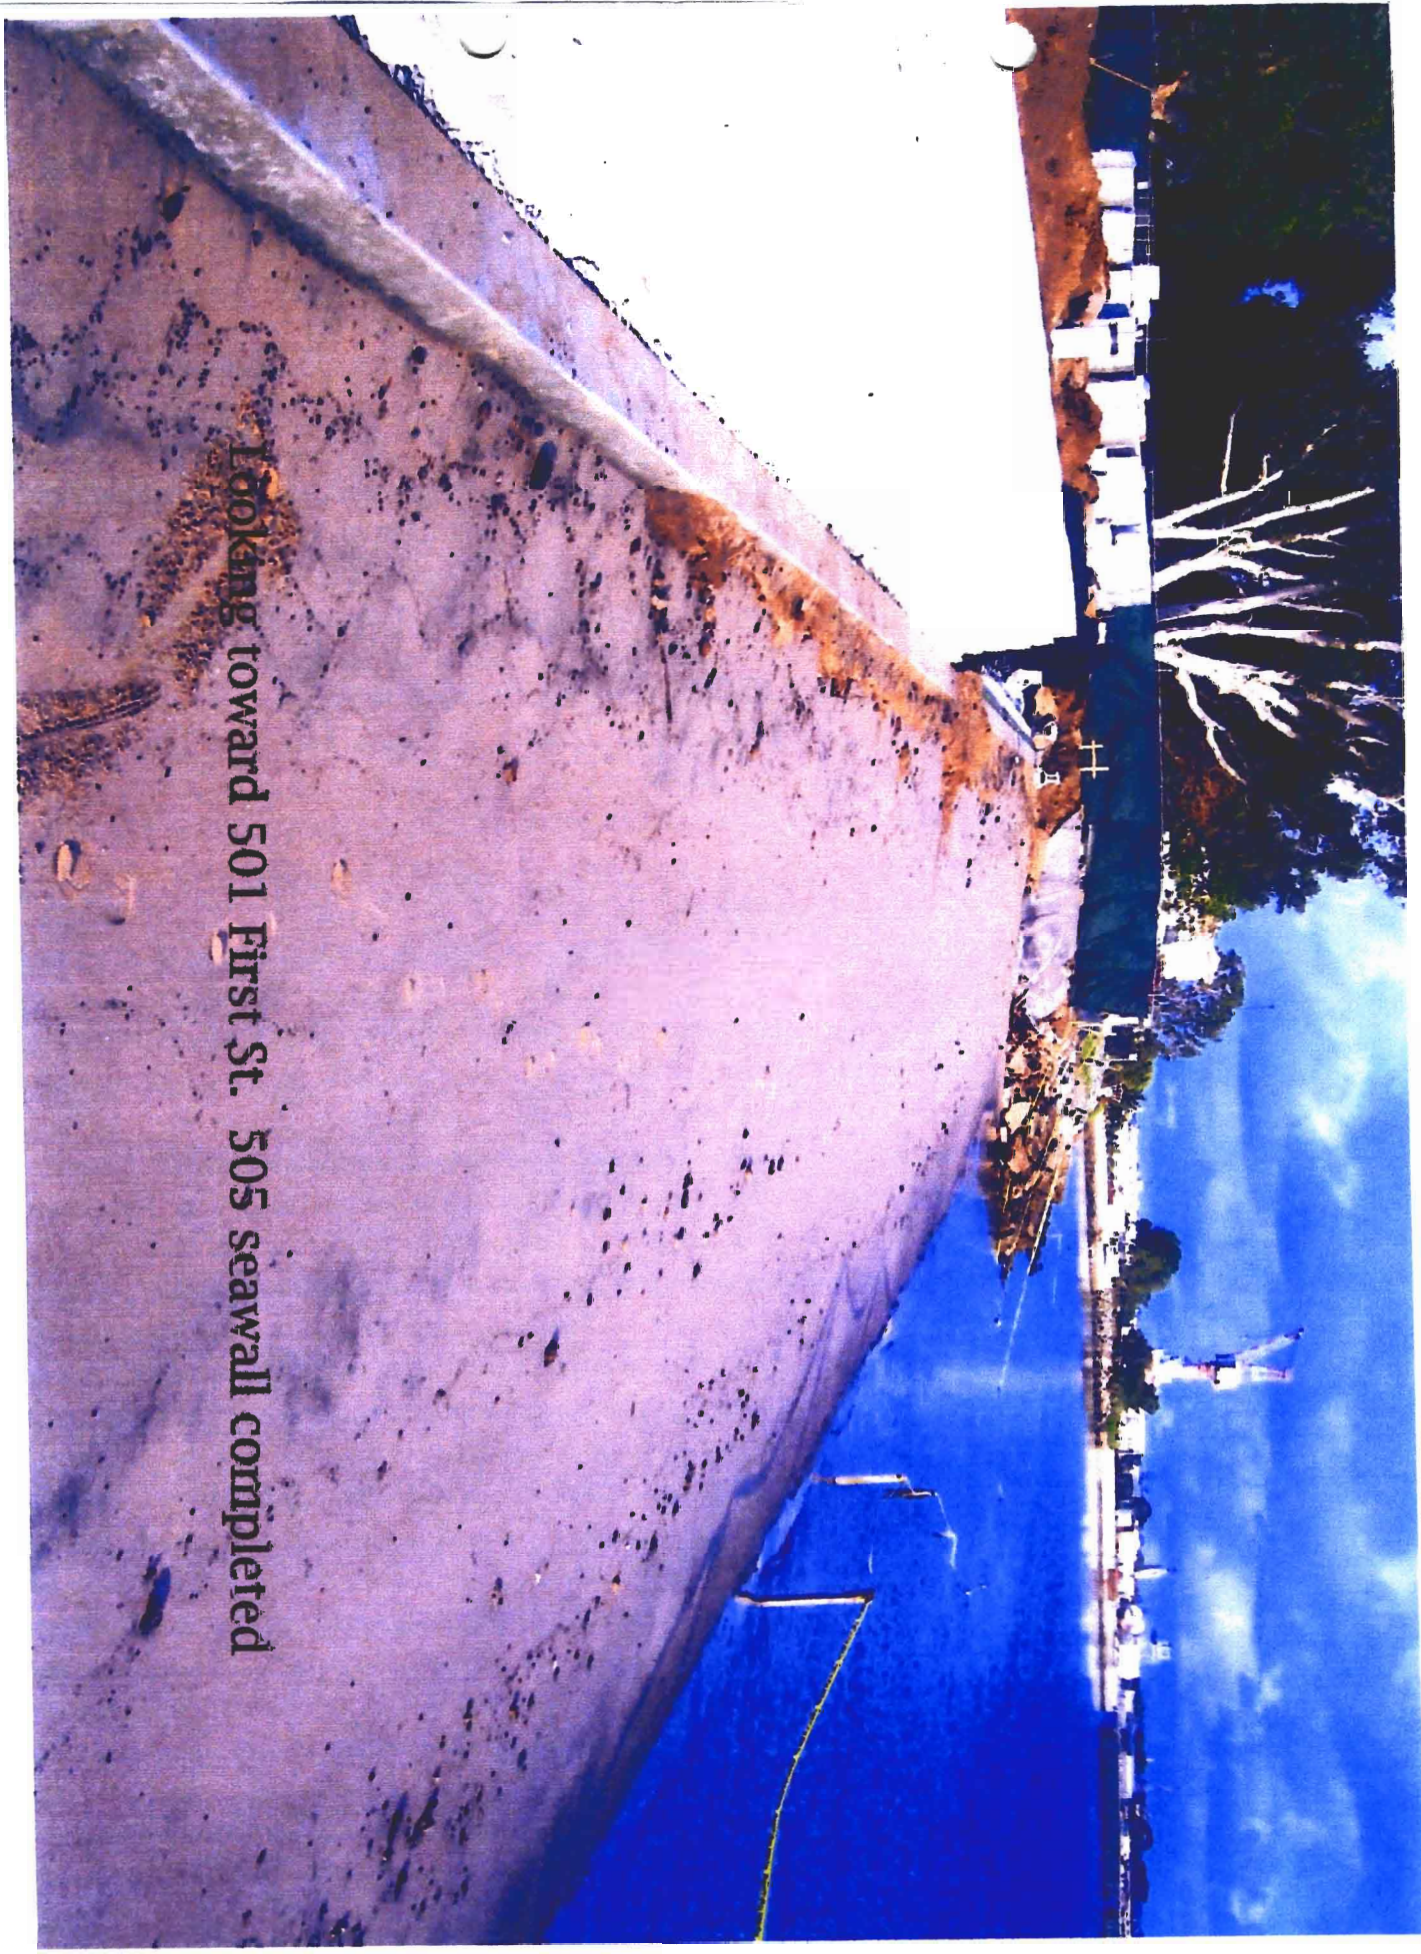
The last picture shows the area after completion of the 505 seawall. Please note the beach from 505 through 501 to the park is just a larger version of the native beach that existed throughout the rubble. I suspect the area is closer to the native state then it has been since before WWII.

Looking toward 501 First St. 505 seawall completed
