Judd Creek Monitoring Study Group
Draft Experimental Design
Phase 6 Monitor Fall / Winter 2008

RE: Examples of NTMP road upgrades

**North Coast Regional Water Quality Control Board
Timber Harvest Division
Active/Completion/NOT Inspection Checklist**

LAST RESORT-- NONINDUSTRIAL
TIMBER MANAGEMENT PLAN
S1/2, SE1/4; of the NW1/4 and
NE1/4 of the SW1/4
of Section 36
T43N, R1W., MDM
Scale 1 inch = 500 feet
Contour Int. 40 feet
Prepared from USGA Quadrangle 7.5"
Tennant, CA. 1988

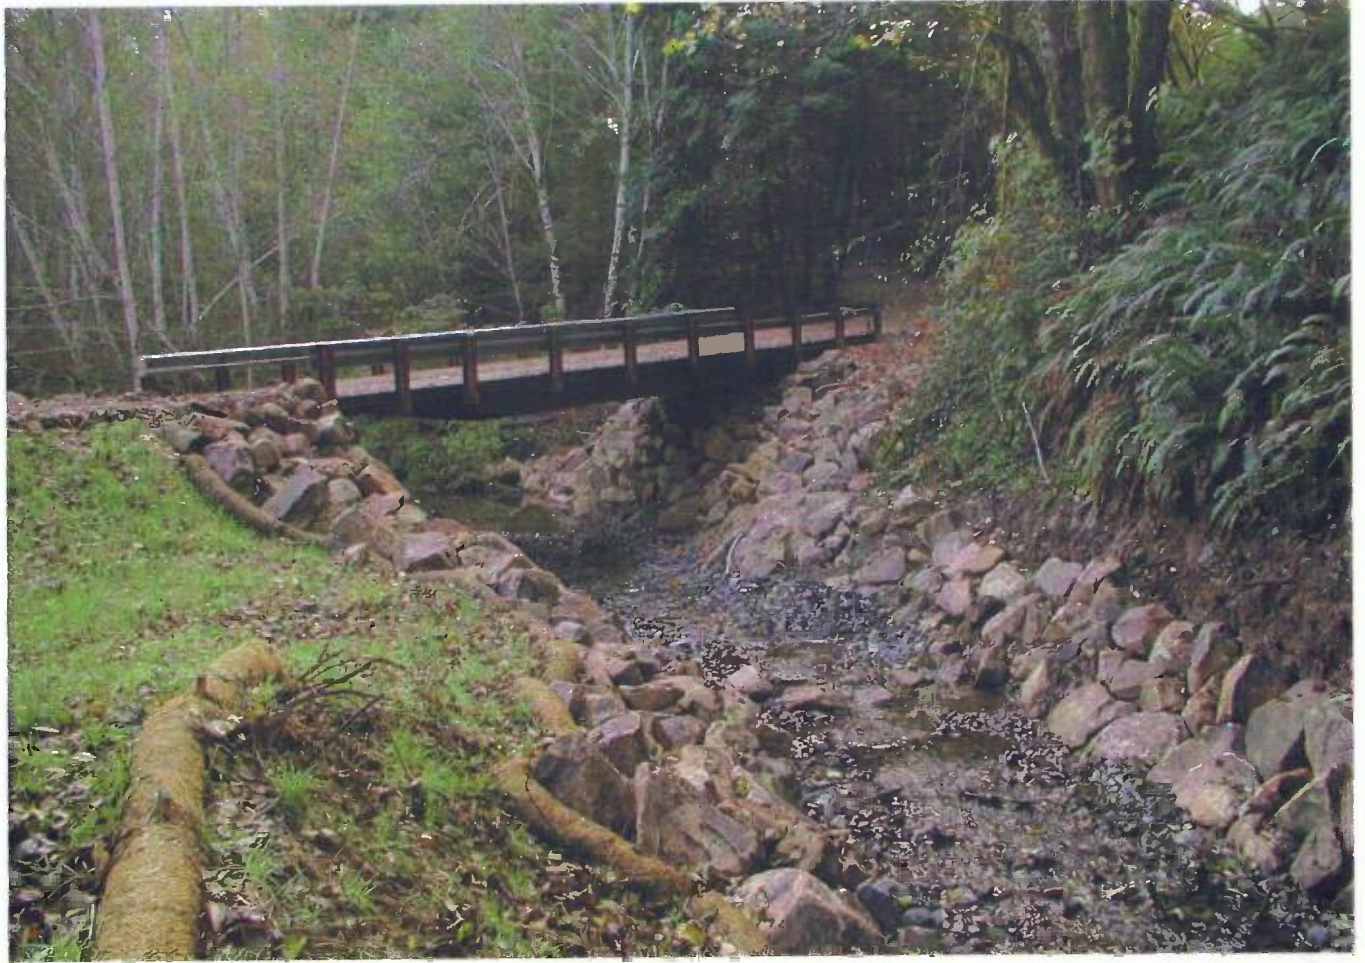
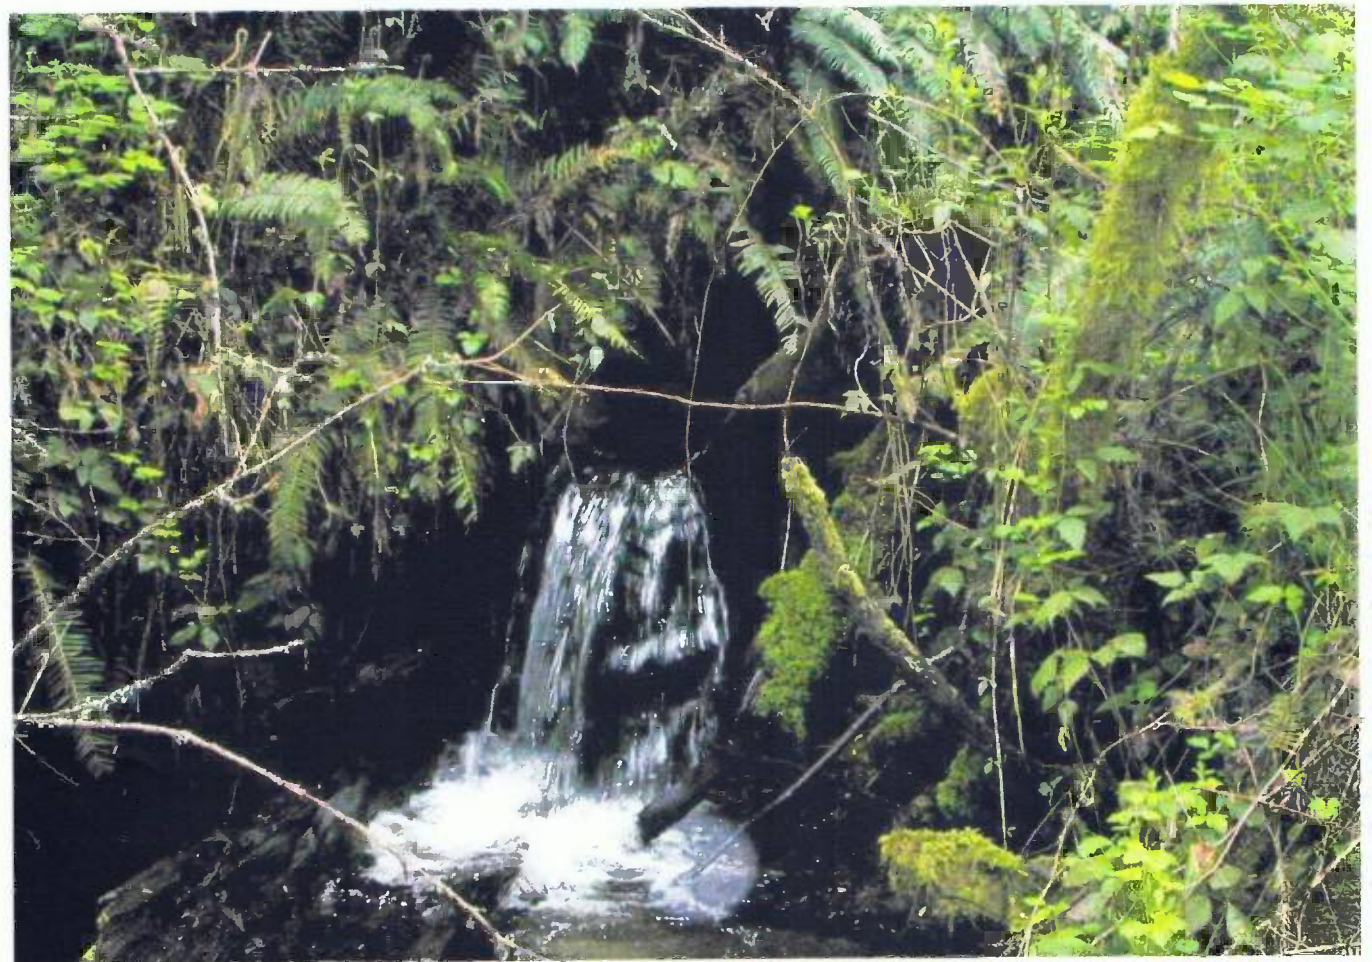
Enclosed are a few photo examples of recent and continuing road upgrades being routinely performed on NTMP 1-99NTMP-014HUM we talked about. In addition to the few crossings pictured, we have performed many other crossing upgrades, surface rocking and stabilization, hydrological disconnects and drainage improvements, armoring, etc. in the course of management over the years. Well before it was required to identify and correct deliverable sediment sources to area watercourses, we have been doing so on a voluntary basis. I know this NTMP is not unique in this regard, as other RPF land managers have also performed similar work on the properties they manage. As you know, road work is expensive and given the log market conditions of the past few years, it is a difficult proposition to impose additional costs onto landowners. I hope CLFA is successful in their efforts to present this case to WQ that yet another layer of regulatory burdens is unnecessary and present unreasonable costs to landowners. Hope this helps.
