- Describes MCR monitoring conducted from 2001 through 2004,
- Summarizes and analyzes the MCR monitoring results, and
- Makes findings and recommendations based on those results.

The purpose of the MCR project has been to determine the adequacy of both implementation and effectiveness of the Forest Practice Rules (FPRs) that are used to protect water quality and riparian/aquatic habitat.

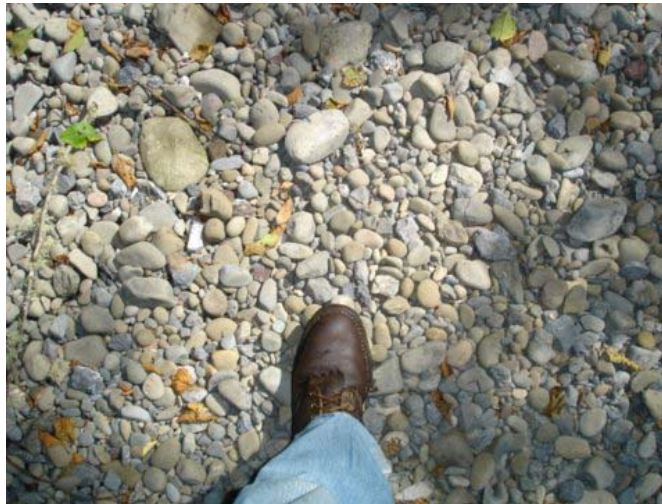
Figure 2. Substrate of a watercourse or stream in a forested watershed on the California coast. Reaches with clean gravel are an important habitat component of many forested streams. A key objective of the water quality related FPRs is to prevent transport of excessive fine sediment (e.g., sand and silt) to watercourse channels.

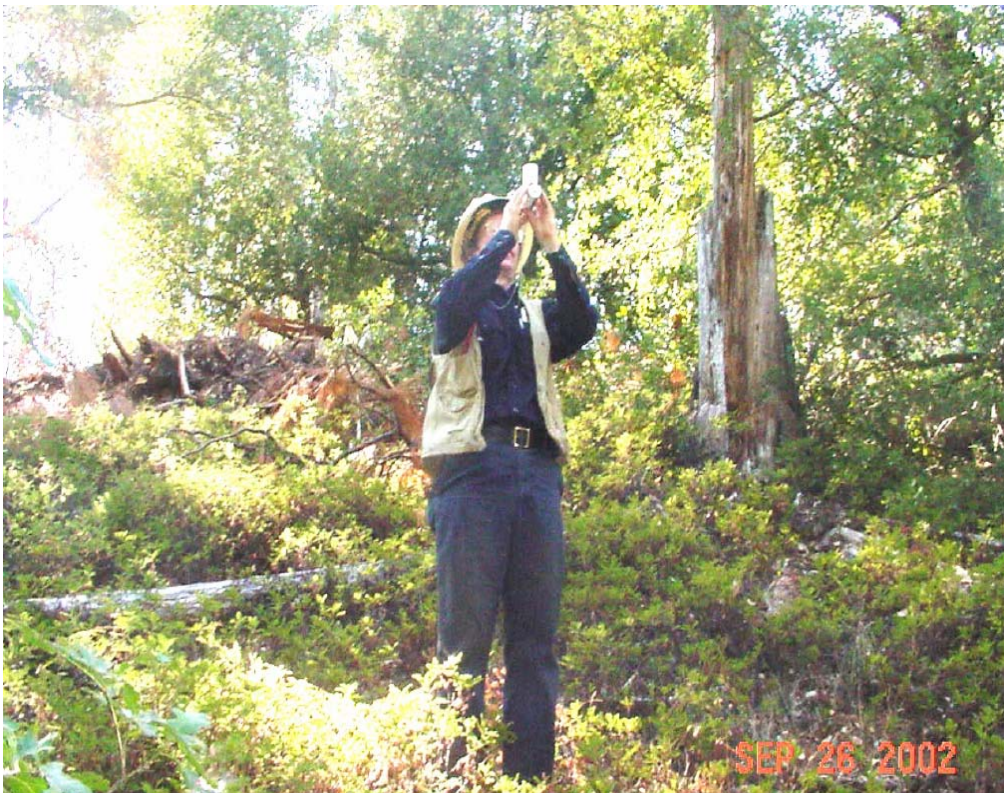
Figure 8. Pete Cafferata, CDF, making canopy cover measurements using a sighting tube.

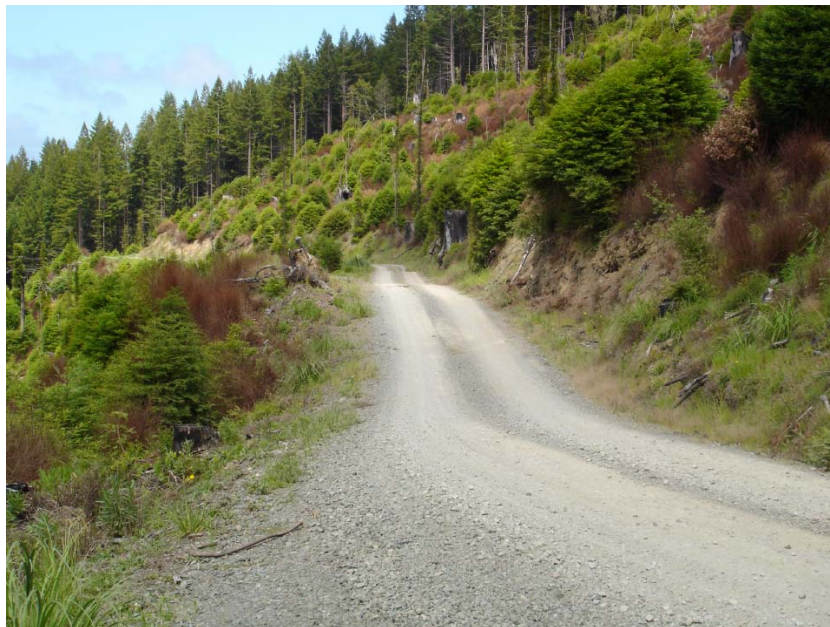
Figure 19. Example of road segment built to drain properly in wet weather. Note the two functional dips and their spacing.

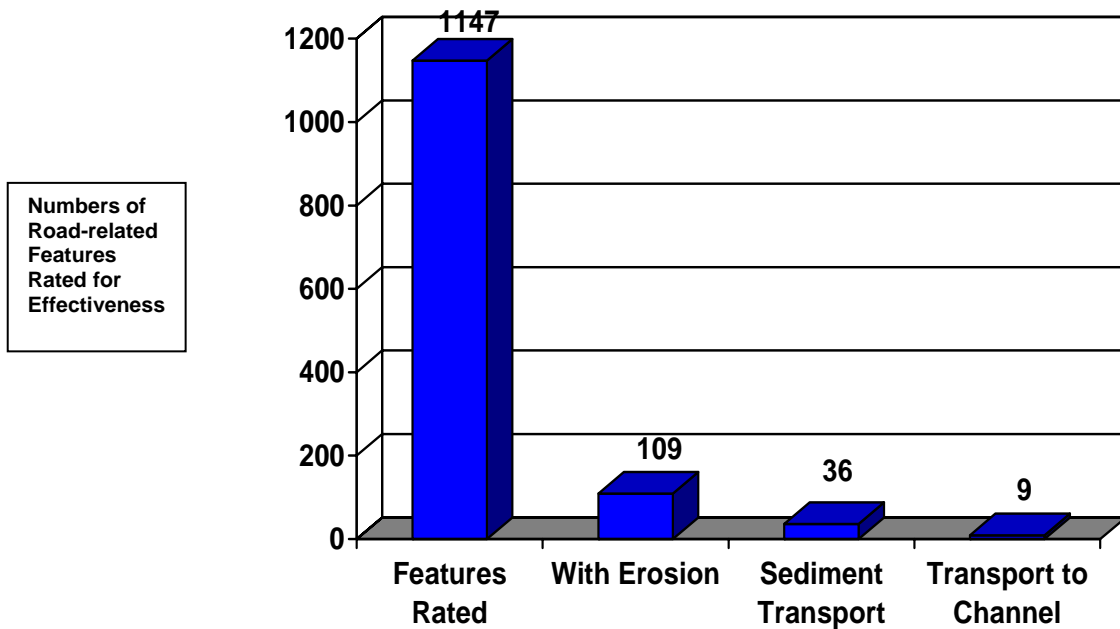
Figure 21. Road-related features rated for effectiveness, comparing the total features rated to the number with evidence of erosion, sediment transport and transport to channel.

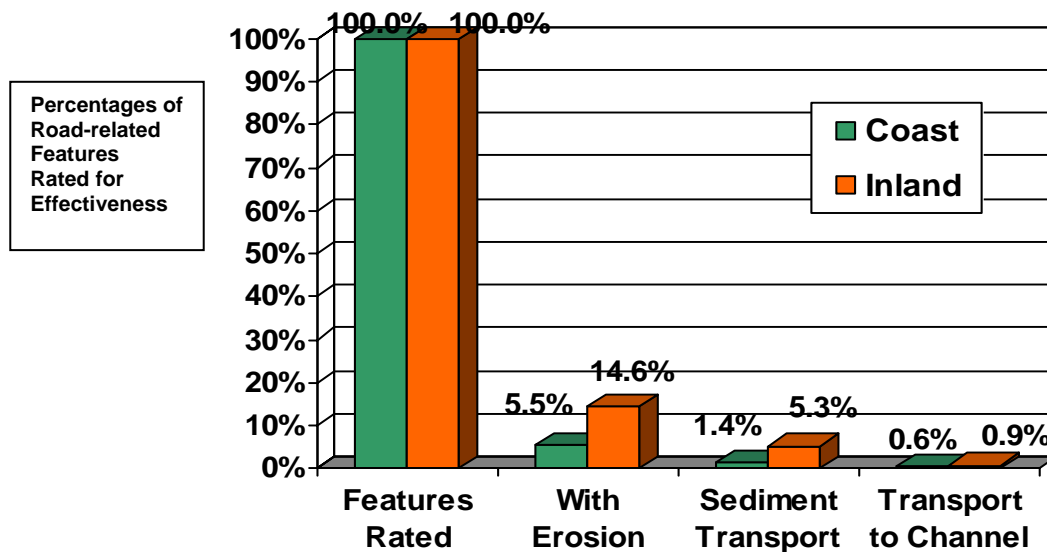
Figure 24. Coast vs. Inland road-related features rated for effectiveness as percentages, comparing the total features rated to the percentage of features with evidence of erosion, sediment transport and transport to channel.

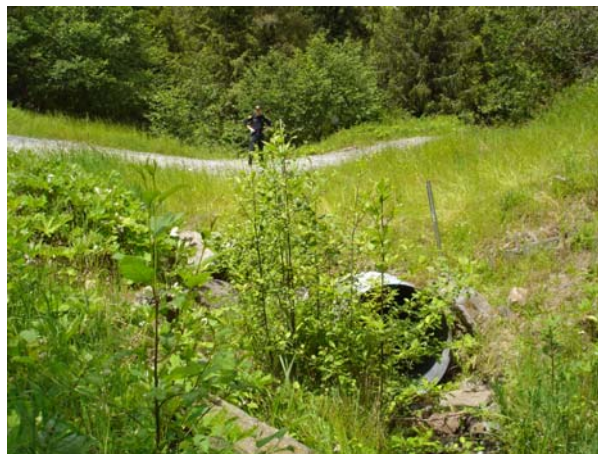
Figure 36. John Munn, CDF, at a culverted watercourse crossing in a forested watershed on the North Coast of California without diversion potential. Munn is standing in the critical dip.

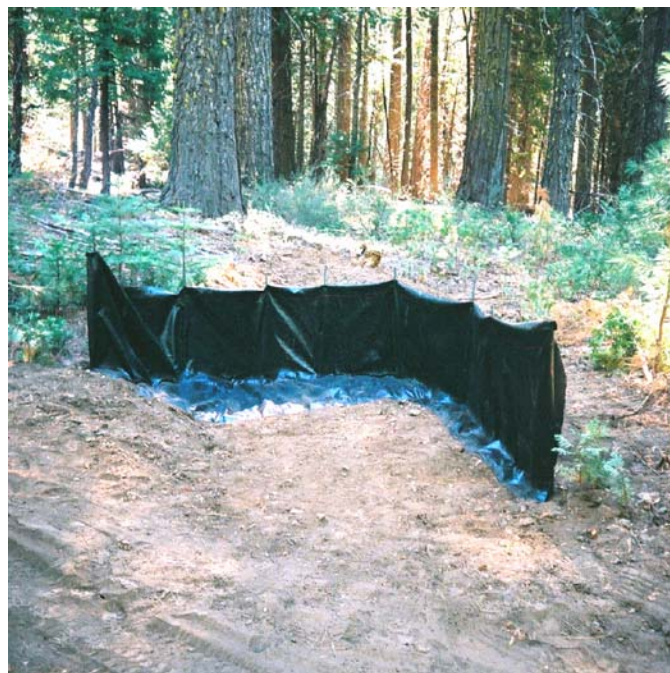
Figure 1. Example of one of 147 sediment fences installed to measure sediment production rates in the central Sierra Nevada Mountains (photo by Drew Coe used with permission).

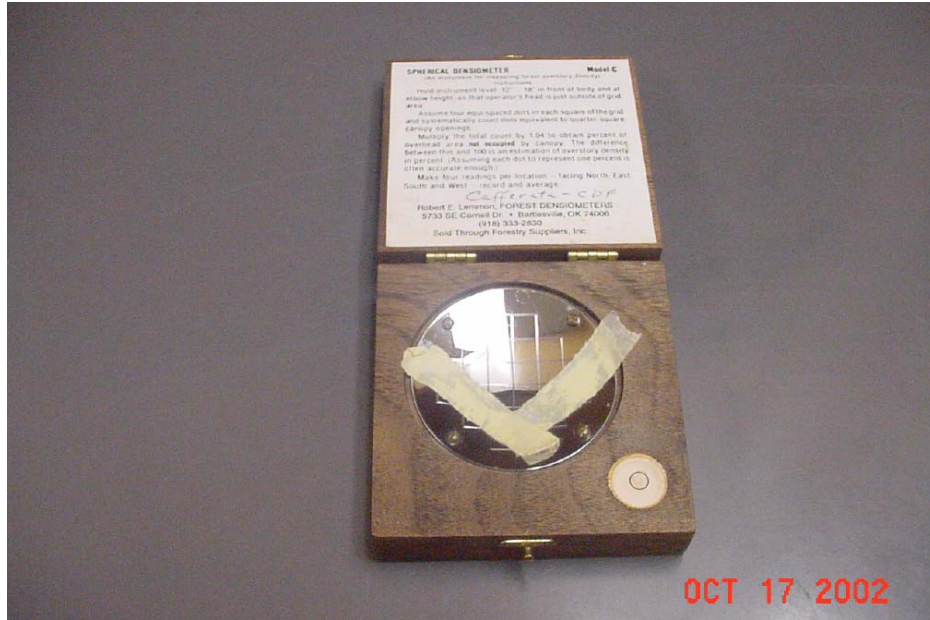
Figure 5. Concave spherical densiometer used for canopy measurements from 1996 to 1998 (the Strickler (1959) modification was utilized in 1997 and 1998 to reduce bias).

From 1999 to 2001, the canopy sampling method for Class I and II watercourses was changed from use of the spherical densiometer (Figure 5) to use of the sighting tube (Figures 6 and 7). This change was based on findings from a recent study that the sighting tube provides unbiased estimates of true canopy cover, while the densiometer does not (Robards et al. 2000). The procedure for estimating canopy was as follows:

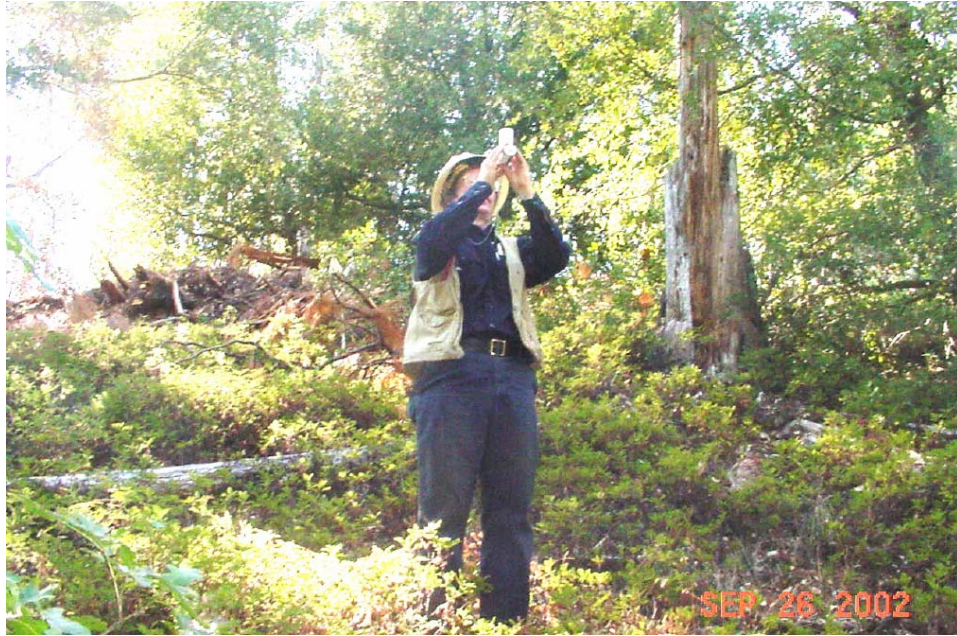
Figure 7. The sighting tube in use in the field. This instrument was utilized for obtaining an unbiased estimate of canopy cover from 1999 through 2001.

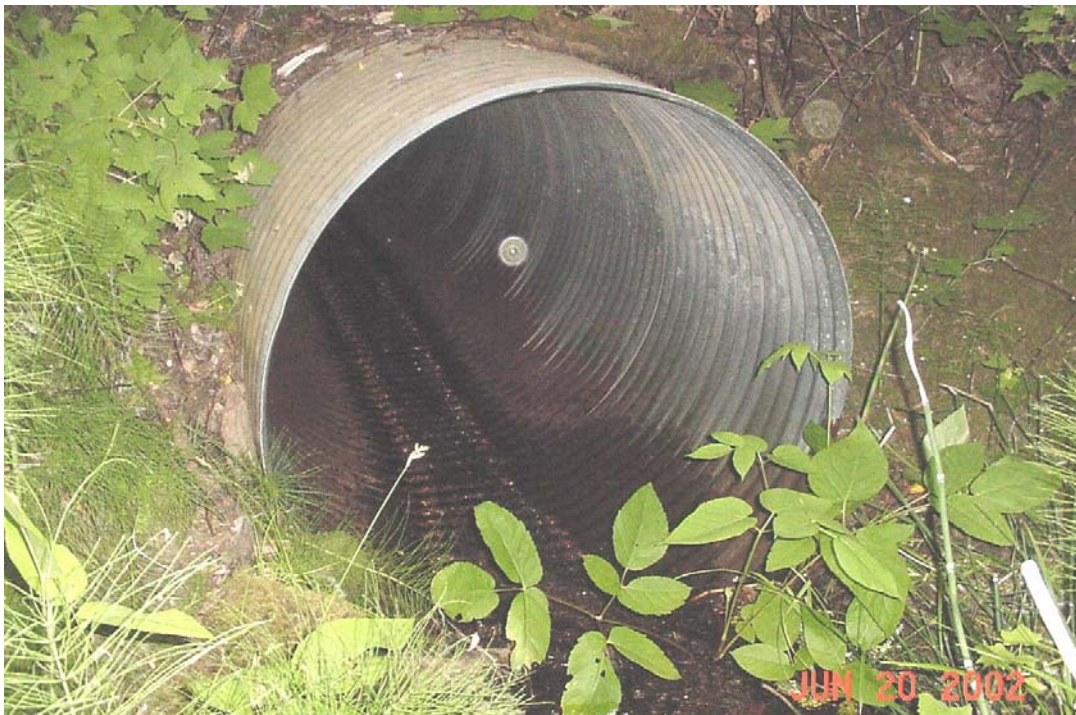
Figure 14. Typical watercourse crossing sampled in the Hillslope Monitoring Program. This culvert was a crossing included in the sample for the 2002 field season.

A total of 491 watercourse crossings were evaluated from 1996 through 2001. Approximately 68 percent of these crossings had existing culverts (Figure 14), 12 percent were abandoned or removed road crossings, nine percent were fords, six percent were skid trail crossings, and two percent had bridges (Figure 15). The distribution of culvert sizes is displayed in Figure 16. The majority of pipe sizes are relatively small, reflecting the sampling criteria that favored choosing crossings located along road transects, which were often located above the break in slope near ridgelines. Approximately 64 percent of the crossings were existing road-related structures built prior to the beginning of the current plan; 18 percent were new road features; 12 percent were abandoned or removed crossings for roads; and six percent were removed, existing ford, or new skid trail crossings. Seventy-three percent of the crossings were associated with seasonal roads, 16 percent with permanent roads, four percent with temporary roads, six percent with skid trails, and less than one percent with abandoned roads. Forty-seven percent of the crossings were located in Class III watercourses, 46 percent in Class II drainages, six percent in Class I's, and less than one percent in Class IV watercourses.

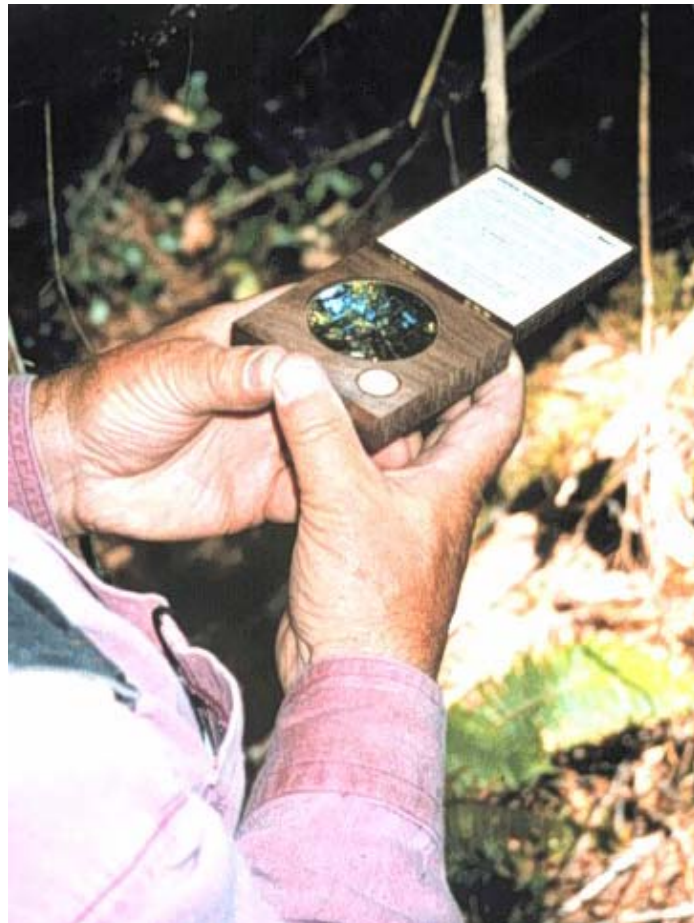
Figure 18. Measuring canopy cover with the spherical densiometer in western Mendocino County in 1996.

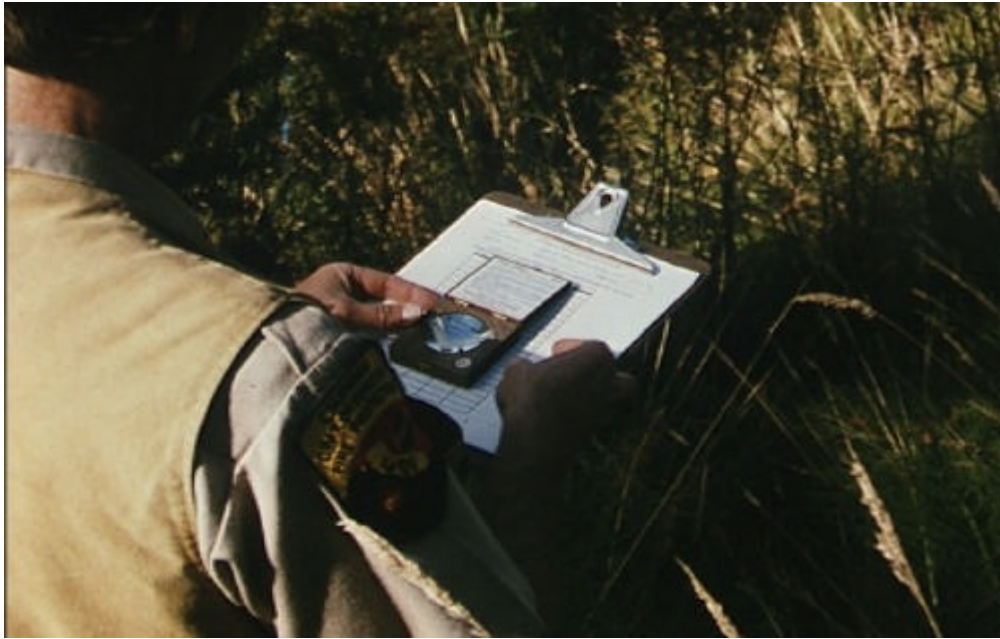
Figure 2. Concave spherical densiometer with the Strickler (1959) modification.

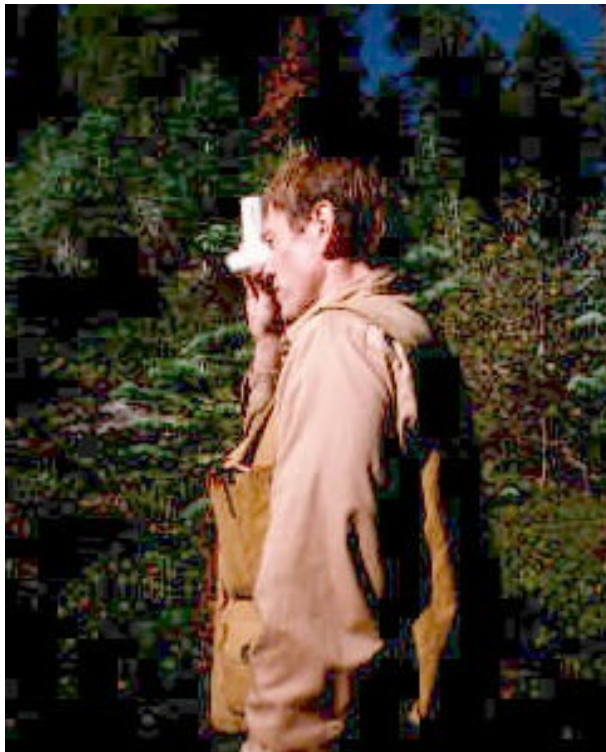
Figure 3. Sighting tube use for unbiased estimate of canopy cover.

Groundcover is estimated in an area with a diameter of approximately one foot located directly in front of the observer's boot toe, where adequate cover is defined as "living plants, stumps, slash, litter, humus, and surface gravel (minimum diameter of 3/4 inch) in amounts sufficient to break the impact of raindrops and serve as a filter media for overland flow." To date, canopy cover has been measured using a spherical densiometer (Figure 2). However, future measurements will be made using sighting tube transects with randomly located starting points to reduce the potential for bias resulting from overstory conditions in areas adjoining the measurement site (Robards et al. 1999) (Figure 3).
