**California Regional Water Quality Control Board
Central Coast Region**

**Total Maximum Daily Loads for Fecal
Coliform in the Pajaro River Watershed
Including, Pajaro River, San Benito River,
Llagas Creek, Tequisquita Slough, San Juan
Creek, Carnadero/Uvas Creek, Bird Creek,
Pescadero Creek, Tres Pinos Creek, Furlong
(Jones) Creek, Santa Ana Creek, and
Pachecho Creek, in Santa Cruz, Santa Clara,
San Benito, and Monterey Counties,
California**

Phase-5: Regulatory Action Selection

**Final TMDL Project Report
March 2009**

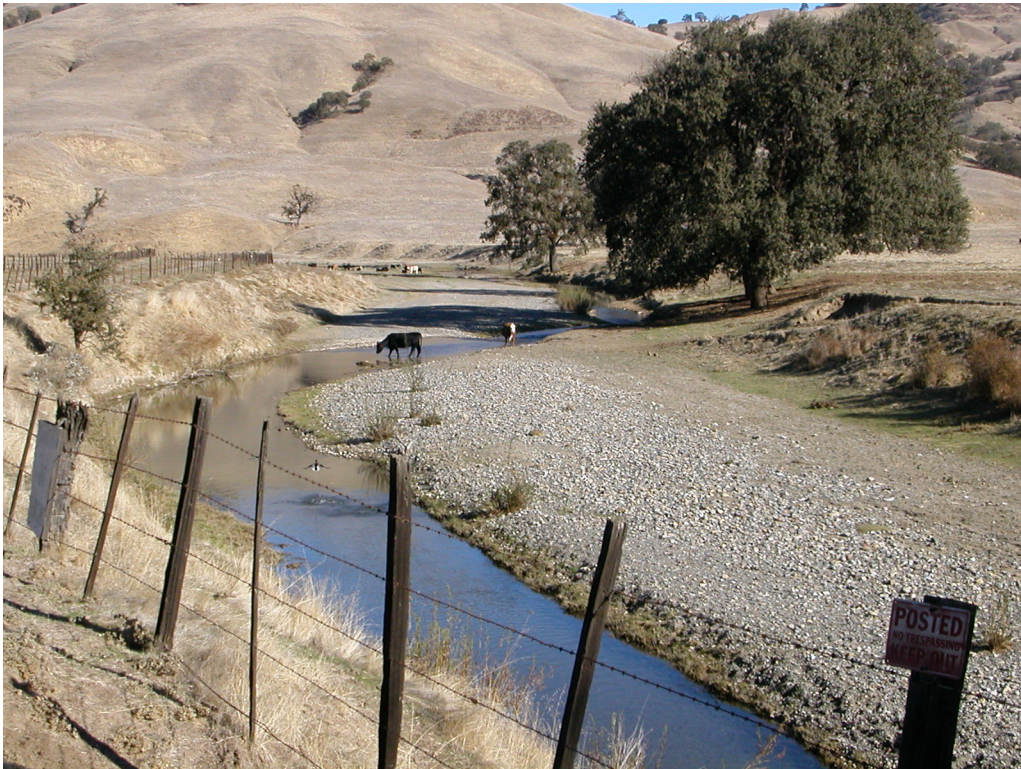
Figure 5-1. Cattle within San Benito River upstream of monitoring station 305SBA. (Water Board staff photograph, Nov. 6, 2006)

FIB sources from open spaces that are grazed, in part, originate from cattle feces entering the water body. Staff observed cattle within the San Benito River and cattle grazing adjacent to San Benito River, Pajaro River, Tequisquita Slough, and most tributary streams (e.g. Pachecho Creek, Tres Pinos Creek, San Juan Creek, and Uvas Creek). *E. coli* values up to 61,000 MPN/100 ml were recorded at monitoring station 305SBA, where staff observed cattle in San Benito River (Figure 5-1). Staff acknowledges the possibility that FIB levels at monitoring site 305SBA may be from natural sources, such as wild pig or other wildlife, however staff noted the presence of cattle in the river during most monitoring events. In addition, the California Food Emergency Response Team (CalFERT) investigation identified *E. coli* O157:H7 in the San Benito River and Pajaro River,

Staff concluded that cattle grazing lands are a source contributing to exceedances of water quality objectives. Actions to control these sources are included in Section 12 Implementation Plan.

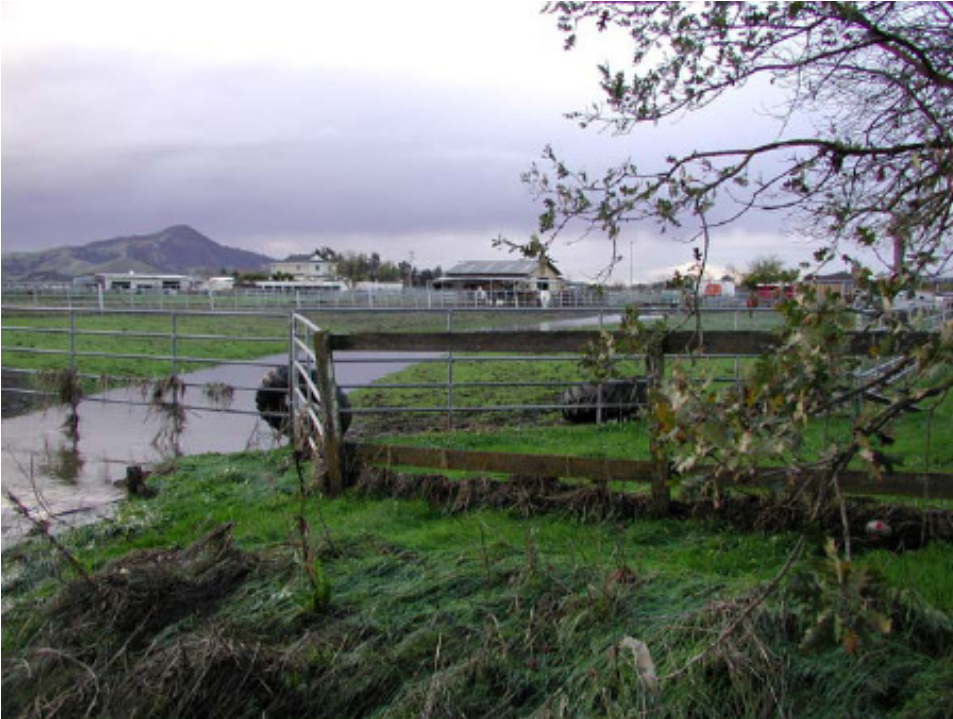
Figure 5-2. East Little Llagas Creek in rural residential pastures west of Llagas Avenue. (Fall Creek Engineering, Inc., 2004).

Staff observed many farm animal operations within the Pajaro River watershed. These operations (commonly referred to as “hobby farming” or “hobby ranching”) are located in rural residential areas where farm animals and livestock such as horses, cattle, chickens, goats, dogs, cats, and other farm animals are housed. These animals may contribute FIB if manure is not properly managed (e.g., retained on site) or if farm animals have access to waterways. Staff observed farm animals in rural areas that are adjacent to impaired reaches and tributary streams throughout most non-urban portions the Pajaro River watershed. *E. coli* values up to 130,000 MPN/100 ml were recorded at monitoring station 305SJM, where staff observed cattle and horses on rural residential properties next to San Juan Creek.

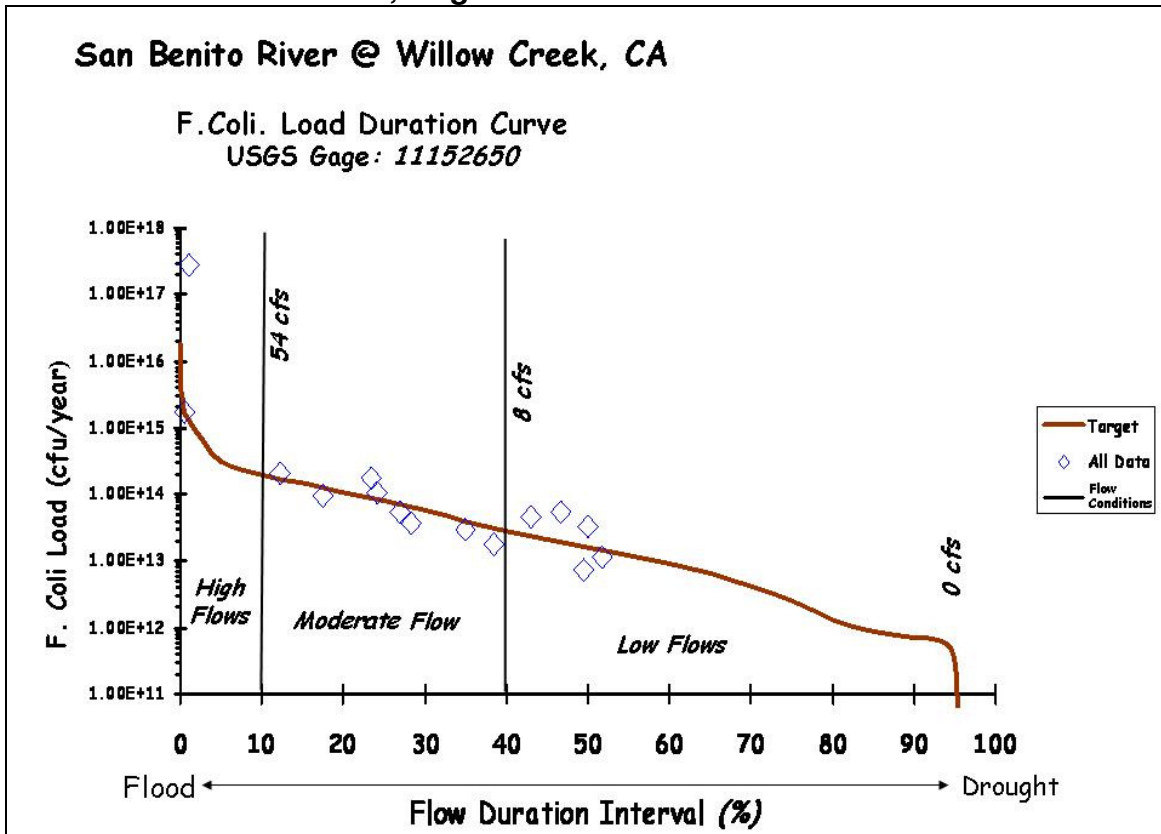
Figure A.4-2: Load Duration Curve, Gage 11152650

To assist in determining potential sources of fecal coliform to the San Benito River in subwatershed BRI_22, a load duration curve analysis (see Cleland, 2002) was developed for USGS gage 111565000 on the San Benito River at Willow Creek. A load duration curve considers how flow conditions relate to a variety of pollutant sources (point and nonpoint sources). It is a method of water quality analysis and display that shows the assimilative or allowable loading capacity, across the entire spectrum of flow conditions. The allowable load plotted as a curve on the graph, is calculated simply as the water quality objective (400 MPN/100mL) multiplied by the flow taking into account unit conversion factors. Monitoring data, plotted as observed loads, which plot above the curve represent exceedances of the allowable load. It is important to note that the fecal coliform loads along the vertical axis are plotted on a logarithmic scale.

The load duration curve indicates that exceedances of the fecal coliform water quality objective are observed during wet and dry weather events. Note that data points above the curve on the left side of the figure are indicative of fecal coliform exceedances during wet weather conditions (higher flows) and data points above the curve to the right side indicate fecal coliform exceedances during dry weather conditions (lower flows). These low flow exceedances indicate that sources of fecal coliform are most likely not related to precipitation events (i.e., runoff). Given the low density of human population in the watershed, the lack of permitted point sources of fecal coliform, the absence of sanitary sewer collection systems, and the low density of septic systems, the most likely source of fecal coliform exceedances during dry weather is via in-stream deposition from wildlife and livestock.

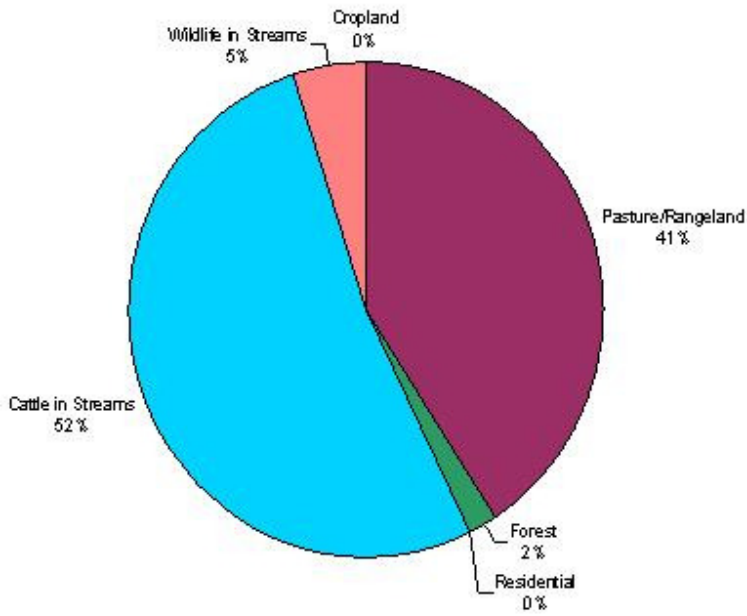
BRI_22 Seasonal Fecal Coliform Load, Dec. 1 to May 31

BRI_22 Seasonal Load, June 1 to Nov. 30

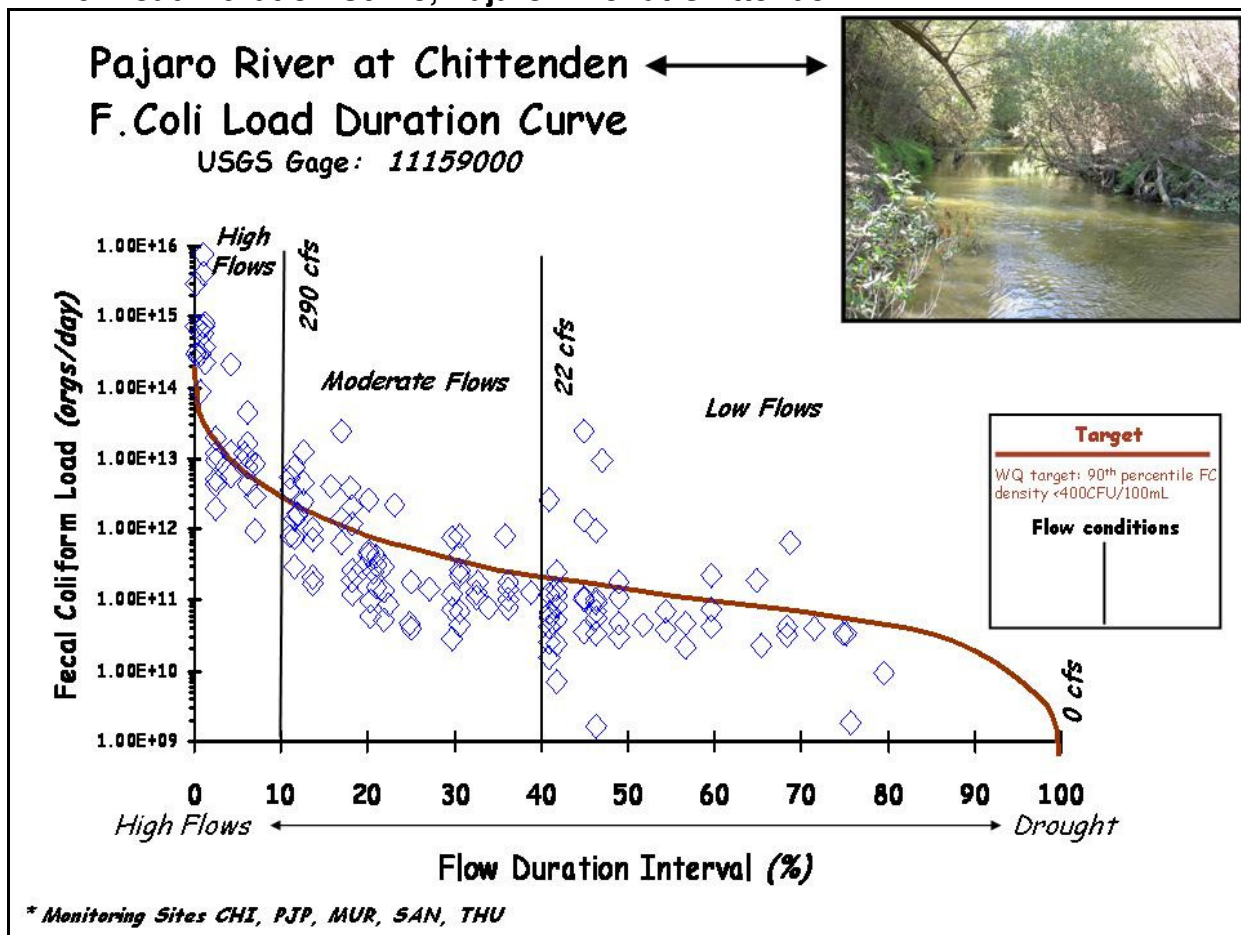
Figure A.4-6: Load Duration Curve, Pajaro River at Chittenden

The aforementioned stream gage at Llagas creek has a limited flow record, rendering it largely inappropriate for load duration analysis. A load duration curve was developed for the USGS gage station at Chittenden on the Pajaro River, to evaluate the range of water quality responses over the entire spectrum of flow conditions (Figure A.4-6). This stream gage is located approximately 13 miles downstream from the City of Gilroy. Monitoring sites that are proximal to the USGS stream gage at Chittenden were used to plot observed loads. It is assumed that resuspension of bacterial regrowths from sediment substrates will be prevalent during high flows and turbulent conditions.

The load duration curve indicates that exceedances of the fecal coliform water quality objective are observed during wet and dry weather events. Note that data points above the curve on the left side of the figure are indicative of fecal coliform exceedances during wet weather conditions (higher flows) and data points above the curve to the right side indicate fecal coliform exceedances during dry weather conditions (lower flows). These low flow exceedances indicate that sources of fecal coliform are most likely not related to precipitation events (i.e., runoff). The distribution of exceedances in both high flows and low flows suggests that both non-point sources, direct in-stream depositions, and point sources may be responsible for water quality impairment. Presumably, high flows and turbulence would be the chief factor in resuspending bacteria from stream bottom sediment sinks.

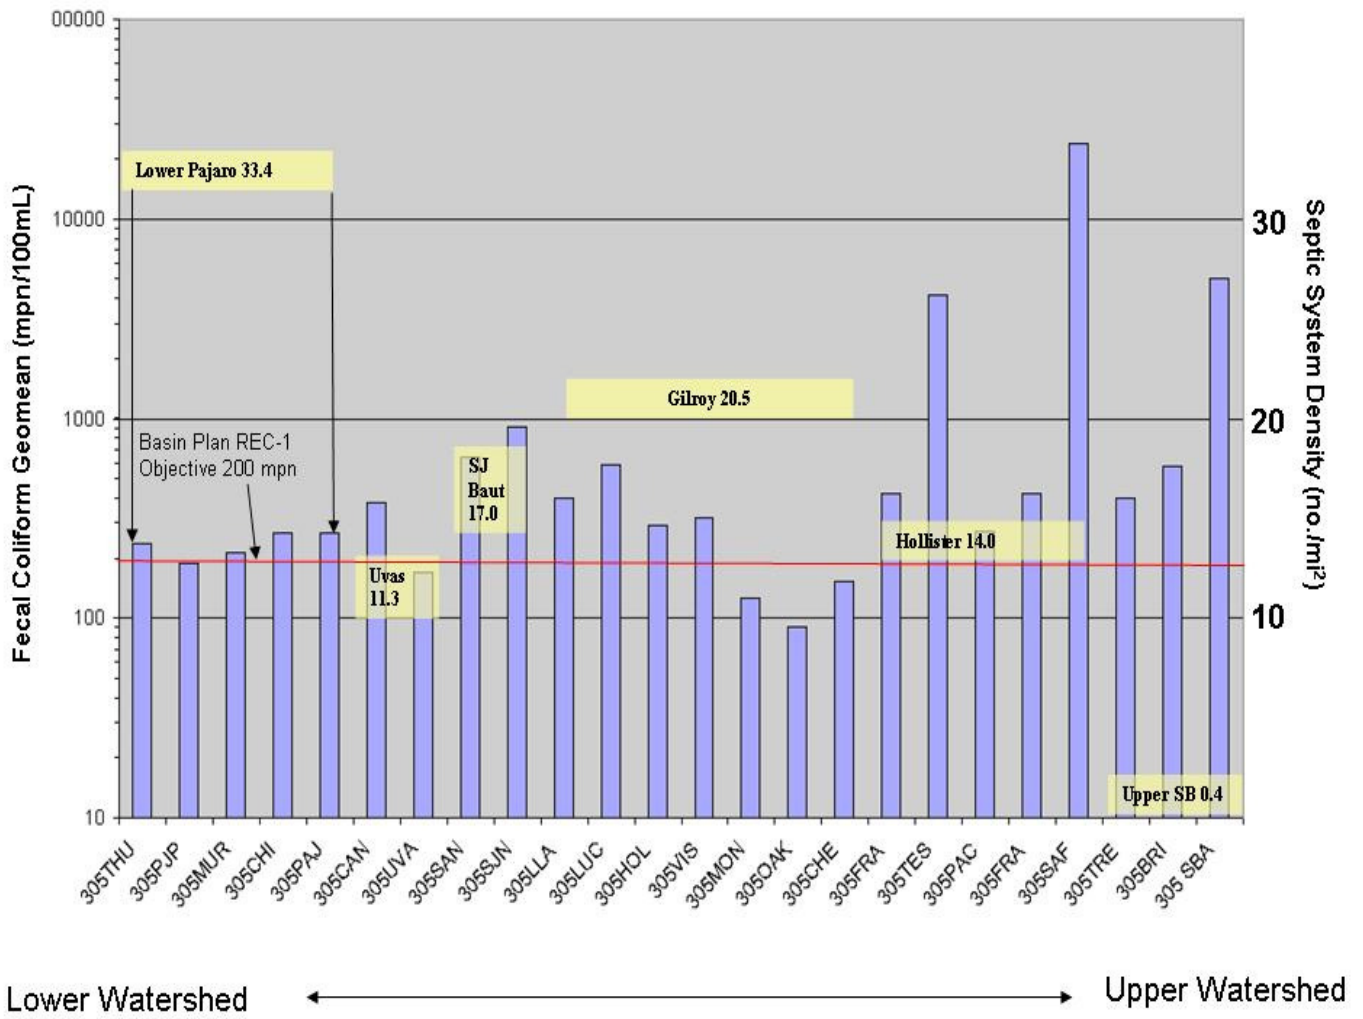
The data do not qualitatively suggest a positive correlation between OSDS density and elevated fecal coliform water quality data. In fact, in areas with the highest OSDS densities, the geometric mean concentrations of fecal coliform tended to be lower, whereas in areas of low OSDS densities, fecal coliform concentrations trended towards higher geometric mean values, as shown below:
