**CALIFORNIA REGIONAL WATER QUALITY CONTROL BOARD
LAHONTAN REGION
CLEANUP AND ABATEMENT ORDER NO. R6V-2020-0035
FOR
WILLIAM GOLDBERG
LOS ANGELES COUNTY ASSESSOR PARCEL 3334-004-011
WDID NO. 6B191908006**

NOTICE OF VIOLATION – AVENUE H8 AND 255th STREET EAST, HI VISTA, LOS ANGELES COUNTY, APN 3334-004-011

Evaluate cannabis cultivation site for potential water quality violations.

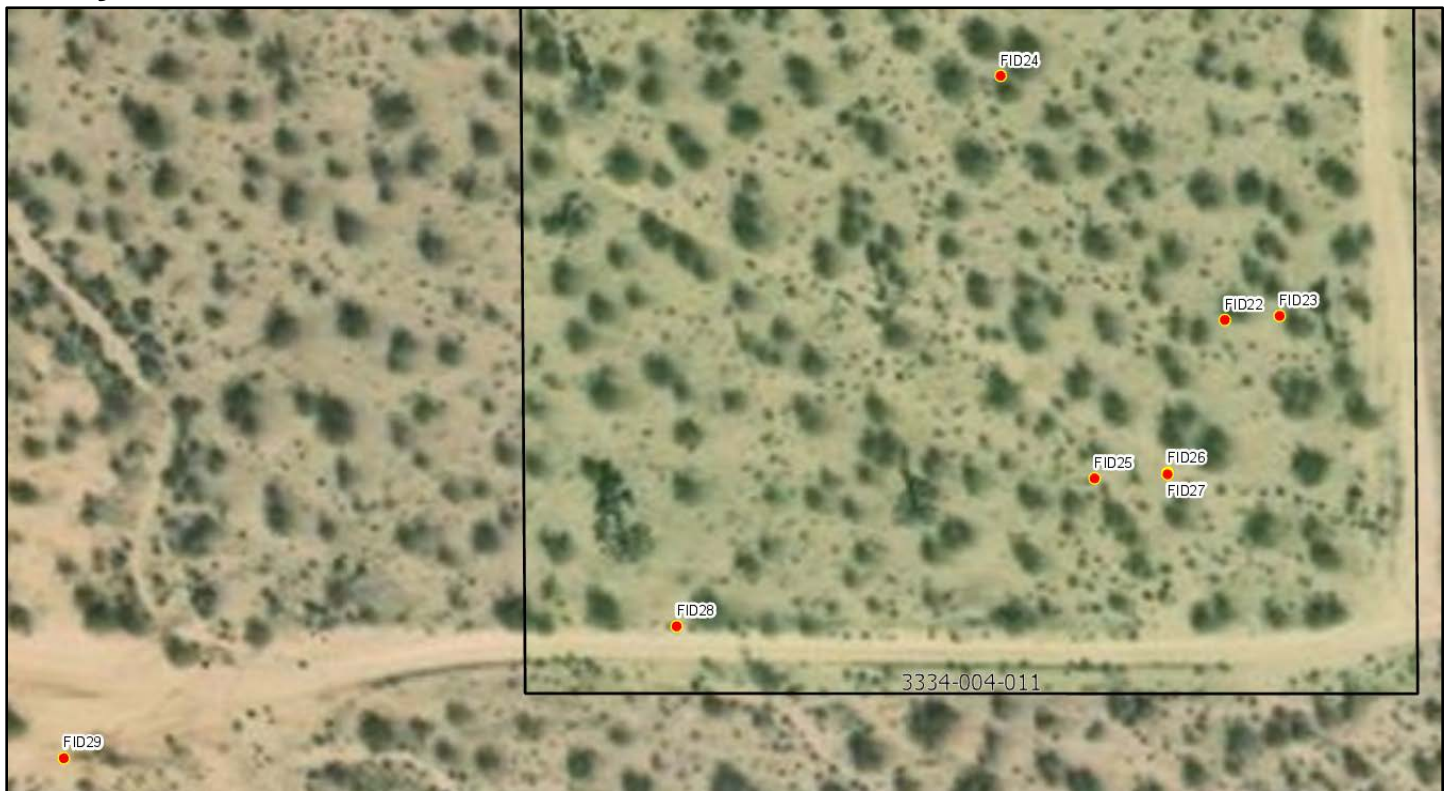
Analysis

Key Features	
FID: 22 - Harvested cannabis cultivation	Associated Photo Numbers: 1, 2
Description: Net covered cultivation with drip system. Plants are in ground and have been previously harvested and dried on-site.	
Water Quality Violation: Yes	
Applicable Water Code: 13260 - Cultivation was not enrolled in the Cannabis Cultivation General Order	
Latitude: 34.7127088166667	Longitude: -117.67622785

FID: 23 - Cultivation related waste	Associated Photo Numbers: 2, 3
Description: Plastic pots and various trash adjacent to the cultivation and living areas.	
Water Quality Violation: Under Assessment	
Applicable Water Code: Under Assessment	
Latitude: 34.7127137166667	Longitude: -117.676160466667
FID: 24 - Vegetation drying area	Associated Photo Numbers:
Description: Cut plants still present under tarp	
Water Quality Violation: Under Assessment	
Applicable Water Code: Under Assessment	
Latitude: 34.7130074666667	Longitude: -117.676503583333
FID: 25 - Unpermitted surface impoundment	Associated Photo Numbers: 5, 8
Description: Excavated area constructed with black plastic liner, with color of water indicating a high algal concentration	
Water Quality Violation: Under Assessment	
Applicable Water Code: Under Assessment	
Latitude: 34.712515	Longitude: -117.676388
FID: 26 - Chemical mixing tank	Associated Photo Numbers: 6, 7

Description: Chemical mixing tank with label indicated the presence of nutrients and fertilizers. Stored without a cover or secondary containment in manner that is not protective of wildlife or the environment.	
Water Quality Violation: Under Assessment	
Applicable Water Code: Under Assessment	
Latitude: 34.71252167	Longitude: -117.6762983
FID: 27 - Fuel storage and water pump	Associated Photo Numbers: 9, 12
Description: Three gasoline cans and one gas-powered water pump within the cultivation area. Stored uncovered and without secondary containment in a manner not protective of wildlife or the environment.	
Water Quality Violation: Under Assessment	
Applicable Water Code: Under Assessment	
Latitude: 34.71252	Longitude: -117.6762983
FID: 28 - Irrigation fire hire hose	Associated Photo Numbers: 10, 13
Description: Fire hose running from the surface impoundment along the easement towards an LA county fire hydrant.

Water Quality Violation: Under Assessment	
Applicable Water Code: Under Assessment	
Latitude: 34.7123340219107	Longitude: -117.67690225766
FID: 29 - LA County fire hydrant	Associated Photo Numbers: 14
Description: Fire hydrant near the cultivation parcel with stripped control valve.	
Water Quality Violation: No	
Applicable Water Code: N/A	
Latitude: 34.7121725584267	Longitude: -117.677656107891

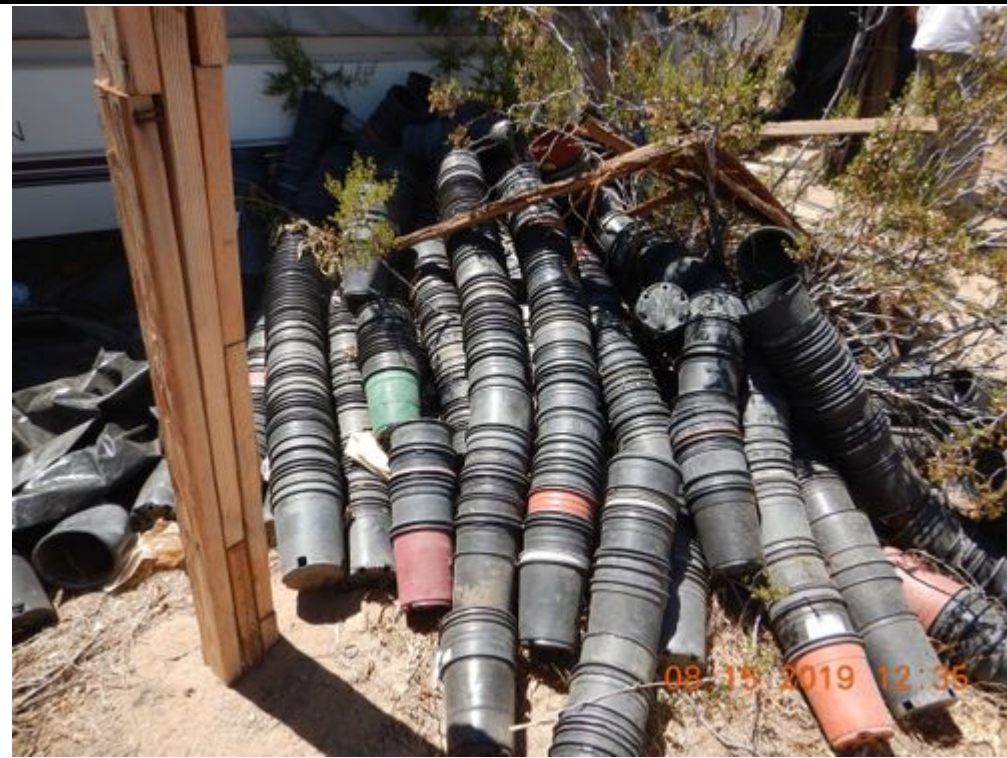
Photo Number: Photo 3
08/15/2019 12:35 PM
Latitude: 34.7127433333333
Longitude: -117.67614
Photographer: Eric Taxer
Camera: NIKON CORPORATION COOLPIX W300
Description: (Filename: DSCN0260_96831.JPG) Used plastic plant pots - cultivation related waste. Location is on the east side of the property where we entered the site. Photo facing south.

Immediately upon entering the cultivation area, we observed cultivation related waste as a large pile of used plastic pots, spent fertilizer containers, and bags of trash (Photos 2, 3 & FID:23). We observed cannabis plants that were both harvested and abandoned in-ground. The site was outfitted with a drip irrigation system with an unpermitted surface impoundment (Photos 5, 8 & FID:25) and chemical mixing tank (Photos 6, 7 & FID: 26) within the cultivation area. The surface impoundment was constructed of a soft plastic liner within an excavated depression, approximately 5-feet deep, 4-feet in width, and 10-feet in length. The bright green color of water within the impoundment indicated

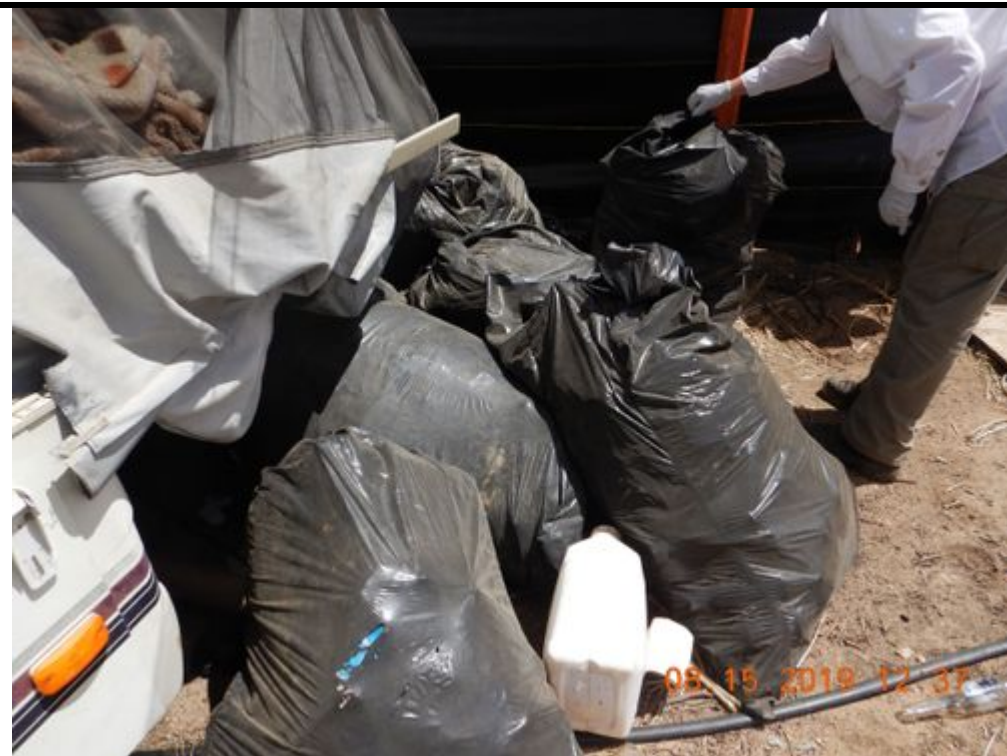
Photo Number: Photo 4
08/15/2019 12:37 PM
Latitude: 34.7126833333333
Longitude: -117.67612
Photographer: Eric Taxer
Camera: NIKON CORPORATION COOLPIX W300
Description: (Filename: DSCN0264_96831.JPG) Cultivation related waste next to discarded pots.

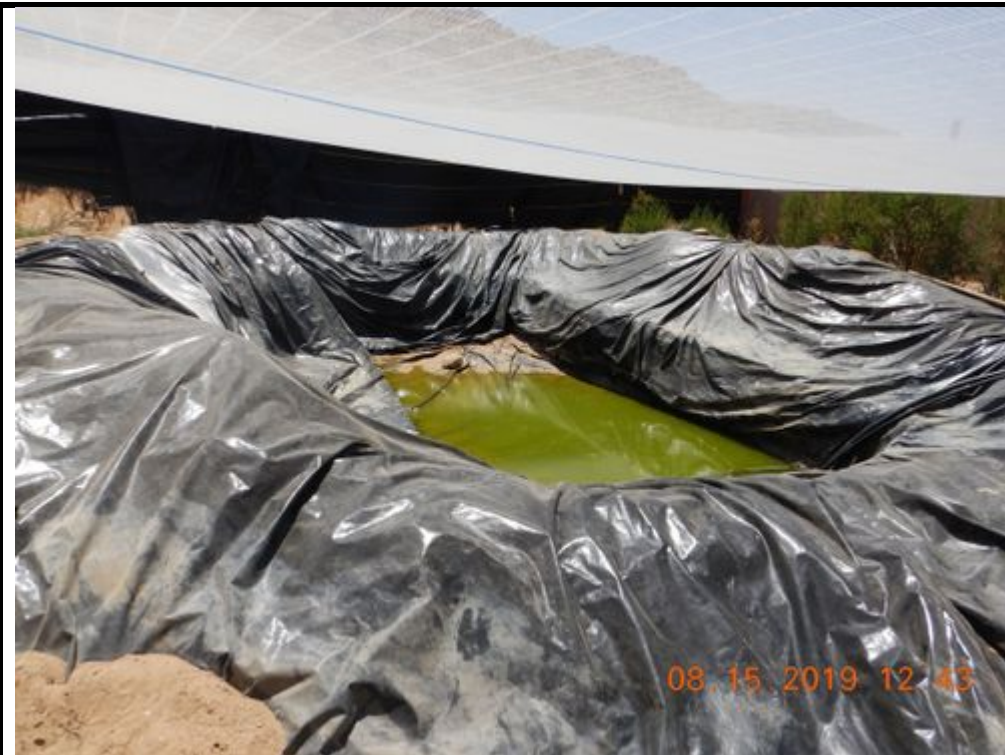
Photo Number: Photo 5

Description: (Filename: DSCN0268_96831.JPG) Unpermitted surface impoundment located on southwest portion of the site. Photo facing southwest.

- b. A constructed surface impoundment was observed on the southwest corner of the cultivation area. The impoundment consisted of an excavated area lined with a plastic tarp. Water within the impoundment was visibly green, indicating the water likely had high algal and/or nutrient concentrations.

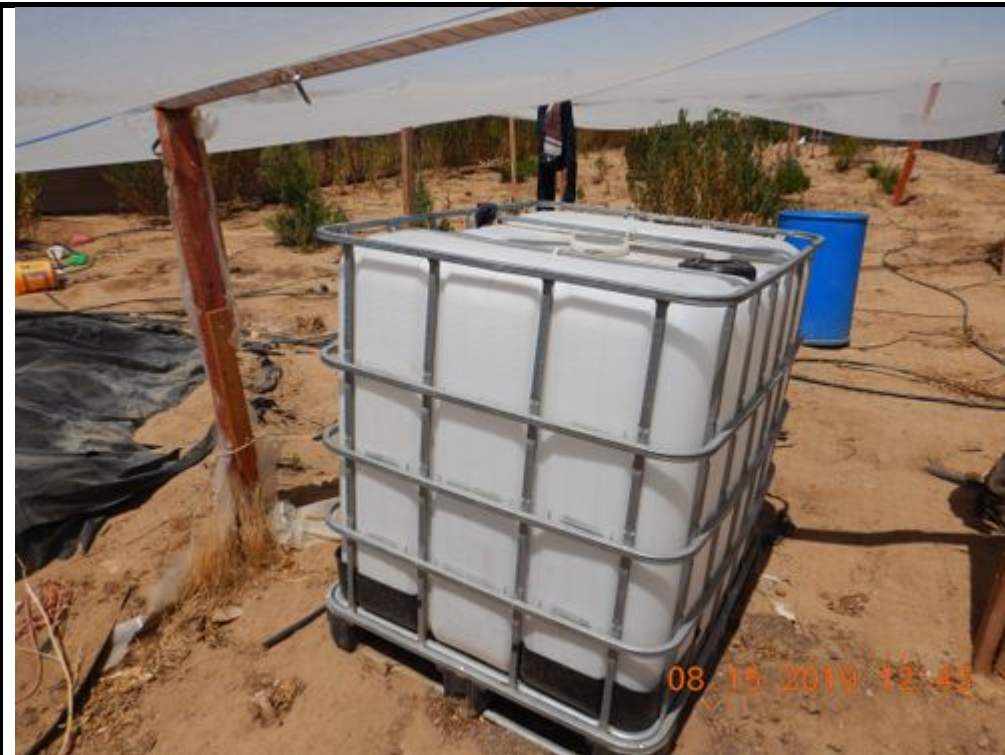
Photo Number: Photo 7

Description: (Filename: DSCN0271_96831.JPG) Chemical mixing tank, located on the east side of the surface impoundment. Photo facing northwest.

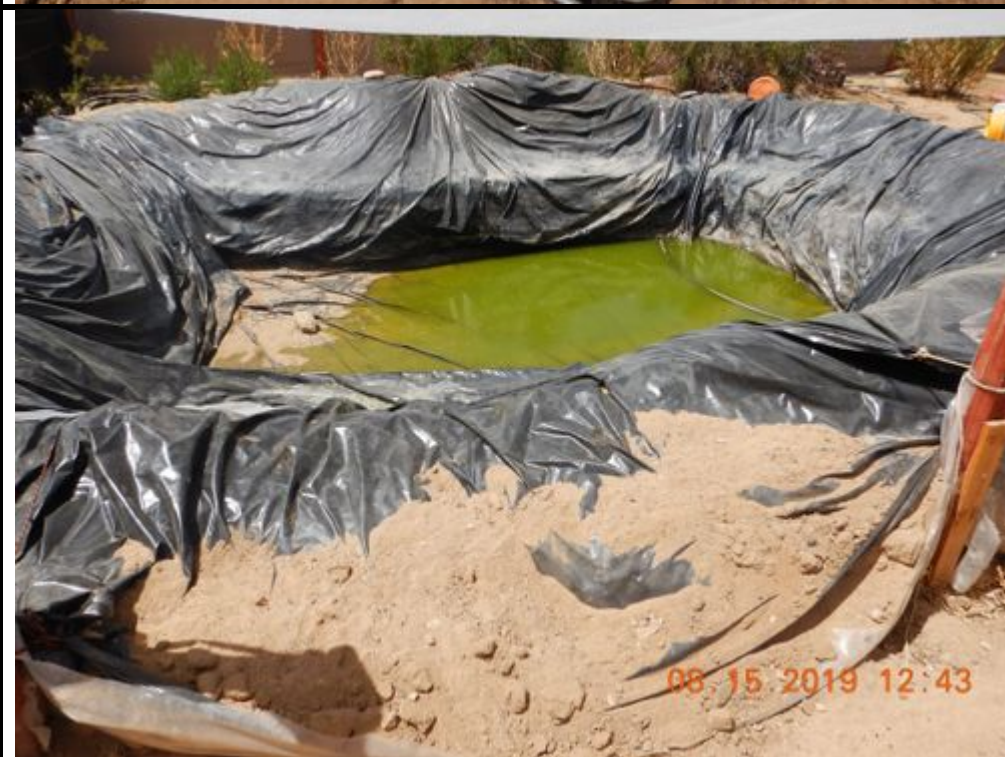
Photo Number: Photo 7

Description: (Filename: DSCN0272_96831.JPG) Unpermitted surface impoundment facing west.

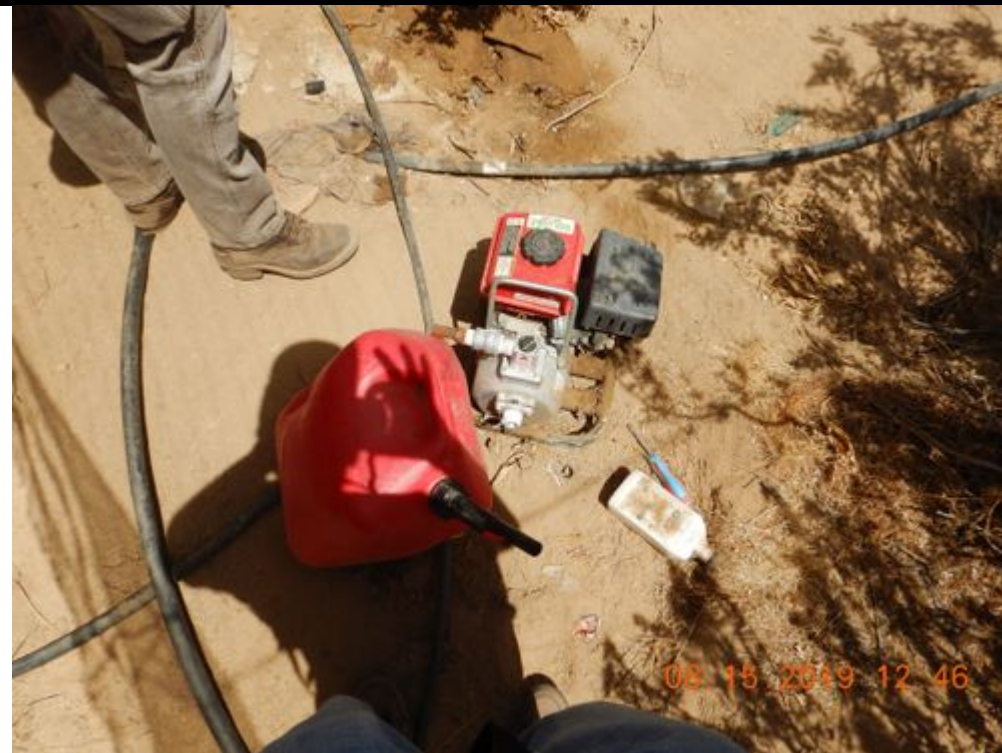
Photo Number: Photo 9
08/15/2019 12:46 PM
Latitude: 34.7125233333333
Longitude: -117.676395
Photographer: Eric Taxer
Camera: NIKON CORPORATION COOLPIX W300
Description: (Filename: DSCN0276_96831.JPG) Fuel storage and water pump within cultivation area northwest of the surface impoundment.

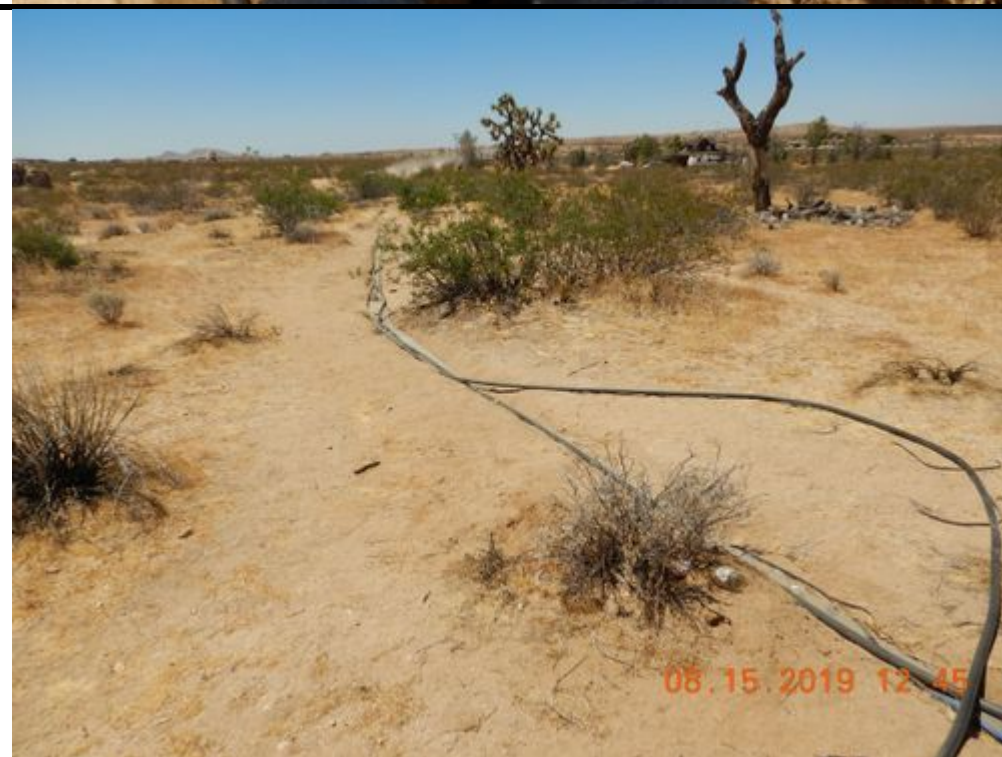
Photo Number: Photo 10
08/15/2019 12:45 PM
Latitude: 34.7124483333333
Longitude: -117.676413333333
Photographer: Eric Taxer
Camera: NIKON CORPORATION COOLPIX W300
Description: (Filename: DSCN0274_96831.JPG) Buried fire hose along parcel and easement west of the site towards nearby LA County fire hydrant. Photo facing west.

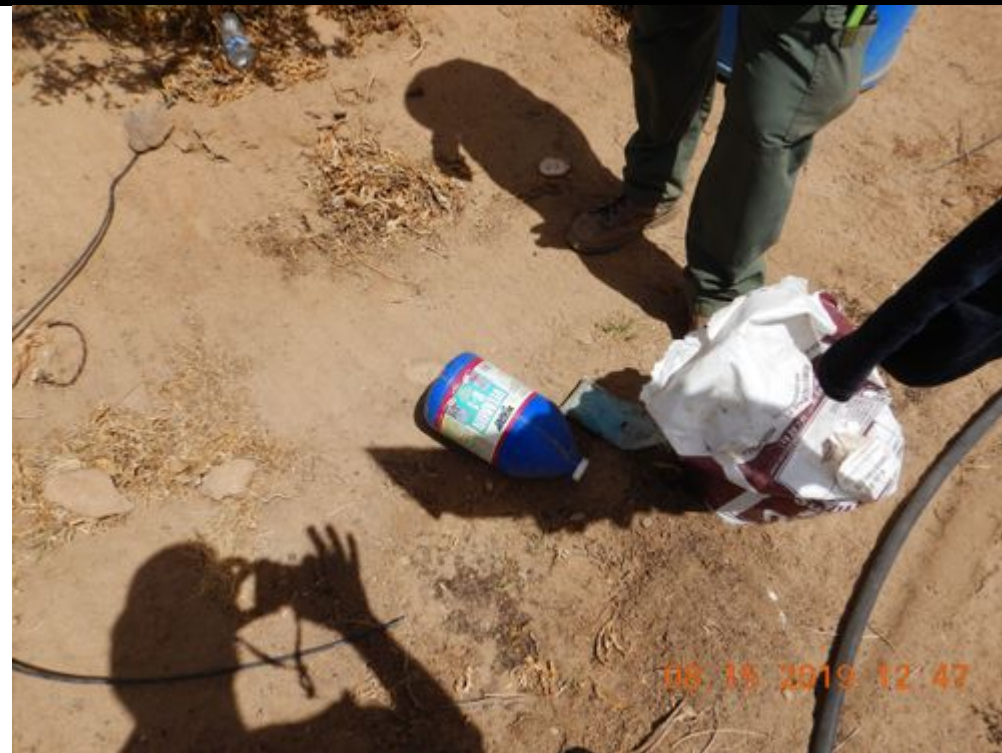
Photo Number: Photo 11
08/15/2019 12:47 PM
Latitude: 34.7125533333333
Longitude: - 117.676291666667
Photographer: Eric Taxer
Camera: NIKON CORPORATION COOLPIX W300
Description: (Filename: DSCN0278_96831.JPG) Stored fertilizer - liquid and granular within cultivation area, north of chemical mixing tank and surface impoundment.

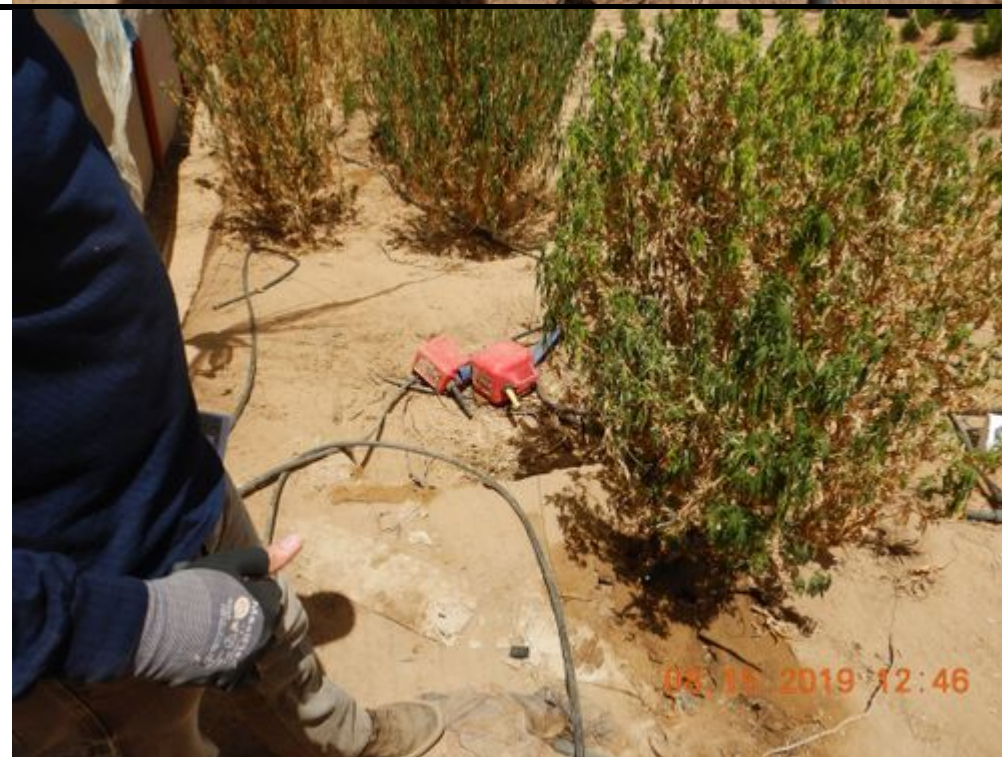
Photo Number: Photo 12
08/15/2019 12:46 PM
Latitude: 34.7125216666667
Longitude: -117.676395
Photographer: Eric Taxer
Camera: NIKON CORPORATION COOLPIX W300
Description: (Filename: DSCN0277_96831.JPG) Stored fuel cans within cultivation area, northwest of surface impoundment and chemical mixing tank.

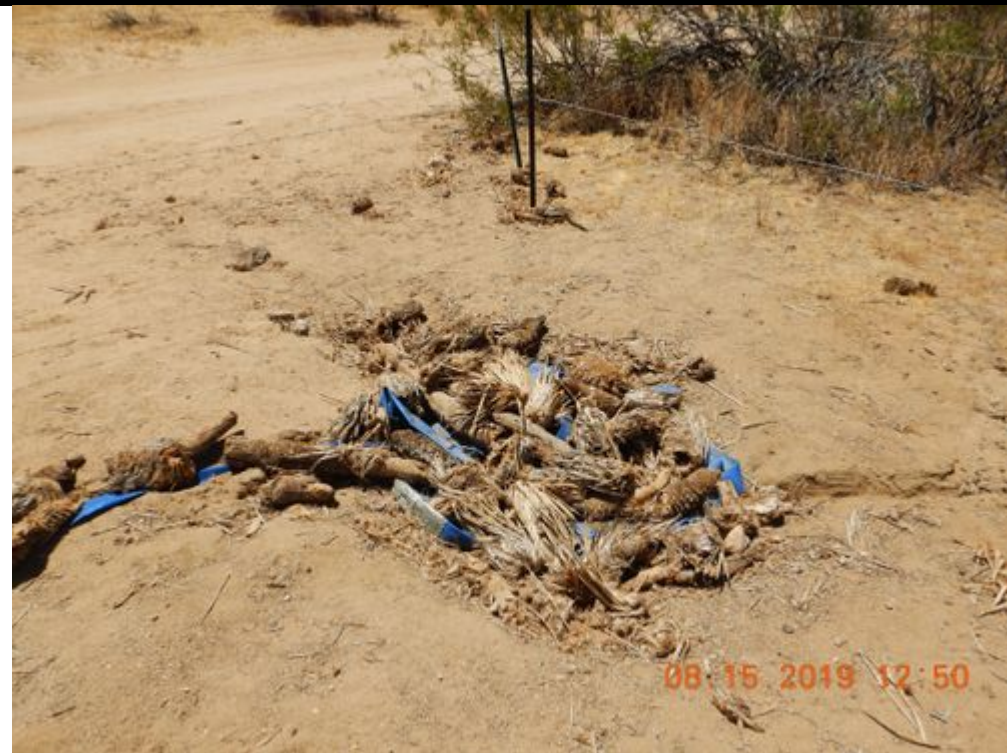
Photo Number: Photo 13
08/15/2019 12:50 PM
Latitude: 34.7124616666667
Longitude: - 117.676891666667
Photographer: Eric Taxer
Camera: NIKON CORPORATION COOLPIX W300
Description: (Filename: DSCN0281_96831.JPG) End of fire hose running towards hydrant along easement approximately 100-feet west of the site. Photo facing southwest.

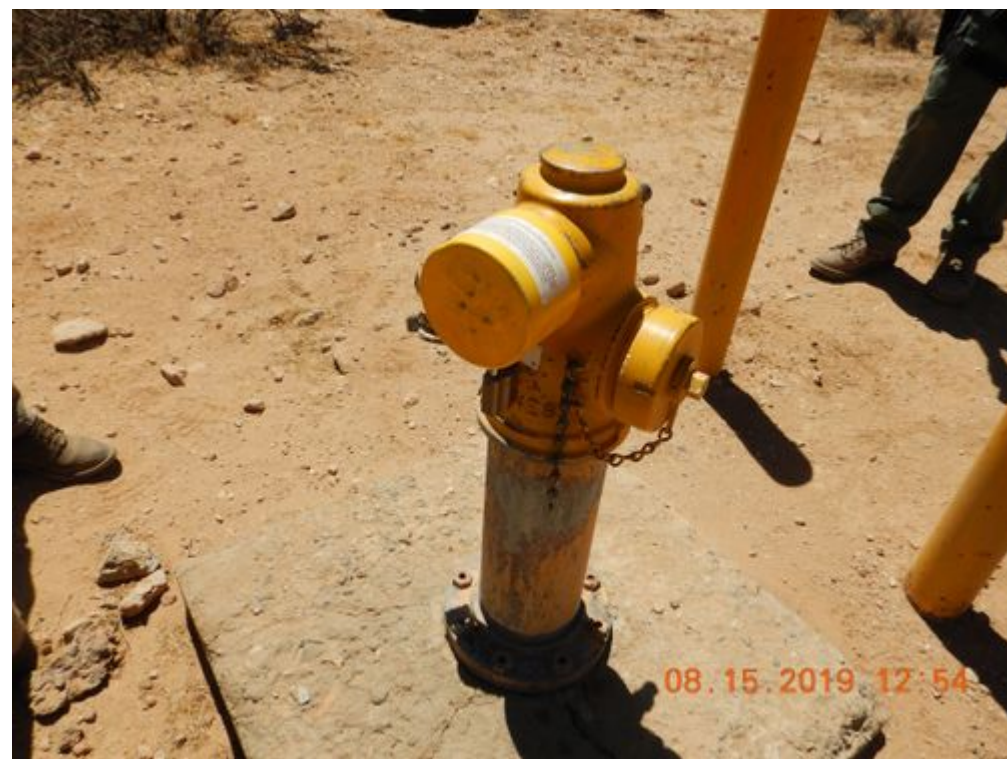
Photo Number: Photo 14
08/15/2019 12:54 PM
Latitude: 34.7122066666667
Longitude: -117.67761
Photographer: Eric Taxer
Camera: NIKON CORPORATION COOLPIX W300
Description: (Filename: DSCN0283_96831) LA County Department of Public Works fire hydrant along easement near cultivation. Suspected water source for the cultivation. Photo facing southeast.

a high presence of algae. Nutrient concentrations of the original contents listed on the chemical mixing tank label ranged between 10,000 to 40,000 milligrams per liter of available phosphate, potash, and total nitrogen. The tank nutrient label had previously been spray-painted and label indicated 98.5% of mineral oil is also affixed to the tank. Near the chemical mixing tank, we observed three fuel cans and a gas-powered water pump (Photos 9, 11, 12, 7 & FID:27). Fuel cans, fertilizer container, and the chemical mixing tank were all stored in the open without secondary containment. We also observed portions of the cultivation area dedicated as drying areas of harvested plants (FID: 24). Sheriff staff discovered a fire house leaving the cultivation area to the west. The hose was slightly entrenched and ended in a coiled pile 55-feet from the western border of the Site (Photos 10, 13 & FID:28). Following the easement of East Avenue H 8 in the direction of the hose, we discovered a Los Angeles County Public Works fire hydrant approximately 170 feet west of the Site (Photo 14 & FID:29).
