### Map Grid Index

## Groundwater Cr(VI) Concentrations in Monitoring Wells:

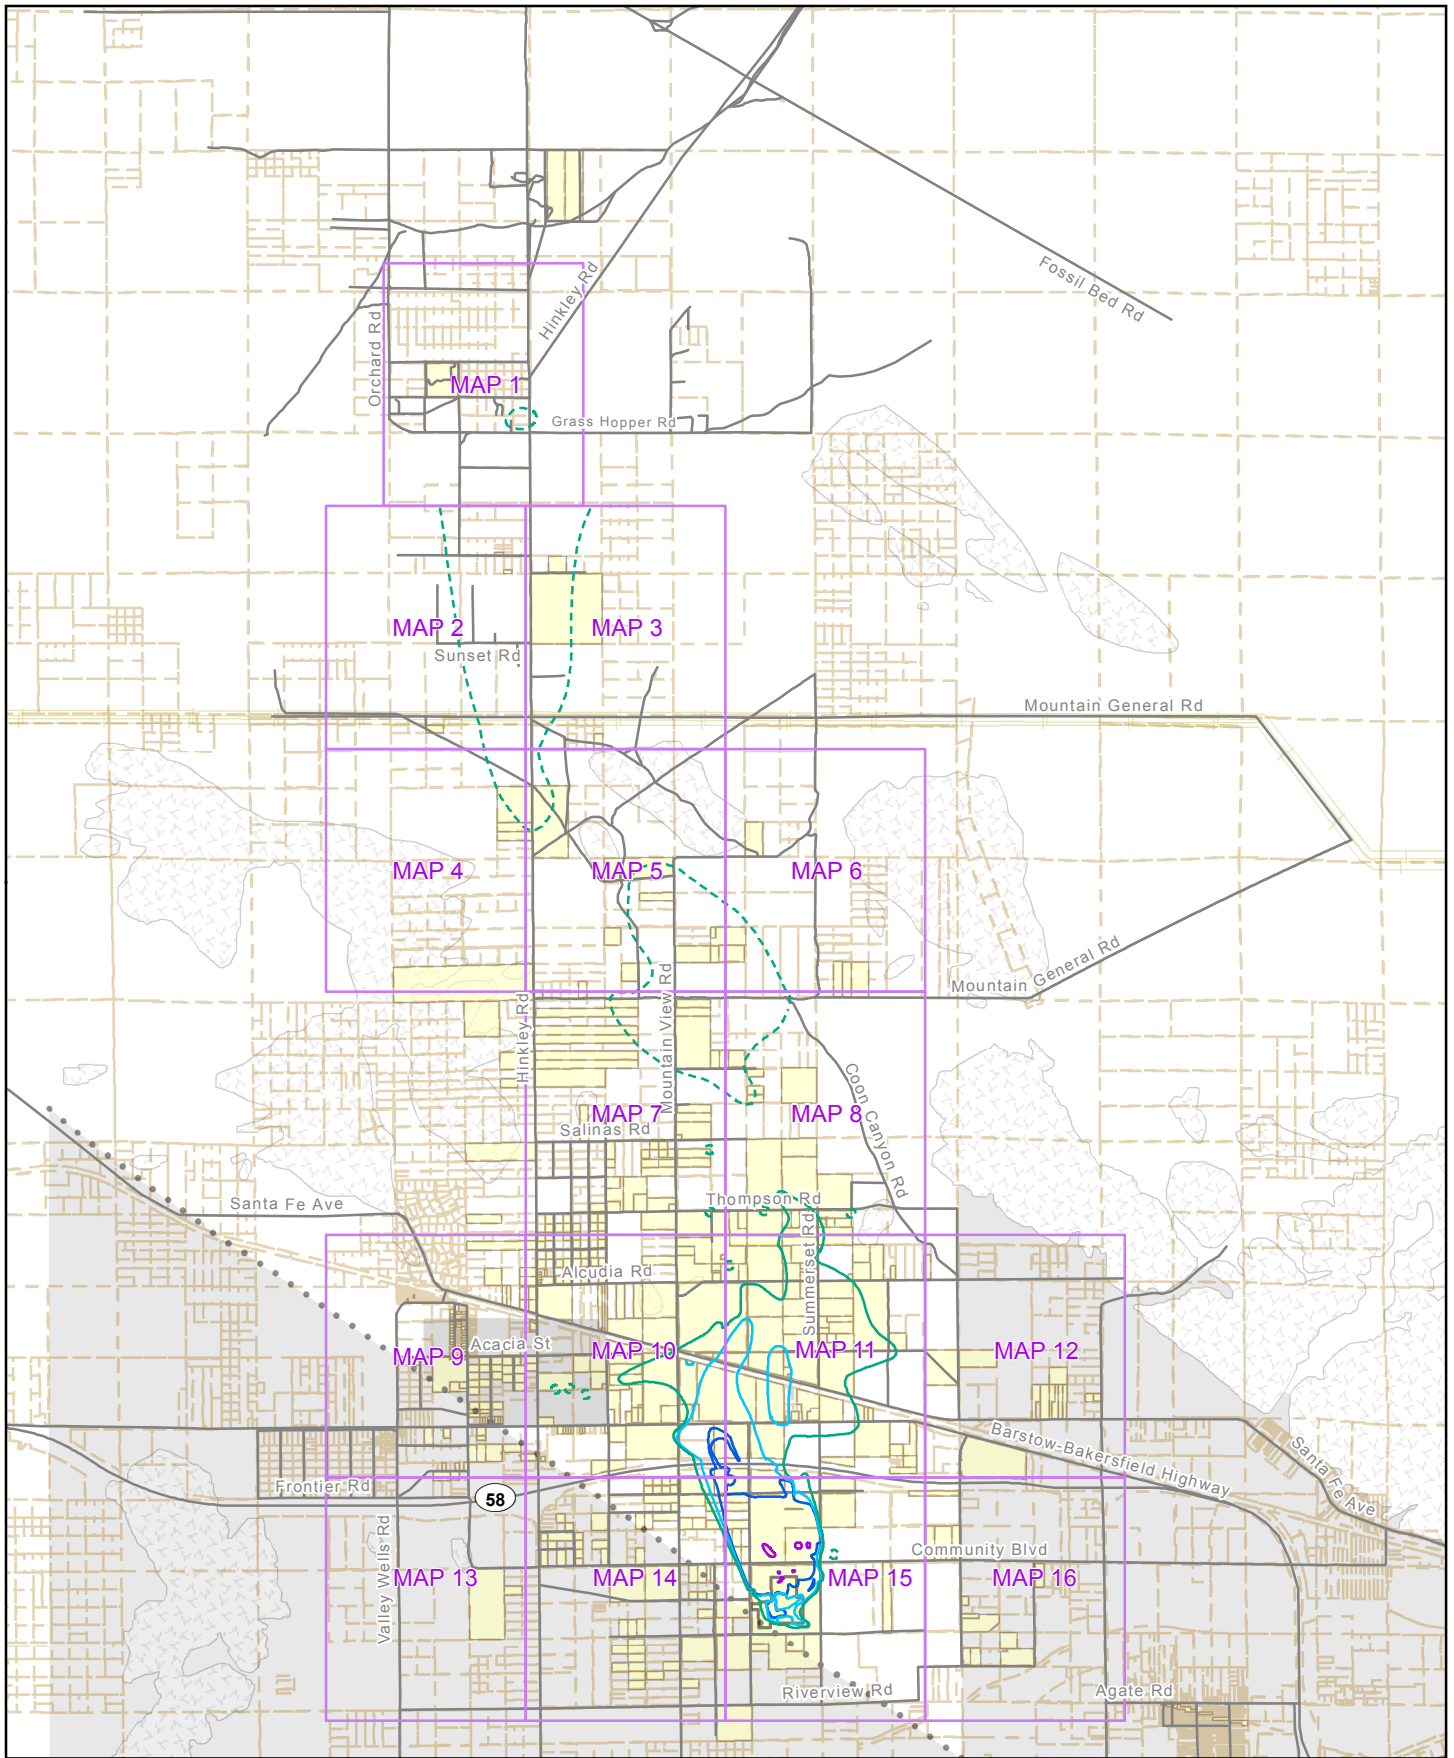
- Chromium results are shown for Site-wide Groundwater Monitoring Program and domestic wells sampled in the Fourth Quarter (October through December) 2018 monitoring period. For wells sampled multiple times during the reporting period, the most recent results are shown.

- The concentration contours are based on Fourth Quarter 2018 chromium results for the groundwater monitoring and extraction wells that are completed in the shallow zone and deep zone of the Upper Aquifer as noted on Figures 5-1 and 5-2. Results for domestic wells (brown-colored labels) were not used for chromium plume contouring, except for those in the northern disputed plume areas, pursuant to the Lahonton Regional Water Quality Control Board's Cleanup and Abatement Order dated November 4, 2015 (Water Board 2015).

- Pursuant to the Lahonton Regional Water Quality Control Board's Cleanup and Abatement Order dated November 4, 2015 (Water Board 2015), groundwater monitoring wells are not used for chromium contouring if they are located in the areas southwest of the Lockhart Fault and on or east of Dixie Road. Monitoring wells sampled southwest of Lockhart Fault and east of Dixie Road were sampled in support of United States Geological Survey background chromium investigations.

- Chromium plume contours in the general area south of Highway 58, were developed using a larger set of monitoring data which is presented in the the Fourth Quarter 2018 Monitoring Report for the In Situ Reactive Zone and Northwest Freshwater Injection Projects (Arcadis 2019). Select wells from that program are shown here for reference.

- Chromium contours were changed on the eastern side of the plume during the Third Quarter of 2016. These changes were made based on discussions with the Water Board, requirements in the Order and professional judgement. These changes to the plume contours on the eastern side of the plume reflect a revised interpretation of monitoring data and do not indicate plume expansion.
