## EXECUTIVE OFFICERS REPORT North Coast Regional Water Quality Control Board

January 2014

## **Introduction to Total Maximum Daily Loads (TMDL) and 2013 Progress Report Cards for Gualala, Mattole and Shasta River**

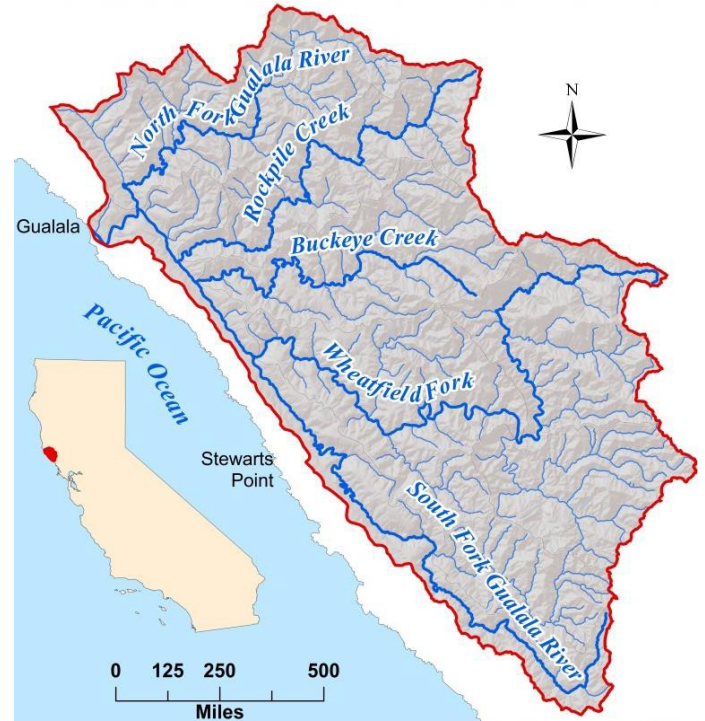
### Gualala River Watershed

Located along the San Andreas Fault, the Gualala River watershed is comprised of a highly dissected stream network. Unstable geology, steep slopes, and large amounts of precipitation make for high rates of natural erosion and landslides and a sensitivity of the land to practices that promote erosion. The primary sediment delivery sources are road-related processes, timber harvesting, agricultural activities, and rural residential development. Excessive sediment delivery from these sources has impaired instream beneficial uses, specifically those associated with salmonids. To address sediment impairment, U.S. EPA Region 9 developed a [TMDL for sediment in Gualala River](#) based on the North Coast Regional Water Board's [technical support document](#). The TMDL was approved by the U.S. EPA in December 2001. The TMDL established load allocations based on inventory information for six human-related sediment delivery sources. The TMDL calls for sediment discharge reductions from road-related sources by 95% and timber harvest-related sources by 86%. Landscape and instream targets were established to gauge the progress of implementing actions in addressing the sediment delivery categories and to measure stream response.

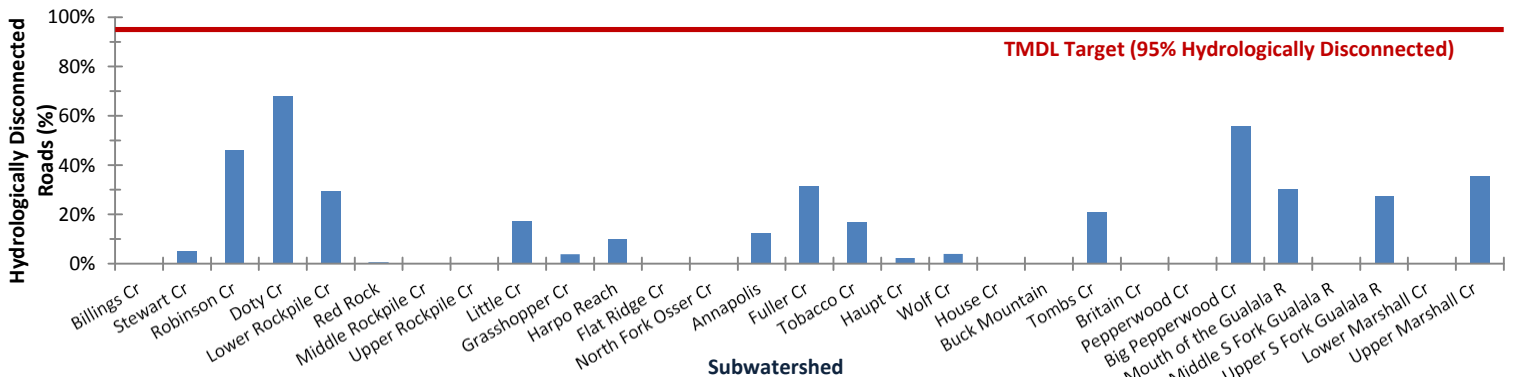
### Percentage of Roads in the Gualala River Subwatersheds that are Hydrologically Disconnected

- The percent of hydrologically disconnected roads has increased; however it is still well below the TMDL target.
- Implementation actions have reduced sediment delivery and improved instream conditions and salmonid habitat.
- Streambed conditions are improving; 82% of monitoring sites show reduced sediment deposition and 85% of resurveyed monitoring reaches show streambed deepening.
- [GRWC's "Large Wood in the Stream" program](#) has improved fish habitat by controlling sediment movement and increasing size, depth, and frequency of pools.
- Road projects on over 263 miles have reduced sediment input by an estimated 500,000 tons.

Hydrologically disconnected roads do not drain directly into stream channels. When the TMDL was adopted in 2001, almost all the roads were hydrologically connected to streams.

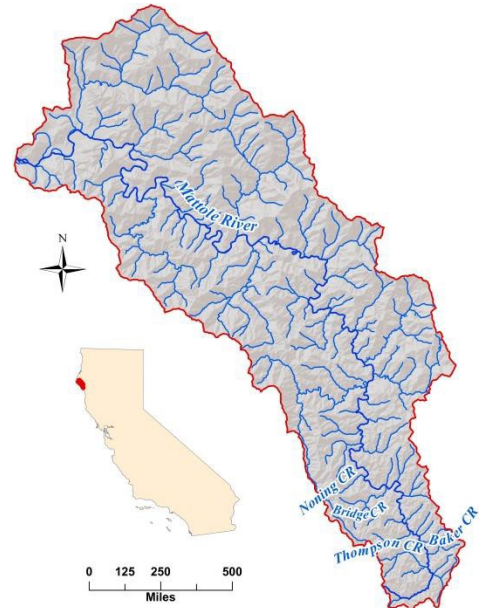
### Mattole River Watershed

The Mattole River is impaired by excessive sediment. Major sediment sources include road usage, rural residential development, and timber harvest activities. These activities have impaired instream beneficial uses, primarily those associated with salmonids. To address the sediment impairment, U.S. EPA Region 9 developed a [TMDL for sediment in Mattole River](#) based on the North Coast Regional Water Board's [technical support document](#). The TMDL was approved by the U.S. EPA in December 2002.

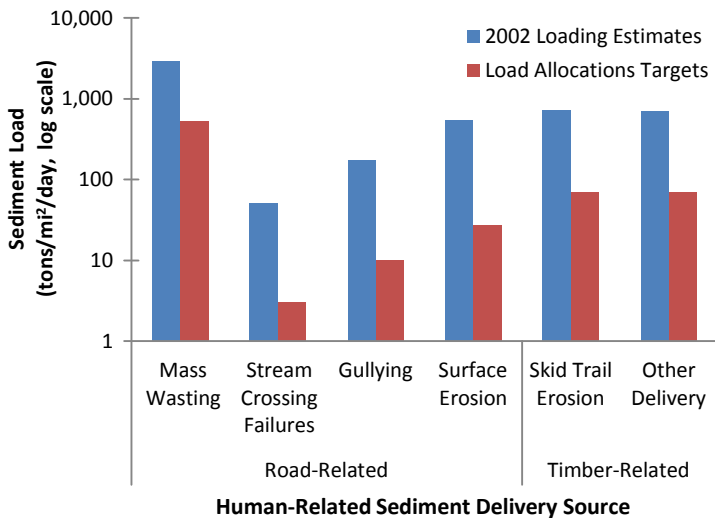
### TMDL Load Allocations

The TMDL established load allocations based on inventory information for six human-related sediment delivery sources. The TMDL also established landscape and instream targets to gauge the progress towards implementing actions to address the sediment delivery categories, to measure responses in the stream, and to gauge progress towards achieving the target of an 86% reduction in human-related sediment delivery. The TMDL is implemented through actions by private landowners, industrial timberland owners, and restoration groups.

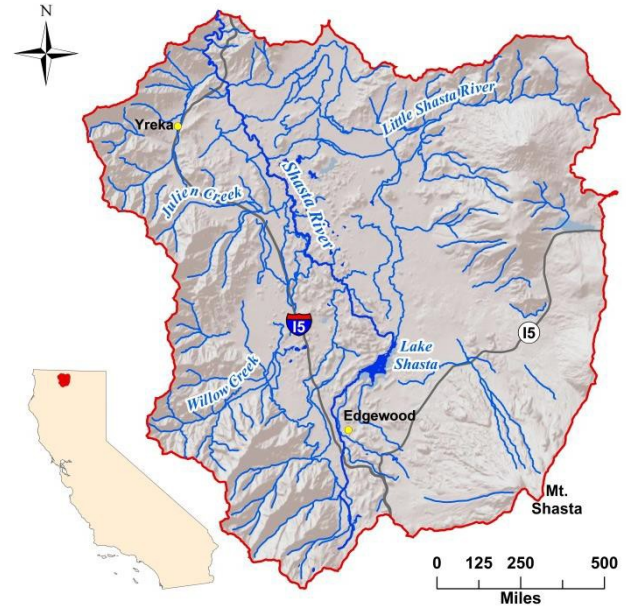
### Shasta River Watershed

The Shasta River is a tributary to the Klamath River and drains a 795 mi<sup>2</sup> basin. Shasta River surface water diversions are used for irrigated agriculture and cow-calf grazing operations. Water temperatures do not meet water quality objectives as they regularly exceed chronic temperature thresholds for salmonids, contributing to a population decline in the basin. The river's temperature is affected by surface water diversions, reduced riparian shade, and warm irrigation tailwater return flows. To address elevated water temperatures, the North Coast Water Board adopted a [TMDL for temperature in Shasta River](#), which was approved by the U.S. EPA in January 2007.

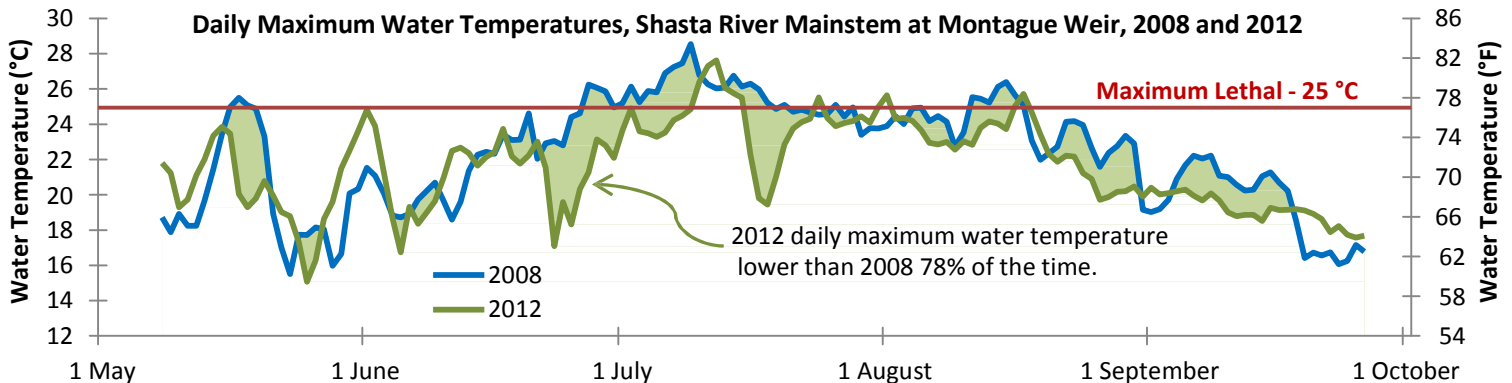
### Shasta River Water Quality

- Water quality data show a decrease in stream temperatures at some locations; e.g., 2012 daily maximum temperatures were lower than 2008 daily maximum temperatures 78% of the time at the Montague Weir site.
- Conditions for coho have improved in the upper watershed areas.
- Four of six identified impoundments have been removed.
- 168 miles (63% of stream length) of riparian fencing has been installed along the Shasta River and five tributary segments to exclude livestock.
- Tailwater neighborhoods have been identified and mapped and improvements are being made by irrigators.
- Efforts to dedicate cold water flows through the [1707 water rights process](#), or the water trust process, are underway.
- Water Board staff are confirming TMDL Waiver participation and compliance through property-by-property assessments.
