Integrating surface water, groundwater and landscape
stressor data into a regional assessment to support
management decision-making

Karen R. Worcester
Senior Environmental Scientist, Central Coast Region

Healthy Watersheds

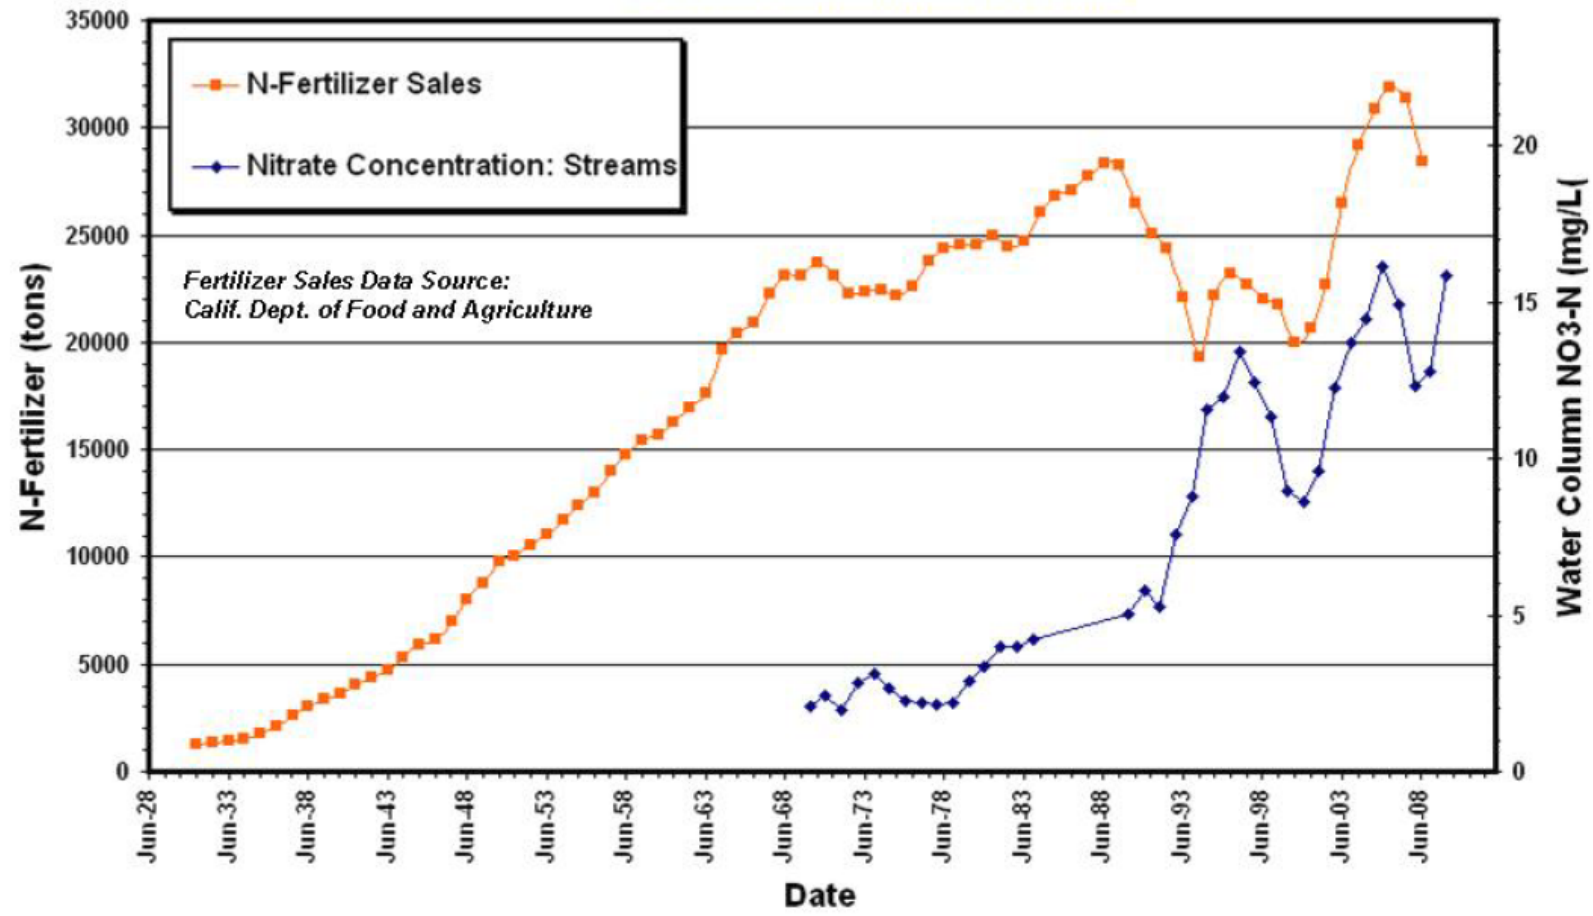
5-Year Moving Averages: N-Fertilizer Sales in Monterey County

with overlay of

5-Year Moving Averages: all NO3 Concentration Data in Streams in Salinas River Basin

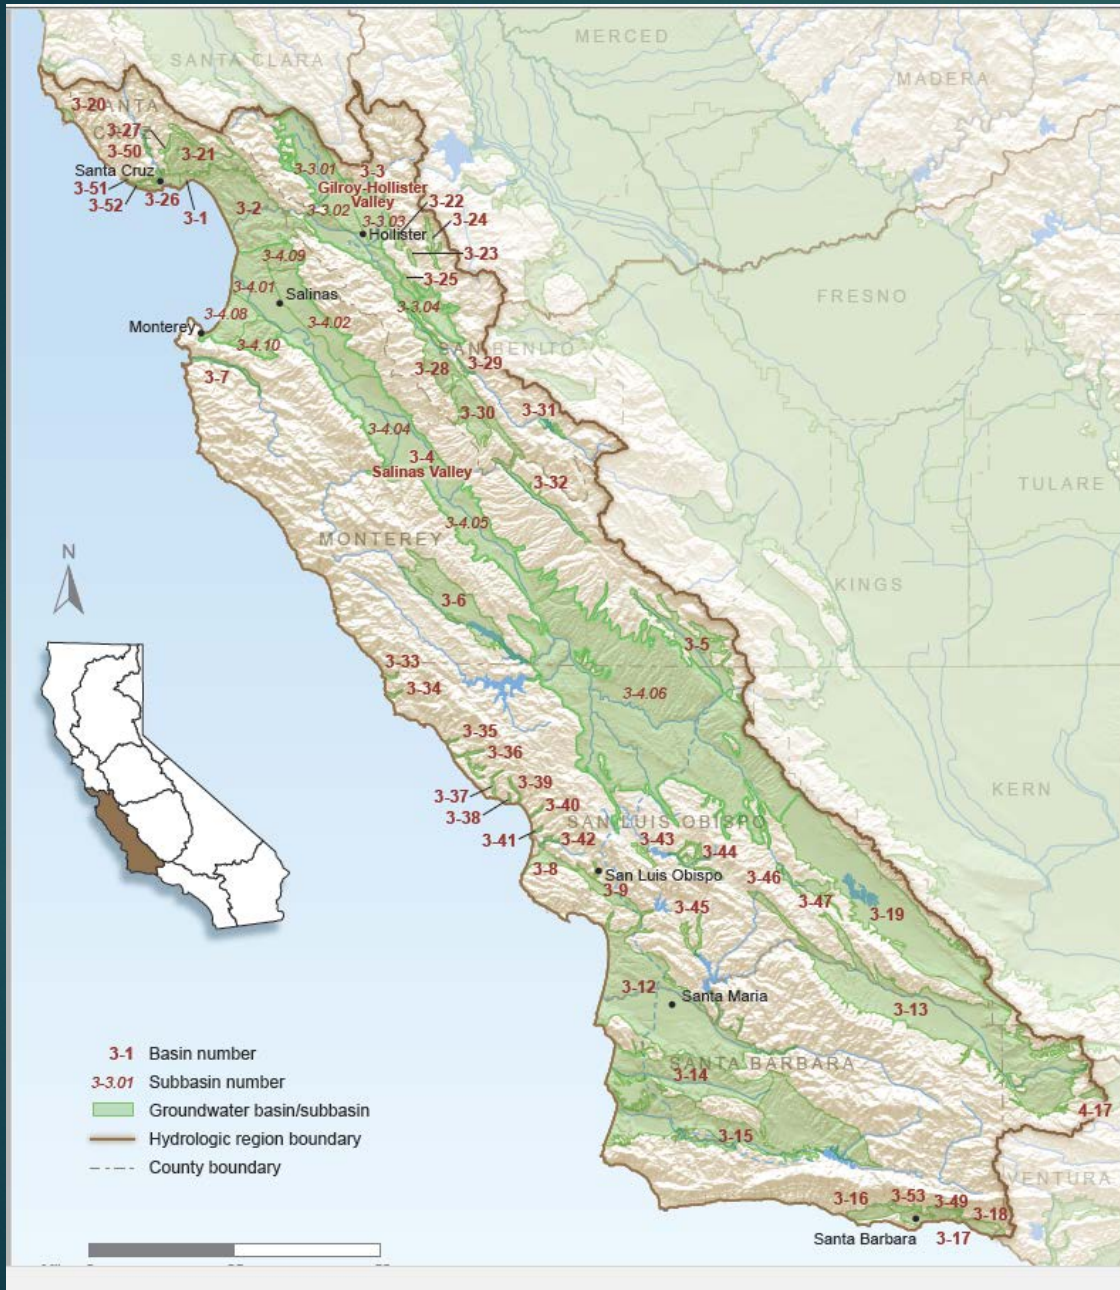
Deciding on spatial scale for a Central Coast groundwater assessment

California's
Groundwater
Basin definitions
come from DWR
Bulletin 118

Groundwater sub-basins, scored for nitrate-N as an average

>0 < 1.0 mg/L
>1 < 2.5 mg/L
>2.5 < 5 mg/L
>5 < 10 mg/L
>10 mg/L

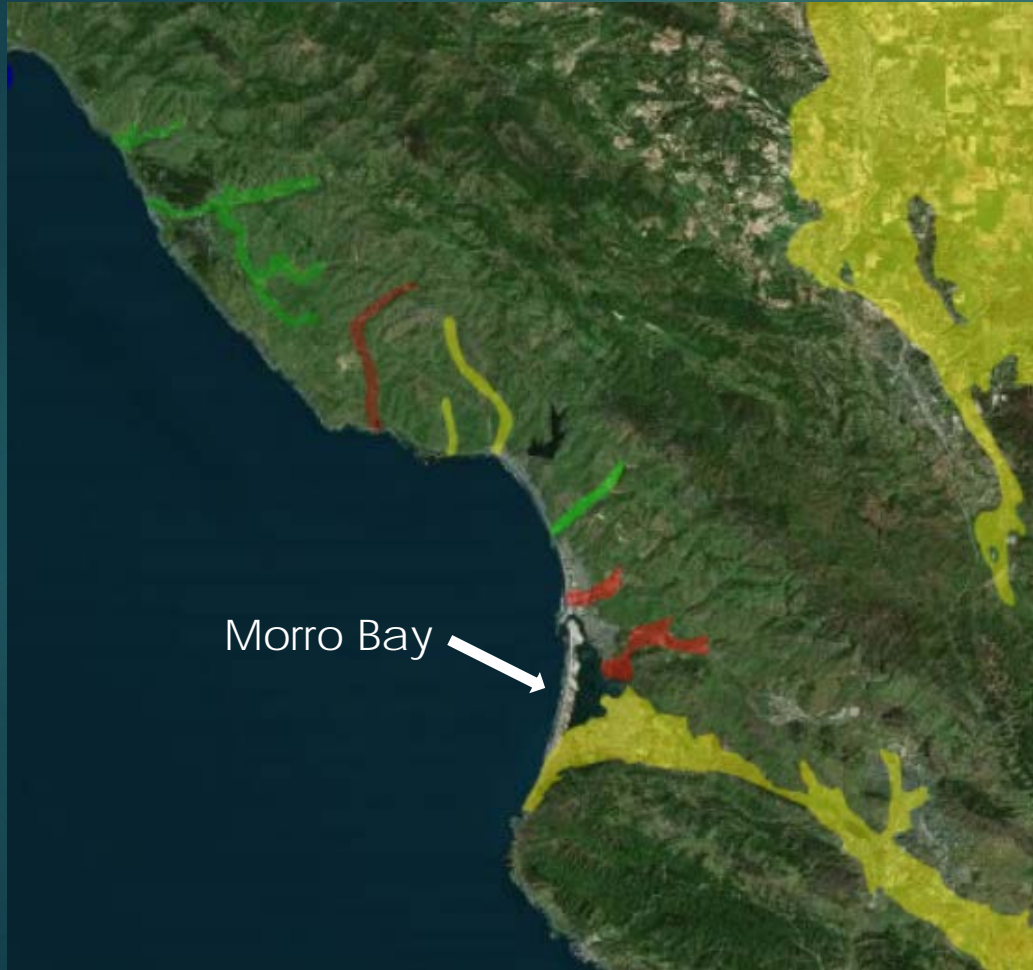
Groundwater Basin size is highly variable

Surface water HUC 12s cover the entire landscape and are often smaller than groundwater basins.
