**2014 and 2015 Inspection Reports
by Regional Board Staff**

March 28, 2014 Inspection Report

SUBJECT: INSPECTION OF AREAS OF FILL OR PLANNED FILL TO DETERMINE PRESENCE OF WATERS OF THE STATE OR WATERS OF THE UNITED STATES

May 4, 2015 Inspection Report

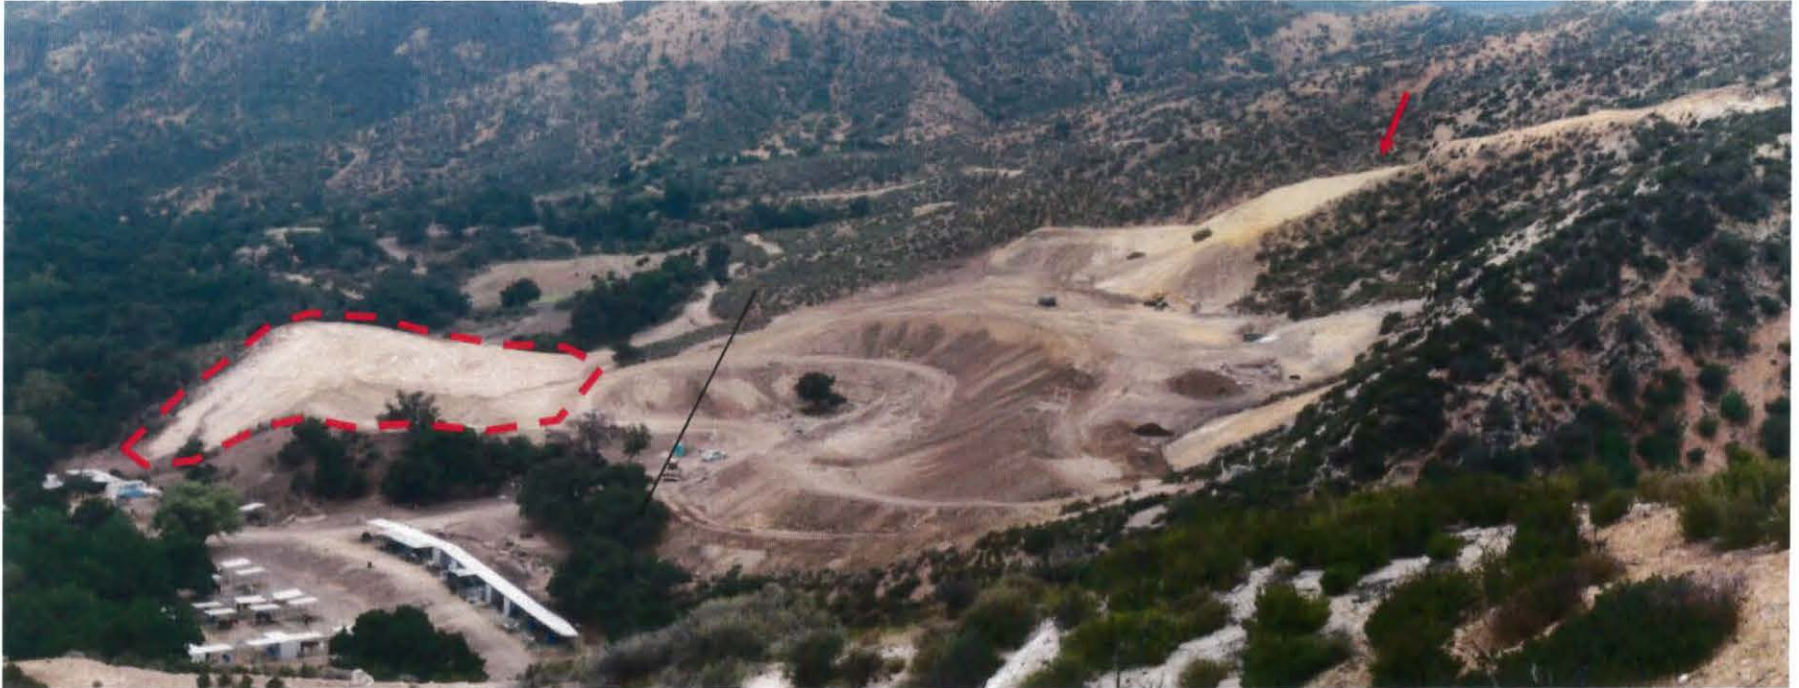
Figure 4:
Panaoramic view looking south from the Browns Canyon Road at grading/fill operations in the parcel 2821-009-030, 2821-009-031 area. The dashed line is the approximate boundaries of a large area (proposed horse arena) not included in the initial grading plans and is encroaching towards Ybarra Creek. Grading for new access to the area (arrow) was also not included in the initial grading plans.

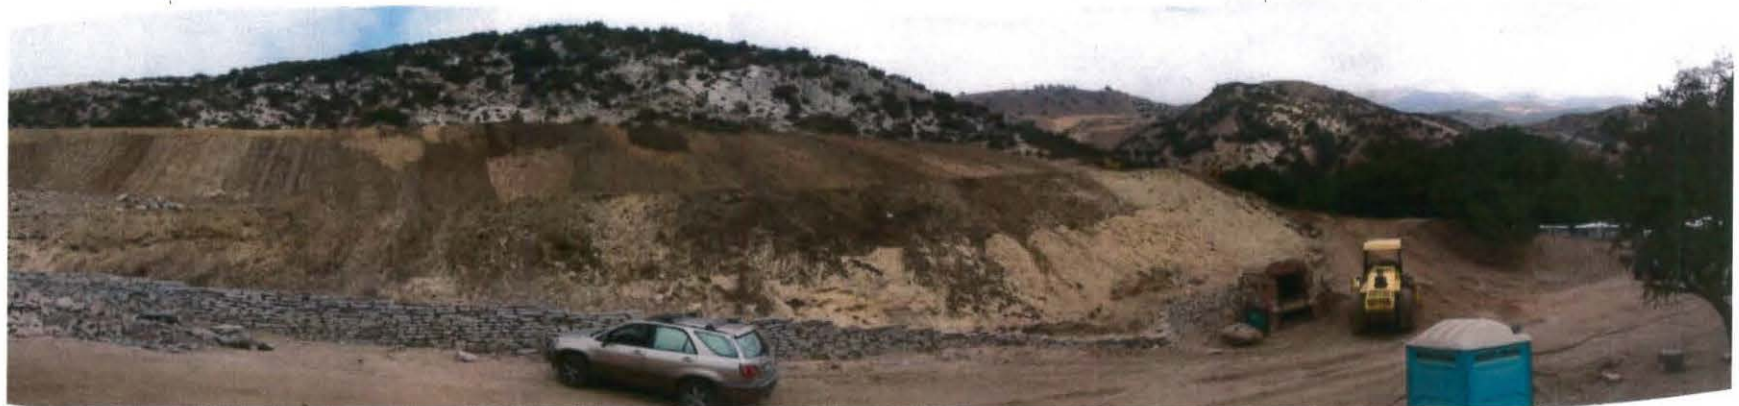
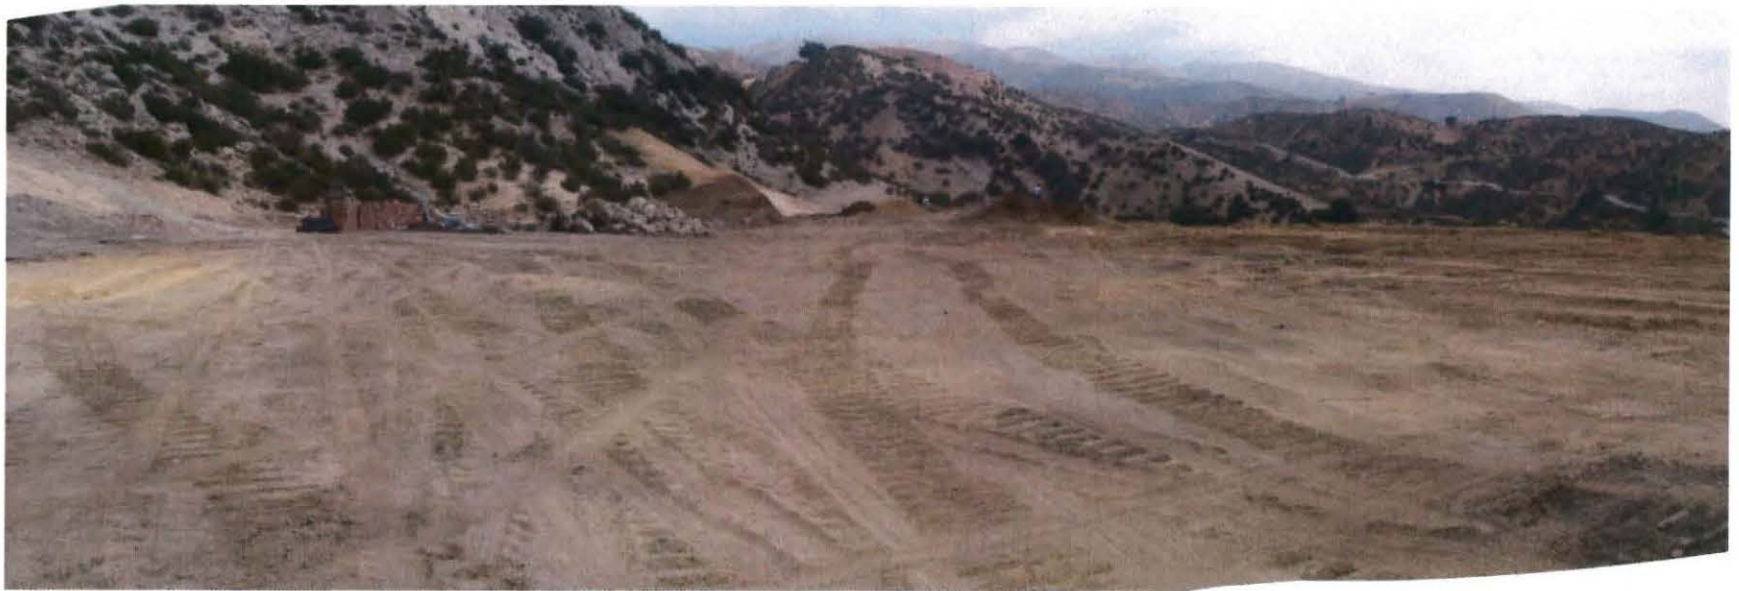
Figure 8:

Views of side slope and deck areas created by grading/fill operations in the area of parcel 2821-009-030 and 2821-009-031 that appeared to be generally consistent with initial grading plans in that native ridges have been terraced to augment inert materials to fill the interior ravines but potentially include significantly greater volumes of fill materials.

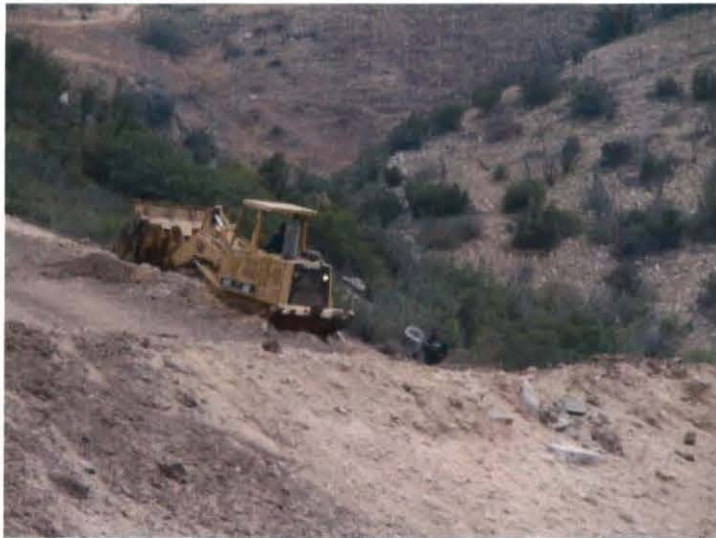
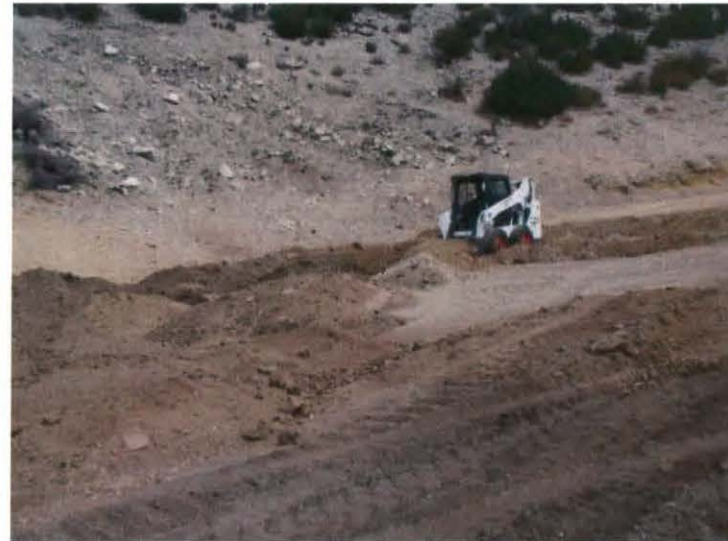
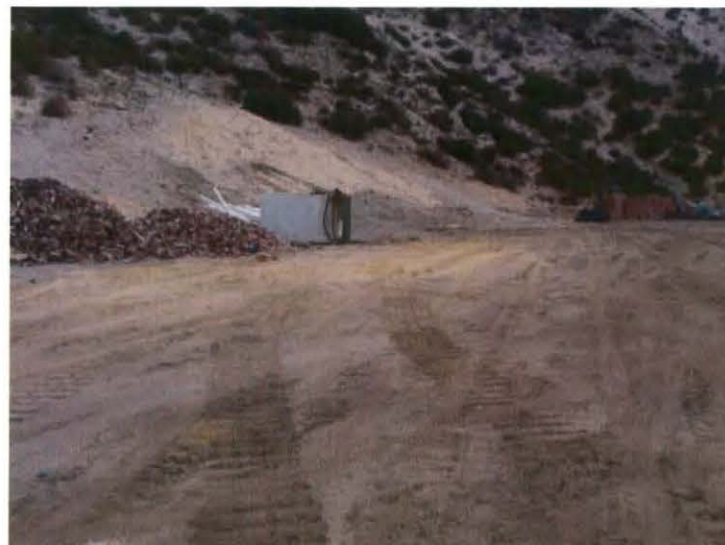
Figure 9:

Observations of grading/contructions activities in parcel 2821-009-030 and 2821-009-031 area. The fuel storage tank had no secondary containment. There were abundant areas of loose bare soil, with no readily evident sediment controls measures.

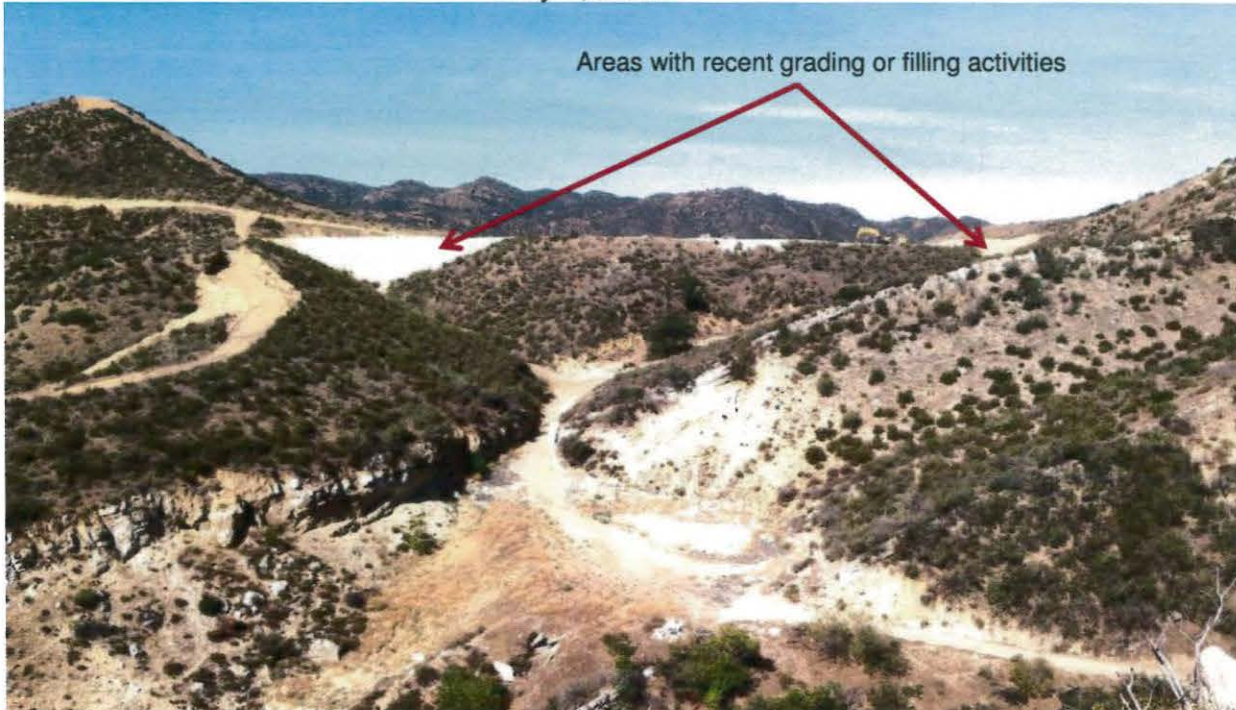
1. APN 2821-002-025 - There had been significant grading/filling activities in the area since the inspection of May 4, 2015. A small valley connected to Browns Canyon appeared to have been filled with debris. The dirt roads in the parcel appeared to have been re-graded or widened recently (Figure 2).
2. APN 2821-002-023 - No significant change was observed in this area since the inspection of May 4, 2015 (Figure 3).
3. APNs 2821-009-030 and 031 - Waste disposal/terracing activities were going on in the area. At least five trucks were observed hauling wastes to that area during the site inspection. Areas of waste disposal/terracing were obviously increased comparing to what was observed during the May 4, 2015, inspection (Figure 4).

Figure 2: APN 2821-002-025, show areas that had been graded or filled since May 4, 2015.

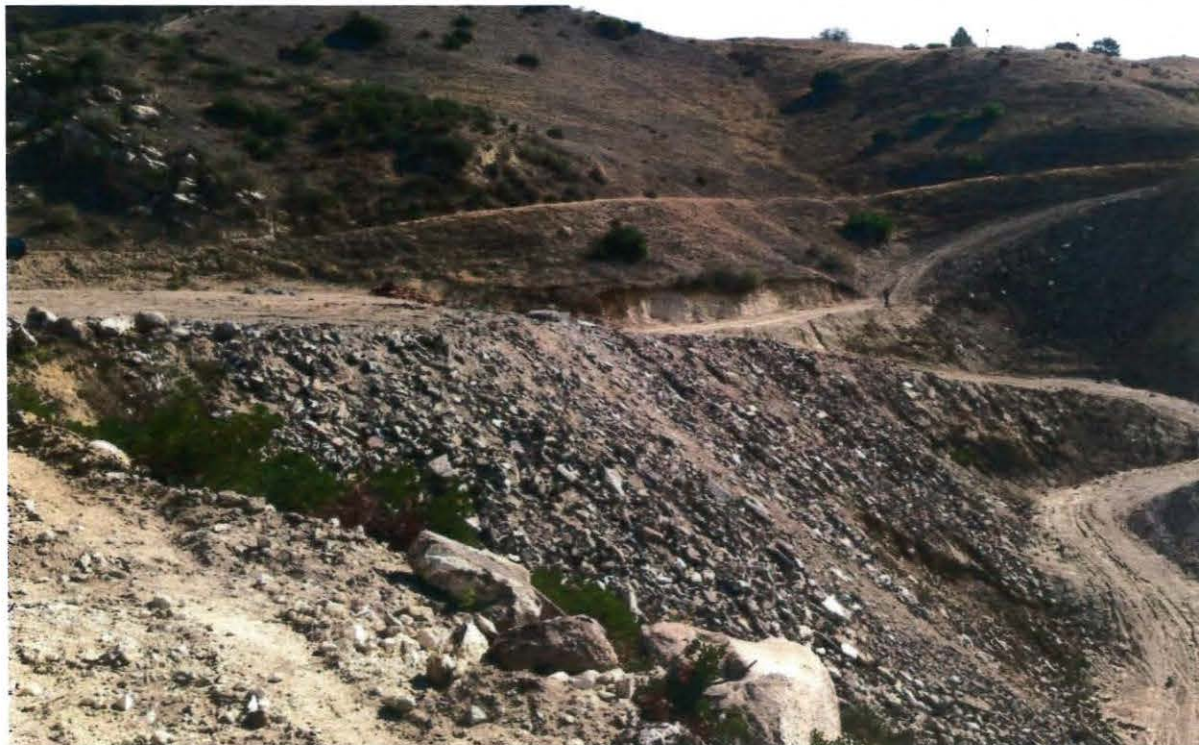
Figure 3: APN 2821-002-023. No significant changes were observed in this area, comparing to what was observed during the inspection on May 4, 2015.

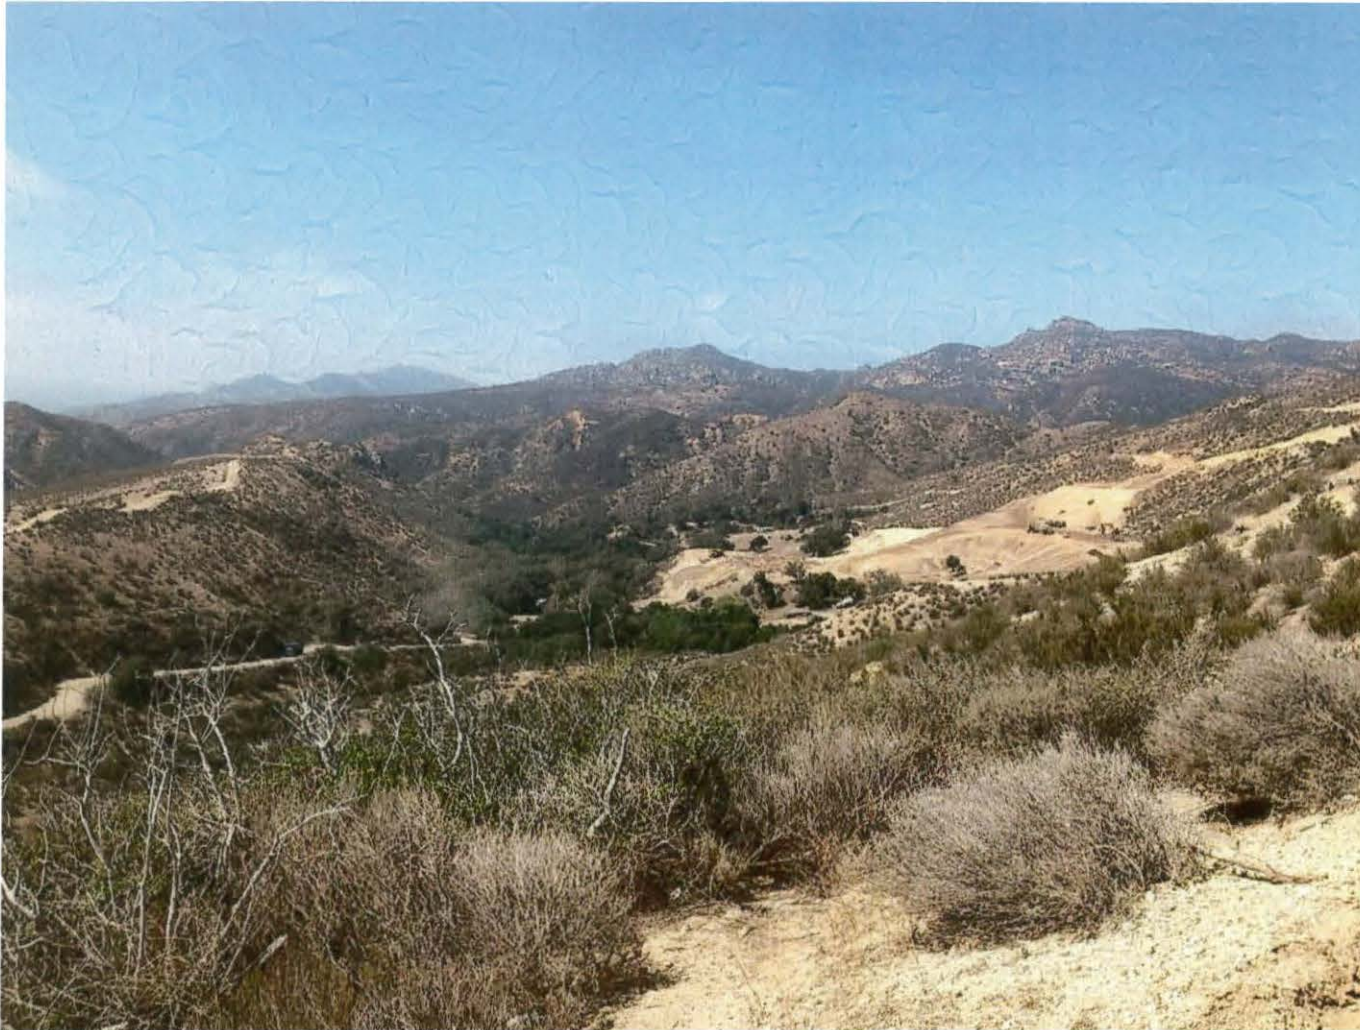
From Brown's Canyon Road, next to the site, and continually during the inspection, we observed trucks both entering and leaving the site. Approximately 60 trucks entered during the three hour period of the inspection. Figure 3 shows the first site next to Ybarra Creek, from Brown's Canyon Road.

Figure 3. This photo was taken from the parking area on Browns Canyon Road looking roughly southwest. The truck route is the dirt road on the left going down to Ybarra Creek. Ybarra Creek is the green ribbon in the center. The first area of impact of lots 2821-009-030 and 031 is in the center of the photo. New roads continue to the right. (LB Nye)

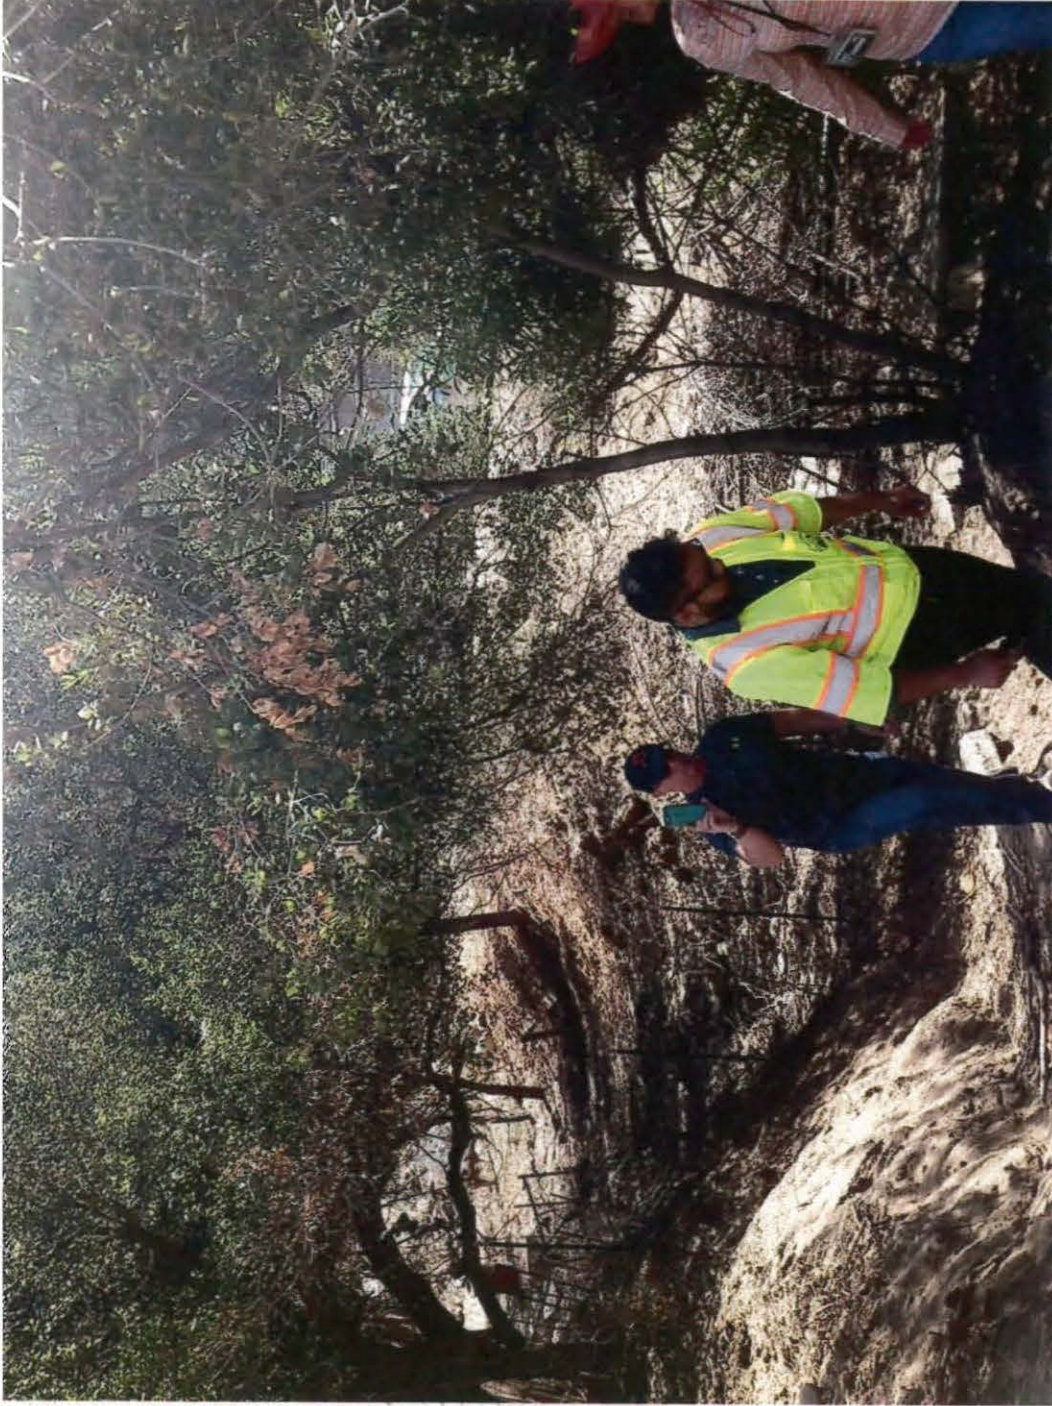
- The Arizona crossing is a dredge and fill activity in a Water of the United States which requires Clean Water Act Section 404 and 401 permitting and which was not permitted.
- Due to the loose silty fill material on the terraced areas and access roads resulting from the grading and landfilling activities, there is a significant sediment storm risk to Ybarra Creek and also to tributaries to Devil's Canyon Creek
- There has been significant grading/filling activities in Parcels 2821-002-023 and 025 beyond the areas inspected by Regional Board staff on March 28, 2014.

Figure 4. Arizona Crossing through Ybarra Creek. (LB Nye)

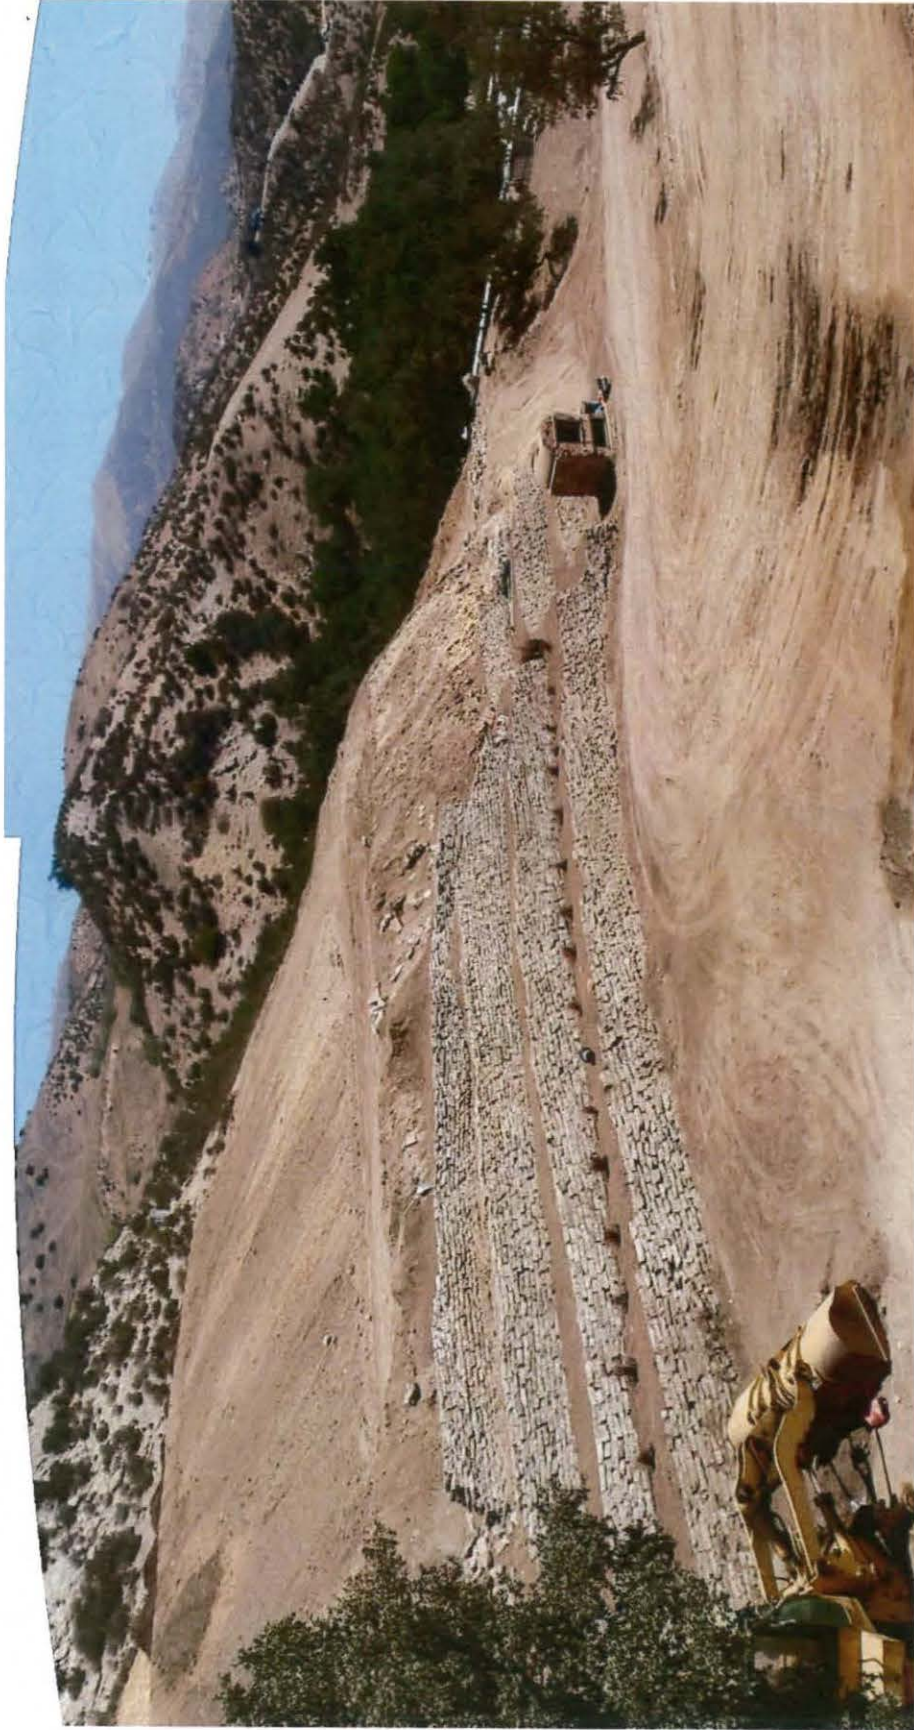
Figure 6. Terracing with concrete. (Enrique Casas)

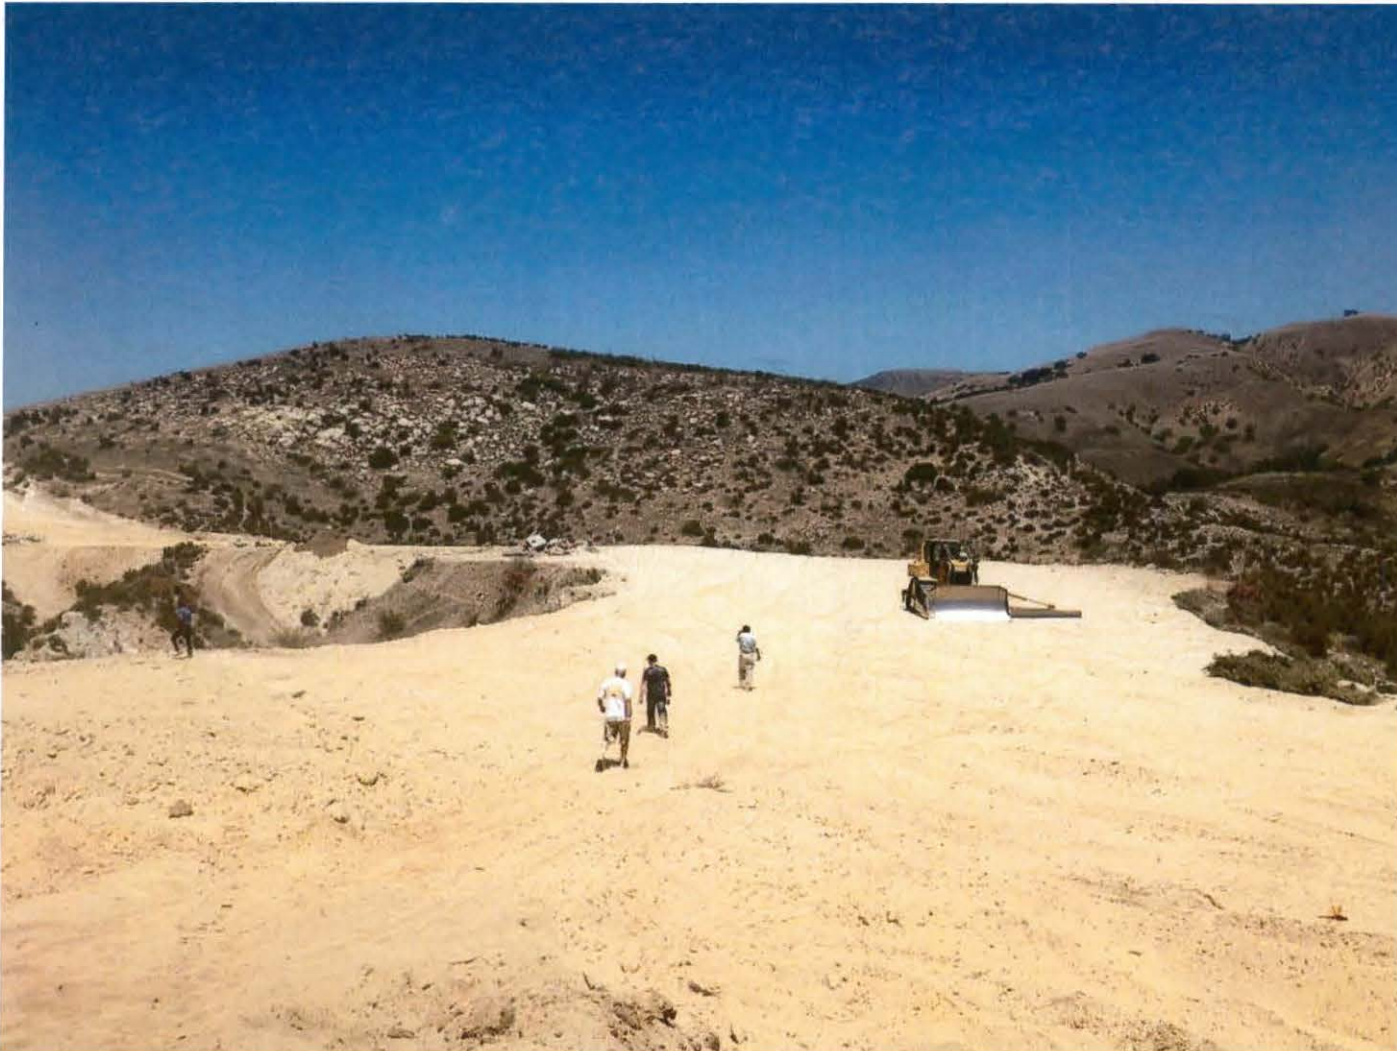
Figure 7. New area of activity for "concrete stockpiling. To the left is a tributary to Browns Canyon and to the right is Ybarra Creek. (LB Nye)

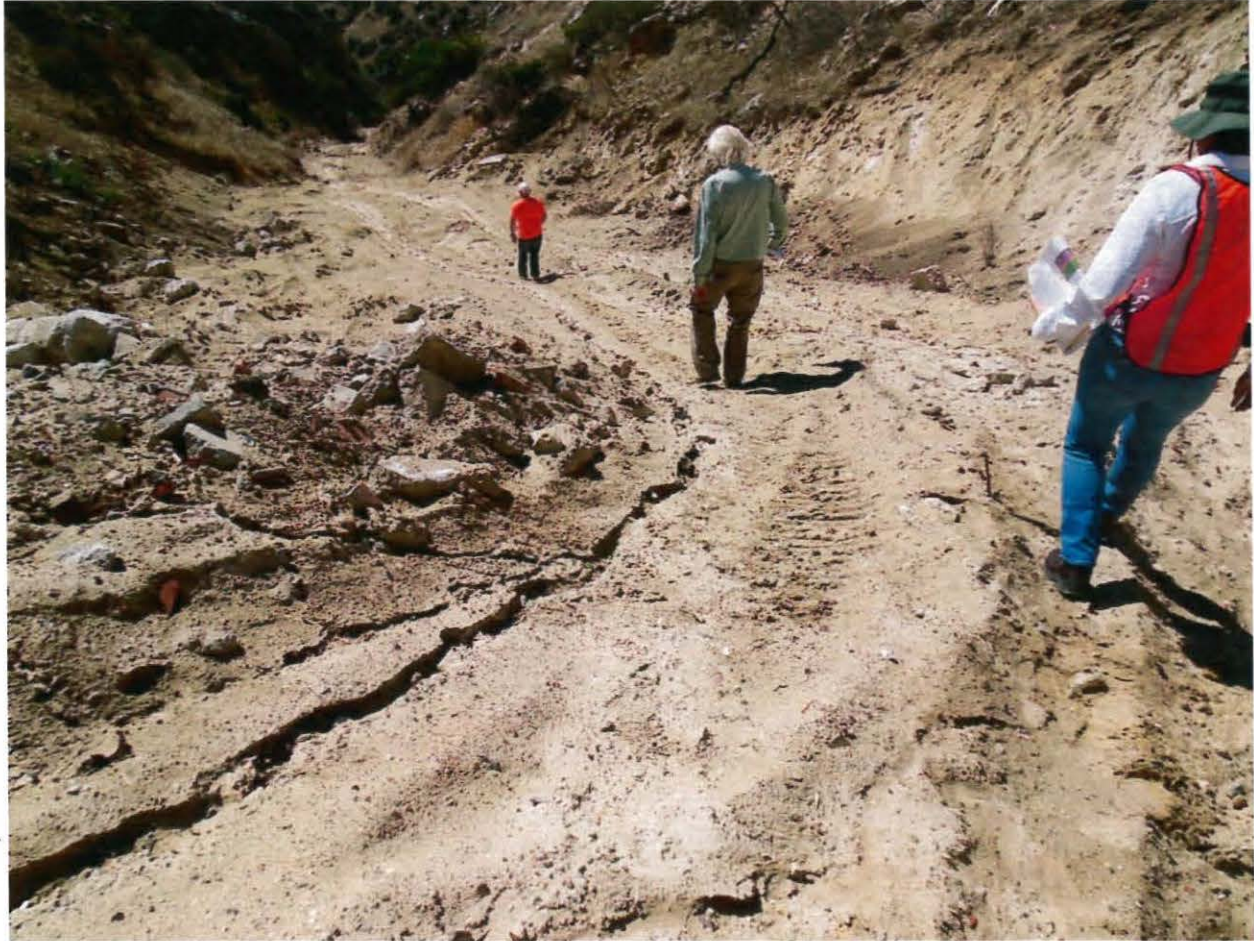
Photo 6. This photo shows the ravine immediately down gradient from the waste stockpile that leads to Ybarra Creek. Note the steep gradient, loose sediment, and rills.

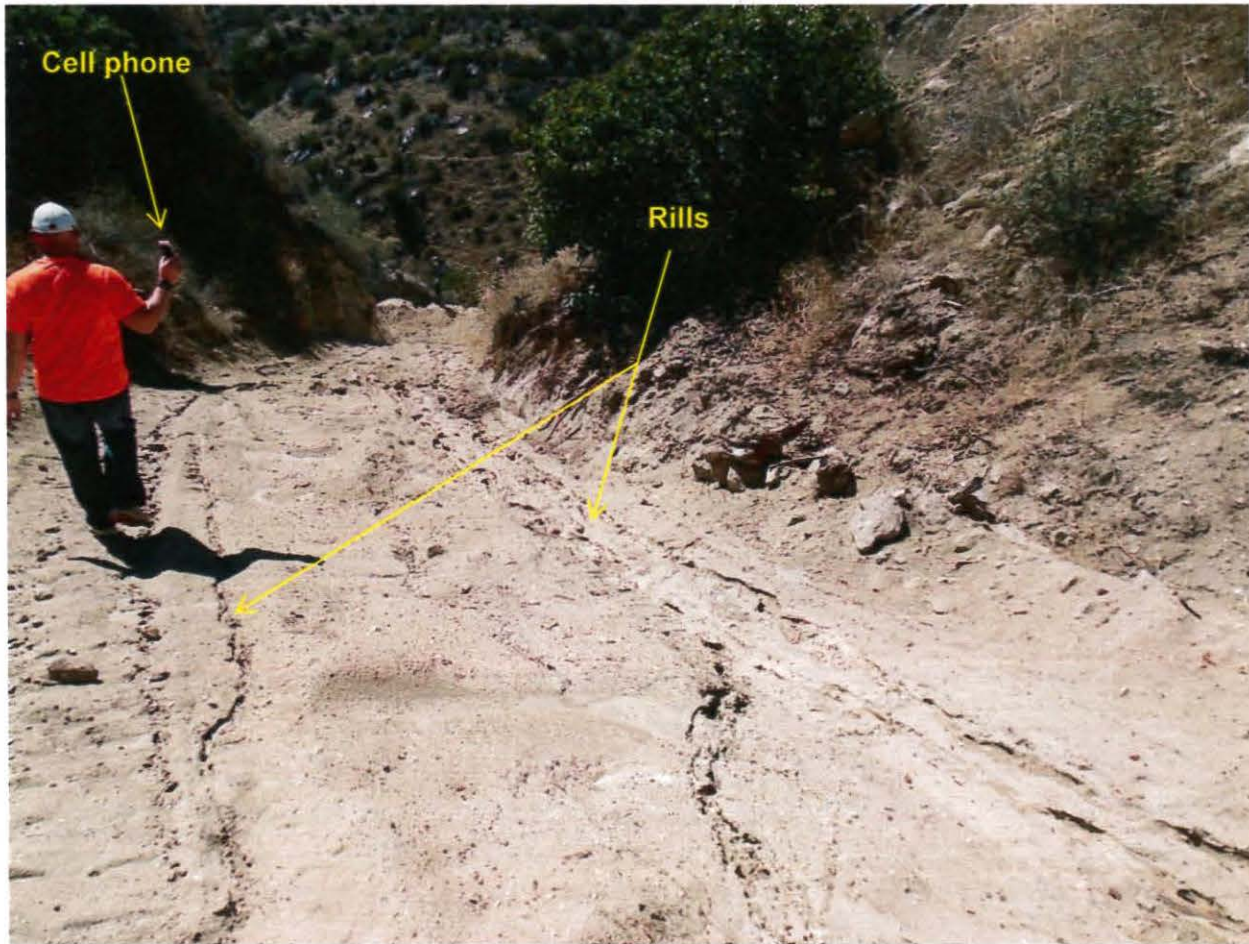
Photo 7. This photo is of Mr. Todd Fishback recording the inspection using his cell phone. In addition, the photo shows rills along the slope flooring the recently graded ravine from the top of the graded area 2 down to a sediment basin (shown in photo 8) above Ybarra Creek.

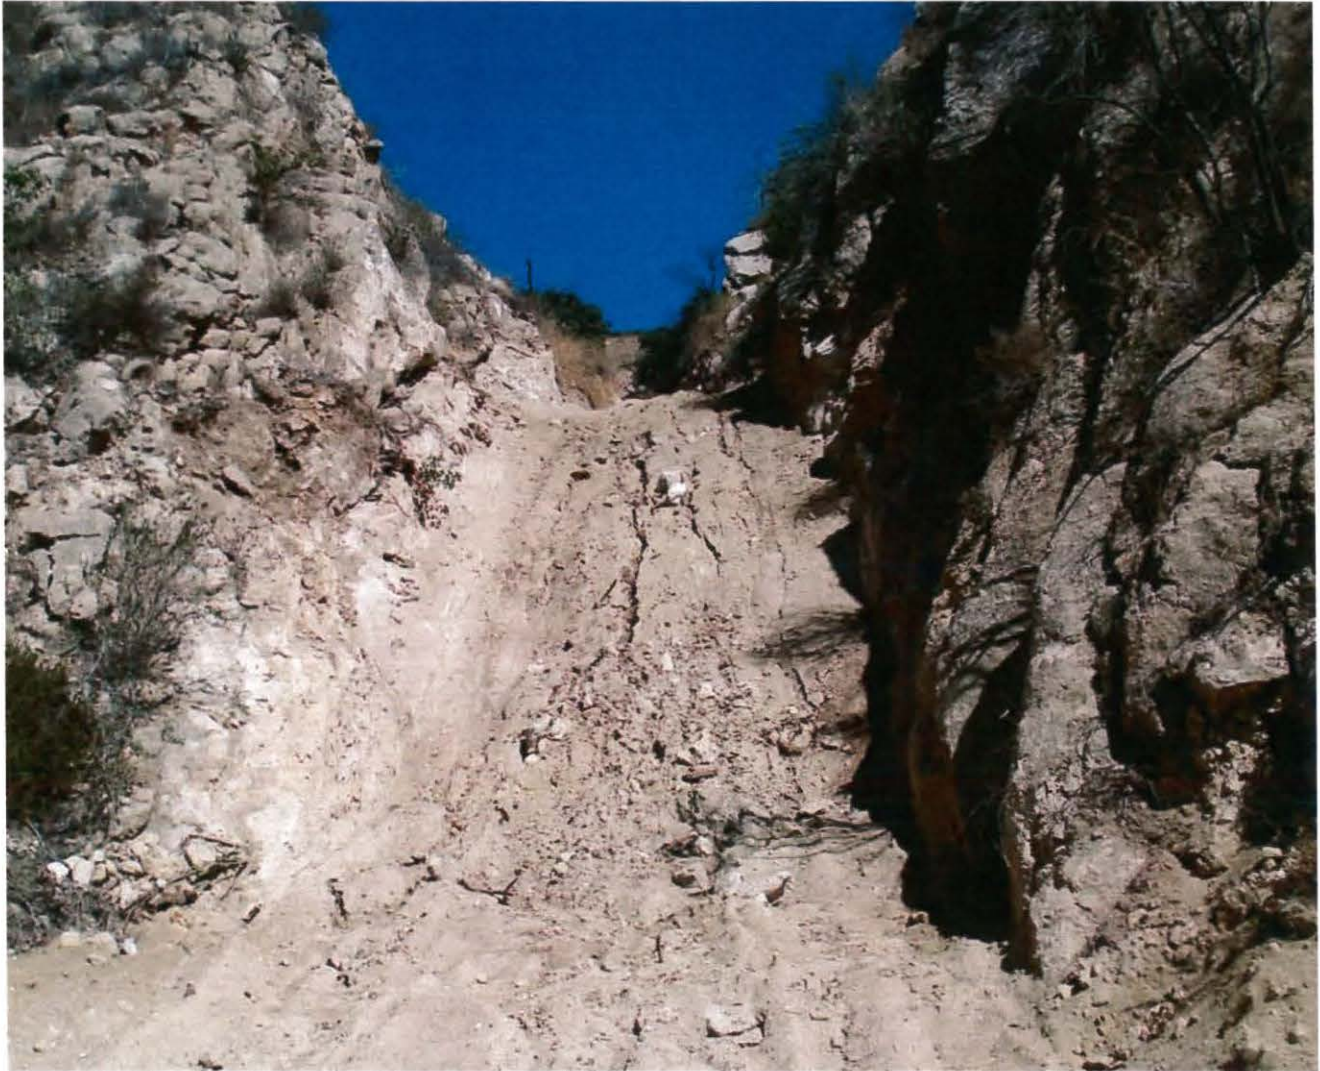
Photo 9. The graded area 2 is so steep that it cannot be freely walked down in places. The steepness and angle of repose entrains some of the material that falls from above, and contained within the steep walls of the ravine.

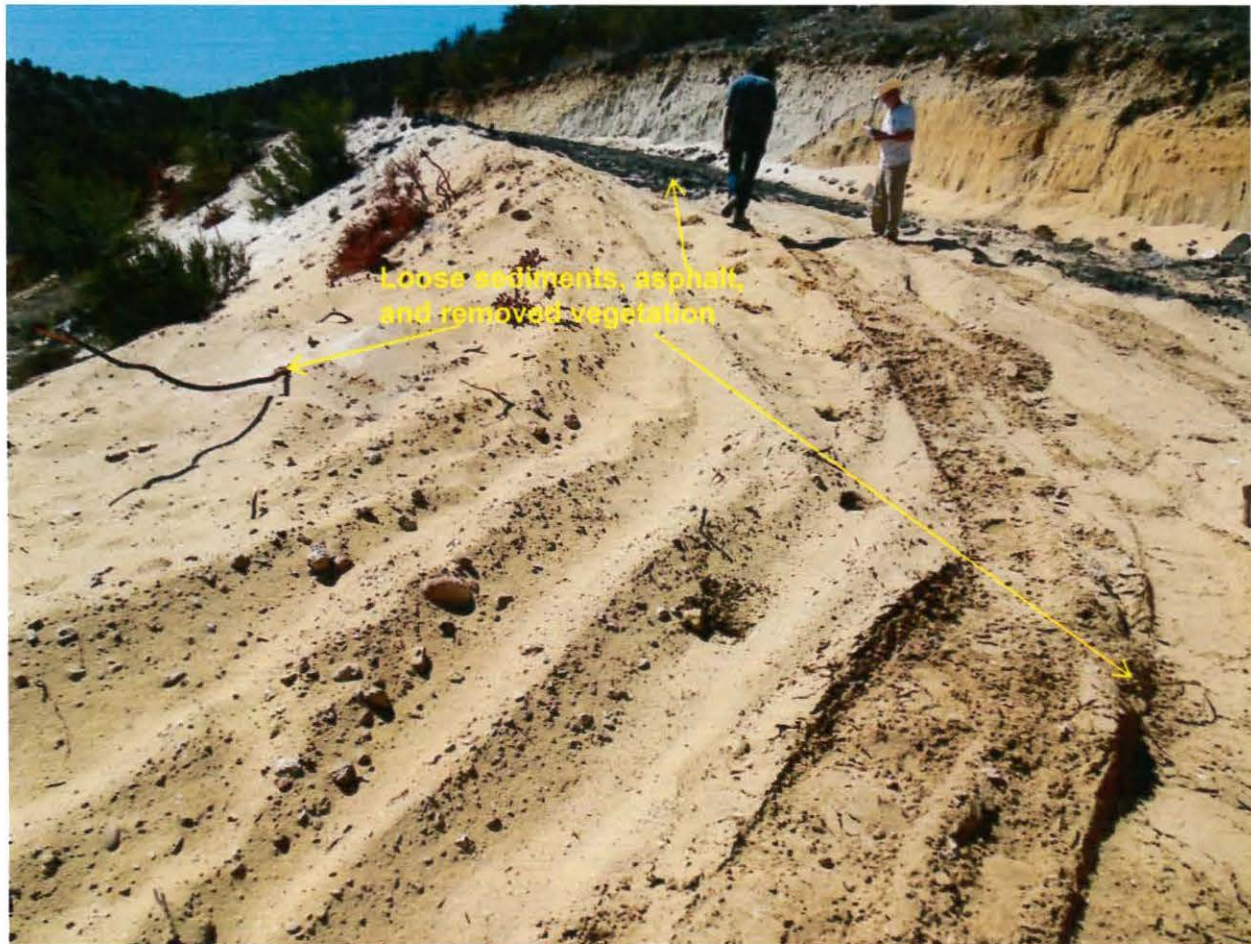
Photo 13. This photo shows graded area 3 with loose sediments, and removed vegetation. Weathered asphalt debris is being used locally to armor/stabilize the roadway.

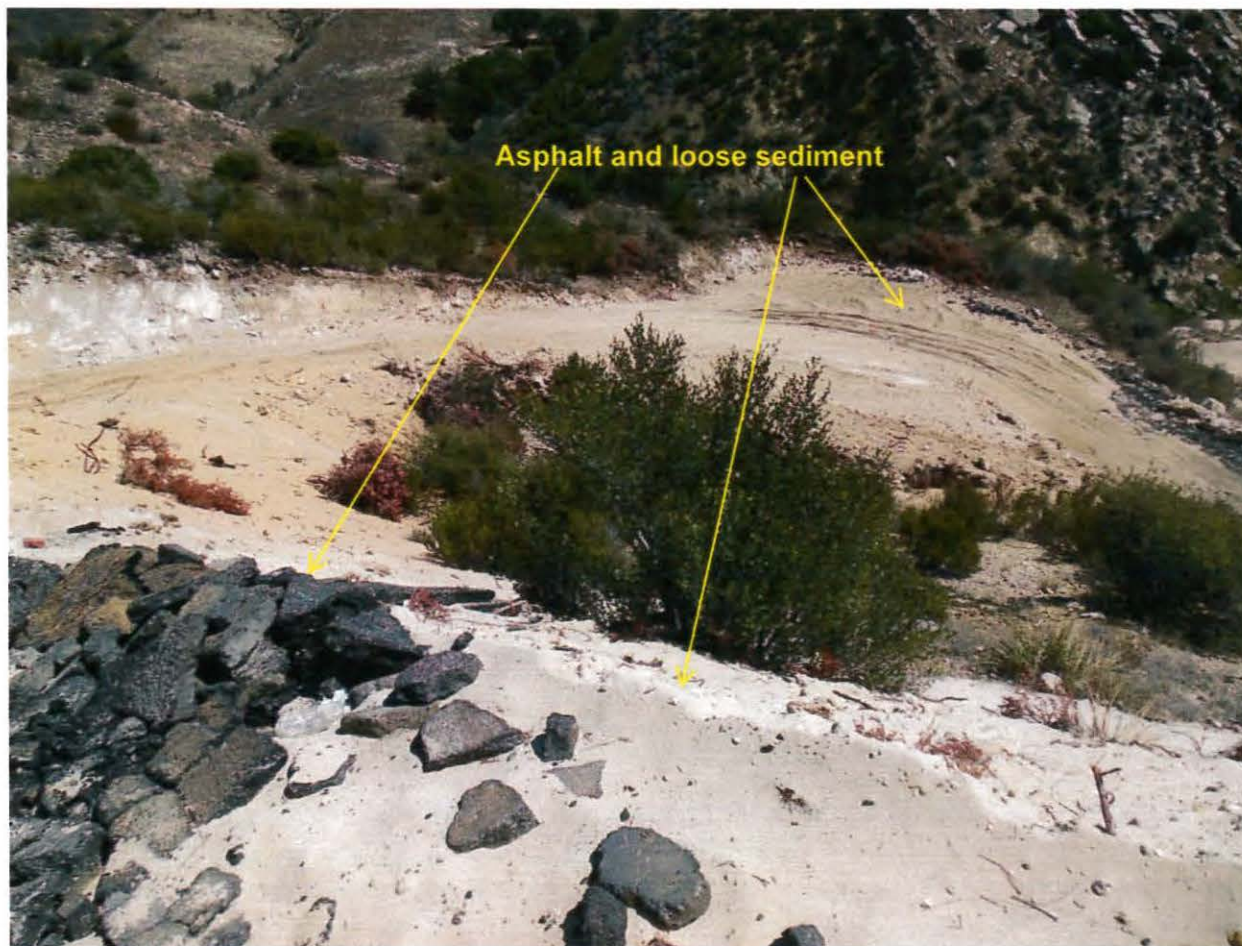
Photo 14. This photo shows pieces of asphalt mixed with soil used to stabilize the roadway, and loose sediments along the road.

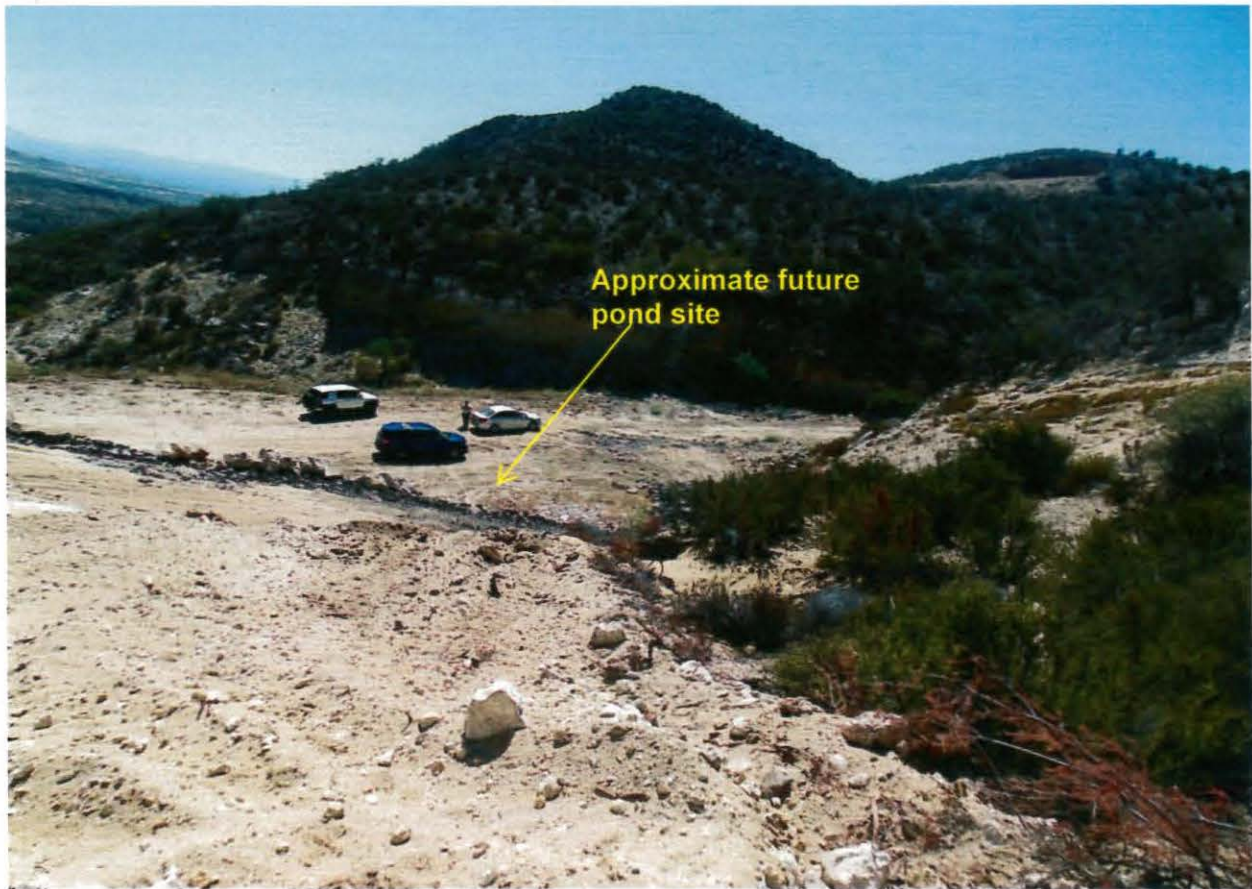
Photo 12. This photo shows graded area 3, and future site of a pond.

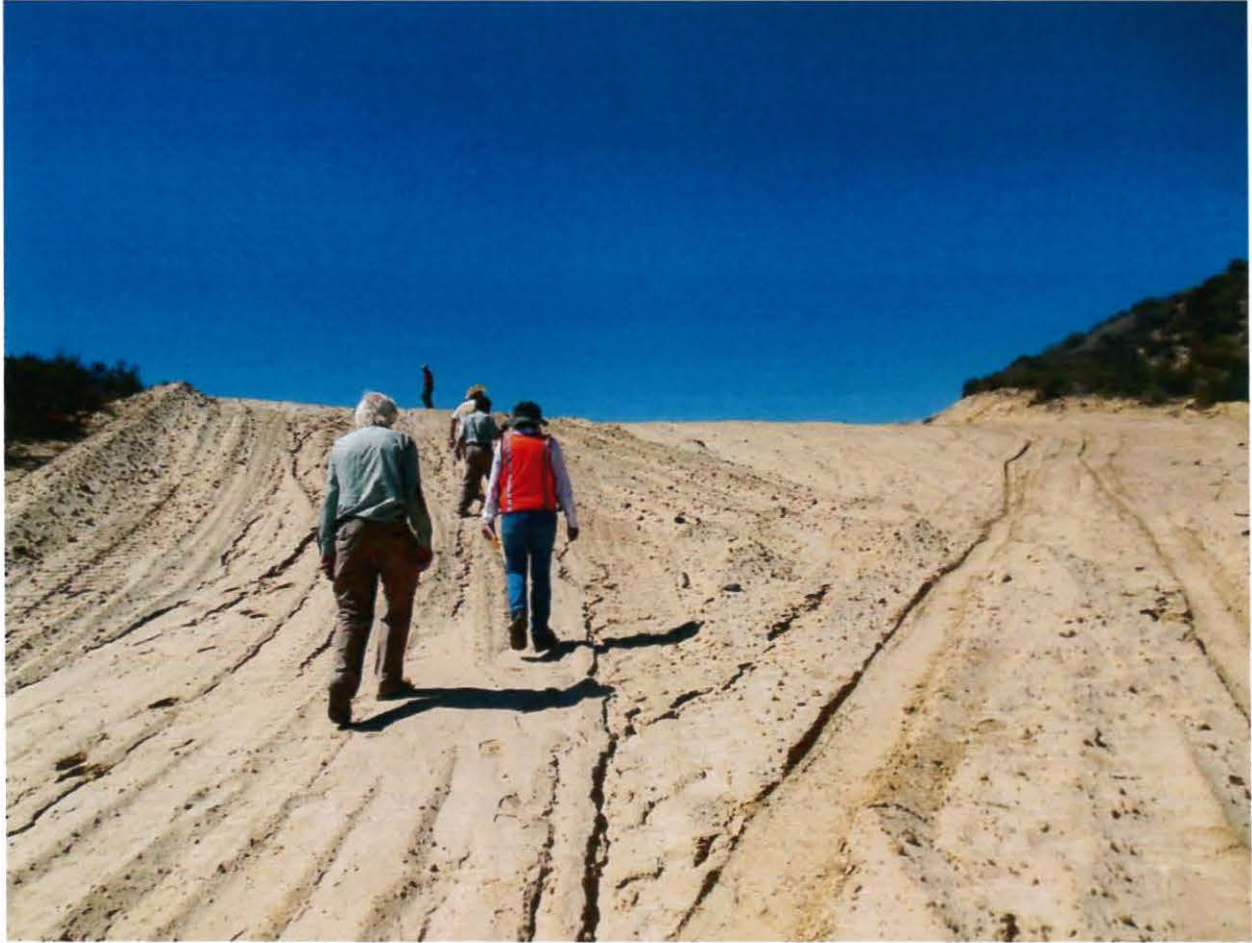
Photo 17. This photo shows another area of graded area 3 with loose sediments and rills.

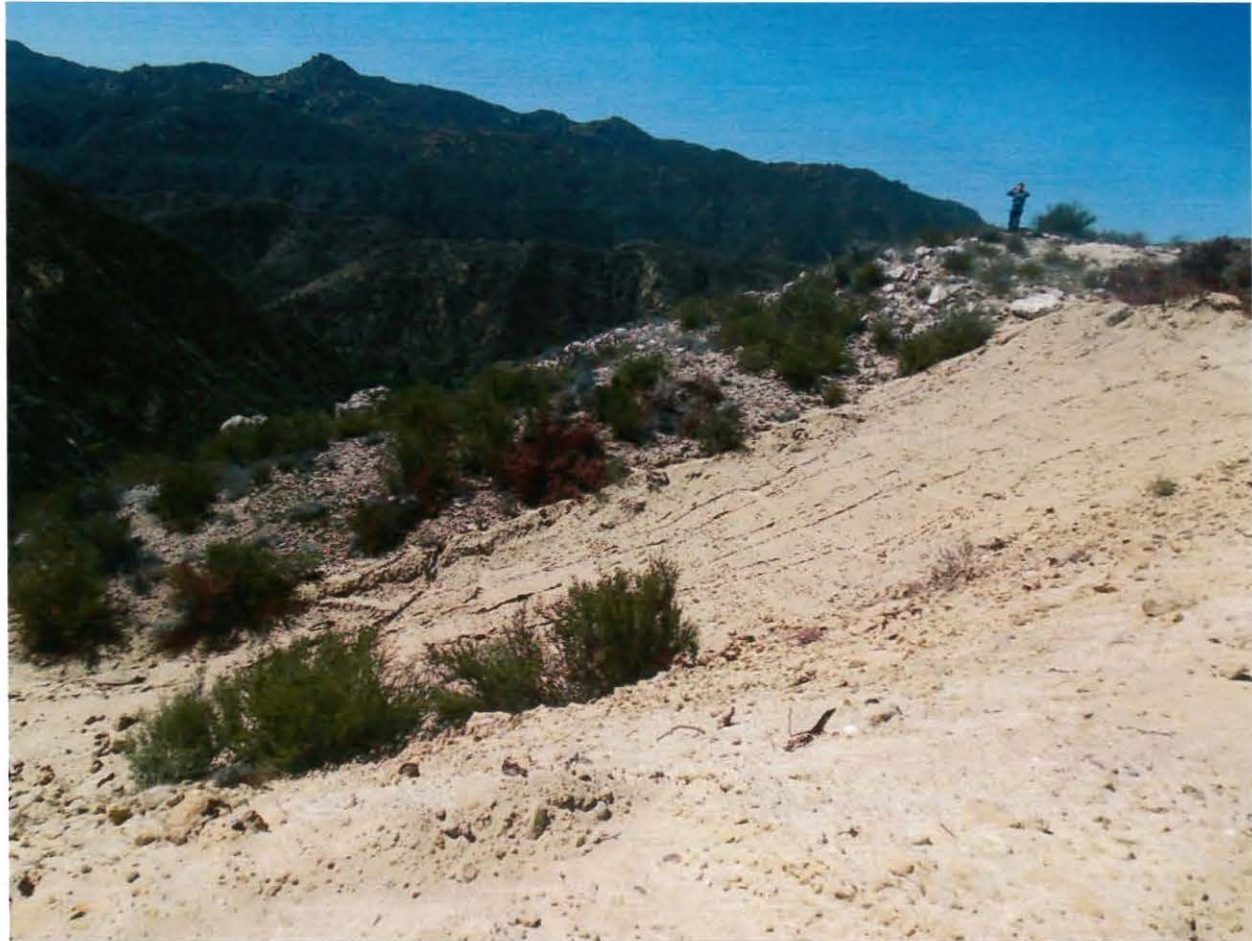
Photo 18. This photograph shows a graded area where vegetation was removed.
