**2014 and 2015 Inspection Reports
by Regional Board Staff**

March 28, 2014 Inspection Report

SUBJECT: INSPECTION OF AREAS OF FILL OR PLANNED FILL TO DETERMINE PRESENCE OF WATERS OF THE STATE OR WATERS OF THE UNITED STATES

May 4, 2015 Inspection Report

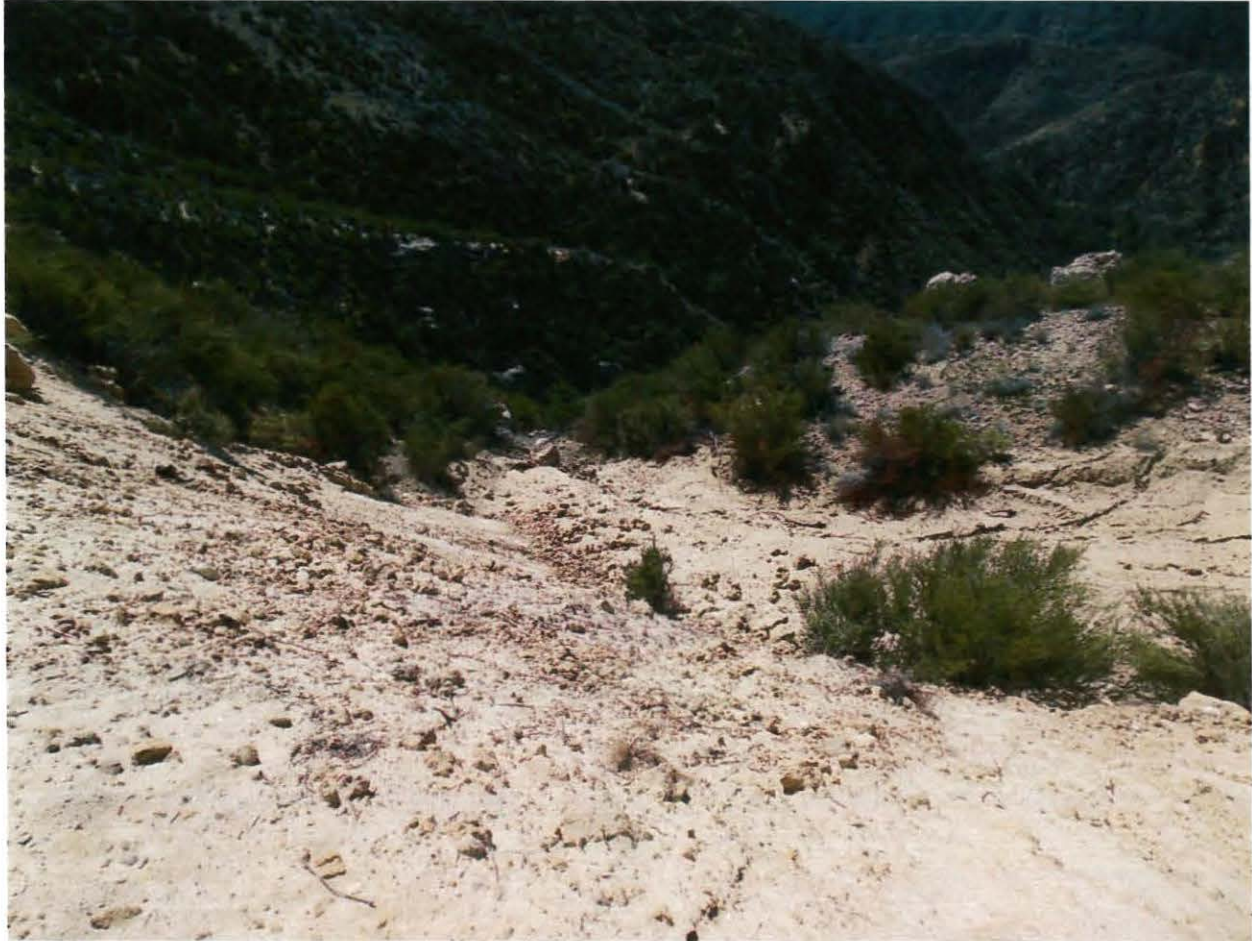
Photo 19. This photograph shows the down gradient of photo 13, above. This area has loose sediment without best management practices (BMPs), and poses a potential for loose sediments to dislodge into the canyon below.

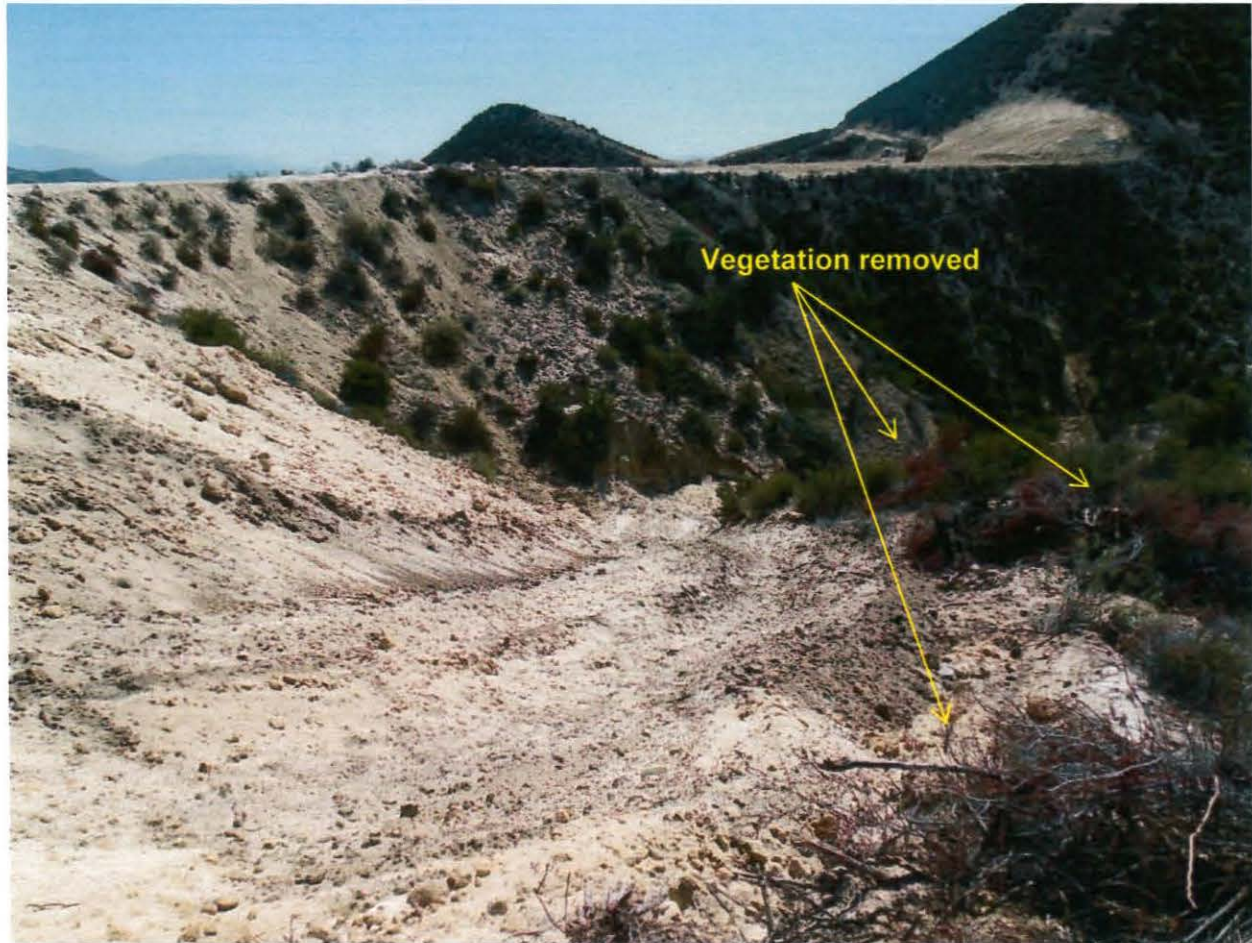
Photo 20. This photo is another view of photo 14, above. In addition, this photo shows vegetation that has been removed and pushed down to canyon walls.

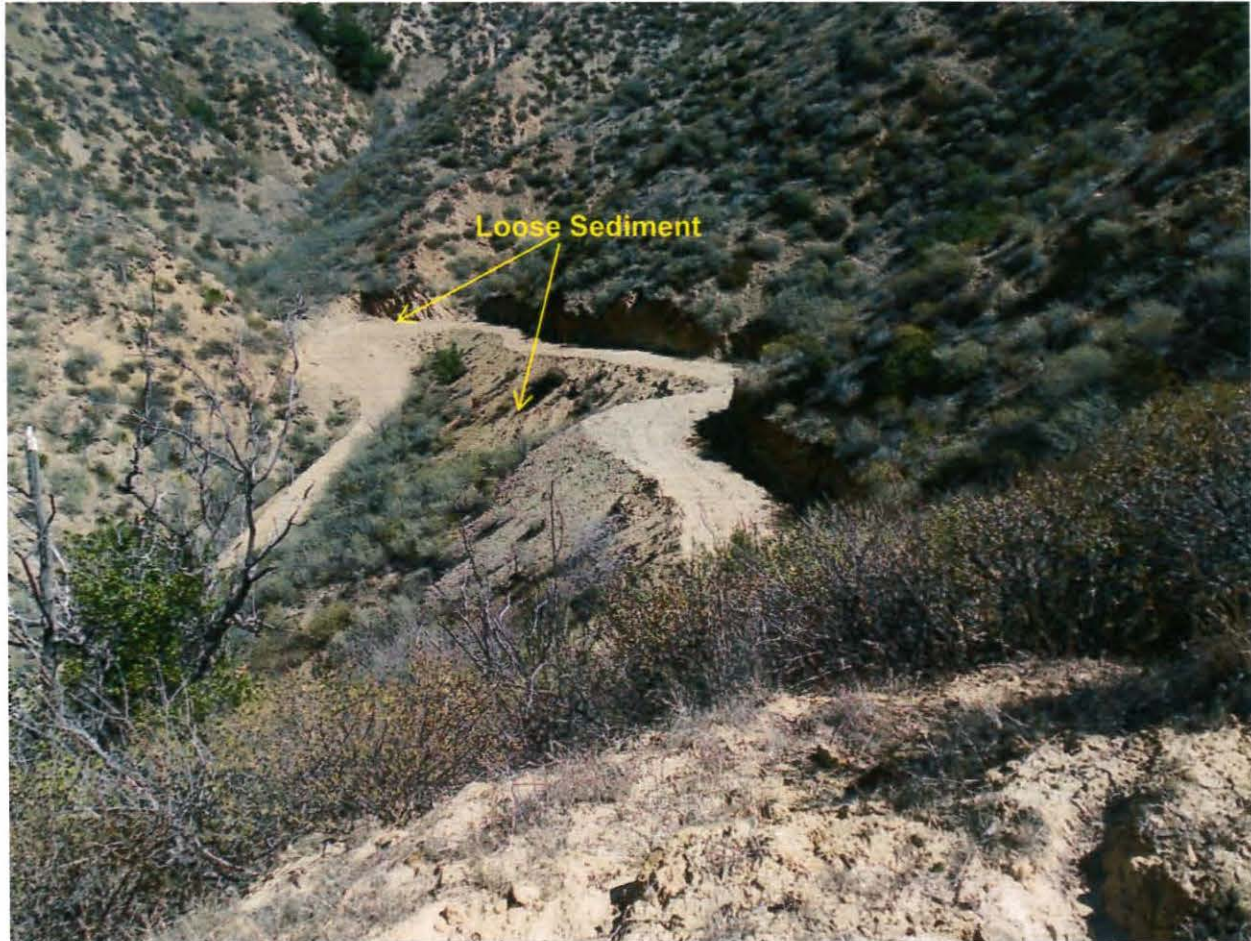
Photo 22. Road leading to Devils Creek with loose sediment and without BMPs.

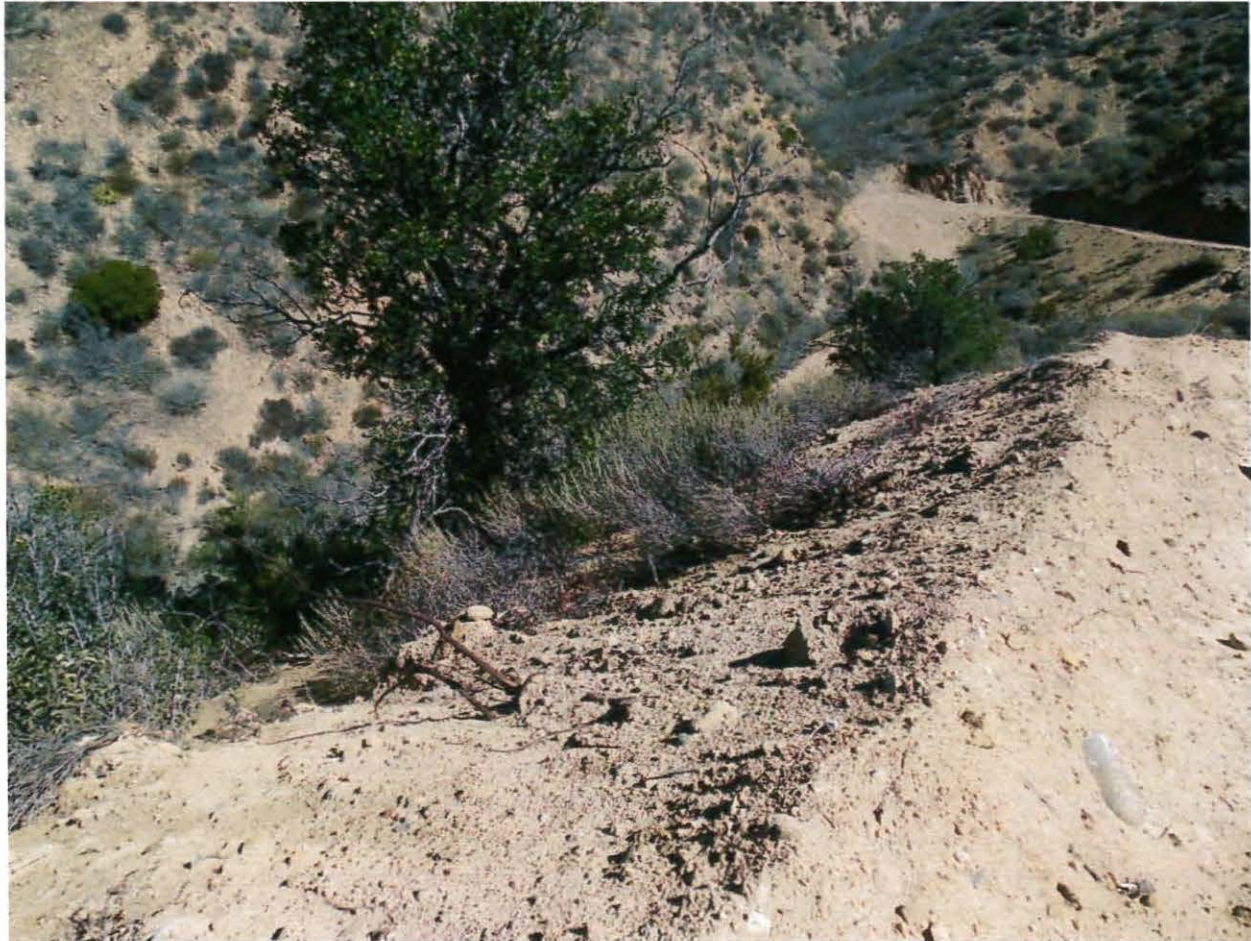
Photo 23. This photo show another view of the loose sediments along the road leading into Devils Creek.

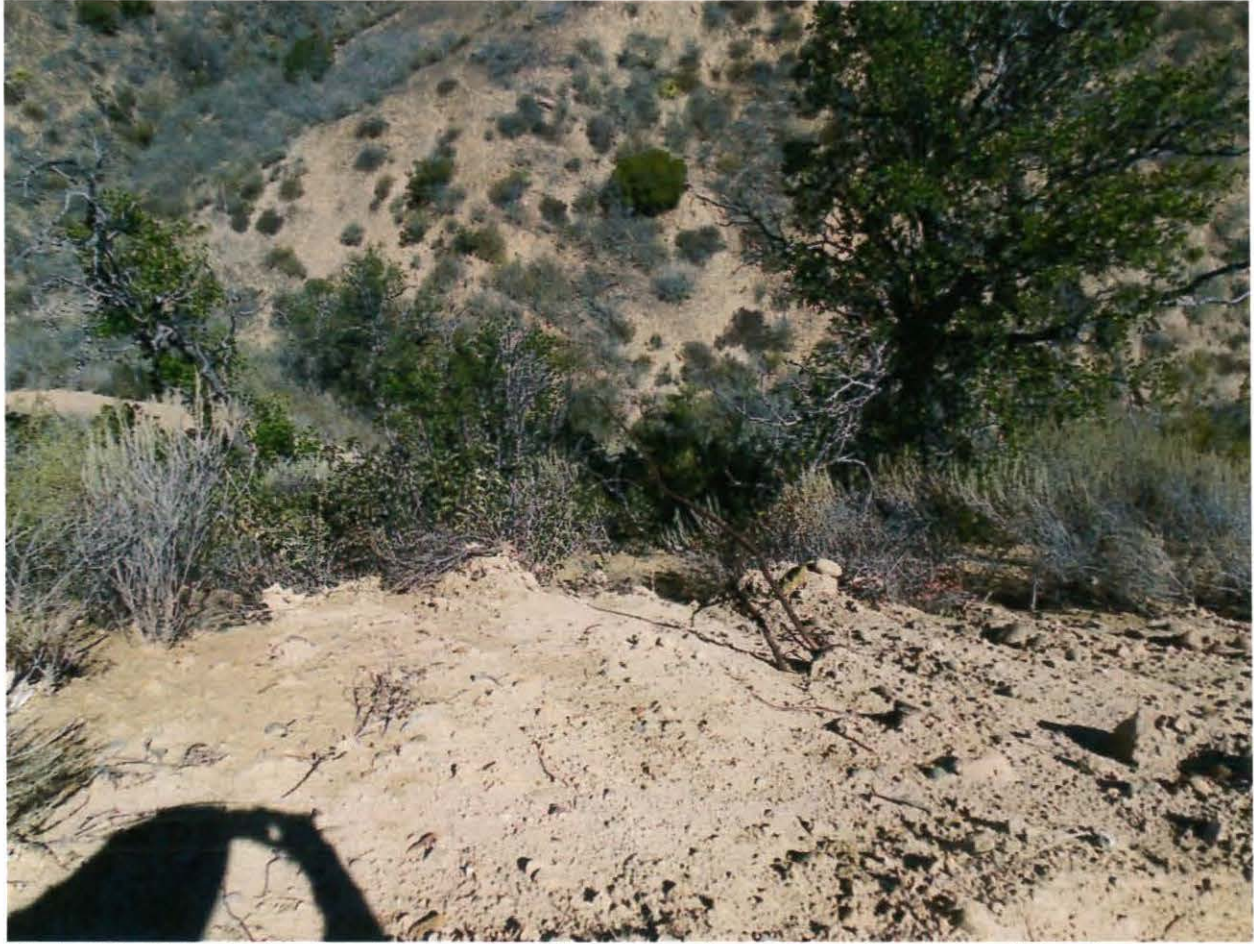
Photo 24. This photo show loose sediments eroding down Devils Canyon and Creek.

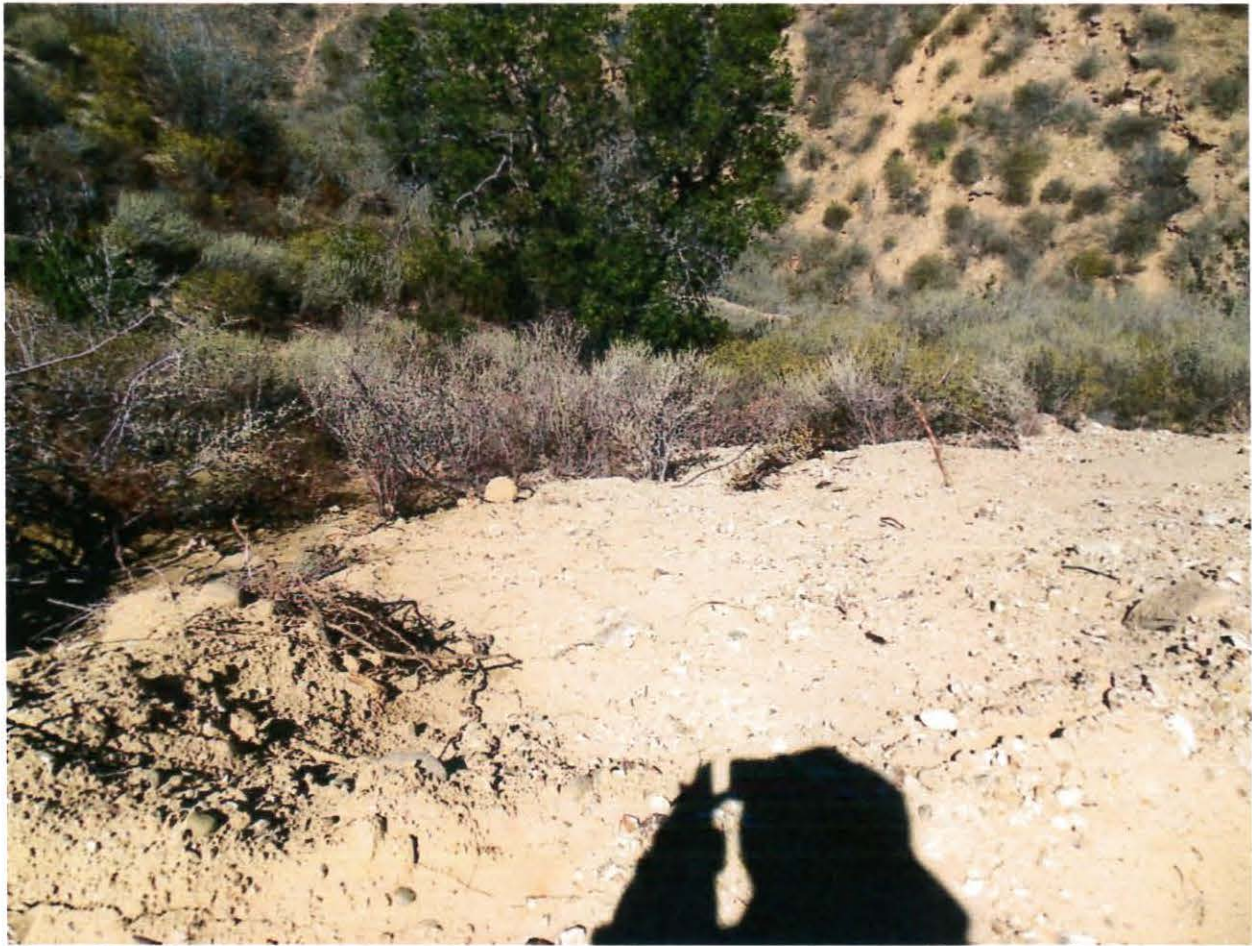
Photo 25. This is another photo of the road leading to Devils Creek with loose sediment and without BMPs.

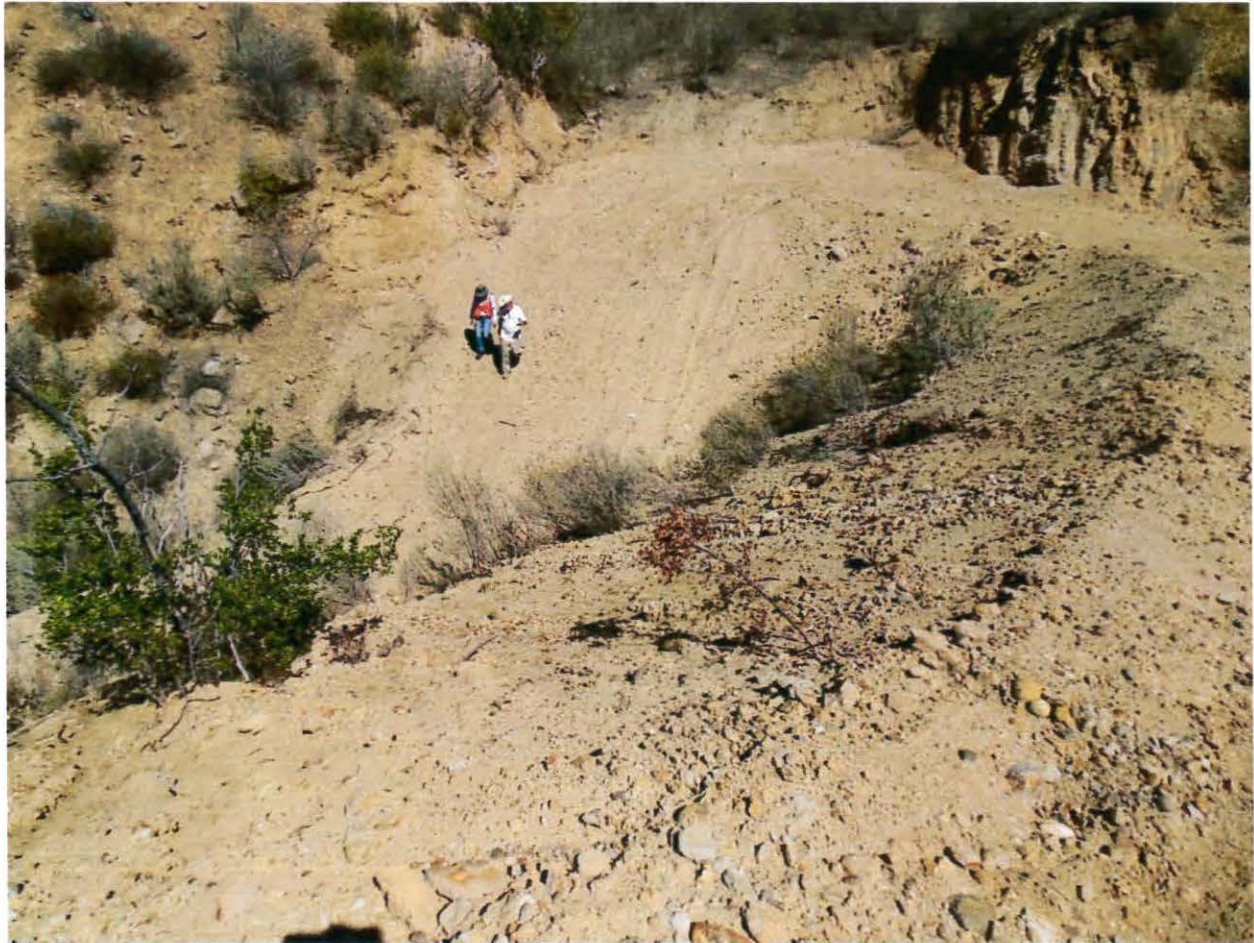
Photo 26. Existing road leading to the Devils Creek and Canyon with loose sediments.

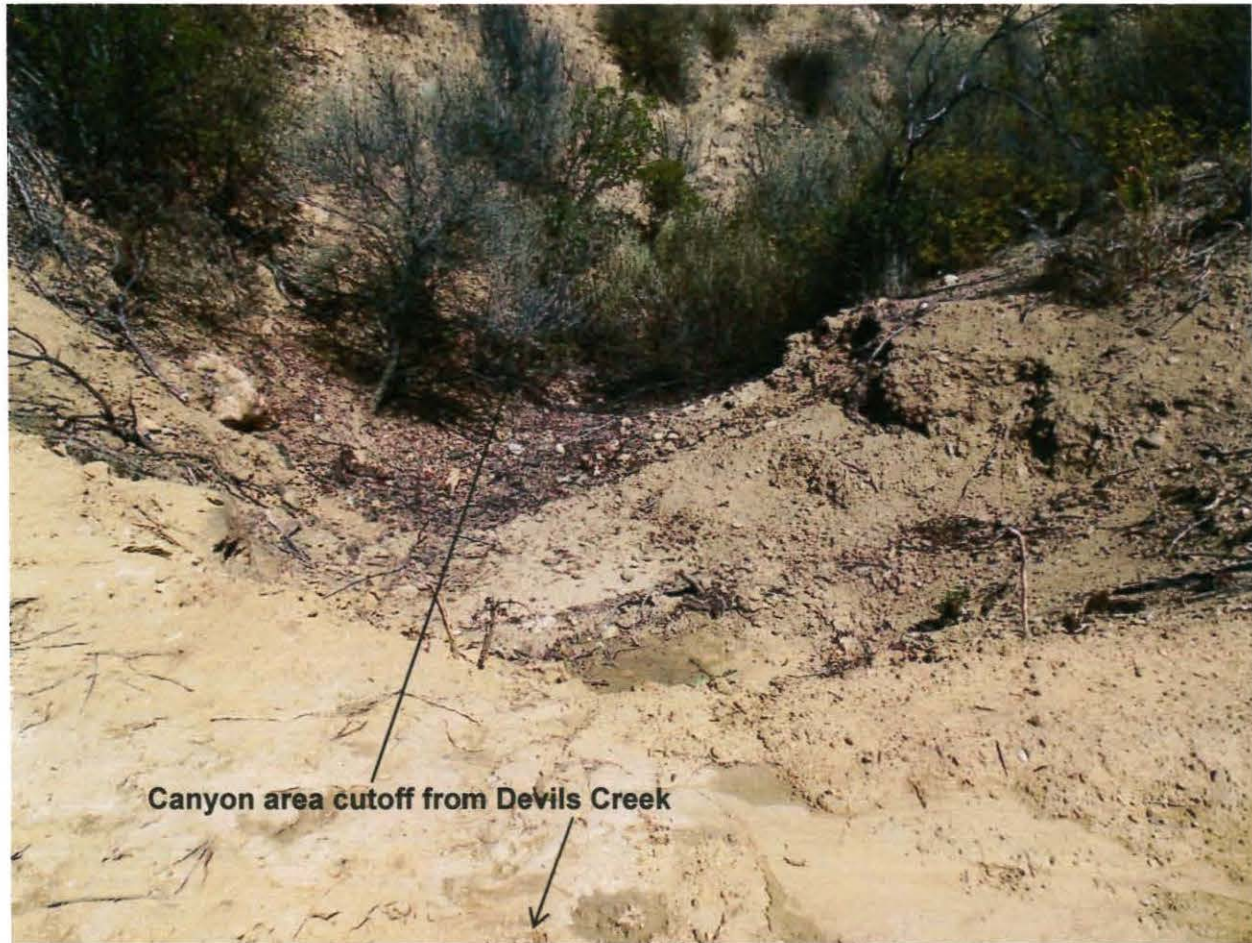
Photo 27. The sediment observed on the road from previous photos (17-21) is collected in a small area above Devils Creek. A road cuts off this area and it is a future site of a pond.

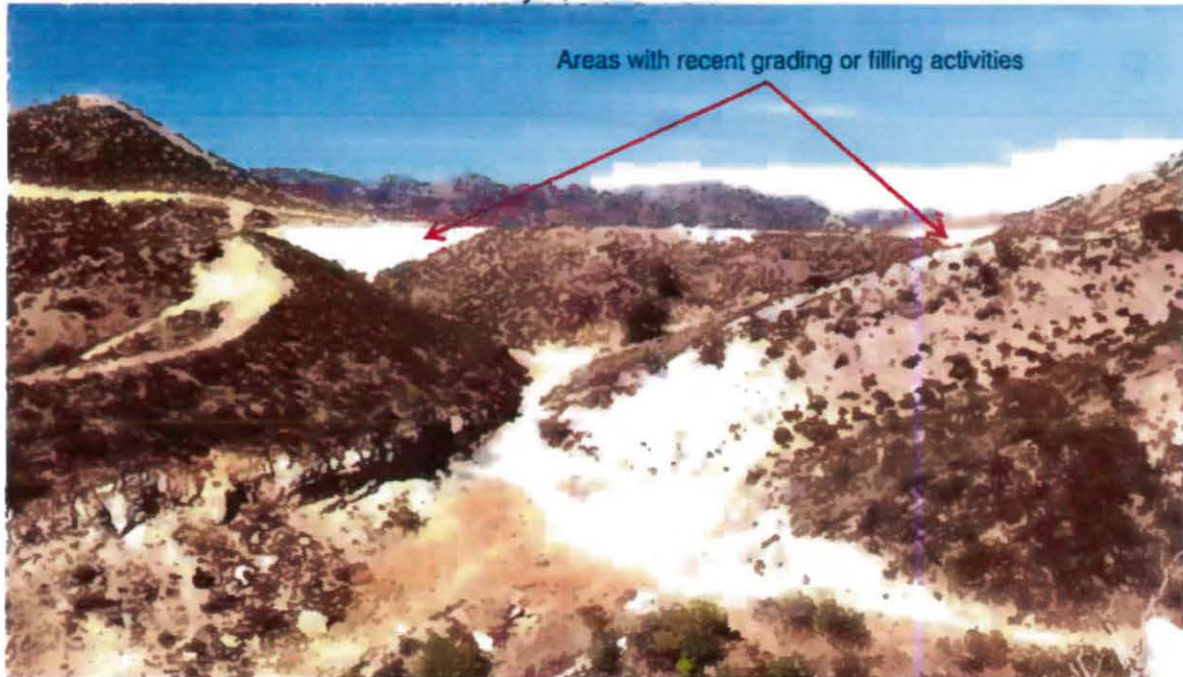
Figure 2: APN 2821-002-025, show areas that had been graded or filled since May 4, 2015.

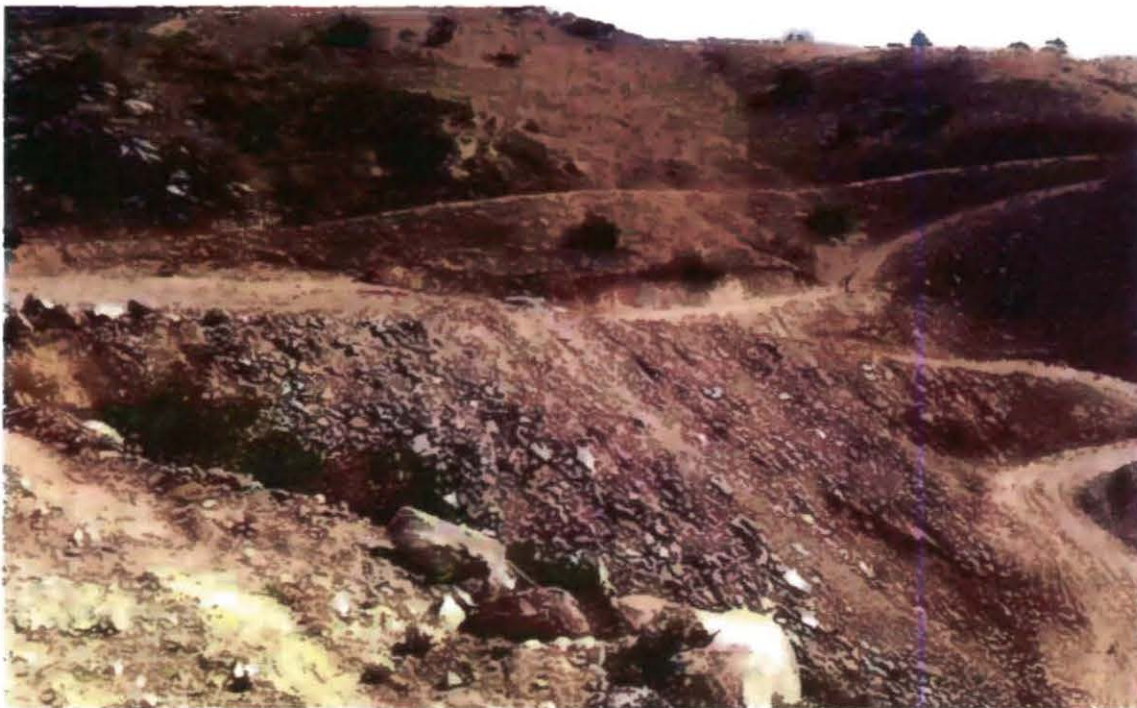
Figure 3: APN 2821-002-023. No significant changes were observed in this area, comparing to what was observed during the inspection on May 4, 2015.
