# ***East Bay Regional Park's***

***Blue-Green Algae – Cyanobacteria – CyanoHAB Monitoring Program***

*Hal MacLean  
Water Management Supervisor*

*HAB Workshop Trudeau Center*

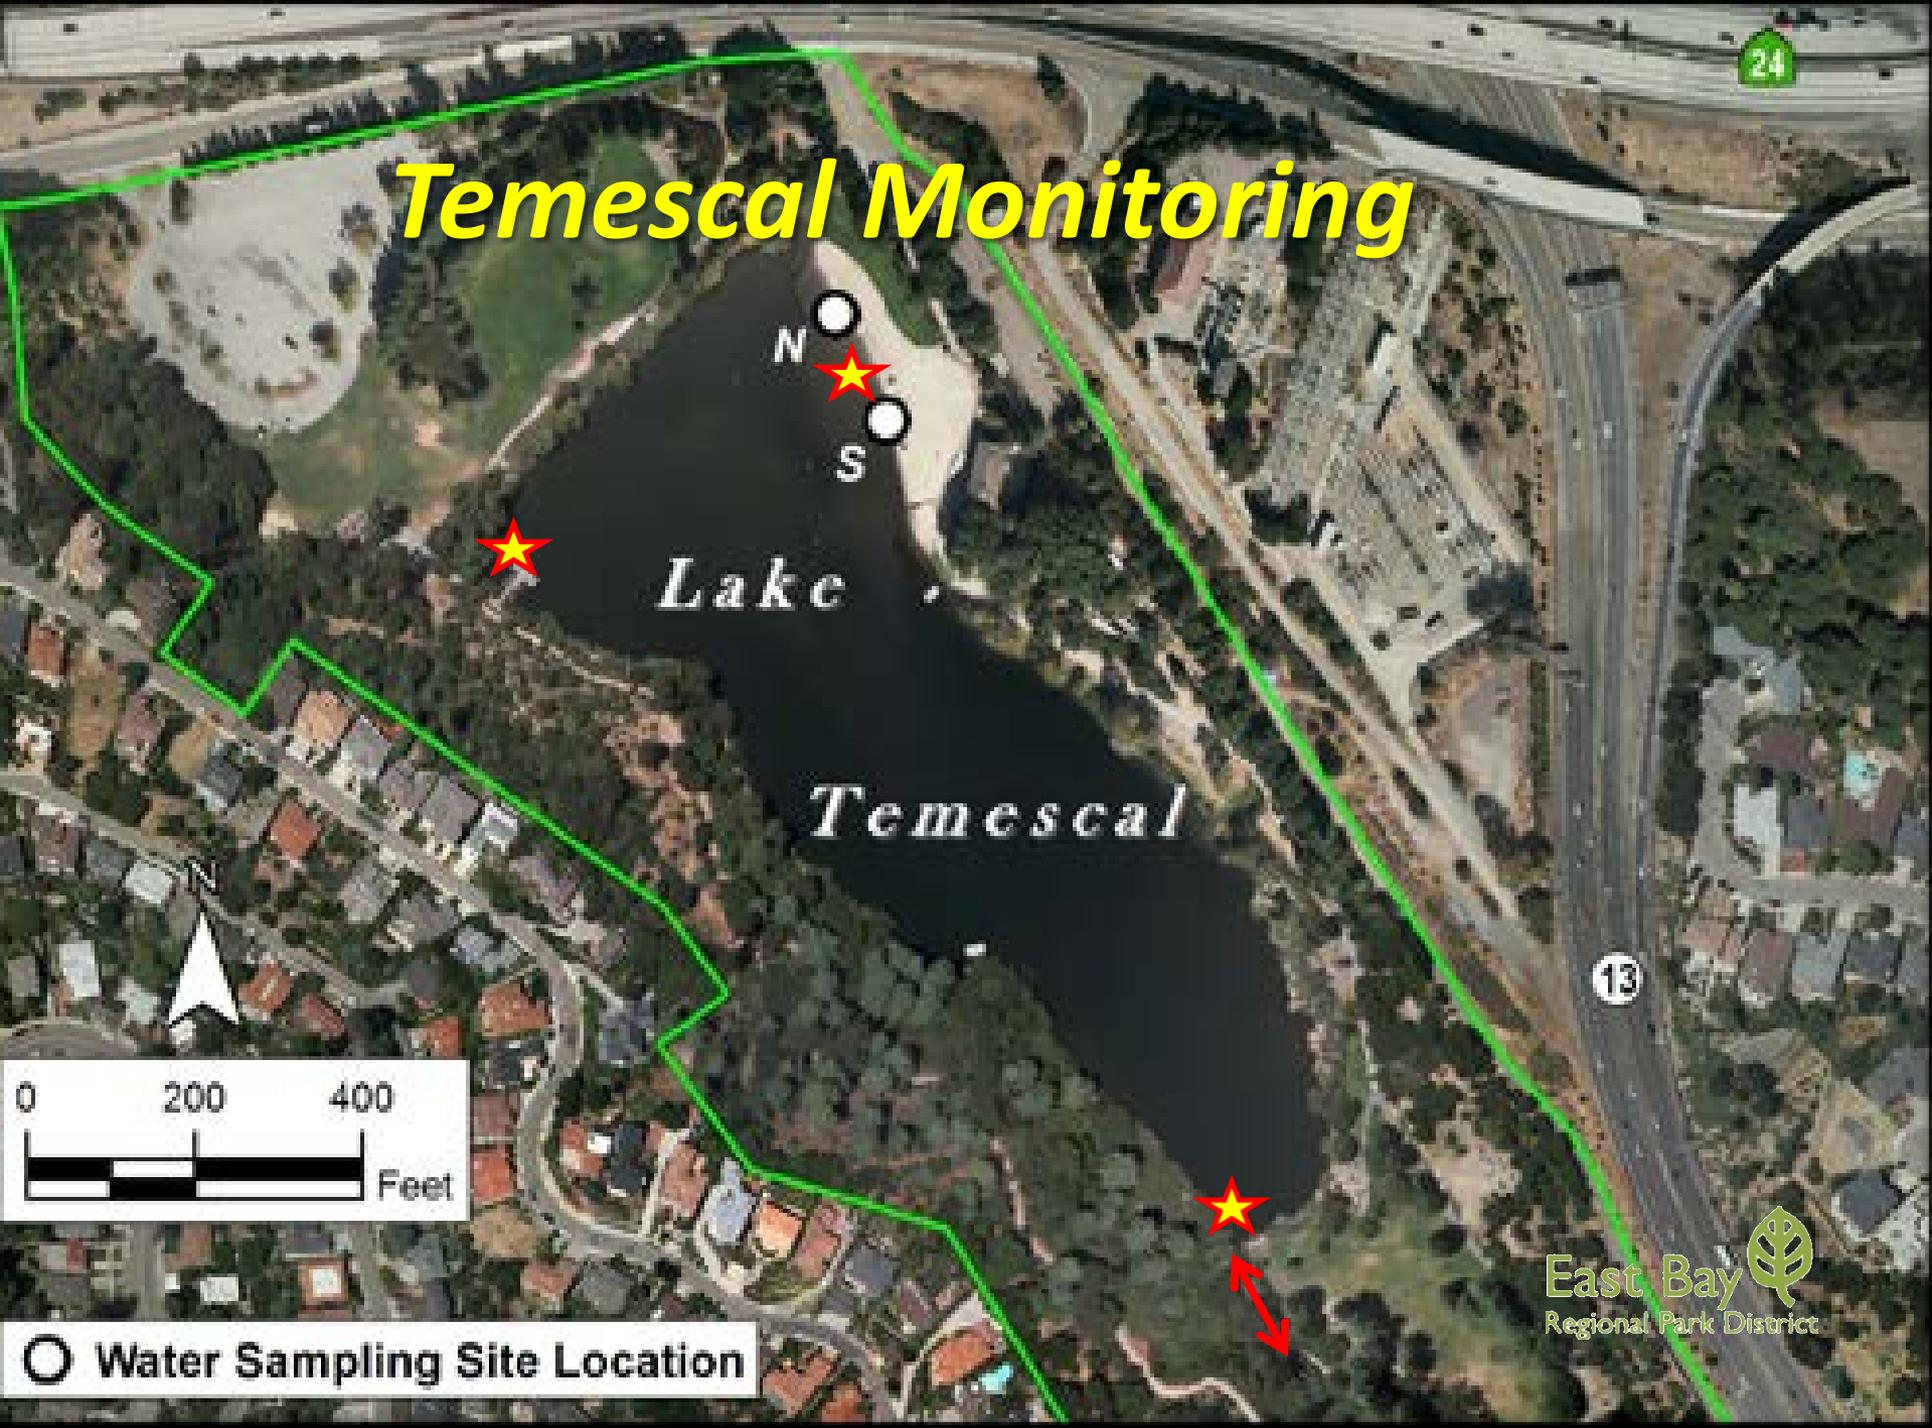
Lake  
Temescal

# *Temescal Monitoring*

○ Water Sampling Site Location

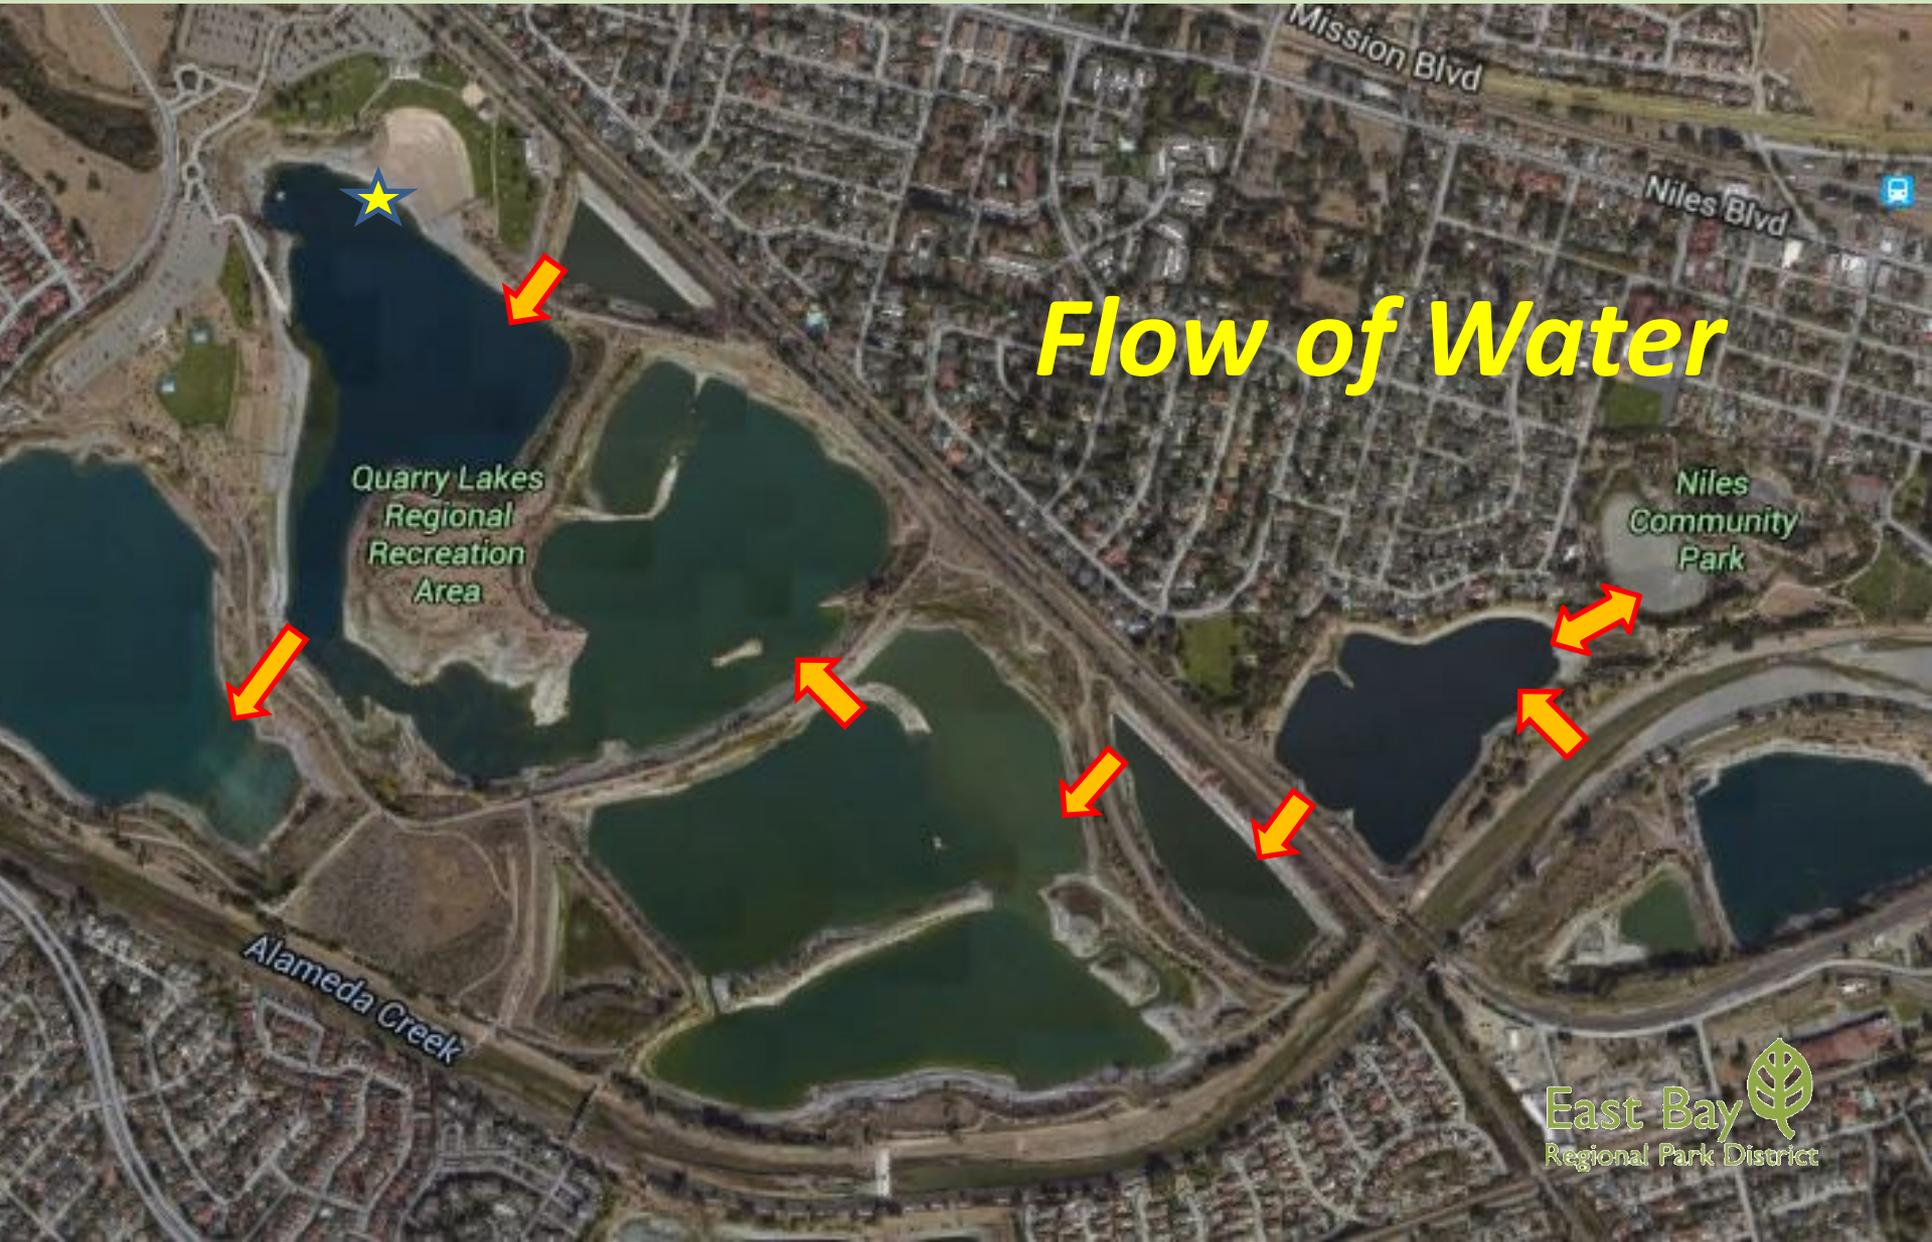
# Quarry Lakes Challenge

*Flow of Water*

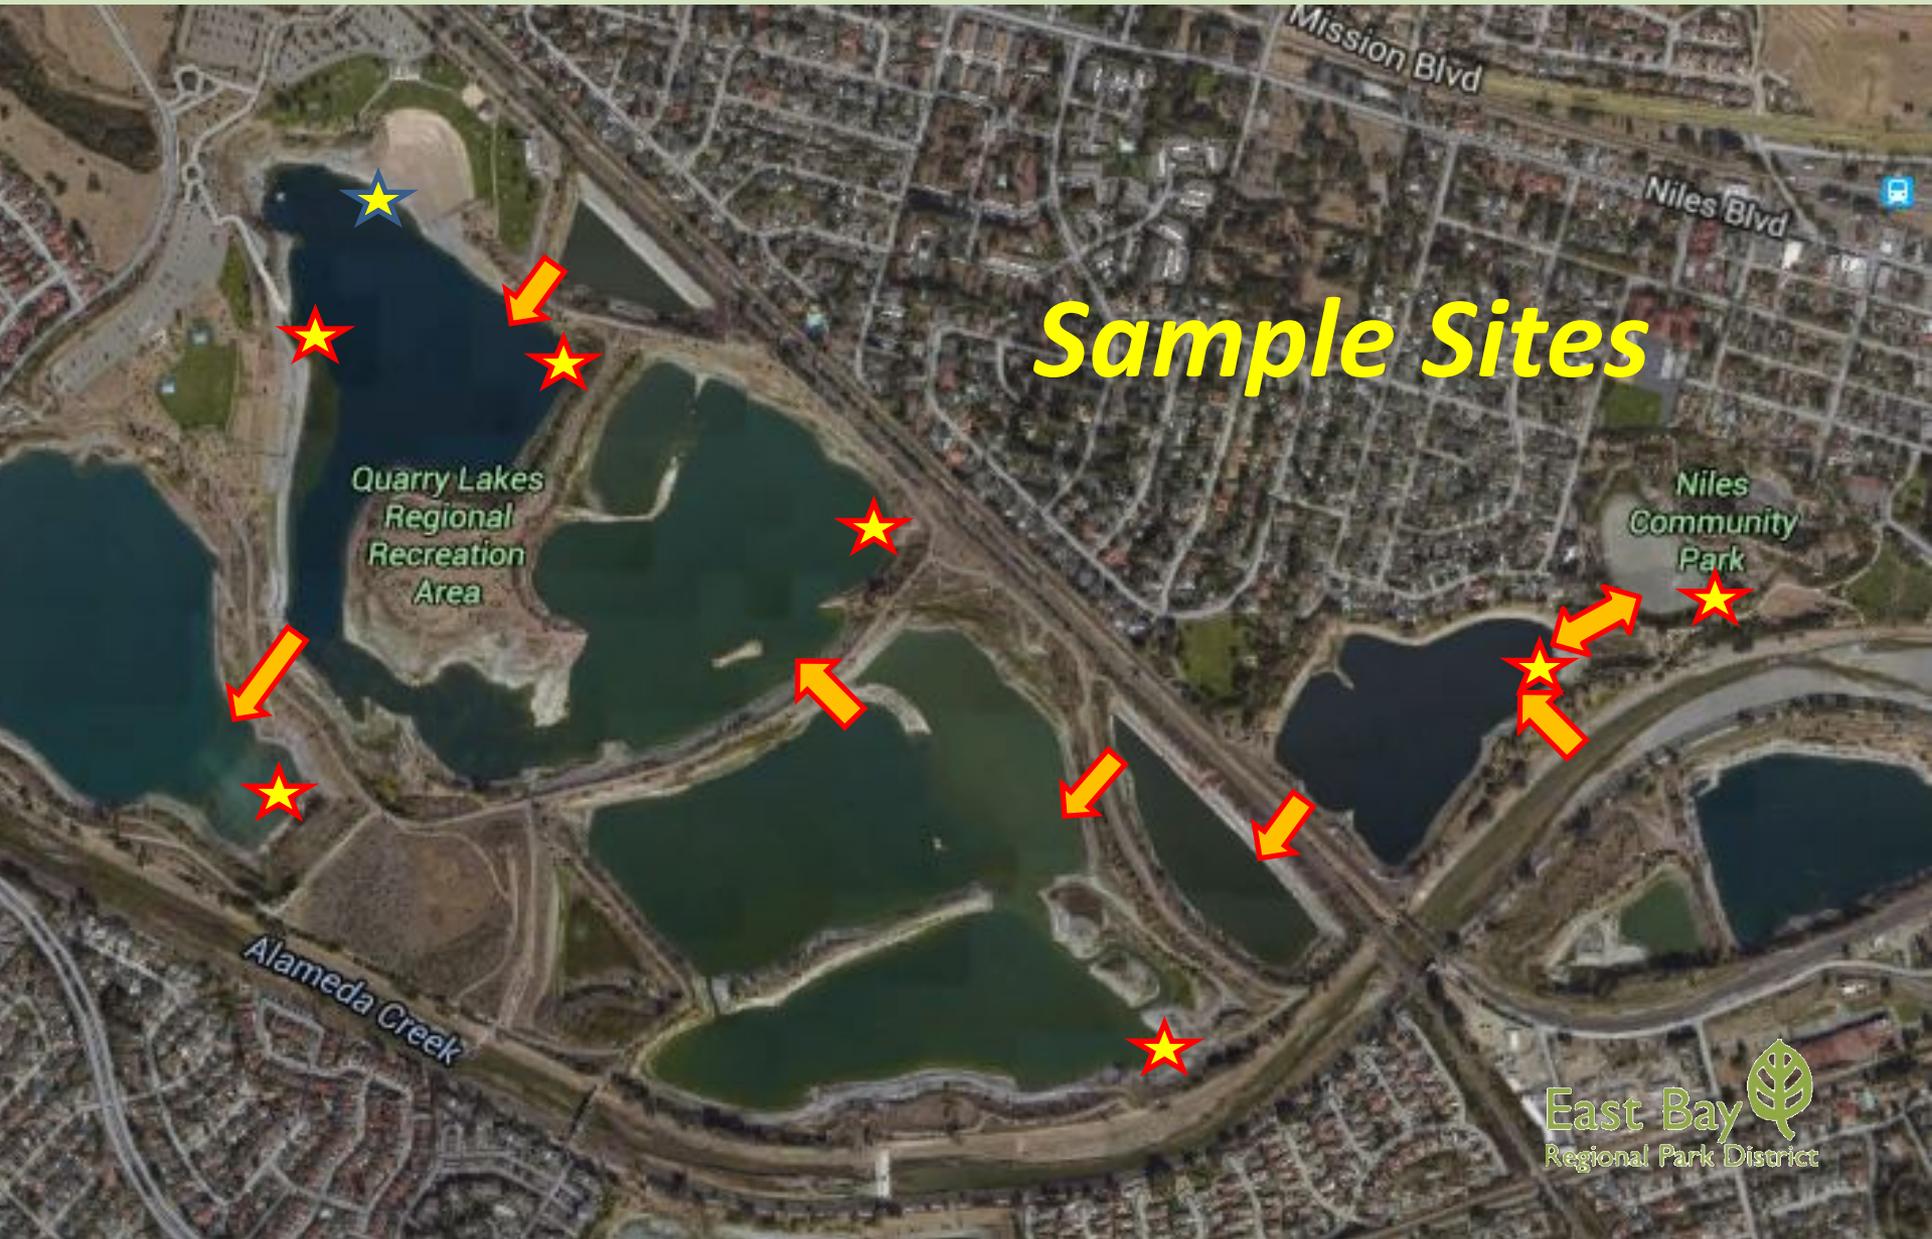
# Quarry Lakes Challenge

**Sample Sites**

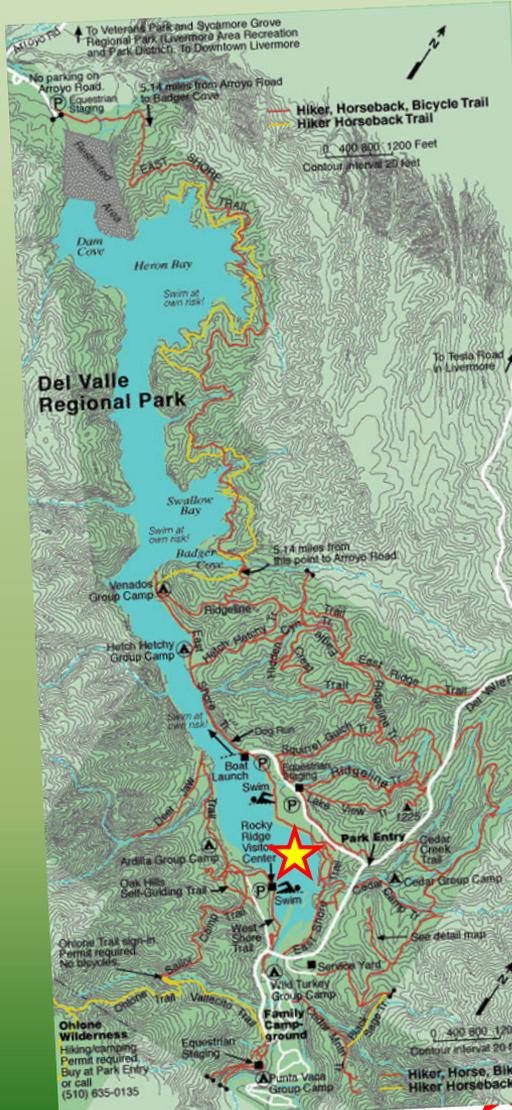
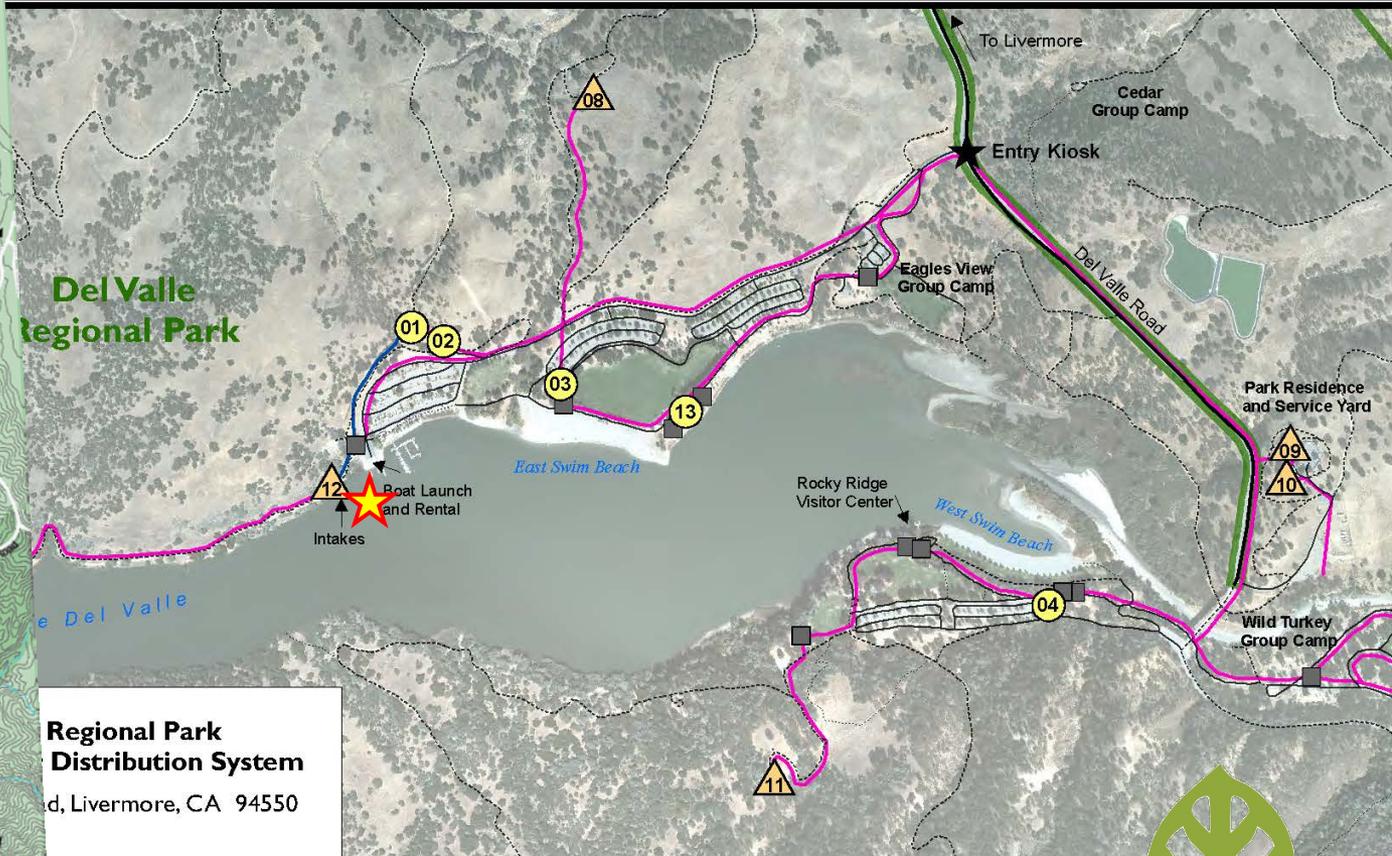
**Regional Park Distribution System**  
 Livermore, CA 94550

# Del Valle Monitoring

- Drinking Water Distribution Line
- Intake Line

## Drinking Water Distribution System Features

Number	Description
01	Drinking Water Intake Sample Spigot
02	Water Treatment Room
03	East Beach Sample Spigot
04	West Beach Sample Spigot
05	Composites #0

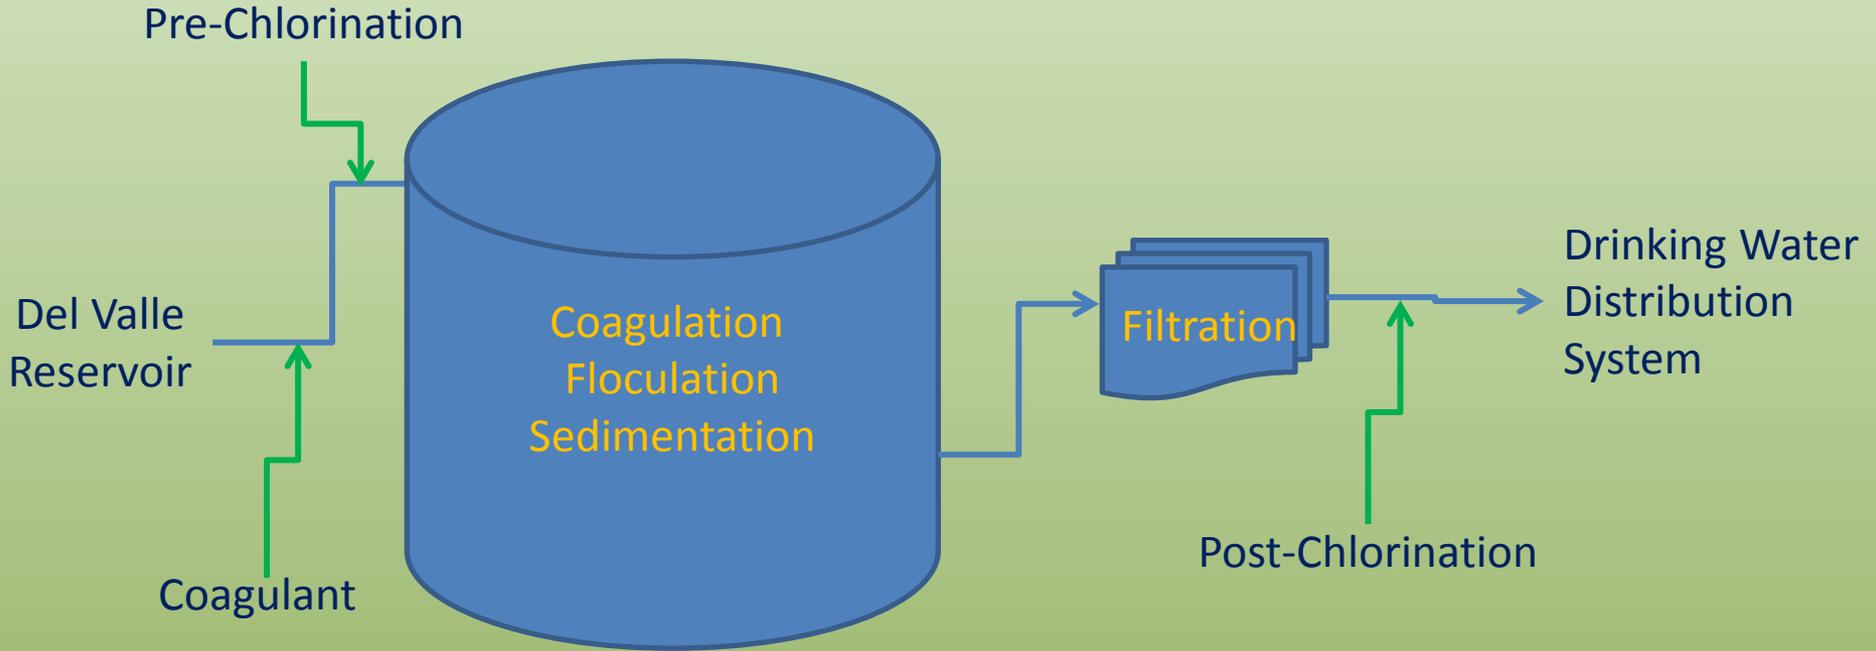
# Normal Drinking Water Strategy

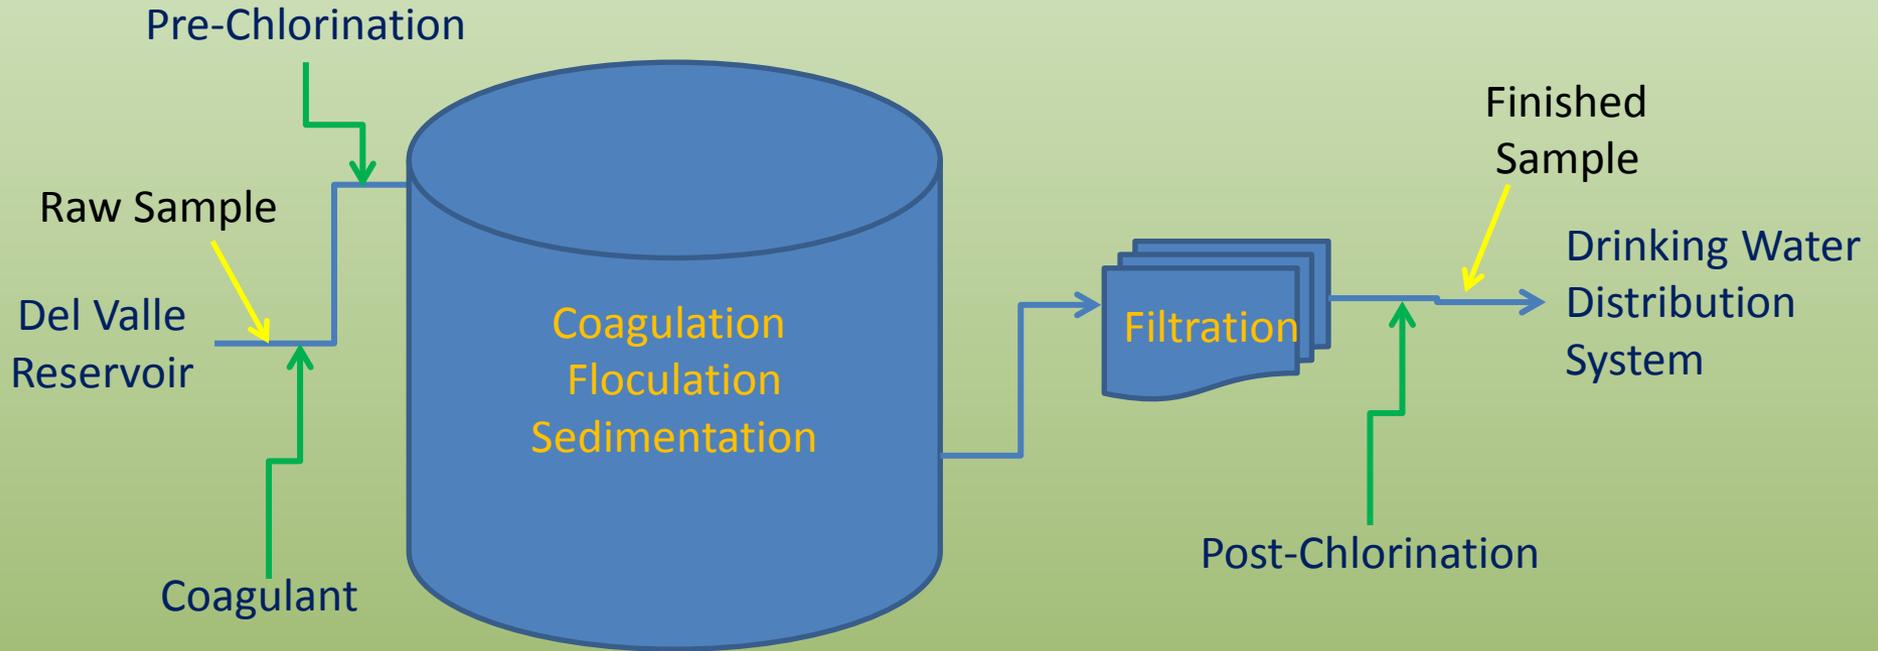
# Normal Drinking Water Sampling

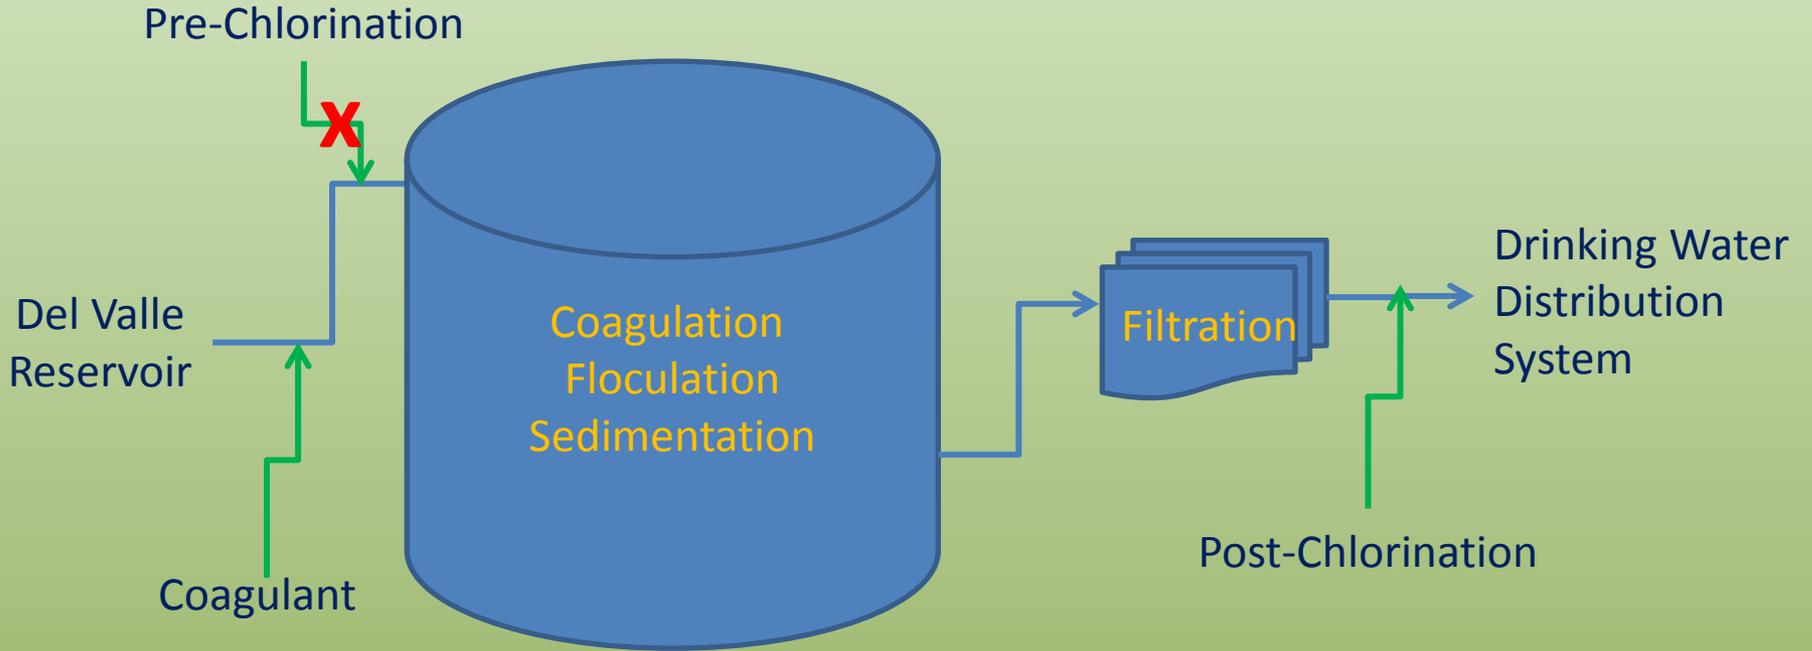
# Drinking Water Strategy with HAB

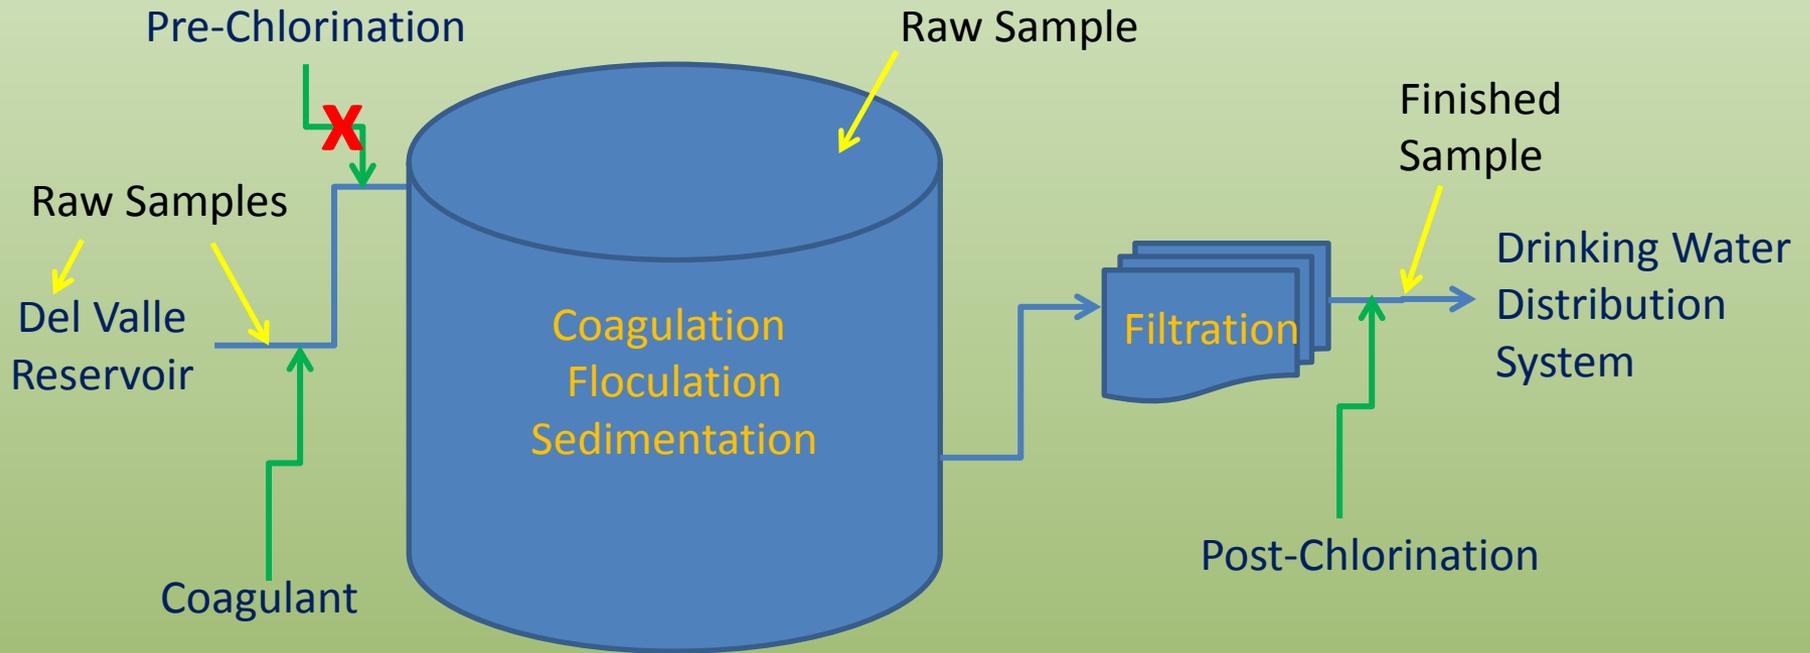
# Drinking Water Sampling with HAB

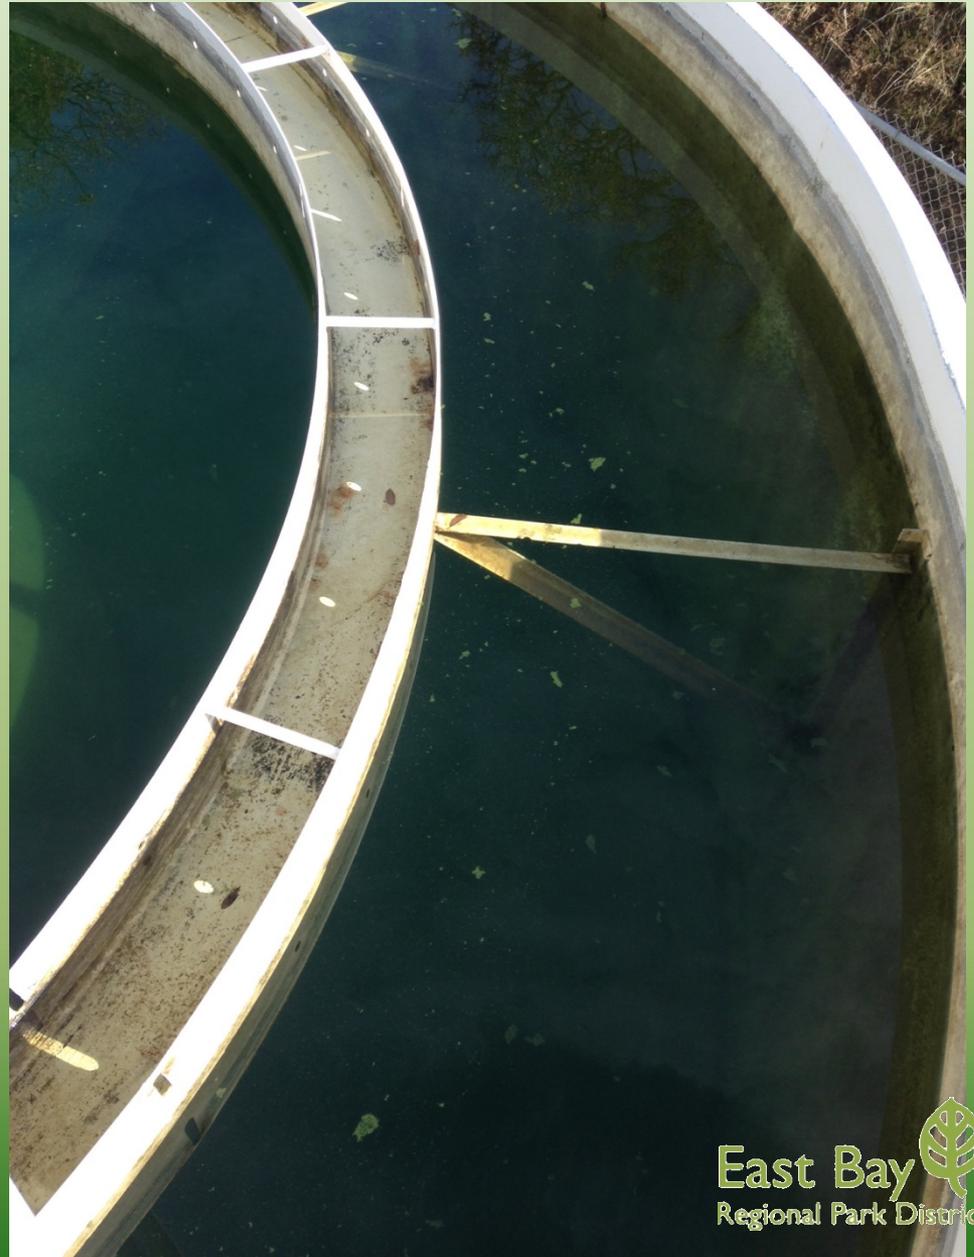
# Treatment Modifications and Special Sample Program
