CENTRAL VALLEY REGIONAL WATER QUALITY CONTROL BOARD

CLOSURE INSPECTION

LOCATION & COUNTY: Reeve Road Heifer Ranch
21070 Reeve Road, Tracy
San Joaquin County

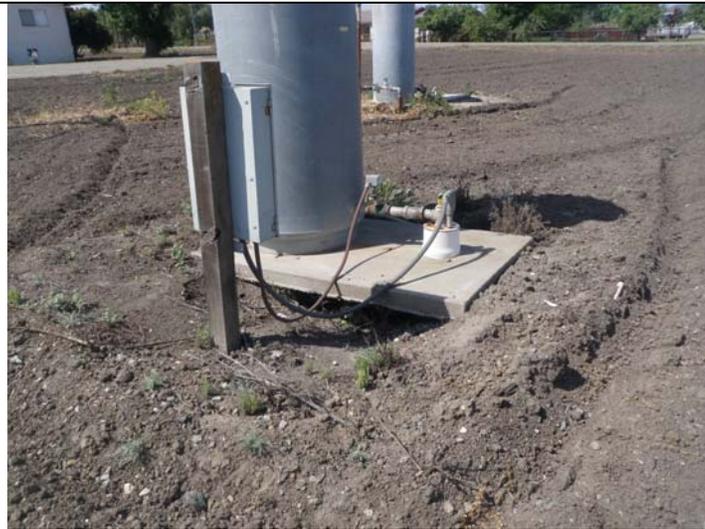
Three wells were inspected. Holes were observed underneath the well-pad at Well #1 (Photo 1). A cracked well-pad was observed at Well #2 (Photo 3). Excessive vegetation and dirt were observed on and adjacent to the well-pad at Well #3 (Photo 2).

Photo 1: Well #1. The well-pad is in good condition. Holes were observed underneath well-pad.

- 3) Repair the well-pads, patch the holes underneath the well-pads, and clear all dirt and vegetation from the well-pads and adjacent to the well-pads at Wells #1-3.

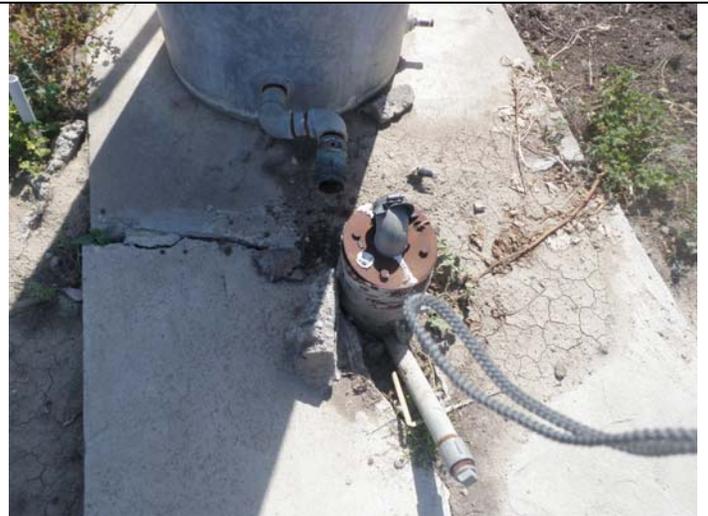
Photo 3: Well #2. Cracked well-pad and holes underneath well-pad.

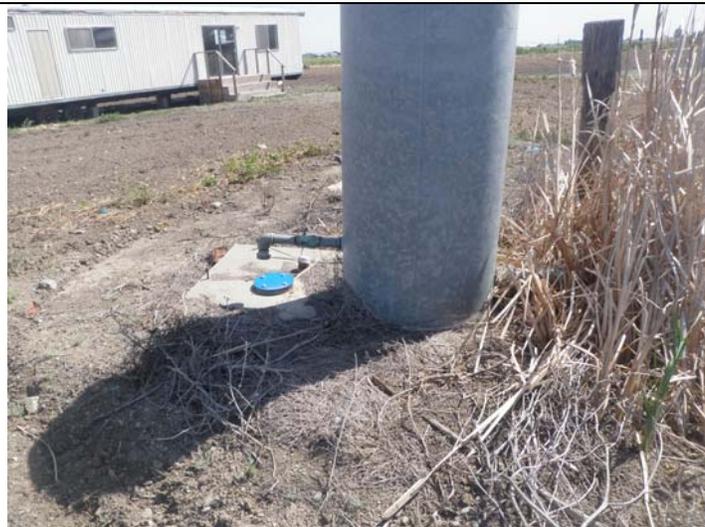
Photo 2: Well #3. Excessive vegetation and dirt on the well-pad.

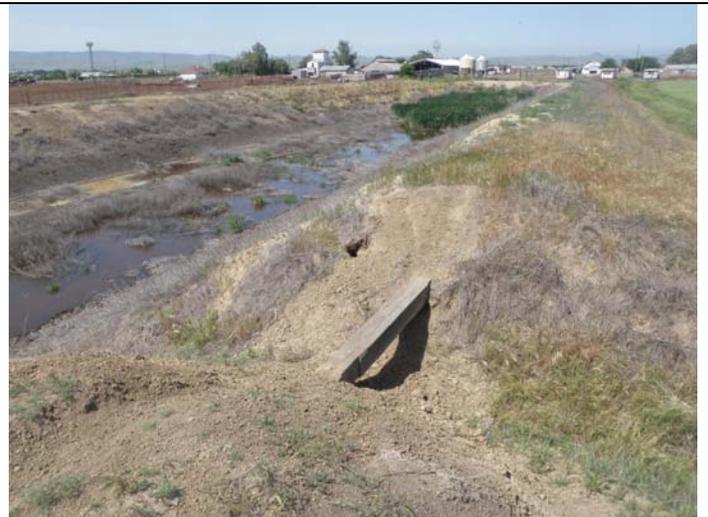
The wastewater storage lagoon is non-operational; there is a large notch cut into the north bank that would allow water to escape (Photo 4).

Photo 4: A large notch cut into the north embankment of the wastewater storage lagoon.

- 4) Remove all manure from the wastewater storage lagoon and export off property. Provide documentation regarding the amount of manure removed and the destination of the manure.

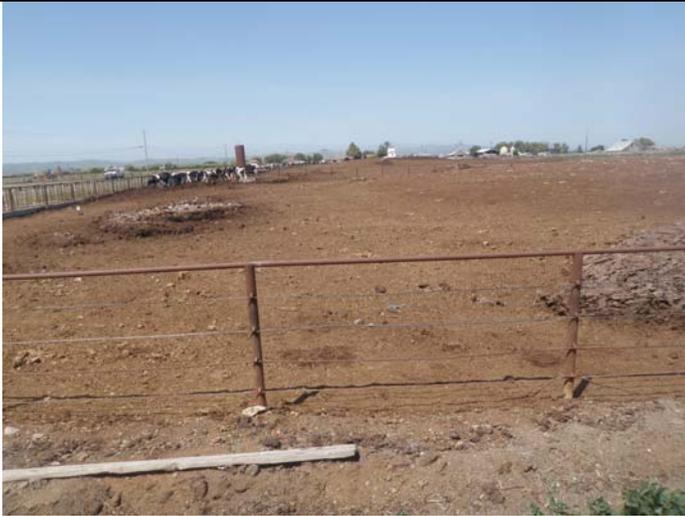
The corrals are contained, clean, and well-graded (Photo 5).

Photo 5: Corrals are clean and well-graded.

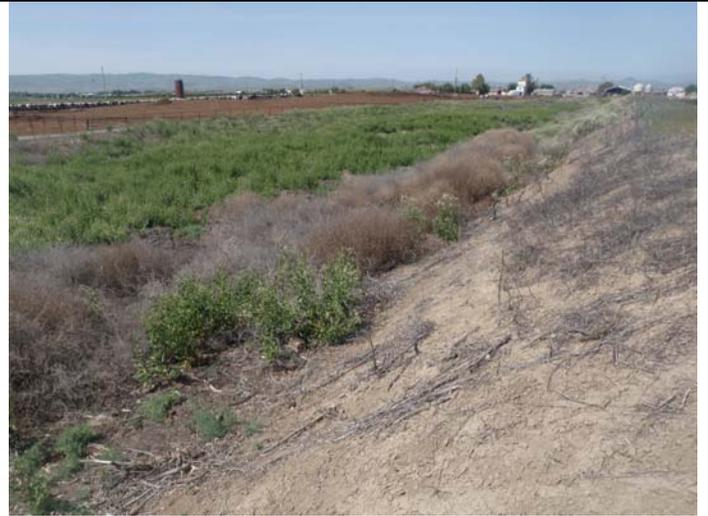
No liquid wastewater or solid manure is applied to the facility's cropland. While inspecting the cropland associated with the Henry Tosta Dairy, Mr. Tosta stated that while dairying at the Reeve Road Heifer Ranch he buried his dead cows immediately south of the wastewater storage lagoon. Staff walked this area and observed a significant amount of bones and solid manure (Photos 6-7). Additional inspection of the cropland revealed an area of disturbed soil.

Photo 7: The area of weeds is located immediately south of the wastewater storage lagoon. Staff observed a significant amount of bones and manure in this area. Later in the inspection, Mr. Tosta stated while he was dairying at this facility he would bury his dead cows in this area (south of lagoon).

- 1) Remove all carcasses, bones, and solid manure from the area south of the lagoon at the Reeve Road Heifer Ranch. All bones and manure must be exported off-site to a landfill. Provide receipts that the bones and manure were exported to a proper facility.

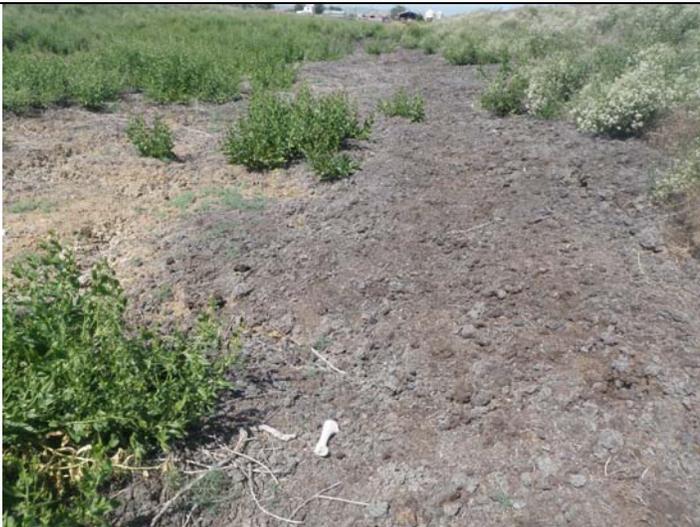
Photo 6: This area is located south of the wastewater storage lagoon. Staff observed a significant amount of solid manure and bones.

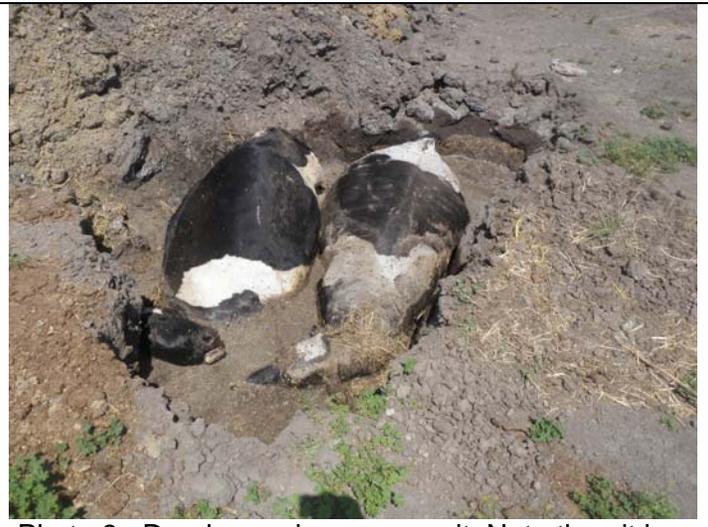
Further investigation revealed an excavation in which two mature cows were being buried; a very strong odor of decaying flesh was also noted in the area (Photos 8-12). The area in the cropland where the dead cows are being buried is immediately adjacent to the Main Drain Canal of Naglee-Burk Irrigation District. Mr. Tosta addressed the issue of burying the dead cows as follows:

Photo 8: Dead cows in an open pit. Note the pit is full of water, but the adjacent fields are dry.

- 2) Excavate all the cows and bones that have been buried in the cropland. All cows and bones must be delivered to a landfill. Provide documentation regarding the number of carcasses removed and the destination of the carcasses and bones. Groundwater samples should be obtained after the animals are removed from the above mentioned area.

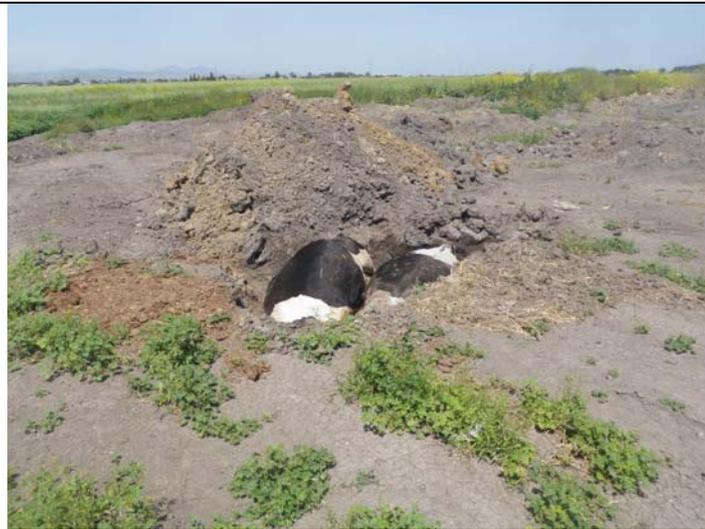
Photo 9: Burying dead cows in the corner of the cropland.

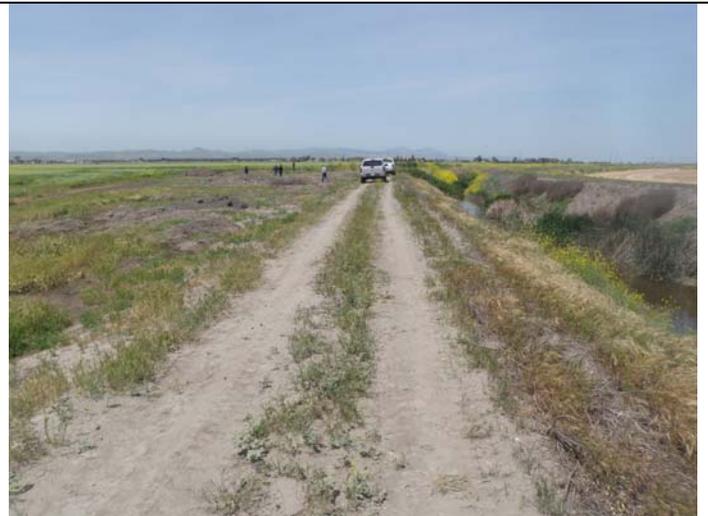
Photo 11: Area where the dead cows are being buried; note the canal on the right is the Main Drain Canal Of Naglee-Burk Irrigation District – this drain discharges directly (via pump) to the Old River which is a major tributary of the San Joaquin River.

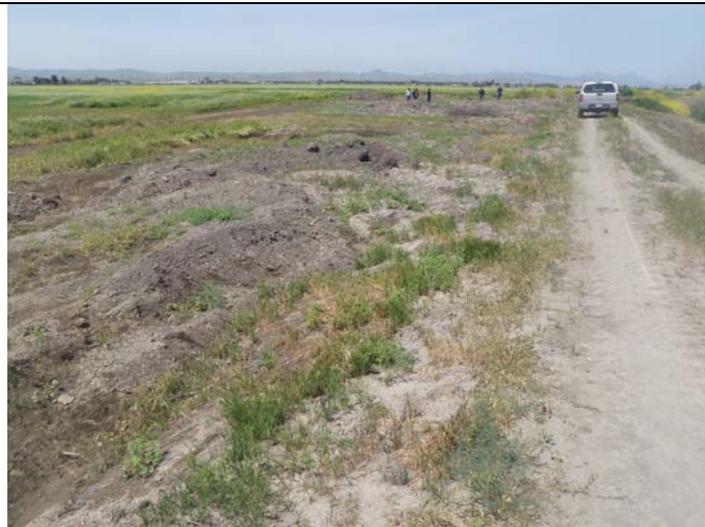
Photo 10: This entire area is being used to bury dead cows.

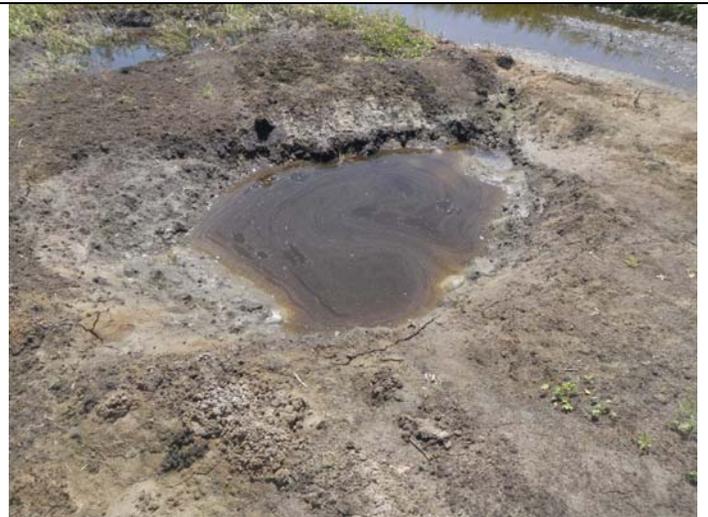
Photo 12: Staff observed several shallow pits like this one at the area of disturbed soil.
