USE ATTAINABILITY ANALYSIS

CUCAMONGA CREEK – REACH 1

Santa Ana Regional Water Quality Control Board

UAA ANALYSIS: CUCAMONGA CREEK - REACH 1

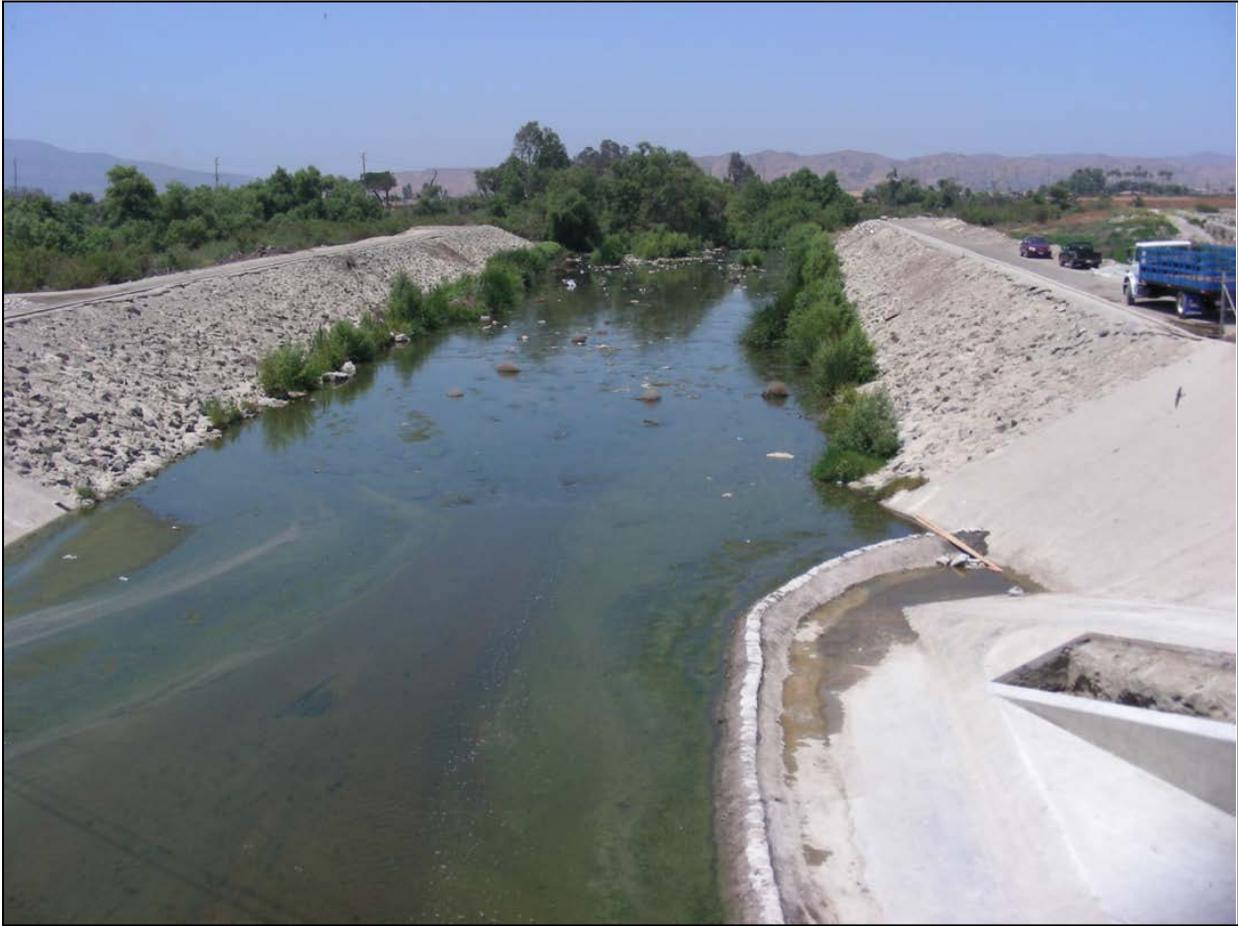
Figure CC-2: Mill Creek at Hellman Ave. in the Prado Basin Management Zone, looking downstream. Cucamonga Creek becomes known as Mill Creek at this point.

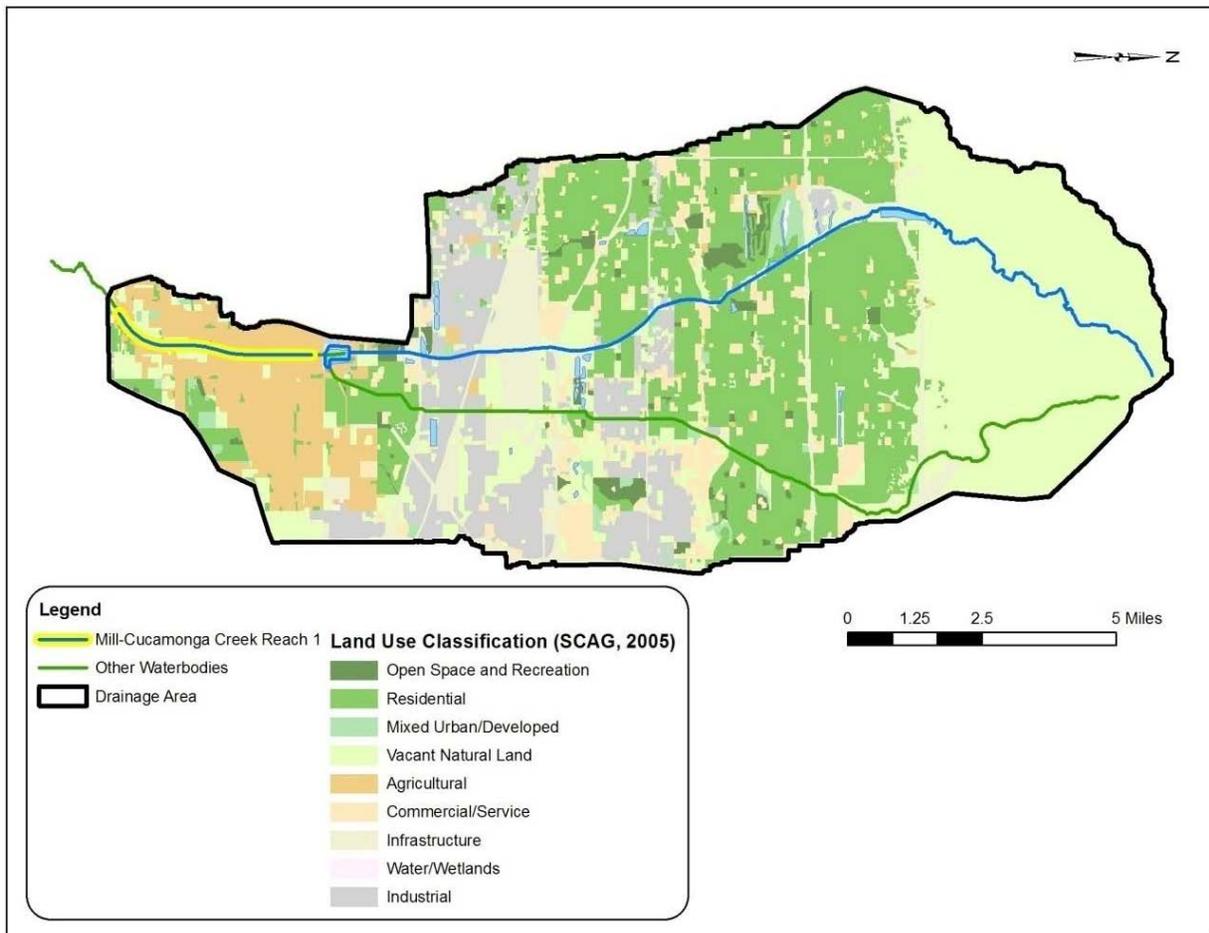
Figure CC-3: Land Use with the Cucamonga Creek Drainage Area

The Reach 1 watershed drains 55,456 acres composed of agricultural, residential, urban and industrial land uses.² The upper half of Reach 1, in the Cities of Ontario, Rancho Cucamonga, and Upland, is predominantly urban and includes a mix of residential, commercial, transportation, industrial and public service land uses. The lower part of Reach 1 is slowly transitioning to more urban land uses as development encroaches on this largely agricultural area of the watershed (Figure CC-3). Land uses adjacent to Reach 1 are summarized in Table CC-1.

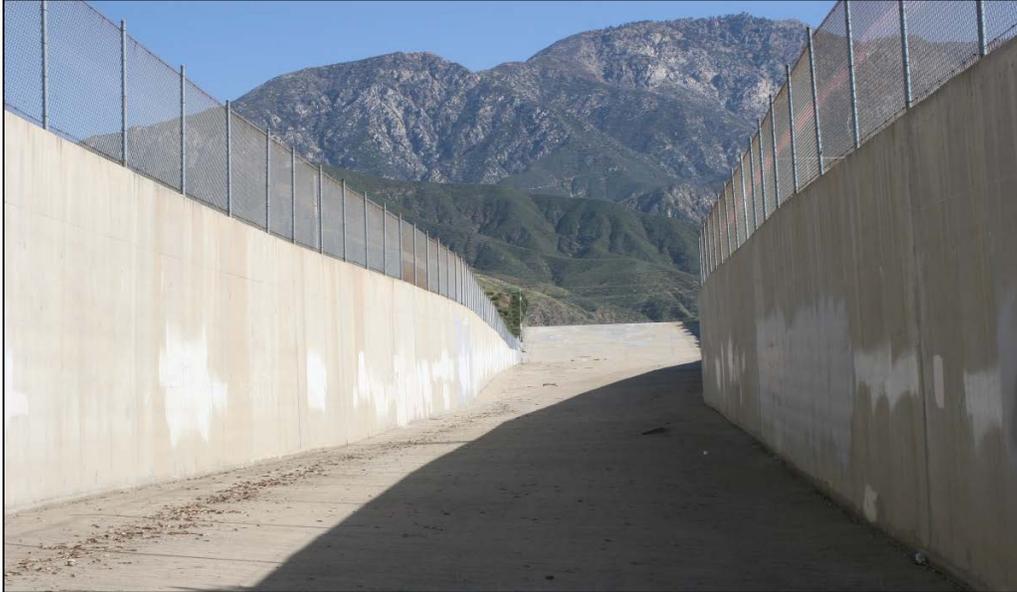
Figure CC-4: The upstream boundary of Reach 1, near Cucamonga Canyon Dam.

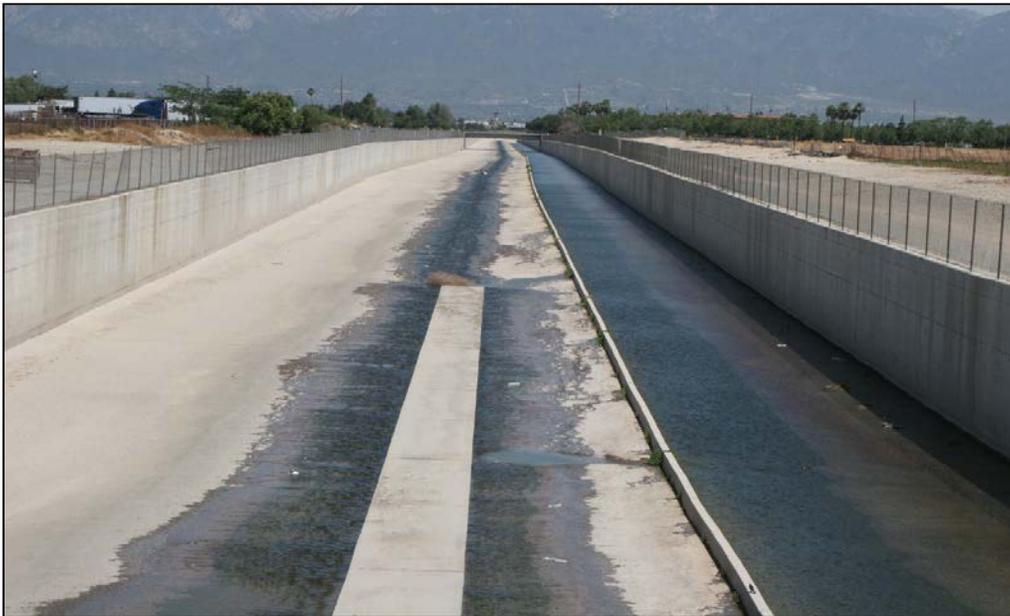
Figure CC-5: Mid-point of Cucamonga Creek, Reach 1. Treated effluent is contained by a berm to the right side of channel while dry weather runoff from the surrounding areas flows on the left side of the channel.

Reach 1 of Cucamonga Creek is fully concrete lined throughout its entire 15 mile length. The upper 11 miles of Reach 1 is a box channel with vertical walls ranging from 12-15 feet high (Figure CC-4). A short section ($\frac{1}{2}$-mile) of Reach 1 passes in a tunnel beneath the Ontario Airport. The channel varies from approximately 25 feet wide at the uppermost end of Reach 1 to nearly 75 feet wide south of the Airport and the 60 Freeway (Figure CC-5).

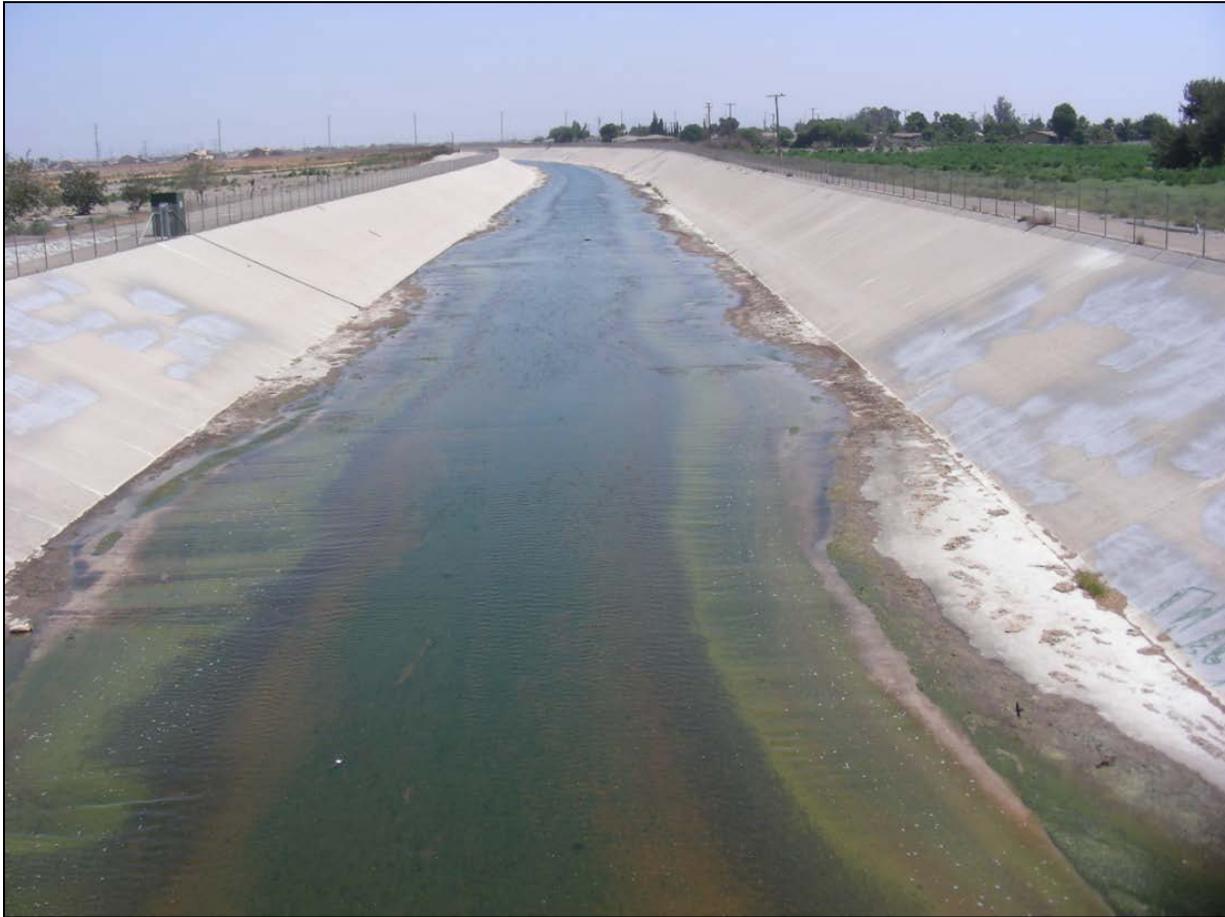
Figure CC-6: Cucamonga Creek - Reach 1 at Hellman Avenue. This trapezoidal walled section of the channel stretches from this location to the confluence with Deer Creek four miles upstream.

The lower 4 miles of Reach 1 is a trapezoidal channel with a 2:1 side-slope. The bottom width ranges between 70-80 feet in this section of Reach 1 (Figure CC-6). The channel characteristics of Reach 1 are summarized in Table CC-2.

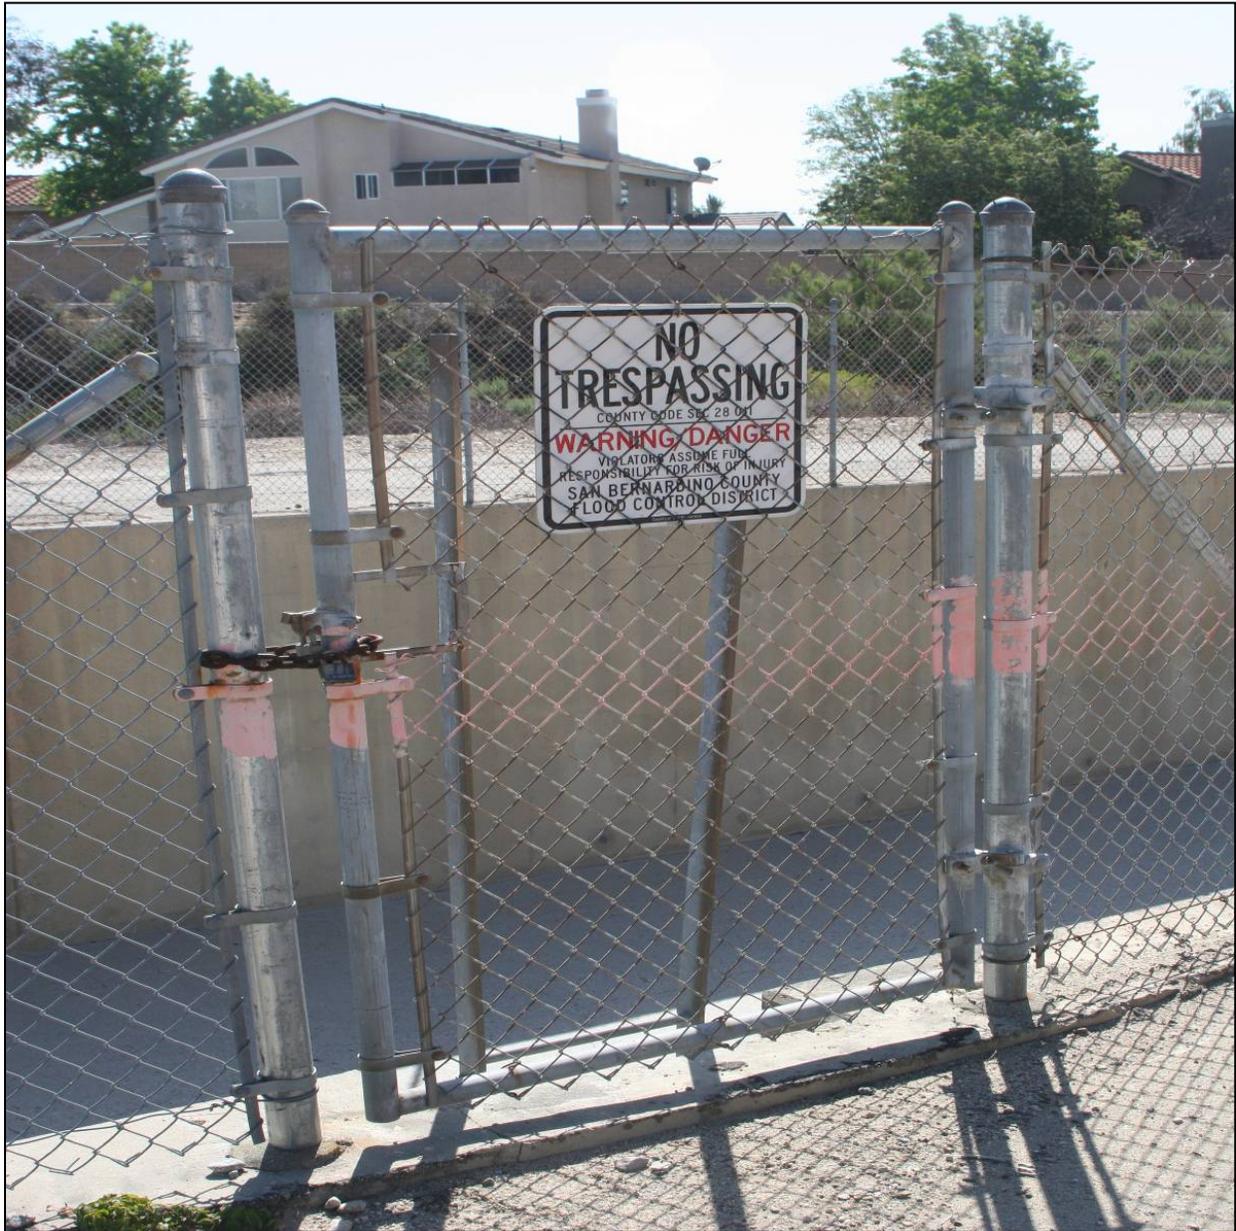
Figure CC-7: Cucamonga Creek-Reach 1 near Baseline St. in City of Rancho Cucamonga

The Riverside County Flood Control and Water Conservation District and the San Bernardino County Flood Control District, which own and manage the channel in Reach 1, prohibit public access into the channel. As a result, the entire length of Reach 1 is fenced with locked gates and posted to keep individuals out of the channel (see Figure CC-7).

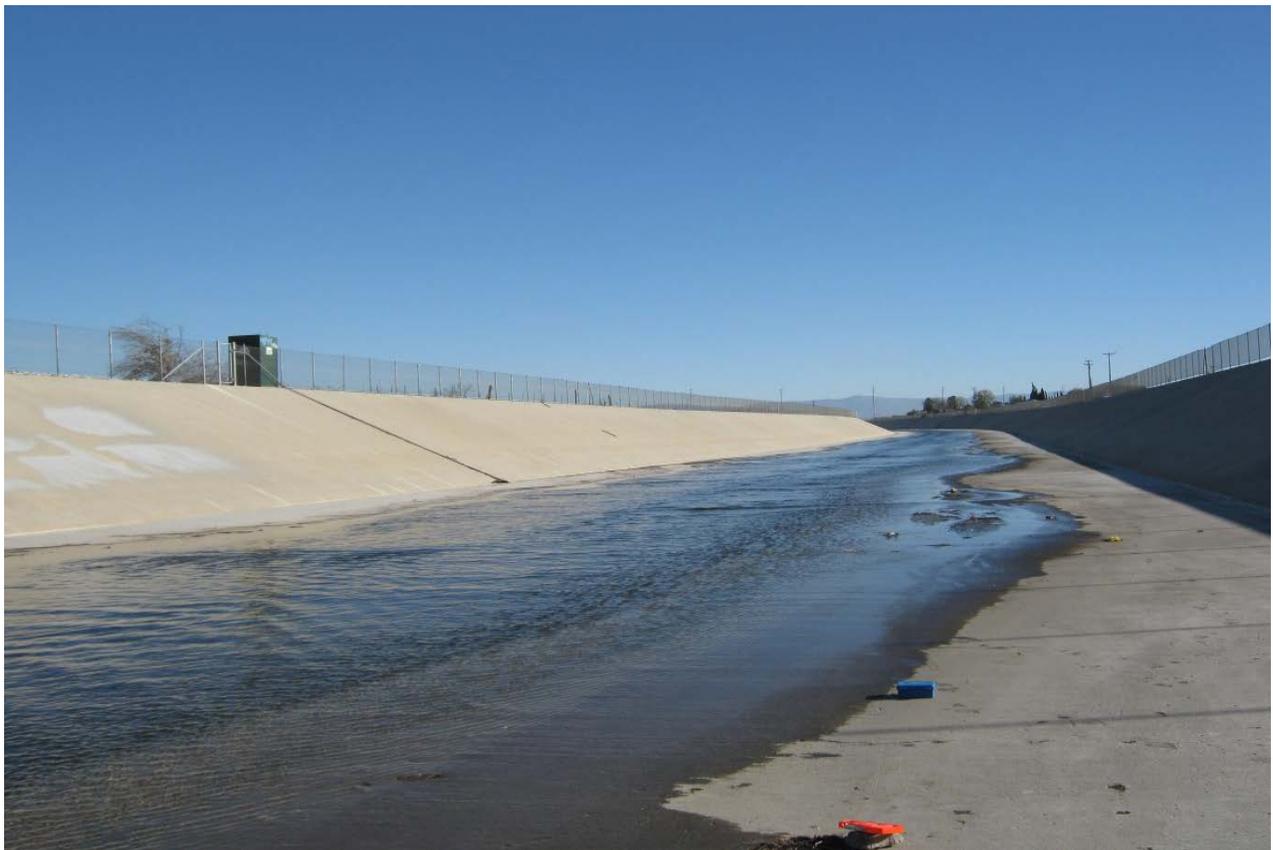
Figure CC-8: Cucamonga Creek upstream of Hellman Ave. during typical dry weather conditions (Feb. 10, 2011)

Depending on the magnitude of nuisance runoff and effluent discharges, dry weather flows in the channel may be limited to part of the width of the channel (see Figure CC-8) or extend across its entire width (see Figure CC-9).

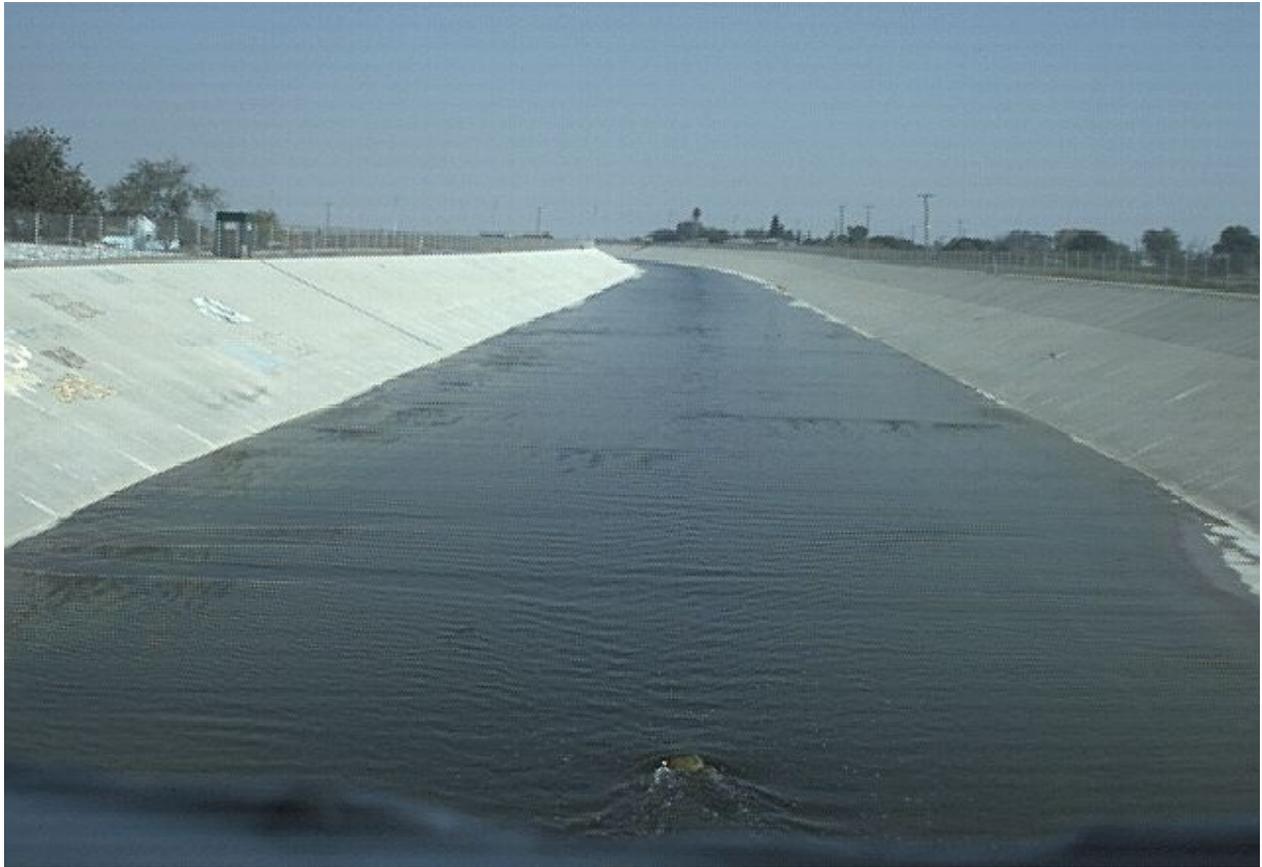
Figure CC-9: Cucamonga Creek at Hellman Avenue Looking Upstream.

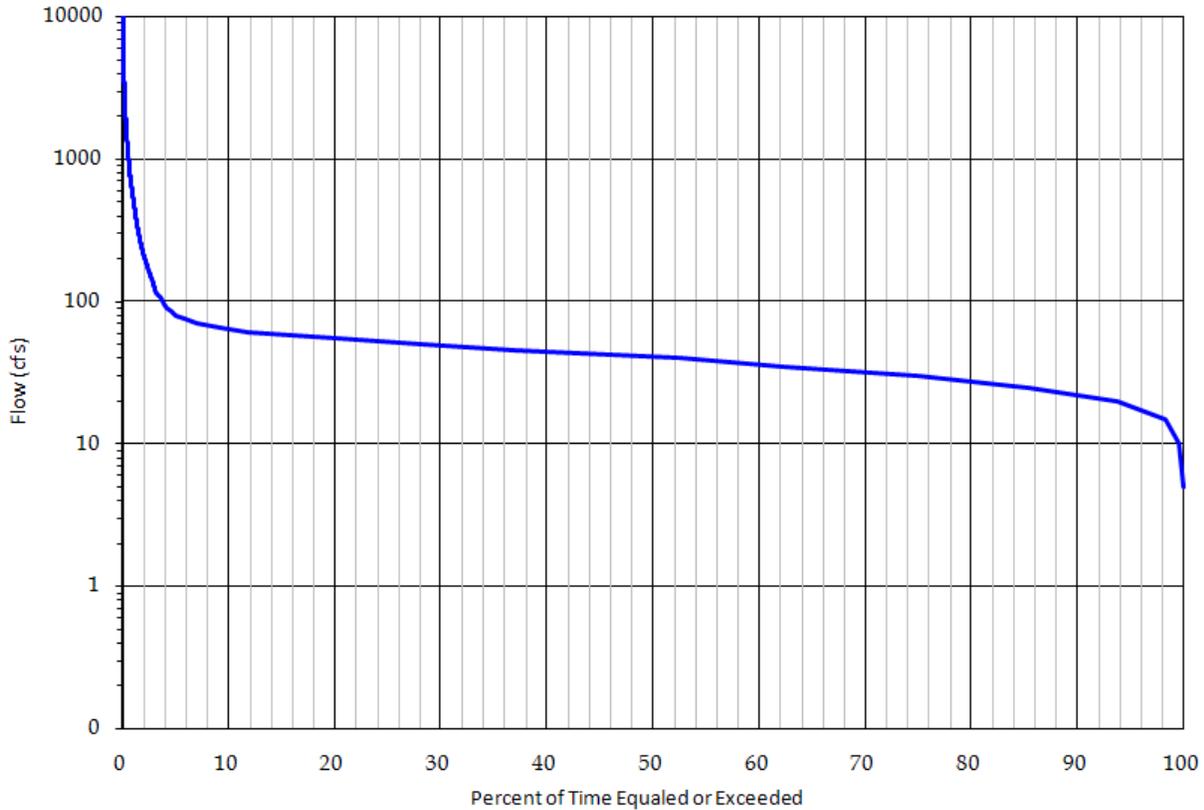
Figure CC-10: Flow Duration Curve for the Cucamonga Channel (1988-2008)

The average dry weather flow in Cucamonga Creek is approximately 31 cfs at the USGS gauging location. And, 87% of this baseflow (27 cfs) is comprised of high quality recycled water discharged by IEUA's treatment plants a few miles upstream.²⁰ Figure CC-10 presents a hydrograph of mean daily flow data from 1988-2008.

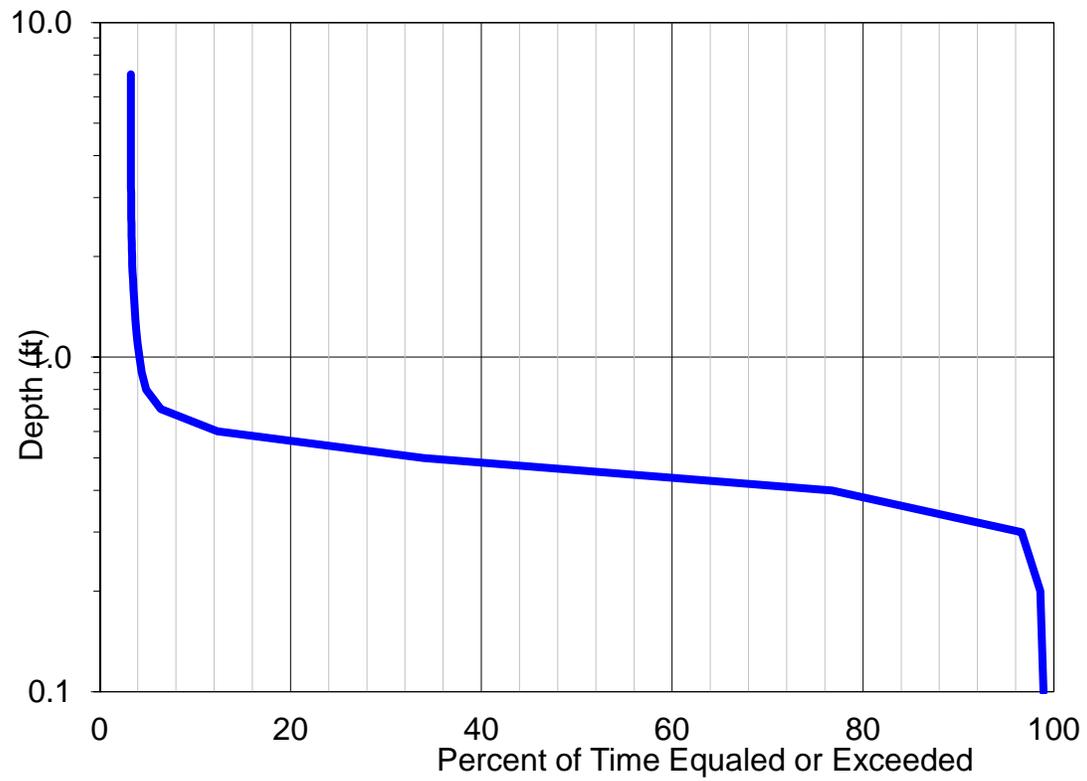
Figure CC-11: Channel Depth Curve for the Cucamonga Creek (1988-2008)

Based on the historical flow gauge data (1998-2008), the stream was less than 1 foot deep, at its deepest point, more than 98% of time (see Figure CC-11).

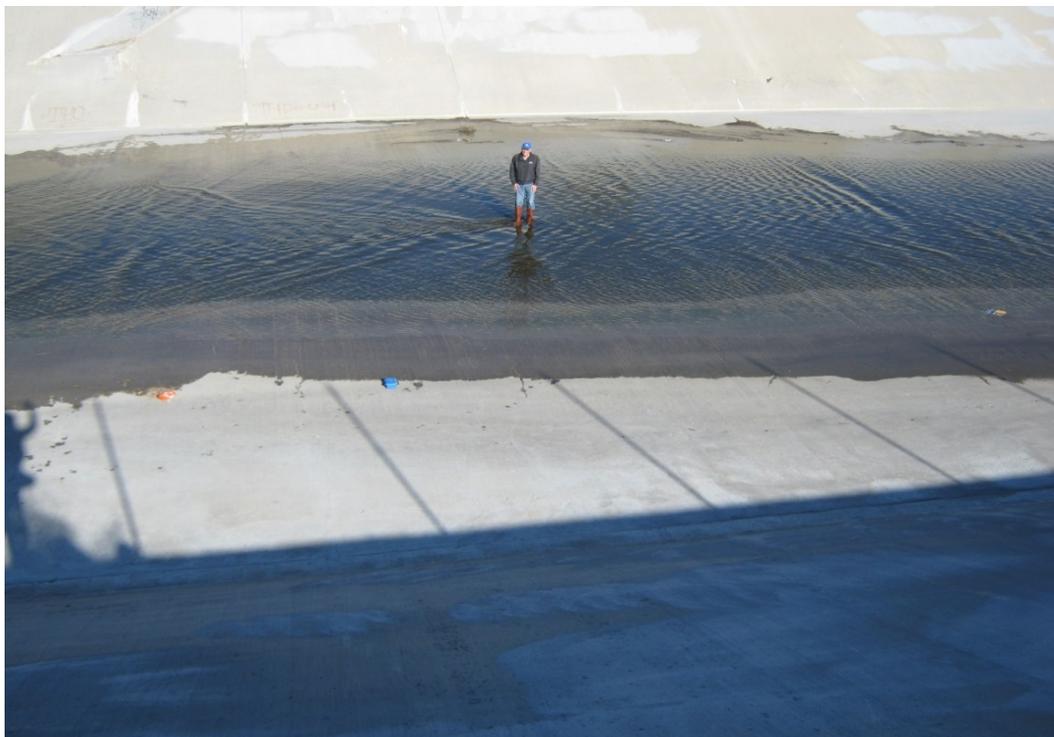
Fig. CC-12: Cucamonga Creek at Hellman Ave. Field Survey Showing Flow Depth <6"

CDM's engineering estimates are consistent with the actual depth measurements collected by Regional Board staff. For example, on February 10, 2011, during a typical dry weather period, stream flow in lower Cucamonga Creek was approximately 5 cfs and extended across $\frac{3}{4}$ of the channel bottom. At this time, the Regional Board staff measured the stream and found it to be 5 inches deep at mid-channel (see Figure CC-12). The most upstream sections of Cucamonga Creek (above the wastewater outfalls) were observed to be dry.

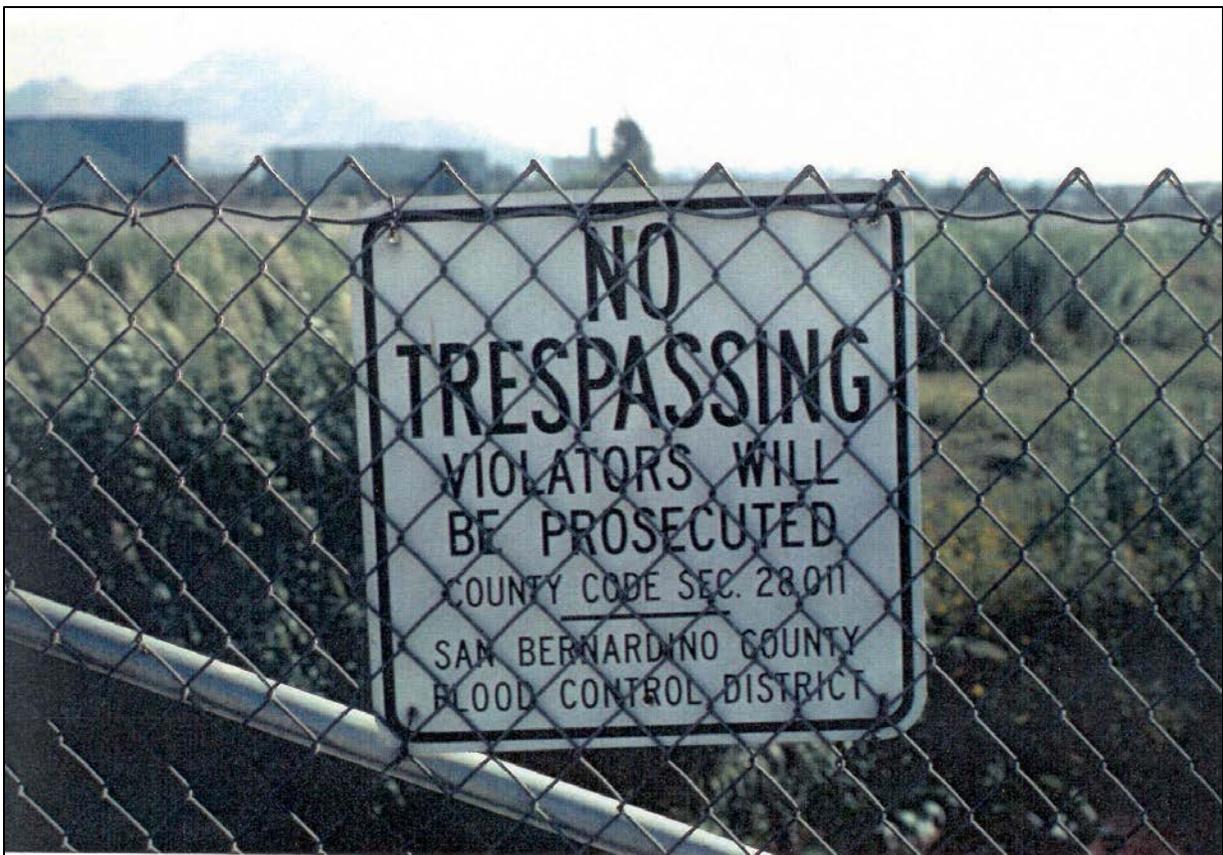
Figure CC-13: Chainlink Fences and Locked Gates Prevent Access to Cucamonga Creek

Cucamonga Creek is a concrete-lined and fenced channel throughout the entire 15 mile length of Reach 1 (see Figure CC-13 and Figure CC-14). Access is further restricted by locked gates at all of the entry points used for flood control maintenance.

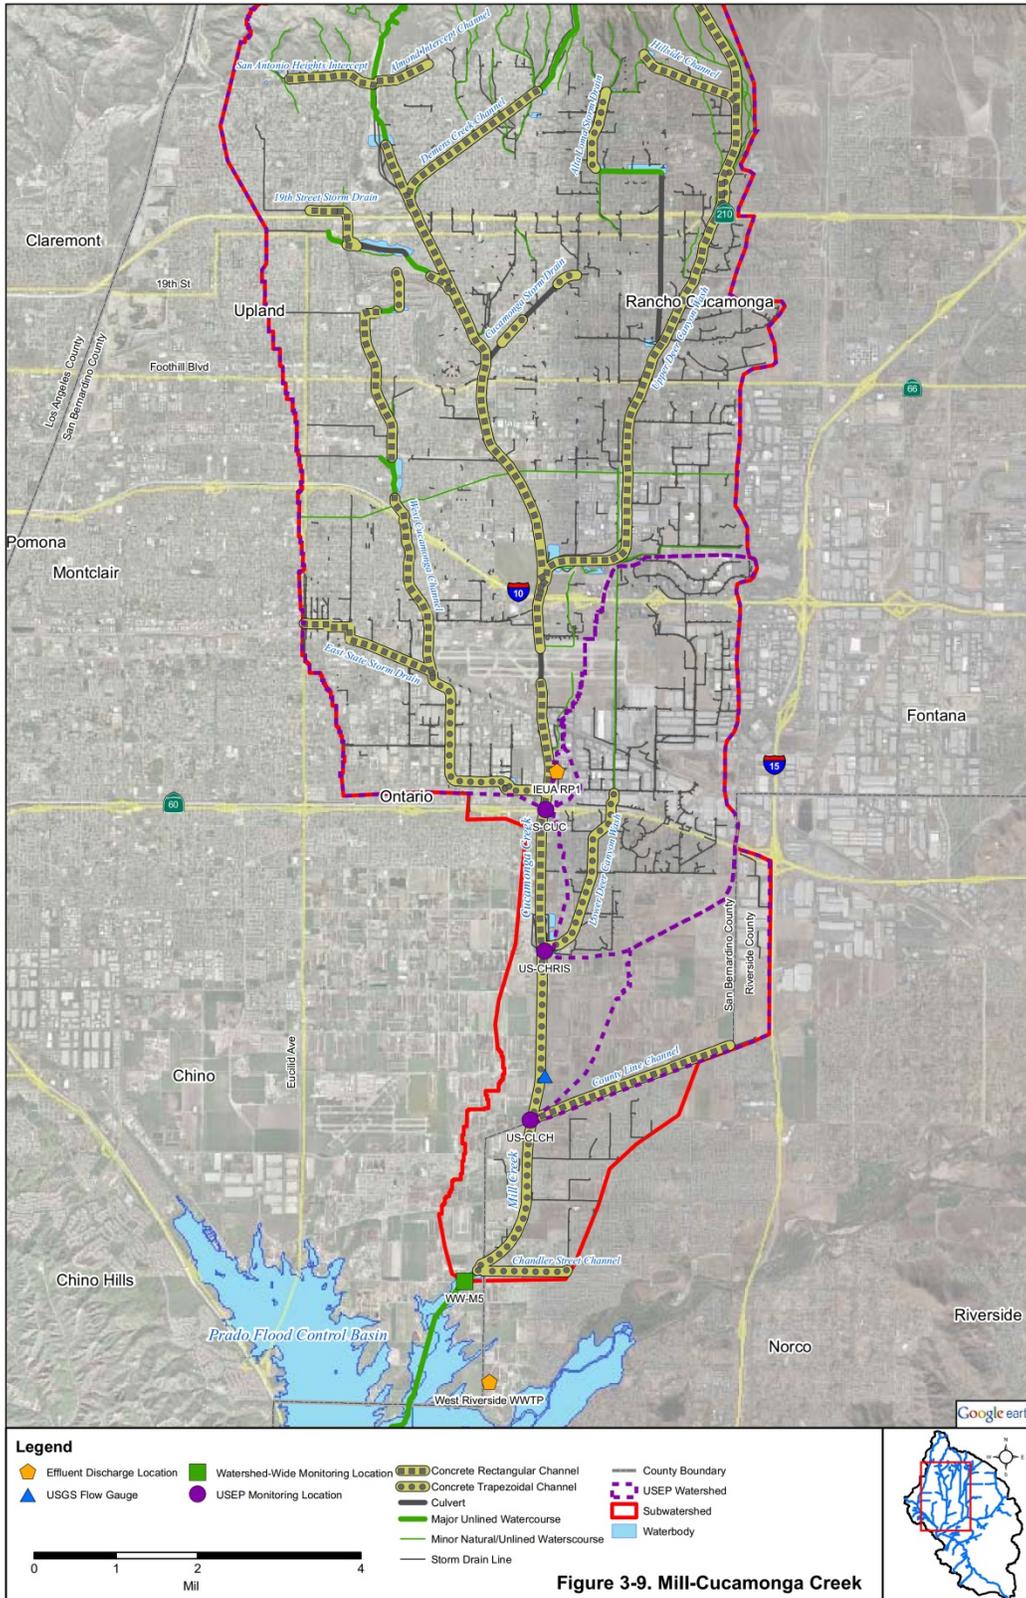
Figure CC-14: Hydrological Modifications in Cucamonga Creek - Reach 1

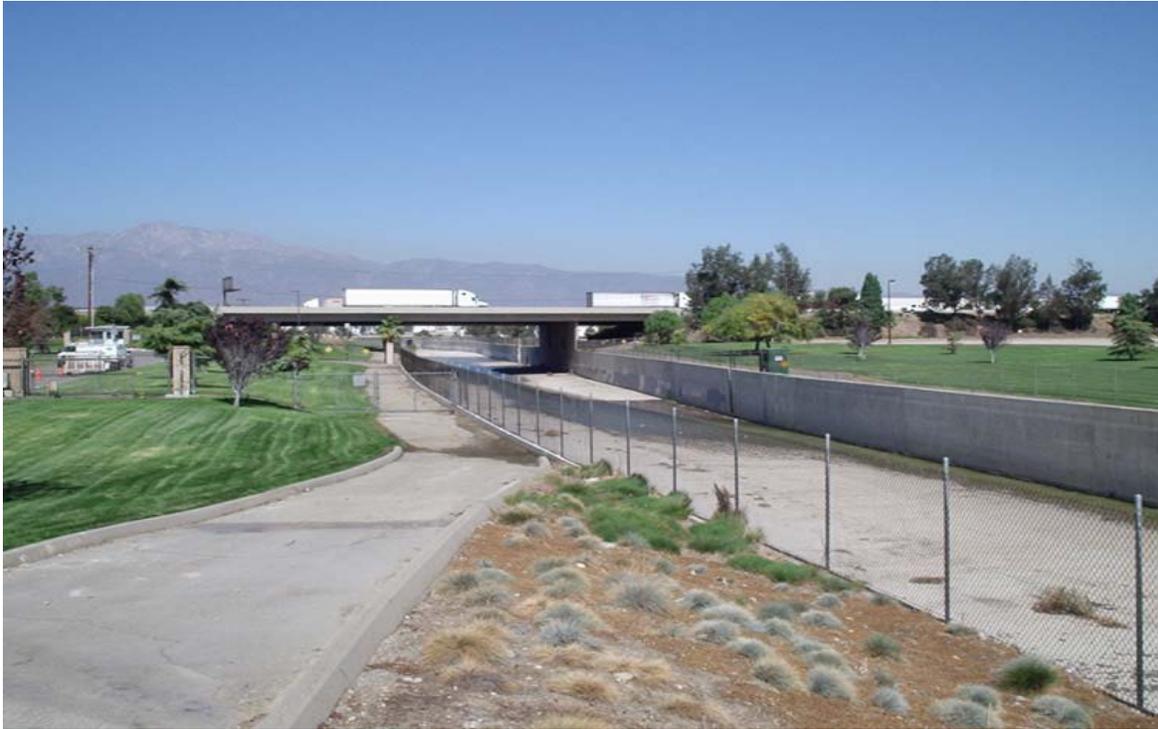
Figure CC-15: Cucamonga Creek South of Highway 60 and the Ontario Airport

For the first 11 miles, the channel is confined by vertical concrete walls that are 12-15 feet high (see Figure CC-15). In the final 4 miles, the channel walls are trapezoidal with a steep, 2:1 side-slope (see Figure CC-16).

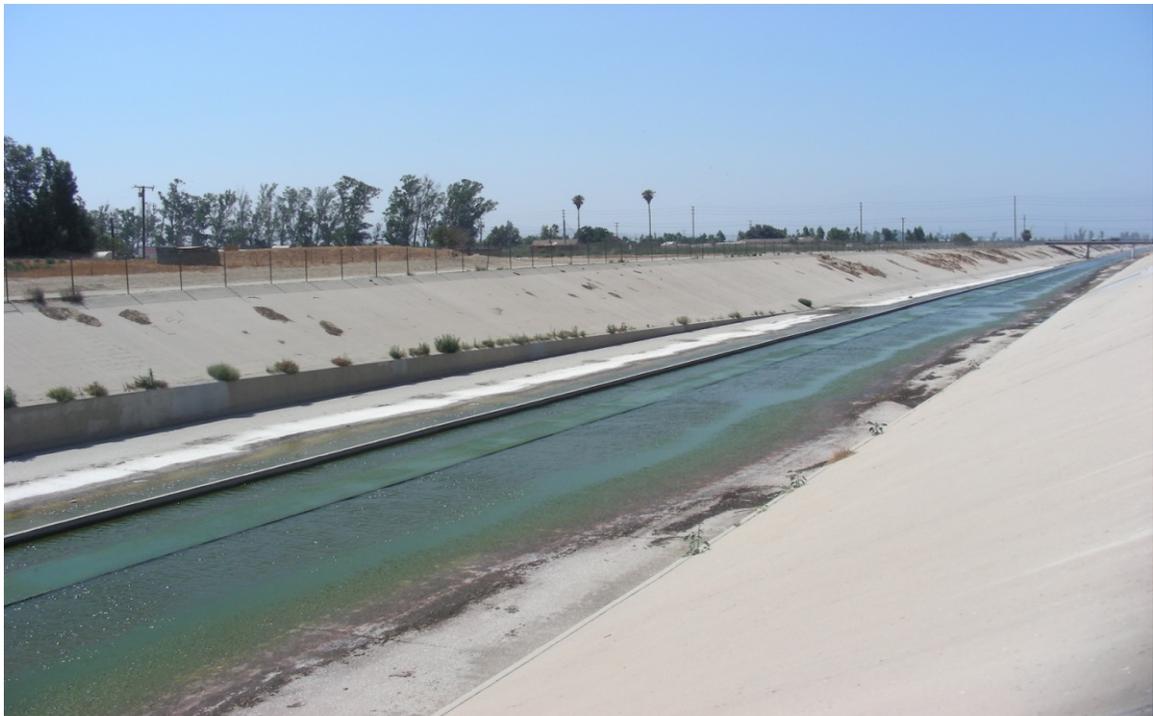
Figure CC-16: Cucamonga Creek Near Confluence with Deer Creek (June, 2009)

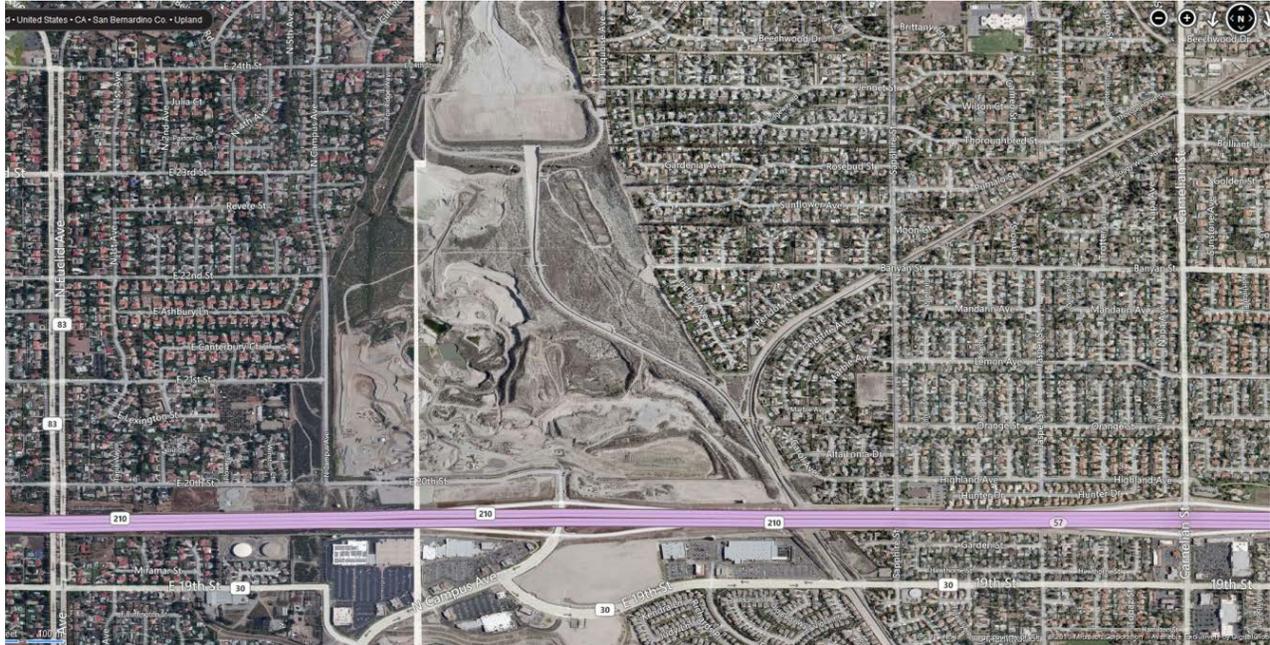
Figure CC-17: Percolation Ponds at the Upstream Boundary of Cucamonga Creek Reach 1

Several large percolation ponds have been built along Cucamonga Creek (see Figure CC-17 and Figure CC-18). These basins are used to improve groundwater storage by intercepting and recharging urban runoff during both wet and dry weather conditions. The dams and diversion structures prevent pollutants from reaching the creek but also reduce stream flows below levels normally considered conducive to water contact recreation.

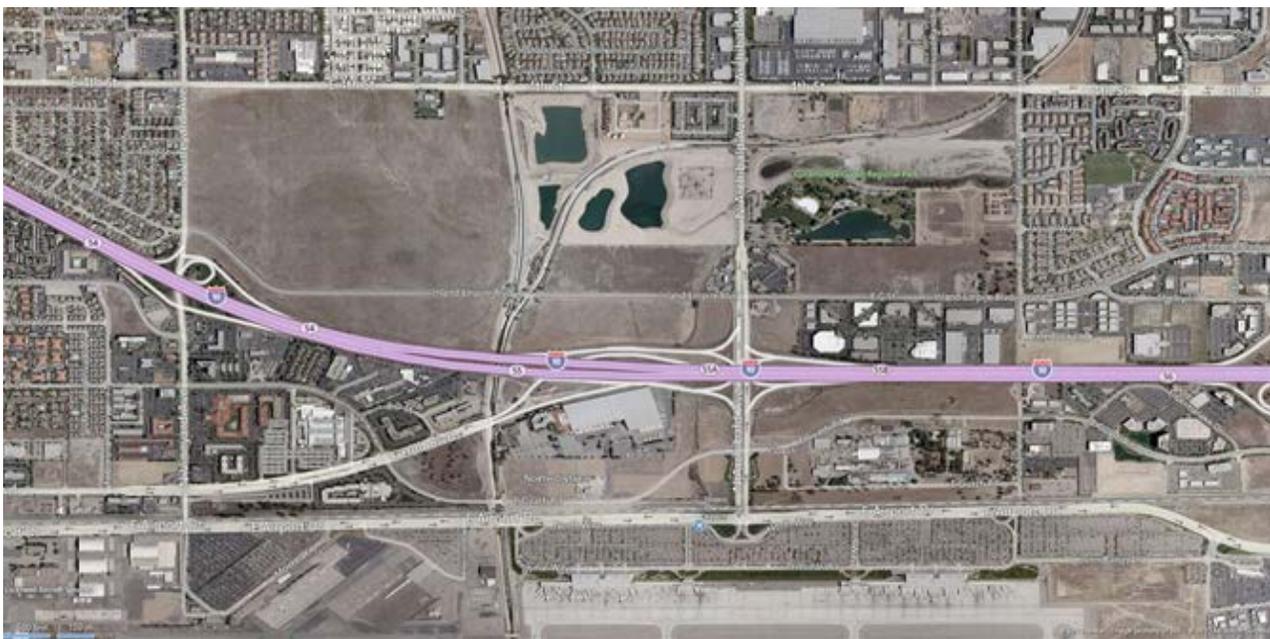
Figure. CC-18: Groundwater Recharge Basins North of Ontario Airport

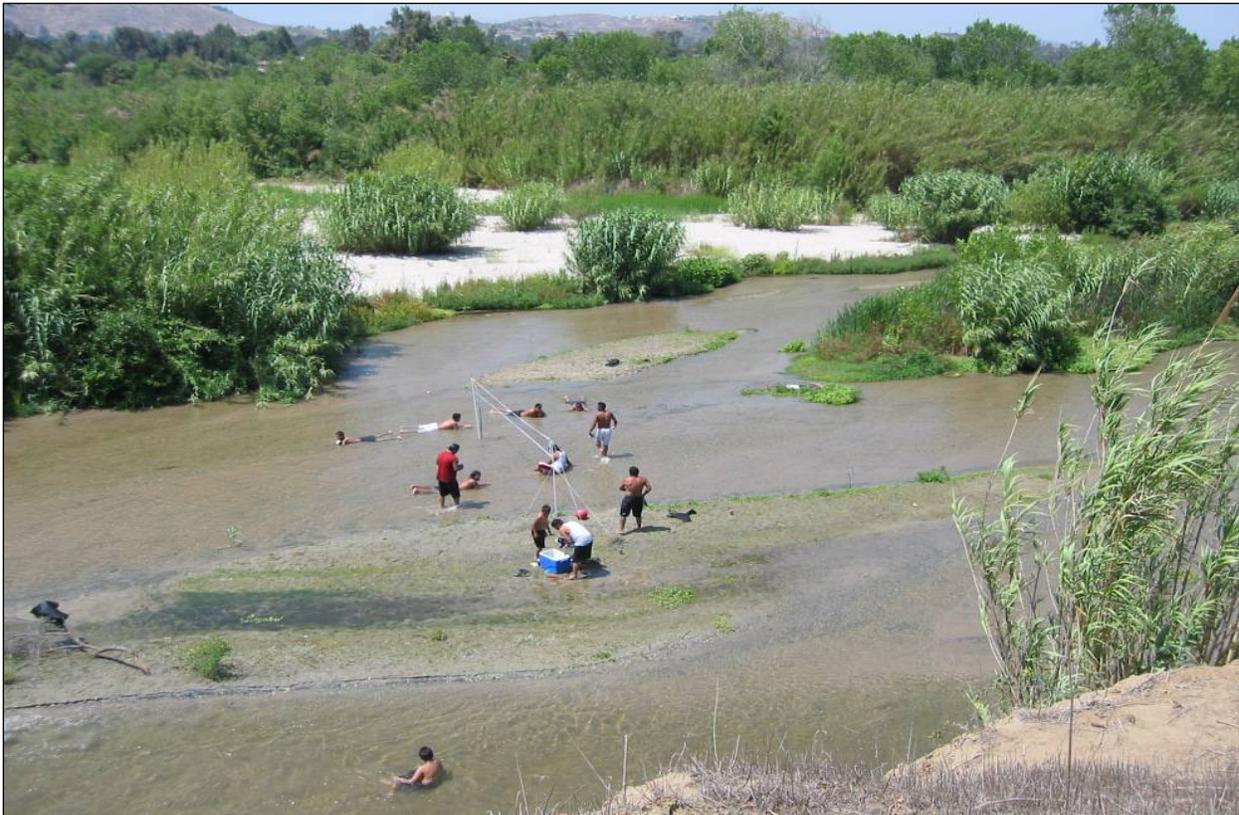
**Figure CC-19: Recreation in Reach 3 of Santa Ana River
(Location is approximately 3 miles from Cucamonga Creek)**

Gaining access to Cucamonga Creek is extremely difficult in the upper section of Reach-1 because one must scale the fence and rappel down the vertical walls before being able to make any water contact. Further, at these locations, the stream flow is usually only an inch or two deep. Access is not much easier in the trapezoidal section. Those intent on water recreation are far more likely to choose the nearby Santa Ana River with its attractive natural stream banks and absence of restrictive fencing (see Figure CC-19).

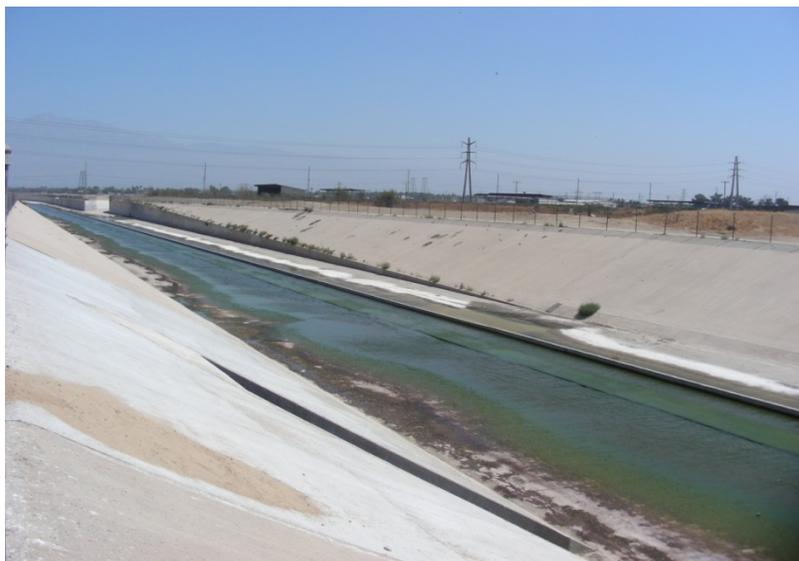
Figure CC-20: Cucamonga Creek downstream of RP1 Near Confluence with Deer Creek.

Further downstream, the concrete-lining precludes the development of suitable habitat conditions despite the presence of perennial flows provided by high quality recycled water discharged by IEUA (see Figure CC-20). There is not much to see or do along this downstream segment of Reach-1 and the County has abandoned its prior (1975) plans to extend the bicycle path along the entire length of Cucamonga Creek.

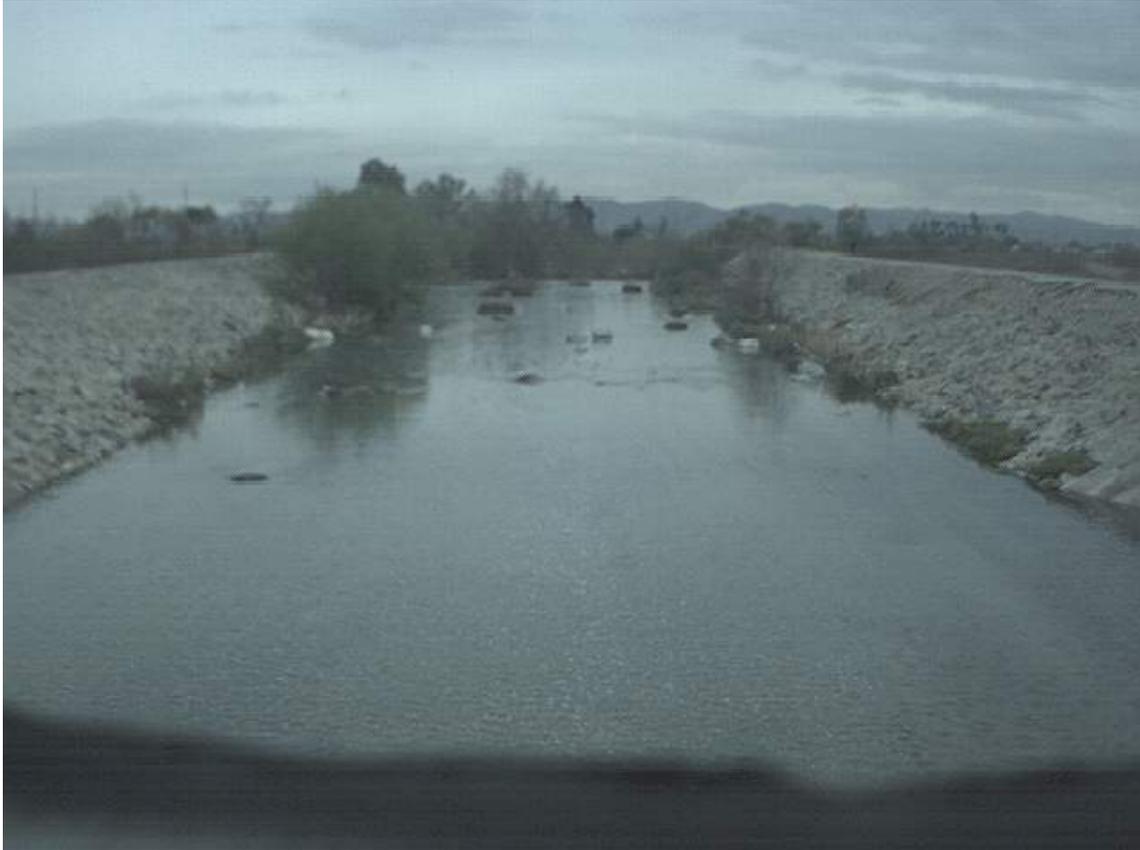
Figure CC-21: Cucamonga Creek at Hellman Avenue Looking Downstream

It should be noted that the reach of Cucamonga Creek downstream of Hellman Avenue is not included in recommendations for changes to water quality standards based on this UAA analysis. The survey at this location (facing downstream at Hellman Avenue) was conducted to provide basic information regarding recreational activity, if any, in the area and to assess whether any such activity might affect recreational use upstream in Reach 1 in the vicinity of Hellman Avenue.

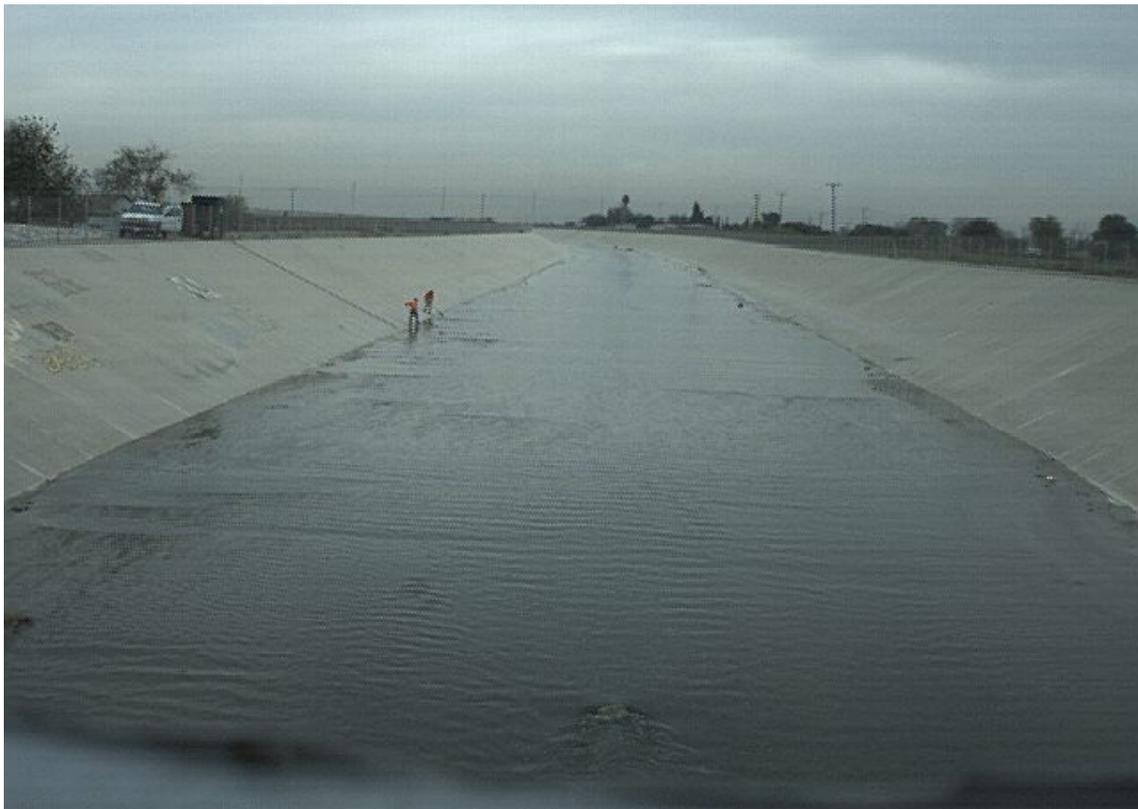
Fig. CC-22: Maintenance Workers in Cucamonga Creek, Upstream of Hellman Ave.

Any image containing a person or persons with channel fencing or boundaries was considered a "potential" recreation event and evaluated more closely. In most cases, subsequent investigation confirmed that the persons seen in the pictures were performing routine maintenance for the flood control district. This was true for the one picture from the Hellman-Upstream camera showing water contact (see Figure CC-22).
