USE ATTAINABILITY ANALYSIS

CUCAMONGA CREEK – REACH 1

Santa Ana Regional Water Quality Control Board

UAA ANALYSIS: CUCAMONGA CREEK - REACH 1

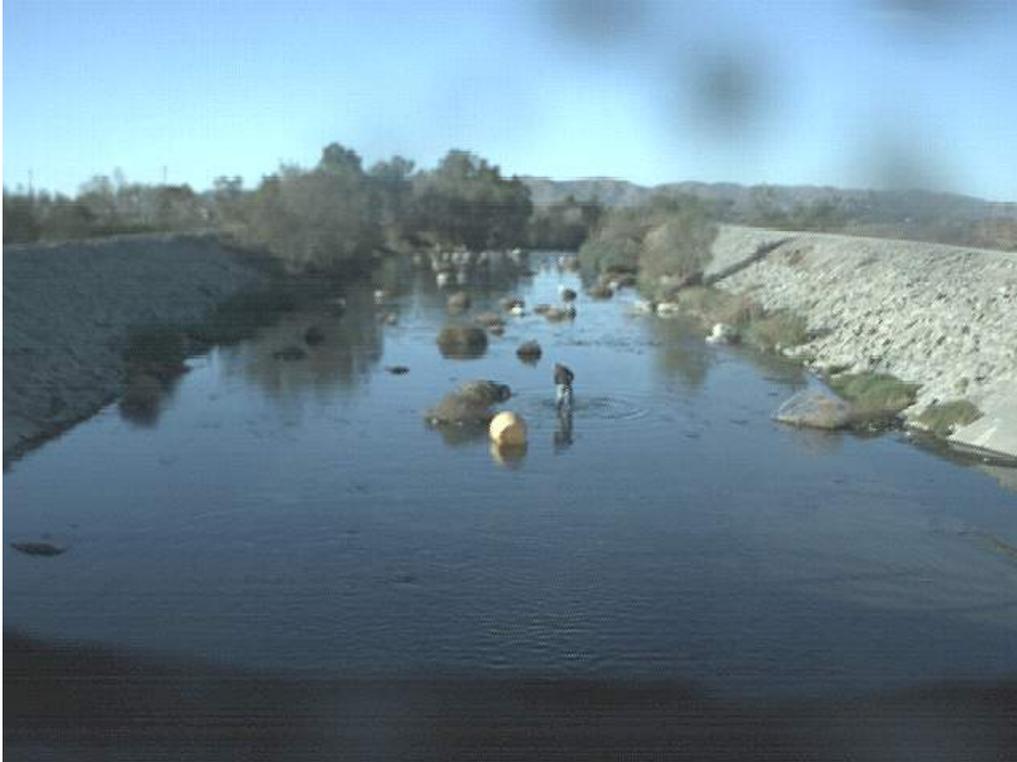
Fig. CC-23: Water Quality Sampling in Cucamonga Creek, Downstream of Hellman Ave.

Many of the pictures showing water contact downstream of Hellman Avenue were also determined to be county personnel collecting water quality samples (see Figure CC-23). However, there were also some photos of actual recreation at this location (see Figure CC-24). Overall, the photographic survey indicated that no water contact recreation activity of any kind was occurring in Reach 1 of Cucamonga Creek. This is the concrete-lined segment above Hellman Ave. There is evidence of water contact recreation in the more natural section of Cucamonga Creek below Hellman Ave (and outside of Reach 1). Consequently, this segment should continue to be designated REC-1 in the Basin Plan.

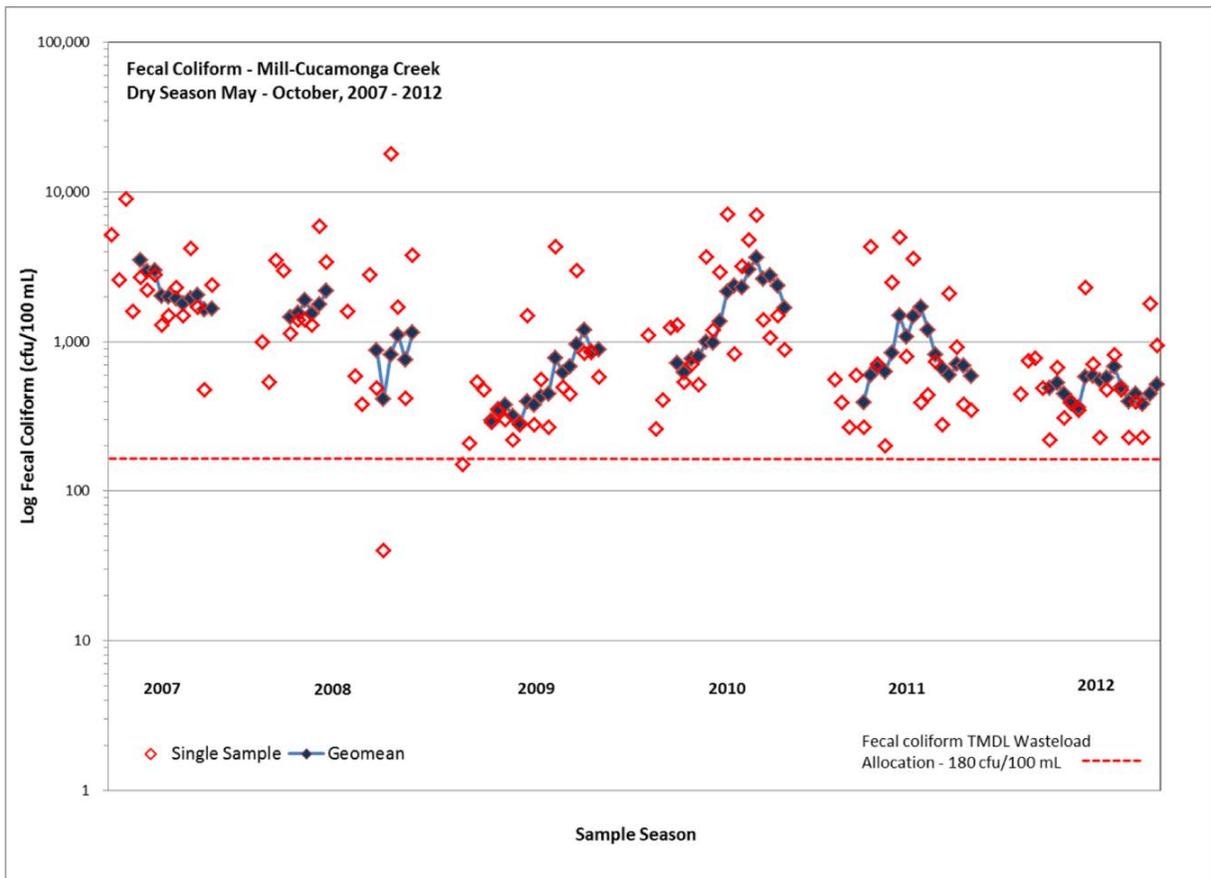
Figure CC-25: Fecal Coliform Concentrations in Cucamonga Creek (2007-2012)²⁶

The routine water quality sampling data shows that the existing REC1 pathogen indicator objectives not consistently attained in Reach 1 of Cucamonga Creek. Figure CC-25 summarizes the monitoring data for fecal coliform during the last 5 years. Figure CC-26 does the same for the *E. coli* data. Data collected prior to 2007 are summarized in Appendix A of this UAA report.

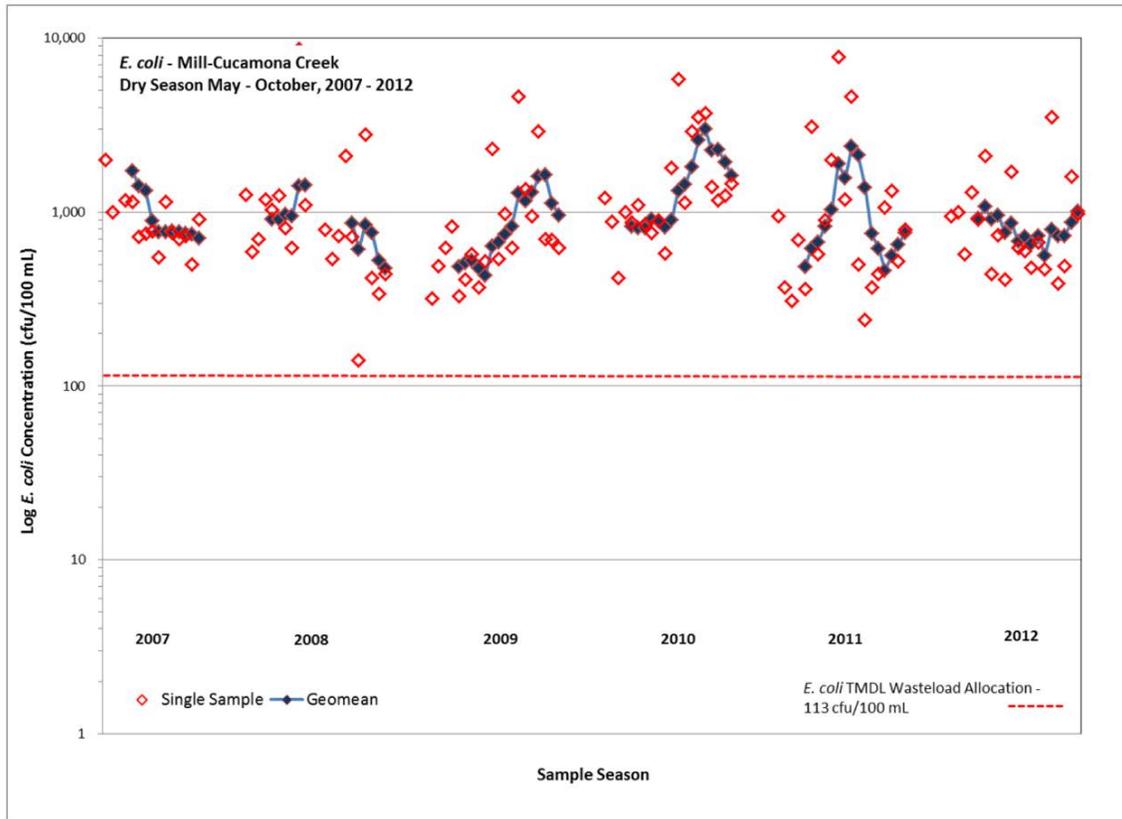
Figure CC-26: *E. coli* Concentrations in Cucamonga Creek (2007-2012)²⁷

Recent monitoring data clearly indicate that water quality in Cucamonga Creek is not meeting the Basin Plan objective for pathogen indicator bacteria. 100% of the geomeans calculated for the period from 2007 to 2012 exceeded EPA's recommended water quality criteria for *E. coli*.²⁸ Consequently, based on the available water quality data, REC1 is neither attained nor an existing use in Reach 1 of Cucamonga Creek.

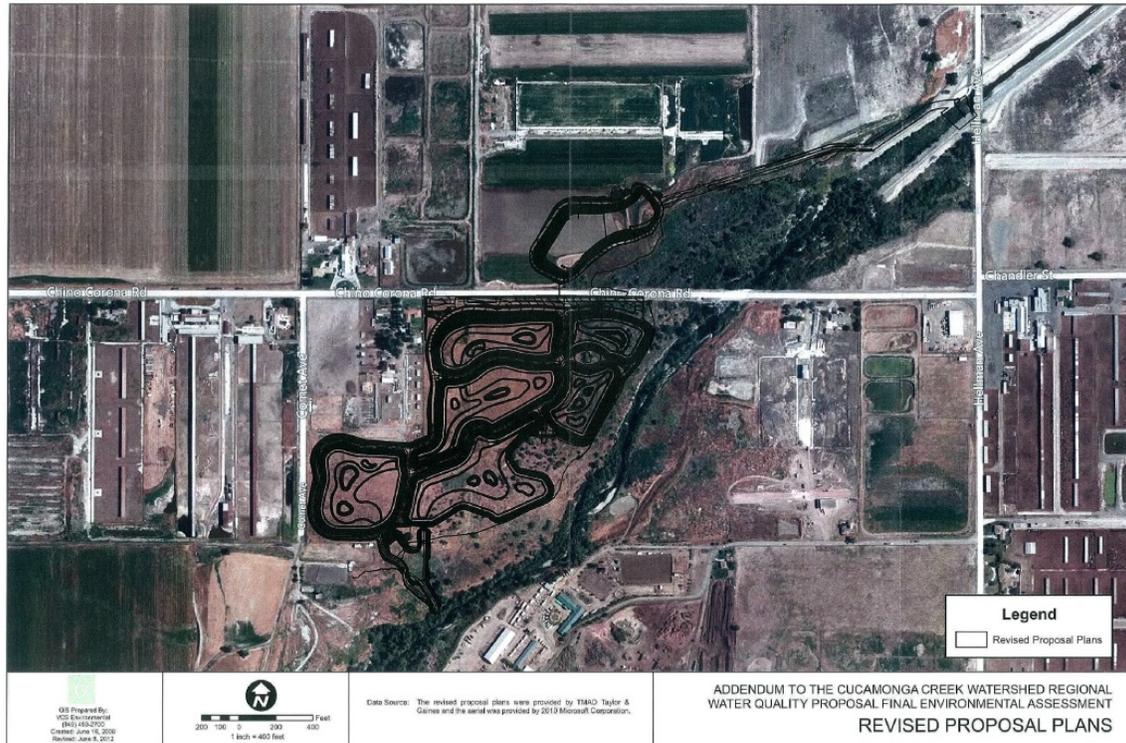
Figure CC-27: Artificial Wetlands Treatment Ponds on Cucamonga Creek

Working with IEUA, the City of Ontario has constructed a series of off-channel artificial wetlands ponds near the end of Cucamonga Creek - Reach 1 (see Figure CC-27). As of the fall of 2013, approximately half of the dry weather flow (≈ 15 of 35 cfs) is already being diverted out of Cucamonga Creek just downstream of Hellman Ave. More will be diverted when the project is completed in the spring of 2014.

These constructed wetlands are expected to significantly reduce the concentration and mass of pathogens entering the Santa Ana River from Cucamonga Creek. This is important because, while there is no known REC1 or REC2 activity occurring in Cucamonga Creek, there is considerable water contact recreation occurring downstream in Reach 3 of the Santa Ana River. Therefore, this project is expected to provide significant improvements in downstream water quality.
