USE ATTAINABILITY ANALYSIS (UAA)
For
GREENVILLE-BANNING CHANNEL – REACH 1

Santa Ana Regional Water Quality Control Board

October 4, 2013

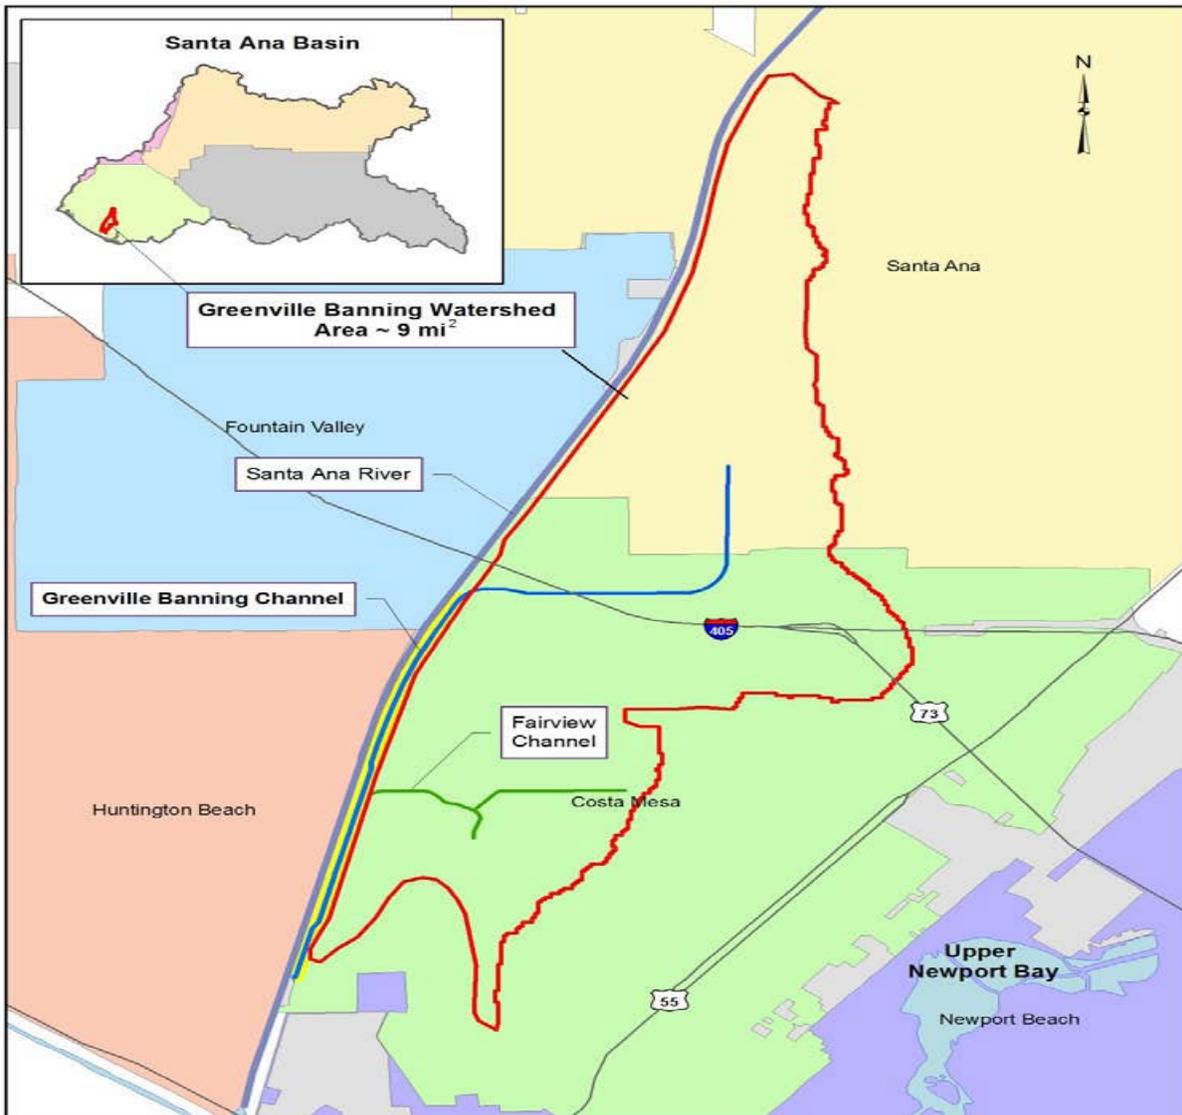
Figure GB-1: Map of Greenville-Banning Channel Watershed. (Source: Use Attainability Analysis Technical Report for Greenville-Banning Channel, CDM, August 2010, Figure 2-1)

The Greenville-Banning Channel (GBC) is a man-made flood control conveyance located in Orange County and is tributary to Reach 1 of the Santa Ana River. Stormwater runoff from the Cities of Costa Mesa and Santa Ana drains to the GBC (see Figure GB-1). Reach 1 of the GBC is located entirely within the City of Costa Mesa.

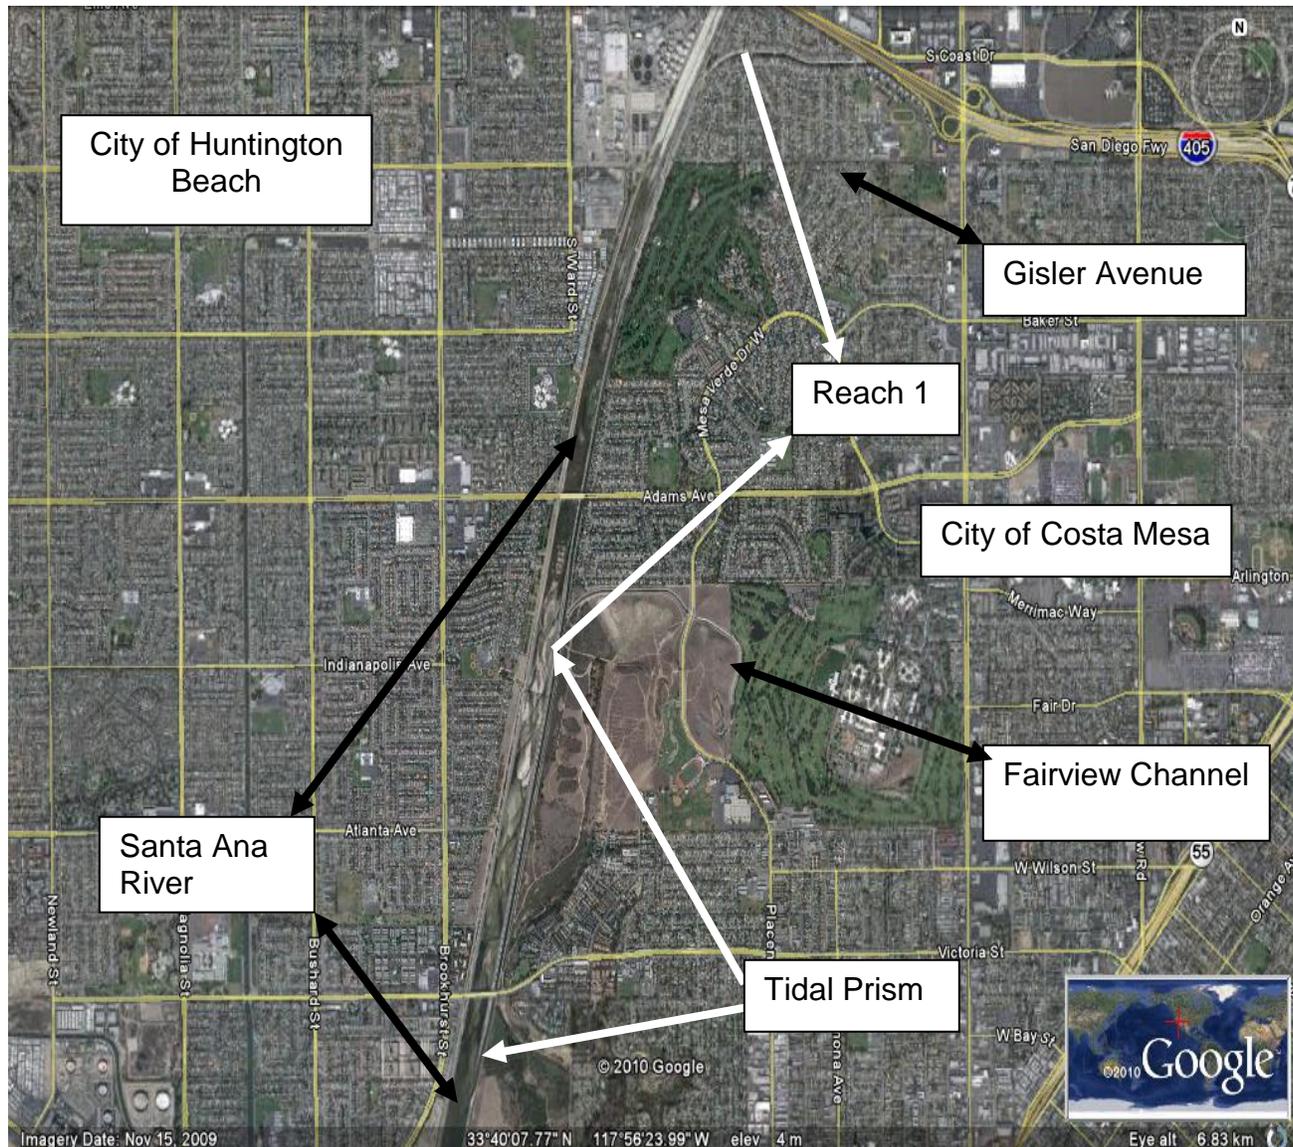
Figure GB-2: Proposed Tidal Prism and Reach 1 of the Greenville-Banning Channel. The Channel lies adjacent to the Santa Ana River from its confluence with the River to upstream of Gisler Avenue at the California Street crossing.

GBC is 3.35 miles long and is divided into two segments (see Figure GB-2). The lower segment, called the Tidal Prism Reach, extends from the confluence with the Santa Ana River 1.2 miles upstream to an inflatable dam located near Fairview Park. The Pacific Ocean is 1.3 miles further downstream from the point where GBC joins the Santa Ana River. The upper segment, called Reach 1, begins at the inflatable diversion dam and ends where California Street crosses the stream channel - a distance of 2.15 miles. This Use Attainability Analysis focuses exclusively on Reach 1. The lower, Tidal Prism, reach is addressed in a separate UAA. The portions of GBC above California Street have not yet been added to the Basin Plan.

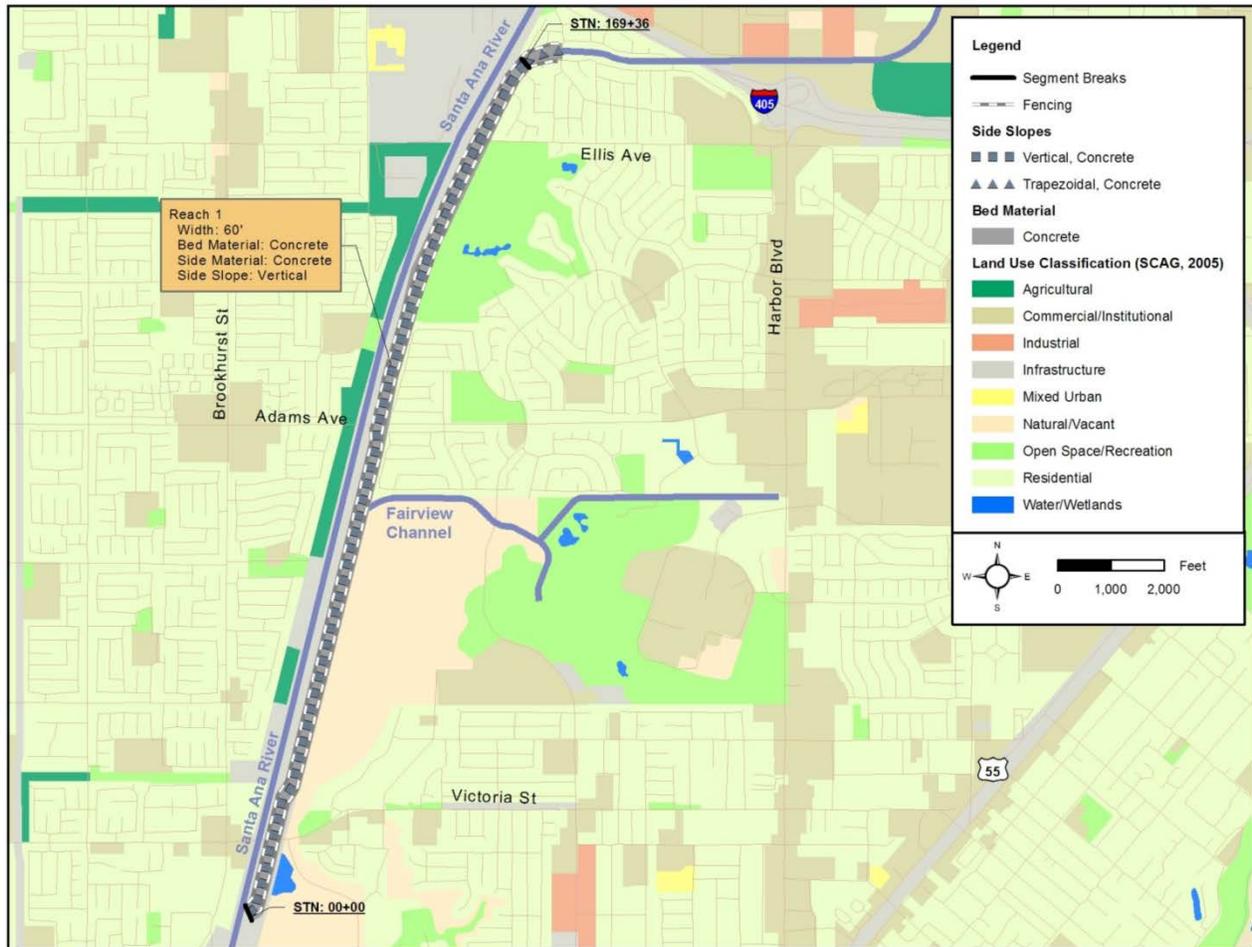
Figure GB-3: Greenville-Banning Channel Characteristics and Adjacent Land Uses
(Source: Use Attainability Analysis Technical Report for the Greenville Banning Channel, CDM, August 2010 Figure 2-4) **(Note to reader: Increase the zoom level of this page to enhance the readability of this figure.)**

The Greenville-Banning drainage area encompasses a 9 square-mile urban area that has been fully developed (see GB-3). The Santa Ana River Channel borders all but 0.2 miles of the western side of Reach 1. A public park, private golf course and single family homes lie along the east side of Reach 1. Table GB-1 provides a detailed breakdown of land uses adjacent to Reach 1.

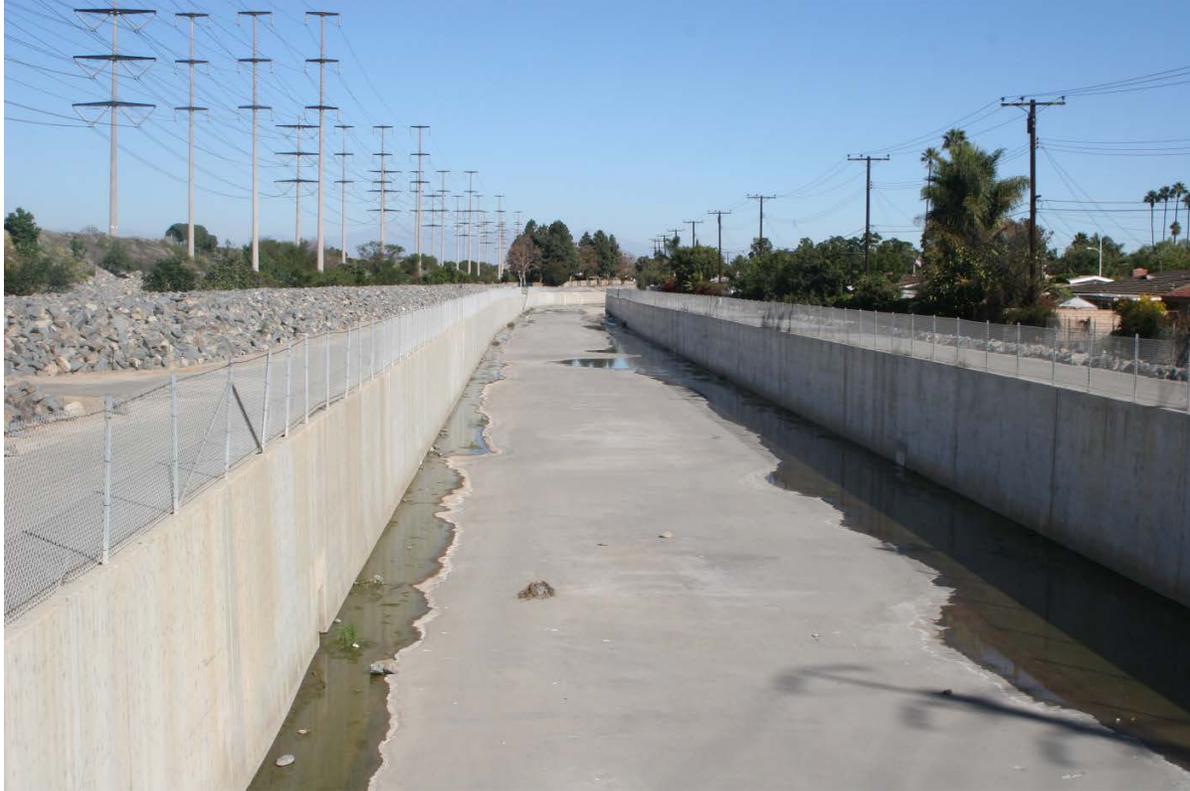
Figure GB-4: Reach 1 of Greenville-Banning Channel, Looking Upstream During Dry Weather. The channel bottom width is 60 ft. and the vertical walls are 20 ft. in height. Dry weather flows characteristically are found mostly along the eastern side of the channel as shown in this photograph. The deepest depth of the low flow at this location as measured in April 2013 was measured to be 4 inches. In the distance, at the curve of the channel, is where the channel transforms to trapezoidal shape. Regional Board staff photograph, December 2010.

Originally constructed as a trapezoidal earthen channel, the GBC Reach 1 and the tidal prism Reach have since been converted to a concrete-lined box channel to provide adequate flood protection. Most of the Greenville-Banning Channel Reach 1 is now fully-lined with a flat bottom that is 60 feet wide and vertical walls that are 20 feet high (see Figure GB-4). There is a short (0.2 mile) section at the uppermost end of Reach 1 that has steep trapezoidal walls and a small (8-9 ft. wide) low flow channel (see Figures GB-5 and GB-6 and Table GB-2).

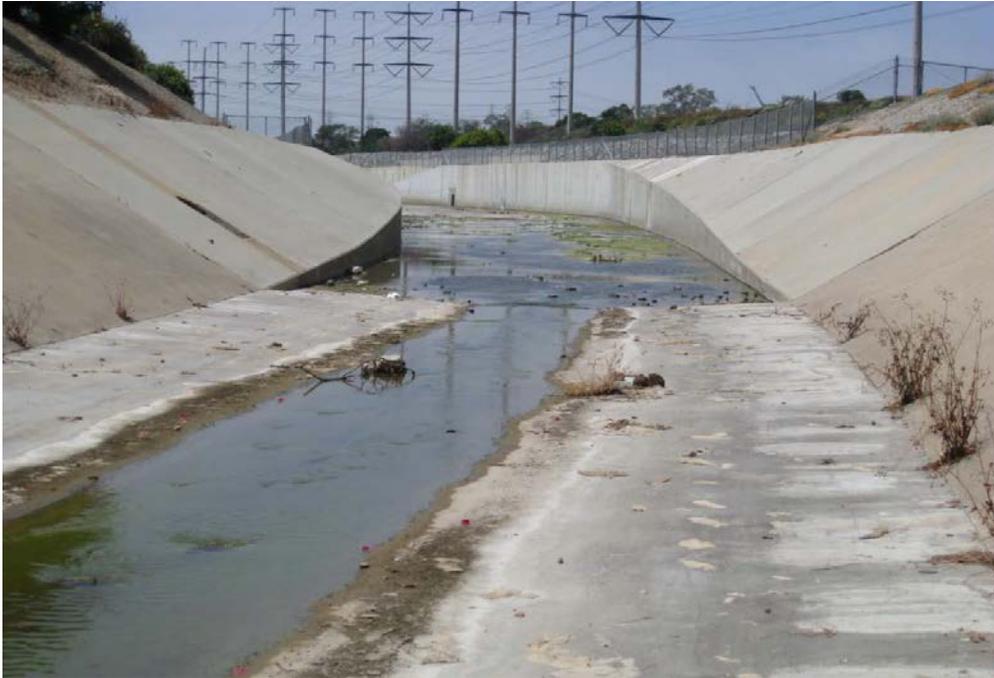
Figure GB-5: Proposed Reach 1 of the Greenville-Banning Channel, Facing Downstream. Trapezoidal to Vertical Channel Transition. (Source: Use Attainability Analysis Technical Report for the Greenville-Banning Channel, CDM, August 2010, Figure 2-9)

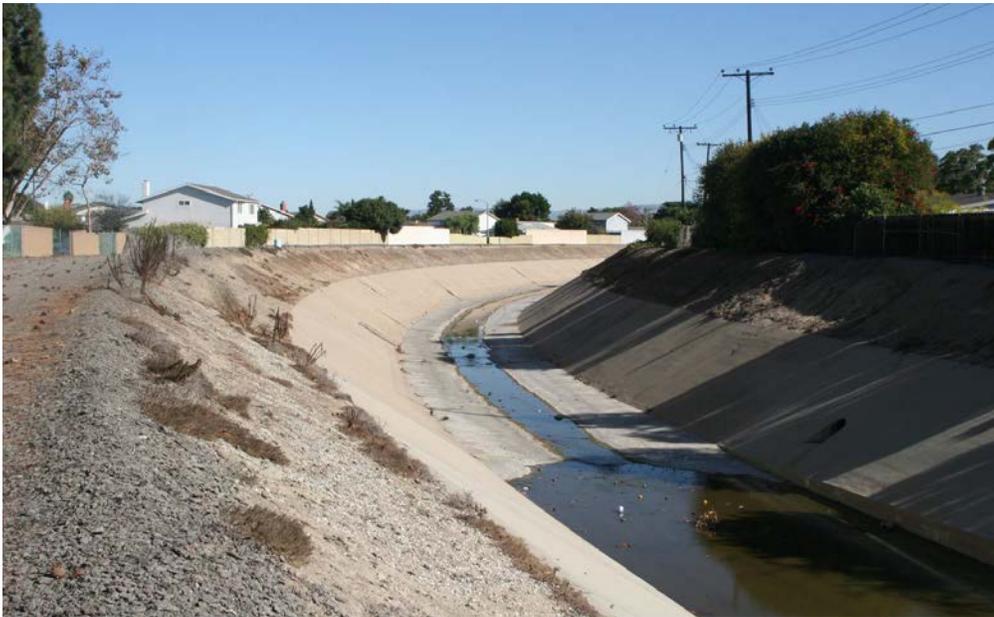
Figure GB-6: The Upper 0.20 mile Segment of Reach 1 Looking Upstream. Just upstream of the curve of the channel shown in this photograph is the proposed upstream boundary of Reach 1, the California Street crossing located in the city of Costa Mesa. The channel dimensions in this segment are approximately: bottom width 24 ft.; low flow channel width 8-9 ft.; and channel depth 20 ft. (Regional Board staff photograph, May 2010).

Over the years, Reach 1 of the Greenville-Banning Channel, which was originally constructed as a simple stormwater ditch, has been significantly modified to provide greater flood control protection. In the 1990's, concrete-lining replaced the existing rip-rap to prevent further erosion, maintain the proper gradient and protect nearby homes (see, for example Figure GB-6).

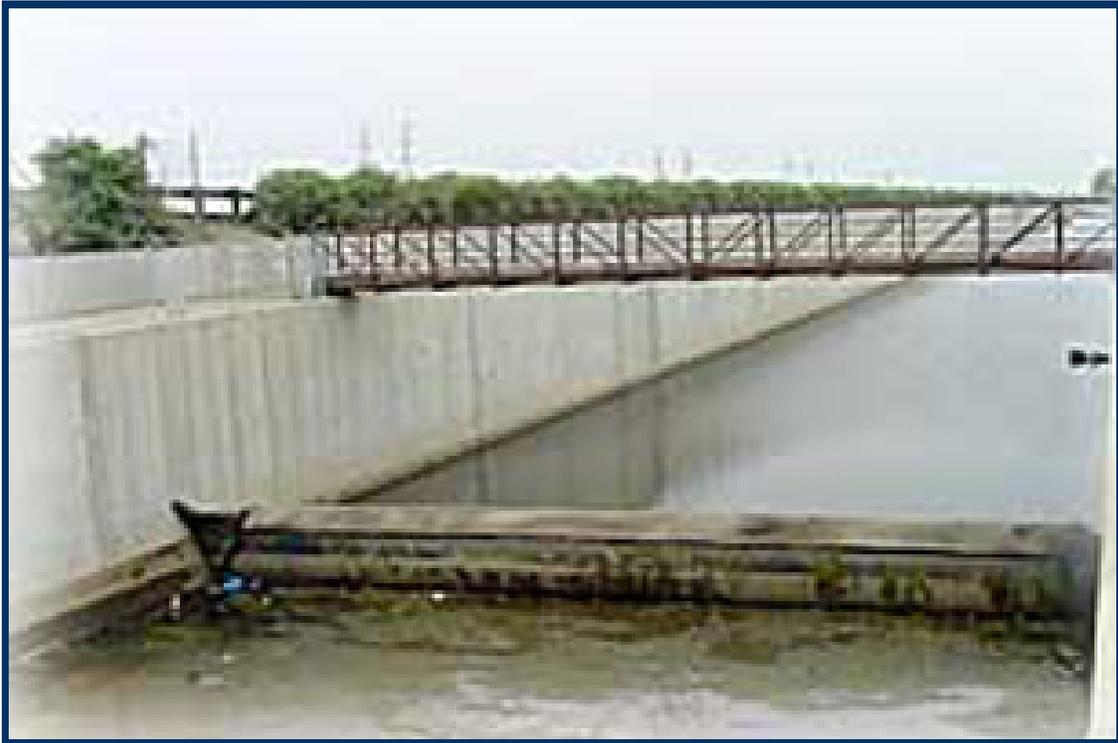
Figure GB-7: Inflatable dam diversion at Greenville-Banning Channel. The inflatable rubber dam impounds low flows, shown in the background of the photo, which are pumped to the sanitary sewer system for treatment and to a nearby constructed wetland. The inflatable dam marks the downstream end of Reach 1. (Photograph from Orange County Public Works)

The dividing line between Reach 1 and the Tidal Reach of GBC is marked by the presence of an inflatable dam (see Figure GB-7). This dam was installed in the late 1990's as part of a project designed to prevent urban runoff from polluting popular beach areas. Water trapped behind the dam is pumped to Orange County Sanitation District's wastewater plant, on the opposite side of the Santa Ana River, for treatment. In addition, beginning in early 2013, impounded flows will also be diverted to an adjacent constructed wetland and riparian area.

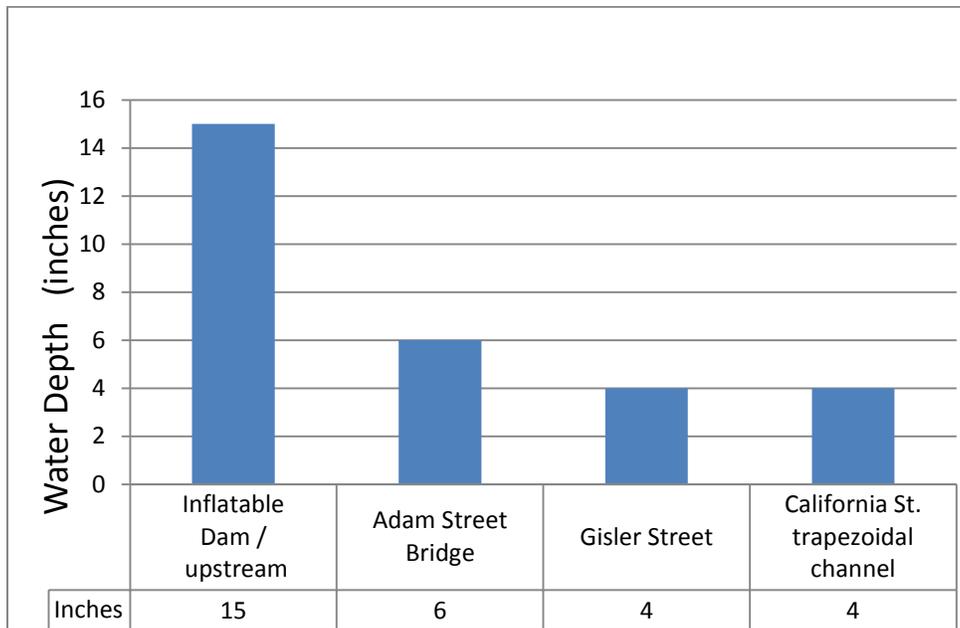
Figure GB-8: Depth of Water in Reach 1 of the Greenville-Banning Channel. The depths are the average of the measurements taken on April 16 and 25th, 2013 from the deepest section of the flow or pooled water.

In April of 2013, Regional Board staff measured the depth of flow at four locations in Reach 1 of the Greenville Banning Channel during conditions typical of the dominant dry weather pattern for this area. The four locations were: 1) immediately upstream of the inflatable dam, 2) at the Adams St. crossing, 3) at the Gisler St. bicycle bridge, and 4) at the California St. crossing. At each site, three measurements were taken across a transect: at one-third, one-half and two-thirds the channel width. Since the bottom of the channel is quite flat, the three measurements were very similar to one another.

In April of 2013, actual field measurements indicated that the stream flow in GBC was approximately 0.83 cfs (0.45 mgd) during dry weather conditions.¹¹ Water was impounded behind the inflatable dam up to about the Adams Street crossing - a distance of approximately 0.45 miles. Stream conditions in April of 2013 were typical of those observed by Regional Board staff during prior reconnaissance surveys over the last few years. The average water depth in the deepest section in each of the following areas of Reach 1 was: 15 inches just upstream of the inflatable dam; 6 inches at the Adams Street Bridge; 4 inches at the Gisler Street Bridge; and 4 inches at California Street Bridge crossing (see Fig. GB-8). Dry weather flows upstream of Adams Street were fully contained in a low flow notch that is about 8-9 ft. wide and 4 inches deep. As stated above, if the dam is not inflated, dry weather depths of an inch or less would be expected.

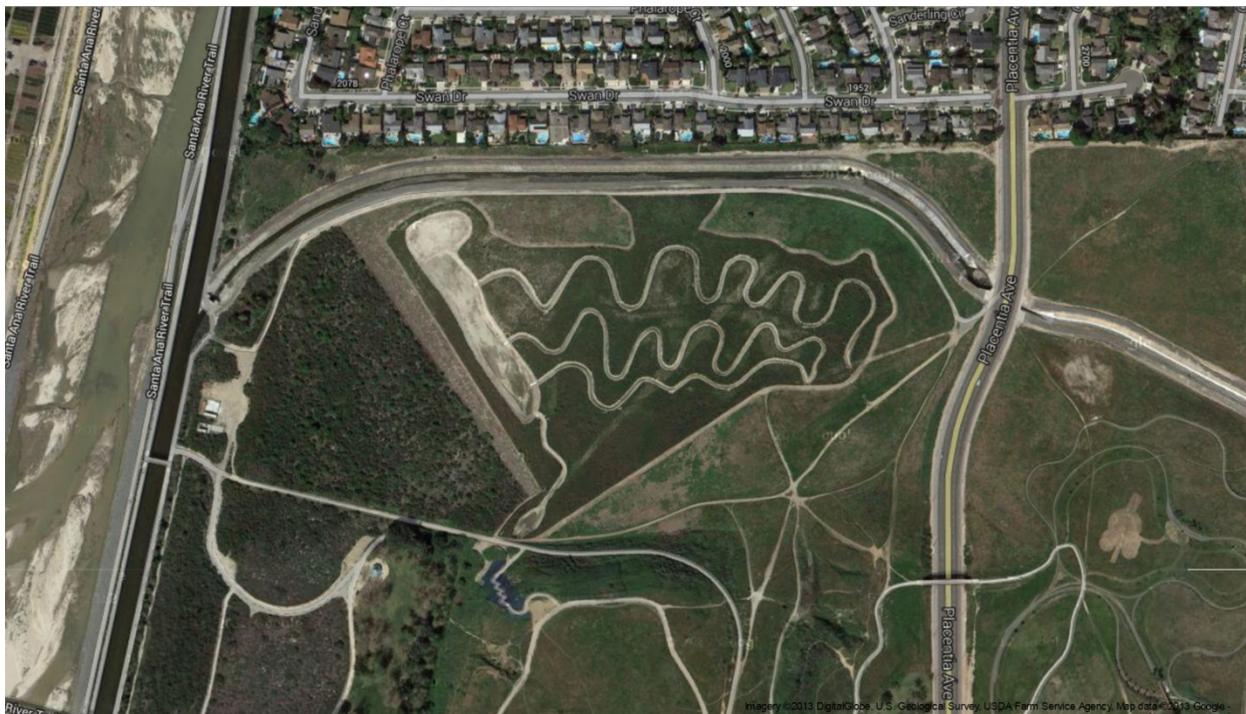
Figure GB-9: Wetlands and Riparian Area Under Construction (now complete) in Fairview Park.

From its inception, GBC was designed and constructed as a flood control facility. It was never natural stream and it is not feasible to convert GBC to a more natural condition without compromising its primary purpose - flood protection. There is no public benefit provided by transforming GBC to a more natural condition as far superior opportunities for water contact recreation are available just a short distance away at Huntington Beach State Park and Newport Beach along the Pacific Coast. Even closer, are the newly-created wetland and riparian area recently constructed in Fairview Park adjacent to GBC (see Figures GB-9 and GB-16).

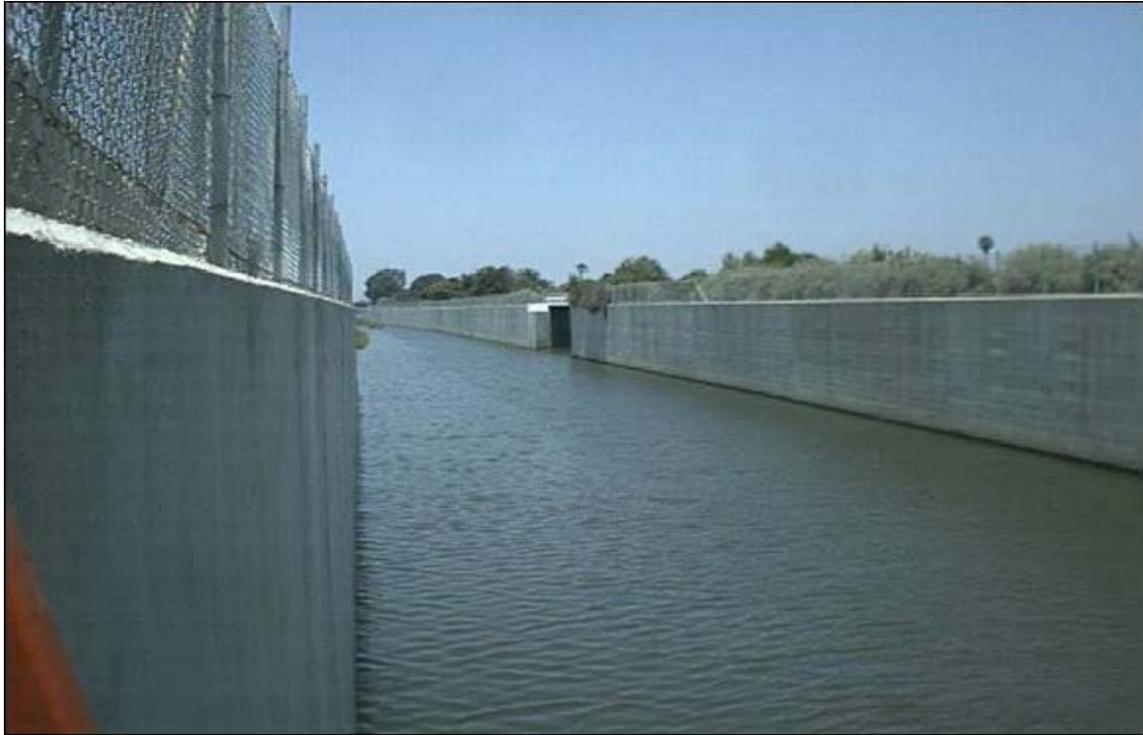
Figure GB-10: Greenville-Banning Channel (looking north toward confluence w/ Fairview Channel) from the Rec-Survey Camera Mounted on the Pedestrian Bridge near Fairview Park.(Source: Recreational Use Survey – Greenville Banning CDM 11/2006)

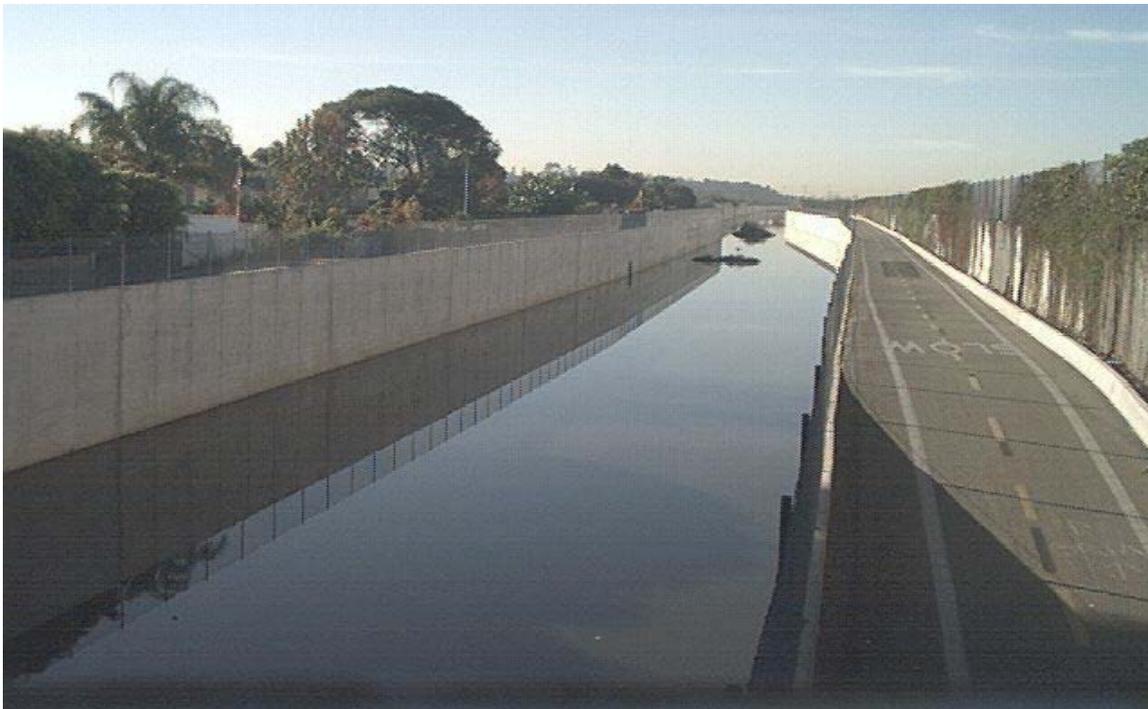
Figure GB-11: Greenville-Banning Channel (looking South) from the Rec-Survey Camera Mounted on the Adams Ave. Bridge (approximately 0.45 mile North of Camera Location in Figure GB-10). (Source: Recreational Use Survey – Greenville-Banning CDM 11/2006)

A second camera was installed on the Adams Avenue bridge approximately 0.45 of a mile north of, and focused downstream toward, the first camera location (see Fig. GB-11). It operated for six weeks and collected 2,552 images before also being destroyed by vandals. No water contact recreation was observed in any of the photographs. Results from the camera survey are summarized in Table GB-3.

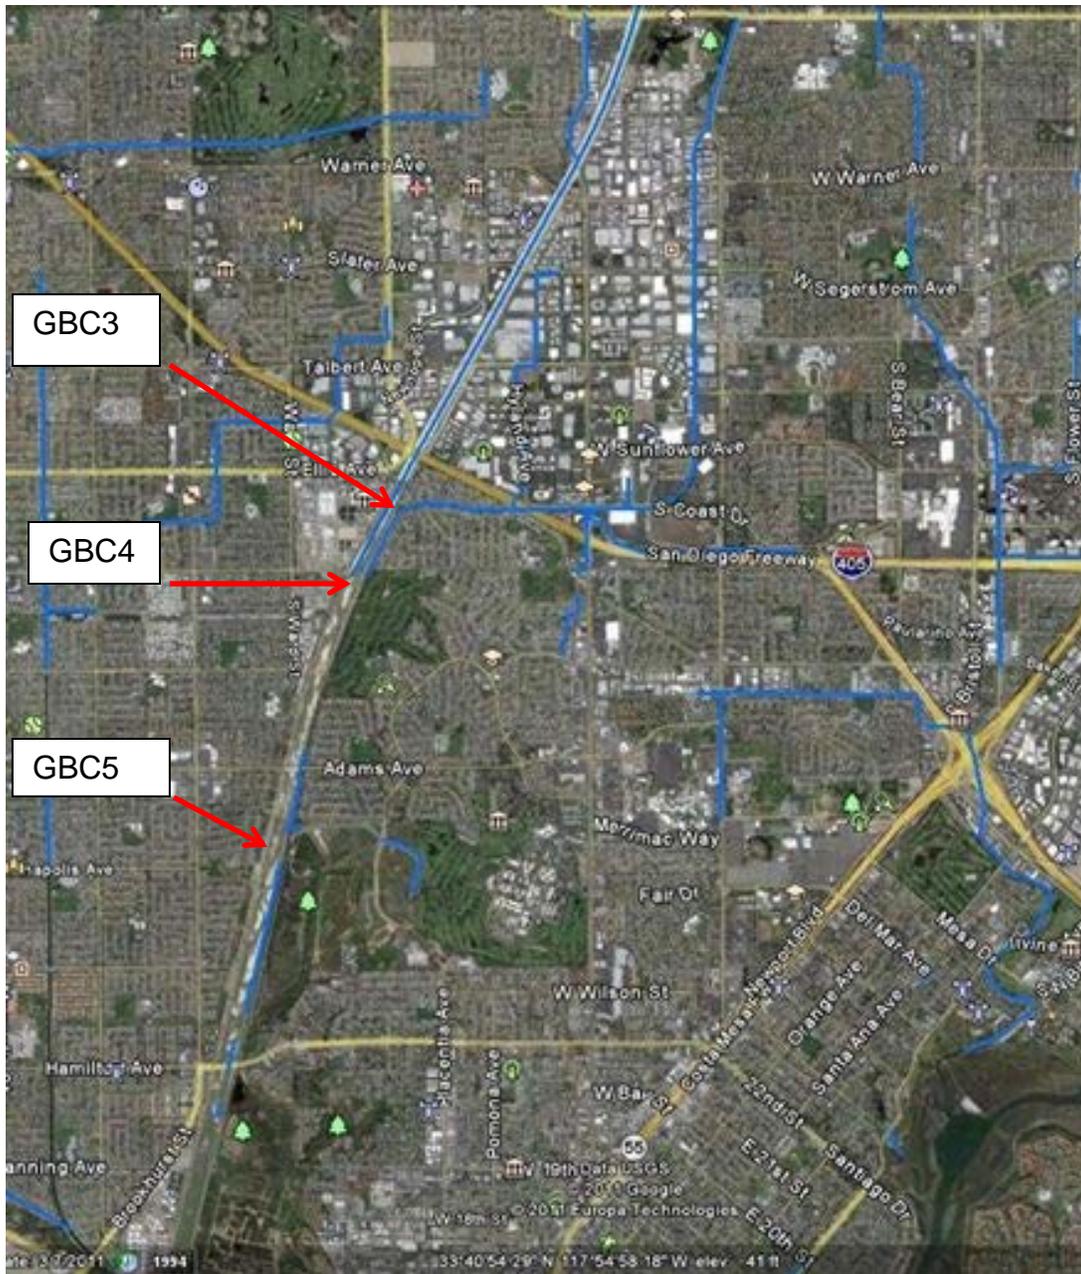
Figure GB-15: Map of Bacteria Sampling Locations on the Greenville-Banning Channel in August-September 2011

In August and September of 2011, Orange County Public Works Department staff collected samples from three locations in Reach 1: California Street (GBC3), Gisler Street (GBC4), and at the inflatable diversion dam (GBC5). The sampling locations are shown in Figure GB-14. The results are presented in Table GB-6.

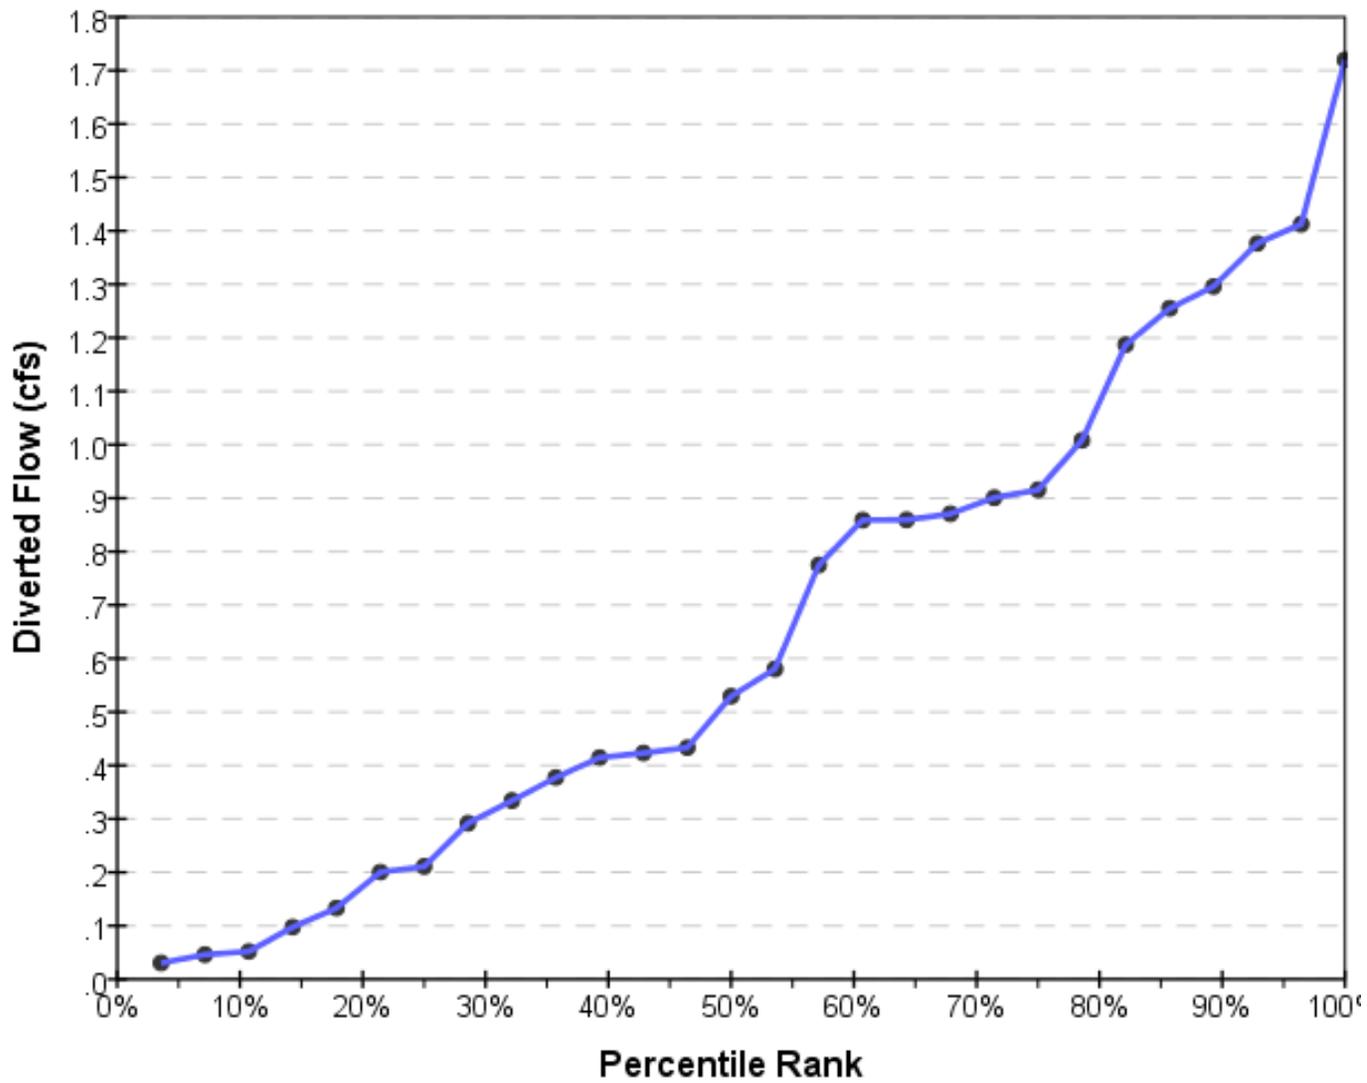
Figure GB-16: Urban Runoff Diversions to OCSD from the Greenville-Banning Channel (2009-2011)

During repair and maintenance operations and during rain events the dam is lowered and no water is diverted. As a result during rainy years not as much water is diverted as during dry years. The diversions reduce bacteria and nutrient²² loading to downstream receiving waters, which include ocean coastal beaches that are heavily used for water contact recreation, particularly during the drier summer months.

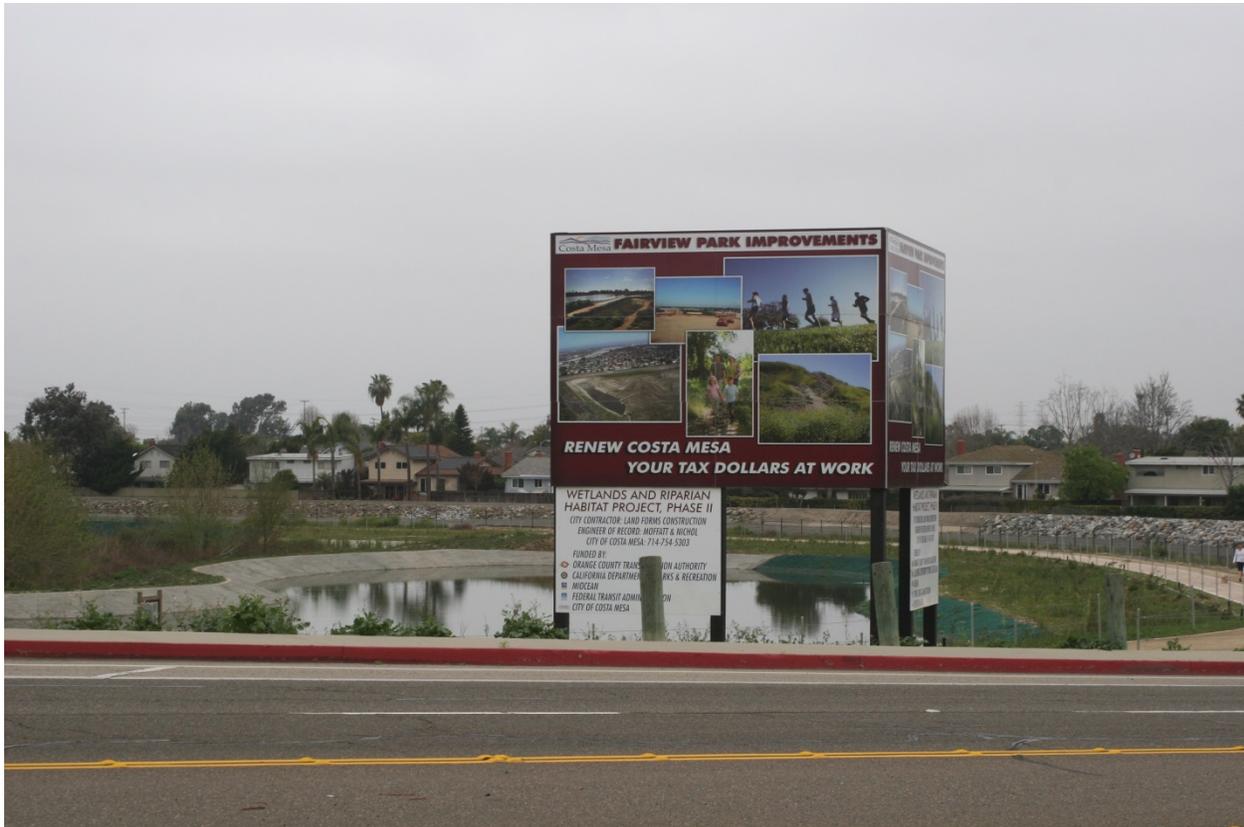
Figure GB-17: Fairview Park Wetland and Riparian Habitat Project. In early 2013, flows from the Greenville-Banning Channel have begun to be diverted into the Fairview Park Wetland and Riparian Habitat area. The diverted flows will fill a series of six ponds and sustain 17 acres of riparian habitat. (Regional Board staff photograph, April 2013)
