Water Quality Improvement Plan to Address the Sediment Impairment on San Gregorio Creek

Draft Staff Report

**California Regional Water Quality Control Board
San Francisco Bay Region**

August 6, 2021

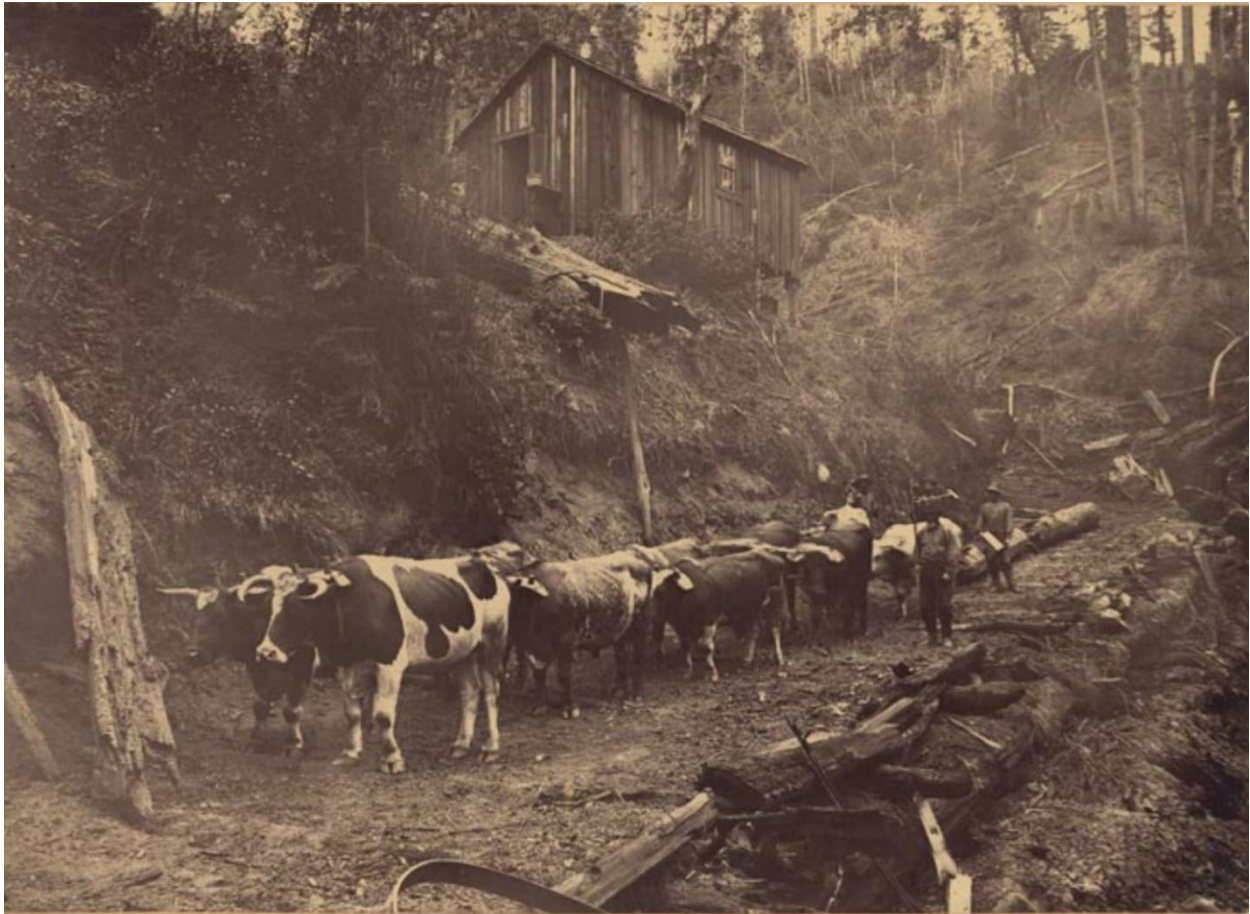
Figure 5.2 Oxen train hauling logs on corduroy road near La Honda (photo taken in 1881; Stanger 1967)

Logging and milling activities caused many adverse impacts to water quality. Construction of skid trails, or temporary roads, and roads for timber harvest increased sediment erosion and delivery to streams, and tree removal increased land surface runoff and consequent erosion. Oxen were used to haul logs, and stream beds were commonly used as 'corduroy roads' where logs were laid perpendicular to the direction of travel to more easily skid logs to their destination, effectively destroying part or all of the channel morphology and substrate (Figure 5.2).

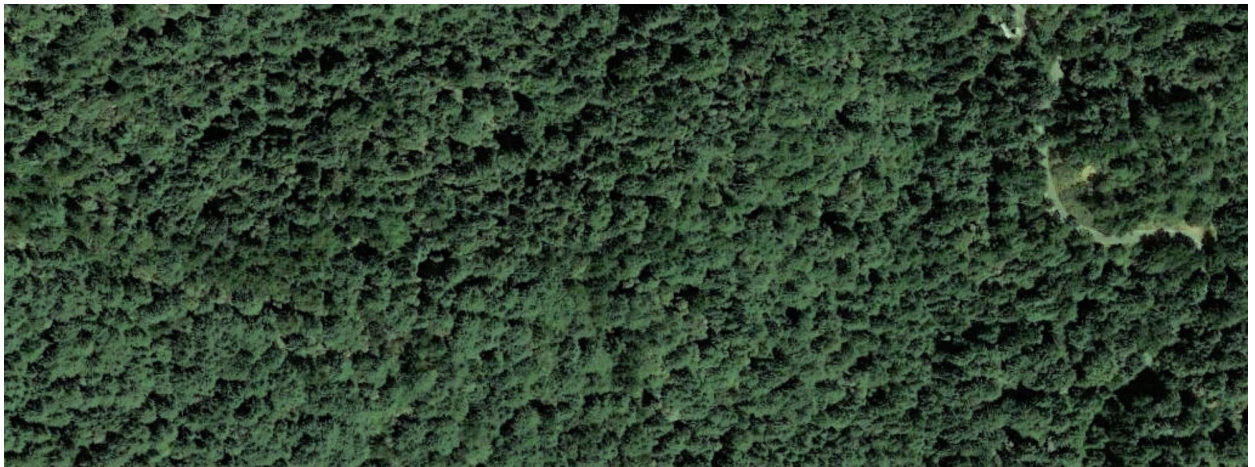
Figure 5.3 Air photo comparison showing effects of heavy logging in 1965 on surface cover (top) and a recovered forest canopy with no logging in 2000 (bottom).

1965 air photo showing effects of logging on land surface cover (lighter areas result from timber harvest activities)

2000 air photo showing recovered forest canopy with no areas of bare surface cover

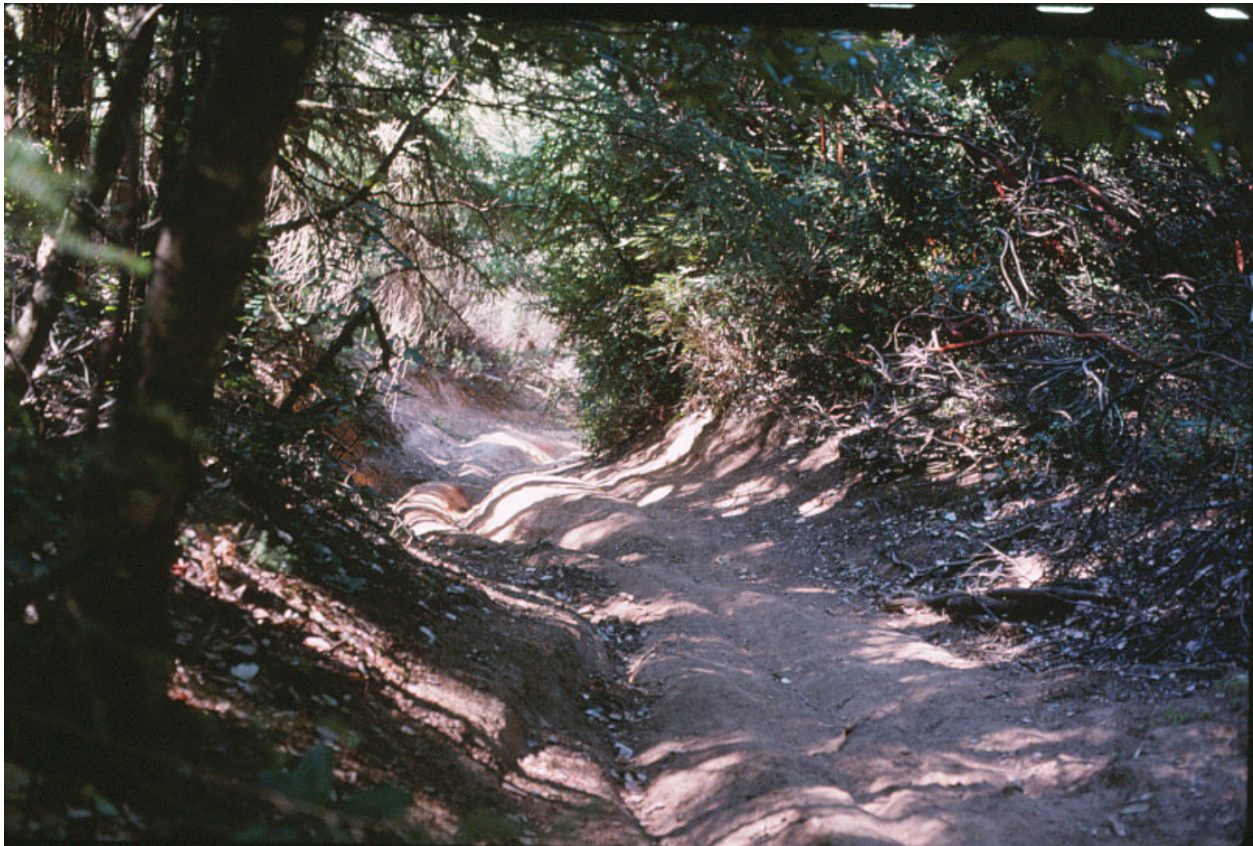
Figure 5.4 Abandoned throughcut logging road with deep rilling in the El Corte de Madera Creek Preserve (photo taken in 1994)

The extent of logging through the 1970s and 1980s is partly known. Midpen reported that the upper watershed of El Corte de Madera Creek was logged intermittently until about 1988, when the land was purchased to form an open space preserve, and that logging in the La Honda Creek subwatershed occurred throughout the 1970s and 1980s until 1988 (Hébert 2020). Although logging had largely ceased by the 1990s, legacy impacts of old logging roads and skid trails remained (Figure 5.4).
