**An Evaluation of Compensatory Mitigation Projects Permitted
Under Clean Water Act Section 401 by the California State
Water Quality Control Board, 1991-2002.**

Final Report Appendices (Review Copy)

California State Water Resources Control Board

August 2006

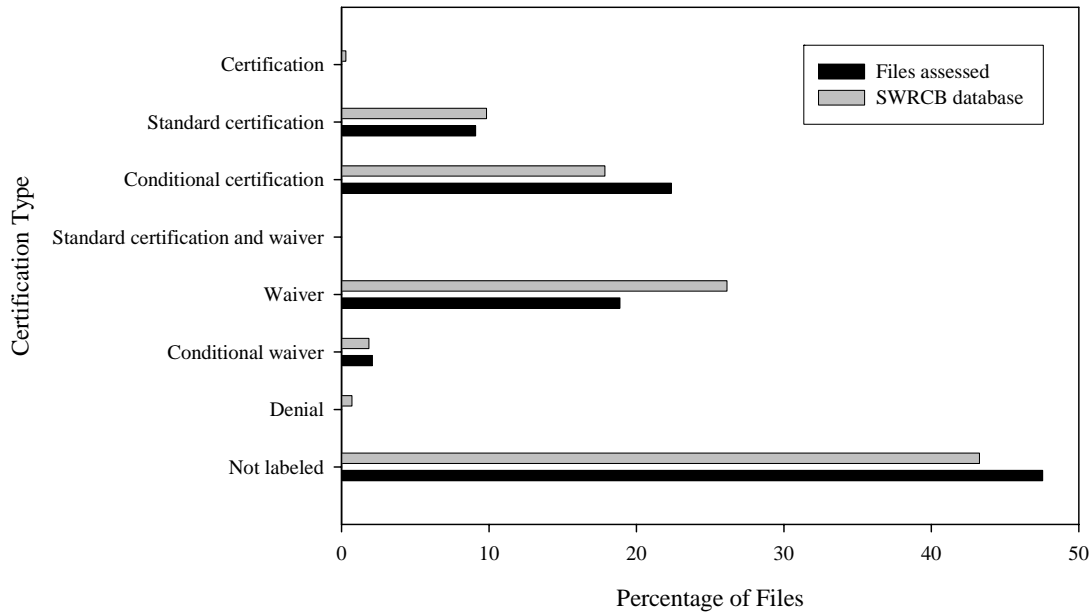
369 **Figure 1-2.** Percentage of files in each certification category listed in the SWRCB database from 1991 to
370 2002 compared with our sample of files assessed fully and for compliance only (N for files assessed=143,
371 N for SWRCB database=9924).

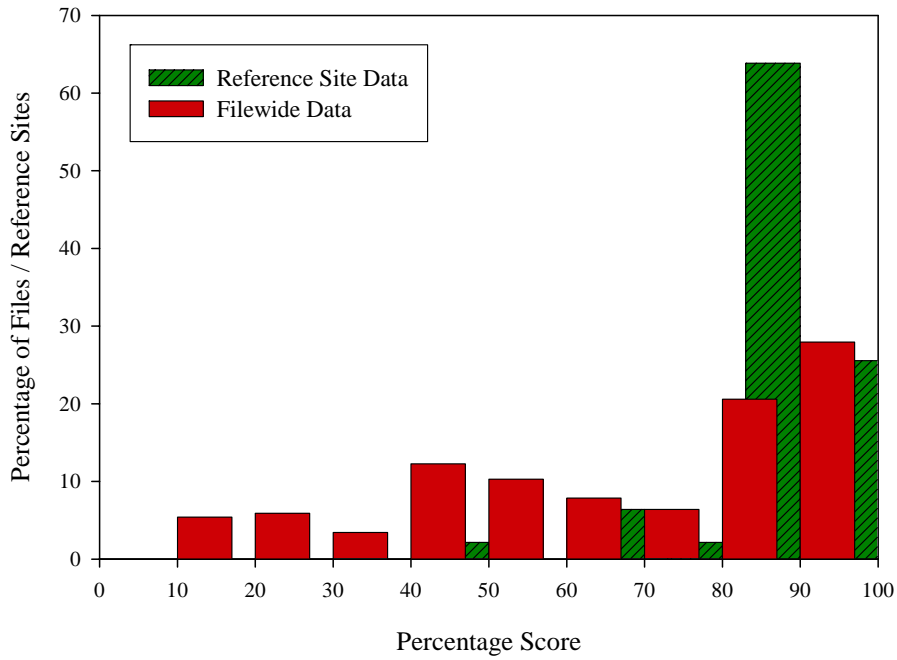
933 **Figure 7-11.** Connectivity scores for each of the 47 reference sites and each of the 204 mitigation sites
934 (representing 129 files) evaluated using CRAM.

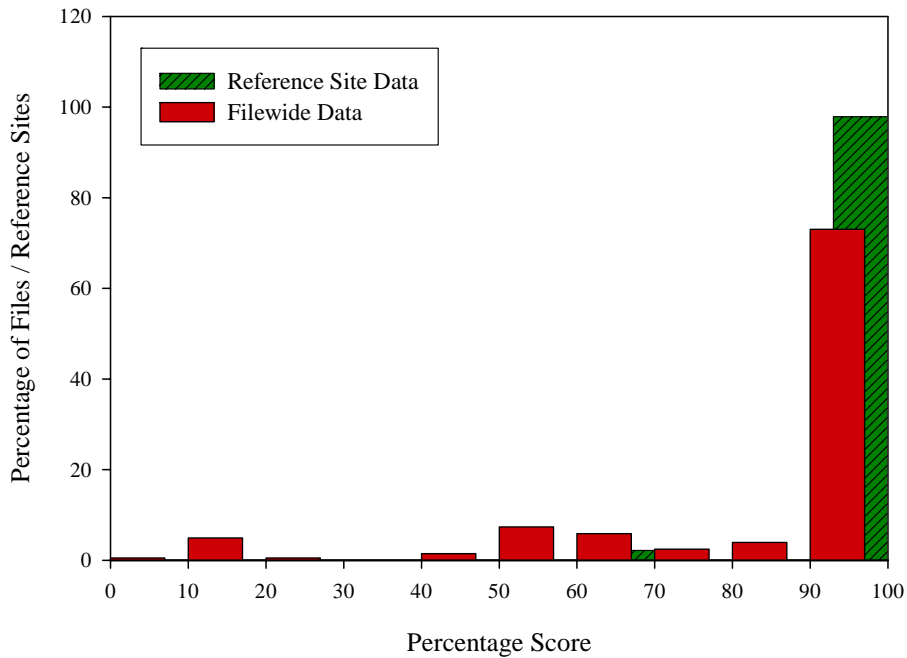
938 **Figure 7-12.** Percent of Assessment Area with Buffer scores for each of the 47 reference sites and for each of the
939 204 mitigation sites (representing 129 files) evaluated using CRAM.
