Environmental Impact Report
 prepared for State Water Resources Control Board
 by GEI Consultants, Inc.

Eastern Riverside County, California

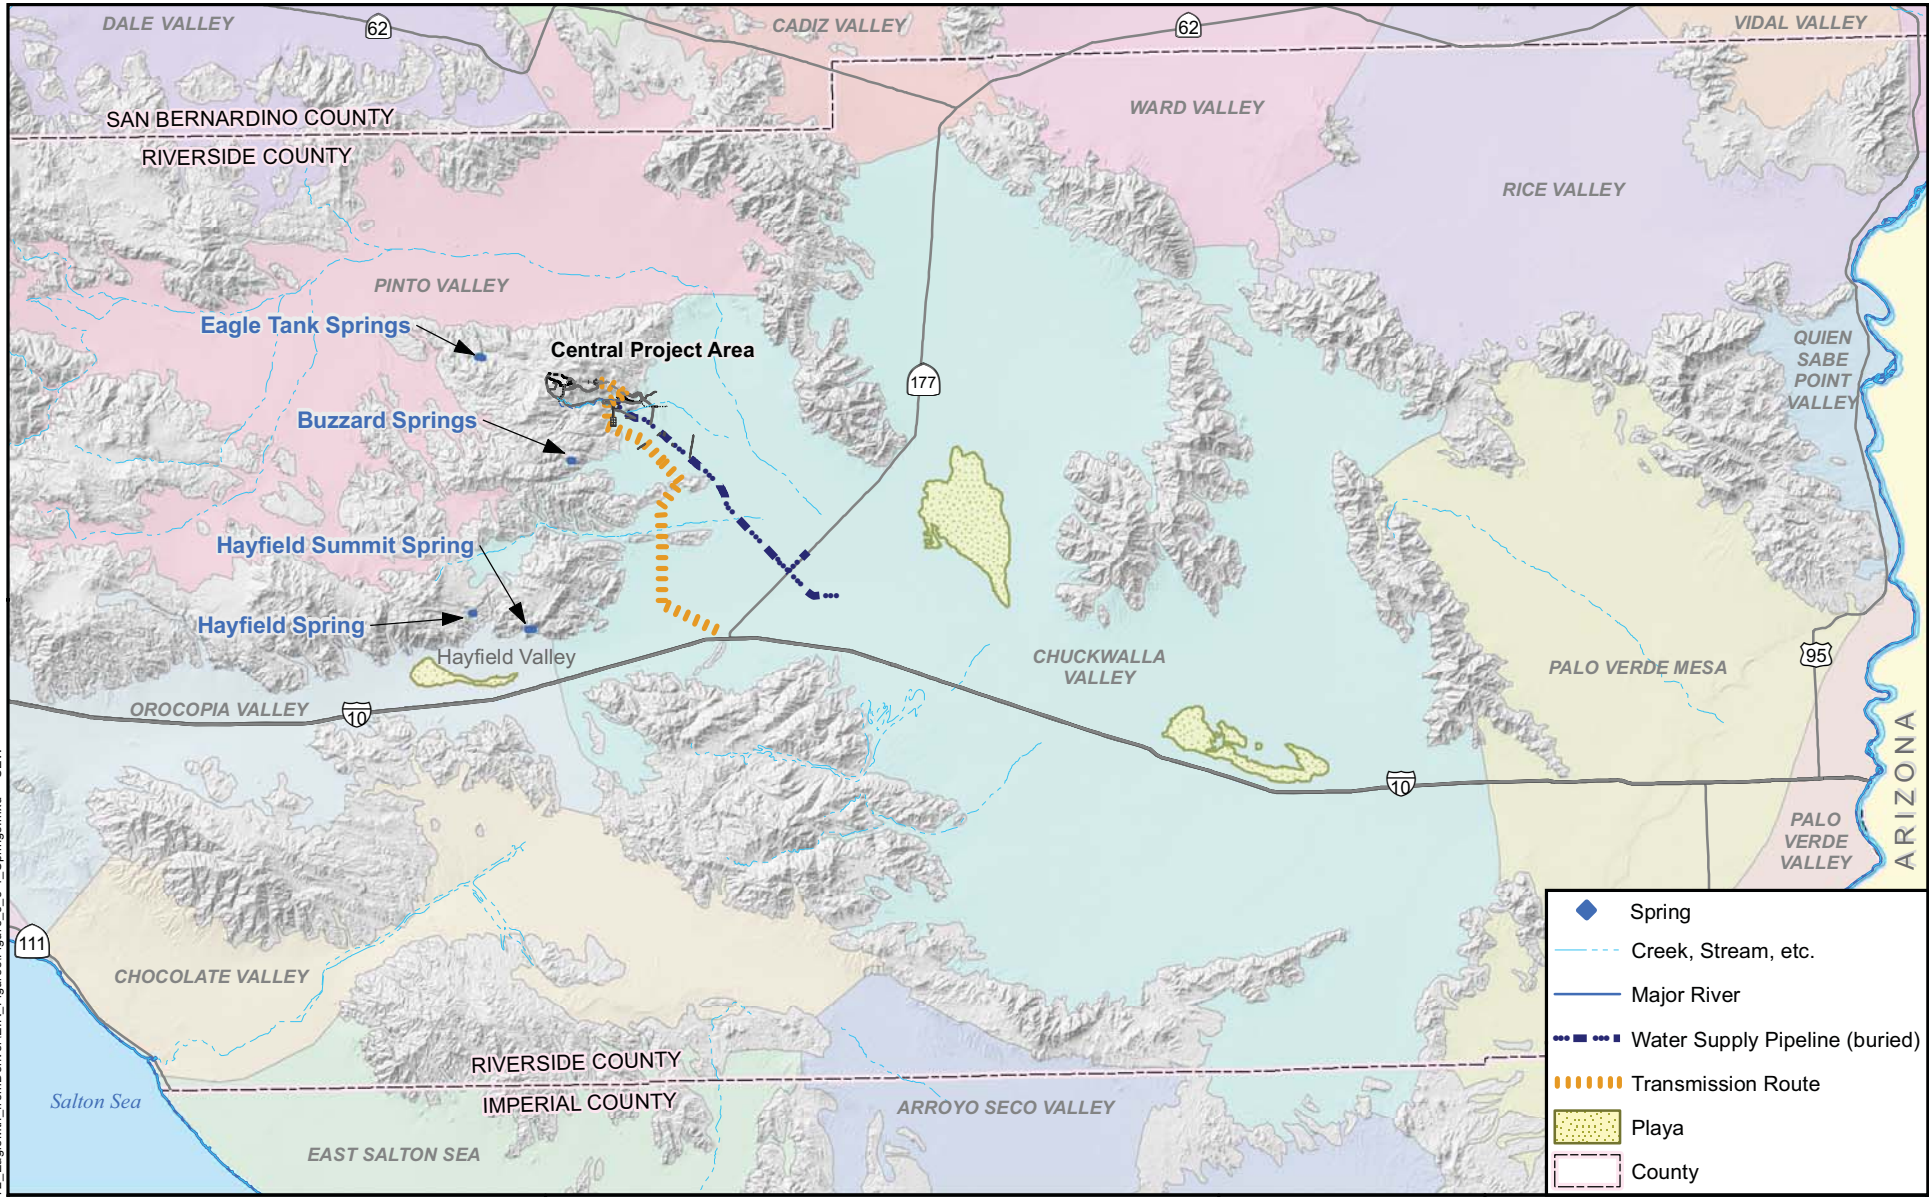
Figure 3.3-1

Springs Near Project Area

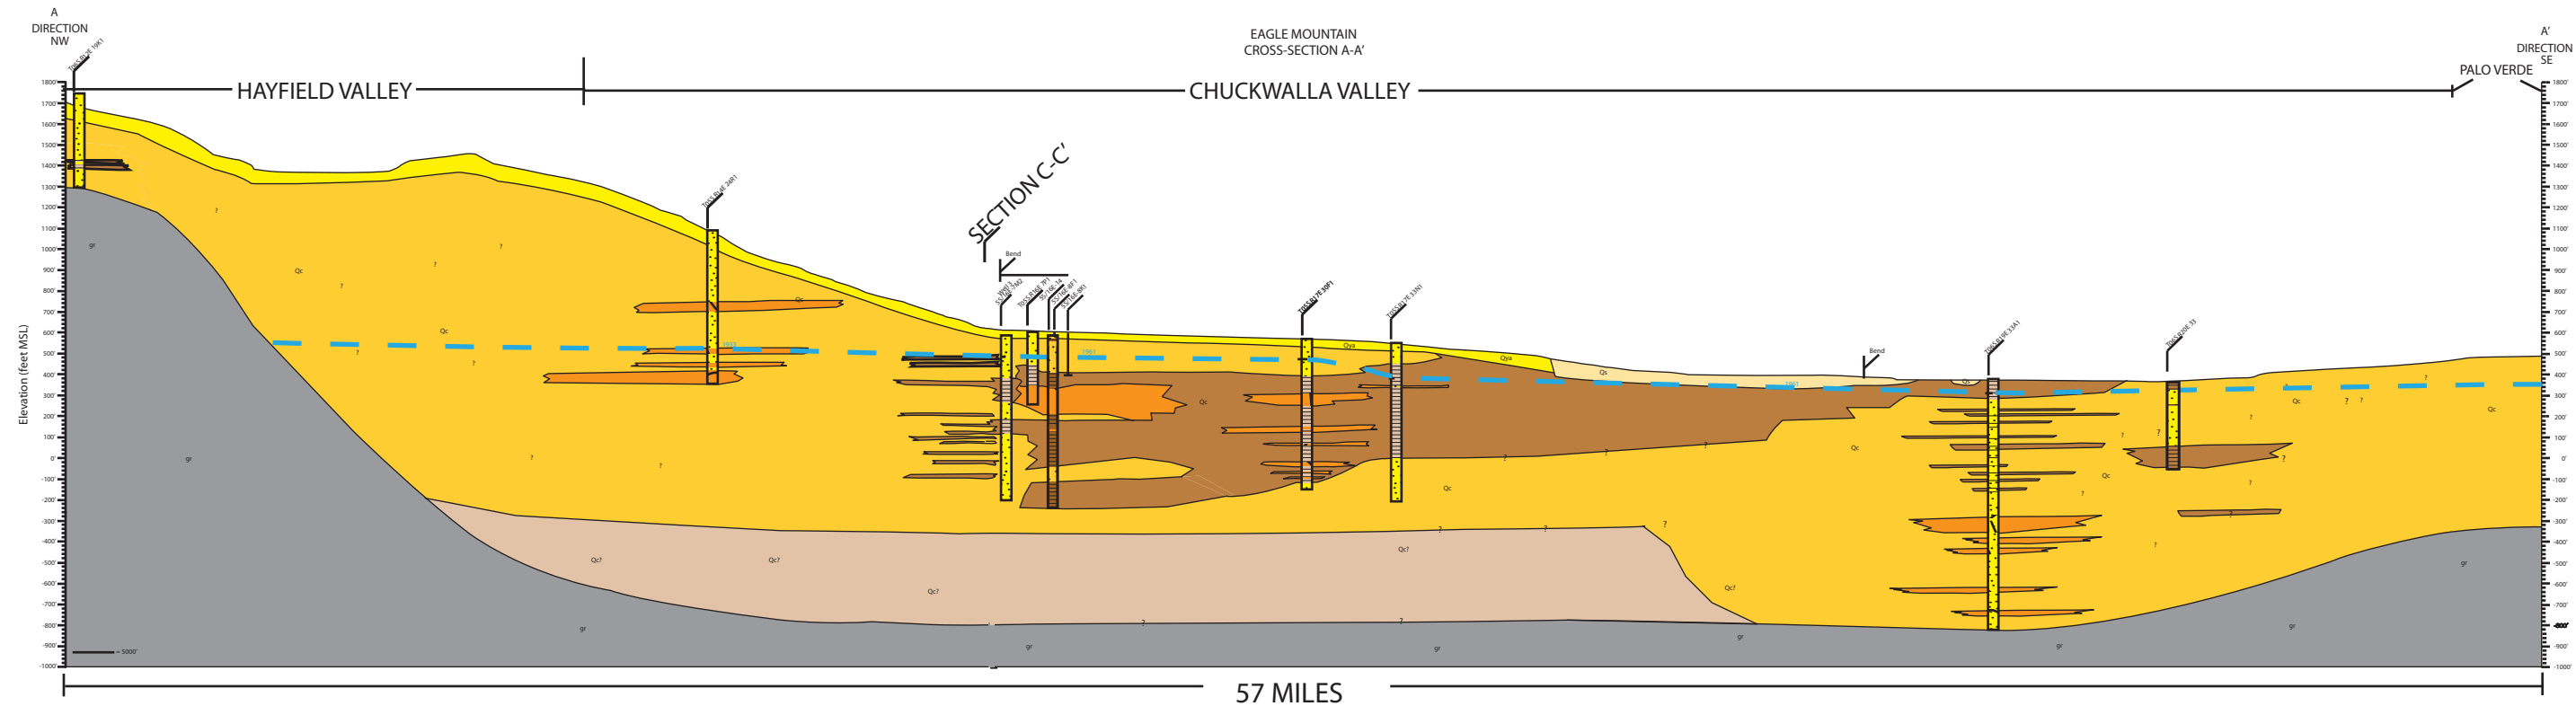
Figure 3.3-4

CROSS-SECTION A-A'

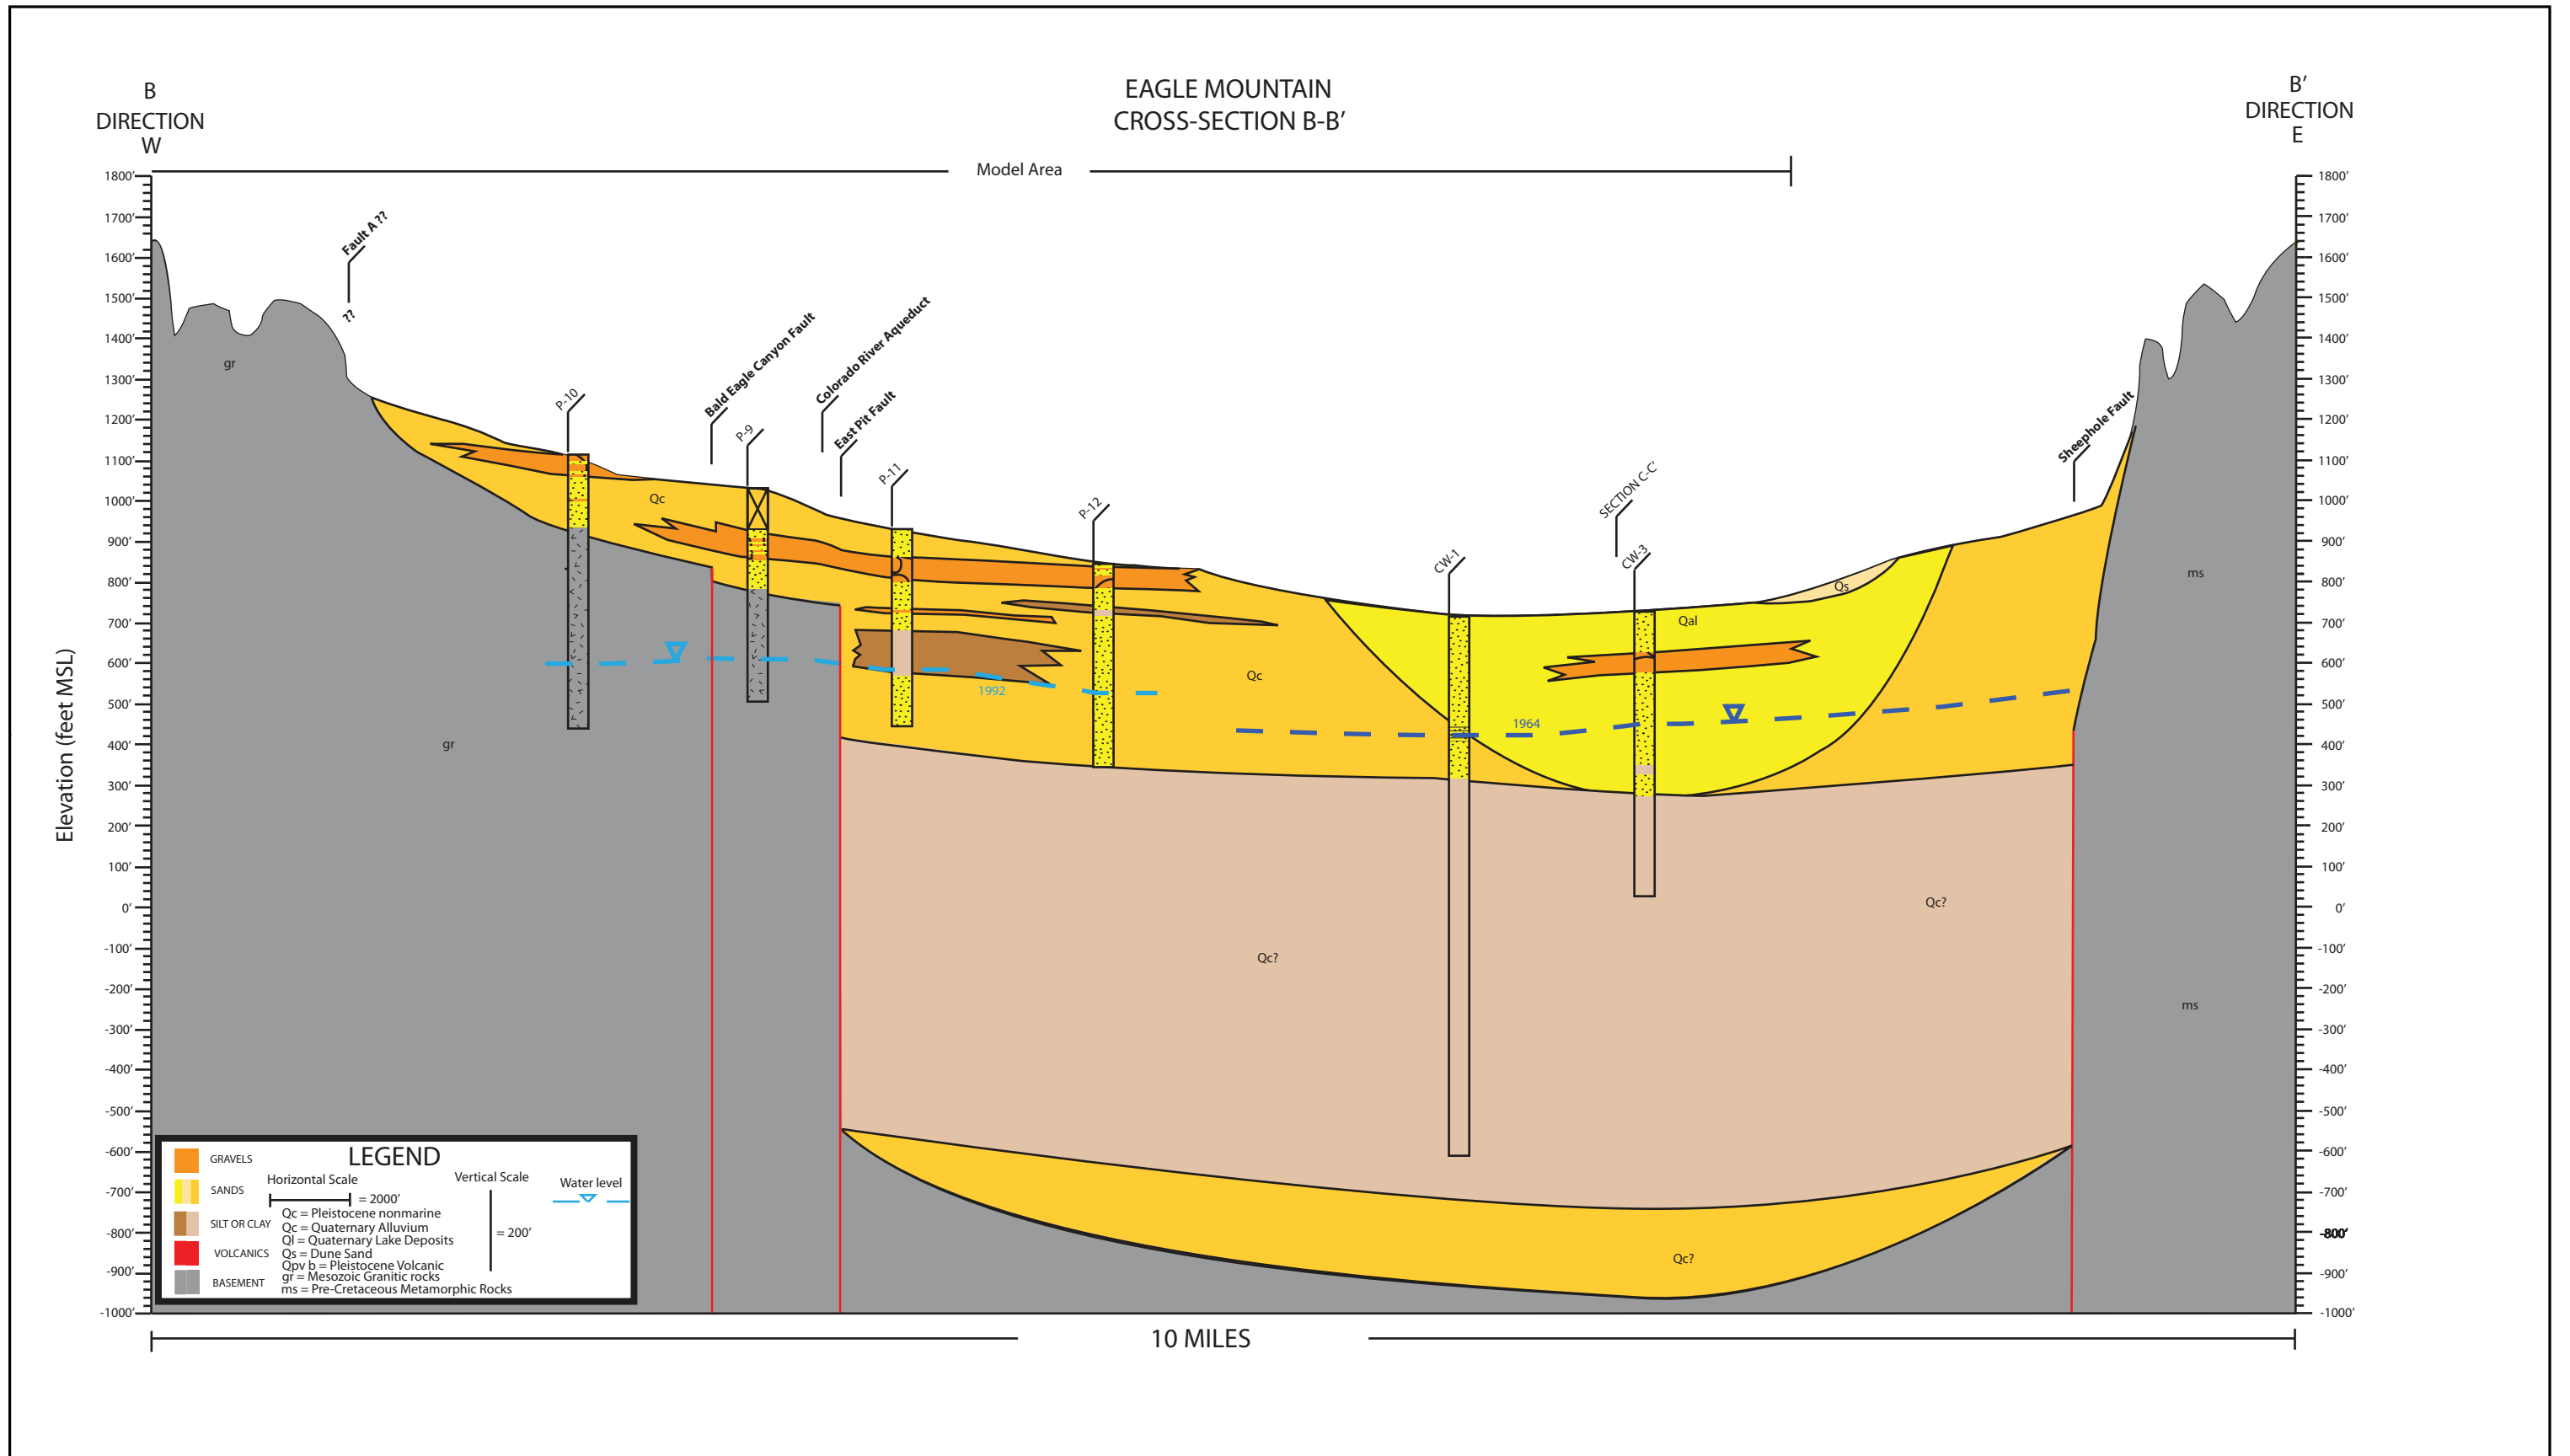
Figure 3.3-5

CROSS-SECTION B-B'

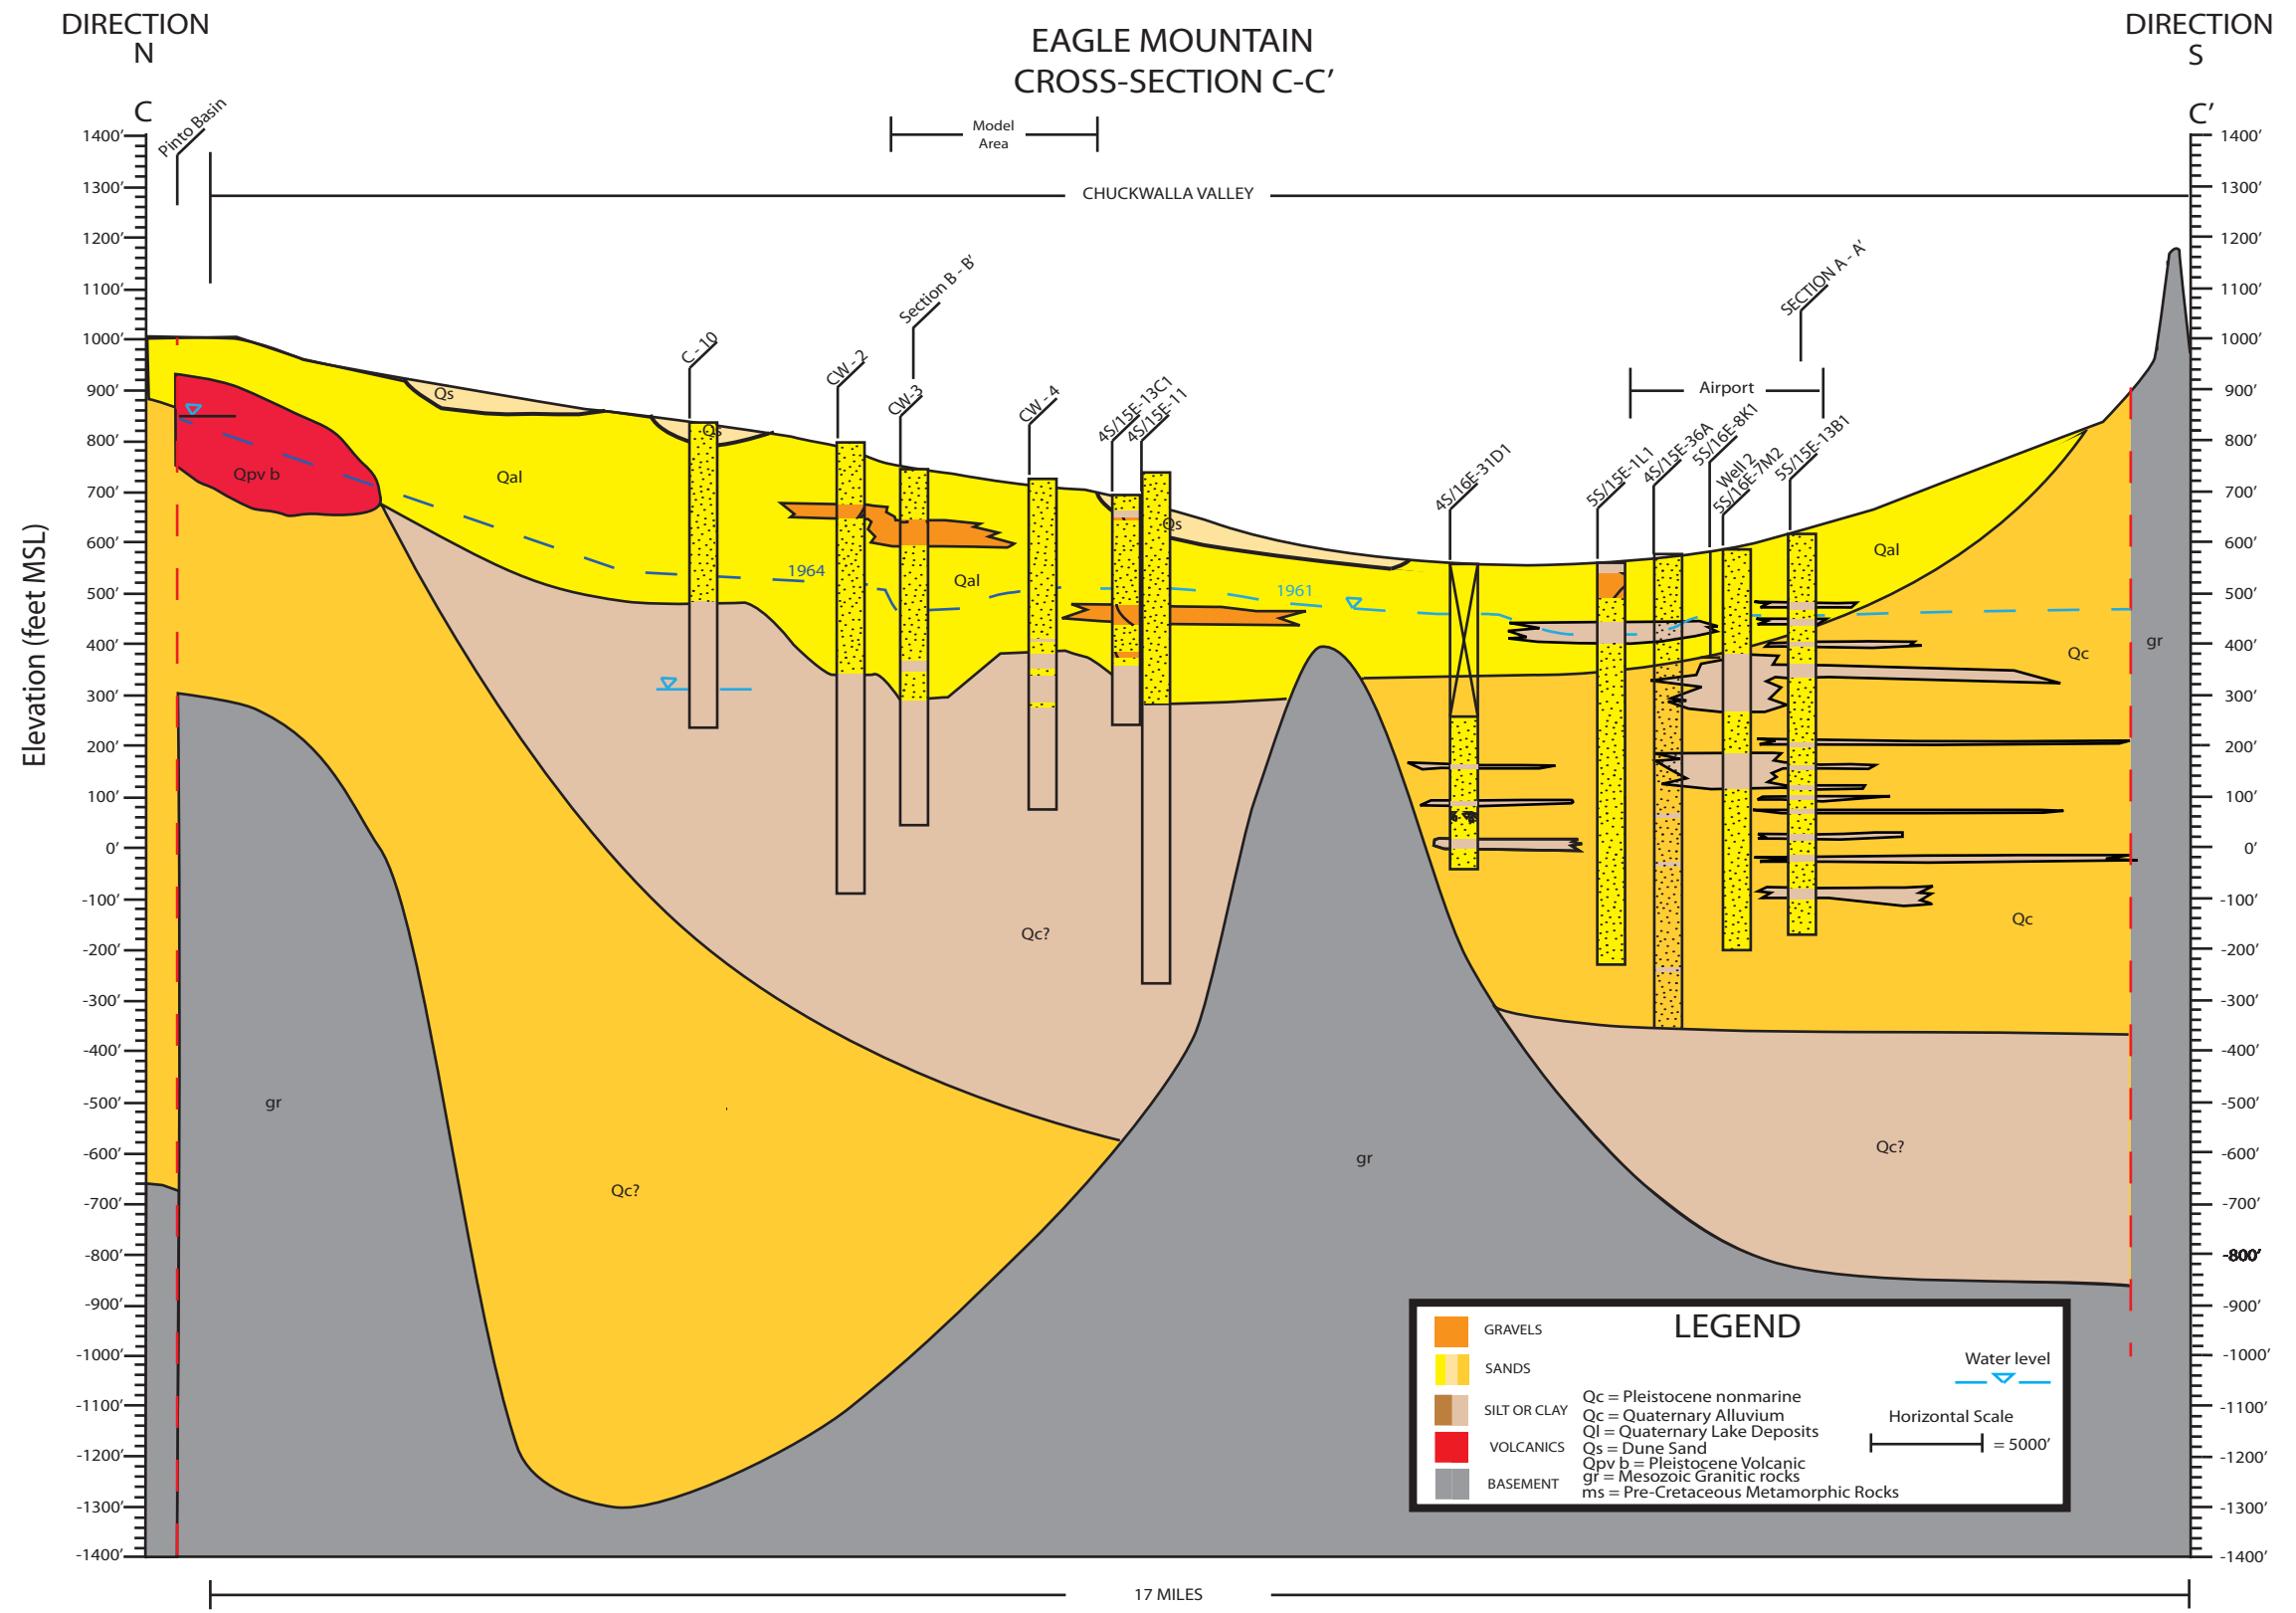
Figure 3.3-6

CROSS-SECTION C-C'

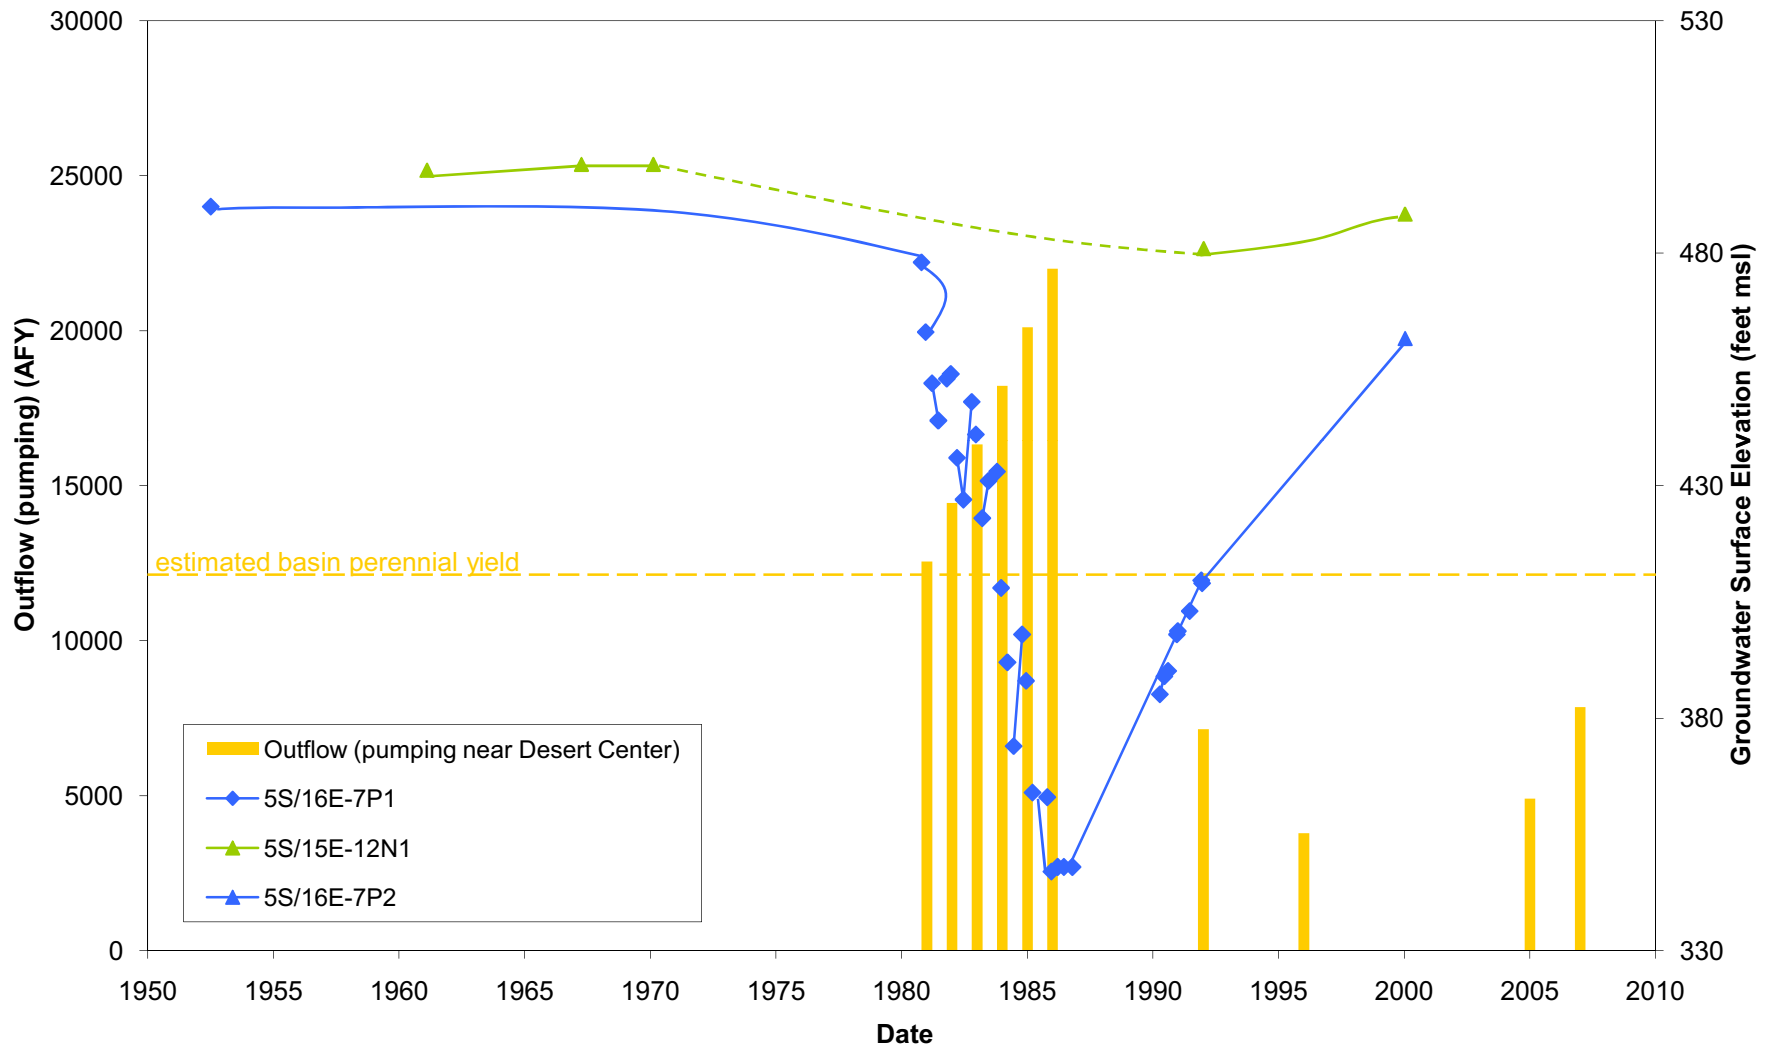
**FIGURE 3.3-7
DESERT CENTER GROUND WATER LEVELS**

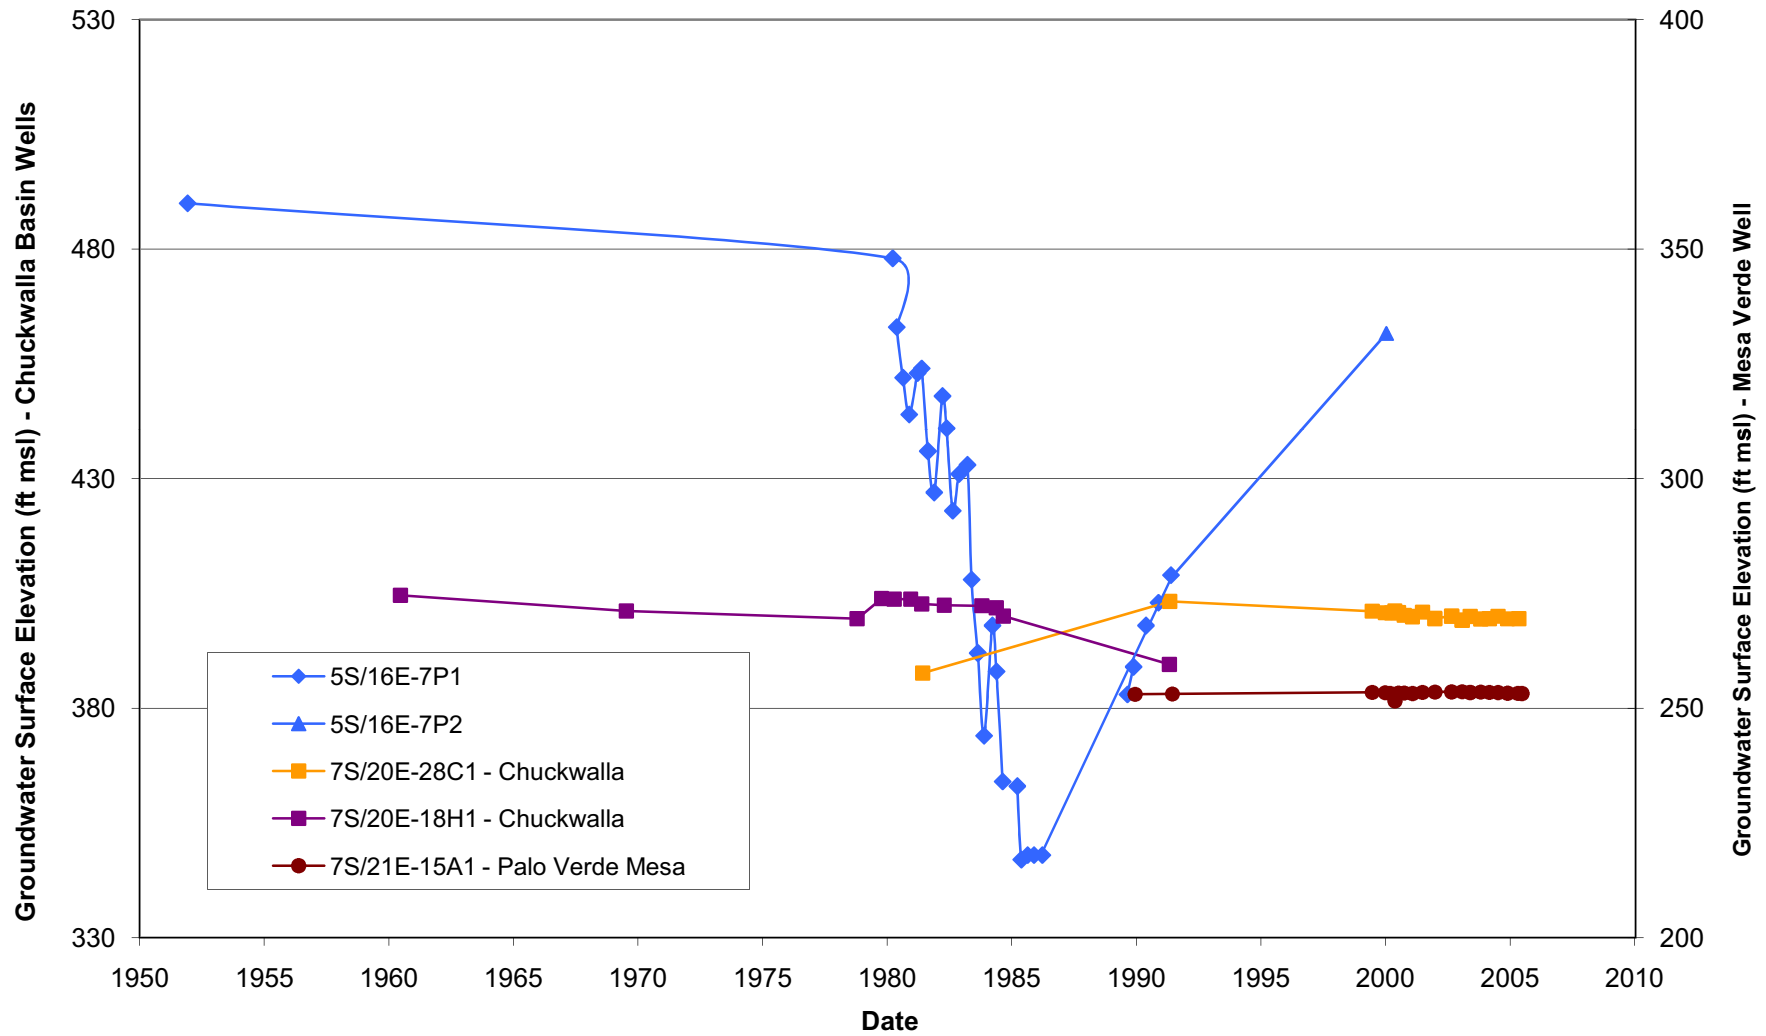
**FIGURE 3.3-8
UPPER CHUCKWALLA VALLEY AND PALO VERDE MESA GROUND WATER LEVELS**

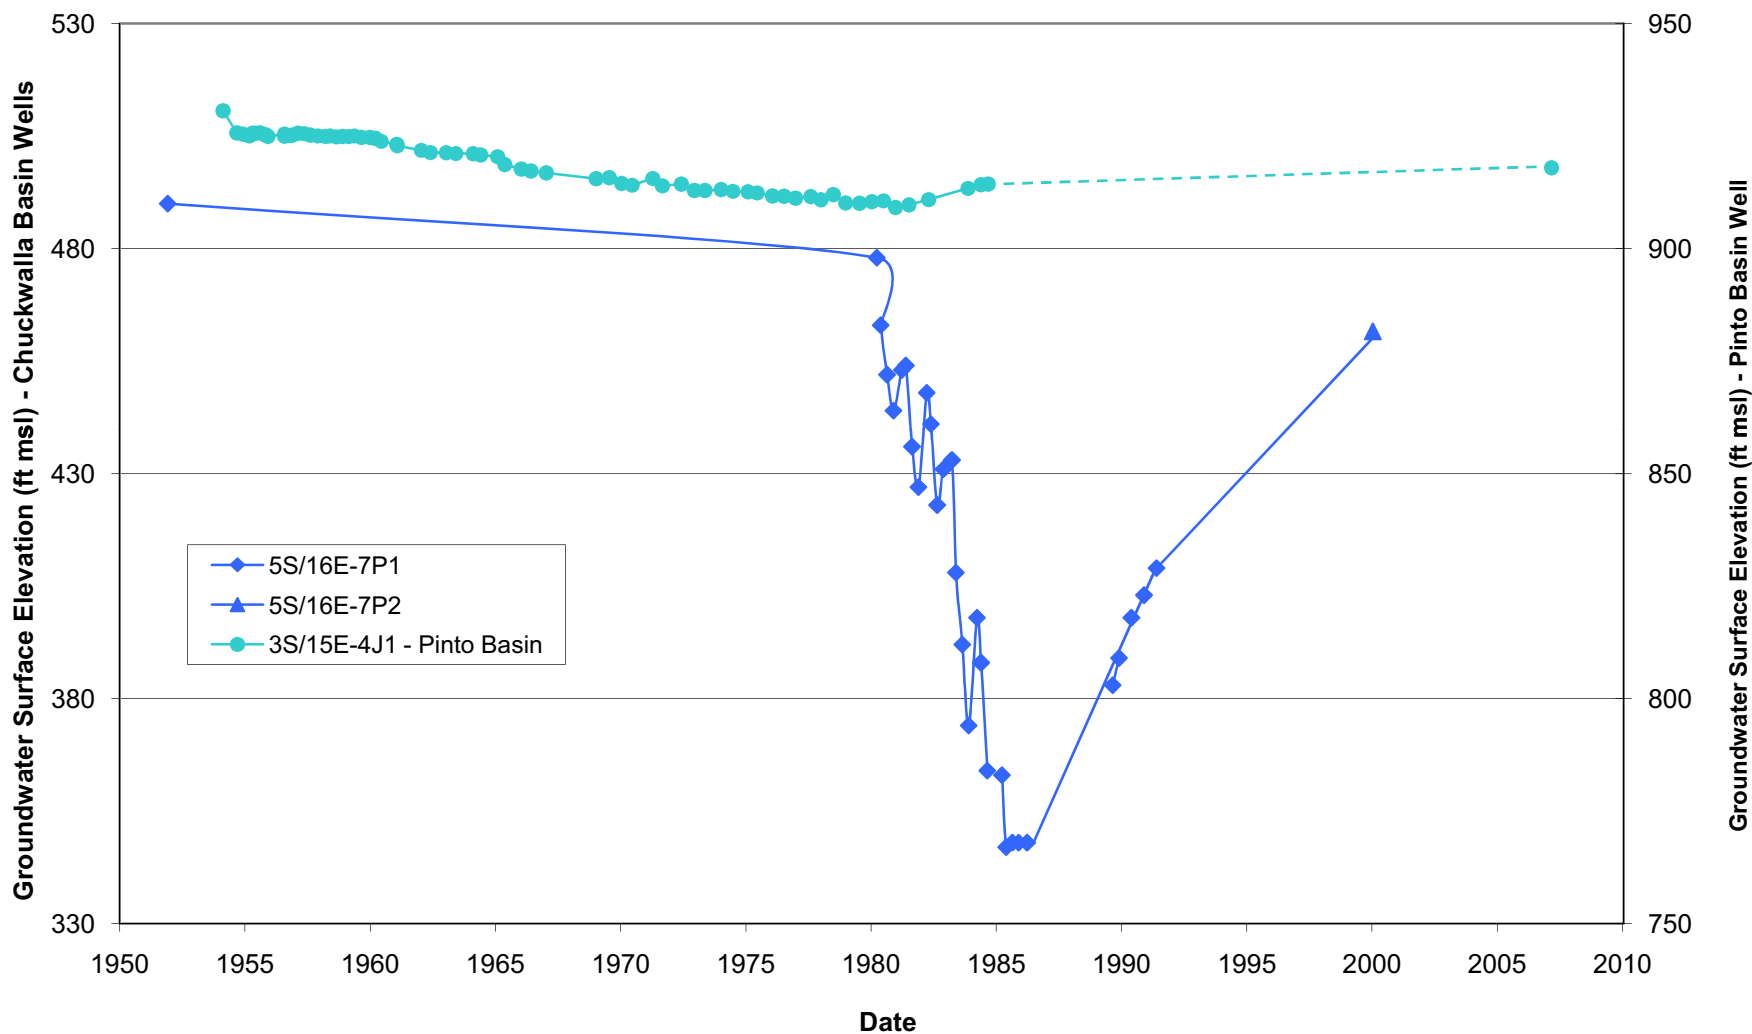
**FIGURE 3.3-9
DESERT CENTER AREA AND PINTO VALLEY GROUND WATER LEVELS**

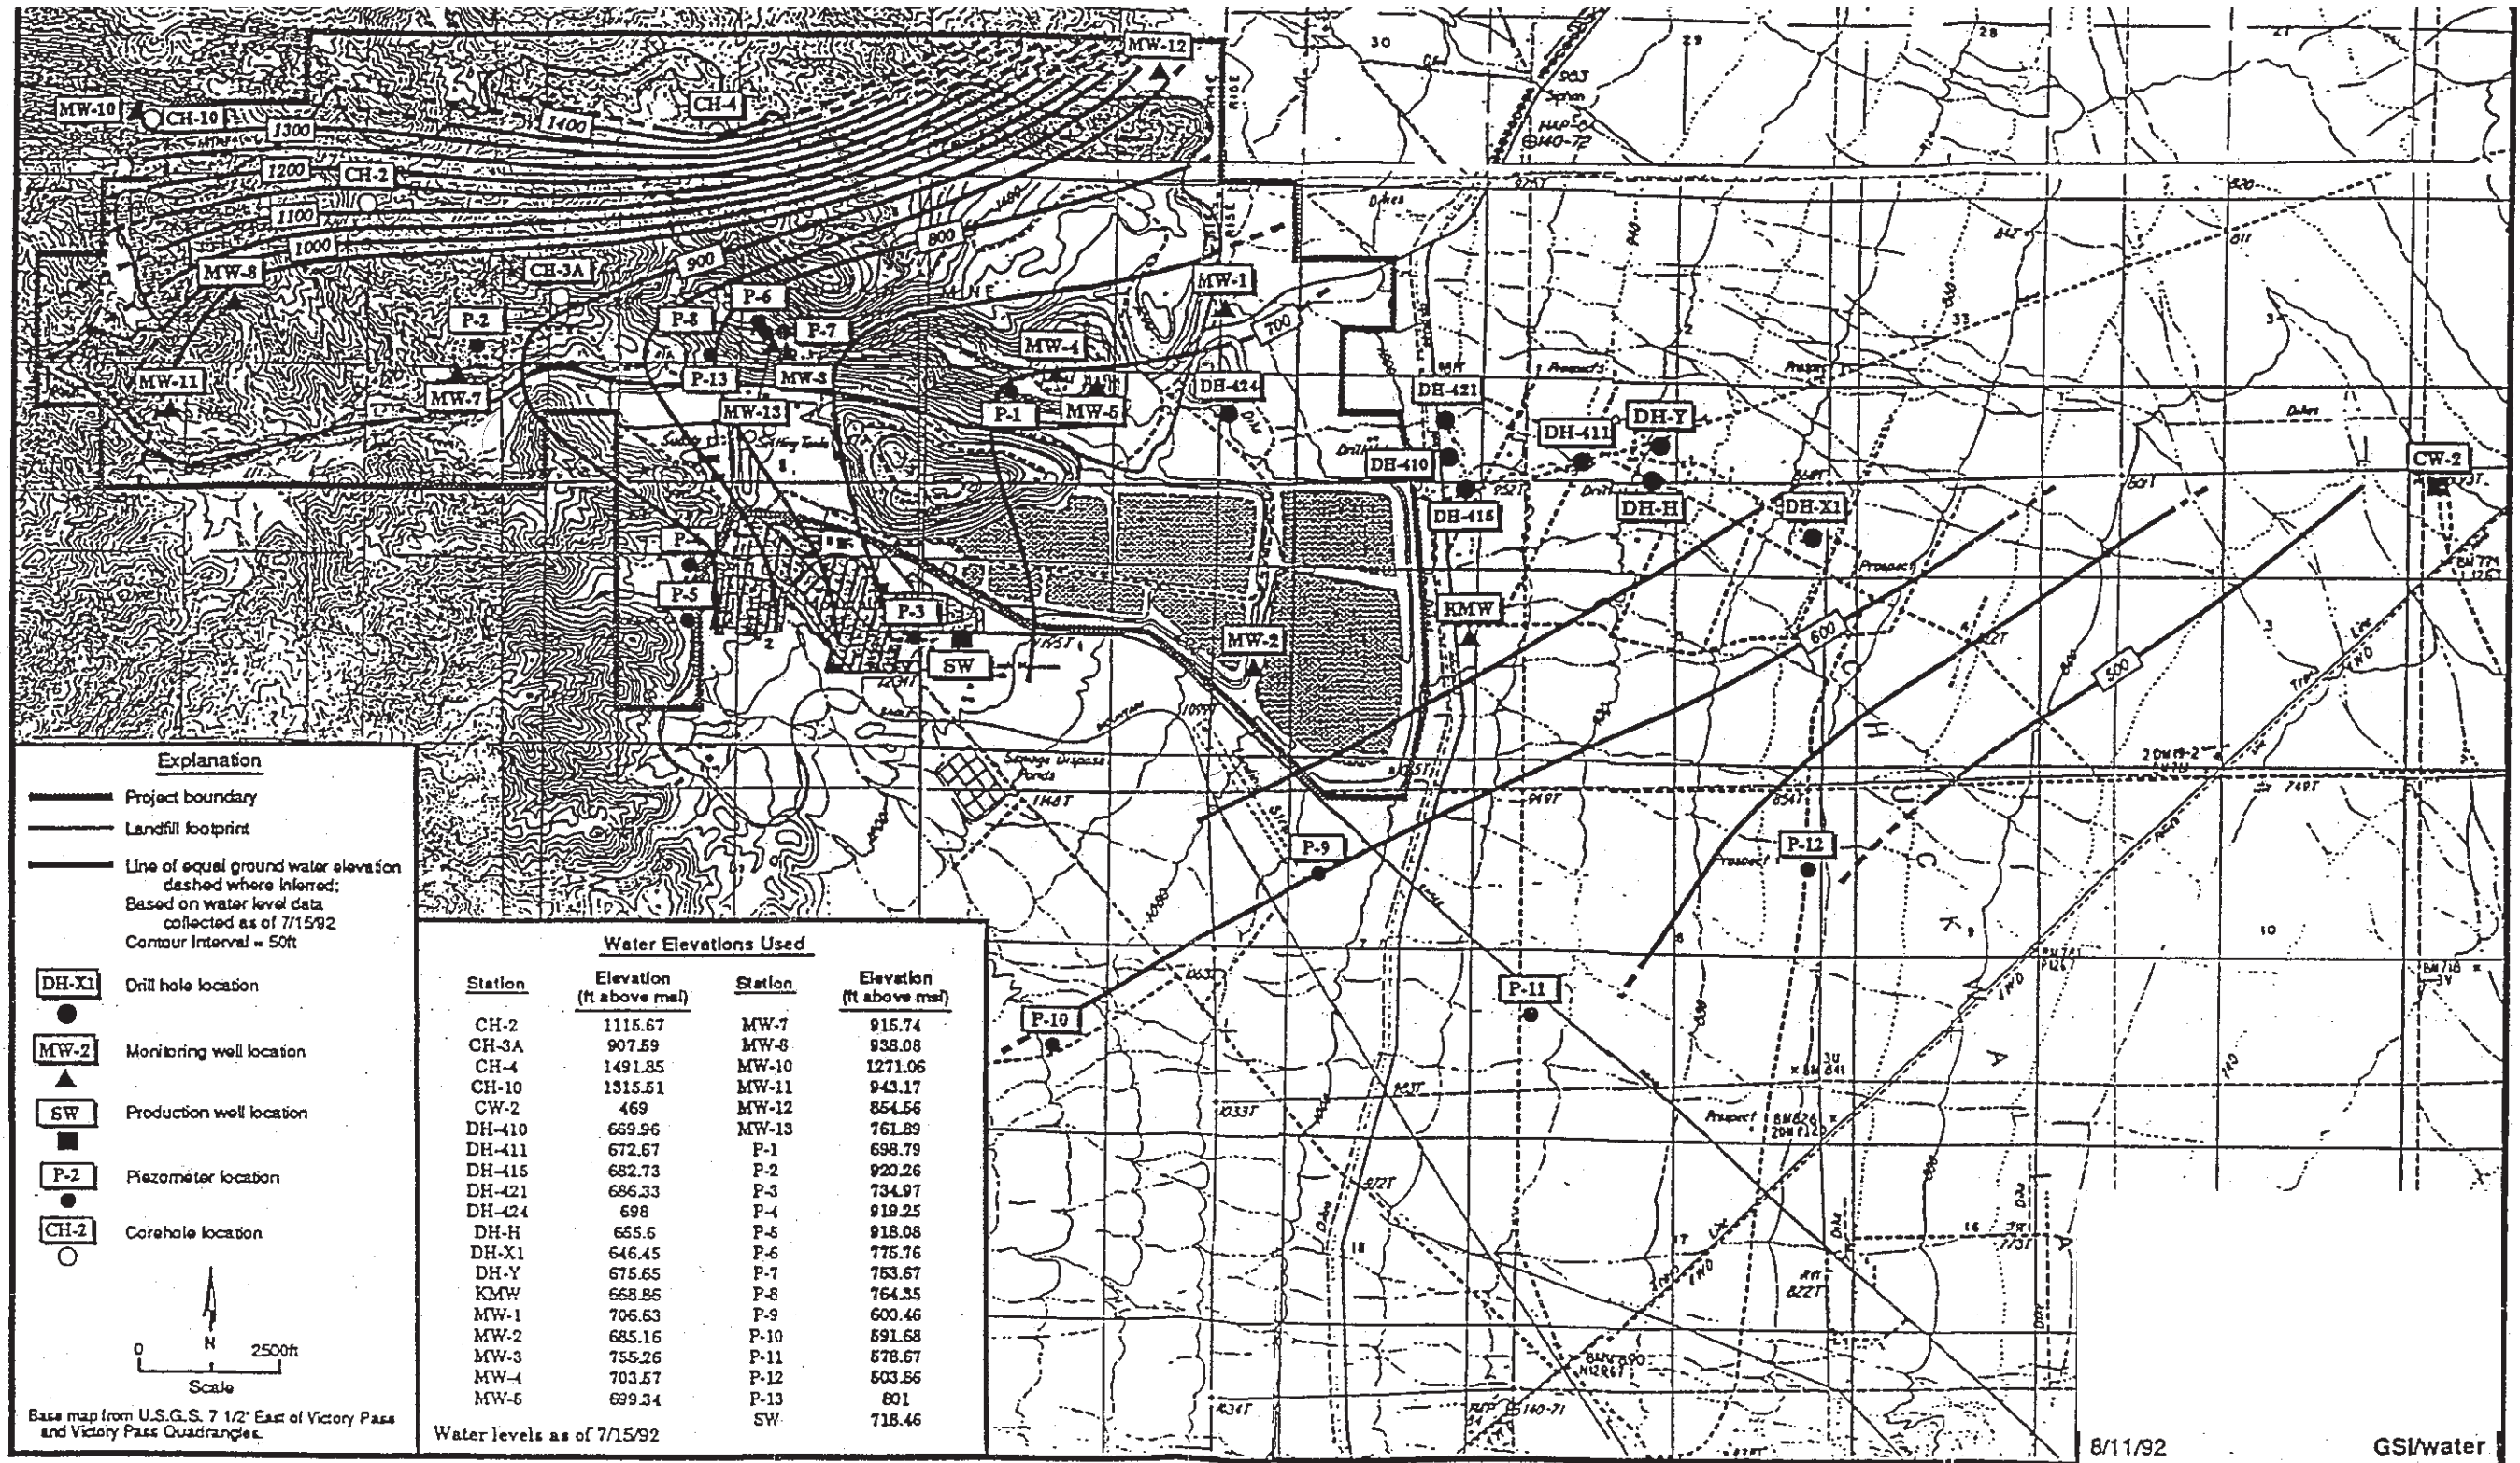
Figure 3.3-11

GROUNDWATER CONTOURS
NEAR PROJECT SITE

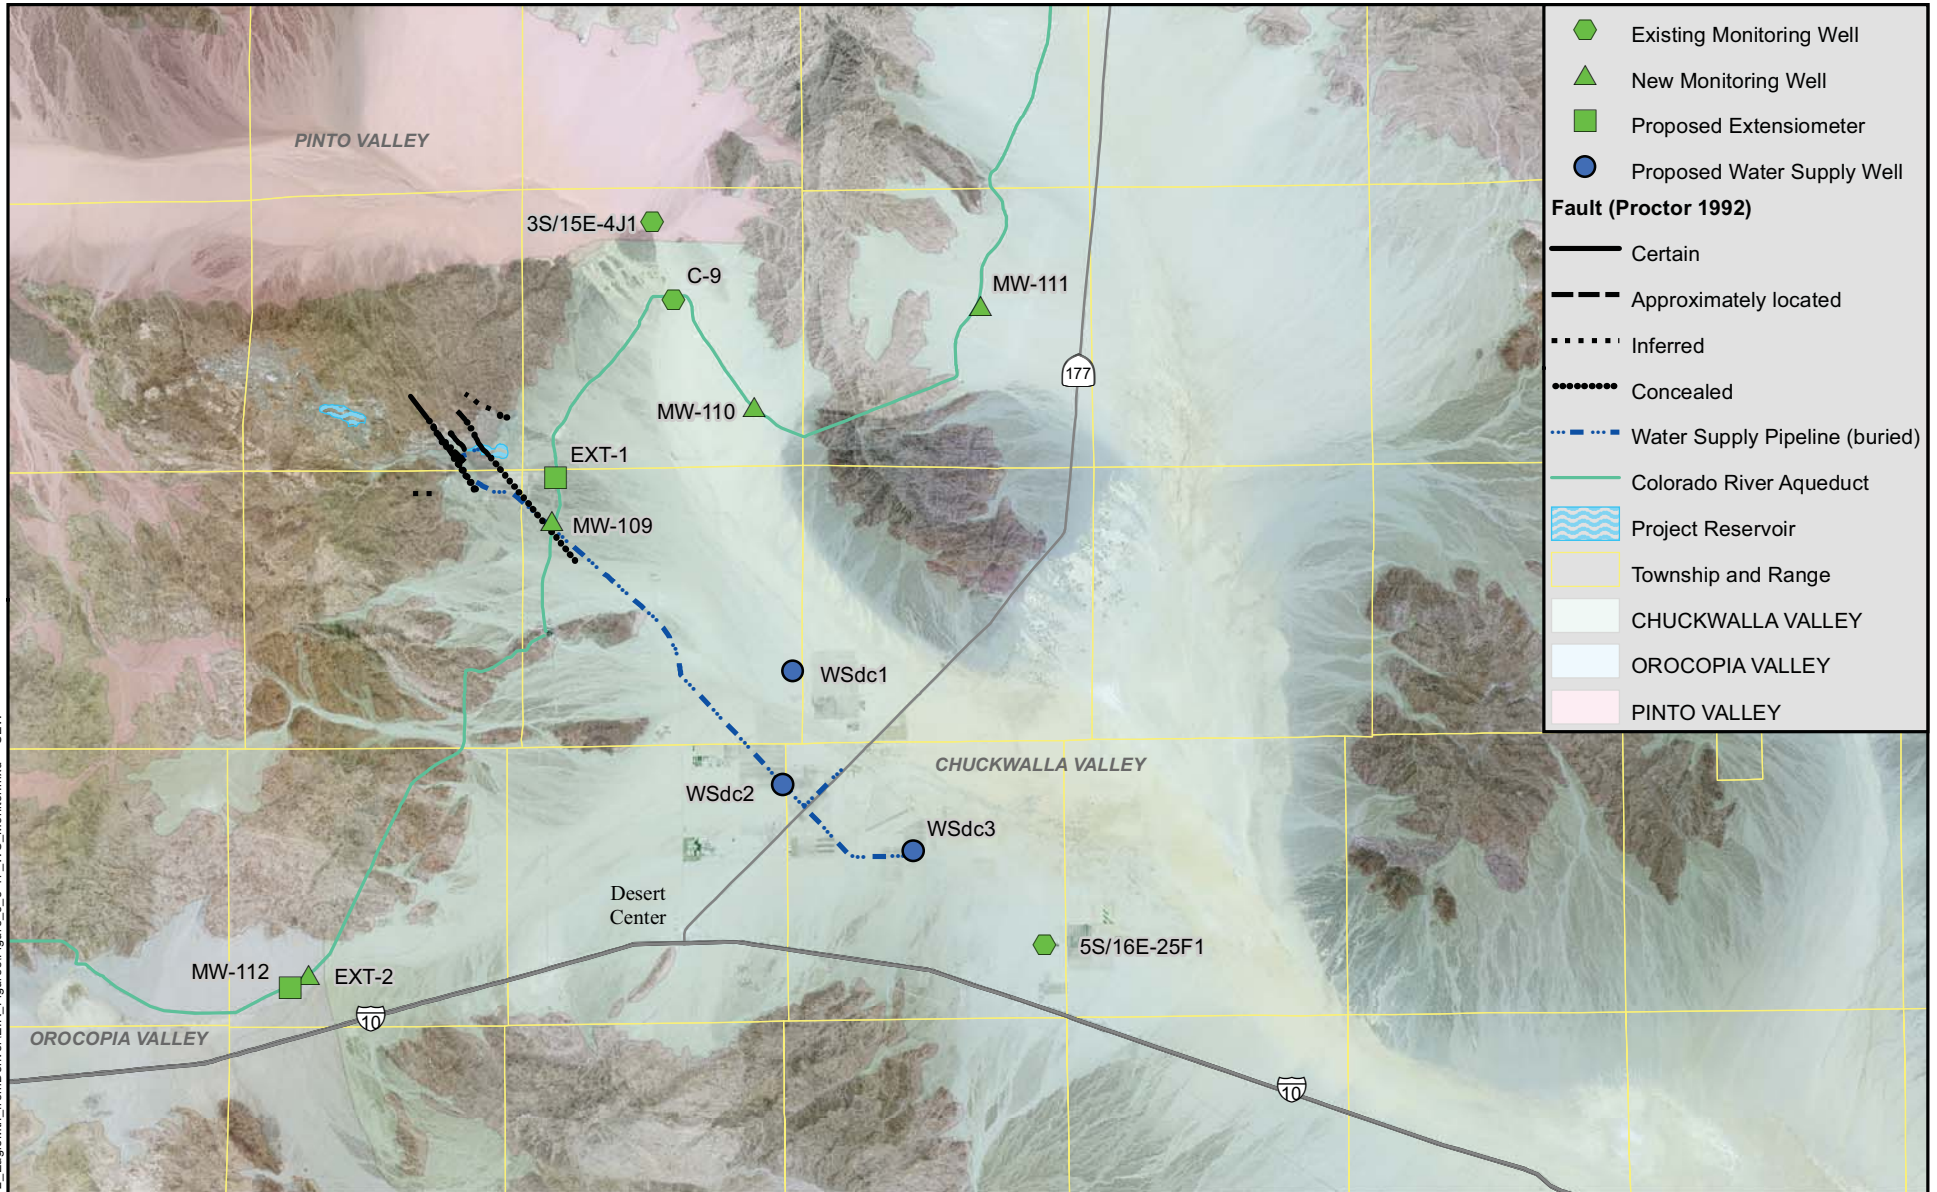
Figure 3.3-17

WATER SUPPLY
 MONITORING NETWORK
