Environmental Impact Report
 prepared for State Water Resources Control Board
 by GEI Consultants, Inc.

Eastern Riverside County, California

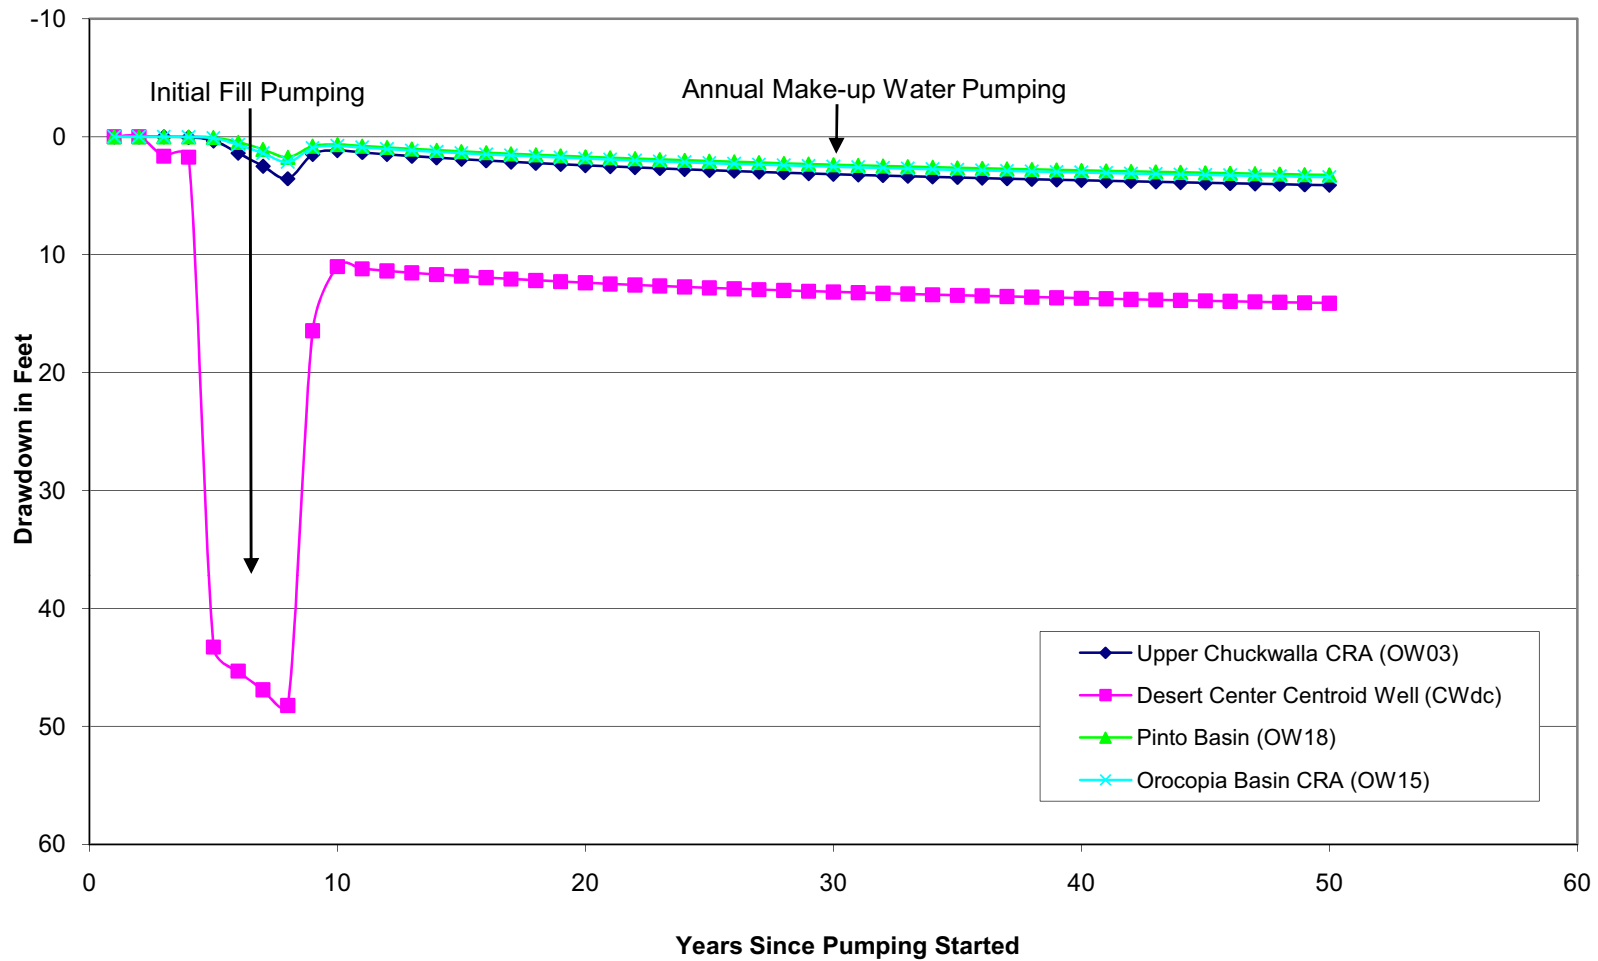
FIGURE 3.3-19
50-YEAR PROJECT PUMPING AFFECTS
