Environmental Impact Report
prepared for State Water Resources Control Board
by GEI Consultants, Inc.

Eastern Riverside County, California

VEGETATION IN
PROJECT AREA

June 2010

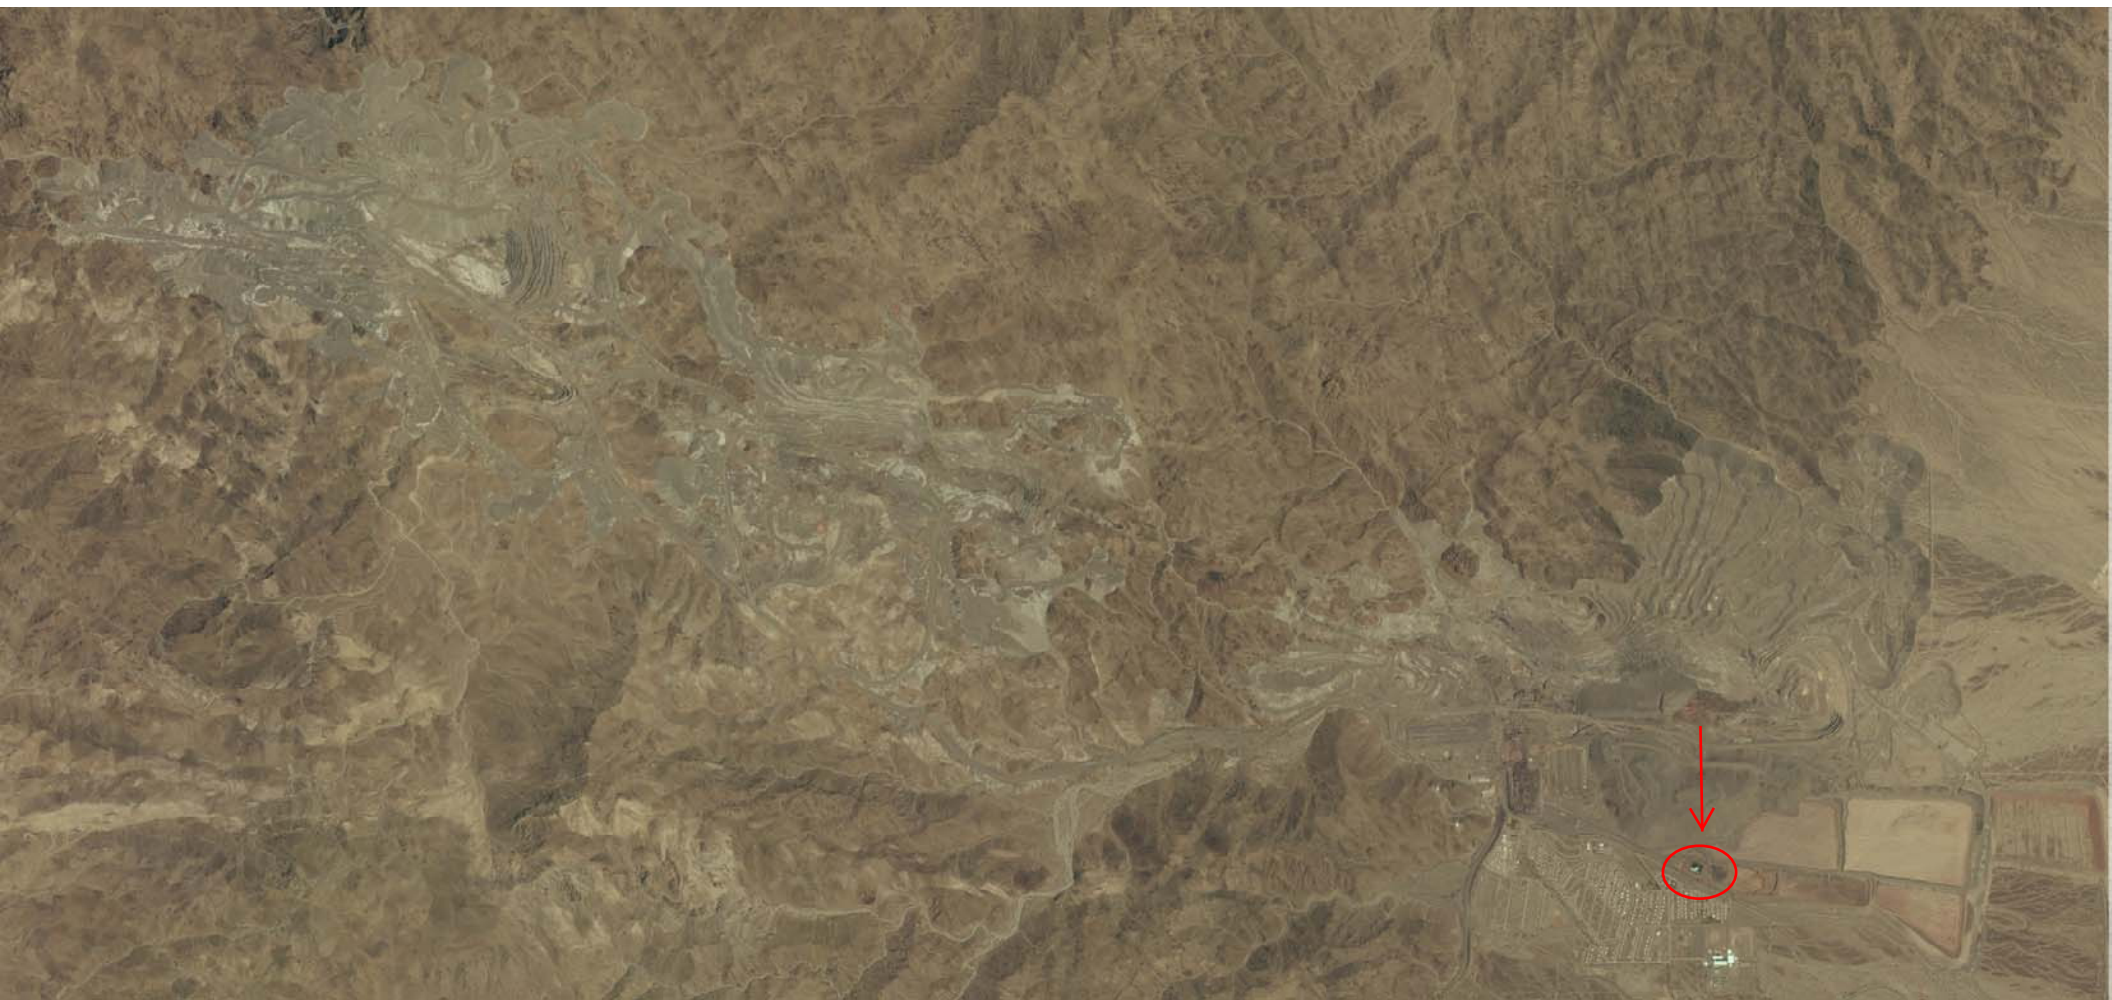
Figure 3.5-11. Aerial view of Eagle Mountain Mine Site, circle shows the location of the existing water treatment pond.

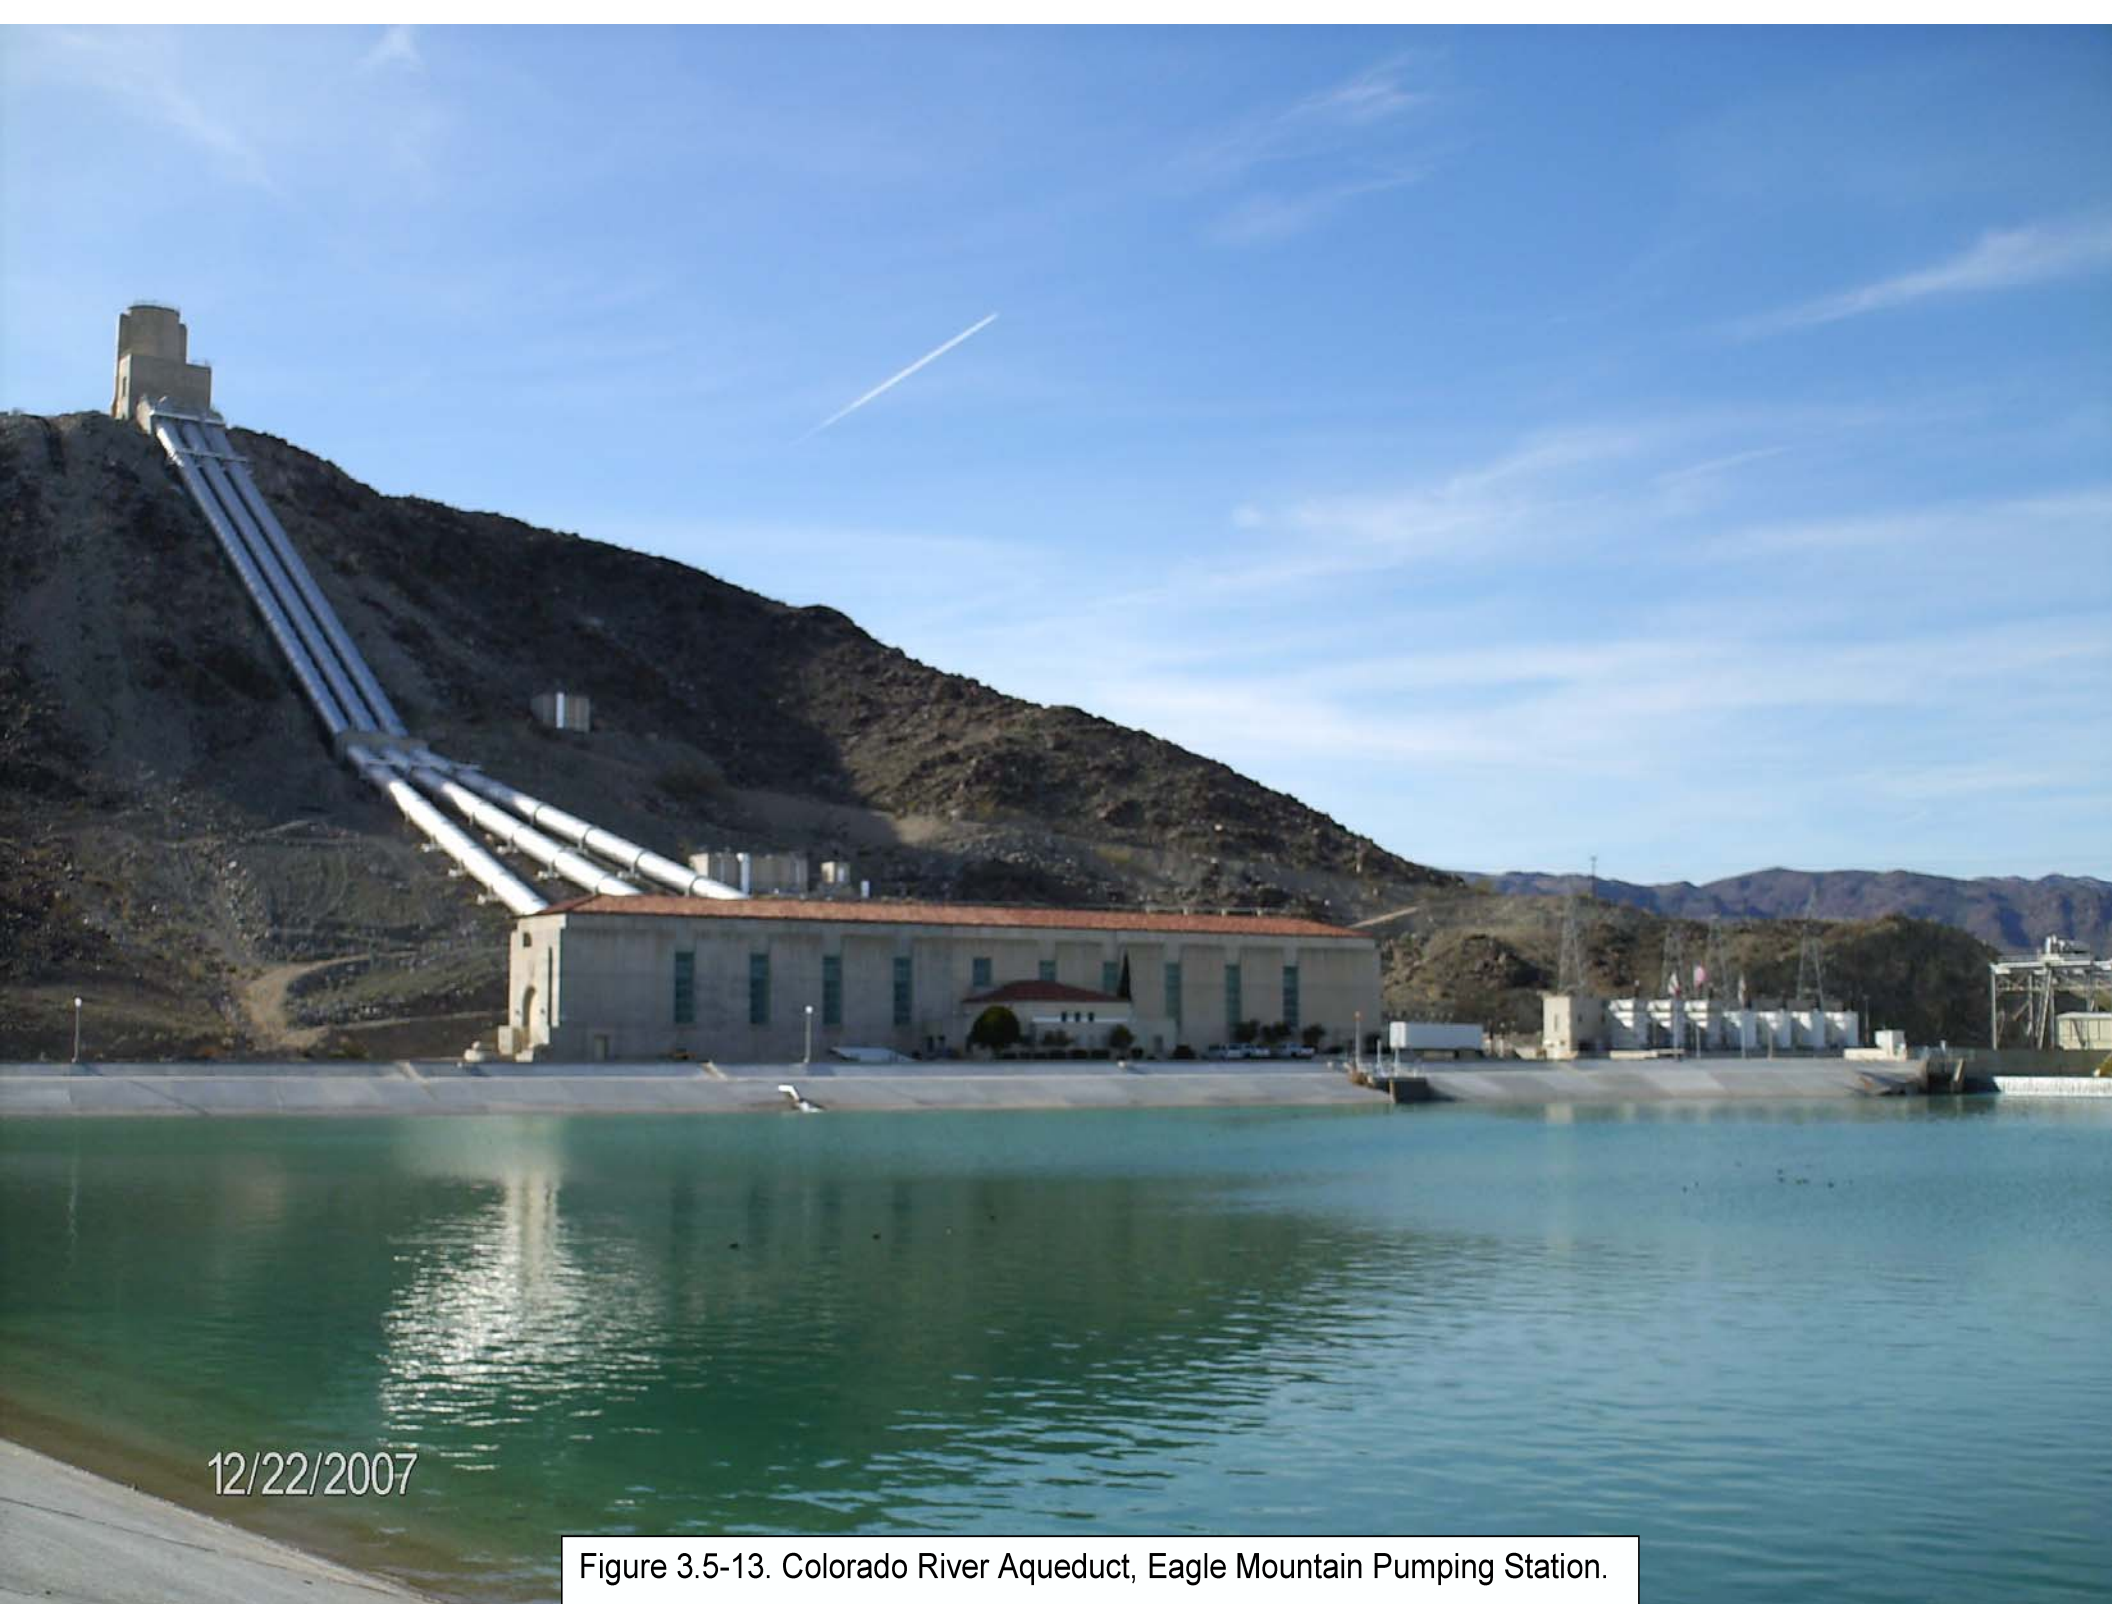
Figure 3.5-13. Colorado River Aqueduct, Eagle Mountain Pumping Station.

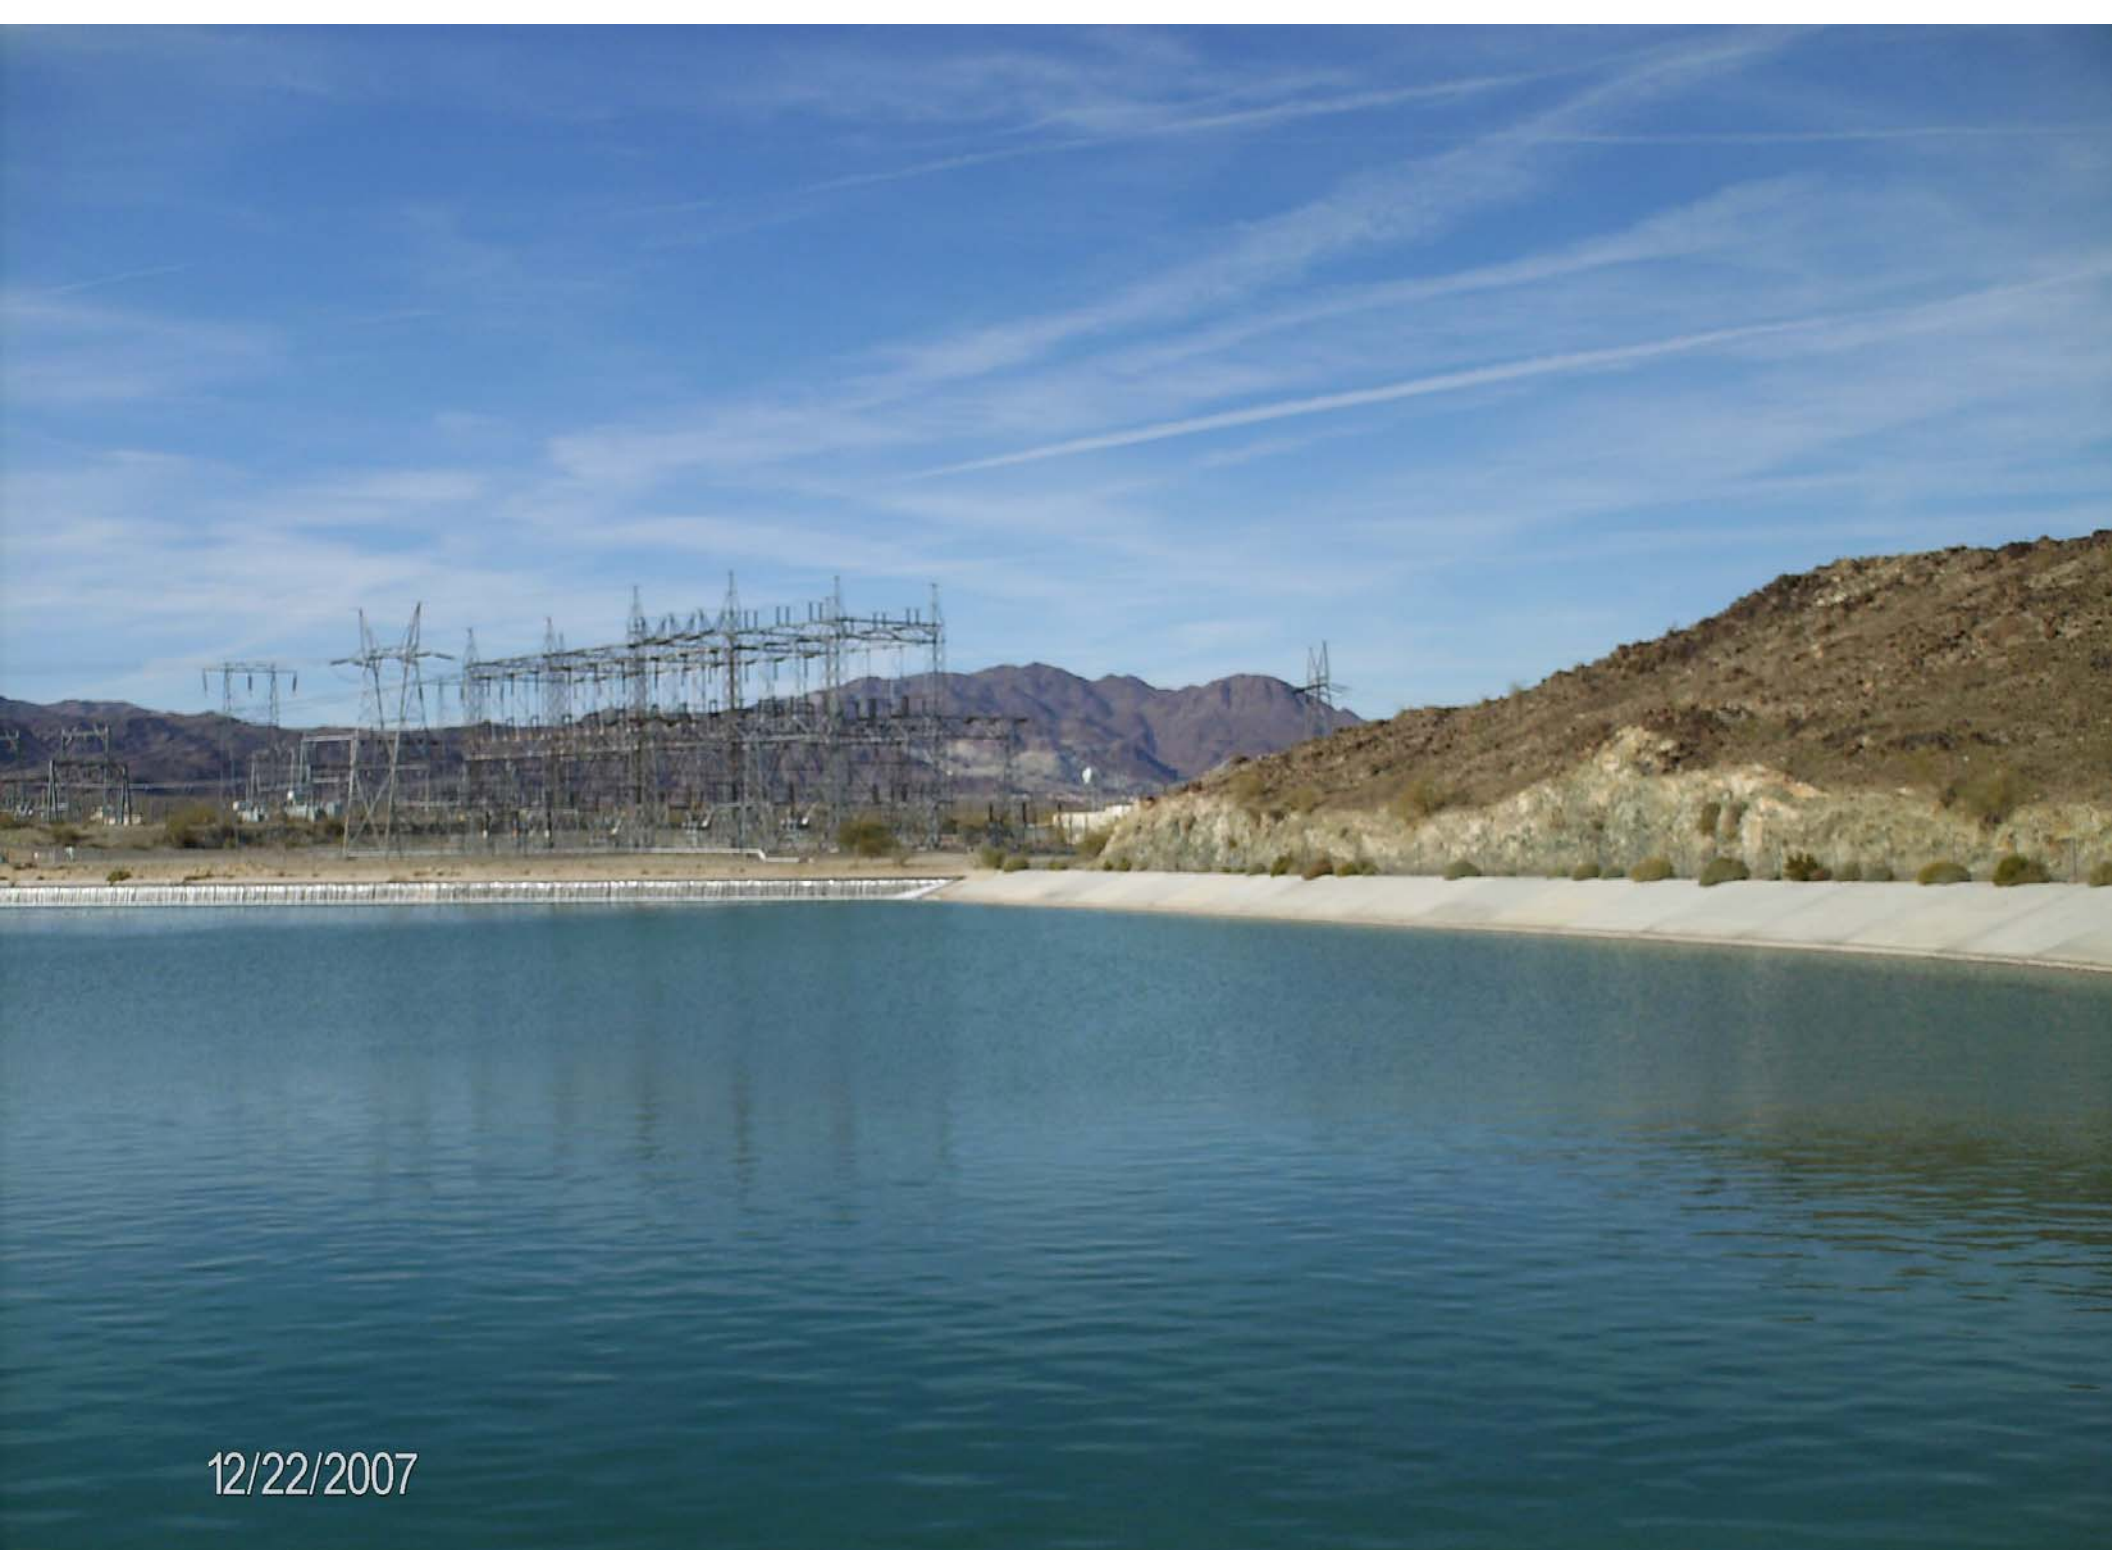
Figure 3.5-14. Colorado River Aqueduct at Eagle Mountain Pumping Station, view NW towards the Eagle Mountain Mine

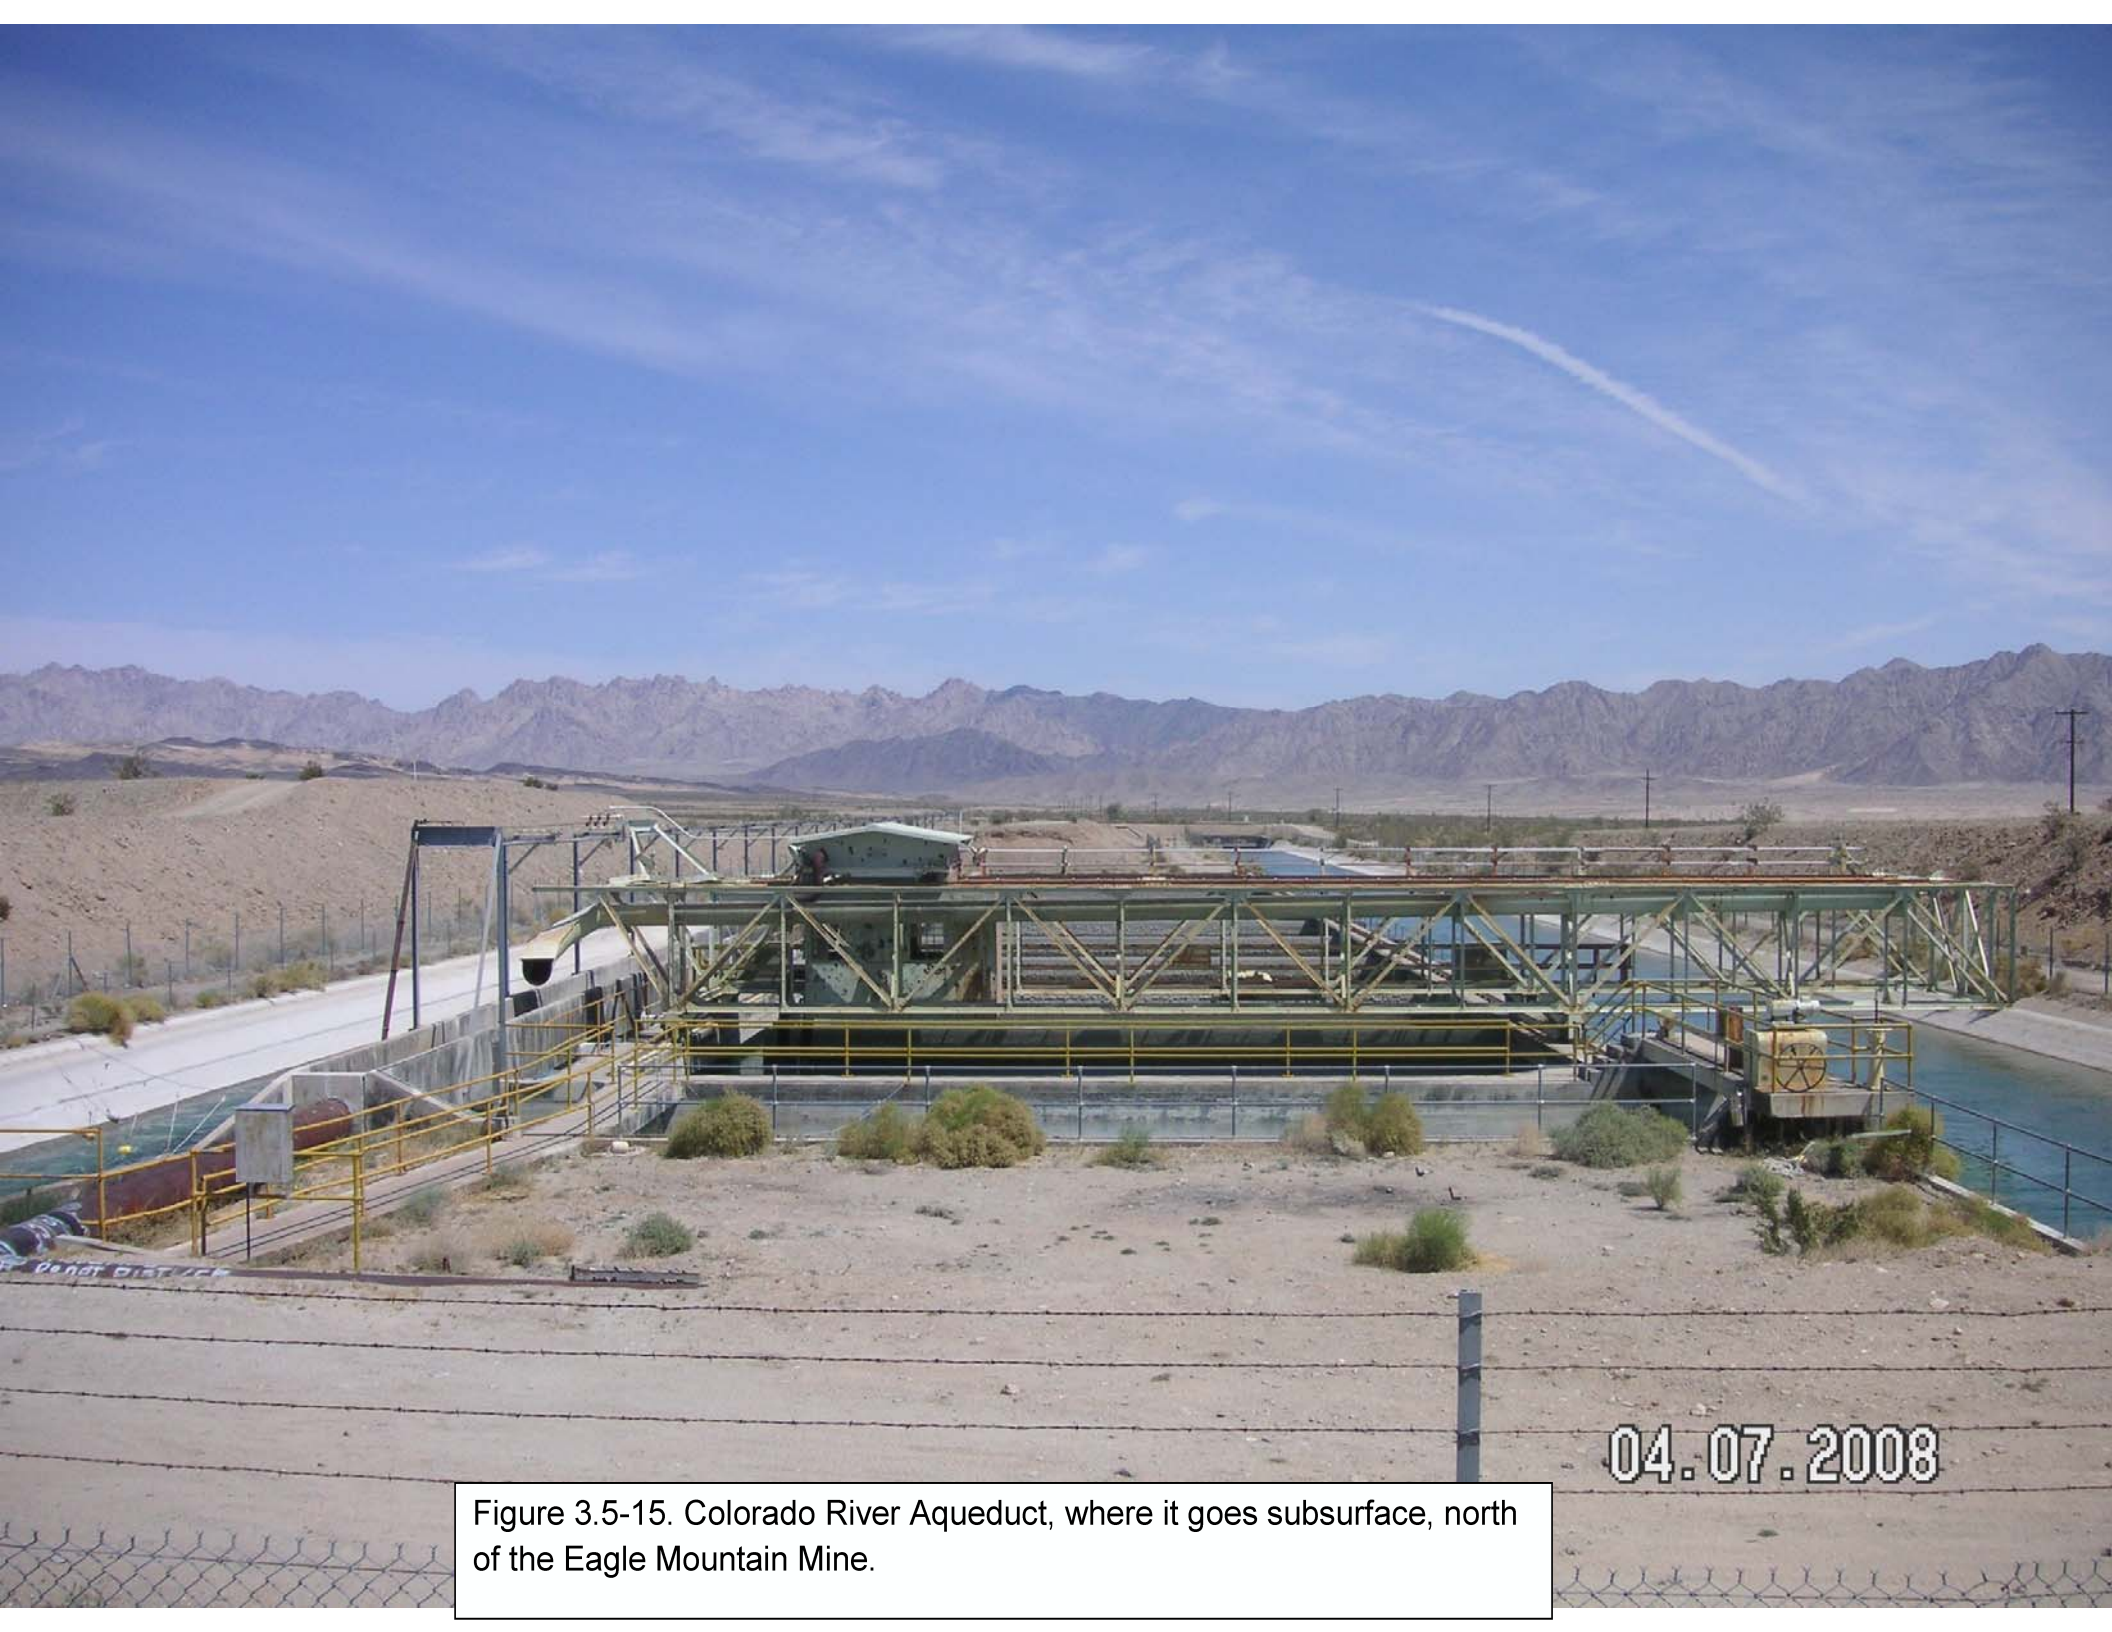
Figure 3.5-15. Colorado River Aqueduct, where it goes subsurface, north of the Eagle Mountain Mine.

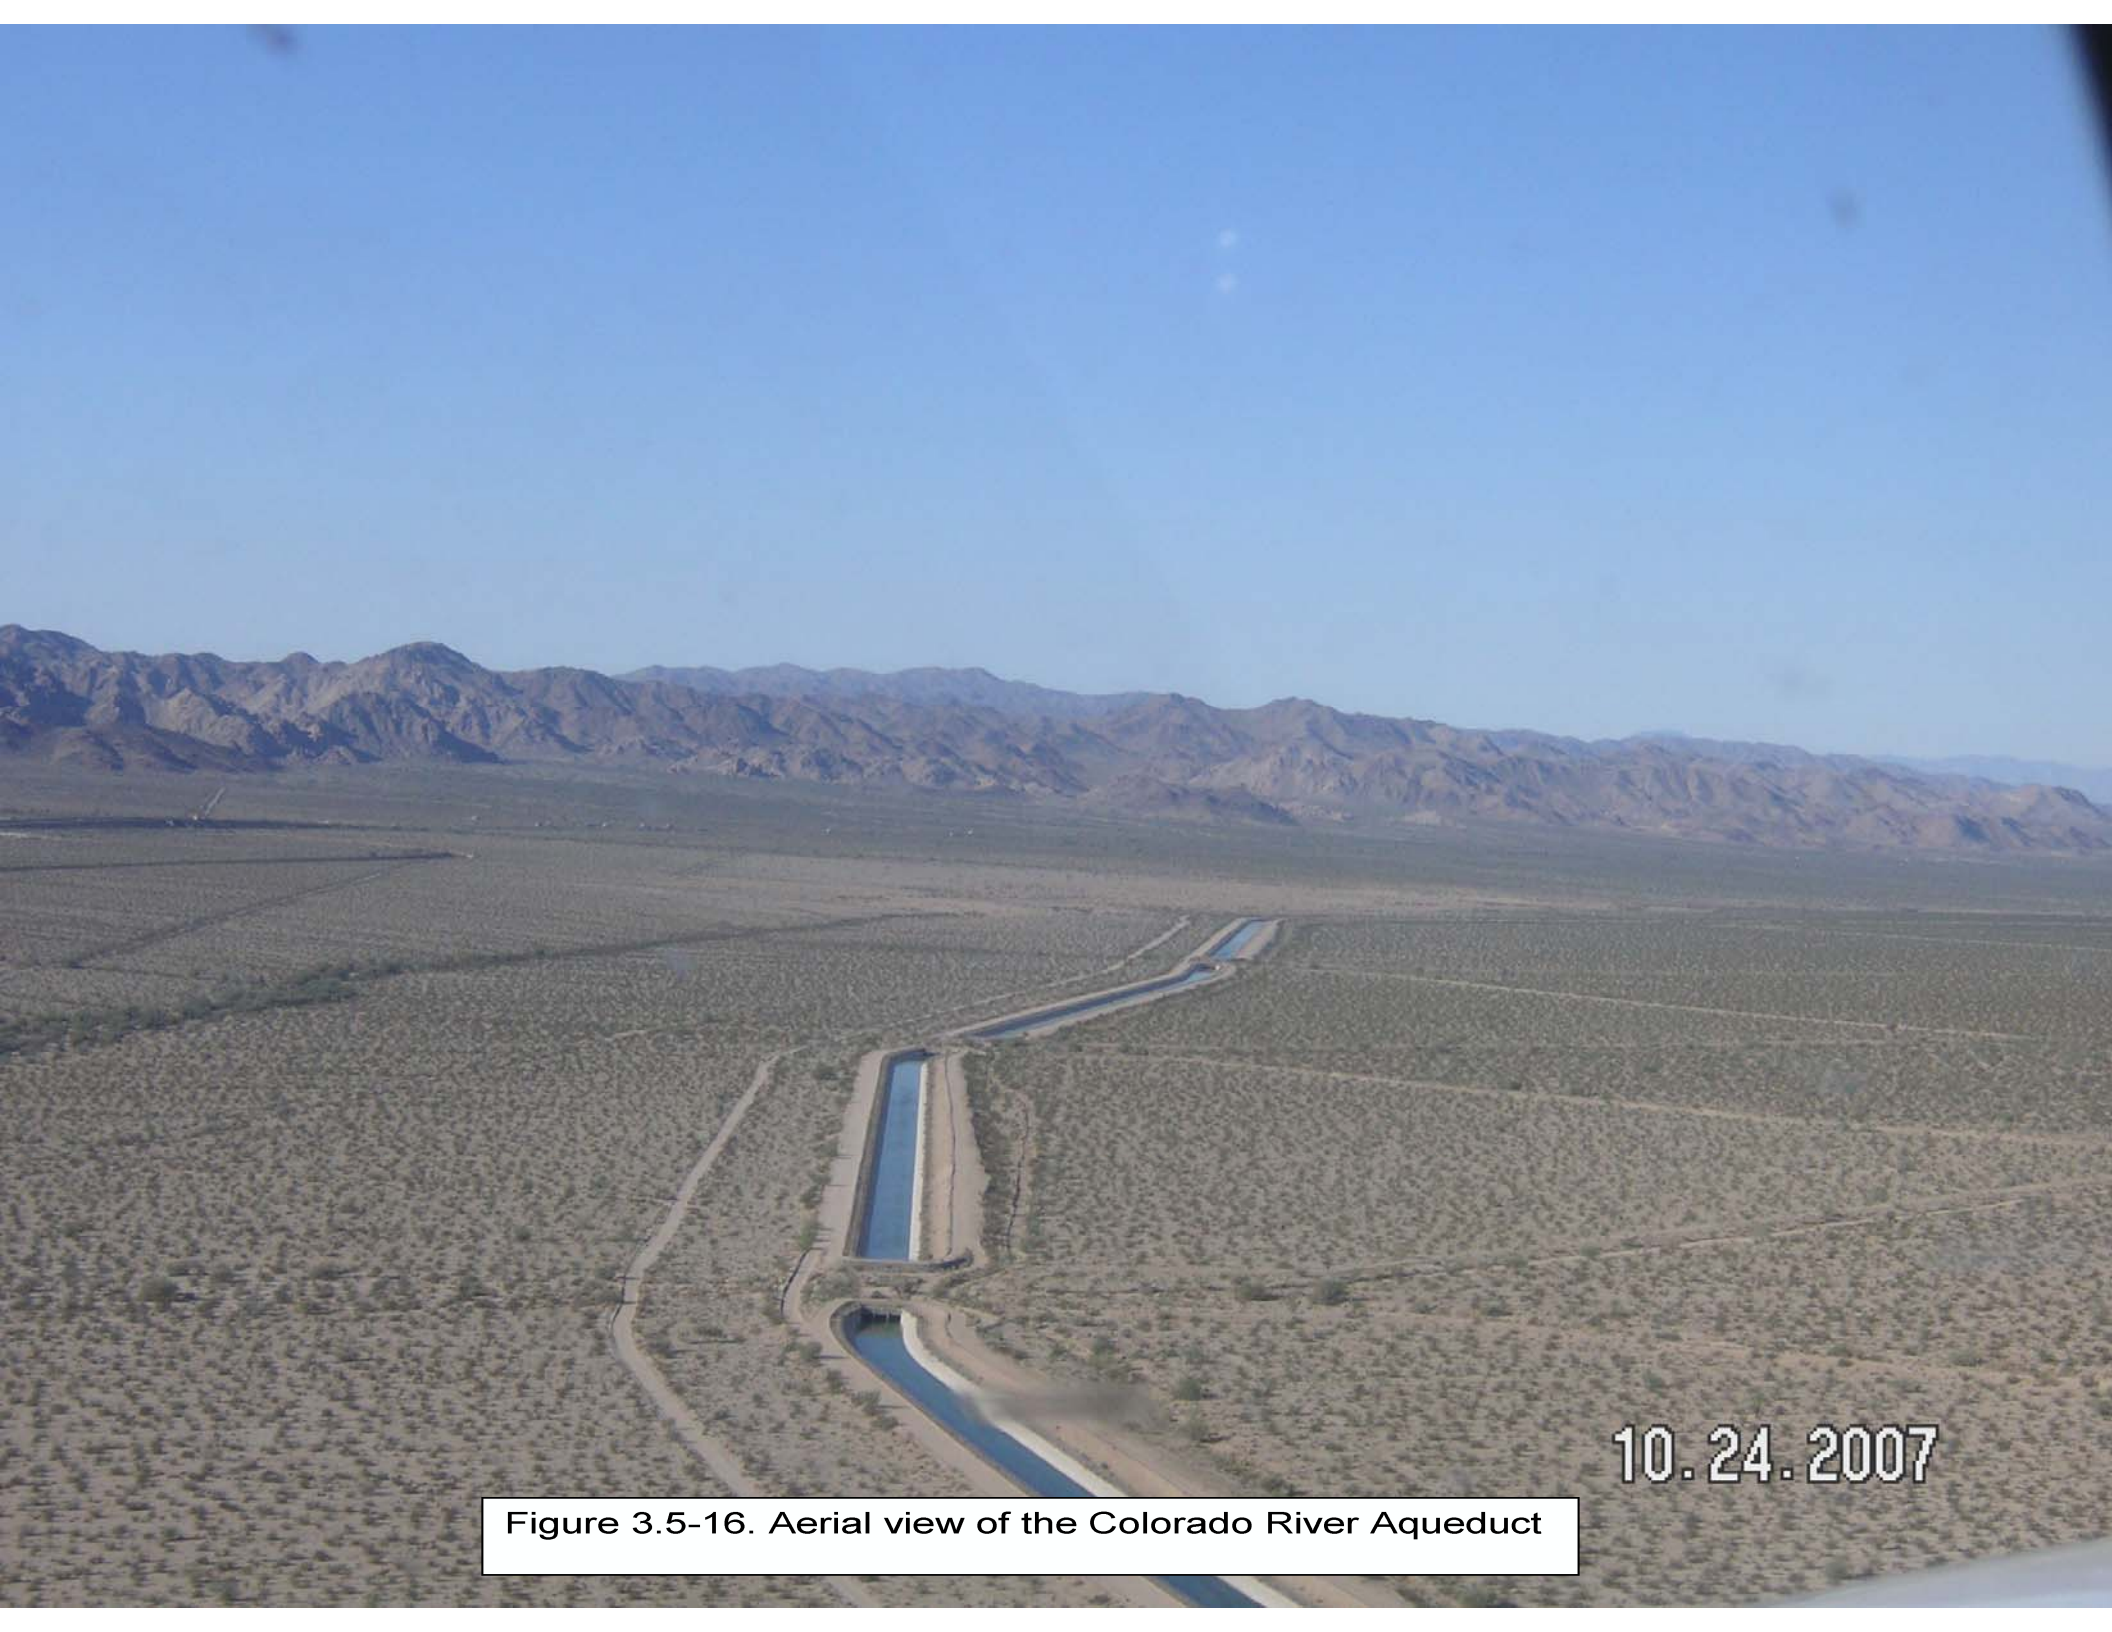
Figure 3.5-16. Aerial view of the Colorado River Aqueduct

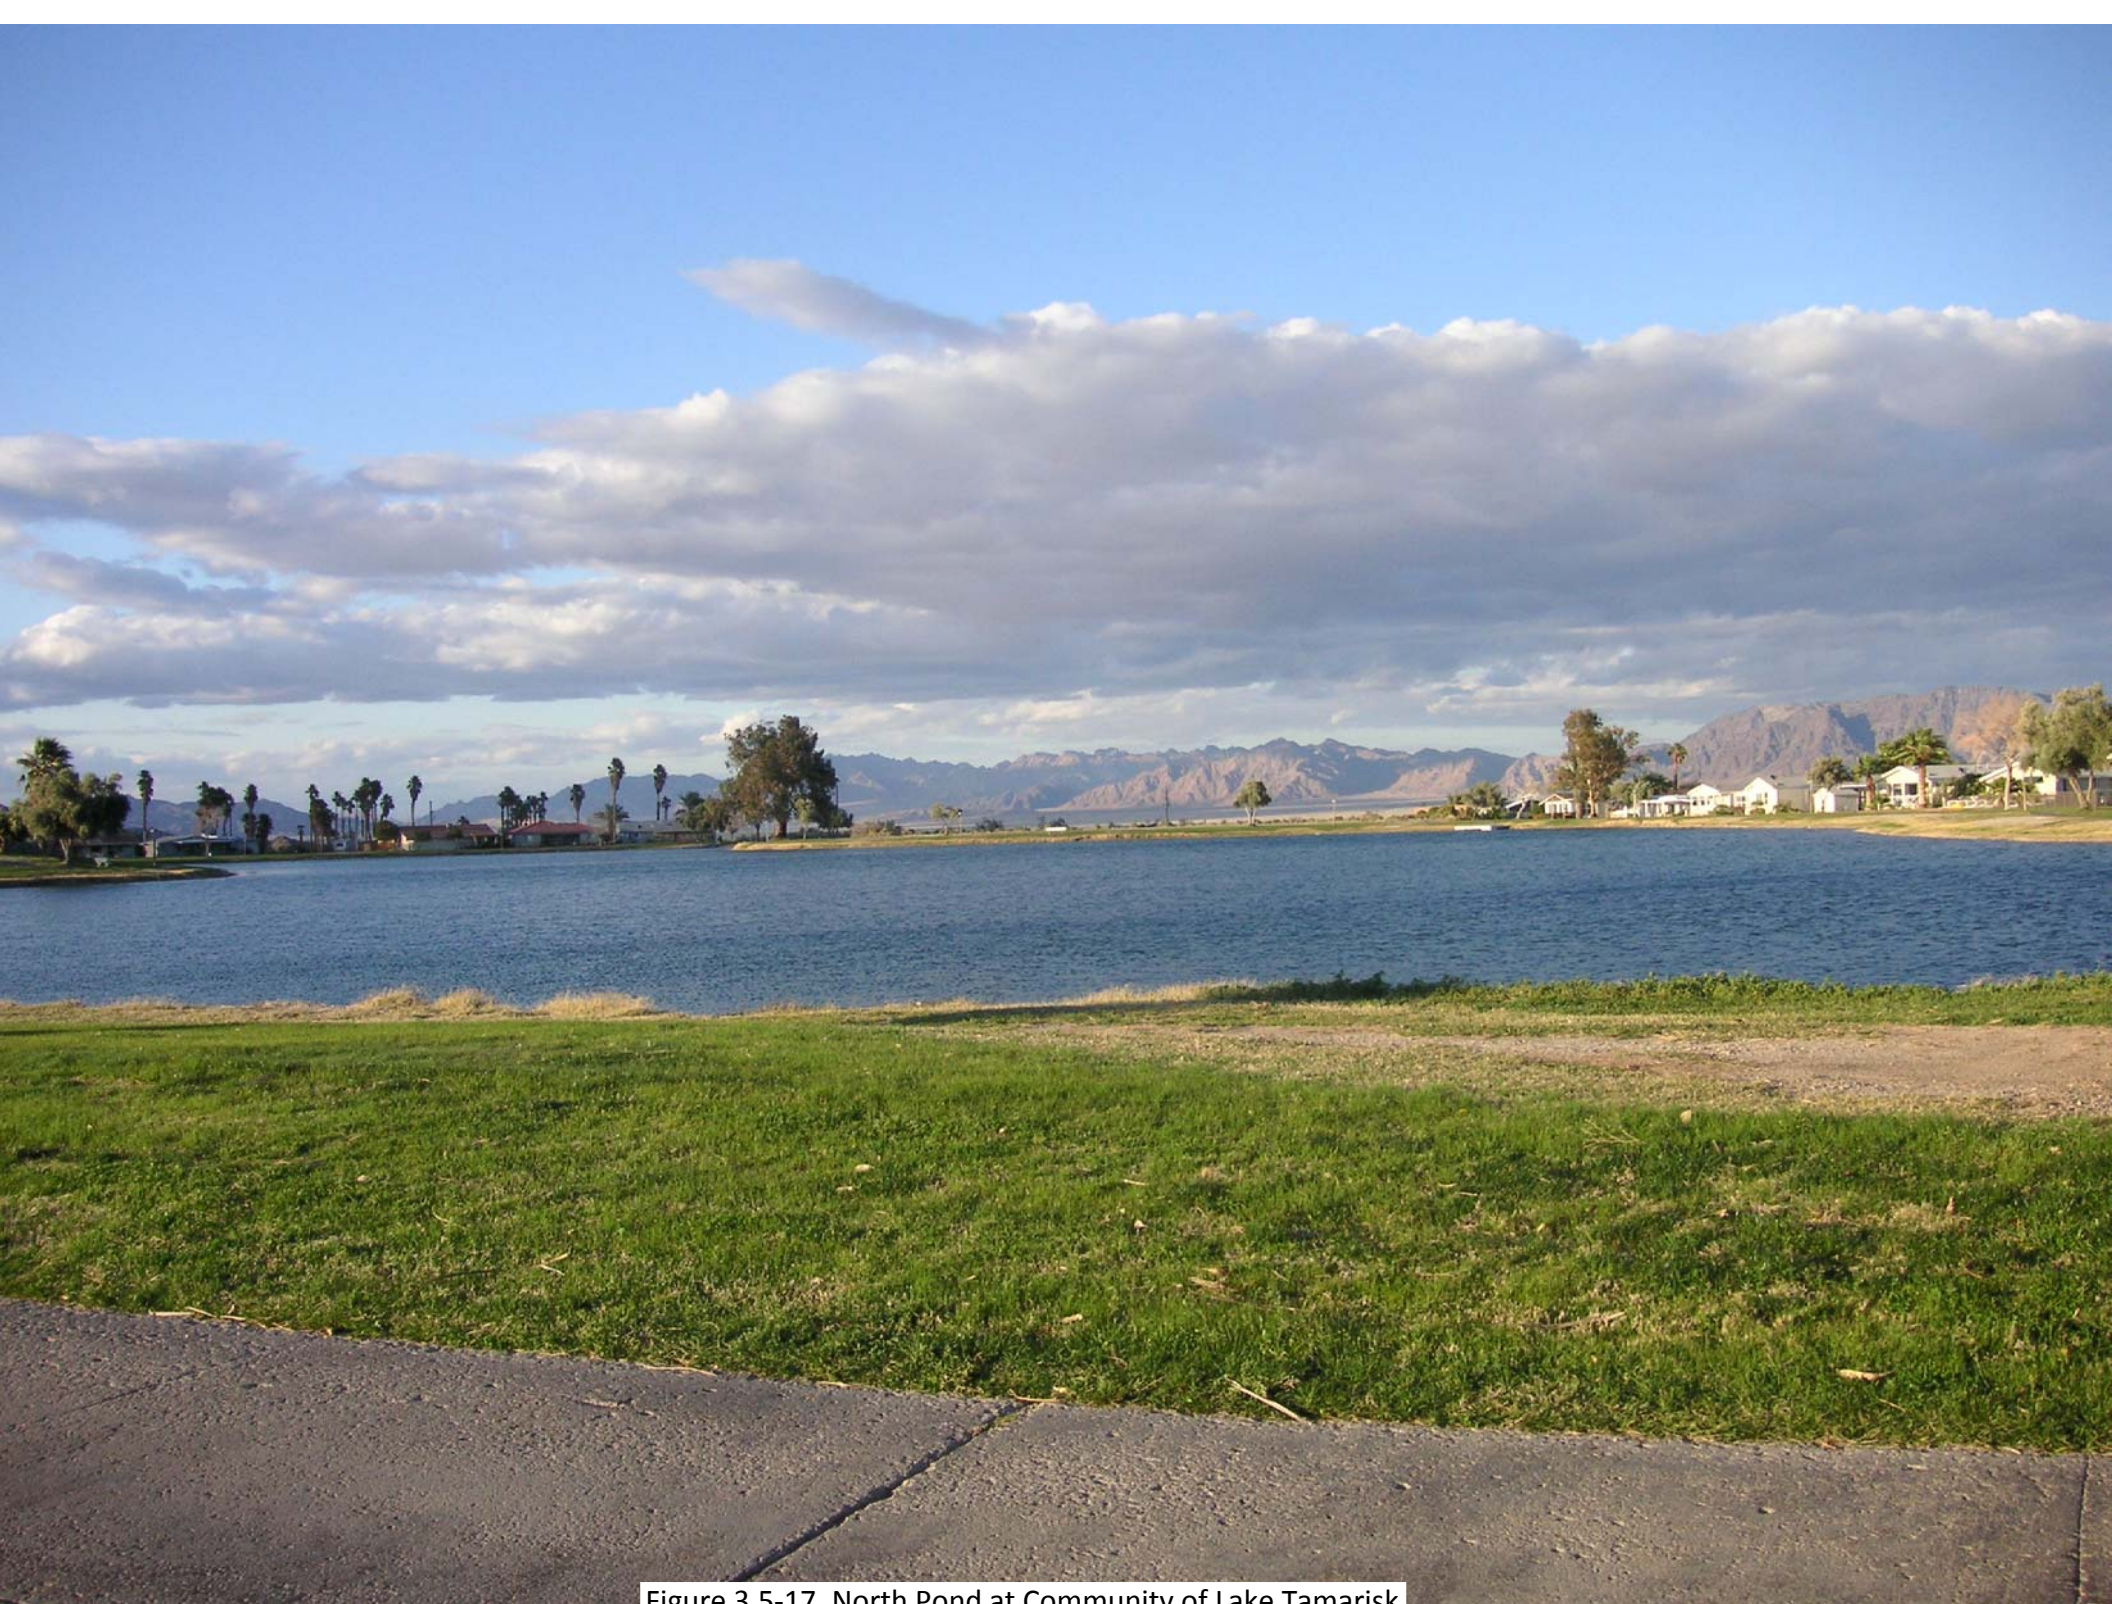
Figure 3.5-17. North Pond at Community of Lake Tamarisk

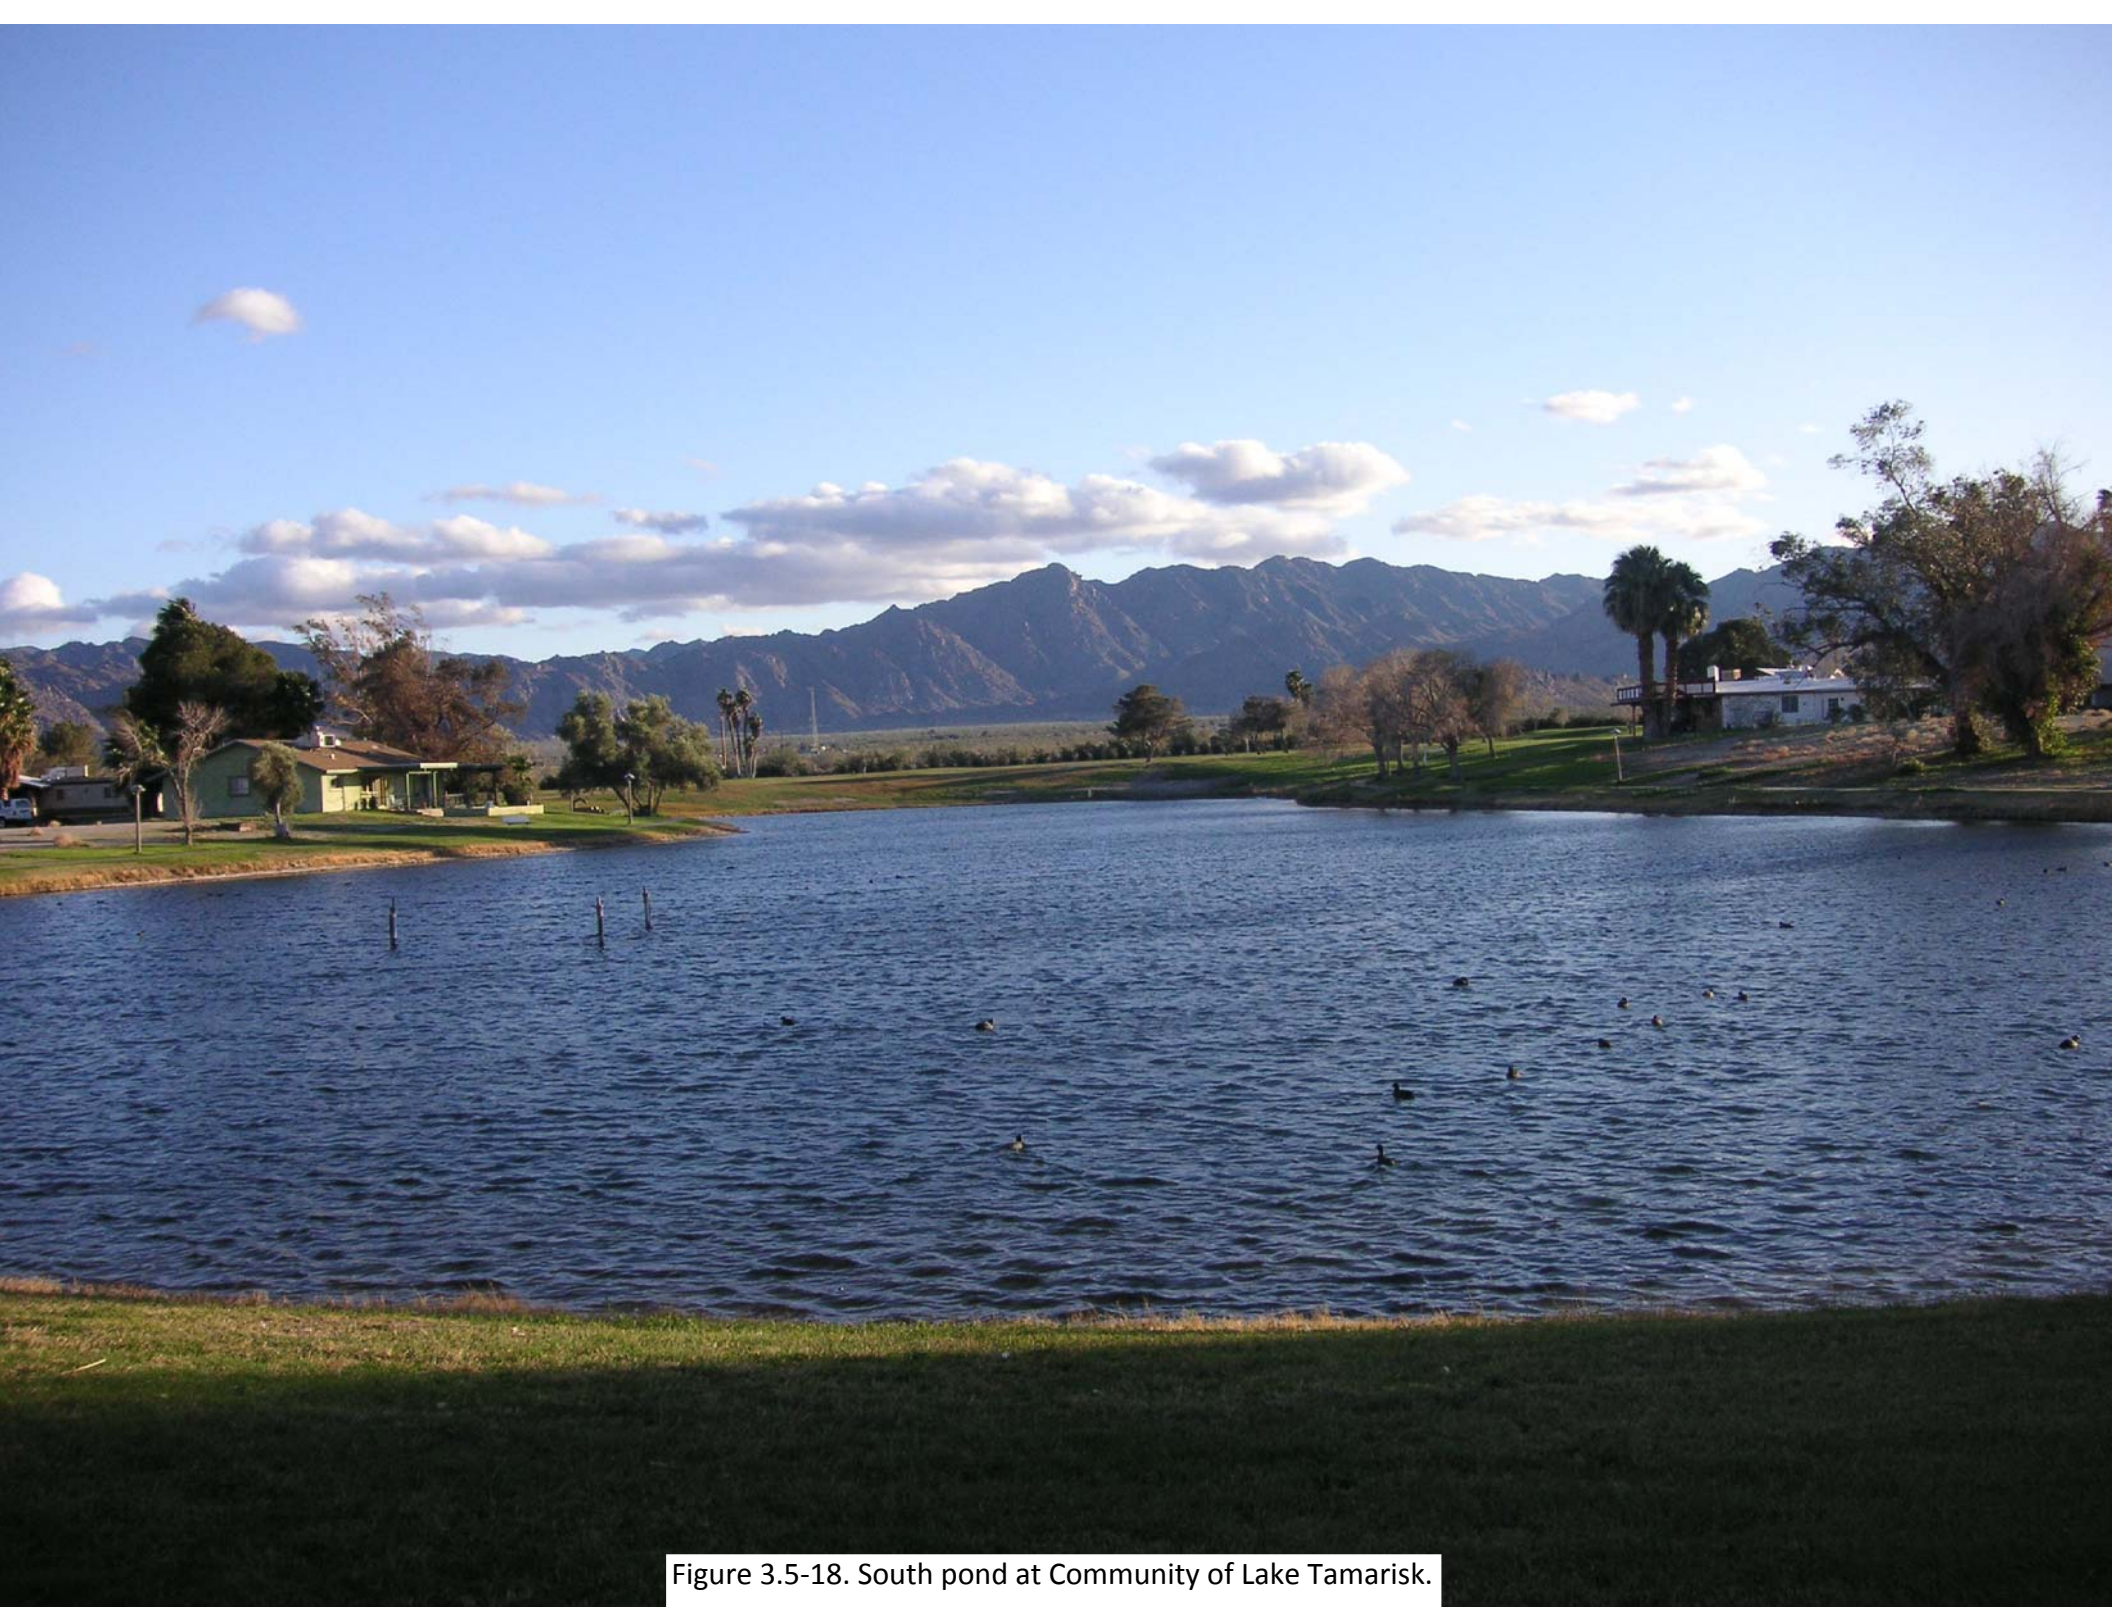
Figure 3.5-18. South pond at Community of Lake Tamarisk.
