NOVEMBER 2023

Trash Assessment Methodology

Caltrans

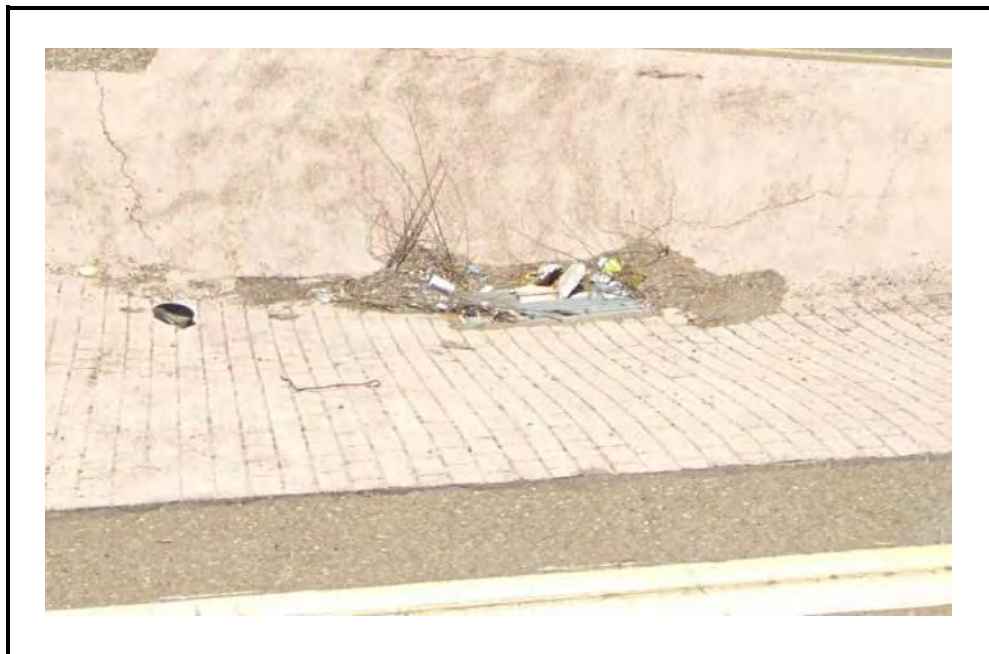
**PHOTO B: CAPTURE DEVICE LOCATION
TRASH AND DEBRIS OBSERVED AT GRATE**

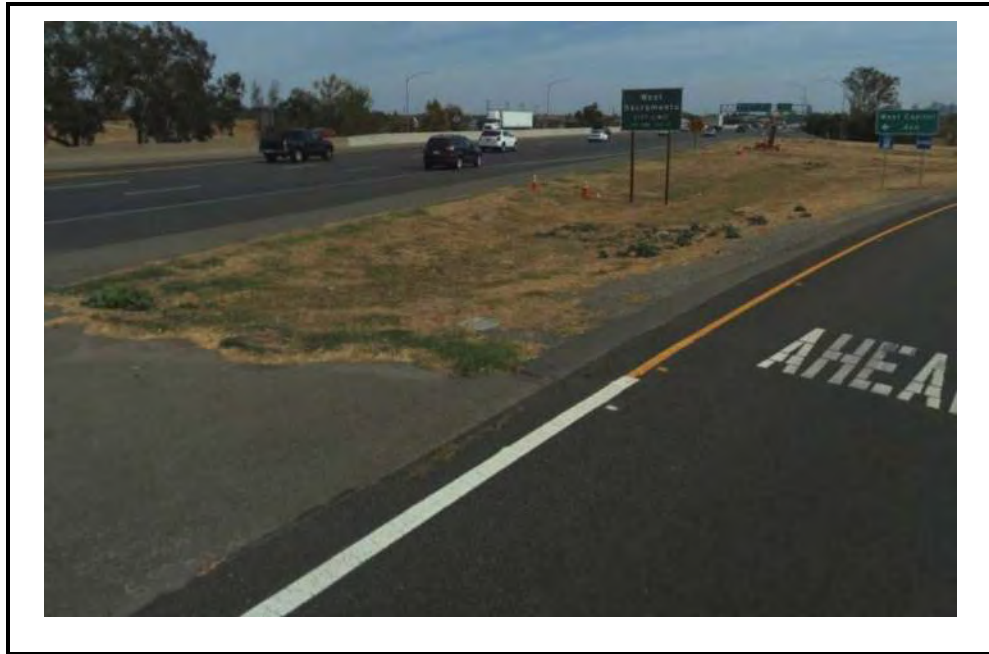
Site: 5.1 - Fill section with roadside vegetation strip slope flatter than 4:1 (sheet flow, 5'-10' to ditch)

PHOTO C: VEGETATED STRIP AND SWALE - (NORTHEAST)

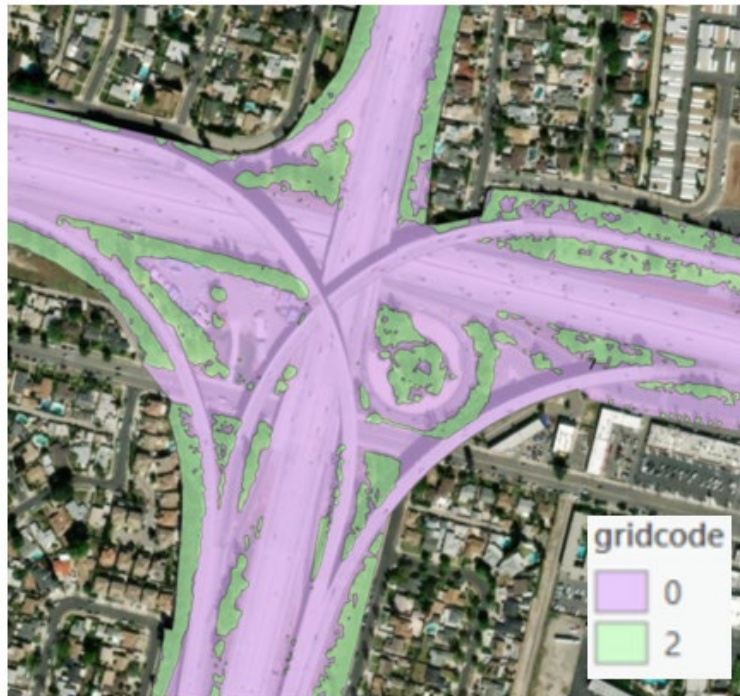
Using the trained model, each pixel of the NAIP images received one of the three classifications. Then, post processing methods were used to denoise the classifications and to impute the shadow areas with a vegetated or non-vegetated label. Additionally, iterative focal majority filters were used to remove large, shadowed areas. Any remaining shadow pixels were removed using ESRI’s “nibble” tool, which replaced shadow pixels with values of their nearest neighbors (vegetated or non-vegetated). Results were then converted from raster to polygon format. Due to the pixelated nature of the raster products, ESRI’s “Simplify Polygon” tool was used to remove relatively extraneous vertices while preserving the essential shape. A sample of the final polygons are presented below. A summary of the entire classification workflow is also provided.

Figure 1: Final Landcover Classification Polygons (gridcode 0 = non-vegetated, gridcode 2 = vegetated)
