Total Maximum Daily Load Progress Report		Chorro Creek Nutrients TMDL	
Regional Water Board	Central Coast, Region 3		
Beneficial uses affected	COLD, WARM, MUN	STATUS	☑Conditions Improving☐ Data Inconclusive☐ Improvement Needed☐ TMDL Achieved/Waterbody Delisted
Pollutant(s) addressed:	Dissolved Oxygen		
Implemented through:	Regulatory and non-regulatory Action		
Approval date:	July 2007

TMDL summary:

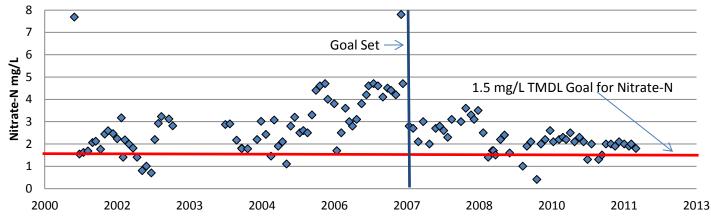
Lower Chorro Creek Water Quality

- The CMC upgrade was completed in May 2007 resulting in significant loading reduction of nitrogen.
- The instream summer median for nitrate-N has declined from 4.2 mg/L in 2007 to 2.0 mg/L in 2011.
- If trends continue, the TMDL may be achieved by the proposed 2016 date.
- Wasteload allocations are not yet consistently met for sodium, total dissolved solids, and temperature.
- A shading restoration project was completed in lower Chorro Creek in 1997; stream shading is improving.
- There is insufficient data at this time to determine if either the load allocation for shading or numeric target for algae is being achieved.
