**California Regional Water Quality Control Board  
Central Coast Region**

**Total Maximum Daily Loads for Fecal  
Coliform in the Pajaro River Watershed  
Including, Pajaro River, San Benito River,  
Llagas Creek, Tequisquita Slough, San Juan  
Creek, Carnadero/Uvas Creek, Bird Creek,  
Pescadero Creek, Tres Pinos Creek, Furlong  
(Jones) Creek, Santa Ana Creek, and  
Pachecho Creek, in Santa Cruz, Santa Clara,  
San Benito, and Monterey Counties,  
California**

**Phase-5: Regulatory Action Selection**

**Final TMDL Project Report  
March 2009**

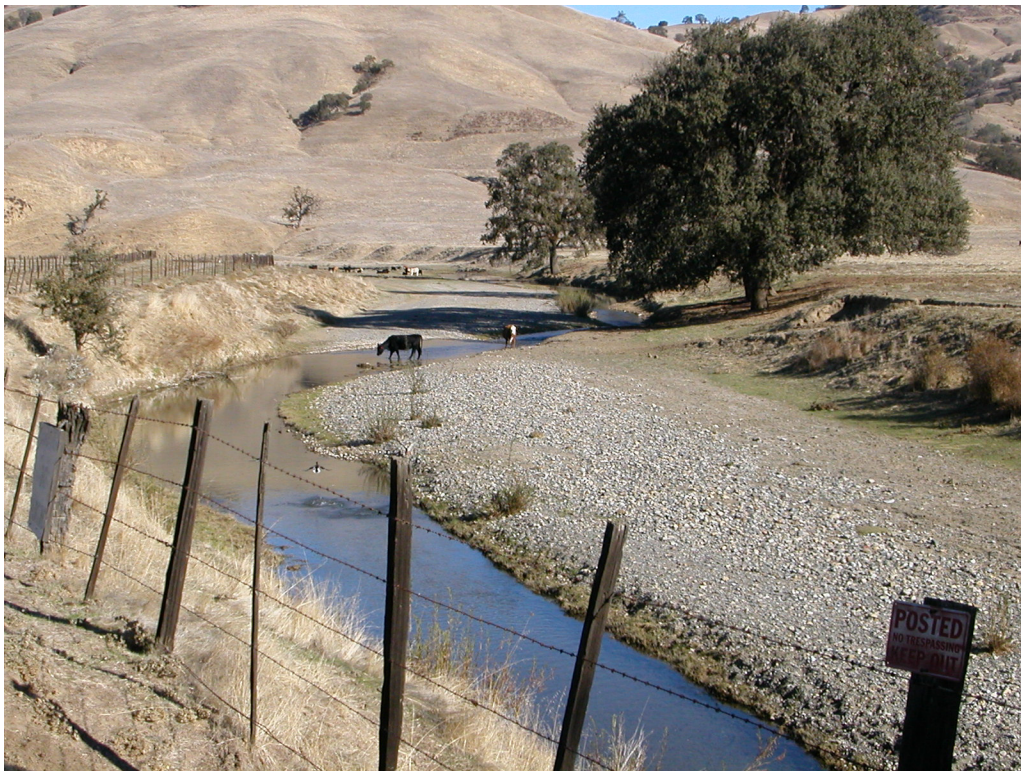
Figure 5-1. Cattle within San Benito River upstream of monitoring station 305SBA. (Water Board staff photograph, Nov. 6, 2006)

FIB sources from open spaces that are grazed, in part, originate from cattle feces entering the water body. Staff observed cattle within the San Benito River and cattle grazing adjacent to San Benito River, Pajaro River, Tequisquita Slough, and most tributary streams (e.g. Pachecho Creek, Tres Pinos Creek, San Juan Creek, and Uvas Creek). *E. coli* values up to 61,000 MPN/100 ml were recorded at monitoring station 305SBA, where staff observed cattle in San Benito River (Figure 5-1). Staff acknowledges the possibility that FIB levels at monitoring site 305SBA may be from natural sources, such as wild pig or other wildlife, however staff noted the presence of cattle in the river during most monitoring events. In addition, the California Food Emergency Response Team (CalFERT) investigation identified *E. coli* O157:H7 in the San Benito River and Pajaro River,

Staff concluded that cattle grazing lands are a source contributing to exceedances of water quality objectives. Actions to control these sources are included in Section 12 Implementation Plan.

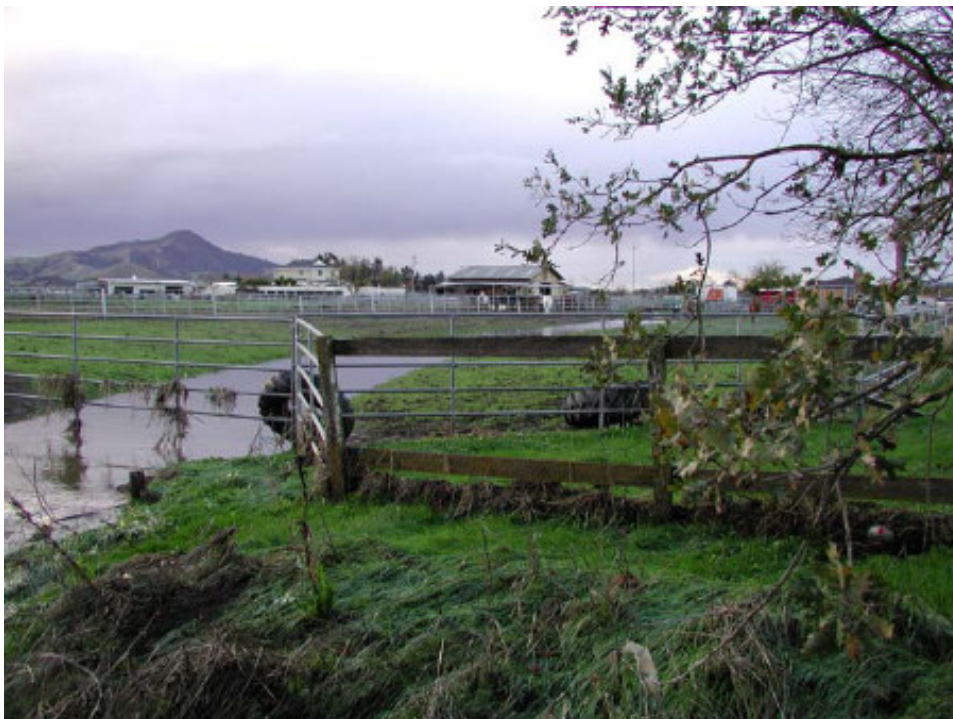
Figure 5-2. East Little Llagas Creek in rural residential pastures west of Llagas Avenue. (Fall Creek Engineering, Inc., 2004).

Staff observed many farm animal operations within the Pajaro River watershed. These operations (commonly referred to as “hobby farming” or “hobby ranching”) are located in rural residential areas where farm animals and livestock such as horses, cattle, chickens, goats, dogs, cats, and other farm animals are housed. These animals may contribute FIB if manure is not properly managed (e.g., retained on site) or if farm animals have access to waterways. Staff observed farm animals in rural areas that are adjacent to impaired reaches and tributary streams throughout most non-urban portions the Pajaro River watershed. *E. coli* values up to 130,000 MPN/100 ml were recorded at monitoring station 305SJN, where staff observed cattle and horses on rural residential properties next to San Juan Creek.

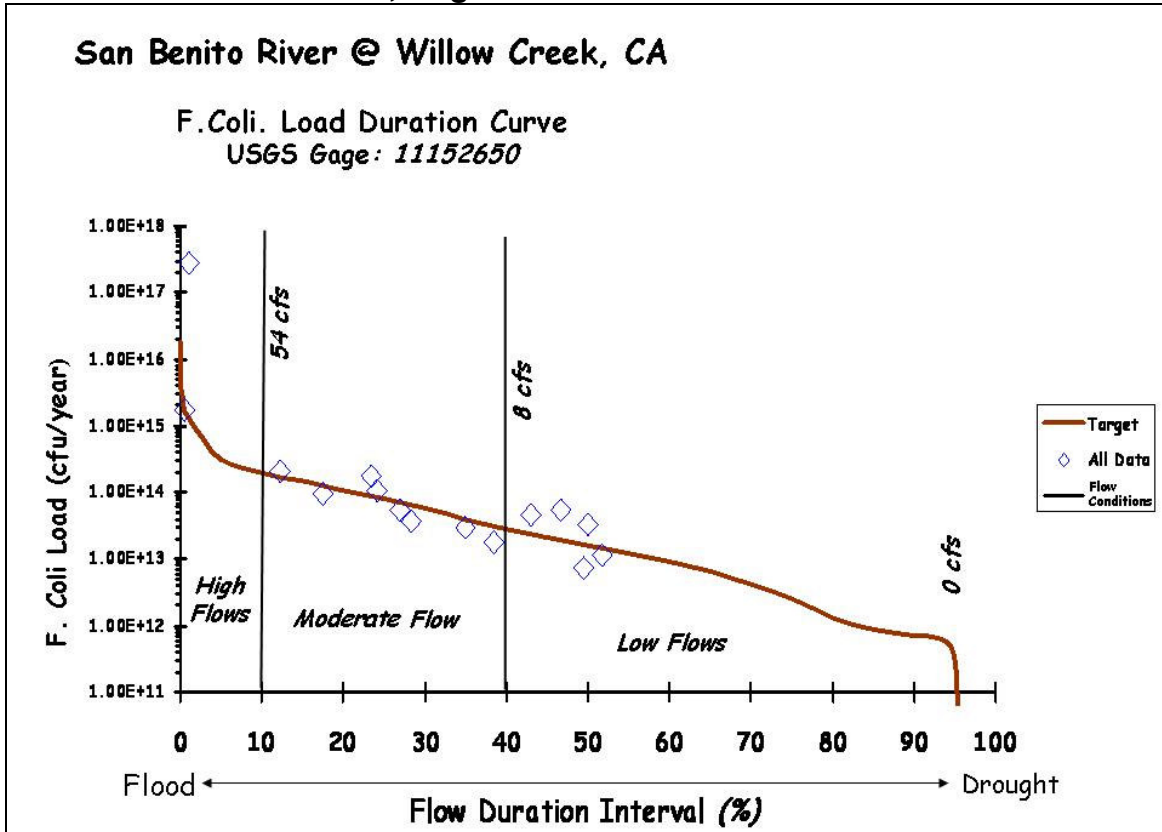
Figure A.4-2: Load Duration Curve, Gage 11152650

To assist in determining potential sources of fecal coliform to the San Benito River in subwatershed BRI\_22, a load duration curve analysis (see Cleland, 2002) was developed for USGS gage 111565000 on the San Benito River at Willow Creek. A load duration curve considers how flow conditions relate to a variety of pollutant sources (point and nonpoint sources). It is a method of water quality analysis and display that shows the assimilative or allowable loading capacity, across the entire spectrum of flow conditions. The allowable load plotted as a curve on the graph, is calculated simply as the water quality objective (400 MPN/100mL) multiplied by the flow taking into account unit conversion factors. Monitoring data, plotted as observed loads, which plot above the curve represent exceedances of the allowable load. It is important to note that the fecal coliform loads along the vertical axis are plotted on a logarithmic scale.

The load duration curve indicates that exceedances of the fecal coliform water quality objective are observed during wet and dry weather events. Note that data points above the curve on the left side of the figure are indicative of fecal coliform exceedances during wet weather conditions (higher flows) and data points above the curve to the right side indicate fecal coliform exceedances during dry weather conditions (lower flows). These low flow exceedances indicate that sources of fecal coliform are most likely not related to precipitation events (i.e., runoff). Given the low density of human population in the watershed, the lack of permitted point sources of fecal coliform, the absence of sanitary sewer collection systems, and the low density of septic systems, the most likely source of fecal coliform exceedances during dry weather is via in-stream deposition from wildlife and livestock.

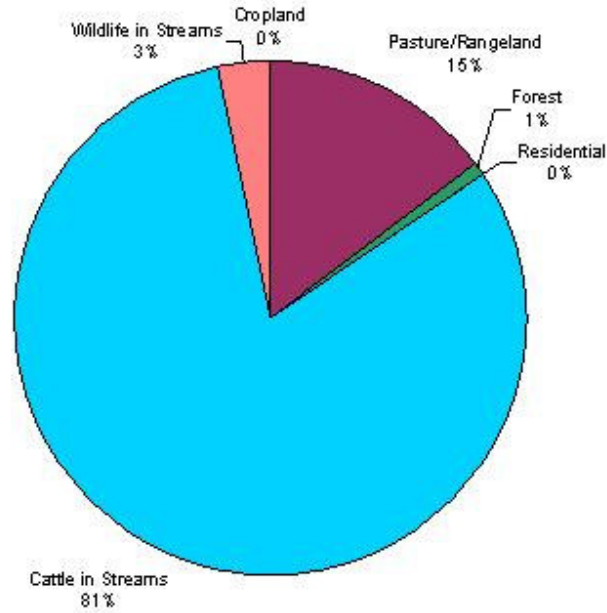
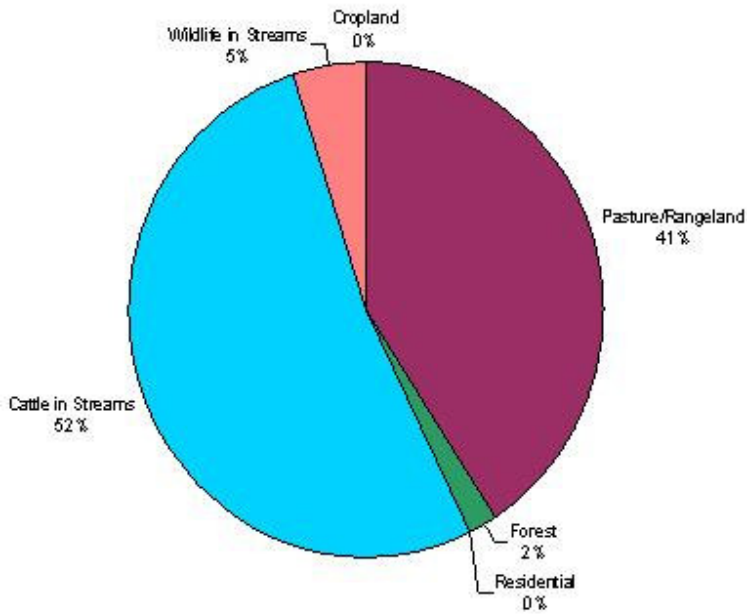
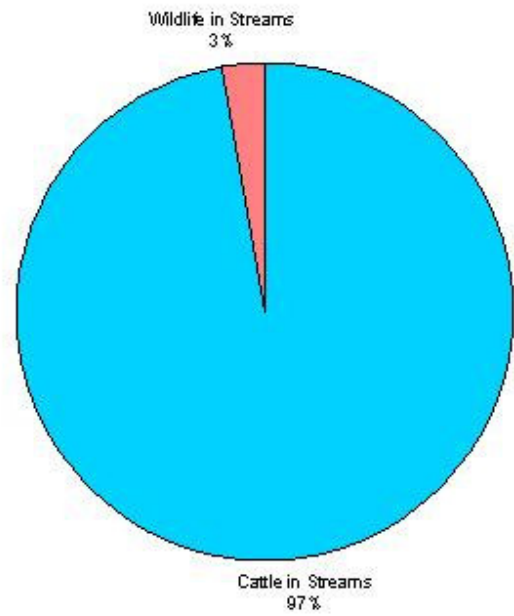
**Figure A.4-4: Proportional Fecal Coliform Source Loading, Annual and Seasonal**

For subwatershed BRI\_22, the relative contribution of various sources to the baseline conditions were estimated from empirical land use, livestock, human, wildlife, data used in conjunction with the Bacteria Source Load Calculator (BSLC) spreadsheet. BSLC characterizes how bacterial loads are spatially and temporally distributed in the watershed from user input, and processes source data to calculate fecal coliform loads to land, and loads to stream from direct in-stream deposition. Estimated stream loads resulting from fecal coliform fraction deposited on land as calculated in BSLC can then be estimated by using reasonable loading and runoff parameters found in the scientific literature.

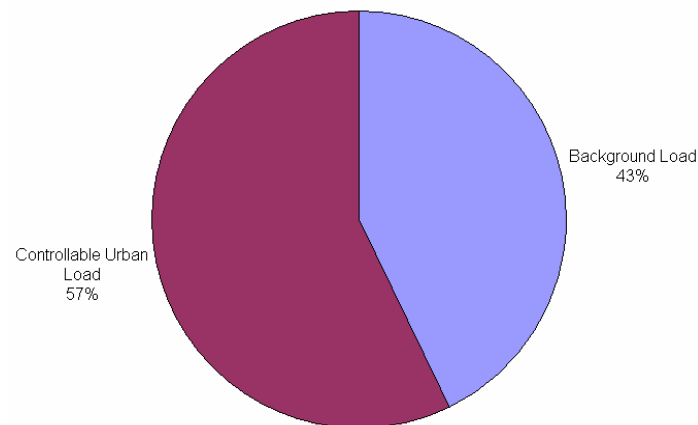
WTM uses input values from the scientific literature for fecal coliform loading rates from various land use categories. It is assumed here that the loading rate associated with “forest” represents a background natural loading rate; 1.2 E+10 MPN/acre-year. Applying this loading rate across the entire geographic extent of the watershed, one can derive a presumed annual fractional “background” load for the urban watershed: (9241 acres) X (1.2 E+10) = 1.12 E+14 MPN. It is assumed, as described earlier, that 75% of the Gilroy urban load drains to Llagas Creek, so the background load to Llagas creek is (1.12 E+14) (0.75)= 8.41 E+13. From Table A.4-10, the total annual storm load to Llagas creek is 1.93 E+14, so the controllable fraction is (1.93 E +14<sub>total load</sub>) – (8.41 E+13<sub>background</sub>) = 1.13 E+14<sub>controllable load</sub>.

Consequently, the fractional loads would be represented in the bubble graph to the right.

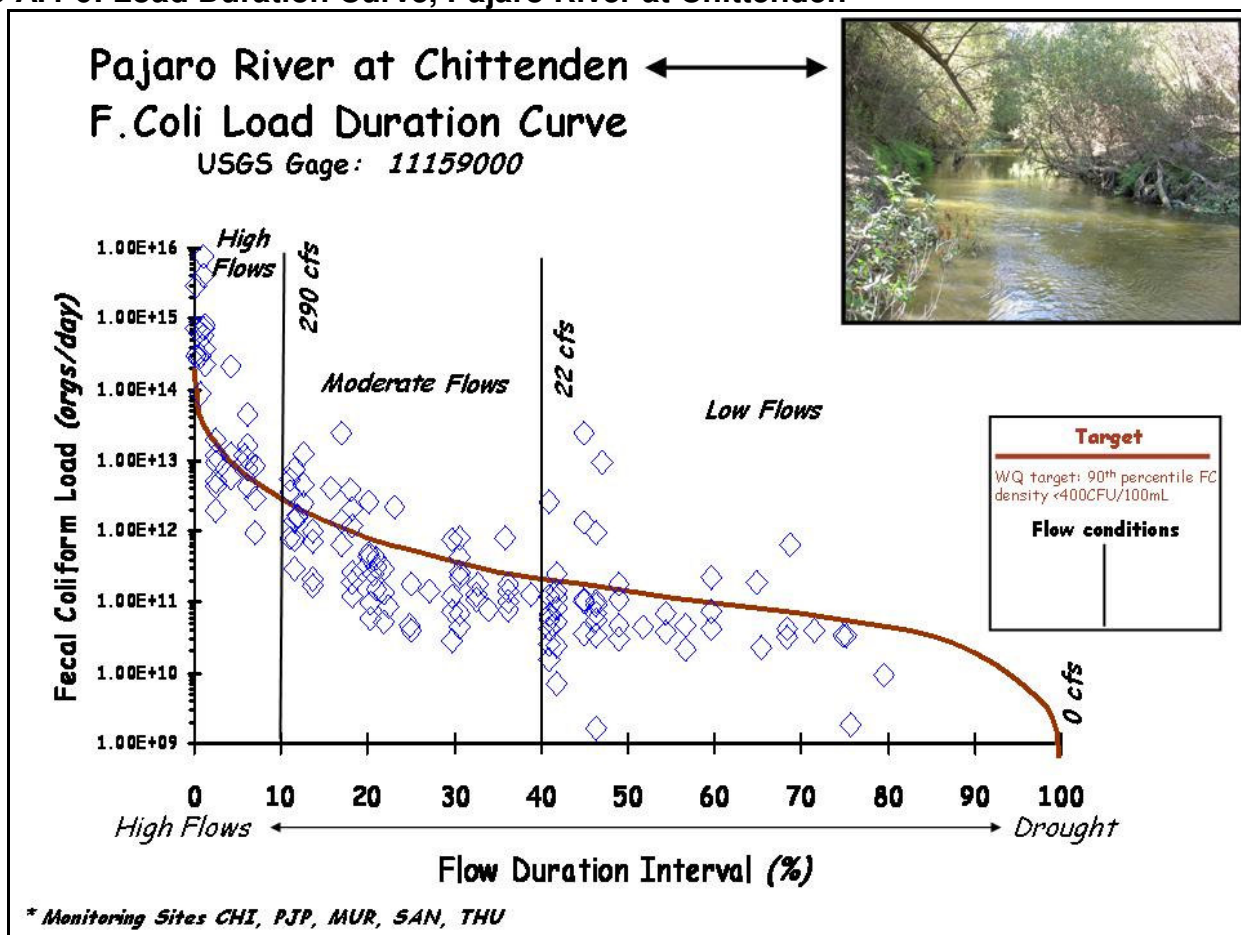
Figure A.4-6: Load Duration Curve, Pajaro River at Chittenden

The aforementioned stream gage at Llagas creek has a limited flow record, rendering it largely inappropriate for load duration analysis. A load duration curve was developed for the USGS gage station at Chittenden on the Pajaro River, to evaluate the range of water quality responses over the entire spectrum of flow conditions (Figure A.4-6). This stream gage is located approximately 13 miles downstream from the City of Gilroy. Monitoring sites that are proximal to the USGS stream gage at Chittenden were used to plot observed loads. It is assumed that resuspension of bacterial regrowths from sediment substrates will be prevalent during high flows and turbulent conditions.

The load duration curve indicates that exceedances of the fecal coliform water quality objective are observed during wet and dry weather events. Note that data points above the curve on the left side of the figure are indicative of fecal coliform exceedances during wet weather conditions (higher flows) and data points above the curve to the right side indicate fecal coliform exceedances during dry weather conditions (lower flows). These low flow exceedances indicate that sources of fecal coliform are most likely not related to precipitation events (i.e., runoff). The distribution of exceedances in both high flows and low flows suggests that both non-point sources, direct in-stream depositions, and point sources may be responsible for water quality impairment. Presumably, high flows and turbulence would be the chief factor in resuspending bacteria from stream bottom sediment sinks.

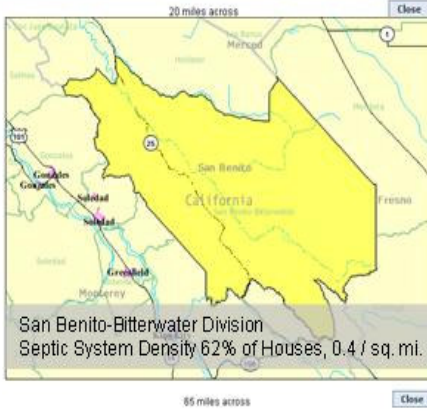
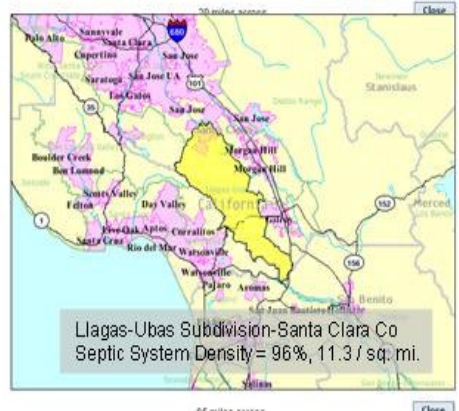
Census Bureau subdivisions:

The data do not qualitatively suggest a positive correlation between OSDS density and elevated fecal coliform water quality data. In fact, in areas with the highest OSDS densities, the geometric mean concentrations of fecal coliform tended to be lower, whereas in areas of low OSDS densities, fecal coliform concentrations trended towards higher geometric mean values, as shown below:
