Lahontan Regional Water Quality  
Control Board

# EXECUTIVE OFFICER'S REPORT

October 2015

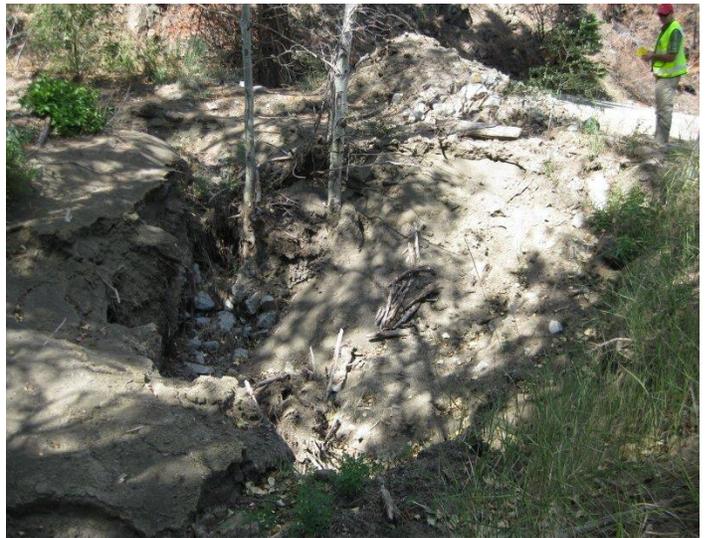
*Culvert under Wolf Creek Road which was buried by the debris flow and subsequently caused flooding and erosion of the road bank and road shoulders*

Caltrans has completed treatment along State Routes 4 and 89 that included removing debris, clearing culverts, and reestablishing road-side swales.

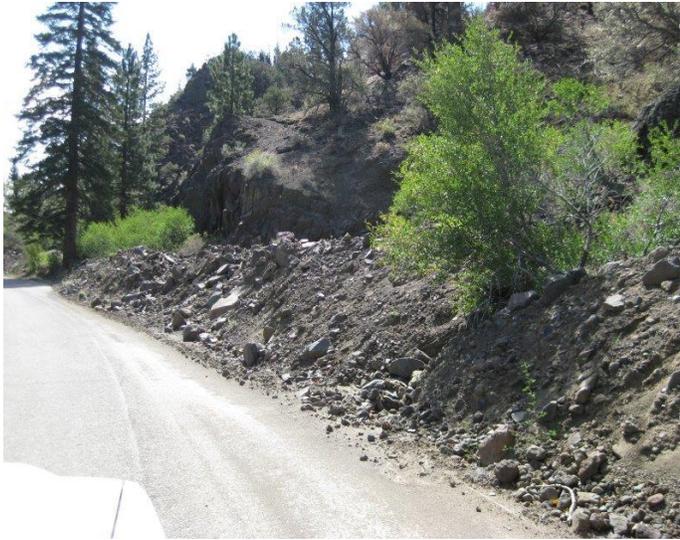
*Accumulated debris along Wolf Creek Road piled in preparation for hauling*

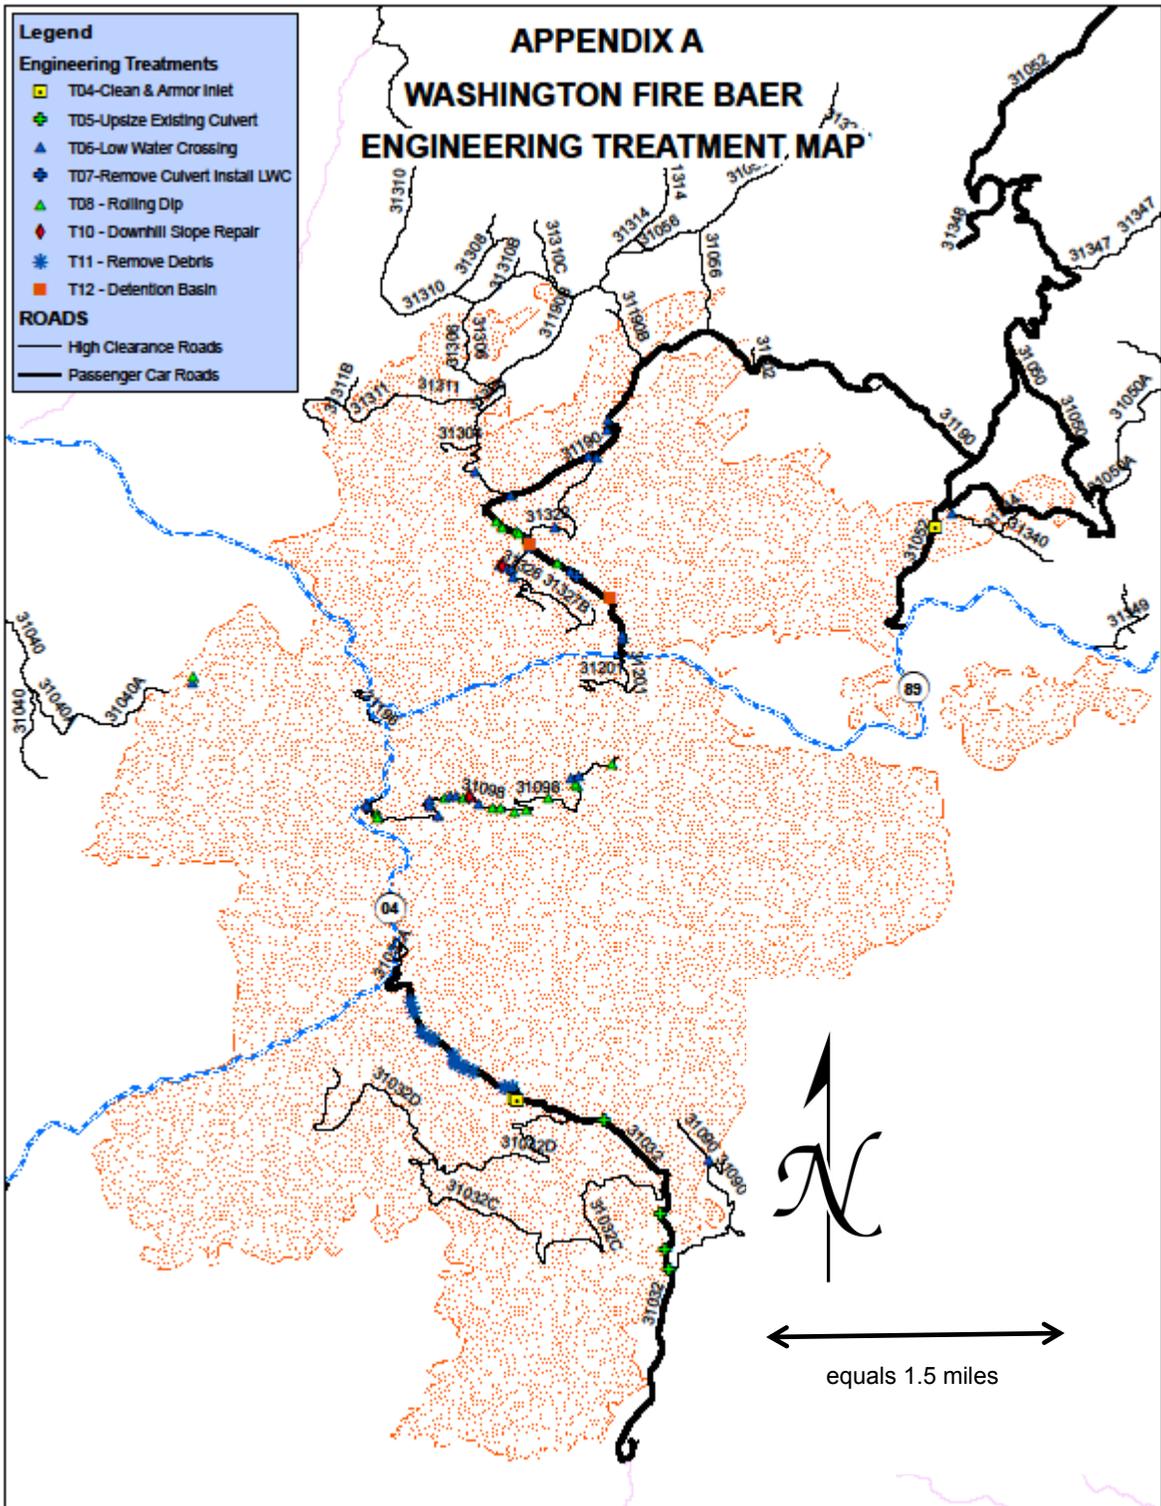
The Forest Service has prepared a BAER report that addresses forest visitor safety and water quality protection for the Washington fire area. Water Board staff reviewed the report, and visited the site on August 27, 2015. The fire resulted in a high risk to road infrastructure due to an increased threat of damage from flooding, debris flows, erosion and deposition. The Forest Service will protect water quality through construction of numerous surface stabilization and drainage improvements along existing Forest Service Roads (see map) that will reduce further erosion and water quality impacts associated with stormwater runoff. The treatments include armored low water ford crossings, rolling dips, detention basins, clear and armor culvert inlets, install larger culverts, and remove accumulated debris. The attached map shows areas of specific treatments prescribed for Forest Service roads within the burn area.
