EXECUTIVE OFFICER'S REPORT • March 2020
Covers January 16, 2020 – February 15, 2020

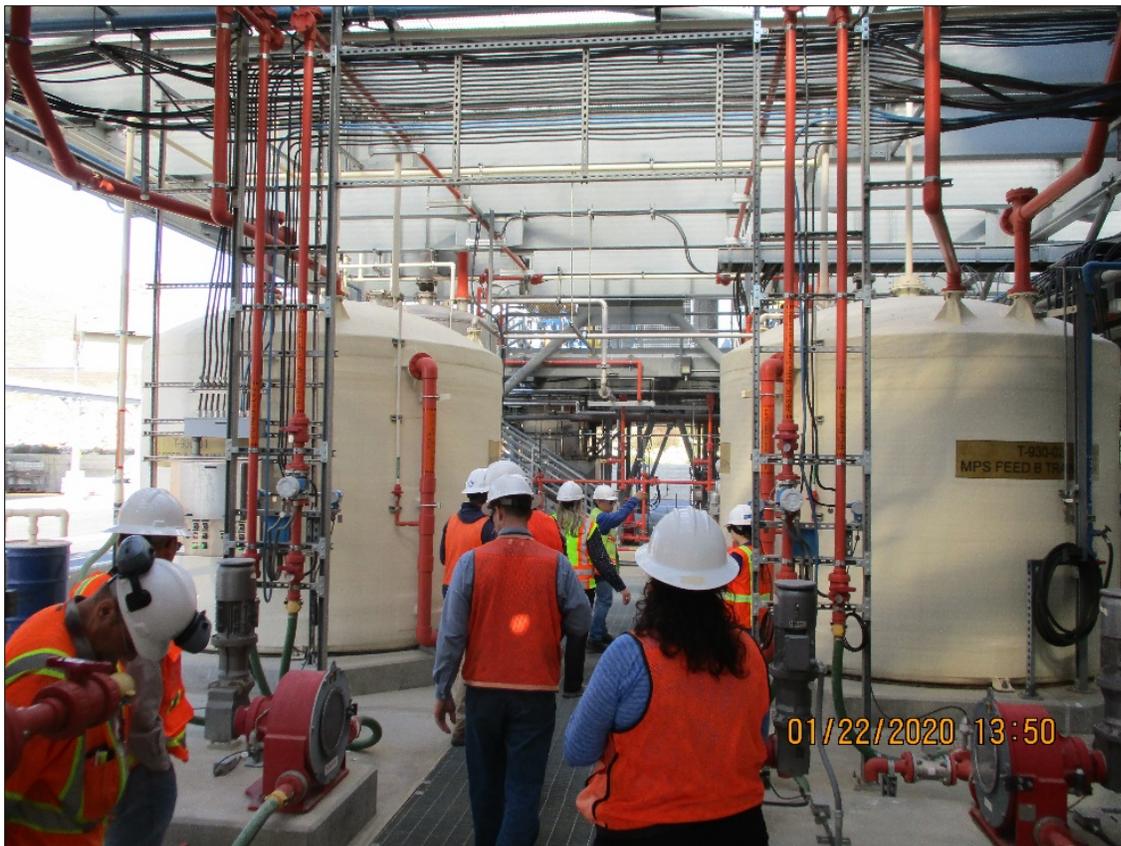
Figure 3.1 - Water Board staff touring the PCTF at the Stringfellow Superfund Site

In addition to the discussion, DTSC personnel provided a tour of the PCTF which was completed in 2016. The PCTF includes treatment processes to reduce the concentration of volatile organic compounds, pesticides, and heavy metals found in groundwater at the Stringfellow Superfund Site. The Tour was informative and Leviathan Mine staff will use the information shared by DTSC personnel in the future during project design, contracting, and construction management at Leviathan Mine.

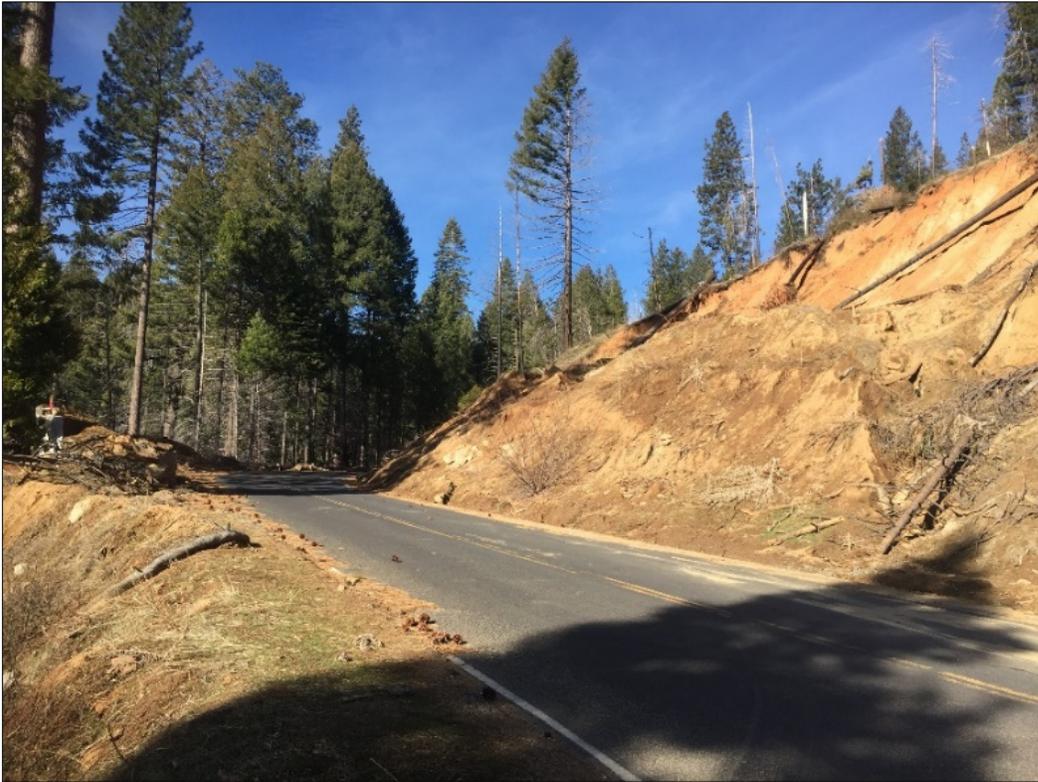
Figure 5.2 - Partially completed restoration of a landslide on a main timber access corridor. Hillside collapse occurred after a series of 2017 rain-on-snow events.

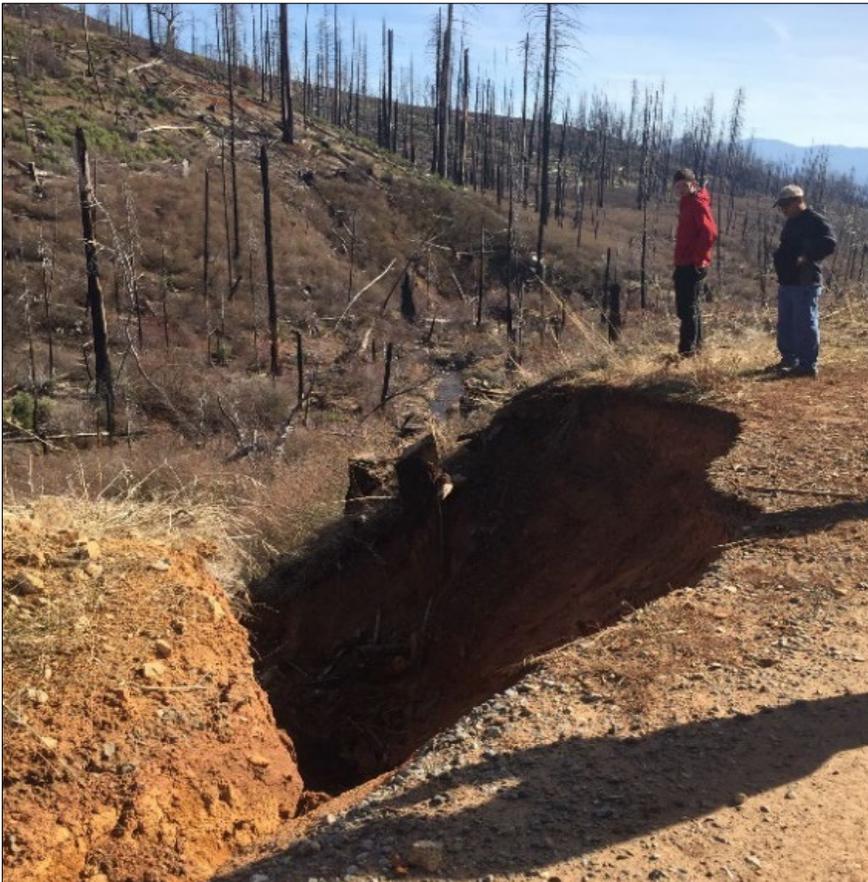
Figure 5.3 - Timber access road fill slope collapse from intercepted surface water conveyance.

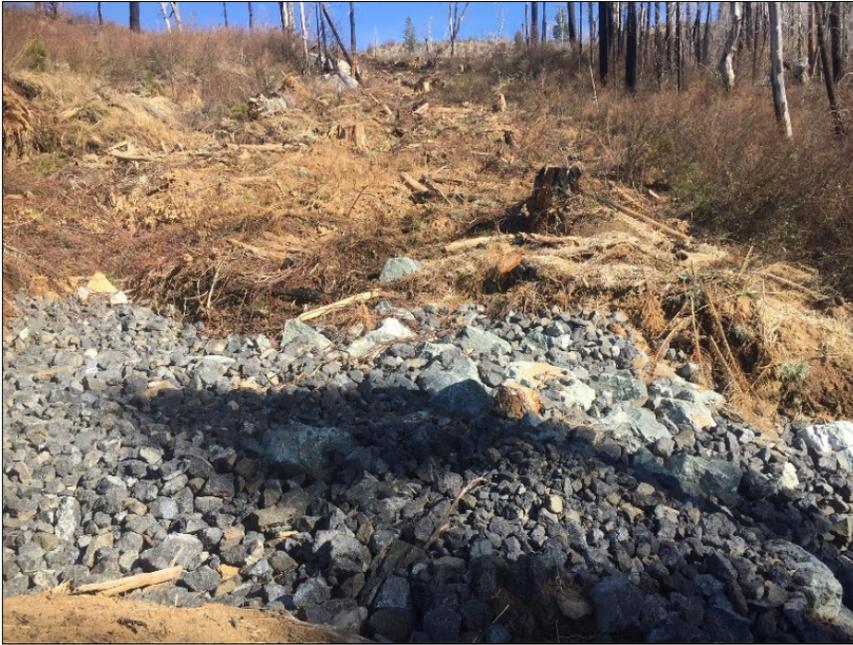
Figure 5.4 - Creek hillside damaged from timber harvesting equipment. Rock fill was used to prevent sediment delivery to the creek below.

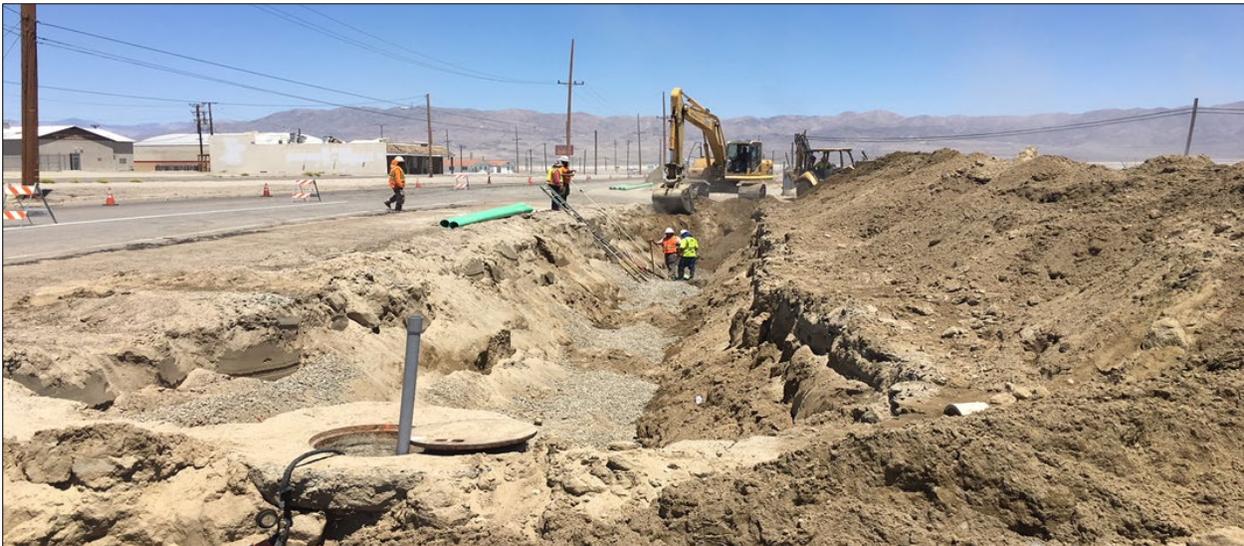
Figure 9.2 - View to north, along CA Highway 178, during replacement of failed collection system pipes.

(CCTV) inspections, the Division repaired collapsed pipelines, off-set joints, and any damaged pipelines identified that required open excavations. Due to shallow groundwater and soil conditions, some of these excavations were extensive.

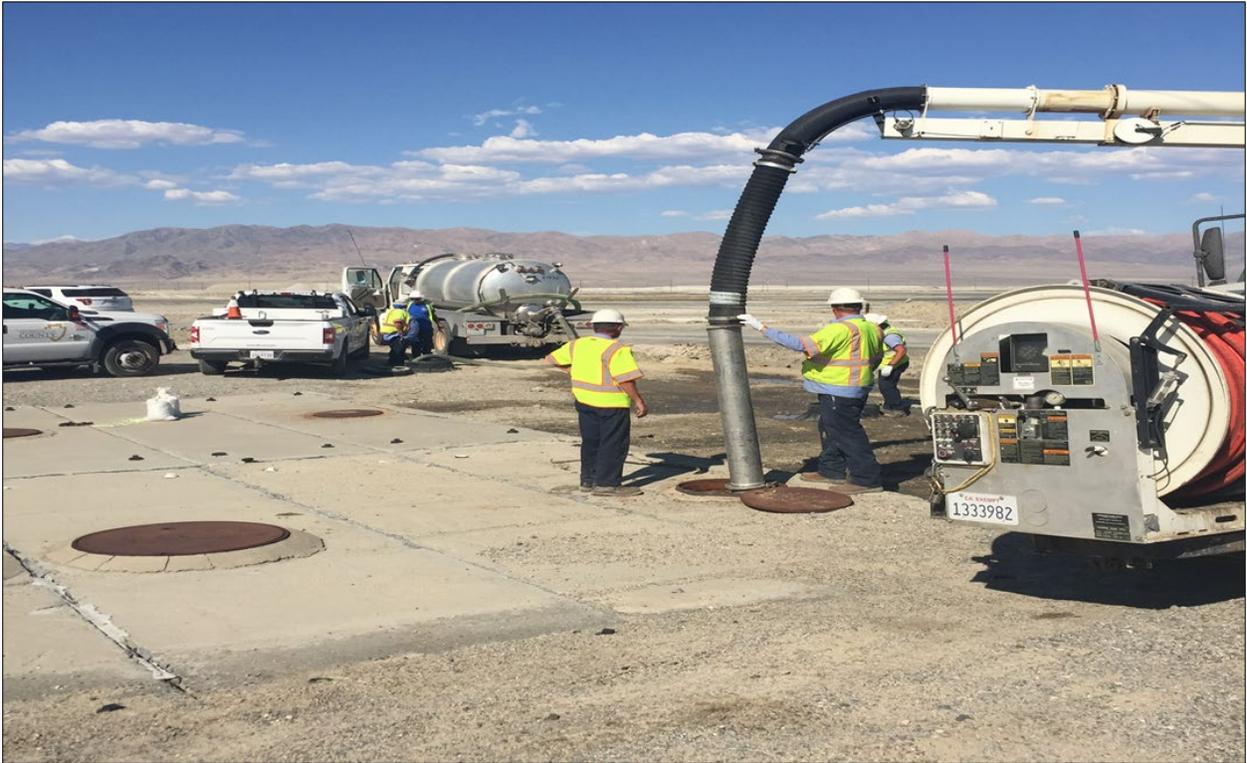
Figure 9.3 - View to east, main Trona septic tanks are pumped, cleaned, and inspected. Removed septage was disposed in the CSA 82 disposal ponds located on the east side of Searles Dry Lake.

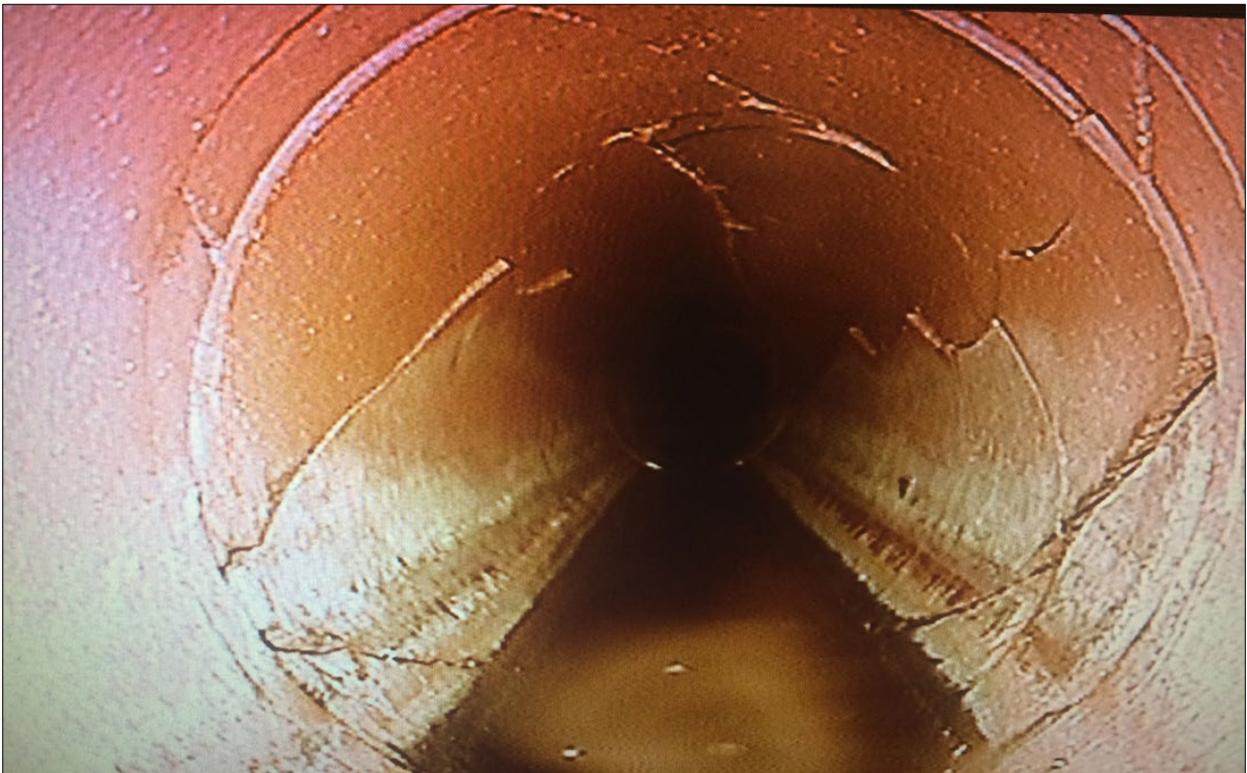
Figure 9.4 - Example of damaged vitrified clay sewer collection system pipeline.

Many of the identified damaged locations are still pending repair due to the depleted financial reserves in the Divisions accounts. As reserves are replenished by reimbursement payments from the California Office of Emergency Services, the Division will continue earthquake-related repairs. During the entire event and with the most critical repairs completed, Division customers did not experience sewer service outages. The Division recognized and thanked Water Board staff for their assistance and partnership during this catastrophic event. District photographs of recovery operations follow (Figures 9.2 to Figure 9.5).

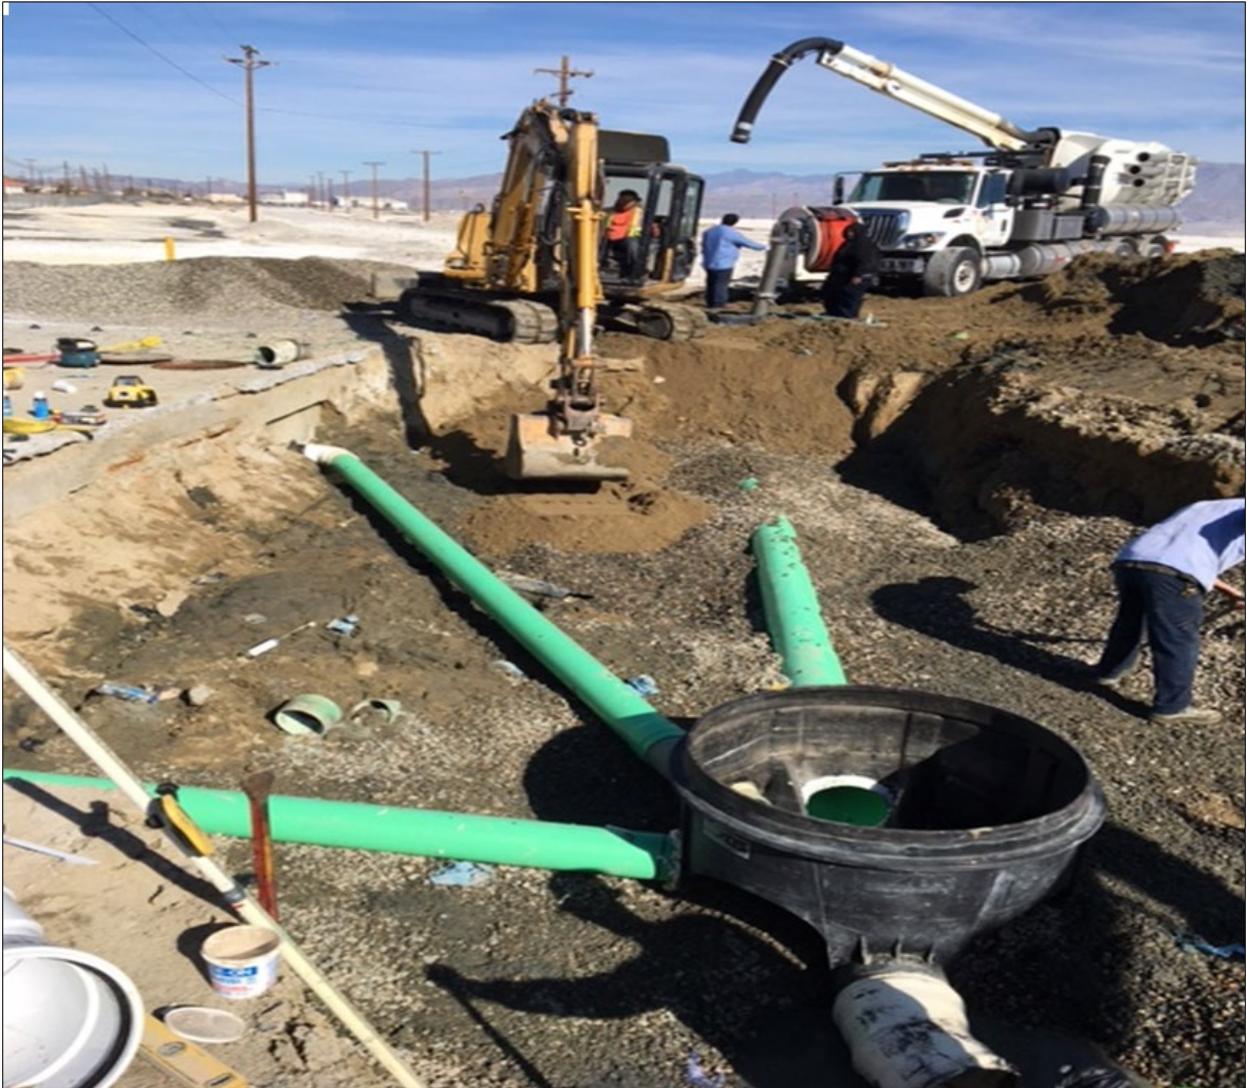
Figure 9.5 - Project to restore flow in the effluent outfall pipeline after earthquake changed infrastructure elevations.

During this time, the communities were without power and water. After setting up an emergency operations center, the Division provided hauled water daily from the City of Ridgecrest to support sewer cleaning work. Bottled water was provided to residences. Because normal water delivery was unavailable to residents at the beginning of recovery efforts, there was no sewer flow during many of the Division's critical repairs. On August 15, 2019, after water service was restored to the communities, the main Trona septic tanks' outfall effluent pipeline began spilling due to the earthquake damage. The Division notified the Water Board and installed a temporary bypass pumping system (identified as By-Pass Line on Figure 8.1), which required daily checks to keep both the Division and Searles Valley Mineral Company from spilling effluent locally as the outfall line is connected to a common header for both. The bypass pumping system continued in operation until flow to the outfall line was restored on January 26, 2020, involving multiple repairs to approximately 3,000 feet of effluent outfall line.

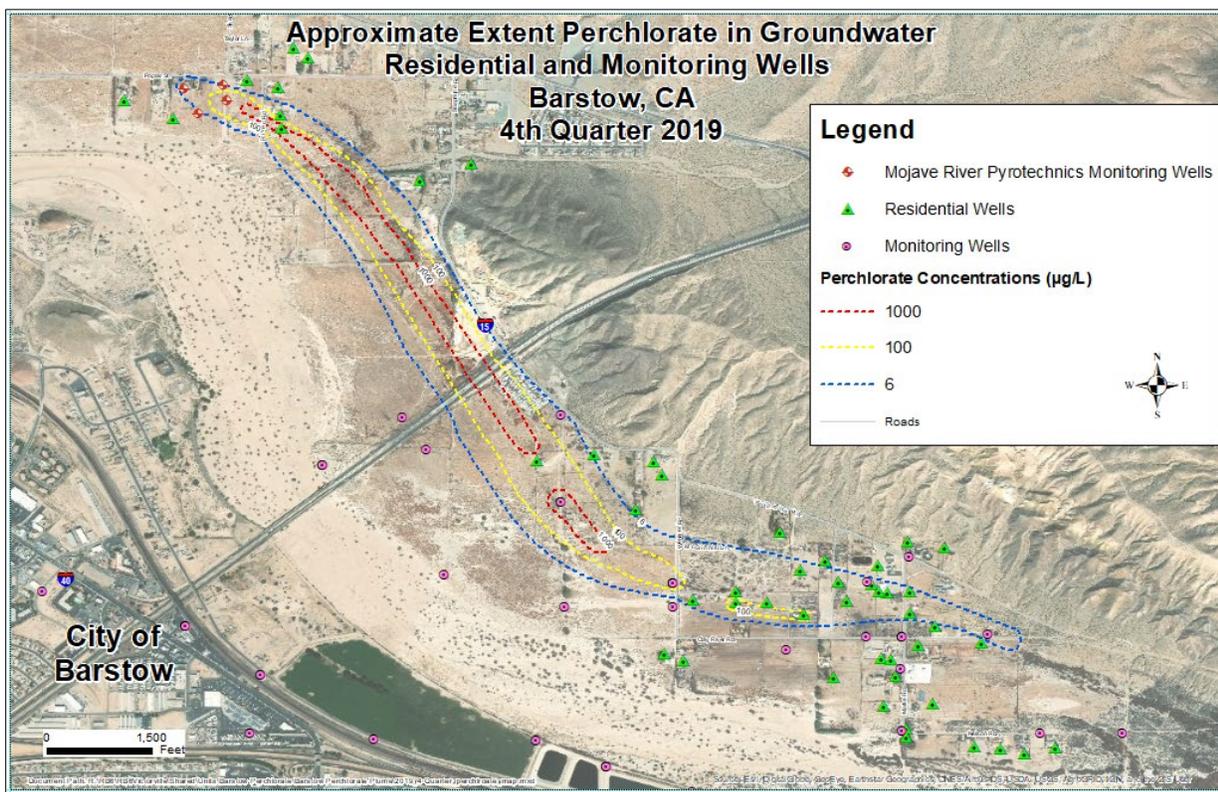
Water Board staff collected fourth quarter 2019 samples from 20 monitoring wells and 38 private residential wells within and around the perchlorate plume area. The plume is approximately 2.5 miles long, as defined by perchlorate concentrations above the 6 µg/L MCL. Figure 12.1 shows the current plume extent based on the data collected in October 2019.

Figure 12.1 - Barstow Perchlorate Plume extent, as of October 2019.

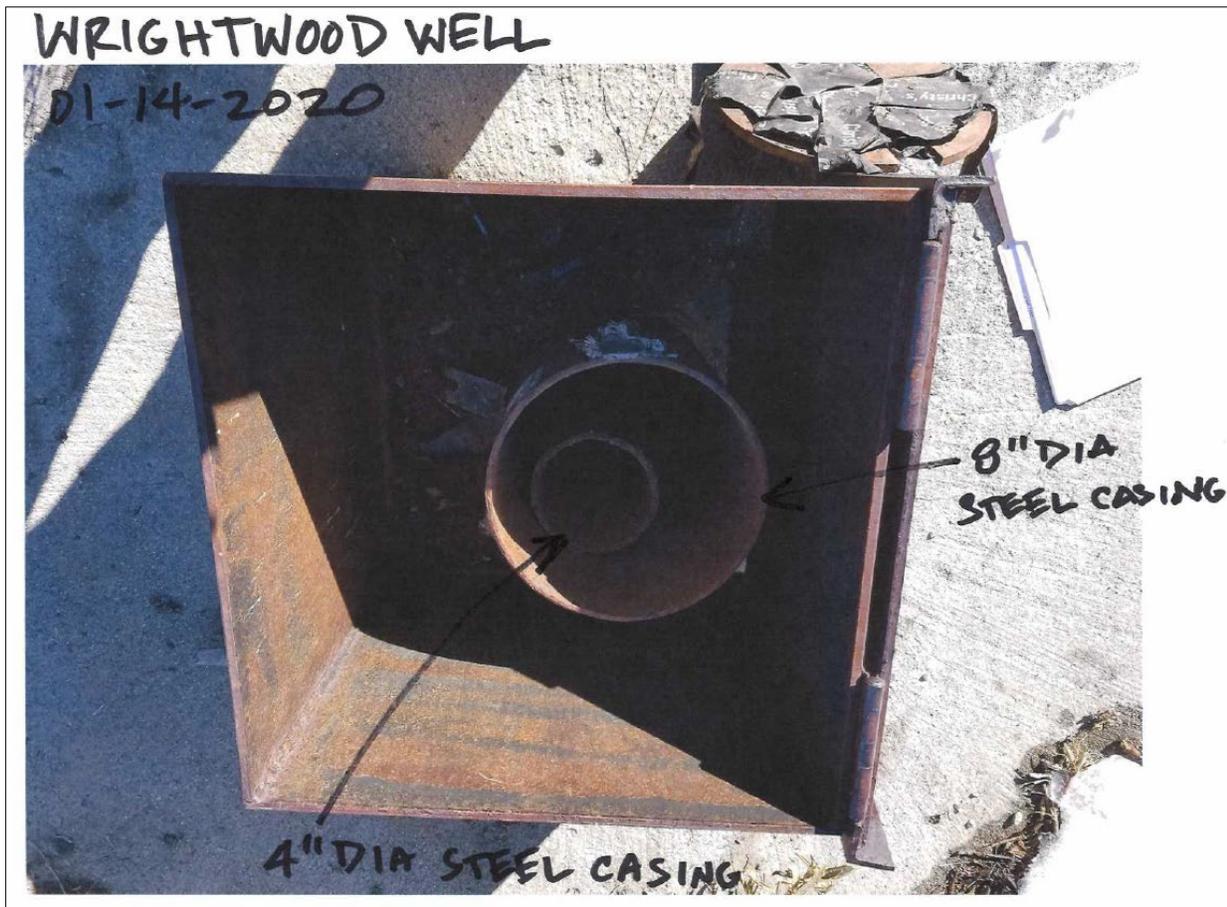
Figure 13.5 - Former San Bernardino County Services Area (CSA) 56 monitoring well. There is no secured cover. The steel casing is not secured and locked and the steel box cover is not secured to.

Attention shifted to securing the well and considering it for possible destruction as required in California Well Standards. During a February 7, 2020 meeting between Water Board staff, District subcommittee members and their counsel, staff of the San Bernardino County Local Agency Formation Committee (LAFCO), and San Bernardino County Department of Environmental Health Services (County) staff, the County agreed to weld a steel cover over the casing and place the well on its registry of abandoned wells for possible well destruction, as the well owner has not yet been determined. Because the well is ideally situated to provide groundwater monitoring data, Water Board staff recommended the well condition be further assessed to determine if it can be rehabilitated and locate a party that would be responsible for continuing data collection.

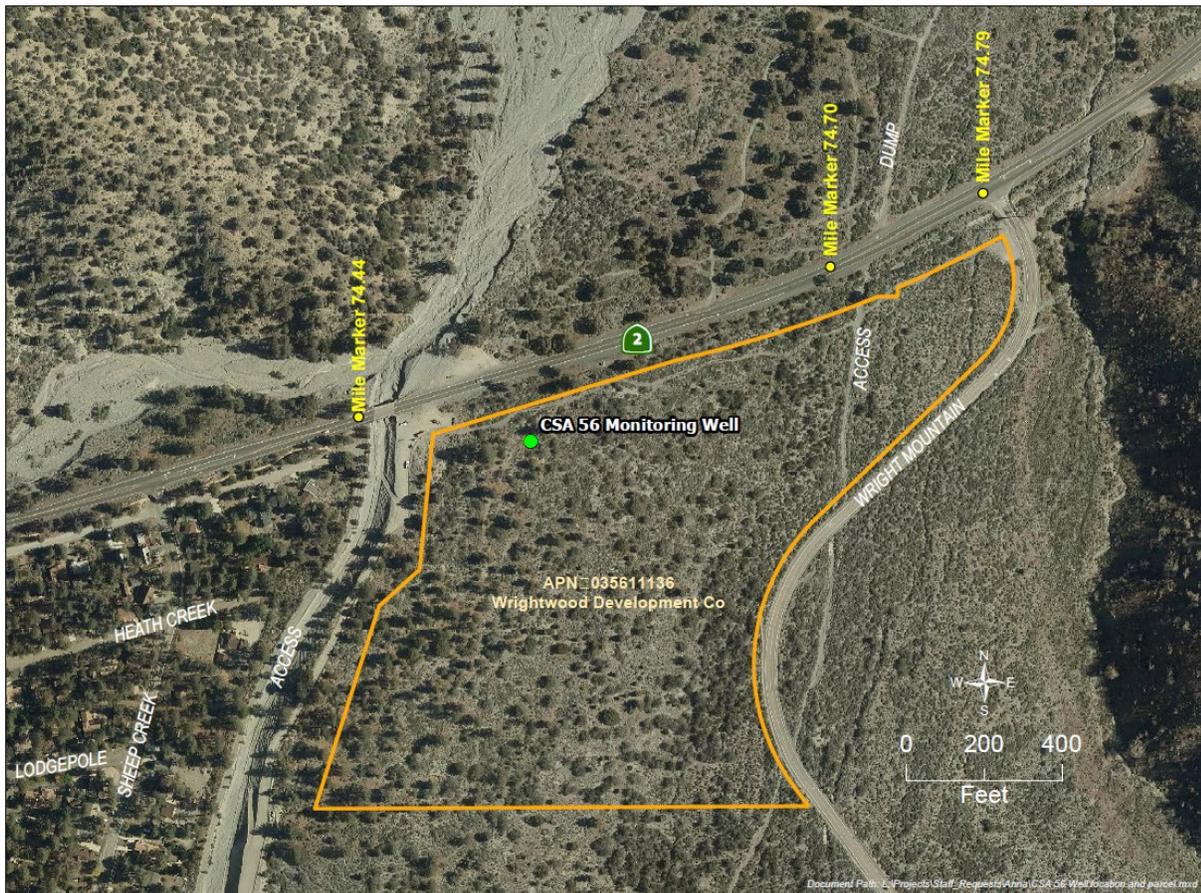
Additionally, while MWA located the original May 1982 Water Well Drillers Report showing the well construction information, they also determined that the well is located on private property. Mr. Zuber indicated that no well easement could be established (Figure 13.2).

Figure 13.2 - Location of former CSA 56 monitoring well located on property owned by the Wrightwood Development Company. The well is located east of Wrightwood near the intersection of Sheep Creek Wash, flowing south to north, and Swartout Creek, flowing west to east.
