**LAHONTAN REGIONAL WATER QUALITY CONTROL BOARD**

**NORTH TAHOE PUBLIC UTILITY  
DISTRICT AND CALTRANS**

**ORDER R6-2025-0020**

**SETTLEMENT AGREEMENT AND  
STIPULATION FOR ENTRY OF  
ADMINISTRATIVE CIVIL LIABILITY  
ORDER; FINAL ORDER**

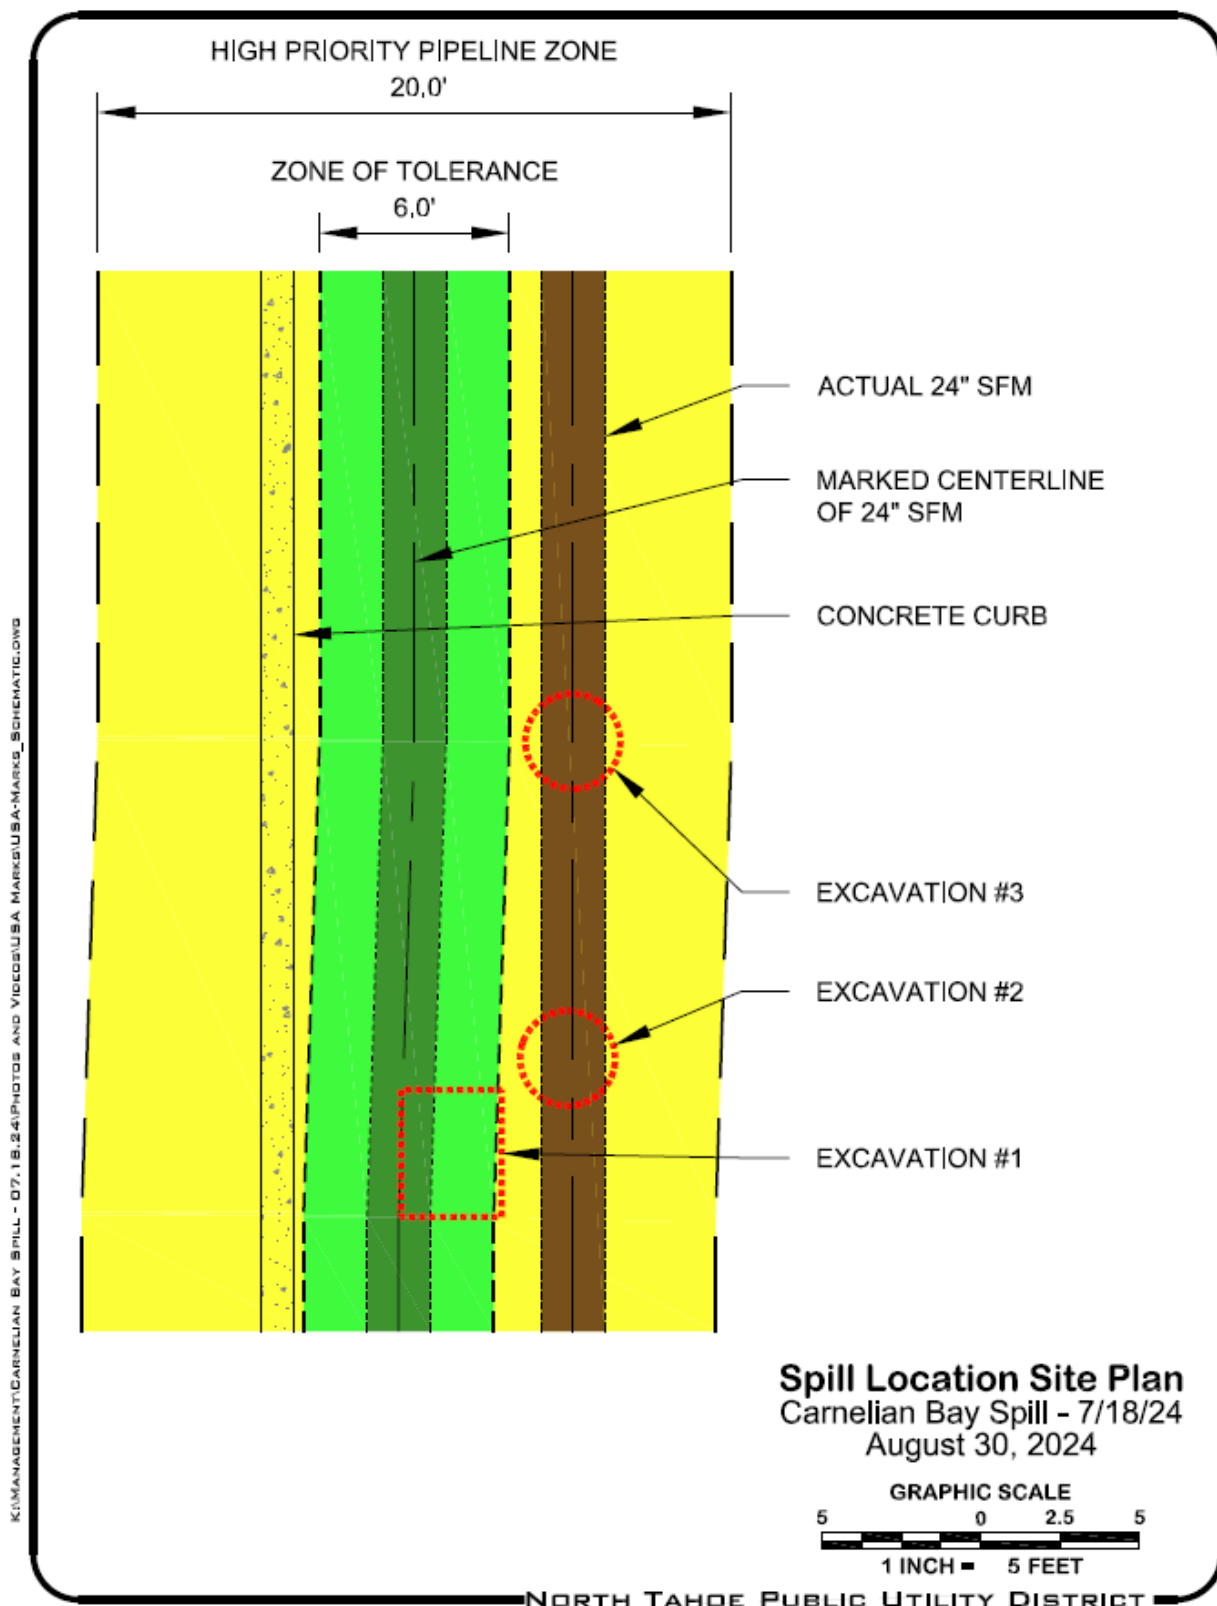
Spill Location Site Plan is uploaded in CIWQS as Attachment M - USA-Marks Schematic.

The District's marking in the field appears to be located over the gas line and not directly over the sewer forcemain, a variance of approximately 60-inches to 66-inches depending on location. The contractor performed three excavations the night of July 18, all three in the high priority pipeline zone and the first excavation was in the tolerance zone of the USA marks. The CalTrans special provisions for Contract 03-A3443 also included very detailed CIWQS Spill Id #895774

requirements for pre-excavation utility location and mapping that does not appear to have been conducted and which would have positively identified the location of the 24-inch forcemain prior to construction.

- Although NTPUD timely responded to the request to mark its facilities and although NTPUD employed industry standard methods to perform the marking, NTPUD's field markings provided an inaccurate representation of the actual location of the 24-inch sewer force main. The perimeter of the excavation at this specific location for the pole foundation was located outside the tolerance zone for the mismarked utility. Had the excavation limits been planned within the tolerance zone of the field marking for the 24-inch sewer force main (in this case, within 36-inches of the centerline marking per California Government Code 4216 (u)(2)), the excavator (Caltrans and/or its contractors) would have been required to determine the exact location of the utility by potholing prior to excavating and the force main strike may have been prevented.
