E2C Remediation 1020 Winding Creek Rd., Suite 110 Roseville, CA 95678	Project: Project Mgr.	Lake Tahoe-Laundry Works VP Well Vapor Samples PHIL GOALWIN	Report Date: Analysis Type:	10/7/2015 EPA Method TO-15
---	--------------------------	---	--------------------------------	--------------------------------------

L:\Projects\Lukins_South_Lake_Tahoe\ArcMaps\Fig1_Site_Location_v2.mxd User: 1/13/2016 Office

Figure 1
 Site Location

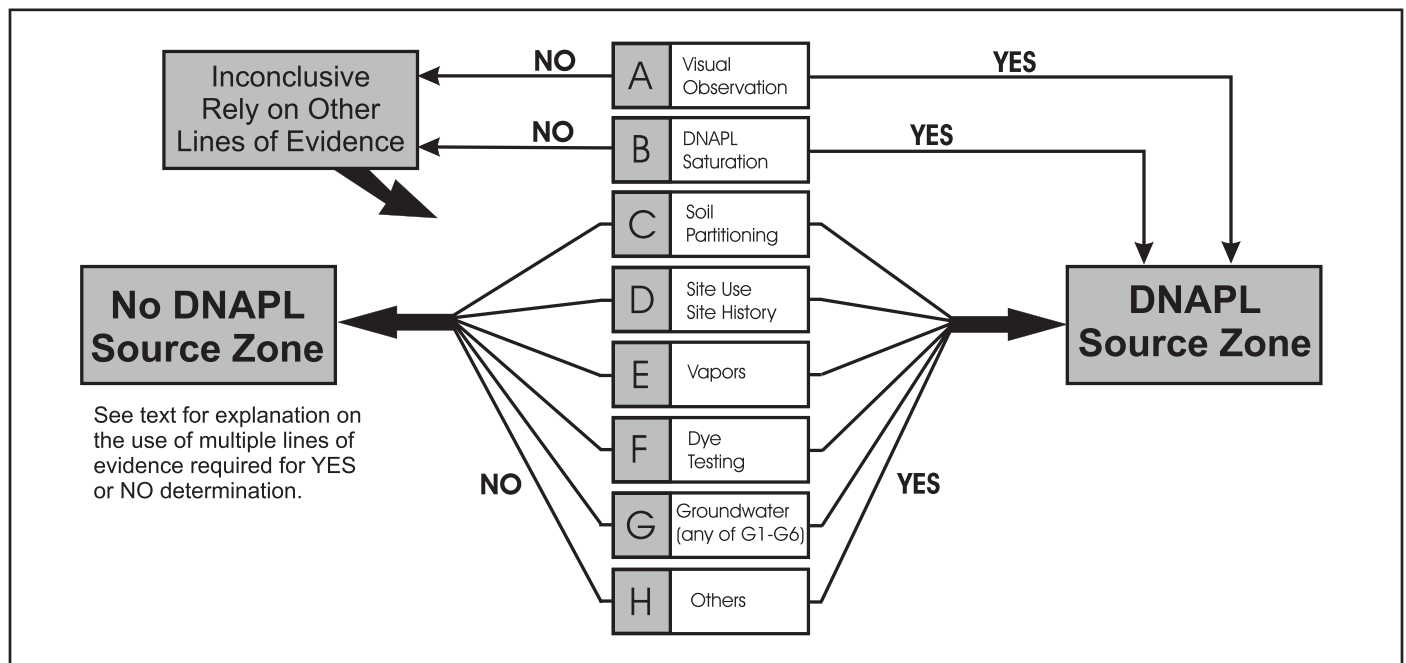
Figure 3 – Converging lines of evidence approach to assessing DNAPL presence. Methods B and C are not applicable to fractured rock.

Converging lines of evidence can be used to determine whether or not DNAPL is present in the subsurface. Figure 3 presents a graphical summary of the converging lines of evidence approach. Example calculation procedures are contained in Appendix A. All lines of evidence are discussed in Section 4, and are applicable to both unconsolidated deposits and fractured rock, unless noted otherwise. As indicated in Figure 3, either line of evidence A or B will lead to the conclusion that DNAPL is present. If A and B are both found to be negative, then the determination of whether DNAPL is present must be made on the basis of a weight of evidence approach, with multiple converging lines of evidence

combining to form either a positive or negative determination. Note that it is not likely that all of C through H will be satisfied at any one particular site, and that neither A nor B are necessary requirements to conclude that DNAPL is present. Most confirmed DNAPL source zones will have some of A through H determined to be negative. Because conditions vary from site to site, this document does not prescribe a specific number of lines of evidence that must be satisfied to arrive at either a positive or negative determination.
