CALIFORNIA REGIONAL WATER QUALITY CONTROL BOARD  
LAHONTAN REGION

**STIPULATED AGREEMENT**  
**WITH THE UNITED STATES FOREST SERVICE, LAKE TAHOE BASIN**  
**MANAGEMENT UNIT**  
**TO MAINTAIN TEMPORARY BEST MANAGEMENT PRACTICES (BMPS) TO**  
**INFILTRATE STORMWATER RUNOFF AT MEEKS BAY RESORT MARINA AND**  
**DEVELOP AND IMPLEMENT PLANS TO COMPLY WITH THE**  
***WATER QUALITY CONTROL PLAN FOR THE LAHONTAN REGION;***  
**MEEKS BAY MARINA,**  
**WDID NO. 6A090050000**  
**ORDER NO. R6T-2017-0013**  
El Dorado County

**NOTICE OF VIOLATION OF NPDES GENERAL PERMIT REQUIREMENTS FOR LAKE TAHOE MARINAS, NOTICE OF VIOLATION OF *THE WATER QUALITY CONTROL PLAN FOR THE LAHONTAN REGION*, AND REQUEST FOR WORKPLAN AND IMPLEMENTATION SCHEDULE - MEEKS BAY MARINA, EL DORADO COUNTY, WDID NO. 6A090050000**

**NOTICE OF VIOLATION OF NPDES GENERAL PERMIT, BOARD ORDER NO. R6T-2011-0024, REQUIREMENTS FOR LAKE TAHOE MARINAS AND VIOLATION OF THE WATER QUALITY CONTROL PLAN FOR THE LAHONTAN REGION - MEEKS BAY MARINA, EL DORADO COUNTY, WDID NO. 6A090050000**

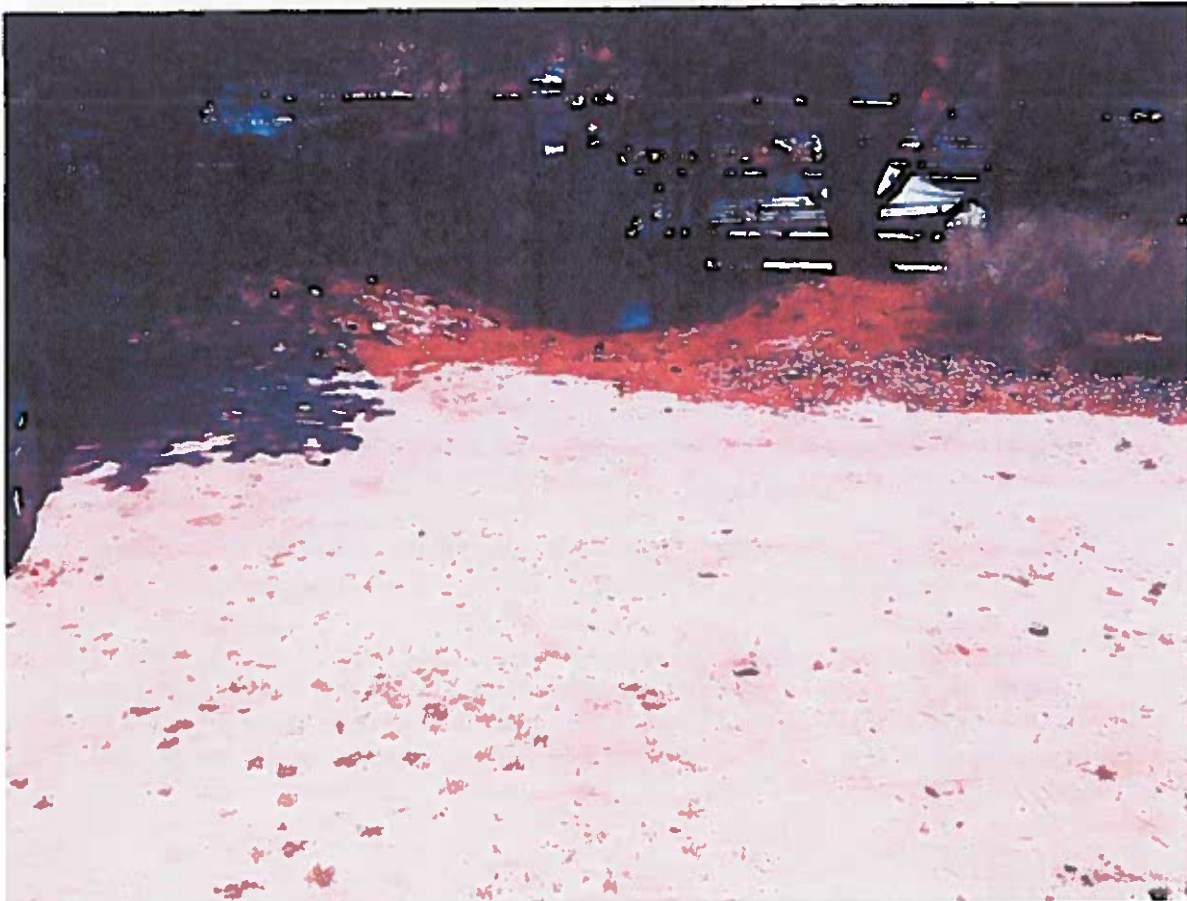
**Picture 1: The parking lot is composed of exposed loose dirt and a small amount of gravel on the edges. The depression in the photo is a gangway to the marina slips below. There is no berm protecting this area from concentrated flow down along the gangway causing erosion.**

**CONDITIONS IN VIOLATION:** Lack of appropriate BMPs to prevent sedimentation from the dirt parking lot into the marina surface waters.

**ACTION SUGGESTED:** Issue a Notice of Violation requiring a site improvement plan.

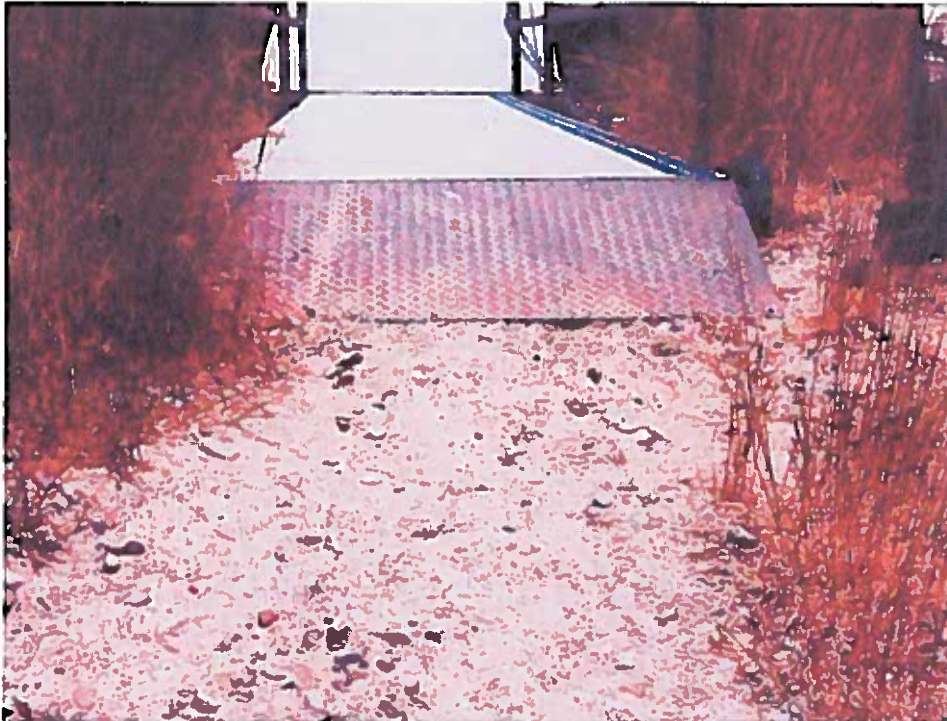
**Picture 2: The walkway is downward sloping from the parking lot to the gangways. Potential for rill or gully erosion into the marina surface waters is possible.**

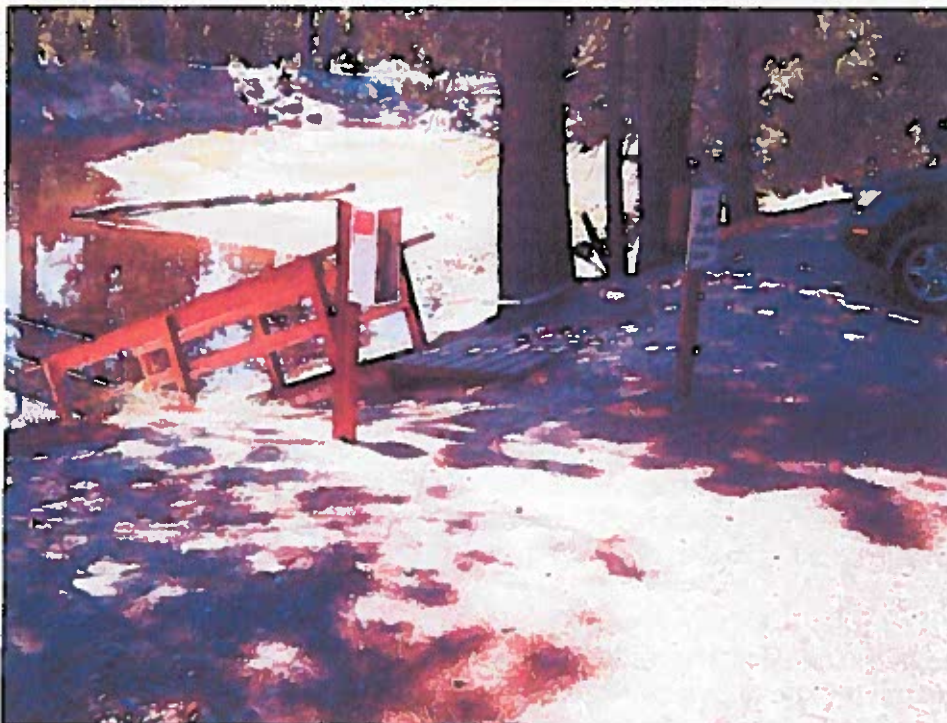
**Picture 3: Gangway number three is also in a low depression of the hillside. These are potential sediment sources as there are no BMPs installed.**

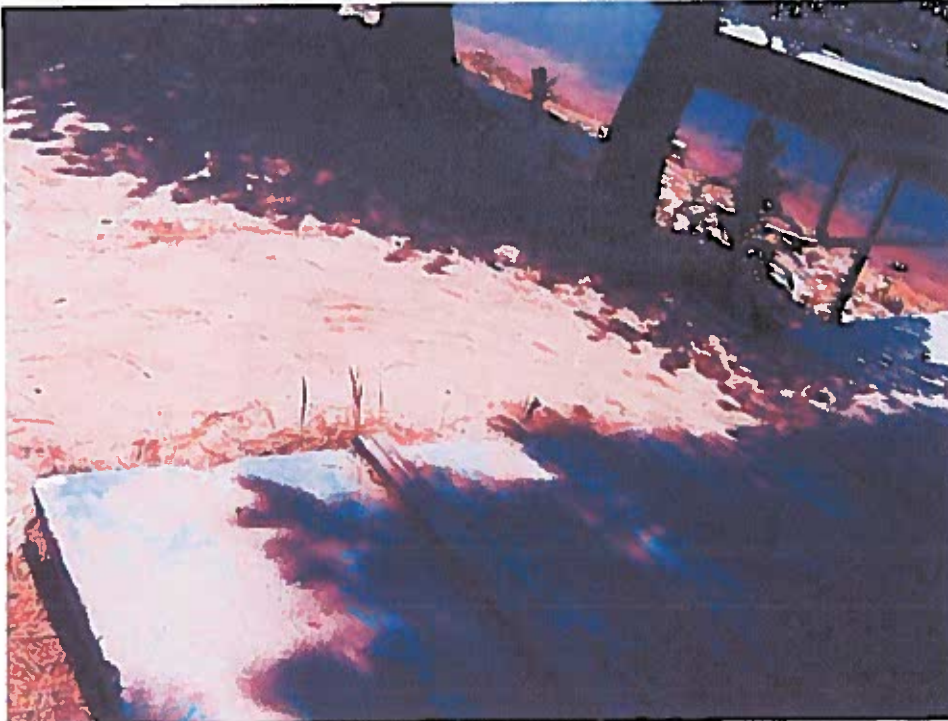
**Picture 4: This is gangway number 1, closest to the lake. Due to the topography of the parking lot, a low spot forms at the top and runs down during significant rain events.**

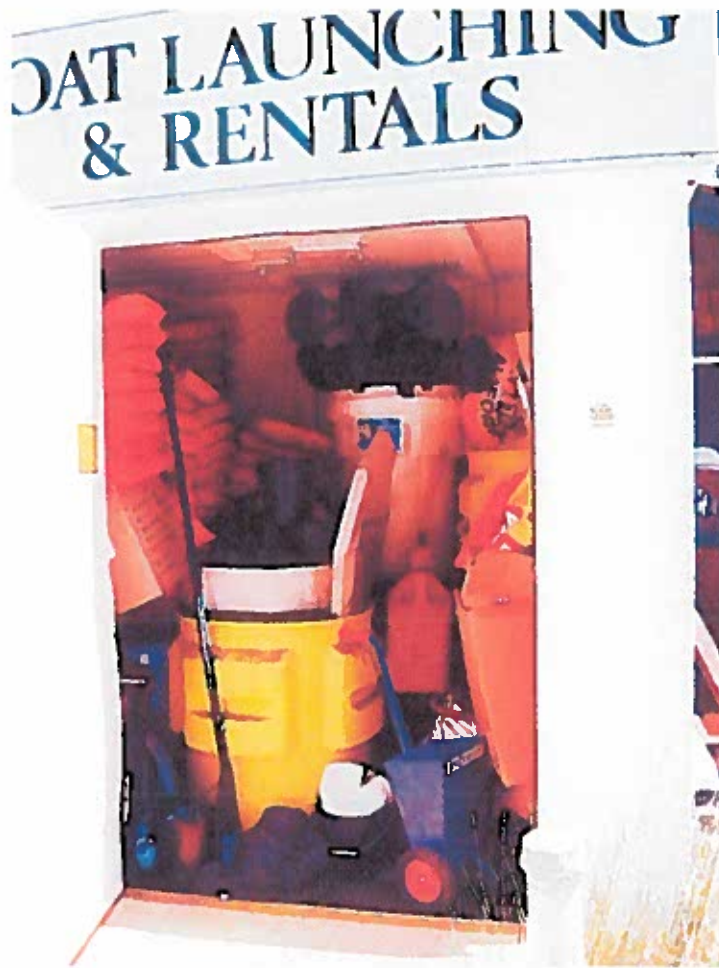
**Picture 5: The waste oil is contained in a second container. Oil rags are also double contained up in the right hand corner. The rest of the items are stored floatation devices, etc.**

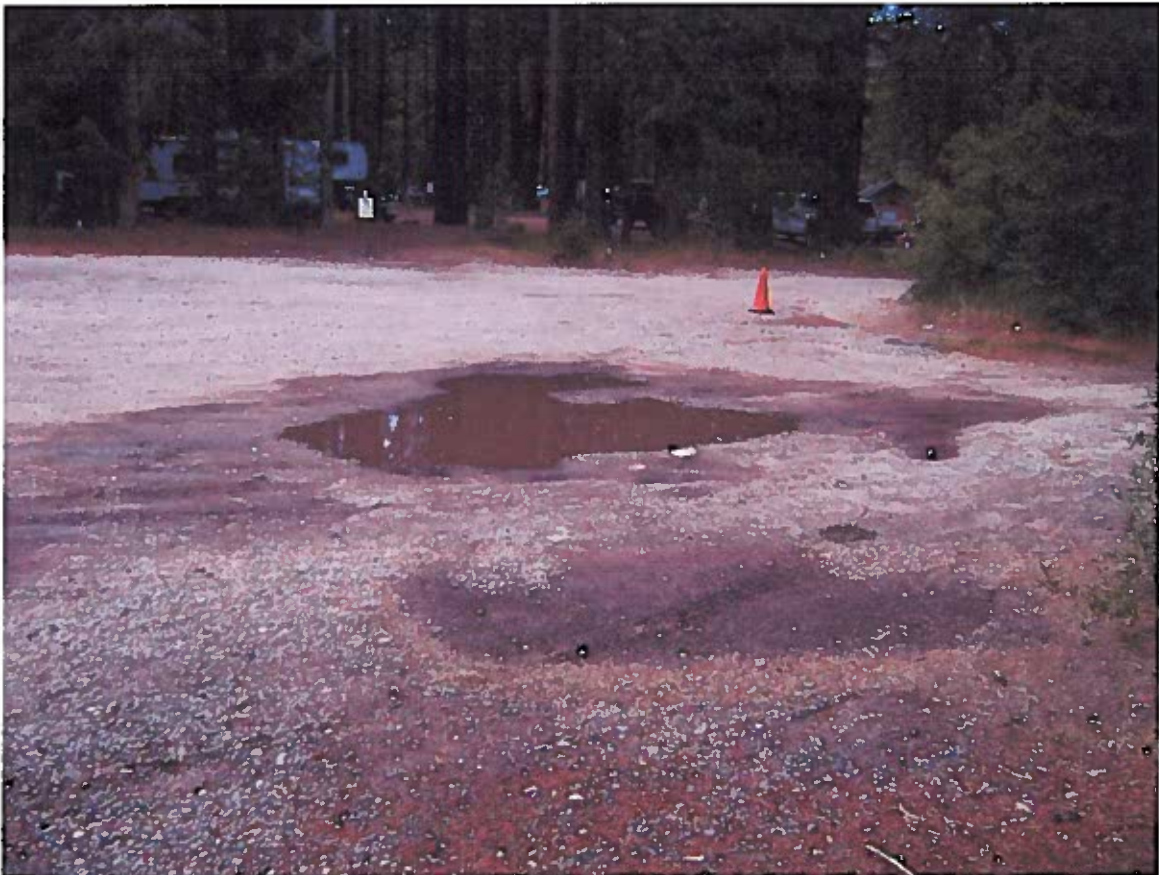
Photograph 02 - Facing West Toward Parking Area, Panning right of Photo 1, Standing Ponded Water in Lot From Recent Rains

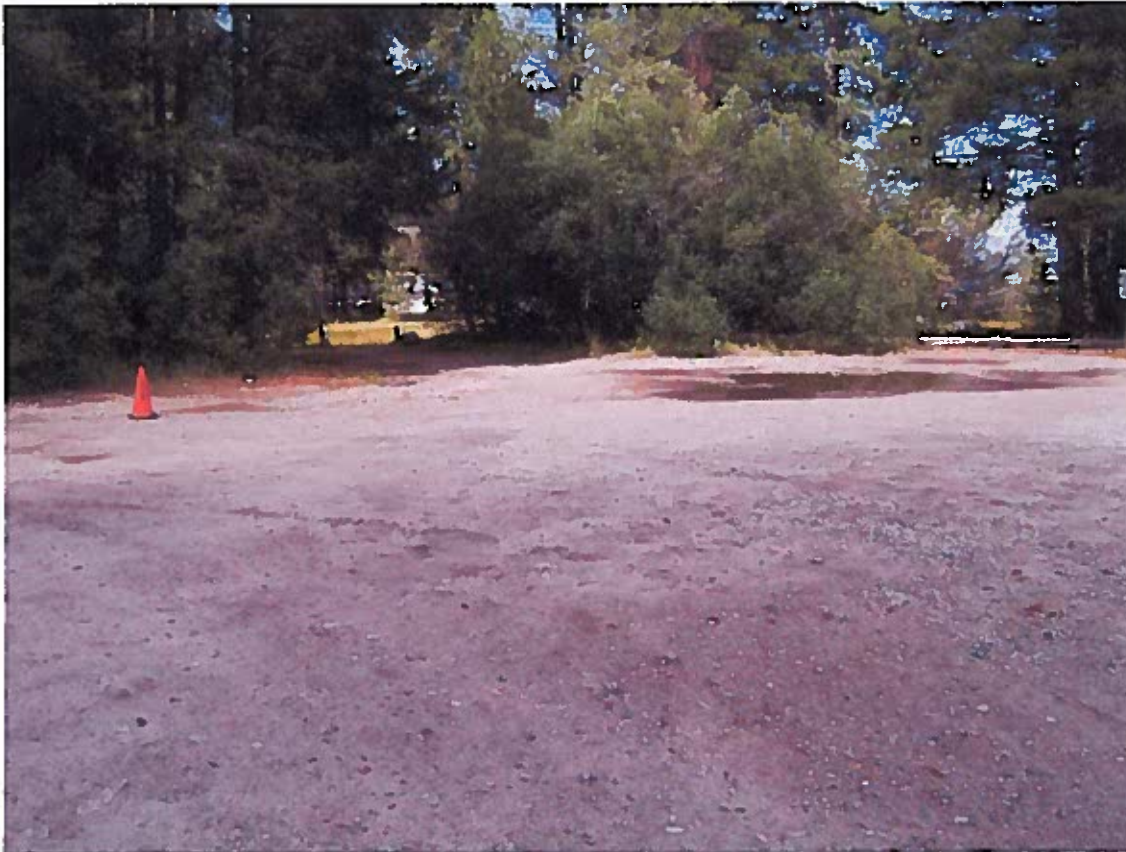
Photograph 03 - At Northeast area, Looking Northeast at Ponded Water In Parking Area. Per the SWPPP, the infiltration area should be located roughly where the willow stand in the center of the photograph is located. This Photograph was taken at the conclusion of the inspection at approximately 3:10 p.m.

1. The existing site gradient prevents stormwater runoff from flowing into the designated infiltration area near the boat ramp.
2. Fiber rolls are not installed in accordance with the SWPPP. Fiber roll ends are not turned up (J-Hooked), are not appropriately overlapped, and are not installed along a level contour.
3. Fiber rolls are not maintained in accordance with the SWPPP. Sections of fiber rolls are flattened or otherwise degraded, resulting in a loss of capacity/effectiveness. Sediments accumulating behind fiber roll sections need to be removed to maintain capacity.

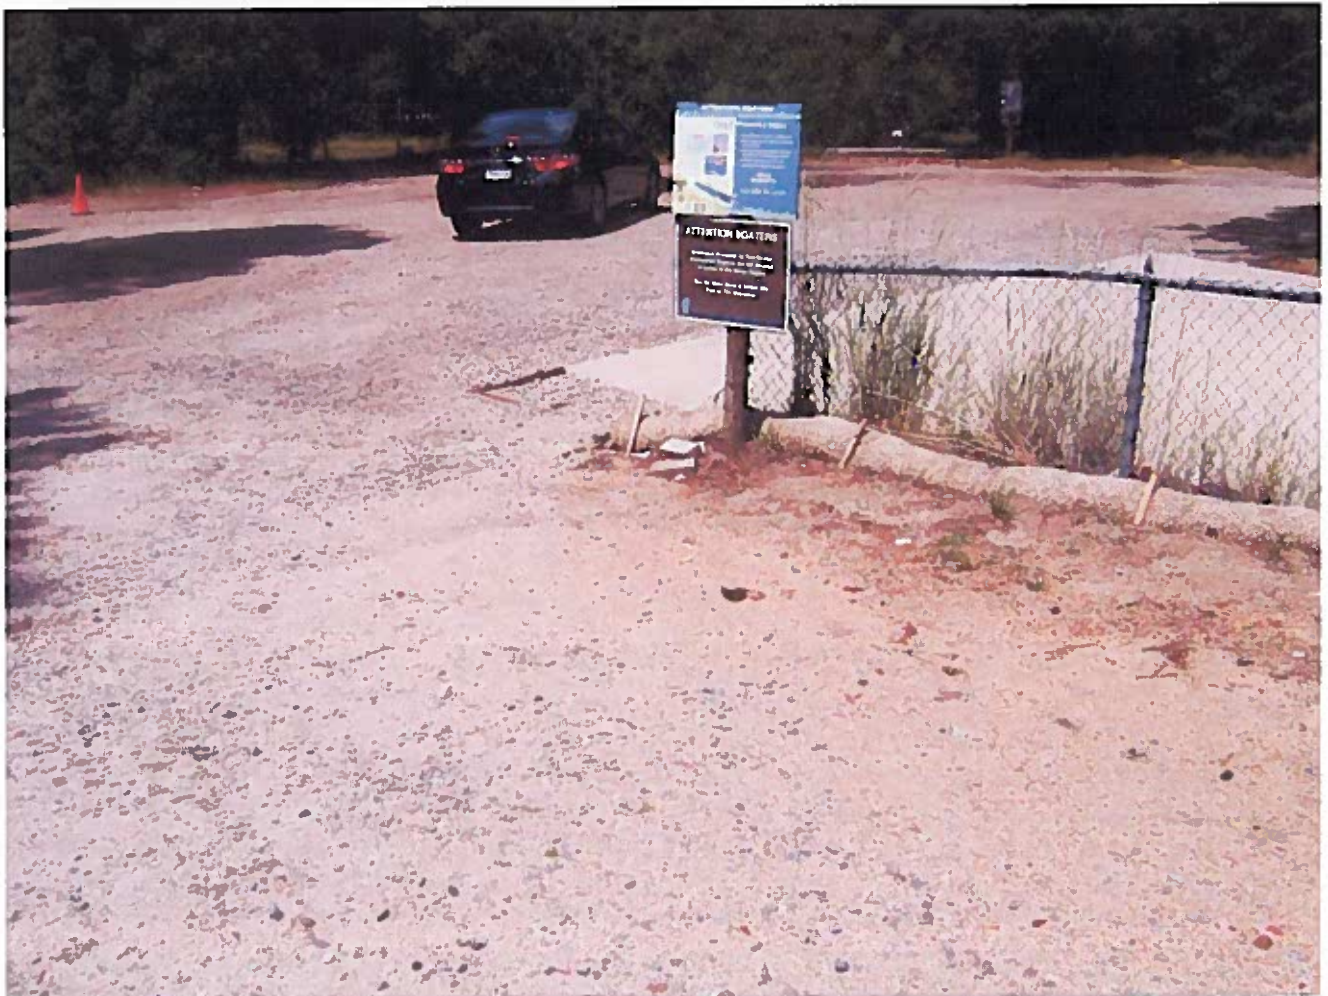
Photograph 04 - Looking East, Northeast at fiber roll. The fiber roll is not J-Hooked at its end which is also installed perpendicular to the grade lower than the rest of the fiber roll, and not parallel to the grade. Any runoff that flows toward the fiber will flow along it toward the downgradient end and, eventually, down the boat ramp and into the marina.

- Install and maintain fiber rolls to maintain a minimum height of four inches of fiber roll above grade (see entrenchment detail).
- Remove accumulated sediment behind the fiber roll when sediment accumulation reaches one-half the designated sediment storage depth, usually one half the distance between the top of the fiber roll and the adjacent ground surface.

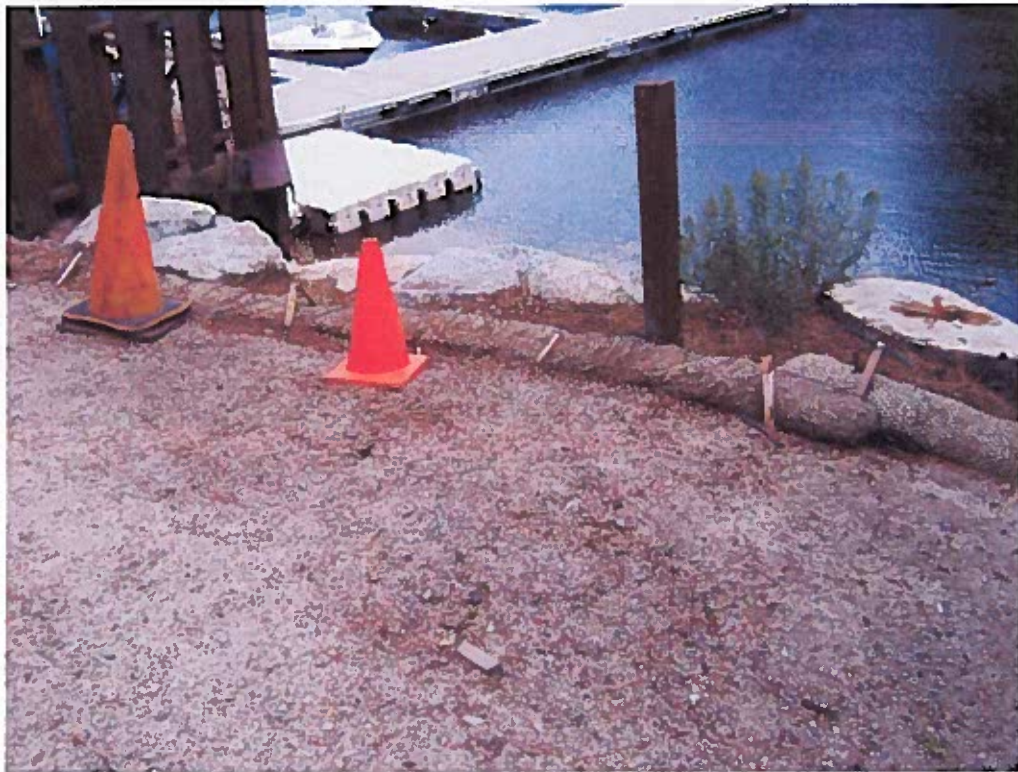
**Photograph 06 - BMP joint is not J-hooked, and the fiber roll section by the pilings has been flattened. This area is by marina office, facing southeast**

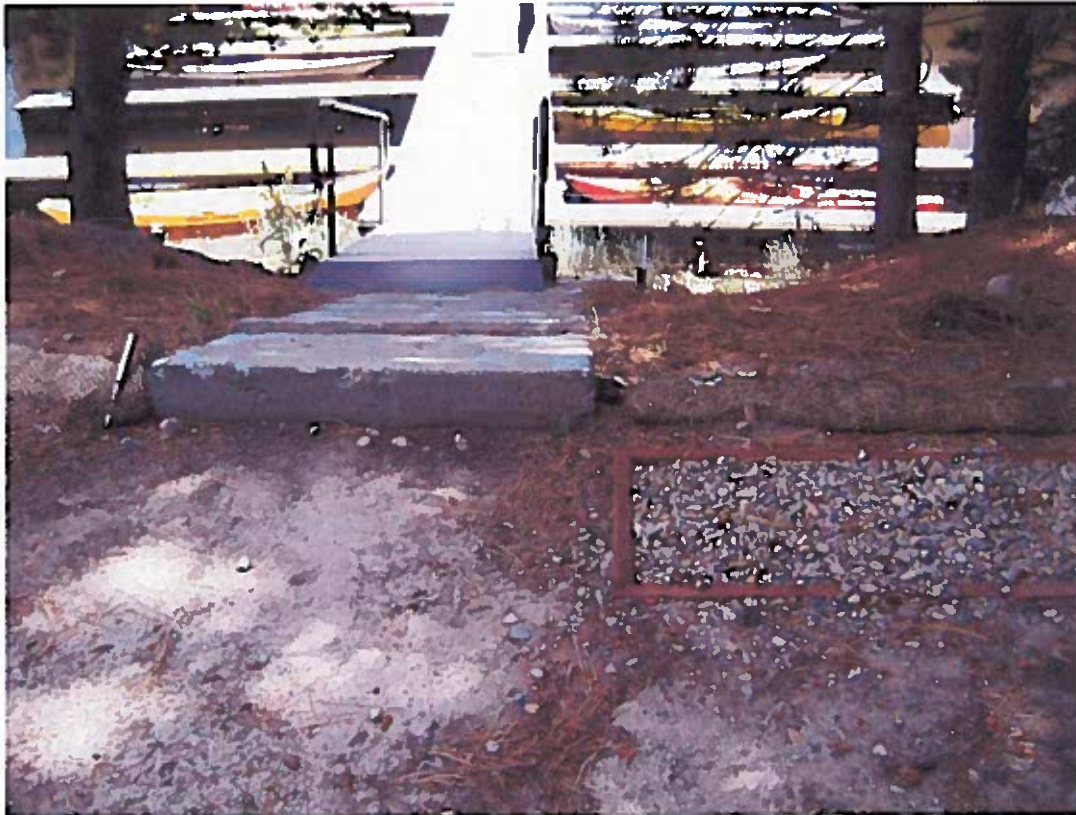
**Photograph 07 - First ramp west of office, facing south. A gap exists between the concrete section of the ramp walkway and the fiber roll to the right (west) of the ramp. Runoff that bypasses the drainage ditch will flow through this area and into the marina.**

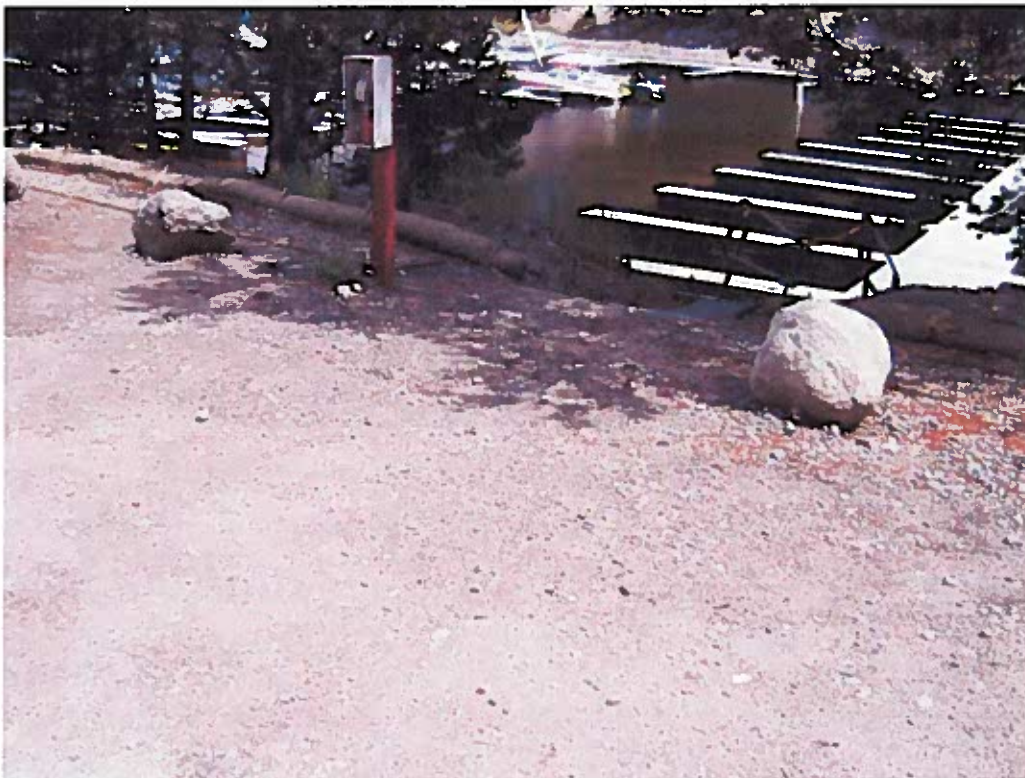
**Photograph 08 - Second ramp west of office, facing southeast. Fiber rolls do not prevent runoff from going down ramp and into marina.**

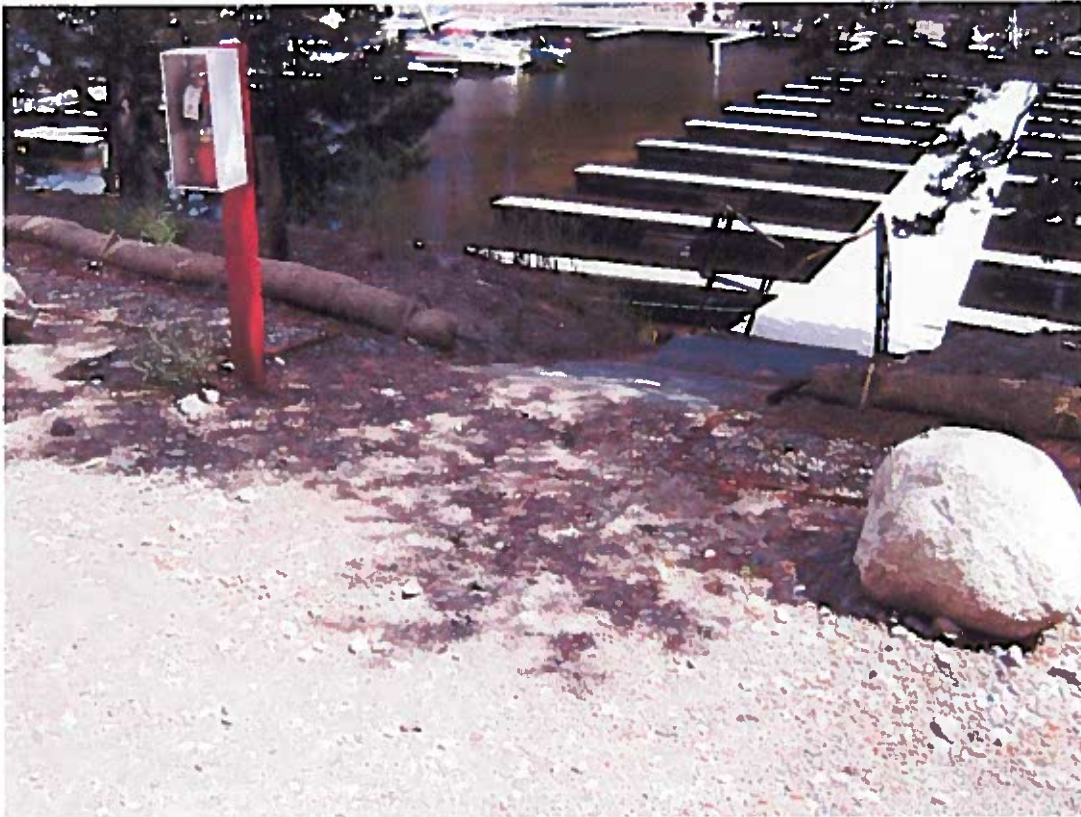
Photograph 09 – Close up of Photograph No. 08. Note that ends of fiber rolls are not J-Hooked.

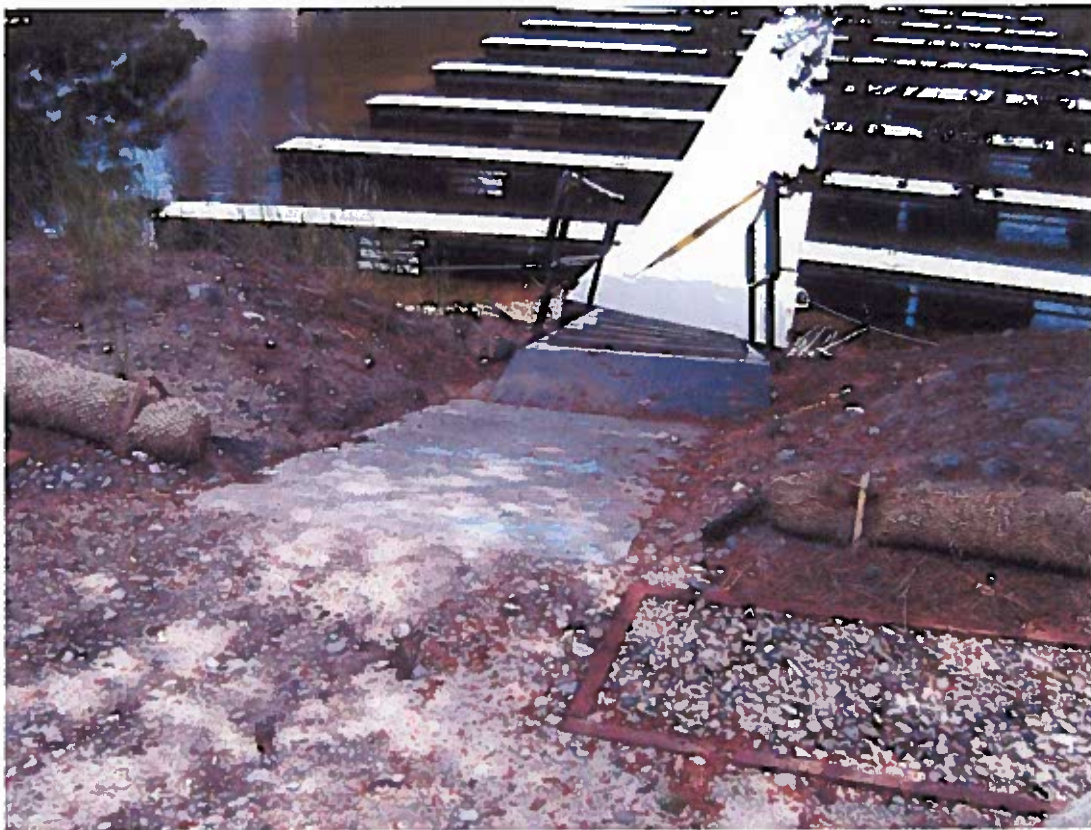
Photograph 10 – Moving closer to the ramp to get a further close-up of Photograph No. 08. Note that the fiber rolls do not prevent runoff from going down ramp and into marina

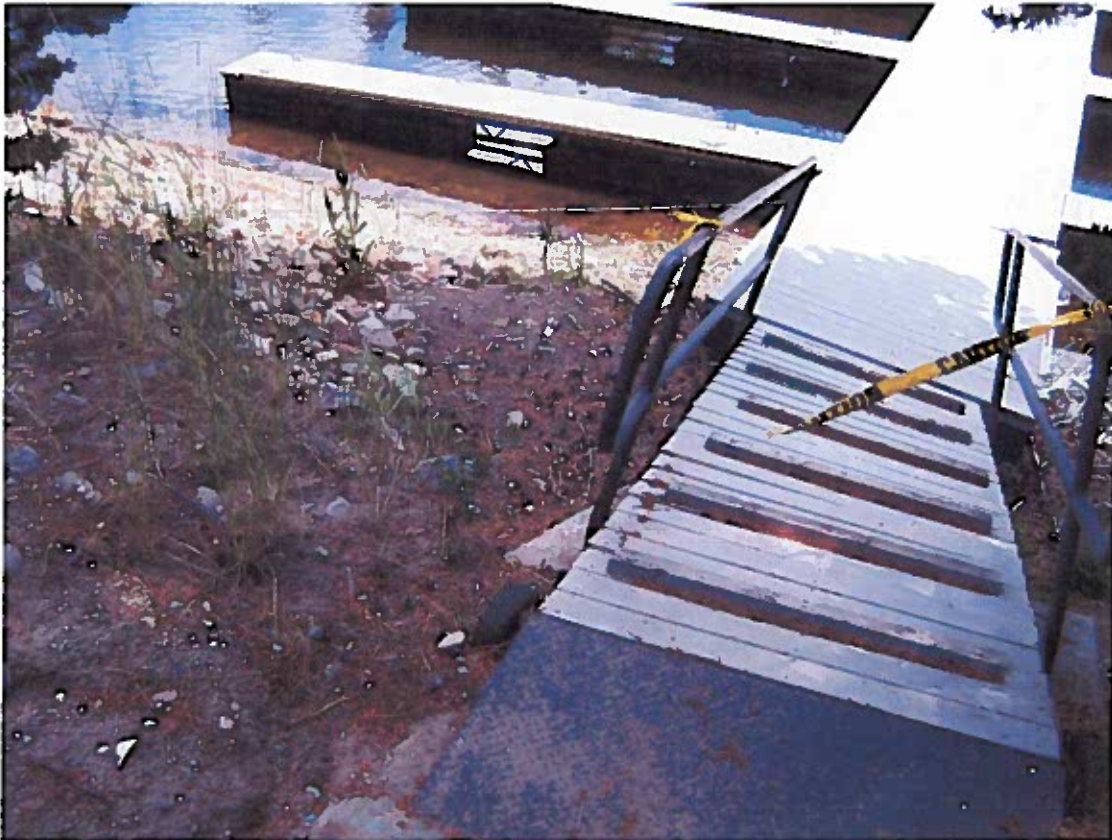
Photo 12 - Moving closer to the second ramp west of office to get a further close up within the marina area. Note that the fiber rolls were unable to prevent runoff from going down ramp and into marina, as evidenced by a sediment deposit in marina located on left (east) side of ramp.

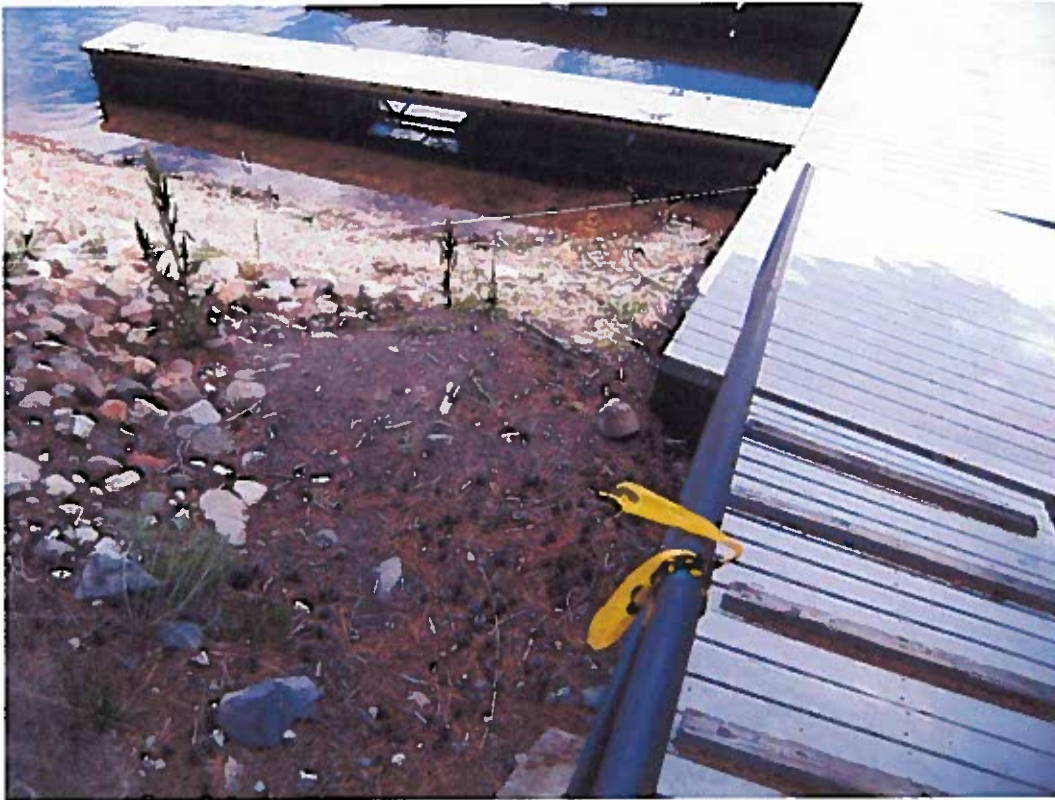
Photograph 13 – Close up of sediment deposit noted in Photograph No. 12.

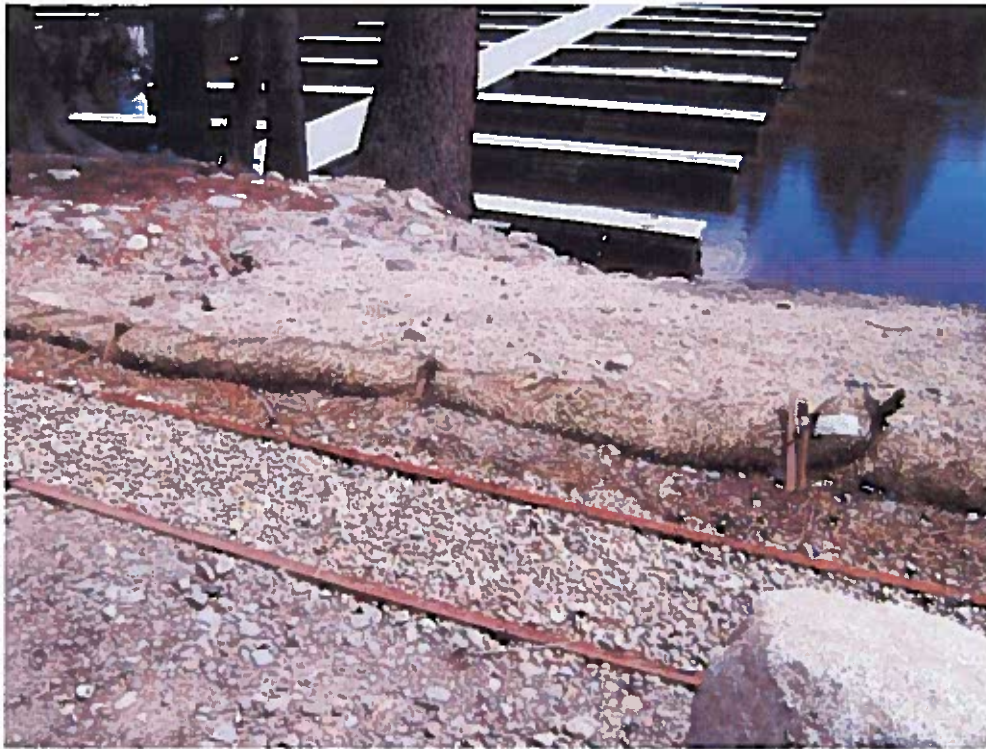
**Photograph 15 - About 20 feet west of 2nd ramp west from office, looking south-southeast. The fiber roll has been degraded degraded and flattened.**

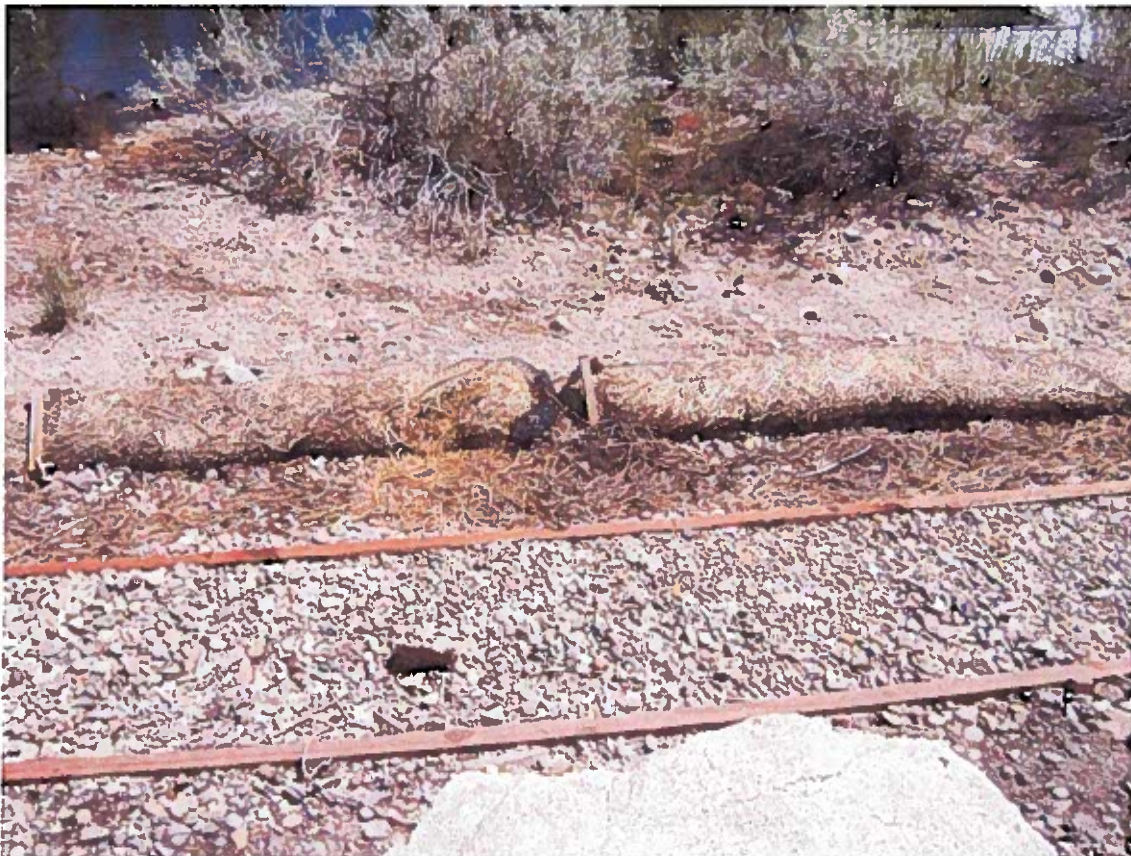
**Photograph 16 - Mid-way between 2nd and 3rd ramps west from the office. The fiber rolls have been slightly flattened, and the ends have not been overlapped leaving a gap between the rolls where stormwater runoff can become concentrated.**

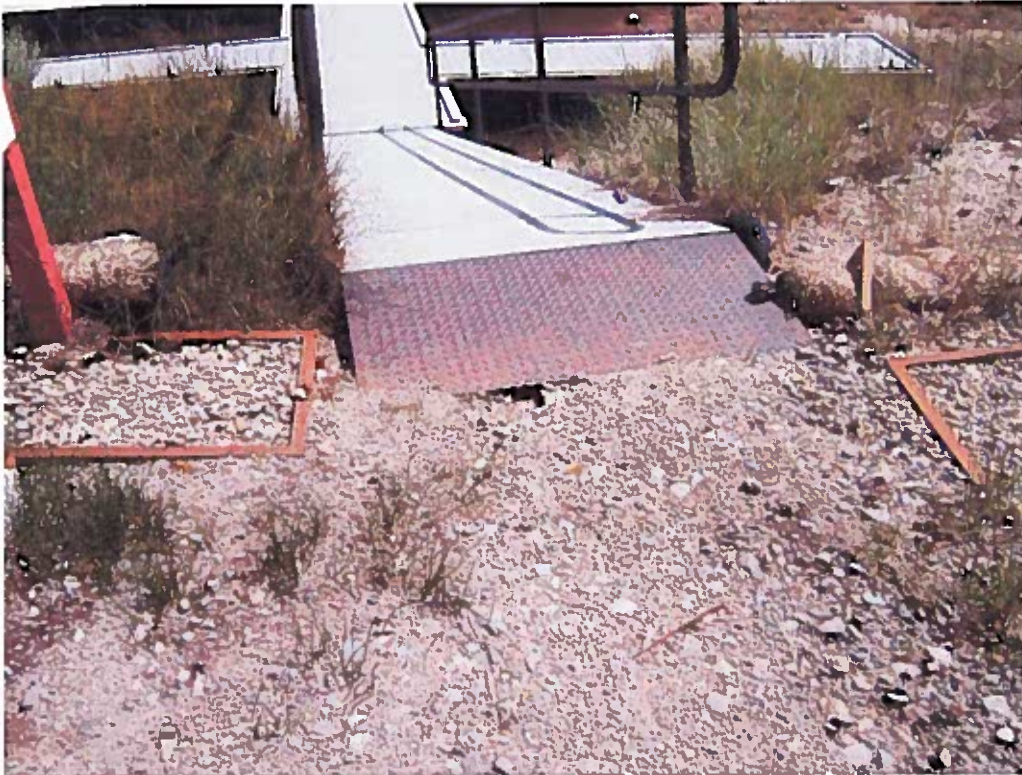
**Photograph 17 - 3rd ramp west from office, facing south. A rill has formed beneath the metal plate, creating a threatened discharge of sediments into the marina. No fiber rolls or other BMP exists to prevent runoff from flowing down this area and causing bank erosion.**

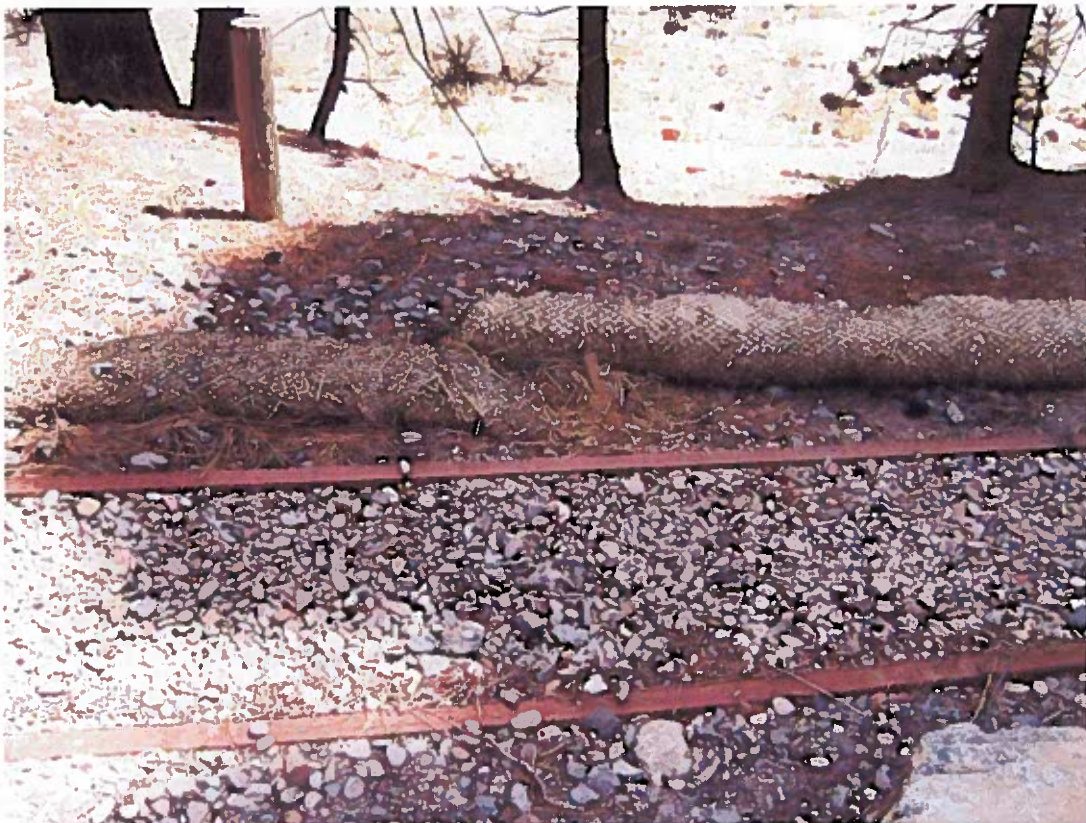
**Photograph 18 - Midway between 3rd and 4th ramps west of office. The ends of the fiber rolls are degrading, and they are barely overlapped.**

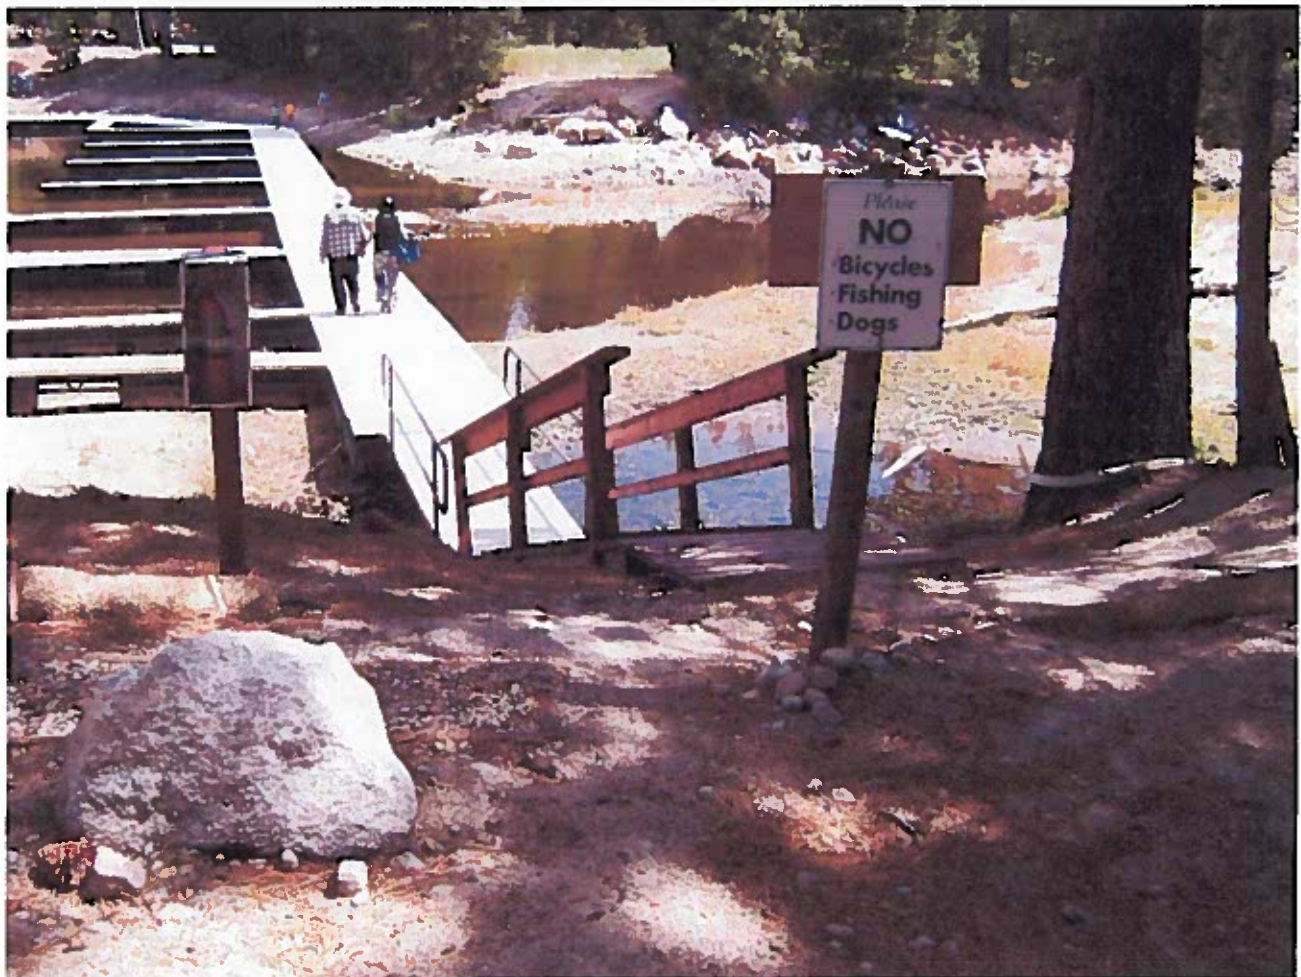
Photograph 20 - At 4th walkway ramp west of office. Fiber rolls to left of walkway and above walkway are not J-hooked at their ends. Fiber roll on right and above walkway is inundated with sediment, and evidence of sediment discharge into the marina is apparent.

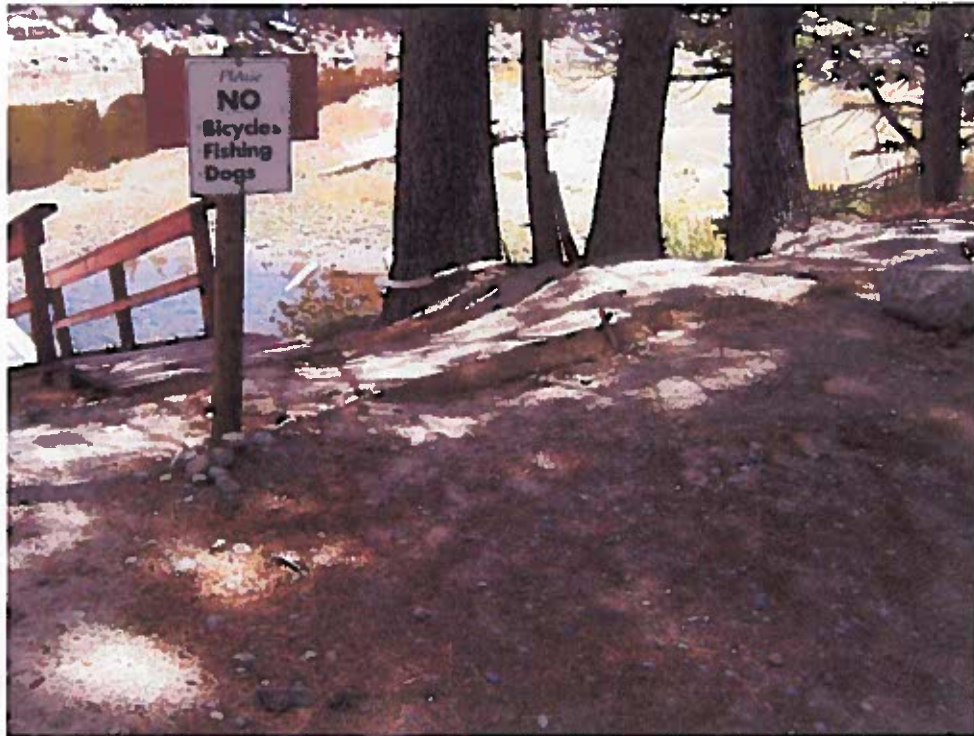
Photograph 21 – Close up of the sediment-inundated fiber roll shown in Photograph No. 20.

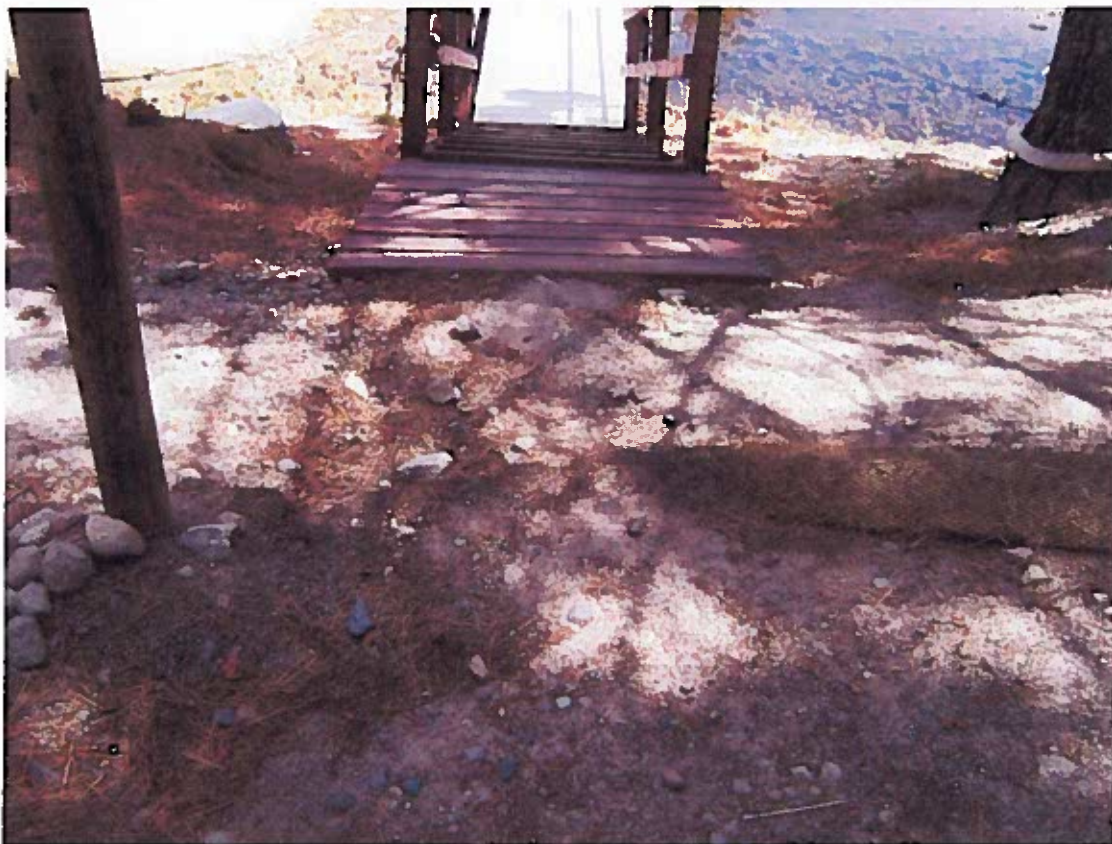
Photograph 22 - Close up of the sediment-inundated fiber roll shown in Photograph No. 20, also showing sediment deposits down along the embankment and into Lake Tahoe.

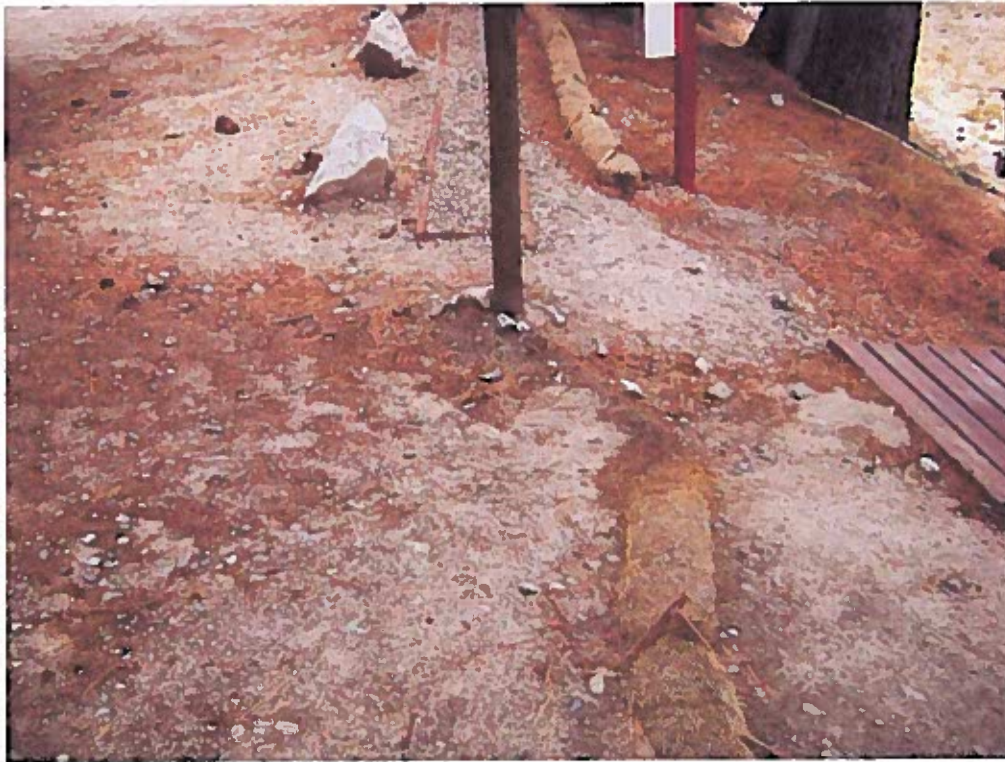
Photograph 23 - Close up of the sediment-inundated fiber roll shown in Photograph No. 20, facing east. The fiber roll end in the foreground was slightly J-Hooked to capture runoff and sediment, while the end of the fiber roll at the top of the photograph is not J-Hooked and allows runoff to flow down the embankment. Photograph taken by Will Chen.

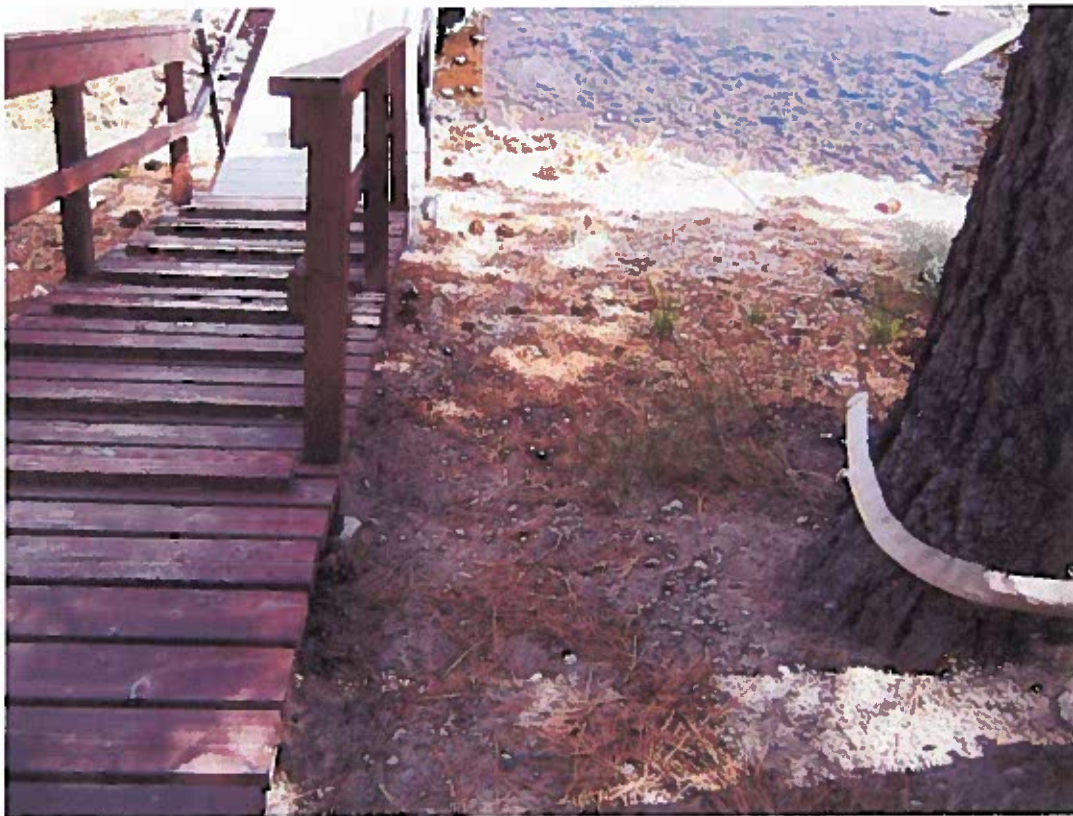
Photograph 24 – Close-up of the west side of the 4<sup>th</sup> walkway shown in Photograph No. 20. Evidence of erosion can be observed.
