CALIFORNIA REGIONAL WATER QUALITY CONTROL BOARD  
LAHONTAN REGION

**STIPULATED AGREEMENT**  
**WITH THE UNITED STATES FOREST SERVICE, LAKE TAHOE BASIN**  
**MANAGEMENT UNIT**  
**TO MAINTAIN TEMPORARY BEST MANAGEMENT PRACTICES (BMPS) TO**  
**INFILTRATE STORMWATER RUNOFF AT MEEKS BAY RESORT MARINA AND**  
**DEVELOP AND IMPLEMENT PLANS TO COMPLY WITH THE**  
***WATER QUALITY CONTROL PLAN FOR THE LAHONTAN REGION;***  
**MEEKS BAY MARINA,**  
**WDID NO. 6A090050000**  
**ORDER NO. R6T-2017-0013**  
El Dorado County

**NOTICE OF VIOLATION OF NPDES GENERAL PERMIT REQUIREMENTS FOR LAKE TAHOE MARINAS, NOTICE OF VIOLATION OF *THE WATER QUALITY CONTROL PLAN FOR THE LAHONTAN REGION*, AND REQUEST FOR WORKPLAN AND IMPLEMENTATION SCHEDULE - MEEKS BAY MARINA, EL DORADO COUNTY, WDID NO. 6A090050000**

**NOTICE OF VIOLATION OF NPDES GENERAL PERMIT, BOARD ORDER NO. R6T-2011-0024, REQUIREMENTS FOR LAKE TAHOE MARINAS AND VIOLATION OF THE WATER QUALITY CONTROL PLAN FOR THE LAHONTAN REGION - MEEKS BAY MARINA, EL DORADO COUNTY, WDID NO. 6A090050000**

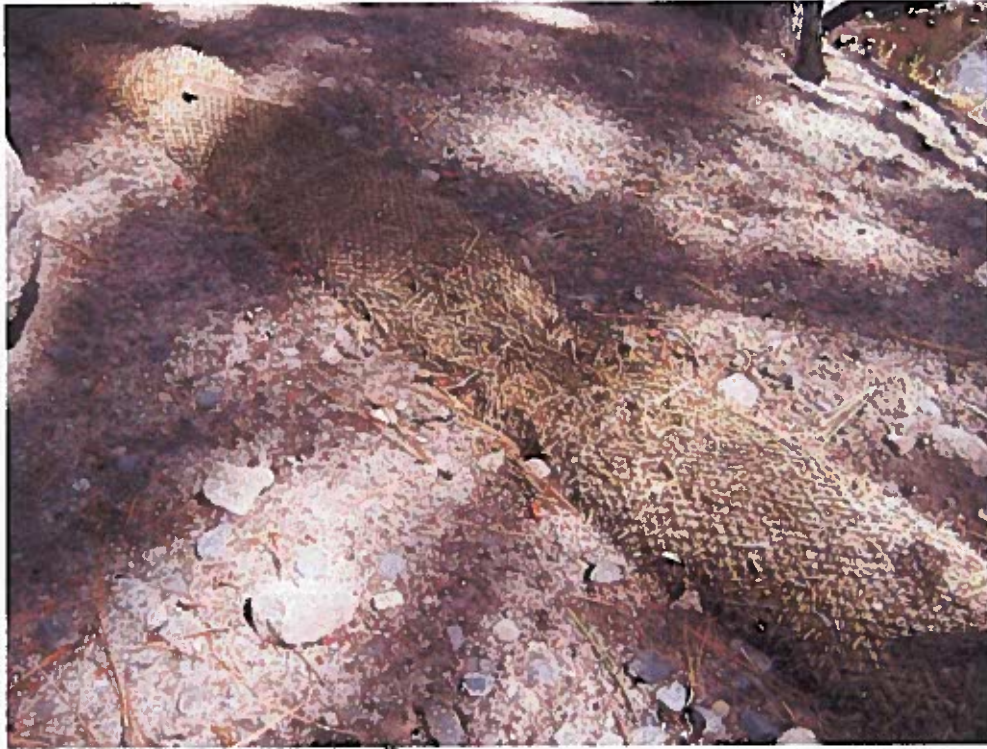
**Photograph 25 - 10 feet west of the 4<sup>th</sup> walkway west of the office. The fiber roll has degraded.**

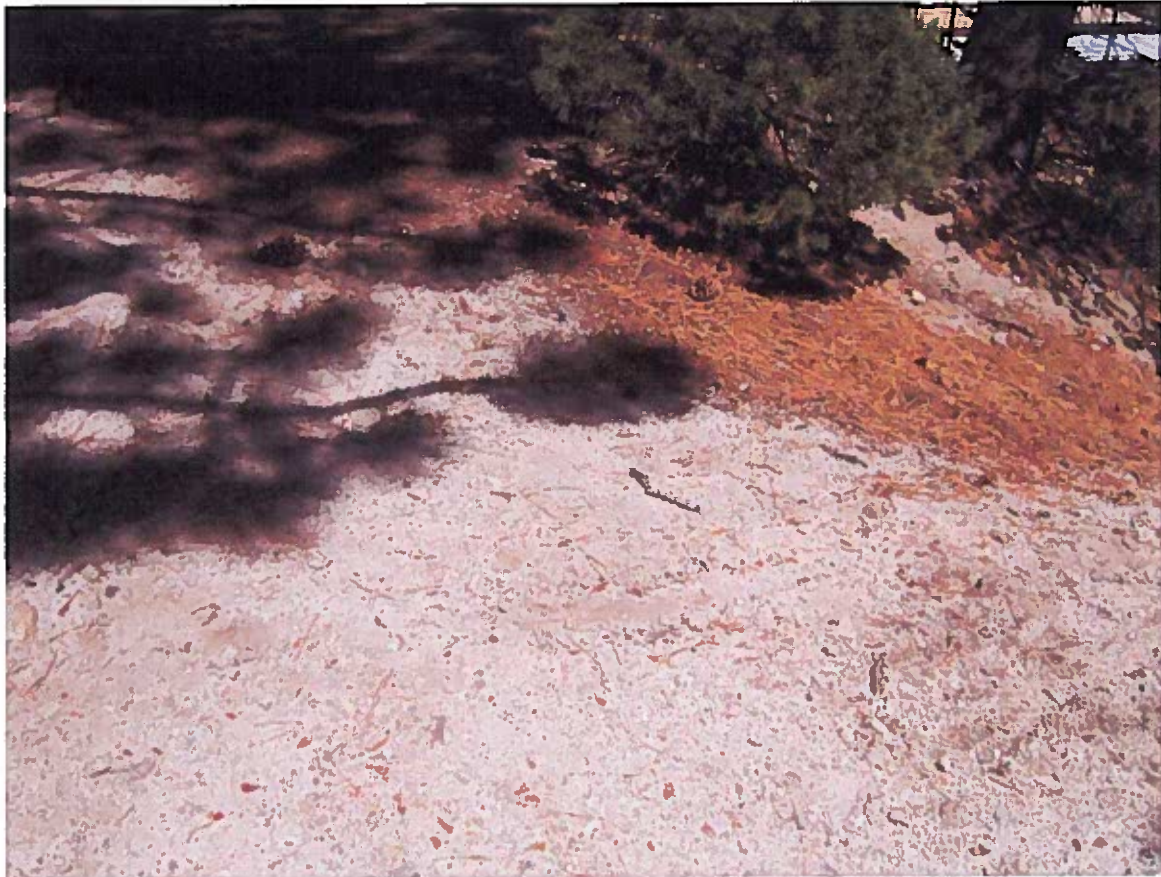
**Photograph 26 - 20 feet west of 4th walkway ramp from office, facing east. No fiber roll has been installed, and a small gully erosion can be observed.**

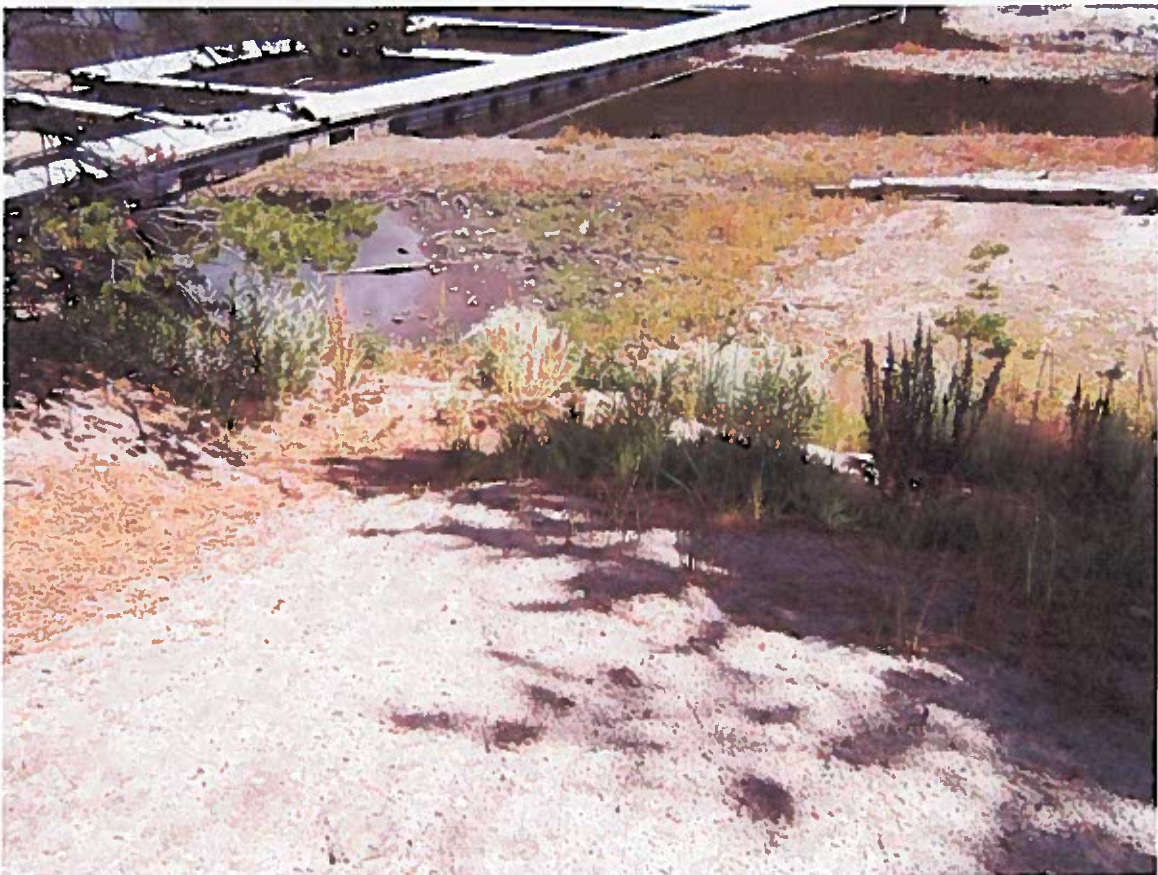
Photograph 27 – Same photo point as Photograph No. 26, panning toward the southeast.

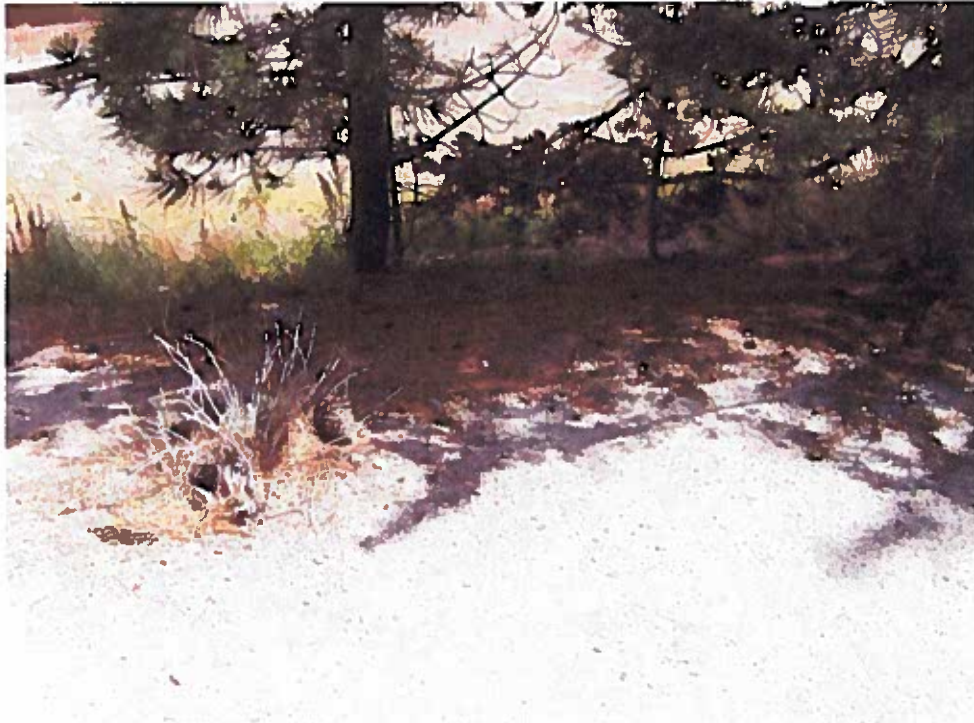
**Photograph 29 - Standing at photo point 28, looking southwest. Fiber rolls have not been placed to collect potential stormwater runoff from the unpaved parking area.**

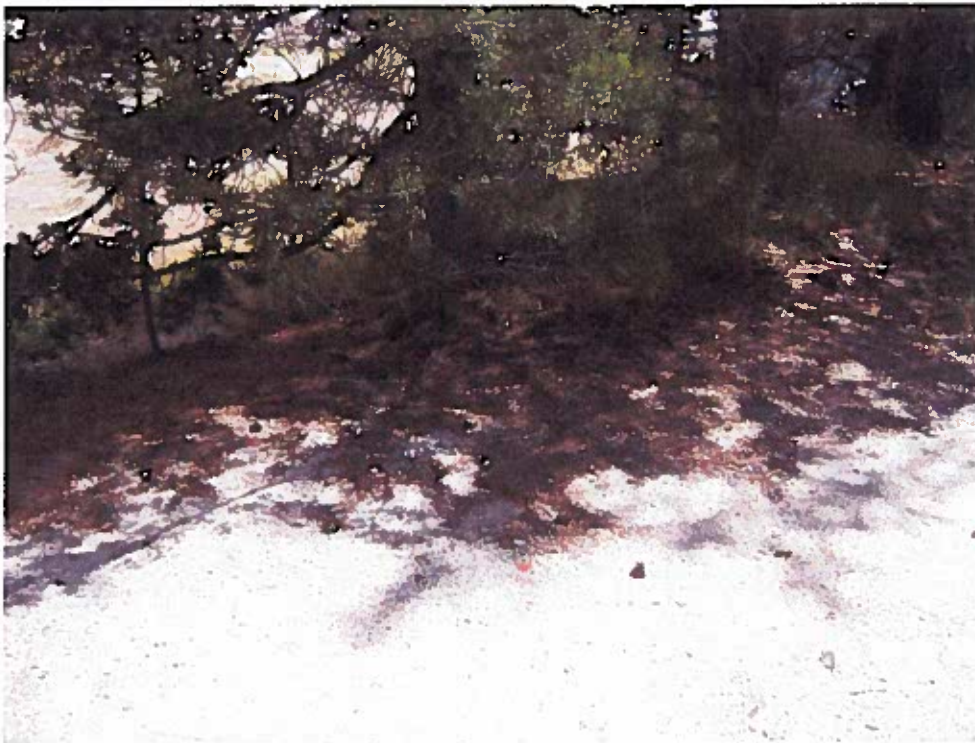
**Photograph 30 - Standing at photo point 28, panning west from photo point 29, looking southwest-west. Fiber rolls have not been placed to collect potential stormwater runoff from the unpaved parking area.**

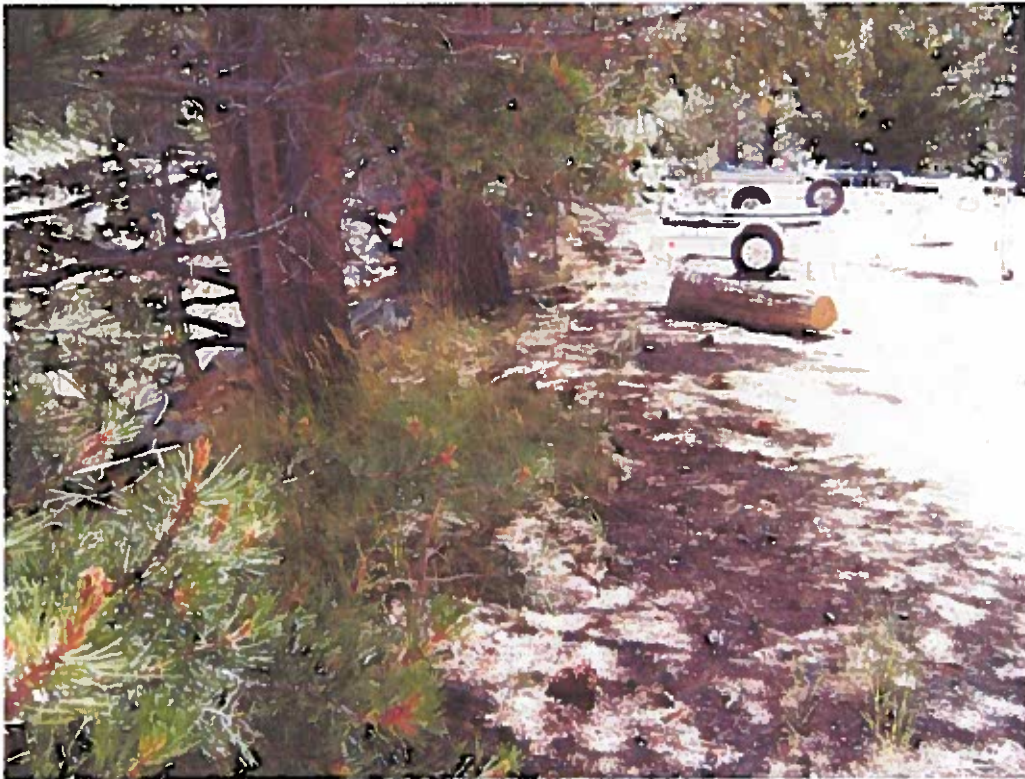
**Photograph 31 - Standing at photo point 28, panning west from photo point 30, looking west to boat trailer parking area. Fiber rolls have not been placed to collect potential stormwater runoff from the unpaved parking area.**

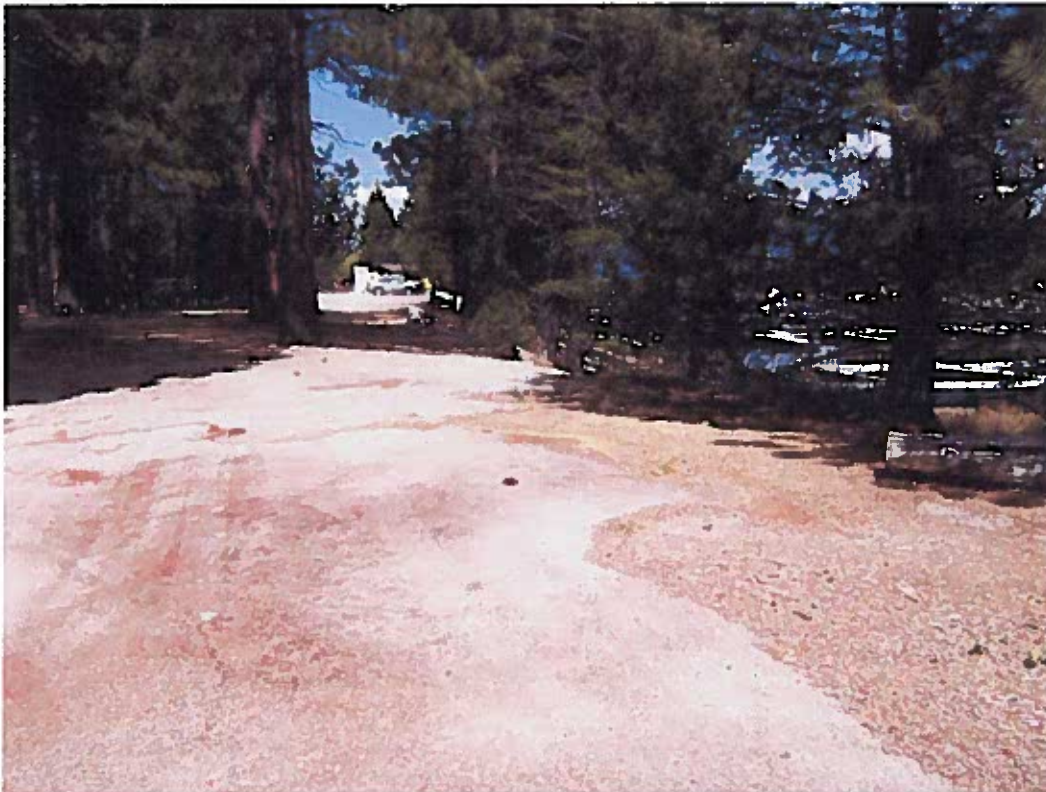
**Photograph 32 - At west end of the marina boundary in the boat trailer parking area looking east. Fiber rolls were not installed at trailer parking area. Note the evidence of ponded water in the middle of the photograph, indicating fiber rolls may not be necessary in this area.**

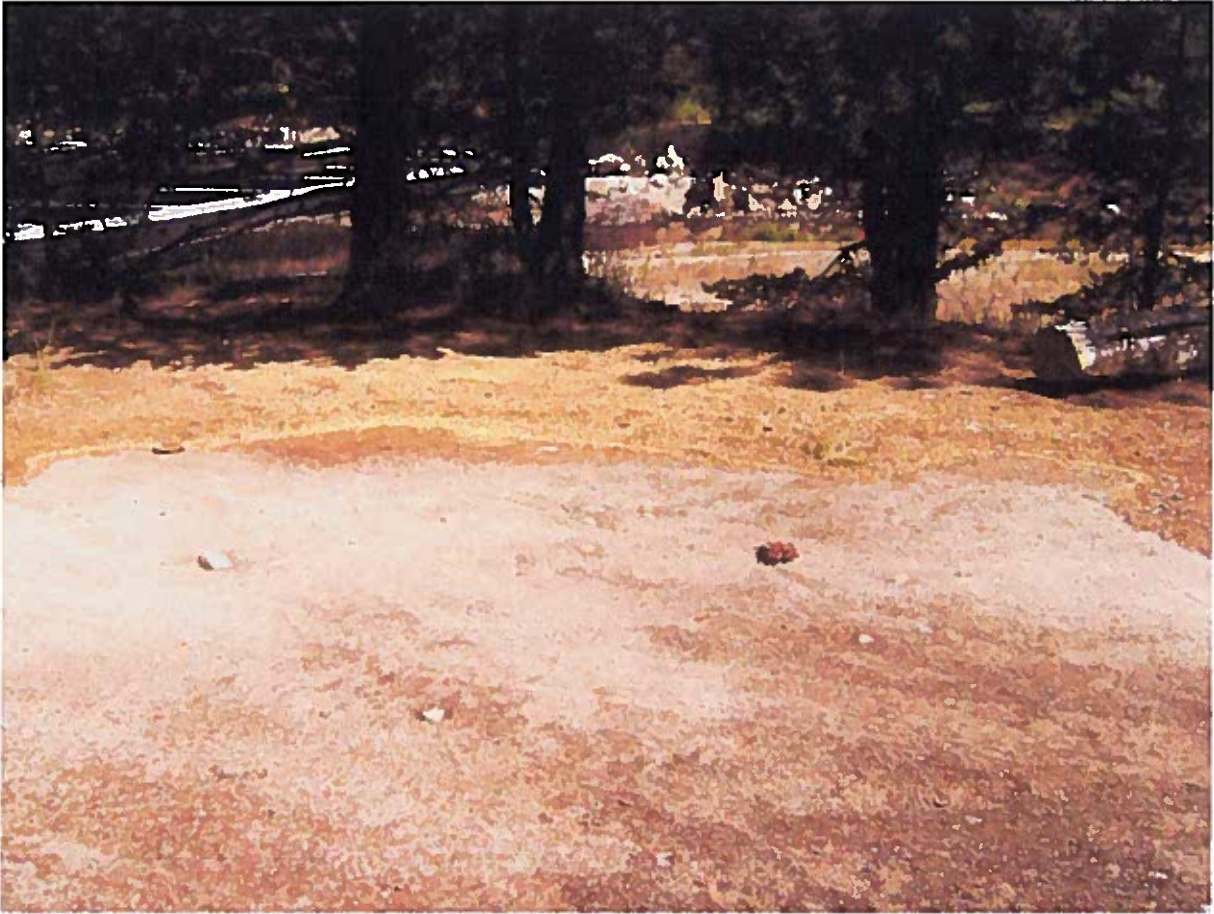
Photograph No. 33 – Close-up of storm water ponding line noted in Photograph No. 32. While there isn't evidence that stormwater runoff discharged over the bank in this area, it is likely that storm water flowed eastward toward the discharge point noted in Photographs No. 26-28.
