Indian Creek Reservoir Phosphorus TMDL Implementation Status Staff Report

California Regional Water Quality Control Board

Lahontan Region

3/30/2026

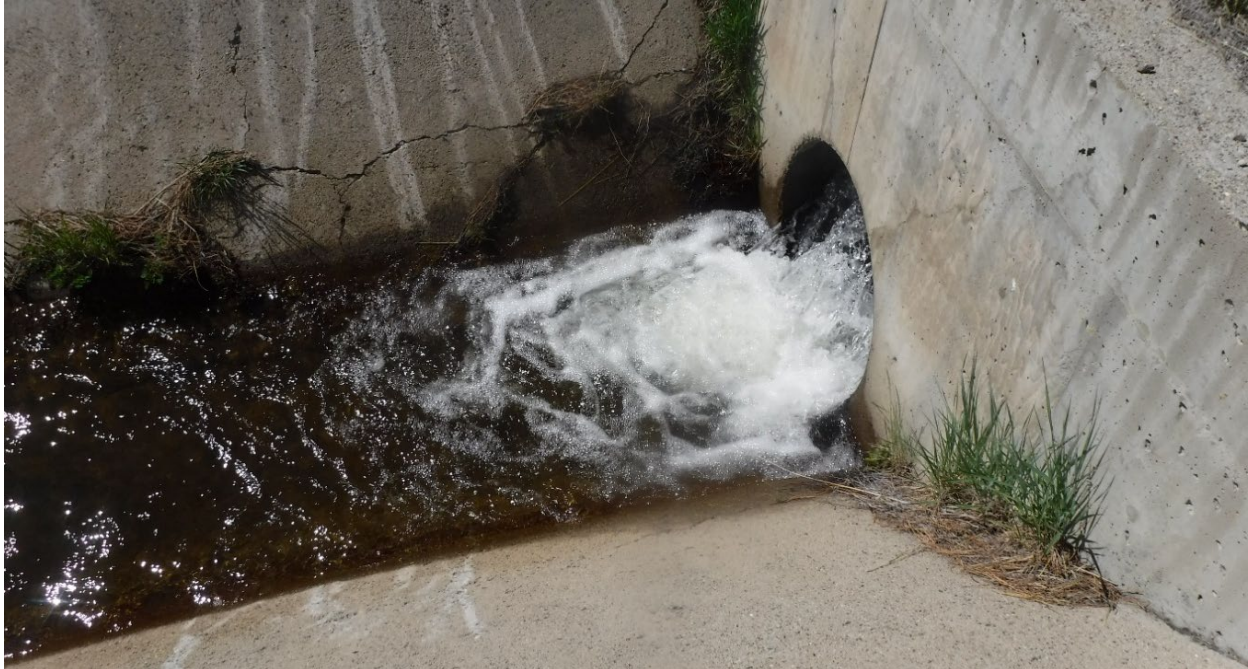
Fig. 2 Outflow of Indian Creek into Upper Dressler Ditch, the main inflow into Indian Creek Reservoir.

Indian Creek Reservoir (ICR) was constructed on an ephemeral tributary of Indian Creek, which itself is tributary to the East Fork Carson River in Nevada (Fig. 1 and 2). It receives flows from both Indian Creek and the West Fork Carson River through diversions into the Upper Dressler Ditch which then discharges into the reservoir. Water from ICR is released back into Indian Creek via Diamond Valley Ditch, and ultimately flows into Mud Lake in Nevada, providing irrigation water for several ranching operations. ICR is relatively shallow with a maximum pool size of 3,100 acre-feet and reaches a maximum depth of 50 feet near its main dam. The reservoir was originally designed to store tertiary-treated domestic wastewater effluent exported by the South Tahoe Public Utility District (STPUD) from the Lake Tahoe Basin, for later use in pasture irrigation. ICR was also designed to serve as a recreational trout fishery to support commercial and sportfishing, as well as water contact and non-contact water recreation. Export of all wastewater from the Lake Tahoe watershed has been required since the 1960s to protect the unique ecological and recreational values of Lake Tahoe; see Section 5.2 of the Water Quality Control Plan for the Lahontan Region. Treatment of wastewater effluent involved processes for nutrient removal including the addition of lime to remove phosphorus. However, some nutrients remained in the effluent such that during the period of wastewater disposal into ICR (1969-1989), it is estimated that roughly 52,000 pounds of phosphorus were added into the reservoir (California Regional Water Quality Control Board Lahontan Region 2001).

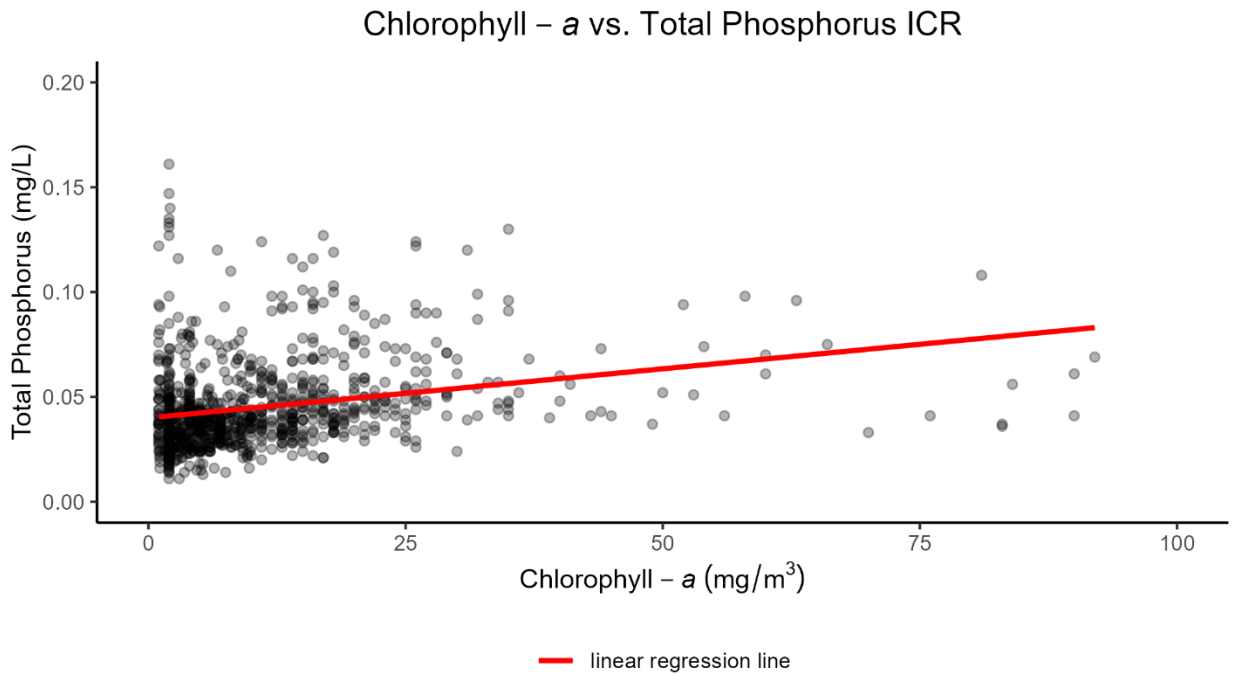
Fig. 6 Visualizing the correlation between total phosphorus and chlorophyll-a in the epilimnion of ICR with linear correlation ($R^2=0.26$).

Similarly, Secchi depth improved to levels that met the objective of 2m after implementation of the hypolimnetic oxygenation system. However, around 2016 Secchi depth was reduced to levels that didn't meet the objective, and clarity has remained relatively low since (Fig. 4). Following this trend, chlorophyll-a appeared to be trending lower between 2008 and 2015 but peaked in 2015. Chlorophyll-a returned to levels that met the TMDL target in subsequent years but reached another peak in 2023 (Fig. 5). In 2023, ICR also experience a "Danger" level HAB advisory. Chlorophyll-a is correlated with total phosphorus in the near-surface of ICR (linear regression $R^2=0.26$, $p<0.00$; Fig. 6)

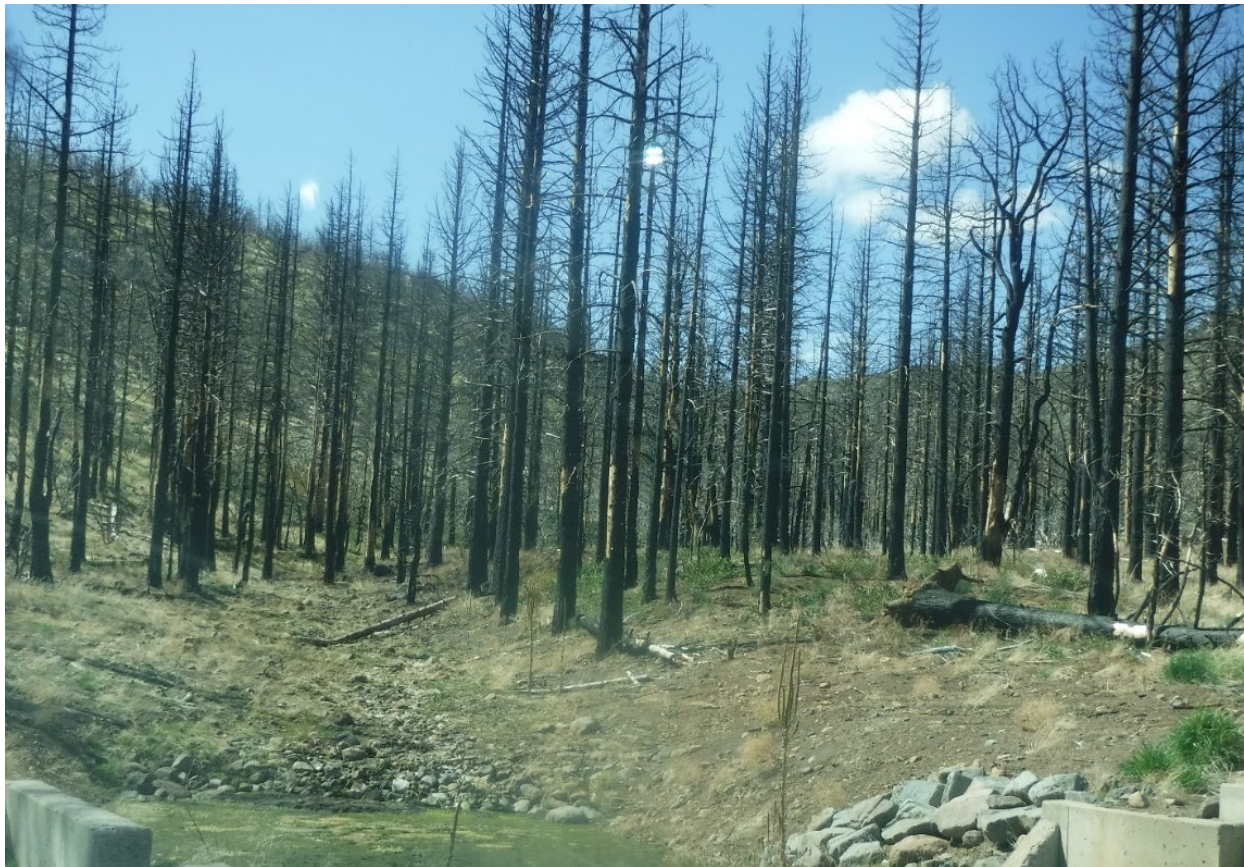
Fig. 8 Burned trees in the Indian Creek watershed adjacent to Upper Dressler ditch (April 29th, 2025).

In 2021, the Tamarack fire burned over 68,000 acres in Alpine County including the land surrounding ICR (Fig. 8). A Tamarack Post Fire Monitoring plan was developed and implemented by Surface Water Ambient Monitoring Program staff to look at the impacts of the fire to water quality. Monthly and storm event monitoring occurred to gather data including total phosphorus, total suspended solids, turbidity, pH, and dissolved oxygen at several locations. Results from this monitoring effort showed highly increased levels of sediment delivery and total phosphorus in the surrounding watersheds in the aftermath of the fire in 2021, followed by a fairly quick recovery. As a result, the Tamarack Fire may have hindered progress being made in

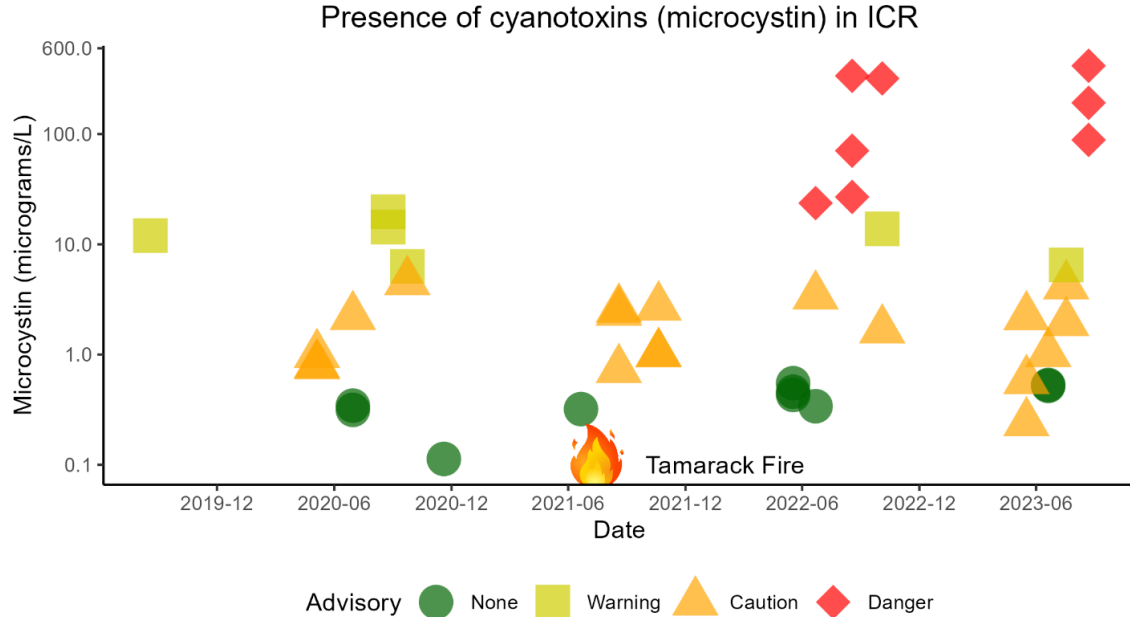
Fig. I.1. Scatter plot of the concentration of microcystin detected in ICR between 2019 and 2023. The y-axis is displayed using logarithmic scale (\log_{10}). The date of the Tamarack Fire is represented by a fire icon on the date axis.

HAB monitoring began at ICR in 2019. “Danger”-level advisories for cyanotoxin presence were issued in 2022 and 2023. These conditions occurred in the years immediately following the Tamarack Fire (Fig. I.1). According to a 2023 annual report by South Tahoe Public Utility District, peak cyanobacteria concentrations occurred in July-August 2023. Of the cyanobacteria species present, *Microcystis* dominates ICR (Fig. I.2). HABs will likely continue to be a nuisance in the reservoir, and changes to weather patterns and temperature due to climate change could exacerbate the issue (Tewari 2022).
