## North Coast Regional Water Quality Control Board

**Subject:** Notice of Violation, Transmittal of Inspection Report for April 13, 2023,  
Inspection of Trinity County Assessor's Parcel Number 024-010-044

North Coast Regional Water Quality Control Board  
 Cannabis Water Quality Inspection Report - Og Kush Diet LLC, WDID 1\_53CC411330

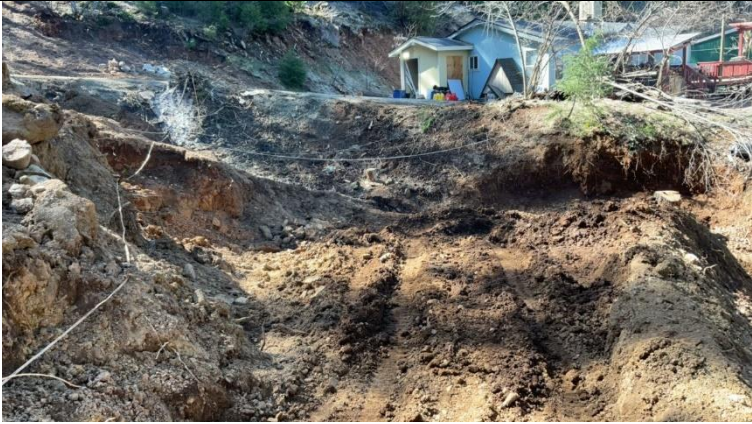
<b>P1</b>	
<b>Category:</b> Riparian Areas (RA)	<b>Violation Present?</b> Yes
<b>Description:</b> Extensive earthwork was done during the rainy season. I observed mounds of bare, unconsolidated soil encroaching on riparian areas. Ivan stated he owns an excavator and that a contractor had used it as recently as three days prior to develop a parking area, gather rocks, and move material from a mud slide.	
 	Photo Number: 1
	Photo Description: Watercourse with downed trees on left bank. Loose earthen material is piled on the right bank and in the watercourse.
	Facing Southwest

P1 and P9: Store stockpile fill, grow bags, slash, trash, and any other materials at least 50 feet away from Class III watercourses, 100 feet away from Class II watercourses, and 150 feet away from Class I watercourses (riparian setbacks).

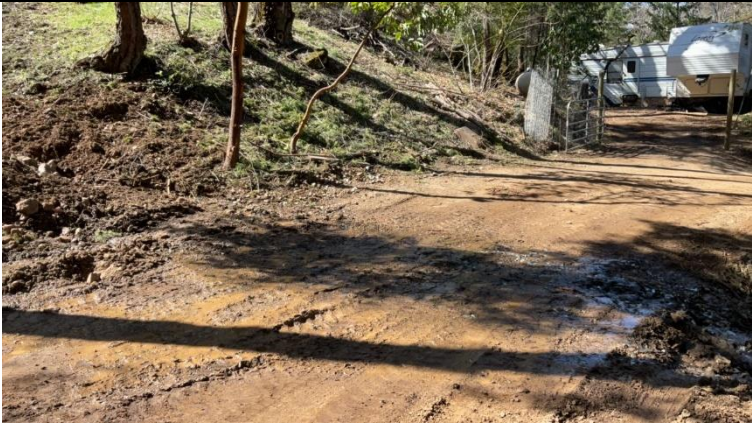
Photo Number: 2
	Photo Description: Watercourse traversing dirt road.
	Facing East

P2, P7, and P9: Apply for a 401 Water Quality Certification to install culvert stream crossings to replace dirt fords.

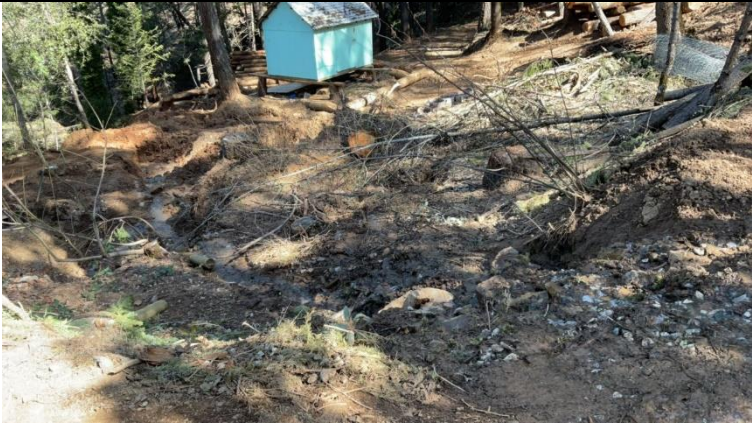
Photo Number: 3
	Photo Description: View of watercourse downstream of ford crossing.
	Facing West

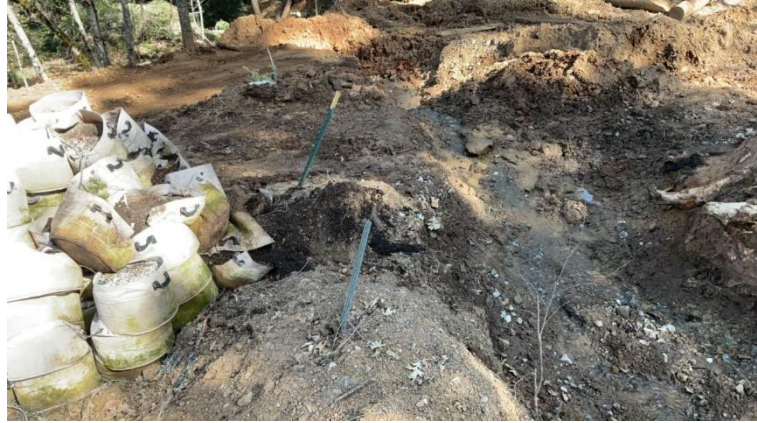
<b>P3</b>	
<b>Category:</b> Soil and Growing Medium (S)	<b>Violation Present?</b> Yes
<b>Description:</b> Approximately 300 grow bags with spent soil stockpiled on watercourse banks.

Photo Number: 1
	Photo Description: Potting soil discharging to watercourse.
	Facing West

P3: Relocate grow bags outside of riparian setbacks. Clean up spilled soil to prevent further discharge of sediment and nutrients/ chemicals to surface waters.

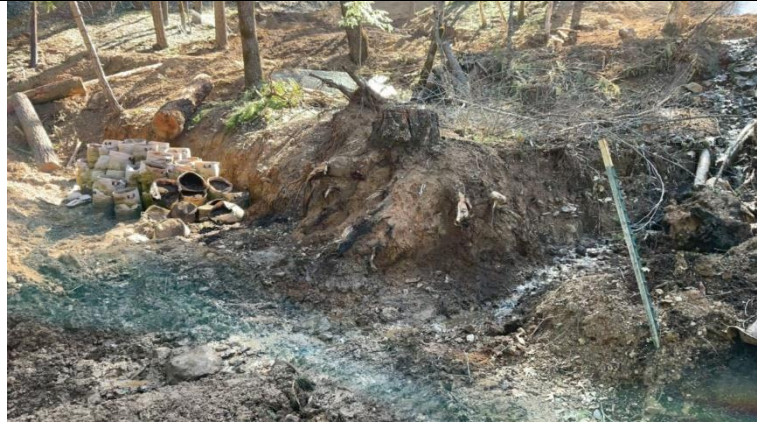
Photo Number: 2
	Photo Description: Excavator tracks through watercourse.
	Facing North

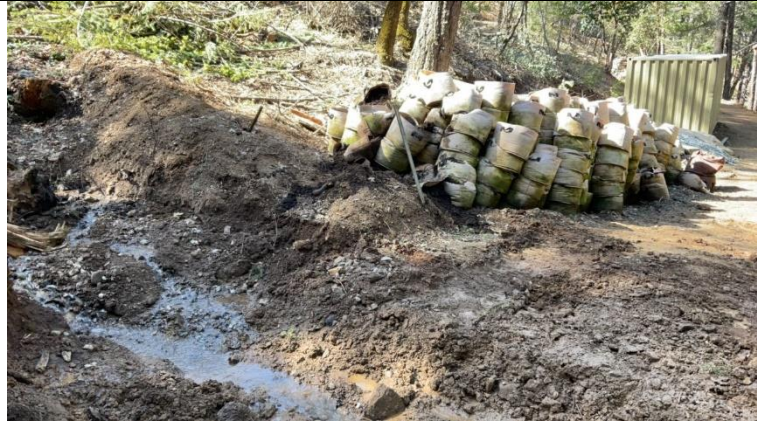
Photo Number: 3
	Photo Description: Bags stockpiled on watercourse bank.
	Facing Southeast
	Photo Number: 4
	Photo Description: View of bags on both sides of watercourse.

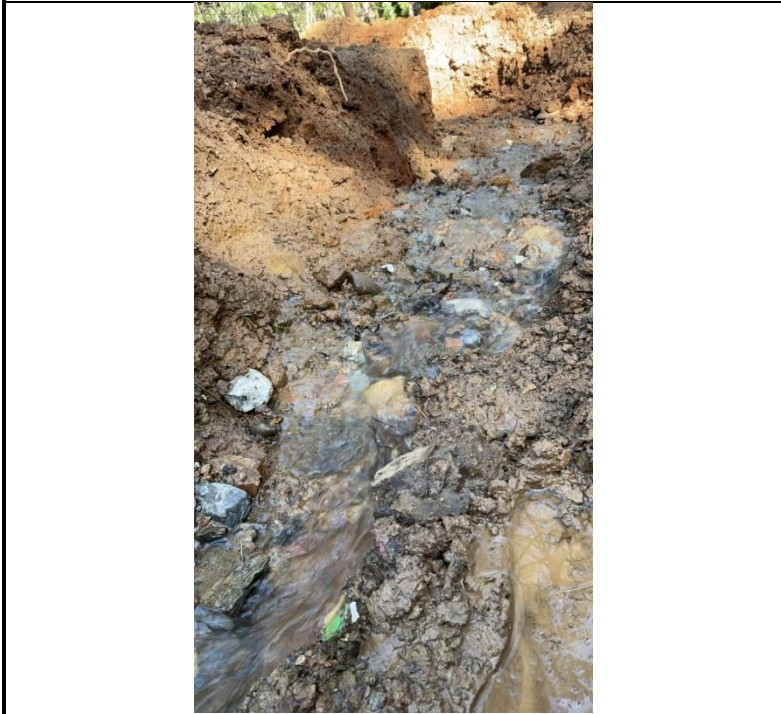
**Description:** Domestic waste in watercourse.

Photo Description: Trash in watercourse.

P4 and P11: Remove trash from watercourse. Contain and regularly dispose of trash outside of riparian setbacks in a permitted transfer station or landfill.

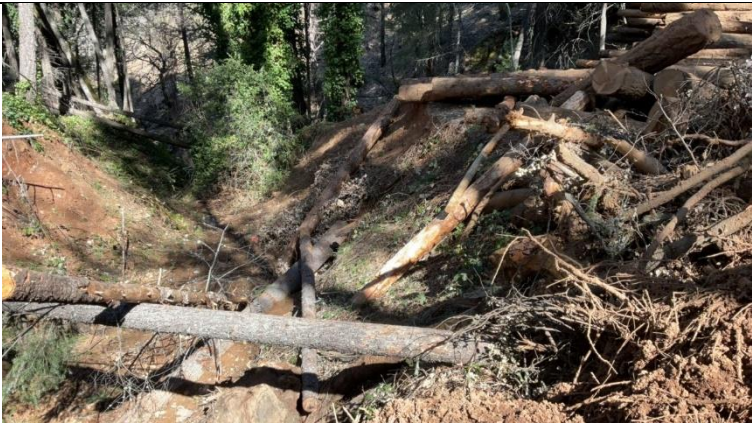
Photo Number: 4
	Photo Description: Slash in watercourse channel.
	Facing Southwest

P5: Submit a proposal through a 401 Water Quality Certification application to remove the stockpiled fill from the watercourse, to realign the watercourse with its channel, and to revegetate the banks with native riparian plants.

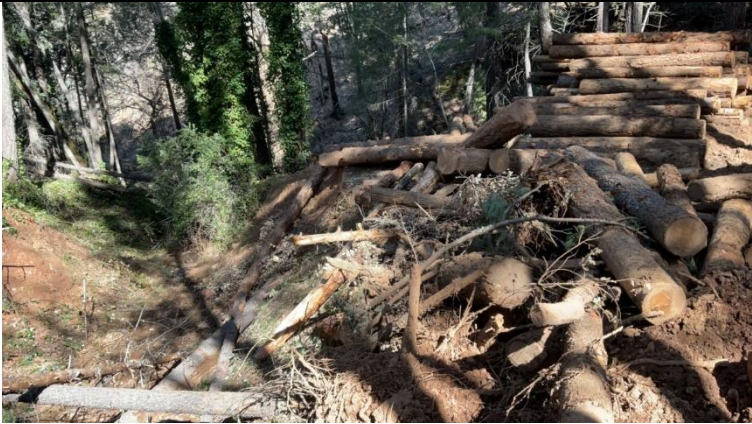
Photo Number: 5
	Photo Description: Slash stockpile on bank of watercourse channel.
	Facing Southwest

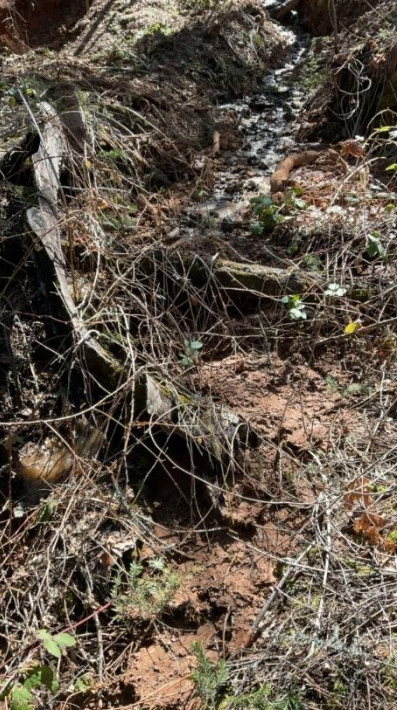
Photo Number: 6
	Photo Description: Water finding new route through fill.
	Facing East

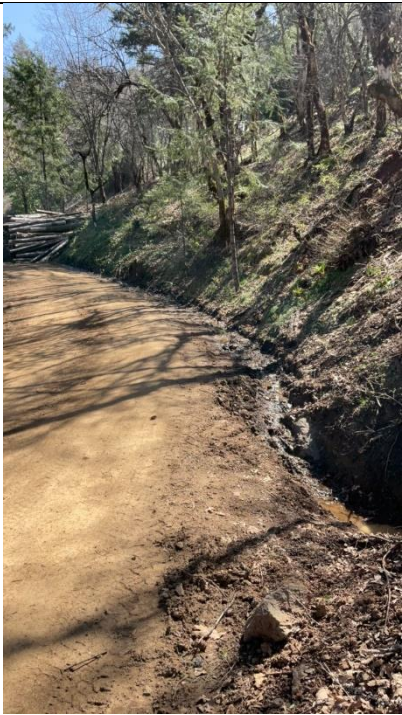
Photo Number: 4
	Photo Description: Ford crossing eroding dirt road.
	Facing South
<b>P8</b>	
<b>Category:</b> Watercourse Crossings (WC)	<b>Violation Present?</b> Yes
<b>Description:</b> Culvert stream crossing with perched outlet.

Photo Number: 1
	Photo Description: Perched culvert outlet.
	Facing Northwest
	Photo Number: 2
	Photo Description: Looking uphill at stream diverted into ditch. Culvert inlet on right side.

P8 and P11: Apply for a 401 Water Quality Certification to replace the misaligned and undersized culvert stream crossings.

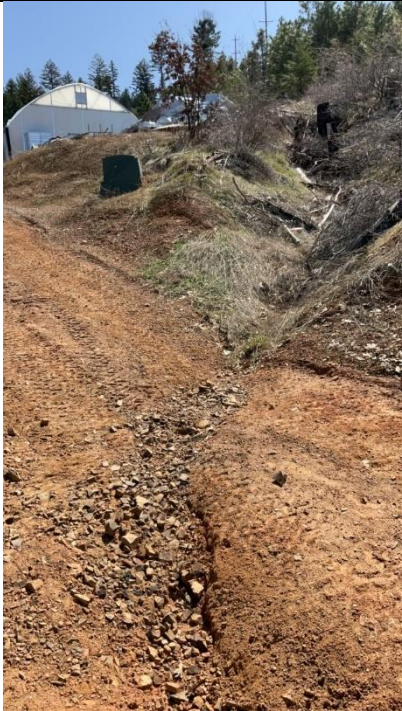
Facing East
<b>P9</b>		
<b>Category:</b> Watercourse Crossings (WC)		<b>Violation Present?</b> Yes
<b>Description:</b> Dirt ford stream crossing.

Photo Number: 1 Photo Description: Evidence of watercourse crossing road. Facing East

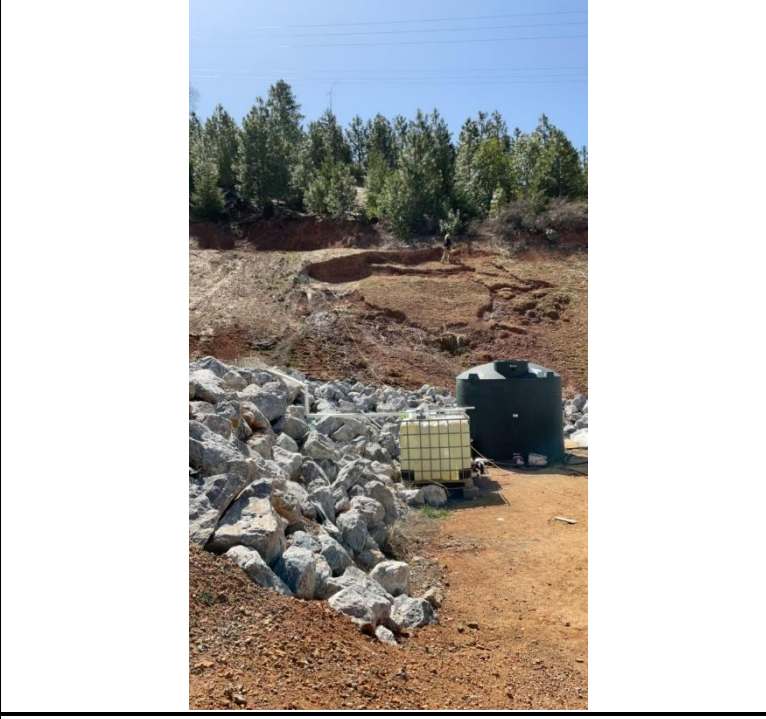
Photo Description: View uphill of greenhouse.

P10: Retain a licensed geologist or engineer to assess the stability of the greenhouse flat.
