**Cleanup and Abatement and
Investigative Order No. R1-2024-0033**

**Laurence Istas, Yesenia Carrillo and Raul Carrillo
Assessor Parcel Number 032-293-15-00
Mendocino County**

Subject: Notice of Violation, Transmittal of Report for May 9, 2023 Inspection of Mendocino County Assessor's Parcel Numbers 032-293-15-00

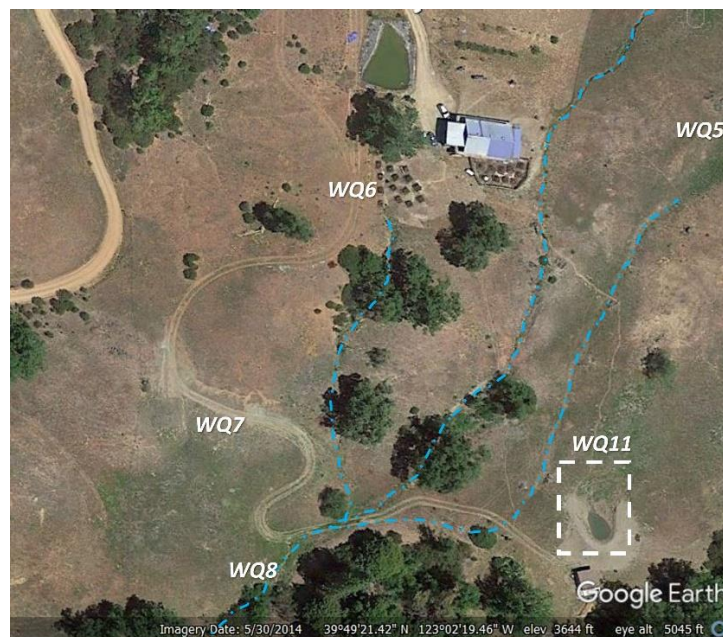
Figure 3— Aerial image of southern portion of the Property taken on May 30, 2014, obtained from Google Earth. Vehicle tracks are visible crossing the watercourse in the bottom of the image and the wetland in the bottom right, at WQ11, has been dredged creating a pond.

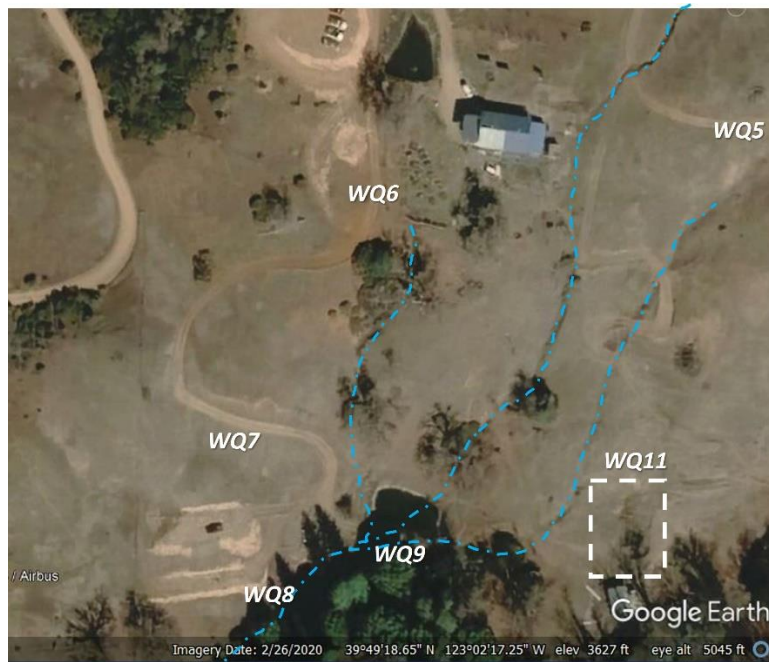
Figure 6— Aerial image of southern portion of Property taken on February 26, 2020, obtained from Google Earth. The Reservoir at WQ9 has filled with water.

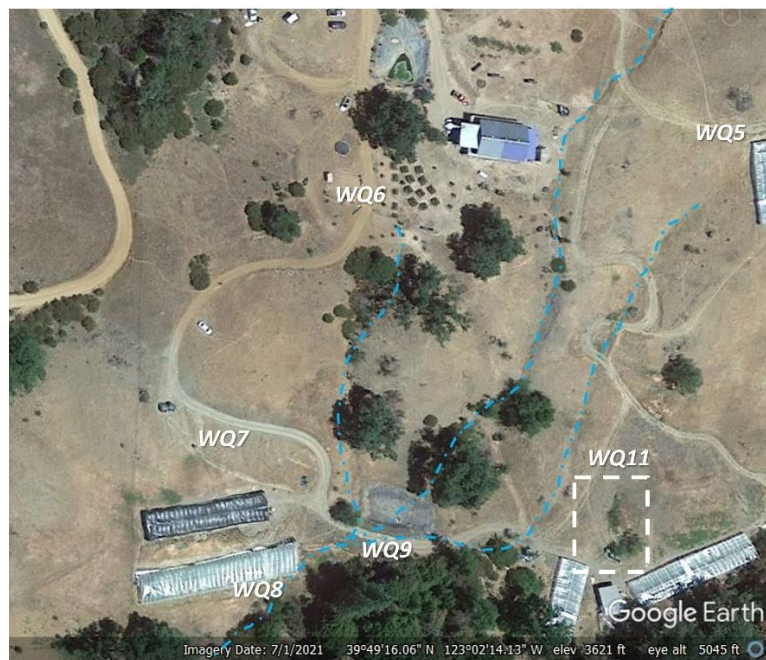
Figure 7— Aerial image of southern portion of Property taken on July 1, 2021, obtained from Google Earth. Hoop-type greenhouses are visible in the lower-left, right and bottom-right of the image.

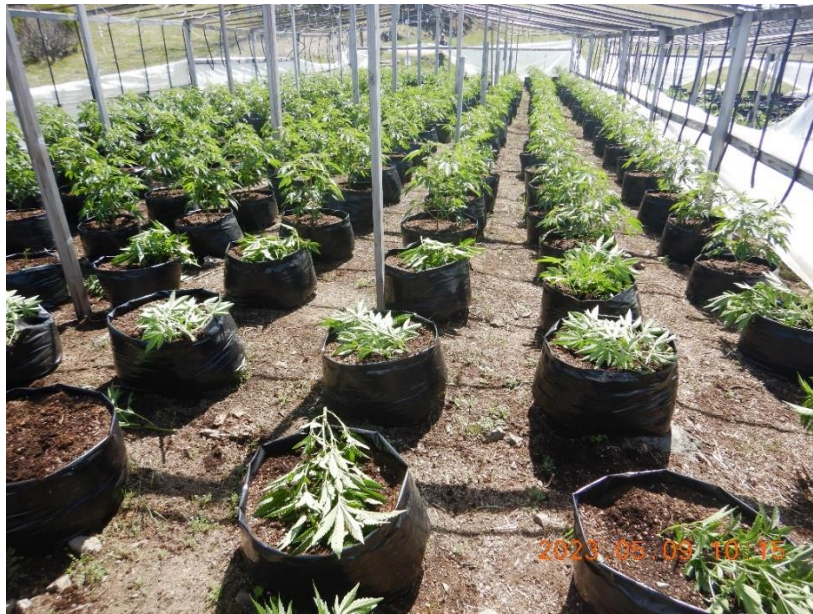
Figure 8—Cannabis plants growing in soil bags resting on permeable ground within a greenhouse at WQ1.

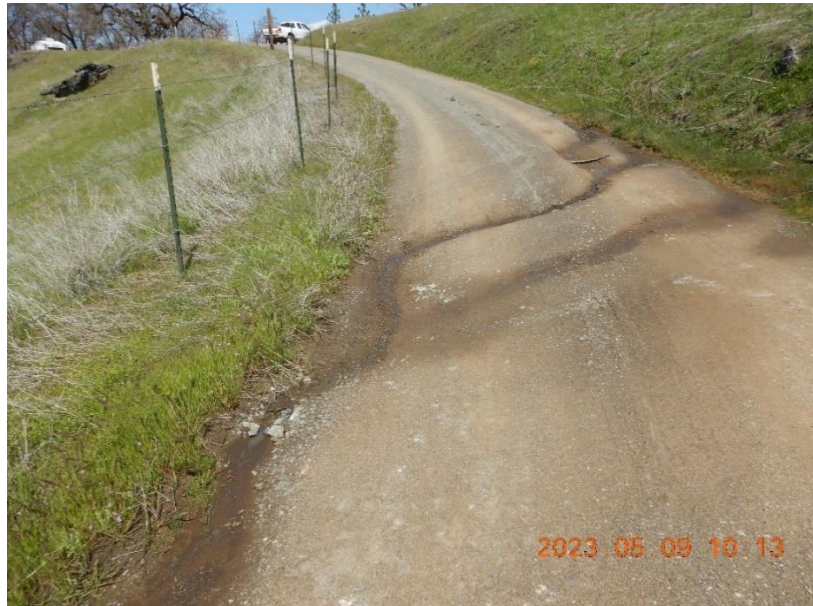
Figure 9—Looking north at road located at WQ2. Groundwater emanating from above the road concentrates on the earthen road surface.

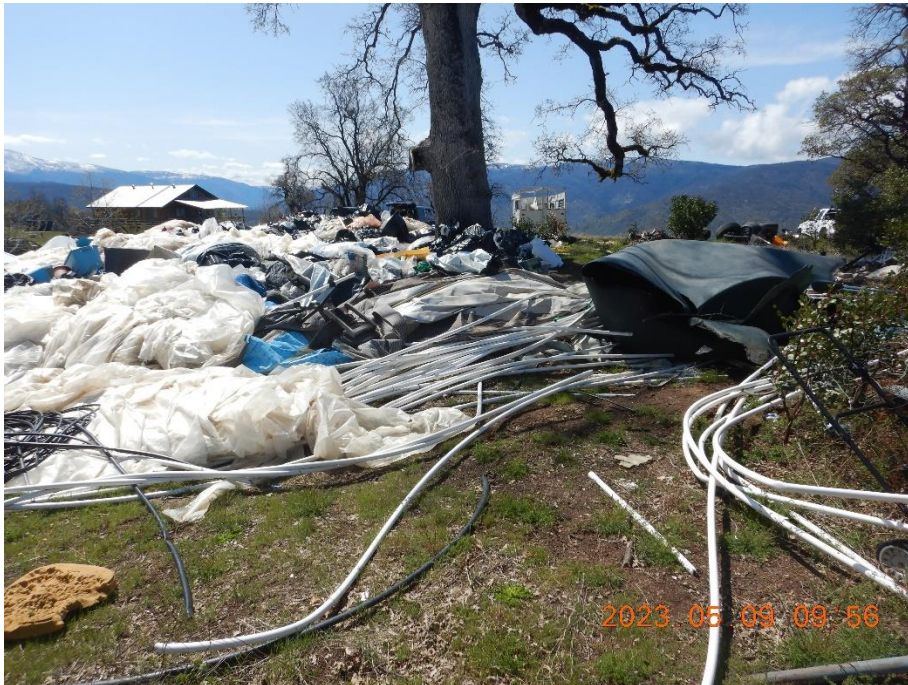
At WQ3, I observed a large area where waste was being collected and sorted. At WQ4, I observed a road fording a watercourse with pooled water on the road surface. The road leads to a greenhouse at WQ5 that covers an area of 6,000 square feet. I observed a graded earthen pad at WQ6 with fabric soil bags from past cultivation. I observed a partially blocked, 12-inch diameter culvert directed into a watercourse on the downslope side of the pad, but I did not find the culvert inlet upslope of the pad. I observed cannabis cultivation waste including plant stalks, slash and wire mesh within the channel downstream from the pad.

Figure 10—Trash including plastic sheeting and pipe in pile at WQ3.

1. Immediately collect all refuse and wastes which have discharged and/or threaten to discharge to receiving waters and which can be collected by hand. You are not authorized to use heavy equipment in a water of the State of California (Water of the State) or modify the bed bank or channel of a Water of the State without a permit from the Regional Water Board (see recommendation 5 below). Properly dispose of these wastes at a licensed waste collection facility.

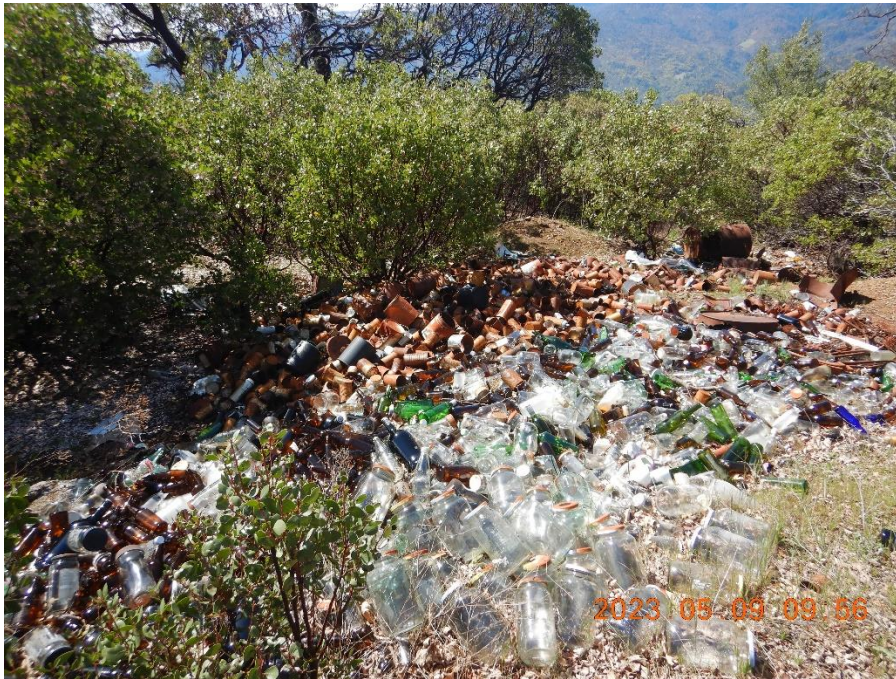
Figure 12— Trash including glass bottles and metal cans in pile at WQ3.

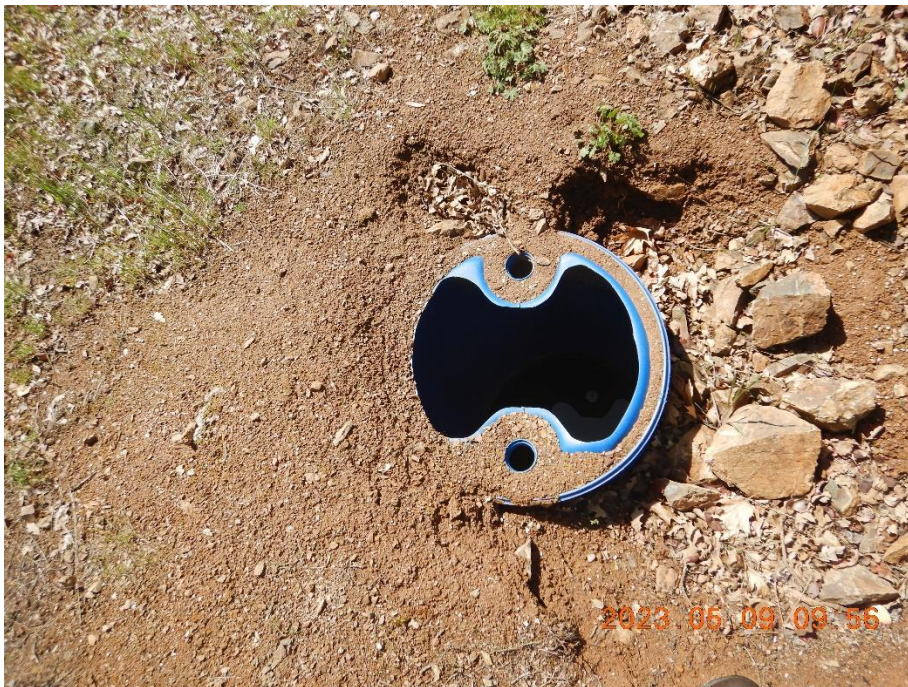
Figure 13— Buried plastic drum within area of large trash pile at WQ3.

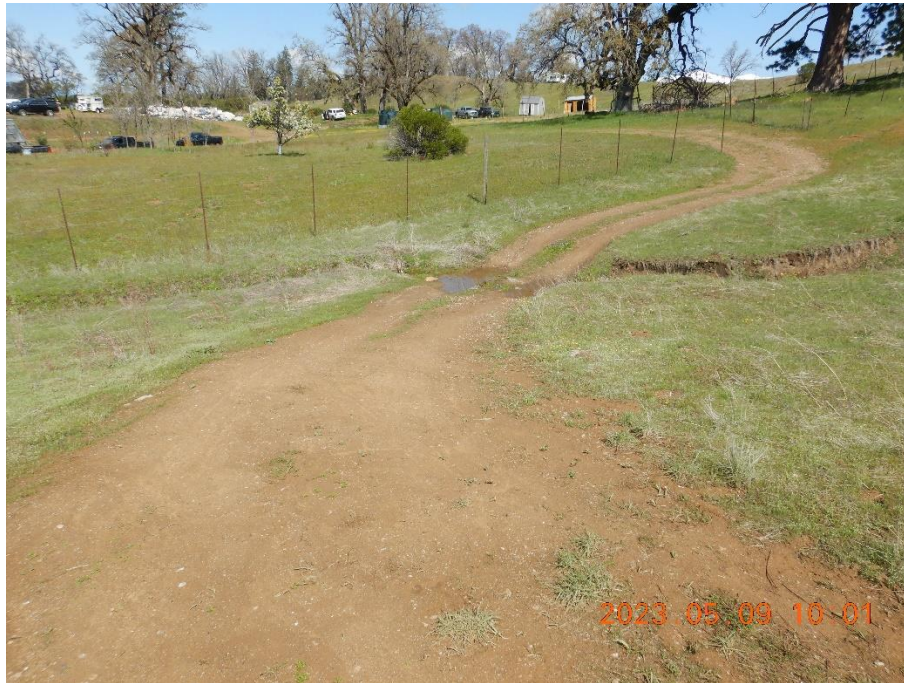
Figure 14—A road fording a watercourse at WQ4.

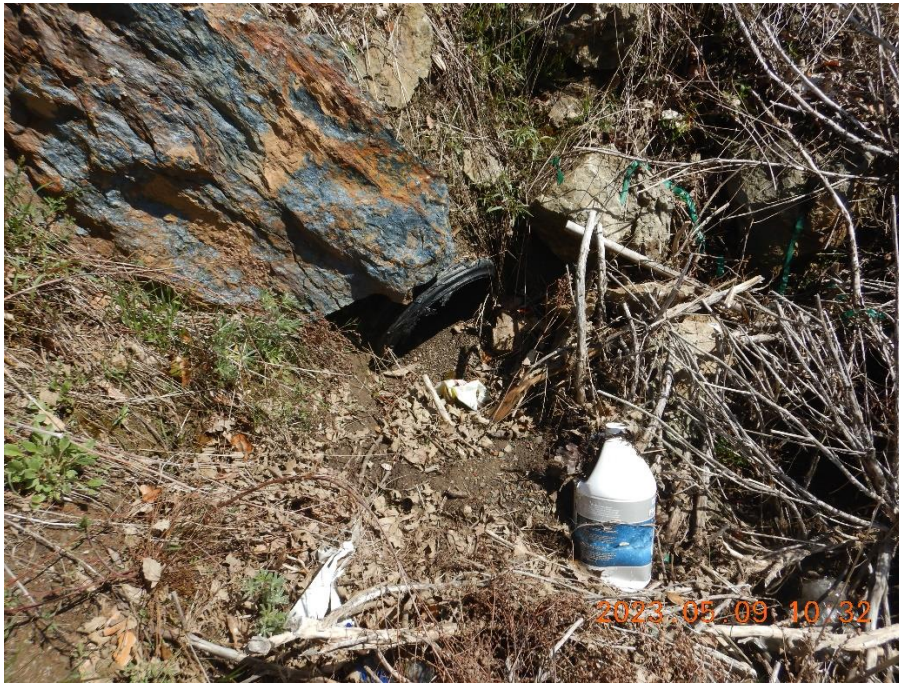
Figure 18—Partially buried culvert outlet at WQ6 among cultivation waste including plant stalks and plastic containers.

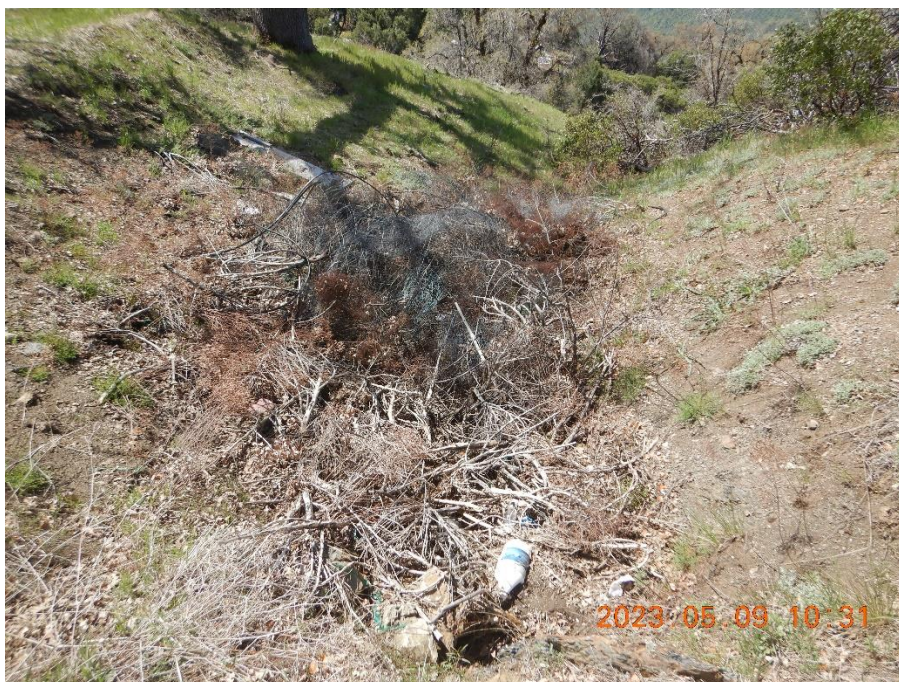
Figure 19—Looking south along watercourse at WQ6.

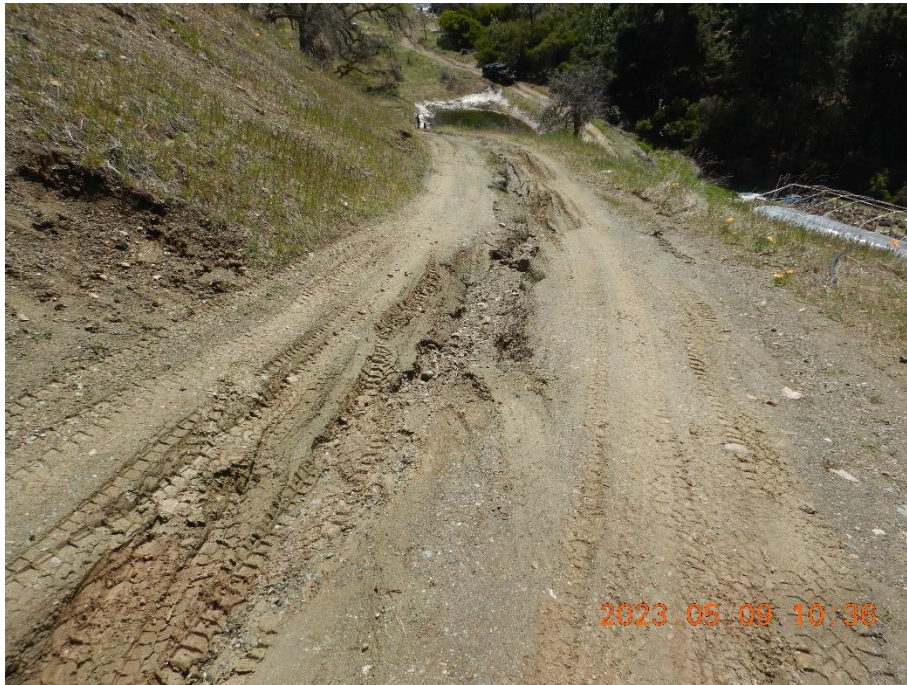
At WQ7, I observed a gully that had eroded into the middle of a dirt road leading to greenhouses covering an area of 12,000 square feet at WQ8 and a reservoir at WQ9. I observed three watercourses approaching the reservoir: the channel from WQ6 passes the western bank of the reservoir and flows over the dirt road transporting fine sediment to the receiving watercourse downstream from WQ9; the channel from WQ4 discharges into the northeast corner of the reservoir; the topography east of the reservoir is shaped in such a way to direct the watercourse originating in the vicinity of WQ5 over a road and into the reservoir. At WQ9, I observed a 20-inch diameter culvert directing the reservoir outfall to a USGS mapped blue line stream. I observed voids surrounding the pipe outlet indicating that earthen fill had been eroded and discharged to the channel downstream. I also observed slash placed in the channel.

Figure 20—A gully eroded along the middle of a dirt road at WQ7. Cannabis greenhouses located at WQ8 are visible in the top-right of the image and an onstream pond located at WQ9 is visible in the top-middle with a pickup truck parked on the reservoir’s impounding berm for scale.

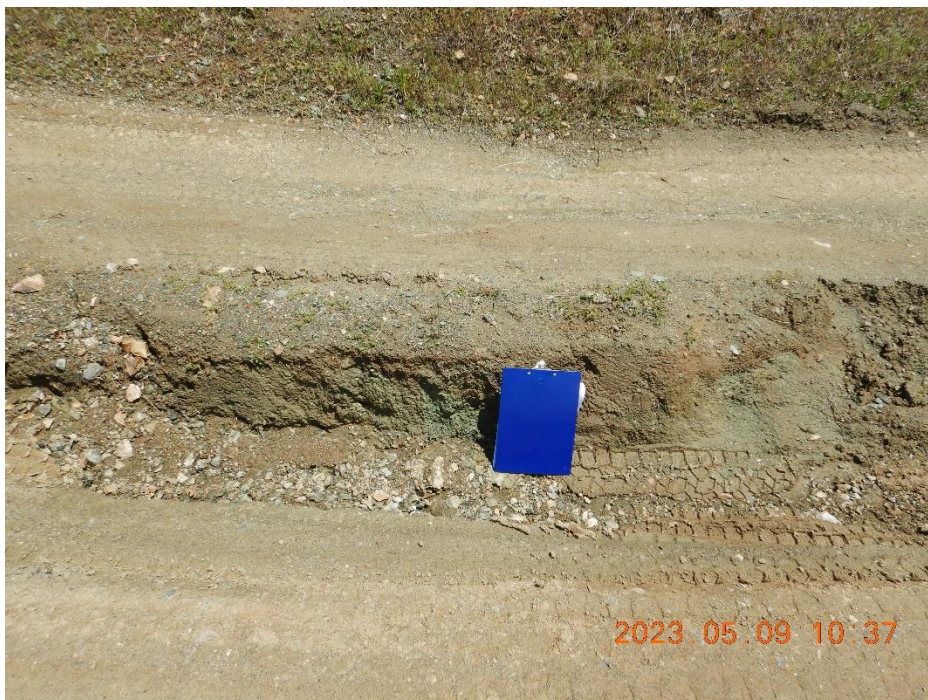
Figure 21—Photo of a 12-inch-tall clipboard in road gully at WQ7.

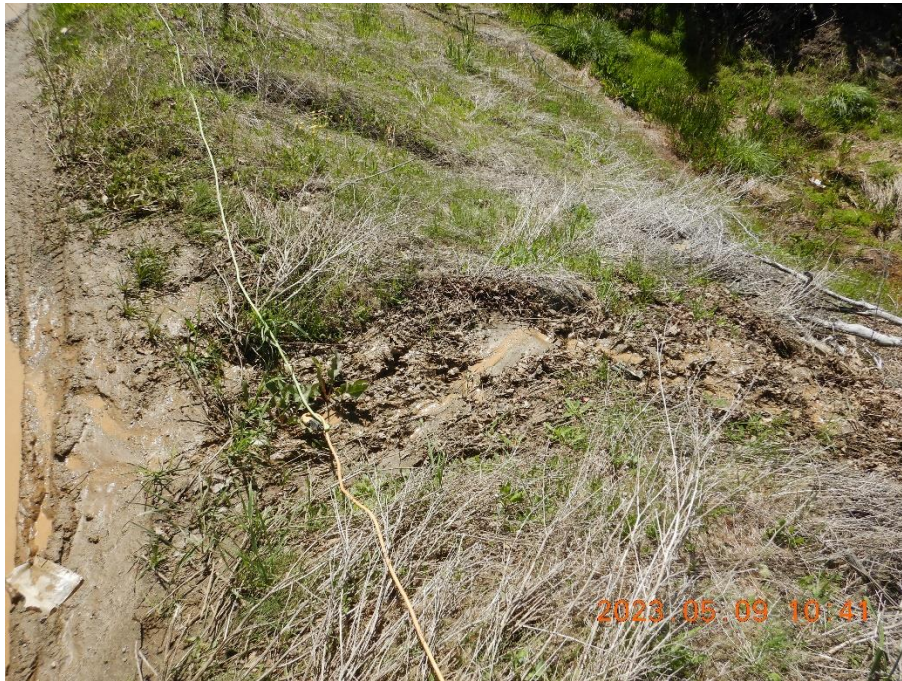
Figure 24—Sediment laden water from road surface pictured in previous image, flowing towards the USGS mapped blueline stream out of view to the right of the image.

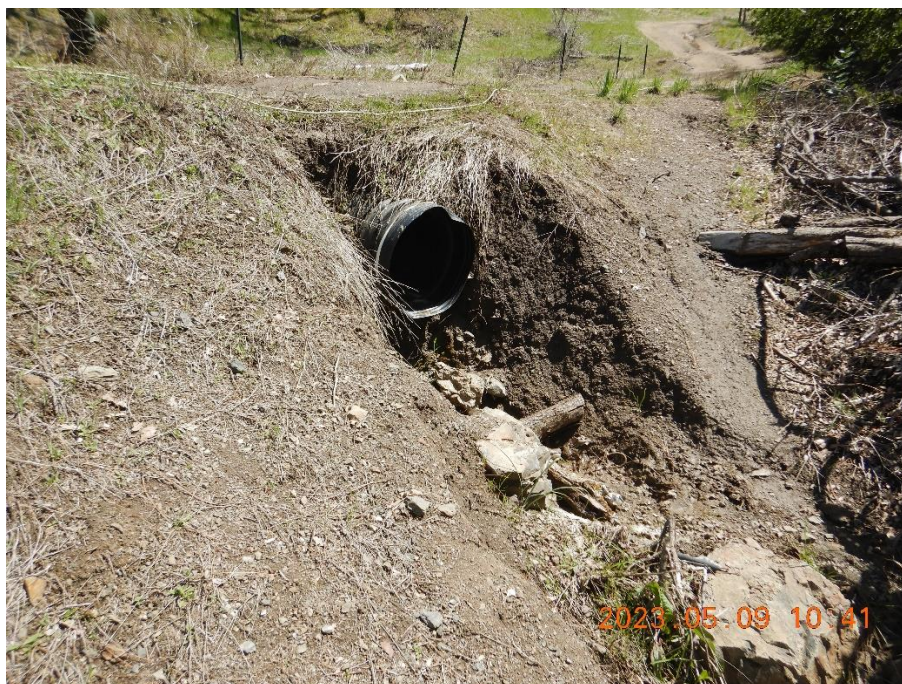
Figure 25—Reservoir outlet drain at WQ9 directed toward USGS mapped blueline stream out of view to the right of the image. The outlet pipe is 20-inches in diameter and lacks armor which has resulted in erosion and downstream transport of the earthen fill.

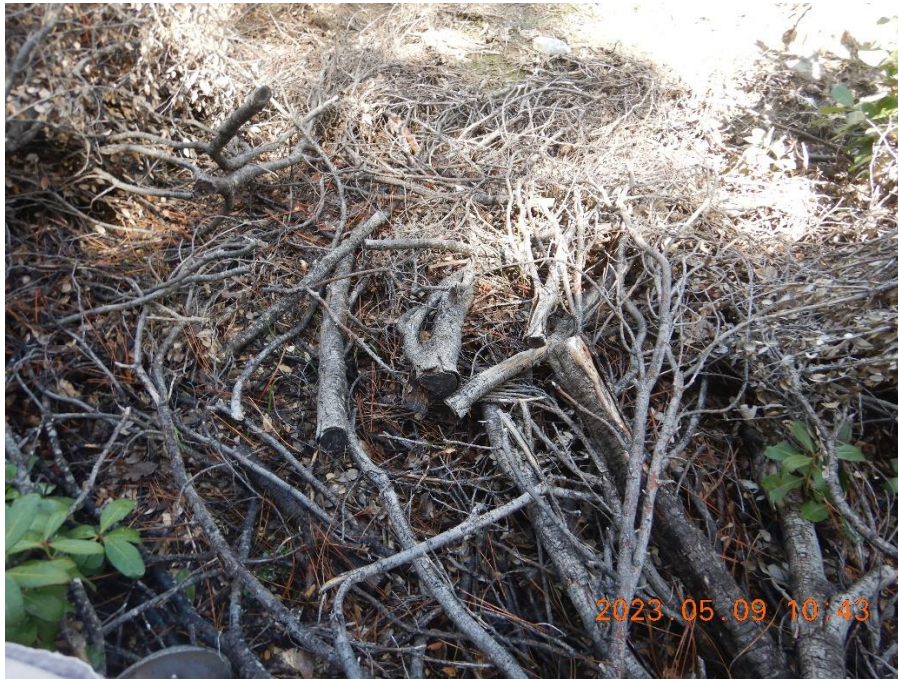
Figure 26—Slash, cut by a saw, and placed into the watercourse downstream from WQ9.

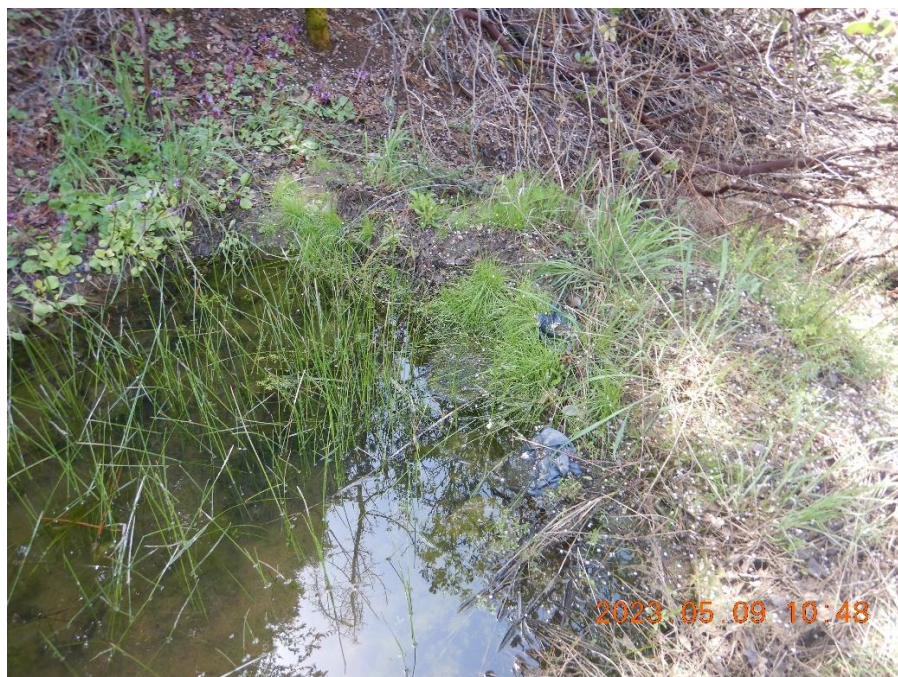
I observed waste potting soils damming the watercourse at WQ10, in an area that appears south of the property boundary mapped in Figure 1; however, I suspect that the waste came from the cannabis cultivation occurring on the subject Property because there is a clear fence separating this Property from the property to the south and it did not appear to be easy to access to the waste discharge location from the southern property. At WQ11, I observed plastic sheeting in the wetland that the below Aerial Images indicate was dredged between July 9, 2012 and May 30, 2014. South of WQ11, I observed another greenhouse covering an area of approximately 5,000 square feet.

Figure 27—Used potting soil, identifiable by white speckles of perlite, damming watercourse at WQ10.
