Item 10: Workshop on Development of the Elk River Sediment Total Maximum Daily Load

March 15, 2012
Fortuna, CA

Adona White, PE
Basin Planning
North Coast Regional Water Quality Control Board

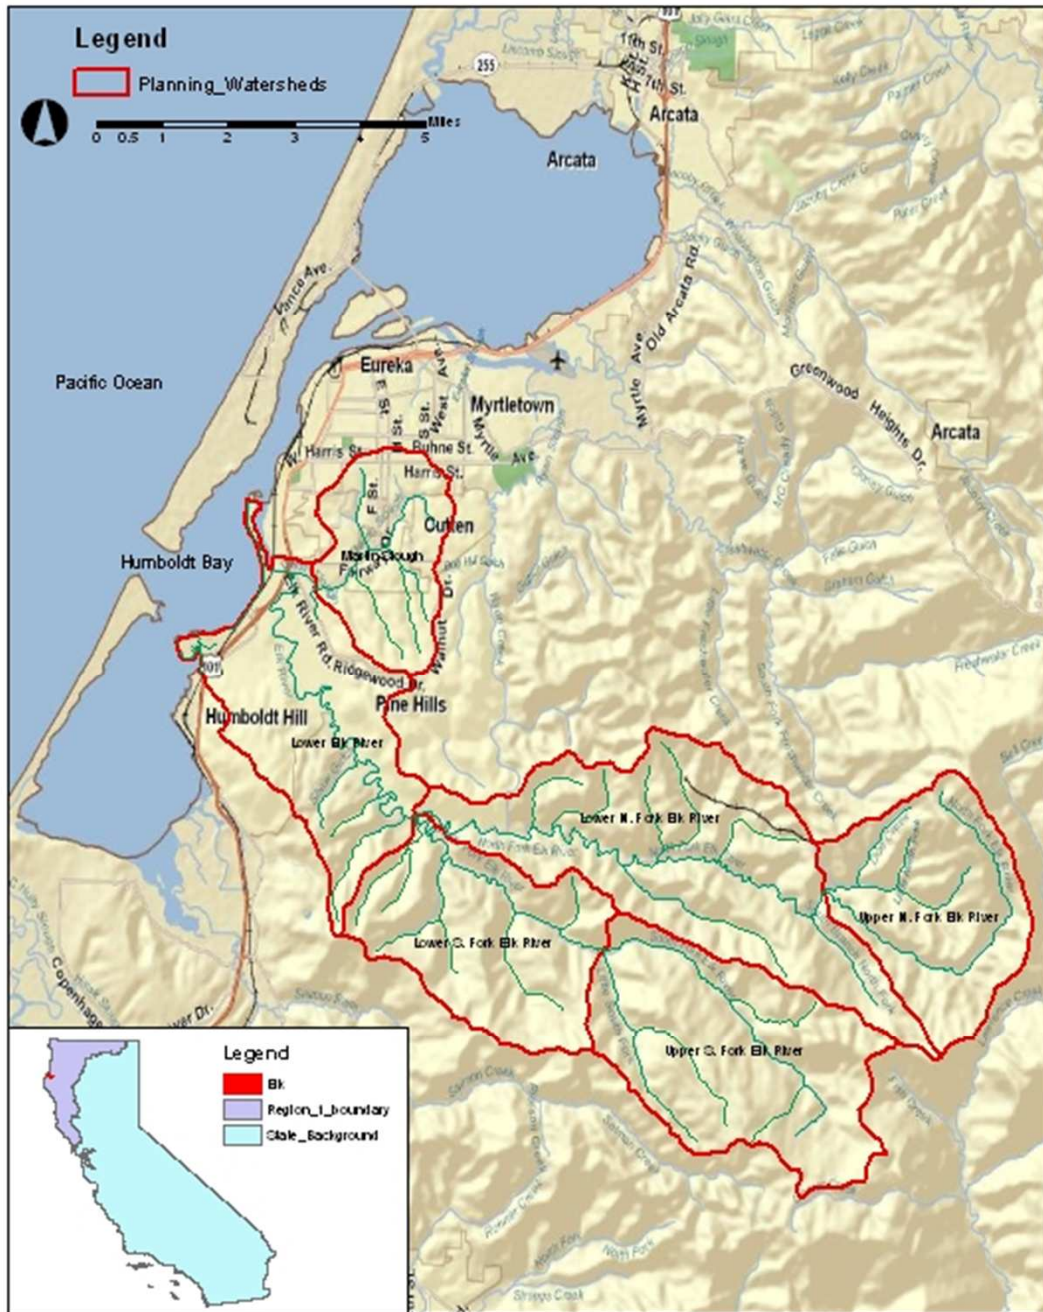
Elk River Watershed

58.3 square miles

- North Fork Elk River (22.5mi²)
- South Fork Elk River (19.5 mi²)
- Lower Elk River (10.4 mi²)
- Martin Slough (5.9 mi²)

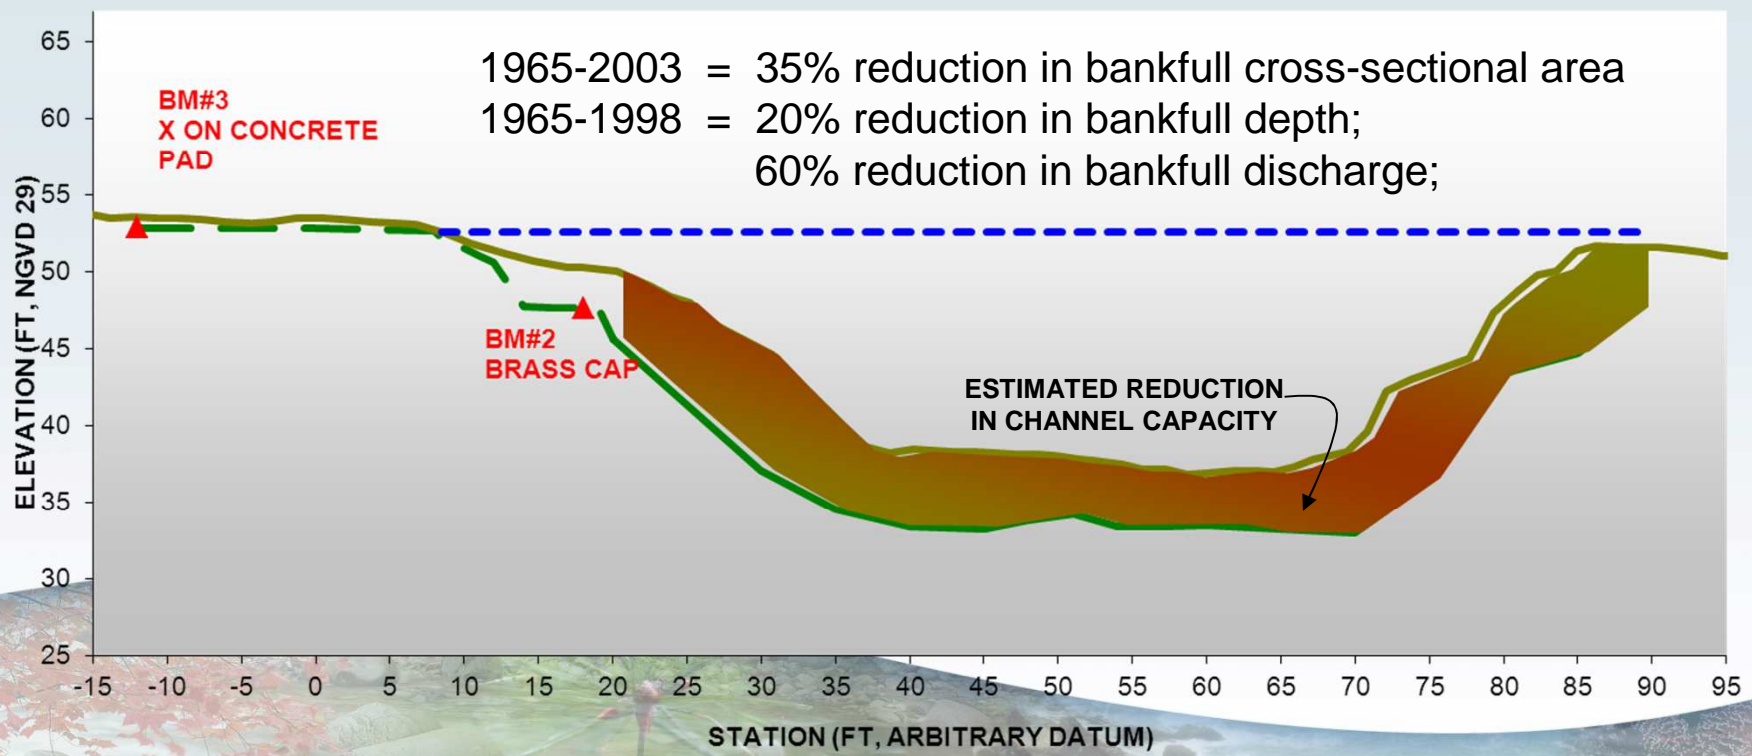
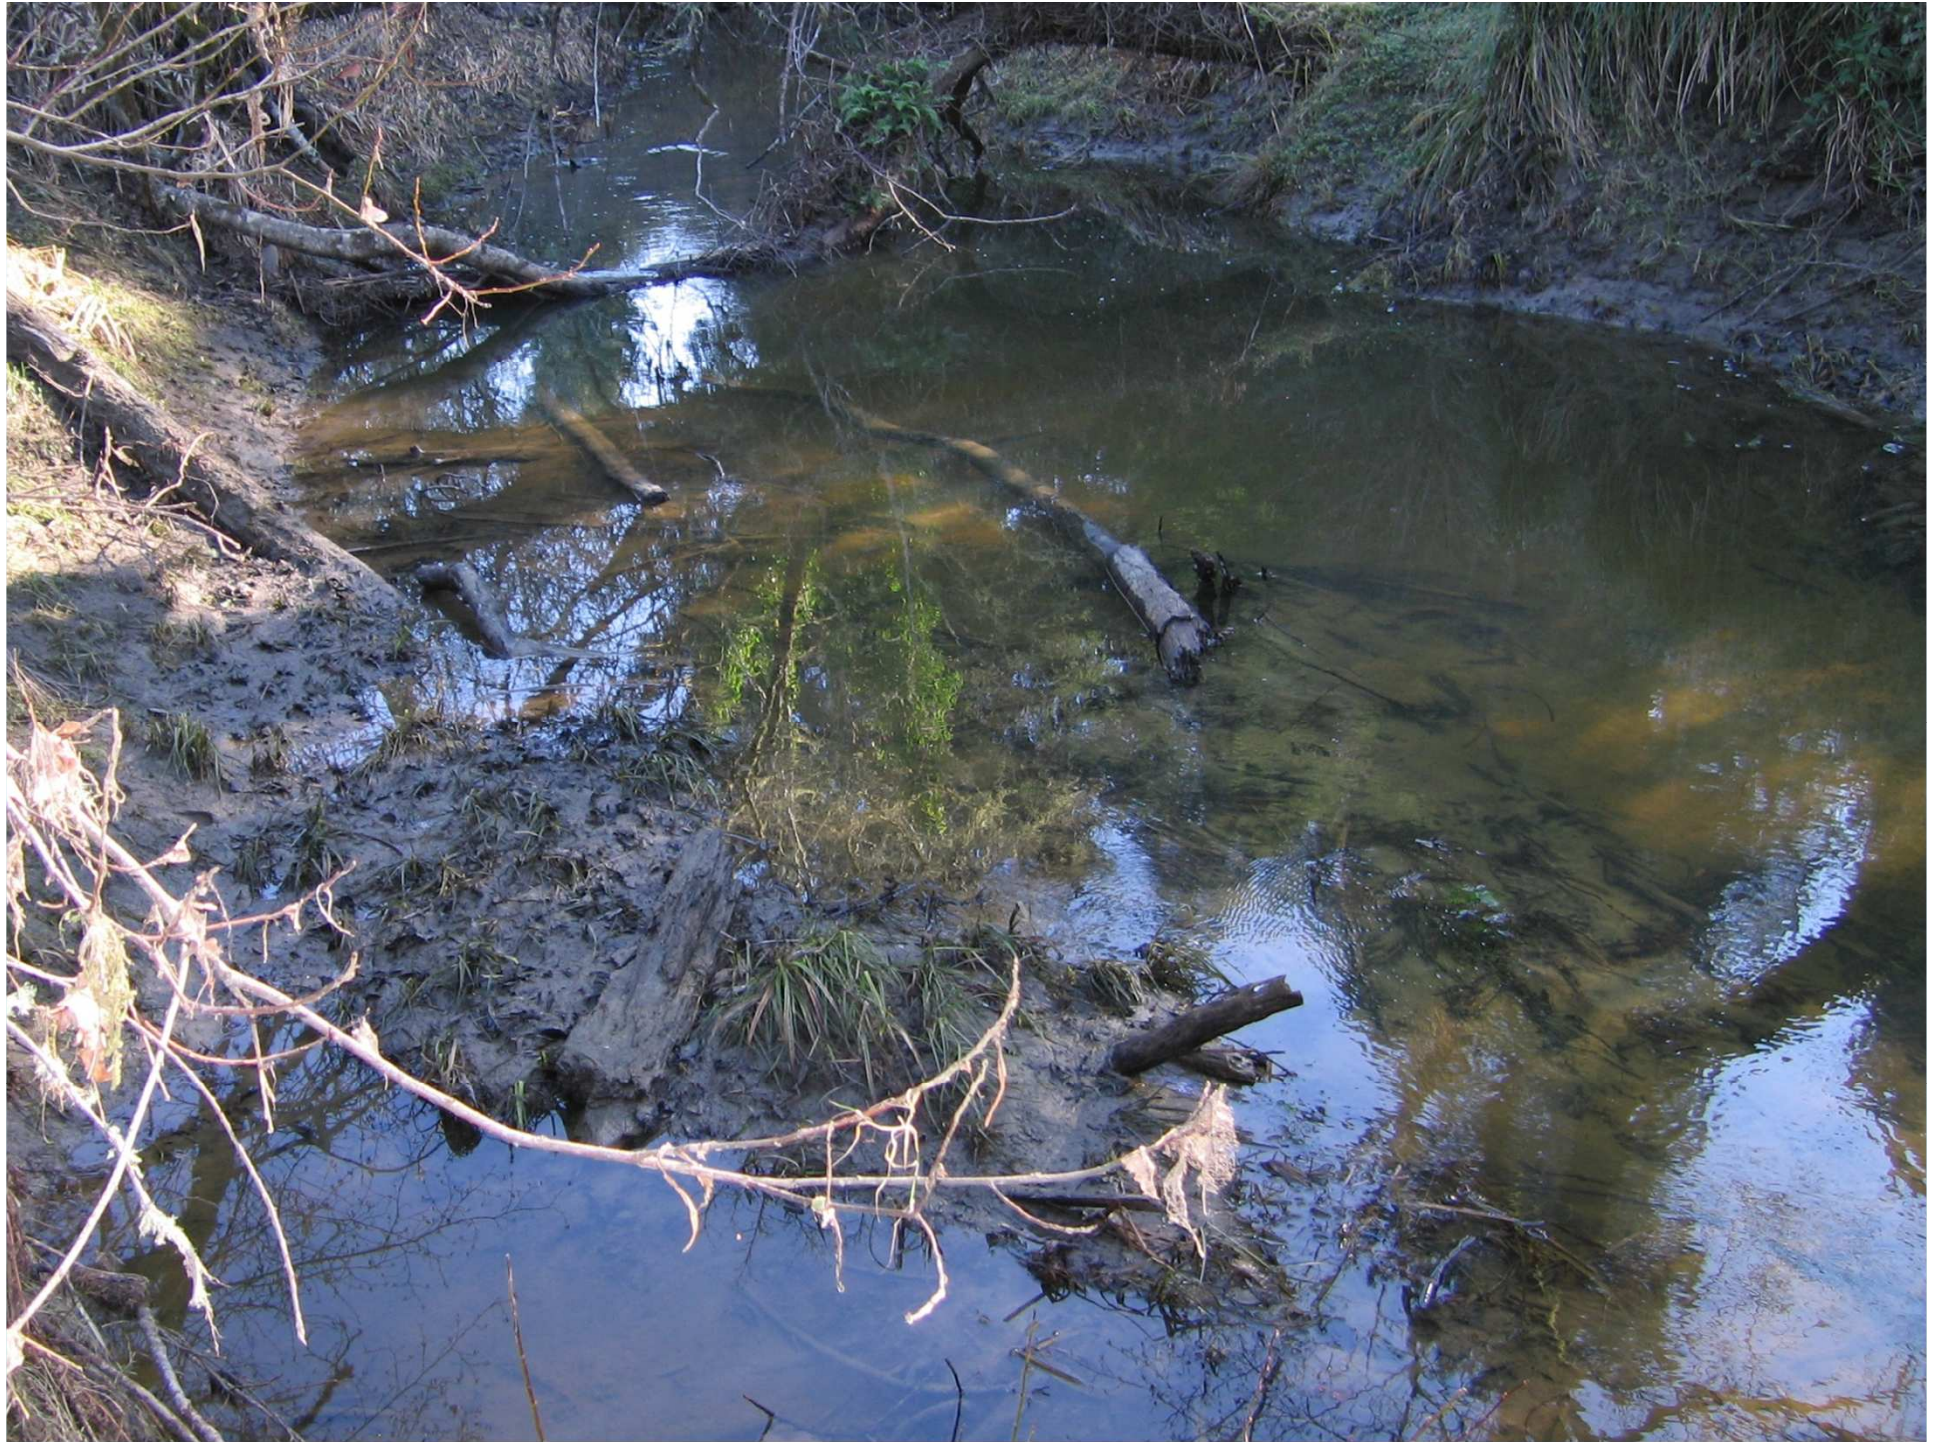
Comparison with historic conditions:

USGS gaged Upper Mainstem Elk (1958-1967)
PL reoccupied site beginning in 1998

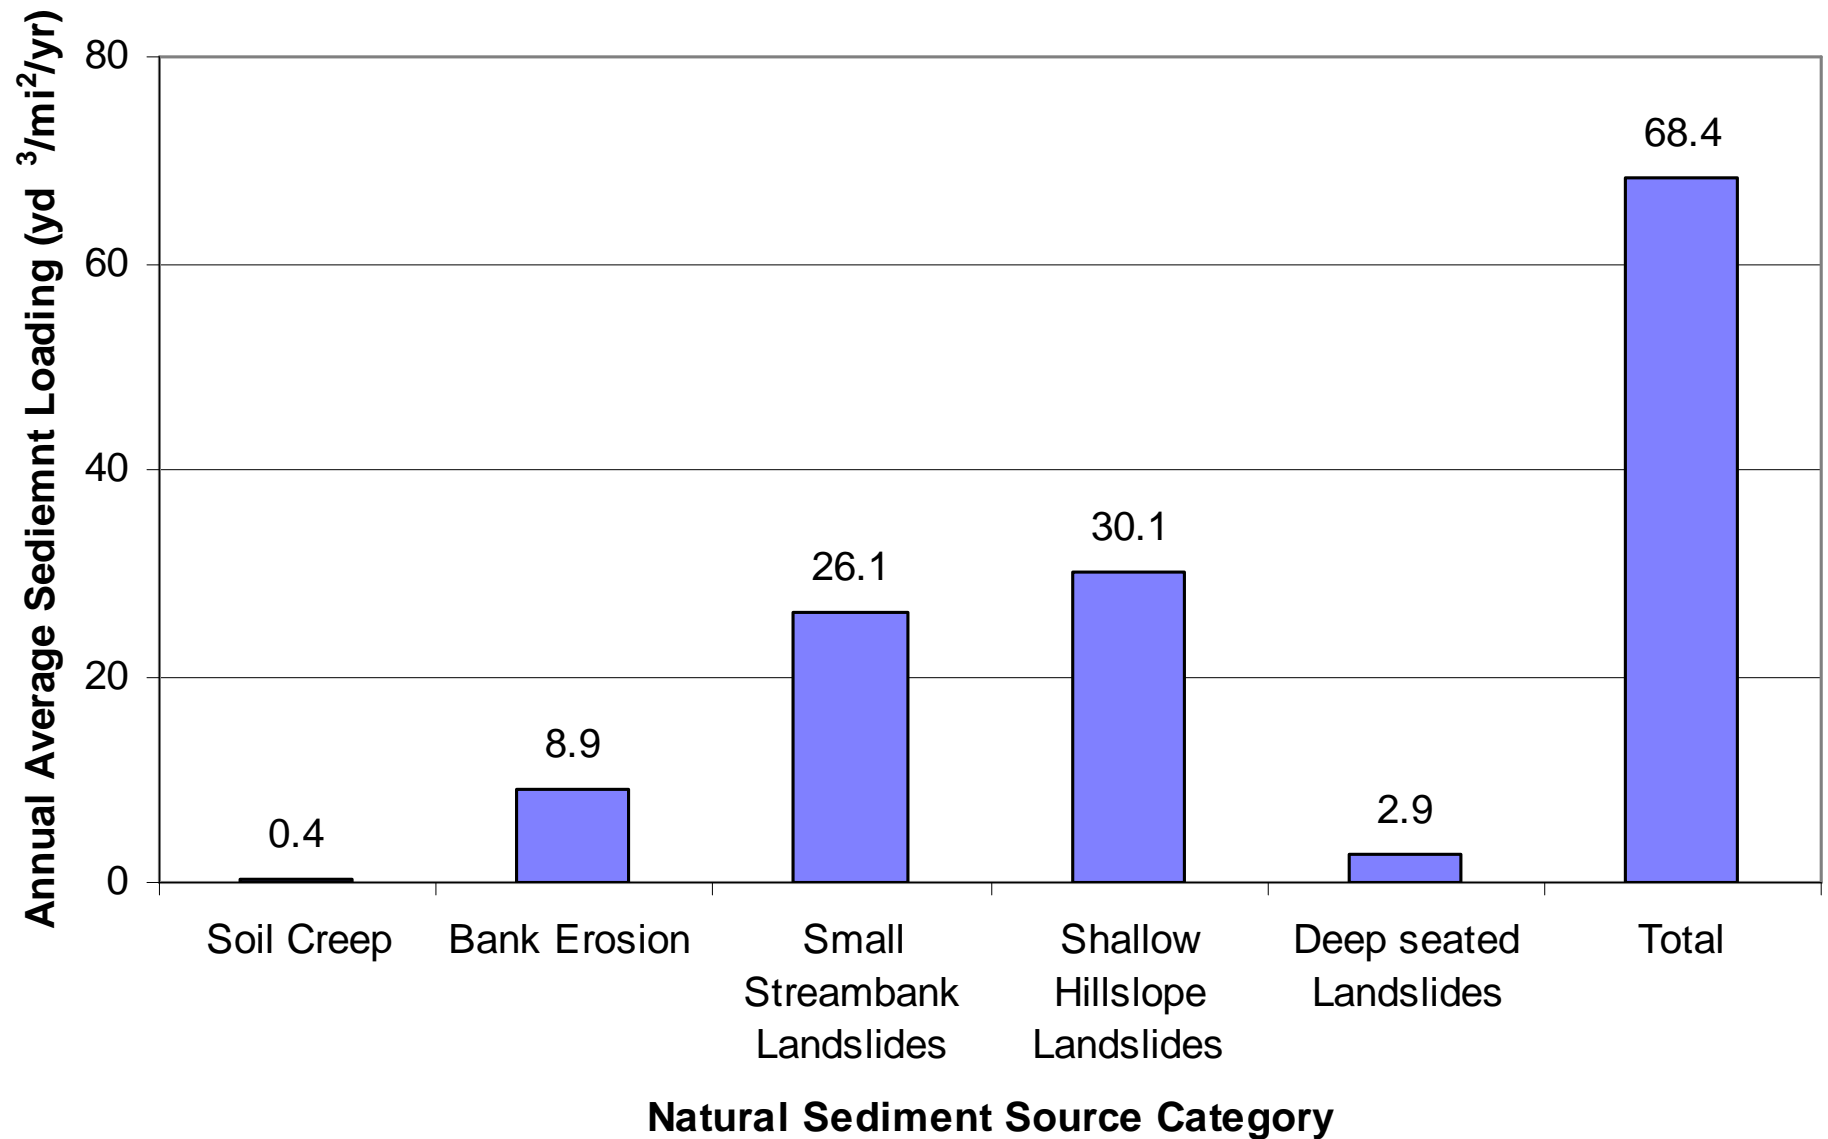
Upper Elk Natural Sources Summary

Sediment Source	Data Sources Relied Upon / Approach
Natural	Soil Creep	Literature
	Bank Erosion	Field surveys; natural drainage density estimate
	Small Streambank Landslides	Field surveys; natural drainage density estimate
	Shallow Hillslope Landslides	Areas not harvested in past 15 years
	Deep seated Landslides	CGS mapped active features; Palco WA rates

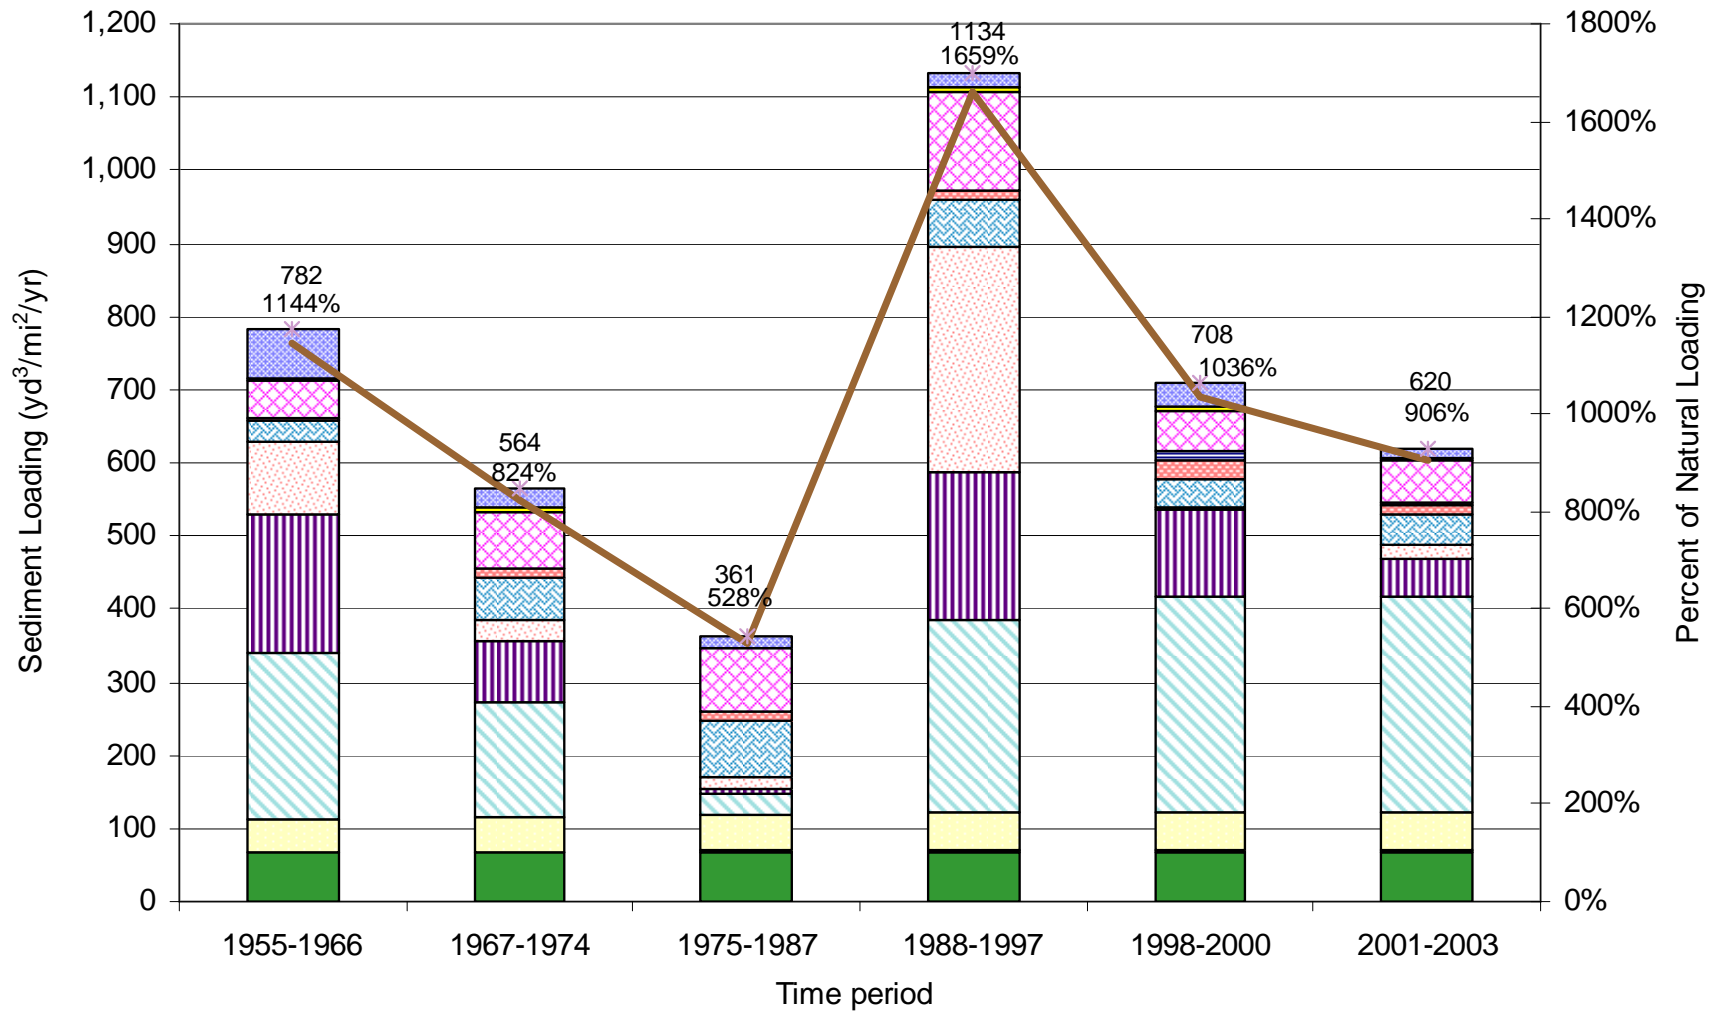
Upper Elk Management Sources Summary

- Natural Loading
- Bank Erosion
- Streamside Landslides
- Soil Creep
- Management-related discharge sites
- Open Slope Shallow Landslides
- Road Surface Erosion
- Harvest Surface Erosion
- Road-related Landslides
- Skid Trails
- Post-Treatment Discharge Sites
- Low Order Channel Incision
- % of Natural Loading
- Total Loading

TMDL		Palco WA	
	Source Category	1988-2000 (yd ³ /mi ² /yr)	Source Category	1988-2000 (yd ³ /mi ² /yr)
Natural	Soil Creep	0.44	Soil Creep	52
	Bank Erosion	9	Bank Erosion	38
	Shallow Landslides	26	Shallow Landslides	68
	Streamside Landslides	30	Streamside Landslides	276
	Deep Seated Landslides	0	Deep Seated Landslides	3
	Natural Total	66	Natural Total	437
Management	Low Order Channel Headward Incision	24		
	Soil Creep	1		
	Bank Erosion	52	Bank Erosion	38
	Streamside Landslides	272	Road-related Streamside Landslides	162
	Open-slope Shallow Landslides	182	Open-slope Shallow Landslides	144
	Road-related Shallow Landslides	237	Road-related Shallow Landslides	168
	Discharge sites	59	Gullies	28
	Skid Trails	15		
	Post-Treatment Discharge Sites	3		
	Road surface erosion	118	Road surface erosion	32
	Harvest Surface Erosion	5	Surface Erosion	6
	Management Total	967	Management Total	579
Total Loading	1,033	Total Loading	1,016

Percent over Natural Loading	1,576%	Percent over Natural Loading	232%
