Sample Identification	PCE	TCE	cis-1,2-DCE	All Other VOCs
AEI-B10-30'-GW	295	ND	ND	ND
AEI-B11-30'-GW	241	2.8	ND	ND
AEI-B12-30'-GW	40.6	ND	ND	ND
AEI-B13-30'-GW	39.9	ND	ND	ND
AEI-B14-30'-GW	195	5.1	ND	ND
AEI-B15-30'-GW	4,920	ND	ND	ND
AEI-B16-30'-GW	347	ND	ND	ND
AEI-B17-30'-GW	92	ND	ND	ND
AEI-B18-28'-GW	1,640	4.3	ND	ND
AEI-B18-31'-GW	1,440	4.0	ND	ND
AEI-B18-37'-GW	1,040	2.0 ^J	ND	ND
AEI-B19-30'-GW	2,600	25.0	15.0	ND

Phase III Subsurface Investigation
 Fountain-Vine Plaza
 1253 Vine Street
 Los Angeles, California 90028
 AEI Project Number 28508

May 15, 2013

Project No. Fountain-Vine.p01

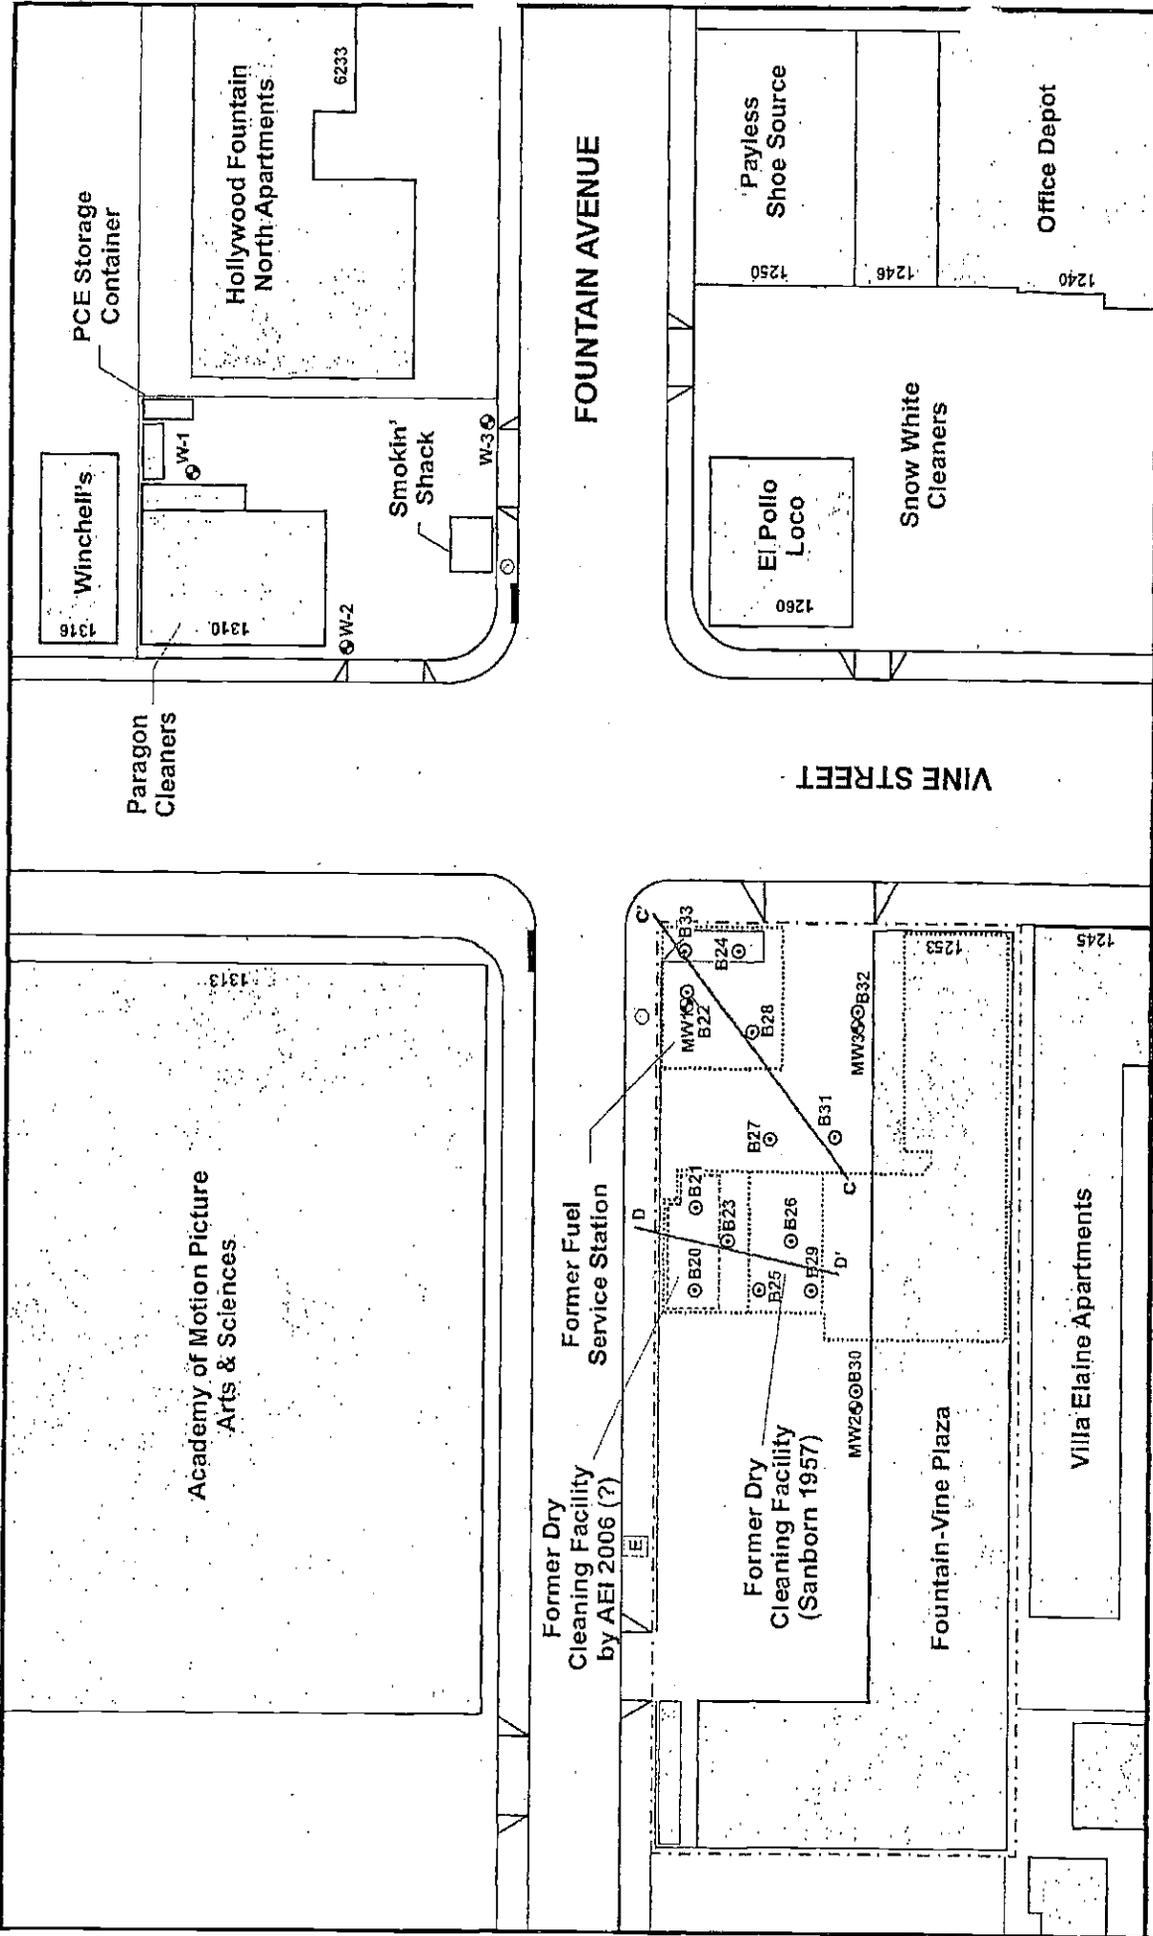
Figure 2: Site Map
 Fountain-Vine Plaza
 1253 Vine Street
 Los Angeles, California 90028

B20 - B33 Soil, soil gas, and groundwater borings (AA&A, 04/2013)
 MW1 - MW3 Groundwater monitoring wells
 D ——— D' Cross Section

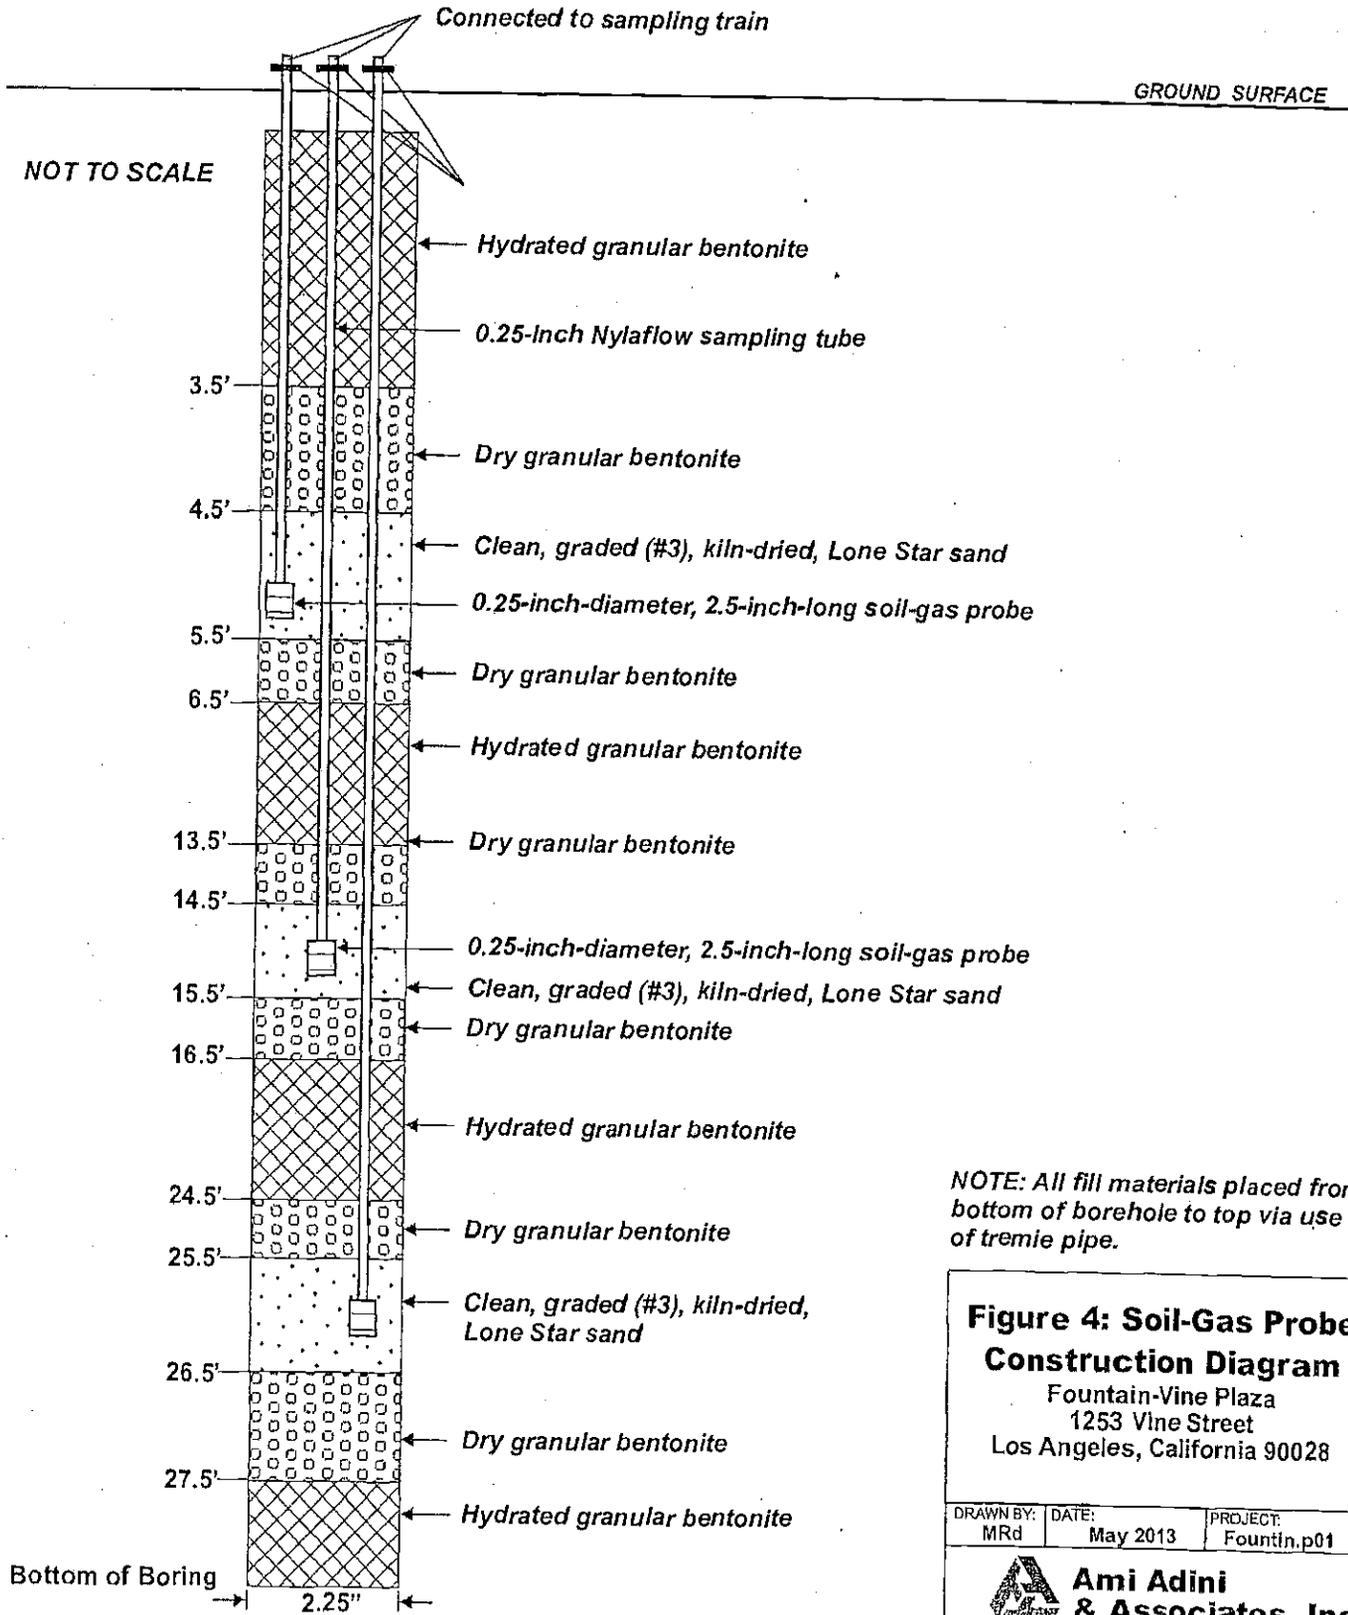
Figure 4: Soil-Gas Probe Construction Diagram
 Fountain-Vine Plaza
 1253 Vine Street
 Los Angeles, California 90028

Soil-Gas Probe Construction Diagram B20 through B33

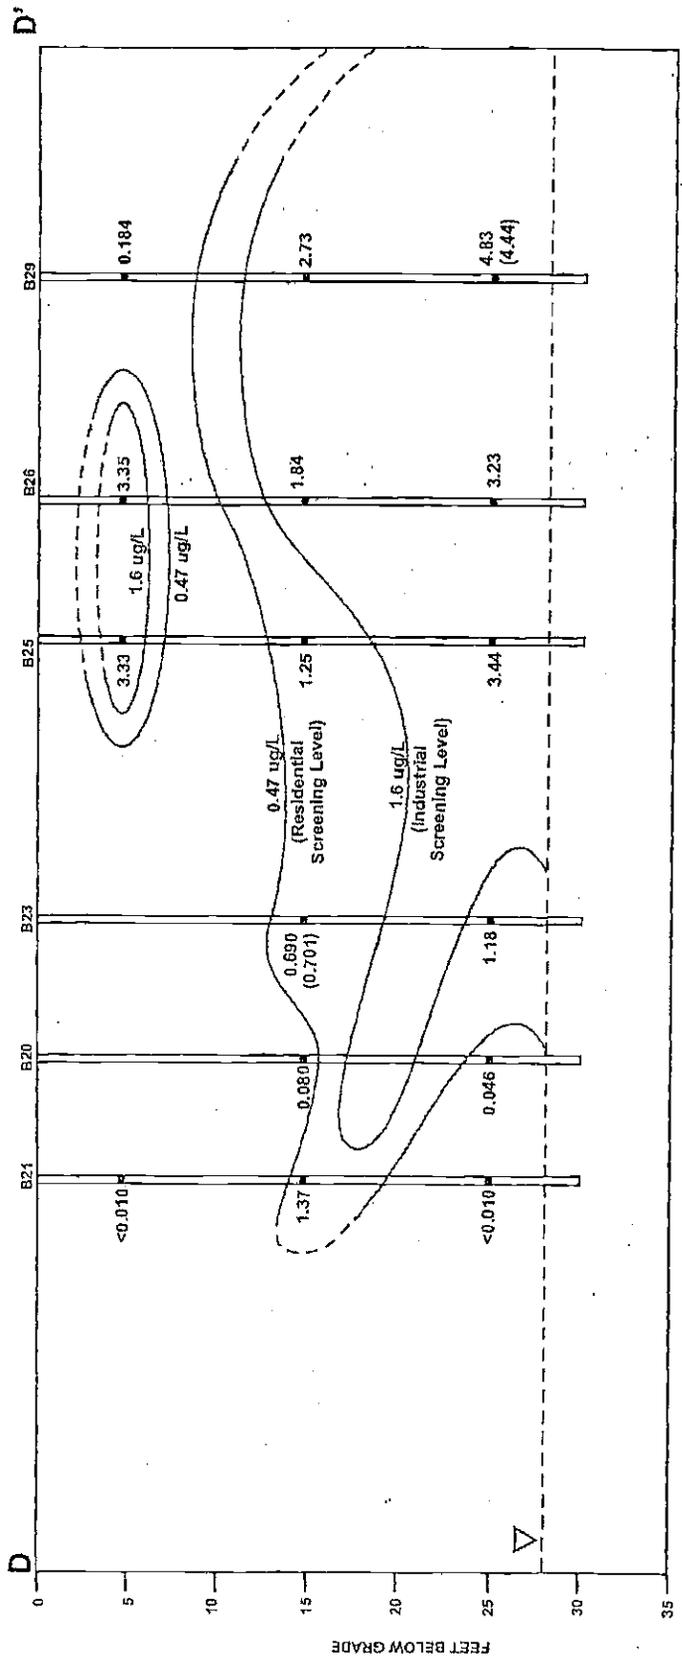
Figure 6: Cross Section with PCE in Fountain-Vine 1253 Vine
 Los Angeles, Calif
 DRAWN BY: MRD/SS DATE: May 201
Ami Adli & Assoc

* Due to transposition of some borings onto cross section, data from boring B22 not used in depiction of soil gas contour lines in favor of data from boring B24 in same transposed location.

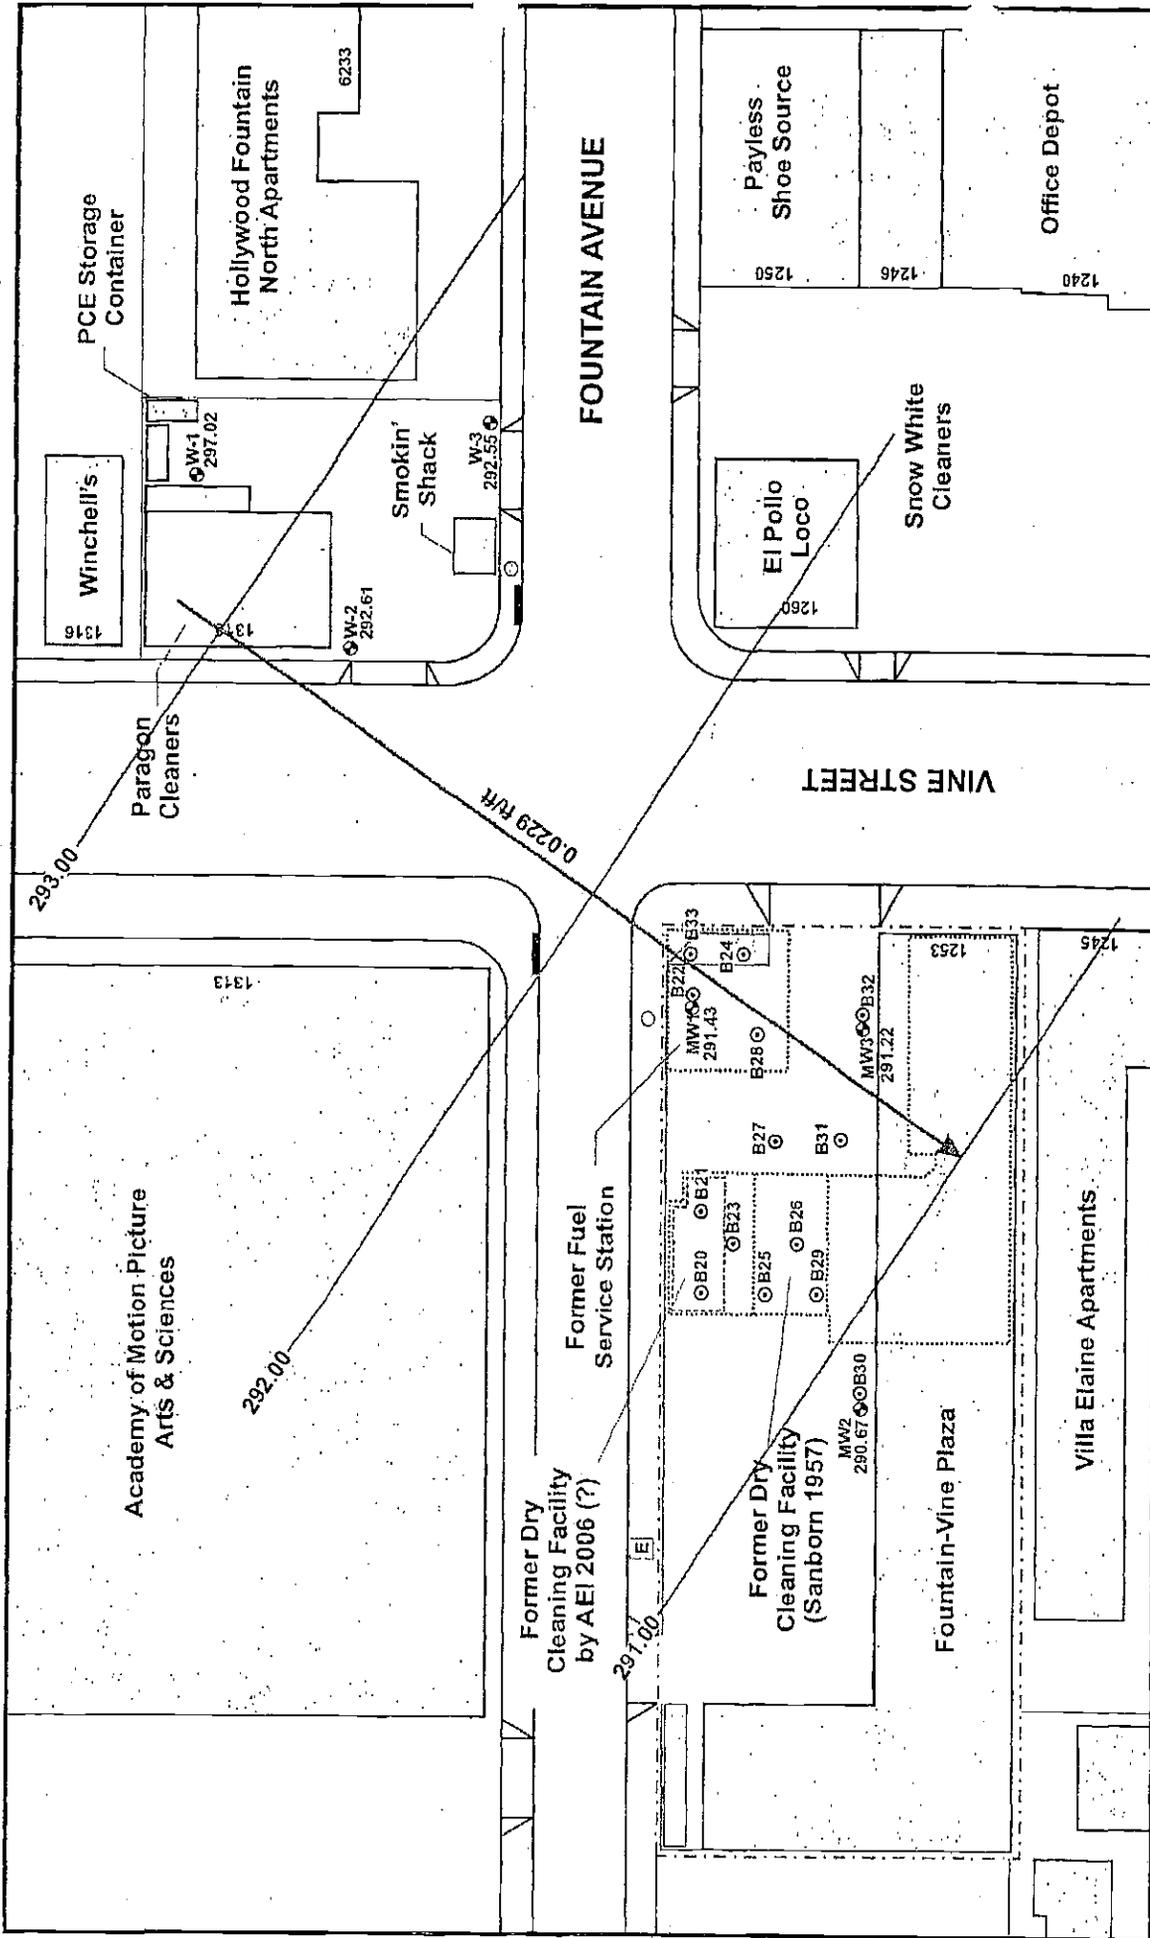
Figure 7: Groundwater Contour Map

0.0229 f/ft

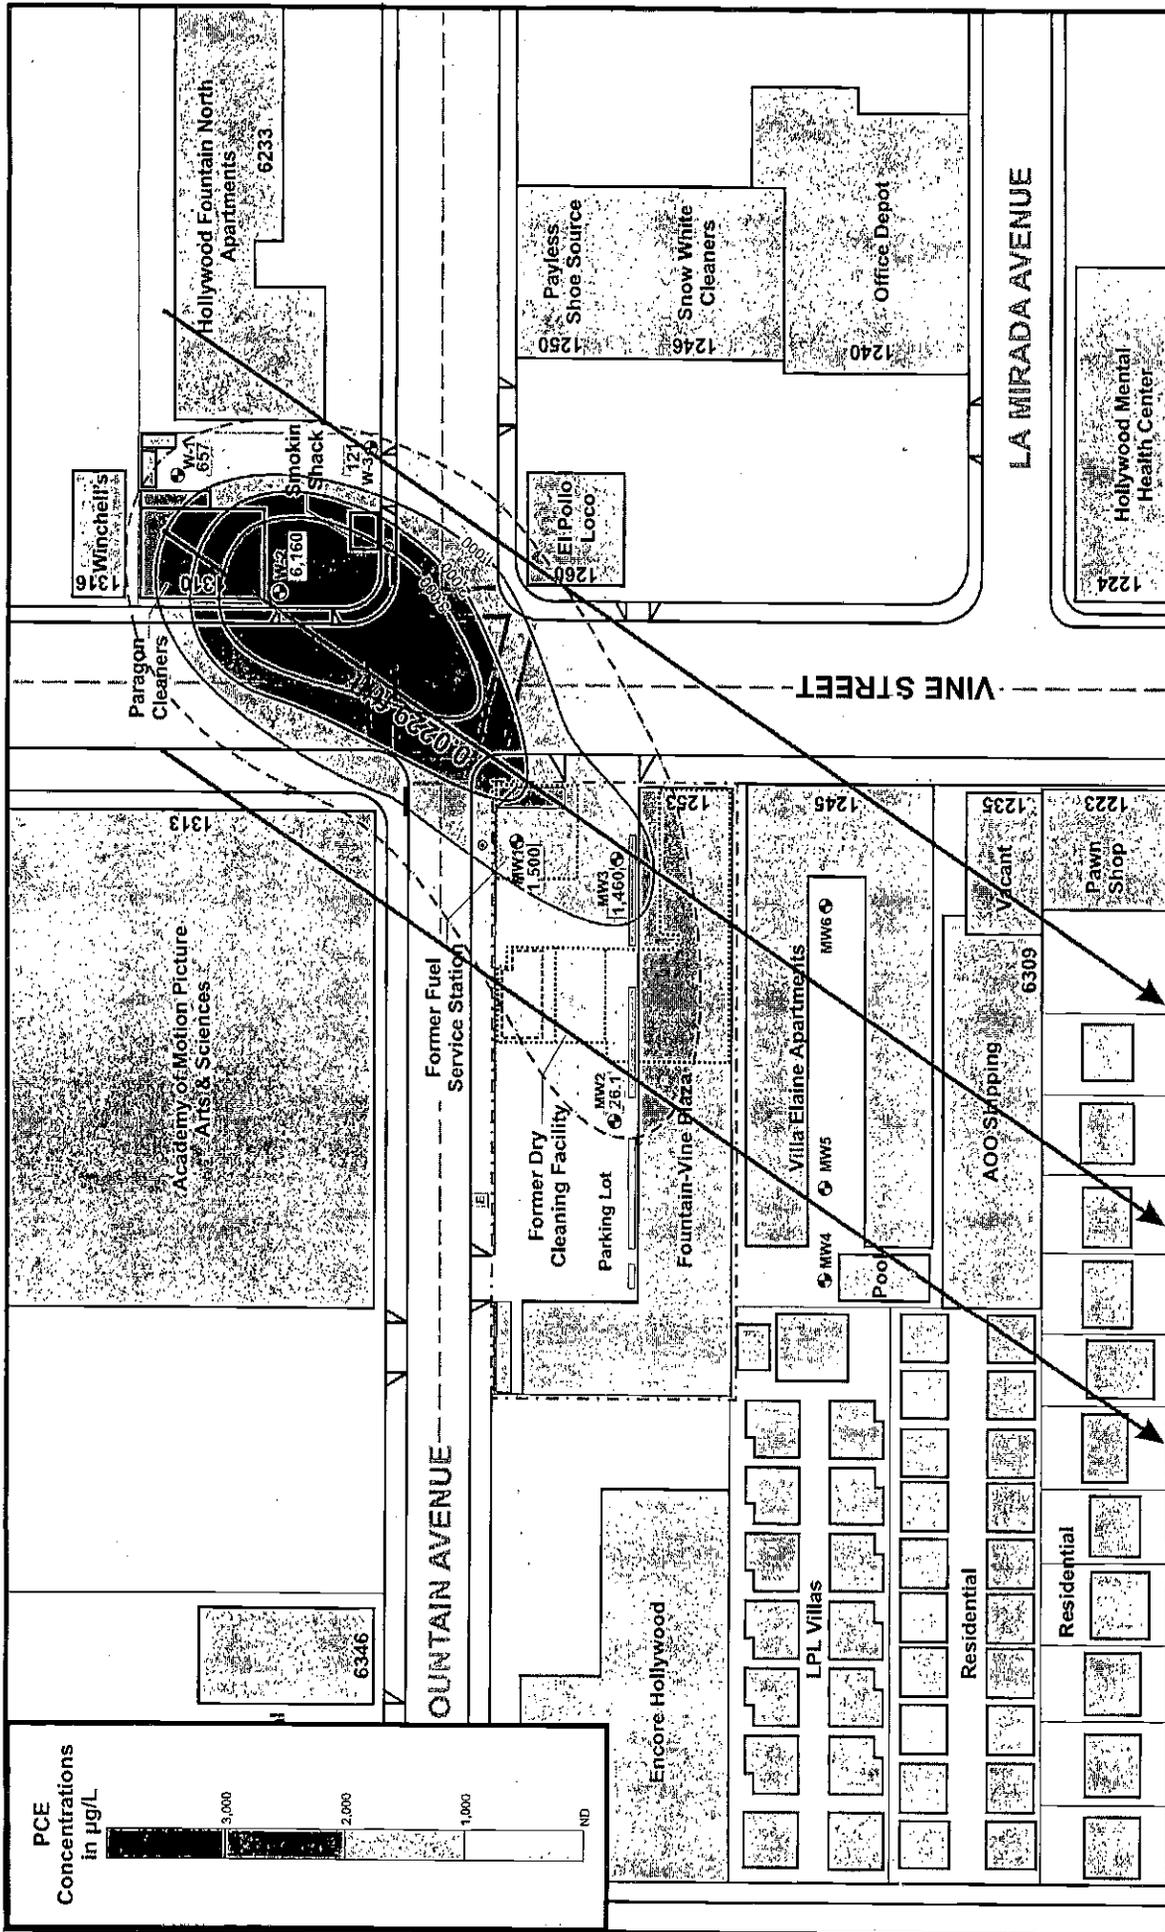
Figure 2: Site Map with PCE Plume in Groundwater - 4/16/13
Fountain-Vine Plaza
 1253 Vine Street
 Los Angeles, California 90028
 DRAWN BY: LW/MRD DATE: October 2013 PROJECT: Fountain-Vine.p01

PCE Concentrations in µg/L

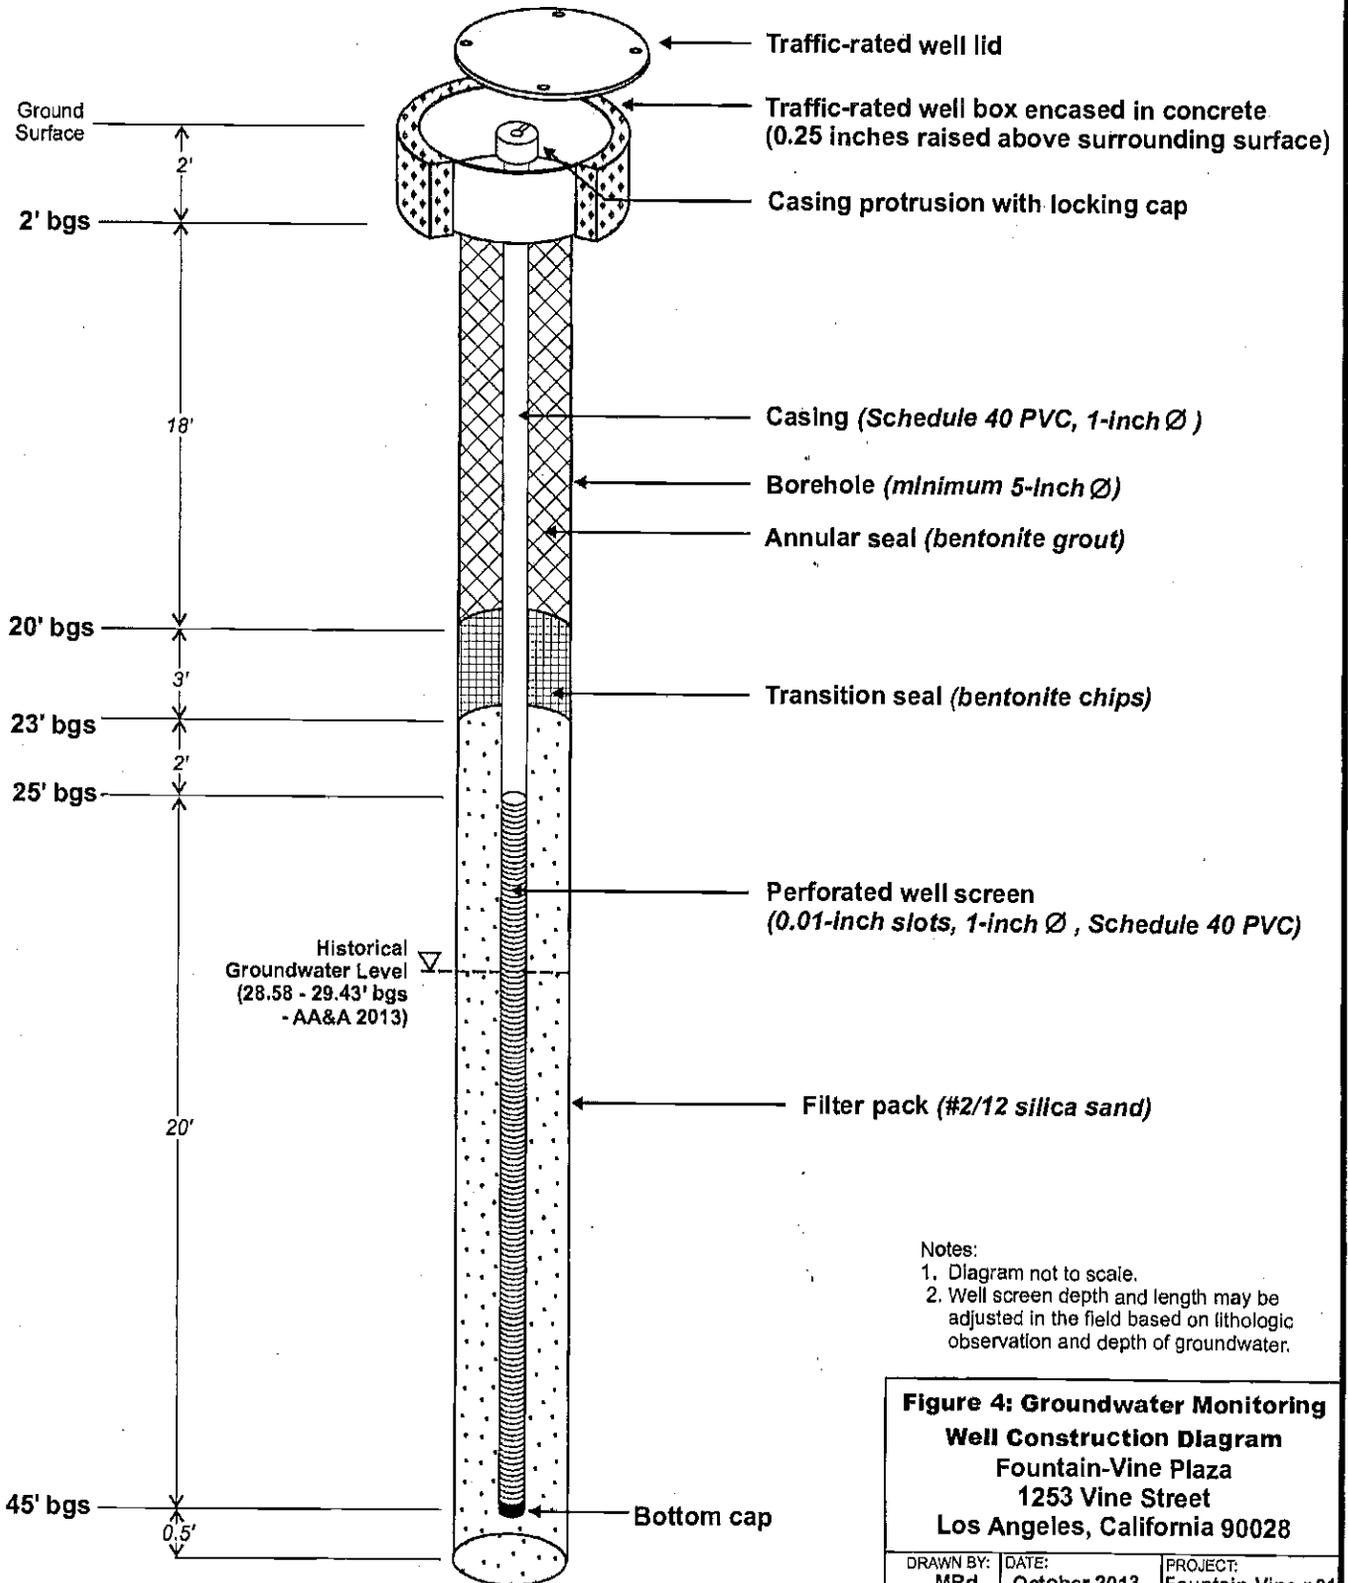
Well Construction Diagram MW4 through MW6

1. Diagram not to scale.
2. Well screen depth and length may be adjusted in the field based on lithologic observation and depth of groundwater.

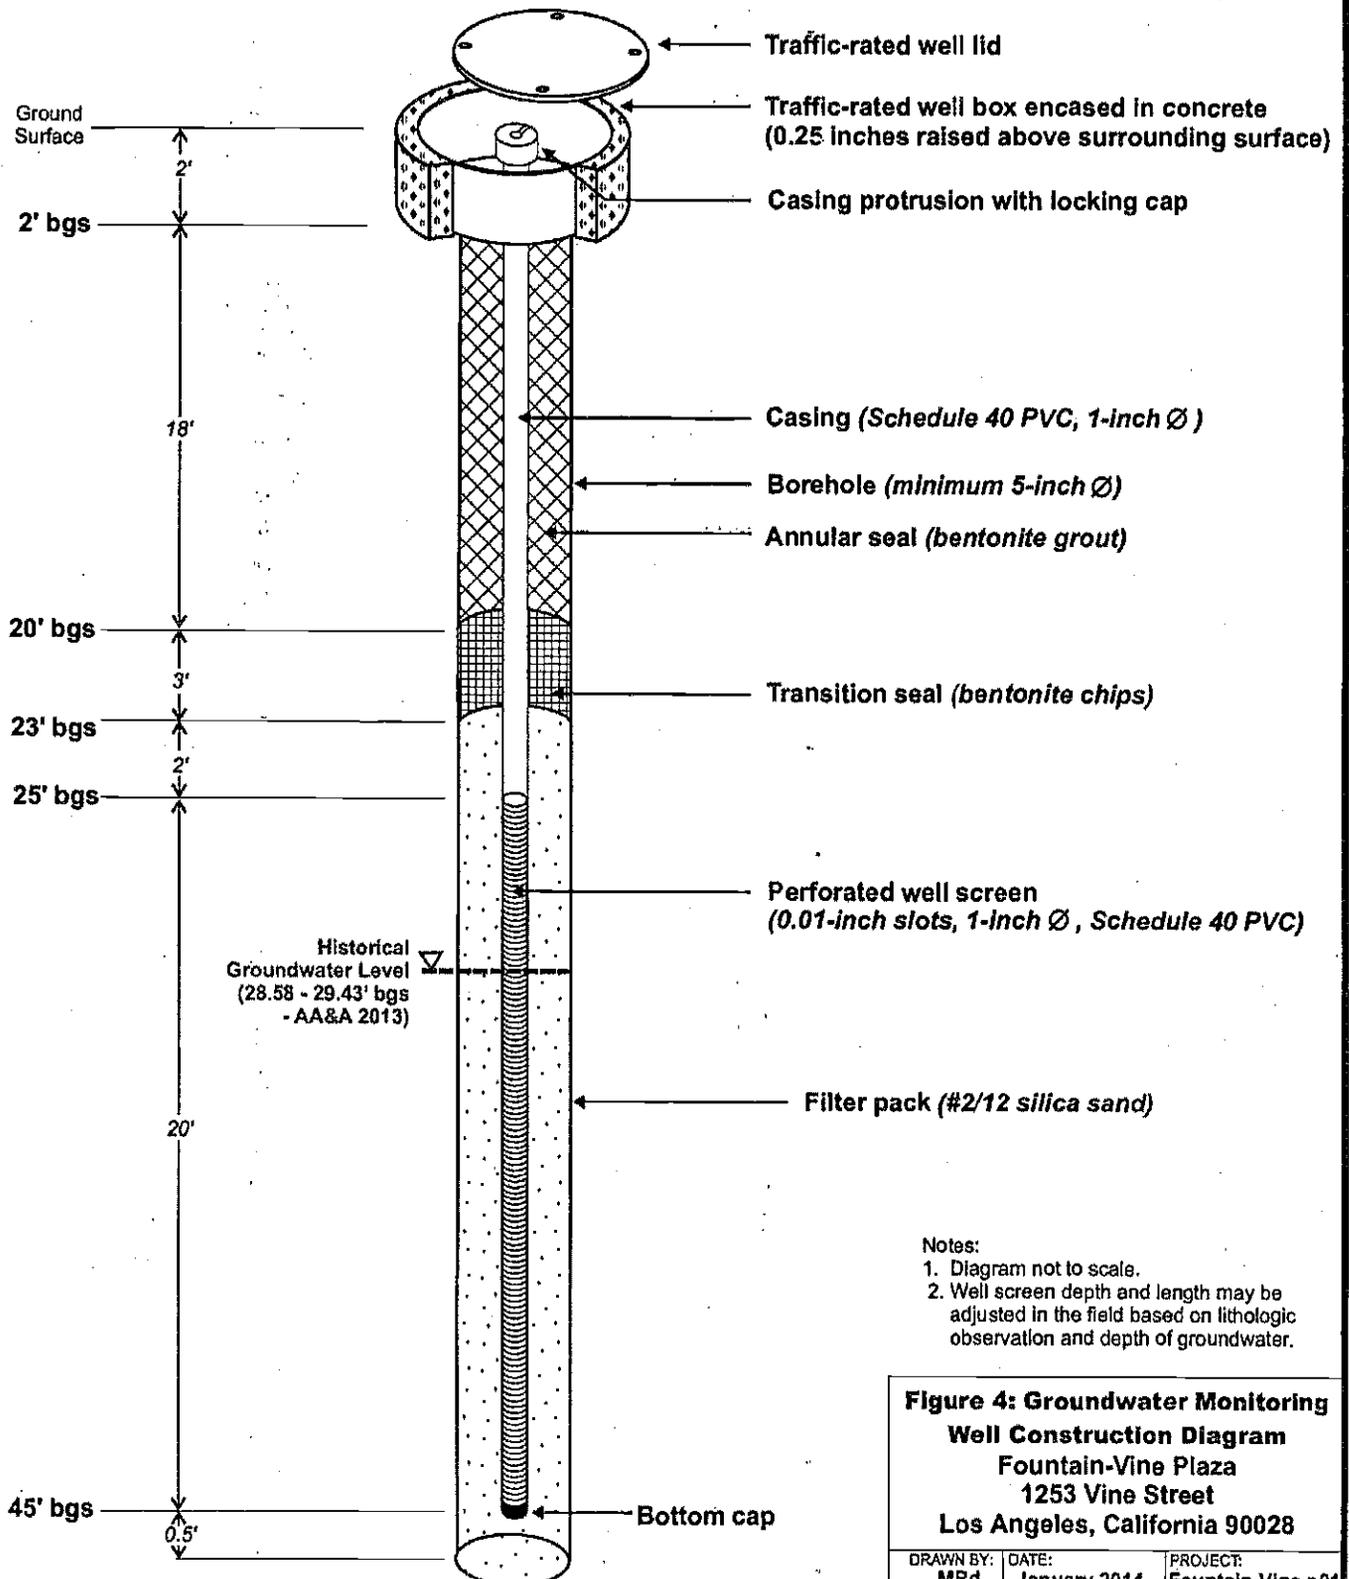
Well Construction Diagram MW4 and MW5

1. Diagram not to scale.
2. Well screen depth and length may be adjusted in the field based on lithologic observation and depth of groundwater.
