California Regional Water Quality Control Board, San Diego Region

Request to Address Mitigation Planting Failure and Onsite Erosion

On February 28, 2014, staff of the California Regional Water Quality Control Board, San Diego Region (San Diego Water Board) observed onsite erosion and the absence of mitigation habitat at your vineyard at 40205 Calle Cabernet. By March 28, 2014, please submit to me a written plan of action to address these deficiencies which are detailed below.

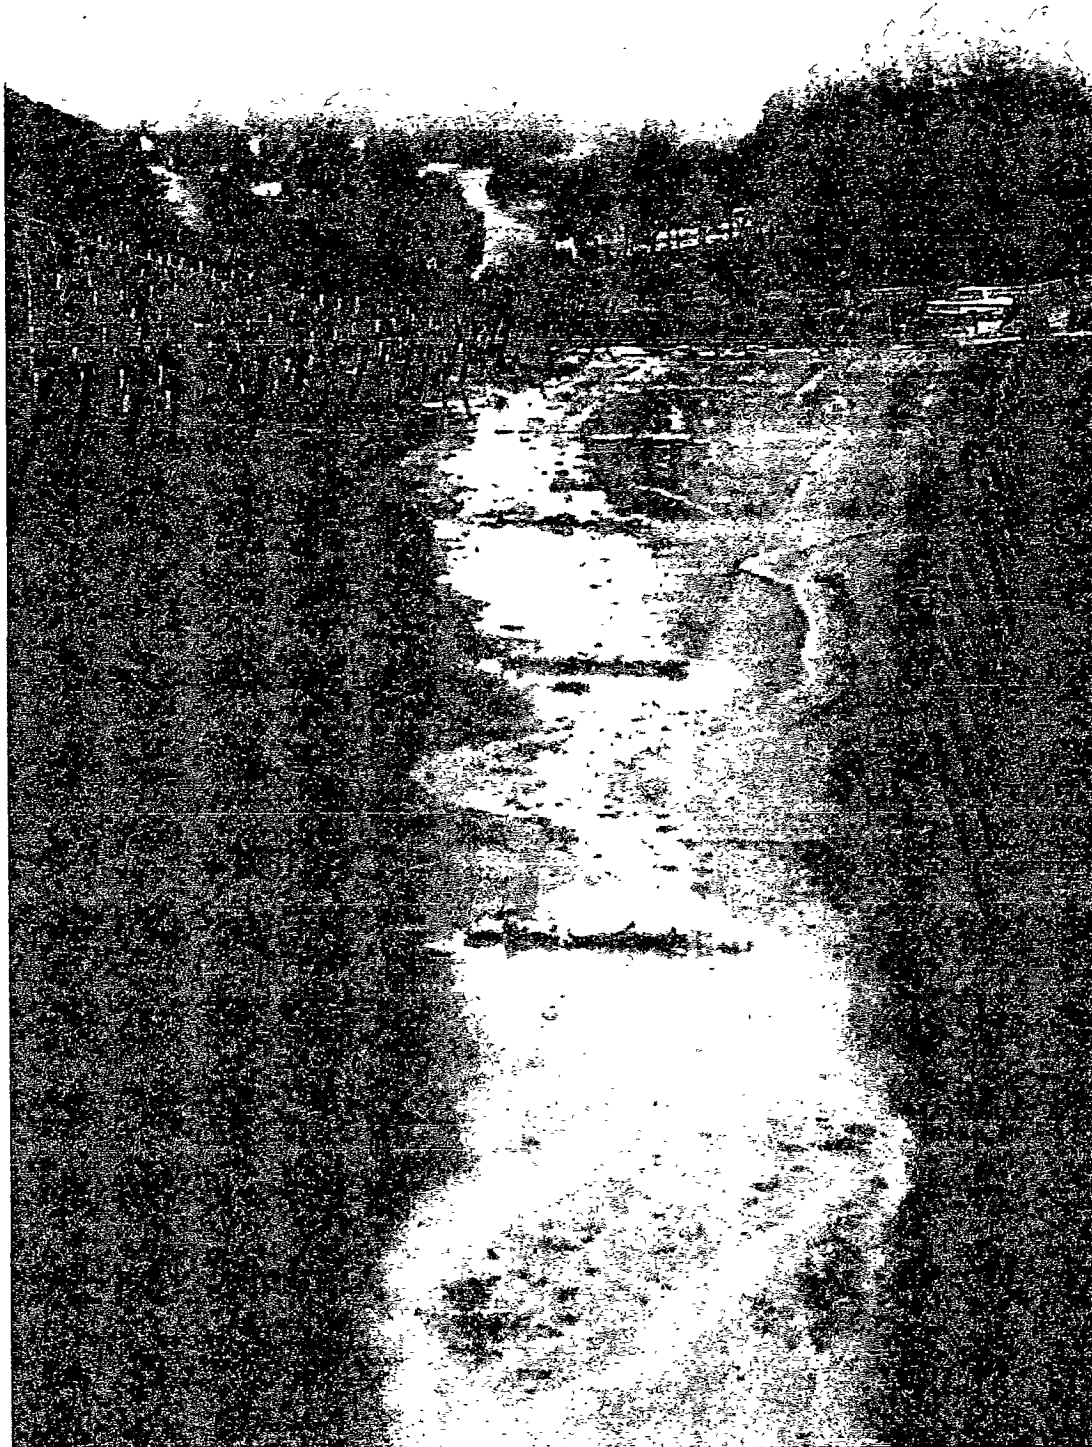
Photograph (20140228_093905.jpg) taken on February 28, 2014, by Frank Melbourn, San Diego Water Board. Photograph taken looking to the west from Calle Cabernet. Runoff can be seen flowing through the streambed. The streambed has intermittent gravel bag check dams; some of which are placed outside the flowpath and therefore ineffective. Note that the streambed is barren of vegetation and lacks mitigation habitat that was planted in the streambed in November 2013.

By letter dated October 8, 2013, you agreed to plant Mulefat in the ephemeral stream bed running across the vineyard as mitigation for the June 2012 unauthorized grading in the stream to construct the vineyard. This vegetative cover is necessary to minimize soil erosion and compensate for habitat loss from your grading activities. On November 13, 2013, you submitted a written statement along with photographs demonstrating the planting of 400 Mulefat seedlings in the streambed. San Diego Water Board staff observed that the streambed is barren, and that the Mulefat seedlings did not survive after their planting. See attached photograph of streambed. Therefore, you must submit a written plan of action to address the failure to mitigate the unauthorized grading (i.e., that you will replant the area with Mulefat seedlings by a certain date, etc.).

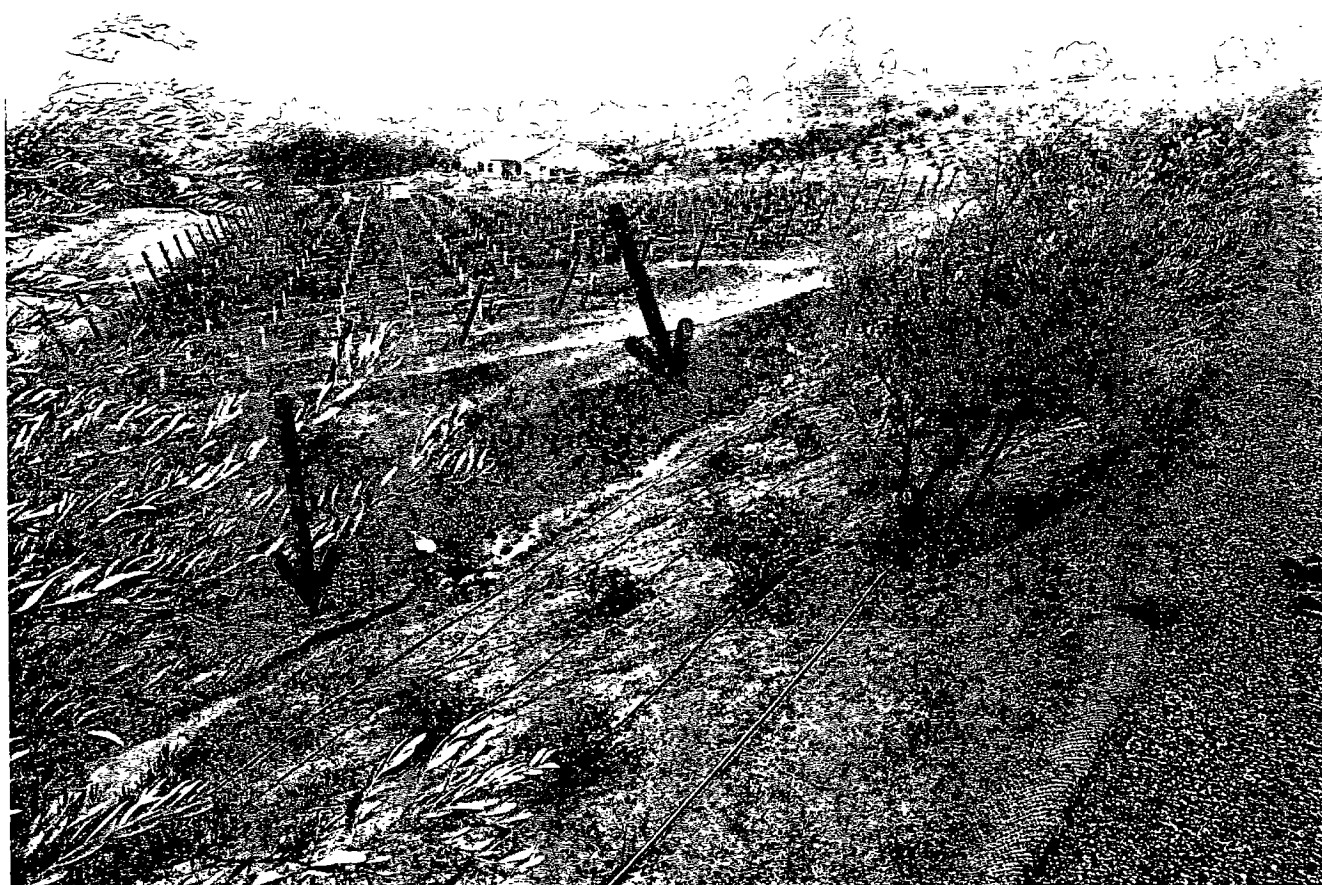
Photograph (20140228_093830.jpg) taken on February 28, 2014, by Frank Melbourn, San Diego Water Board. Photograph taken looking to the northwest from Calle Cabernet. Note the erosion of the earthen drainage ditch where the far sides are slumping into the ditch and turbid soil colored water can be seen flowing from the upper right of the picture to the lower left. The erosion is indicated with the red arrows.

On February 28, 2014, during a storm event San Diego Water Board staff noted erosion along the east side of your vineyard at the base of the slope that runs parallel with Calle Cabernet. See attached photograph of erosion. Therefore, you must submit a written plan of action to address the erosion (i.e., how you will repair the erosion and protect the area from eroding in the future).
