Status Update on a Pathway to Water Quality Restoration in the Santa Margarita River Estuary

Hiram Sarabia, Environmental Scientist

San Diego Water Board September 13, 2017

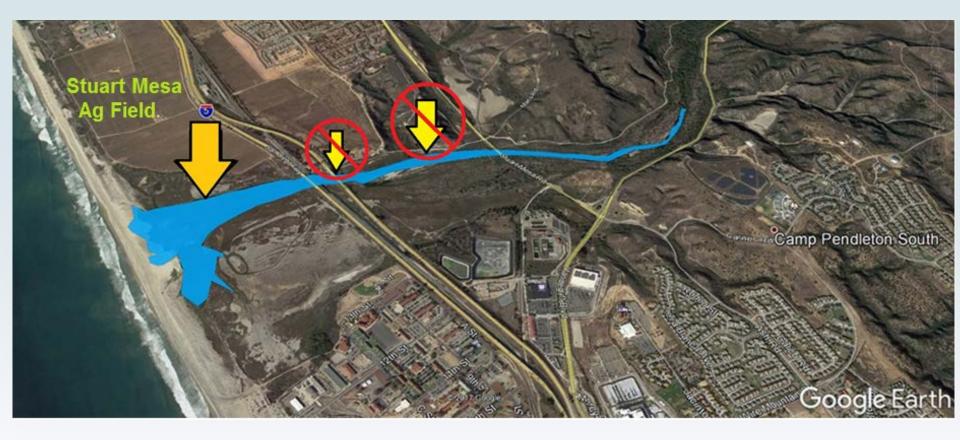
Historic Nutrient Sources

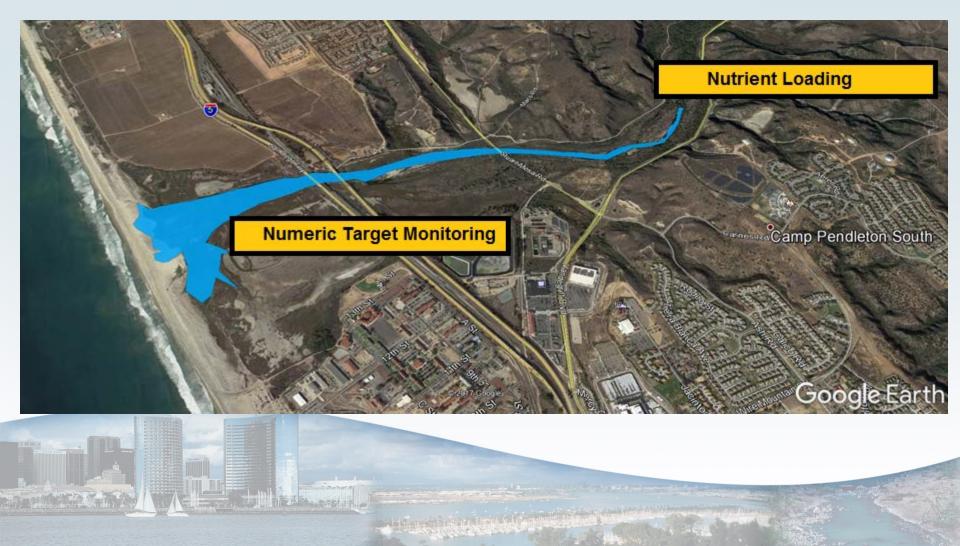
- Implement New and Robust Monitoring and Assessment Program
 - Monitoring and Assessment Framework
