CALIFORNIA REGIONAL WATER QUALITY CONTROL BOARD  
SAN DIEGO REGION

**Amended**  
**TECHNICAL ANALYSIS**

ADMINISTRATIVE CIVIL LIABILITY CONTAINED IN  
COMPLAINT NO. R9-2015-0110

SAN ALTOS-LEMON GROVE, LLC  
VALENCIA HILLS CONSTRUCTION SITE  
WDID 9 37C369143

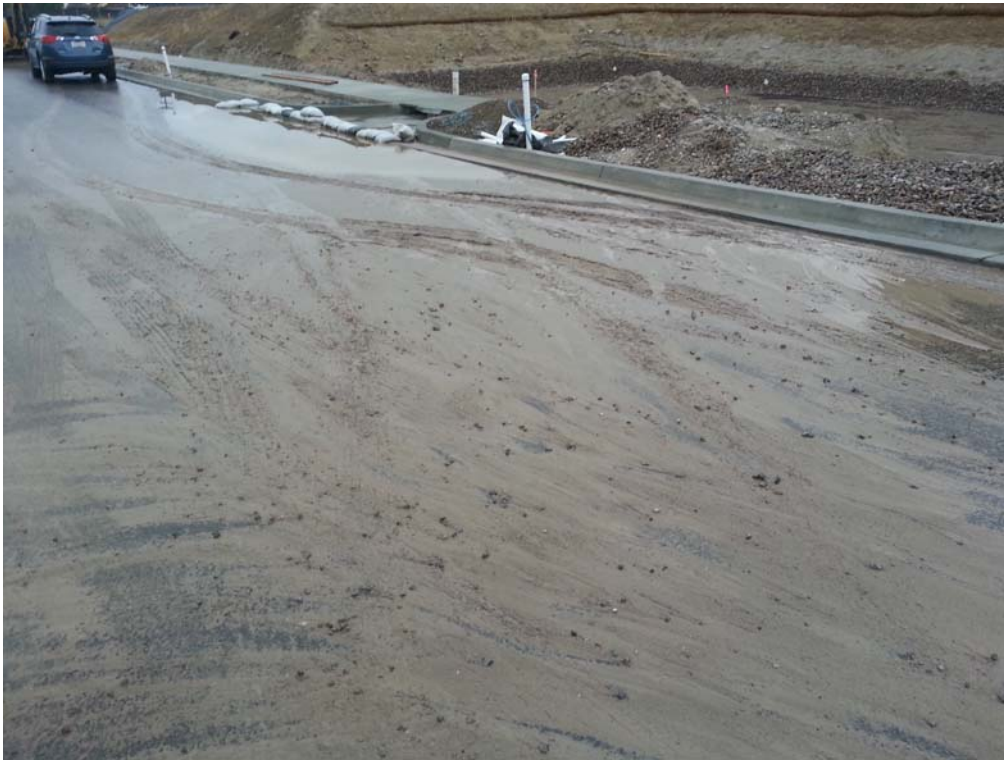
Sediment-laden water was discharged from the Site into Encanto Channel and Chollas Creek on December 4, 12, 17, 31, 2014, May 8, 2015, and September 15, 2015. See Figure 2. May 8, 2015, Sediment Discharge. The violations were noted in the following documents:

**Figure 2. May 8, 2015, Sediment Discharge.** View of sediment in street (Orlando Drive) after storm event. Photograph taken by Frank Melbourn, San Diego Water Board. 20150508\_191716.jpg

The discharges into Encanto Channel and Chollas Creek were unauthorized and a violation of the Construction Storm Water Permit section III.B. because the Discharger failed to reduce or eliminate the pollutants in the storm water runoff prior to discharge (i.e., to implement BMPs that achieve BAT and BCT).

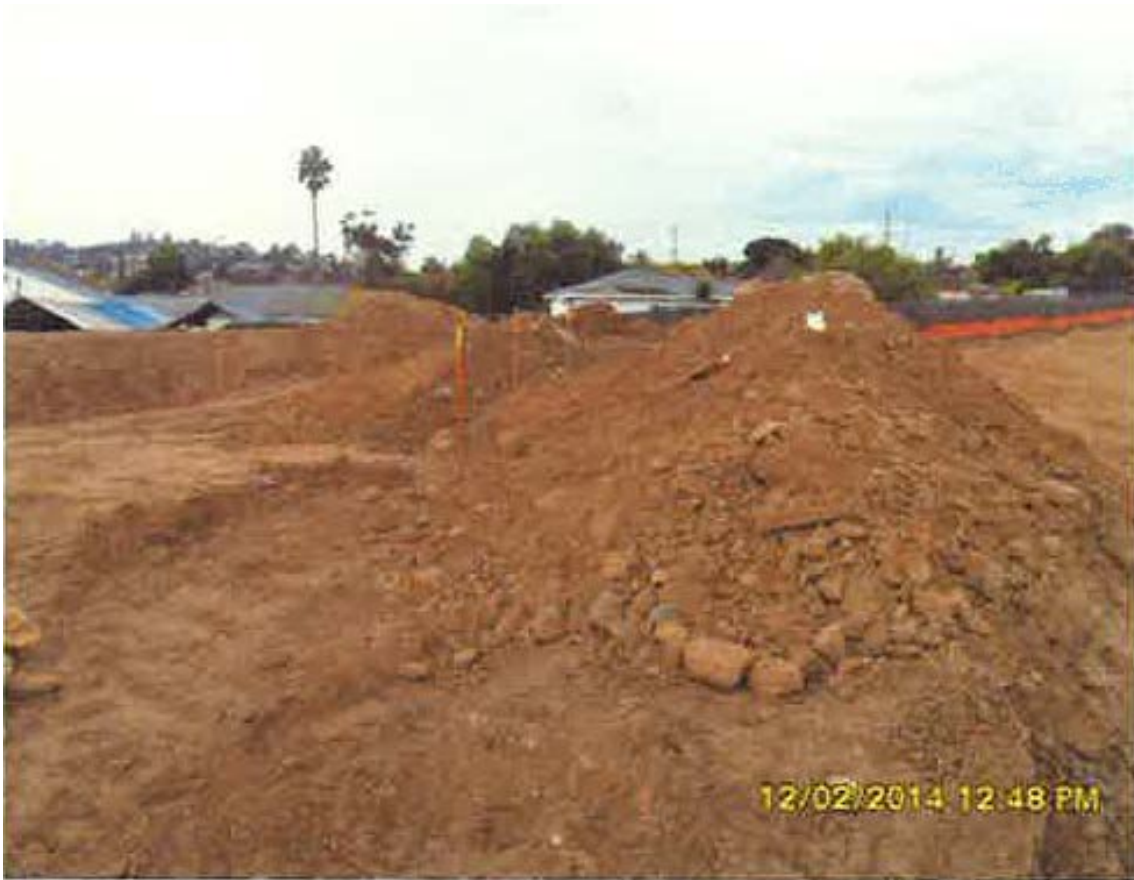
The Discharger was in violation of section B.1.b. for 10 days; from December 2 through 8, 2014, December 15, 2014, May 13, 2015, and September 15, 2015. See Figure 3. Failure to implement material stockpile BMPs. The violations were noted in the following documents:

**Figure 3. Failure to implement material stockpile BMPs.** Photograph taken by the City of Lemon Grove on December 2, 2014.

Pursuant to section B.1.b. in Attachment D to the Construction Storm Water Permit, dischargers are required to “[c]over and berm loose stockpiled construction materials that are not actively being used (i.e. soil, spoils, aggregate, fly-ash, stucco, hydrated lime, etc.).”

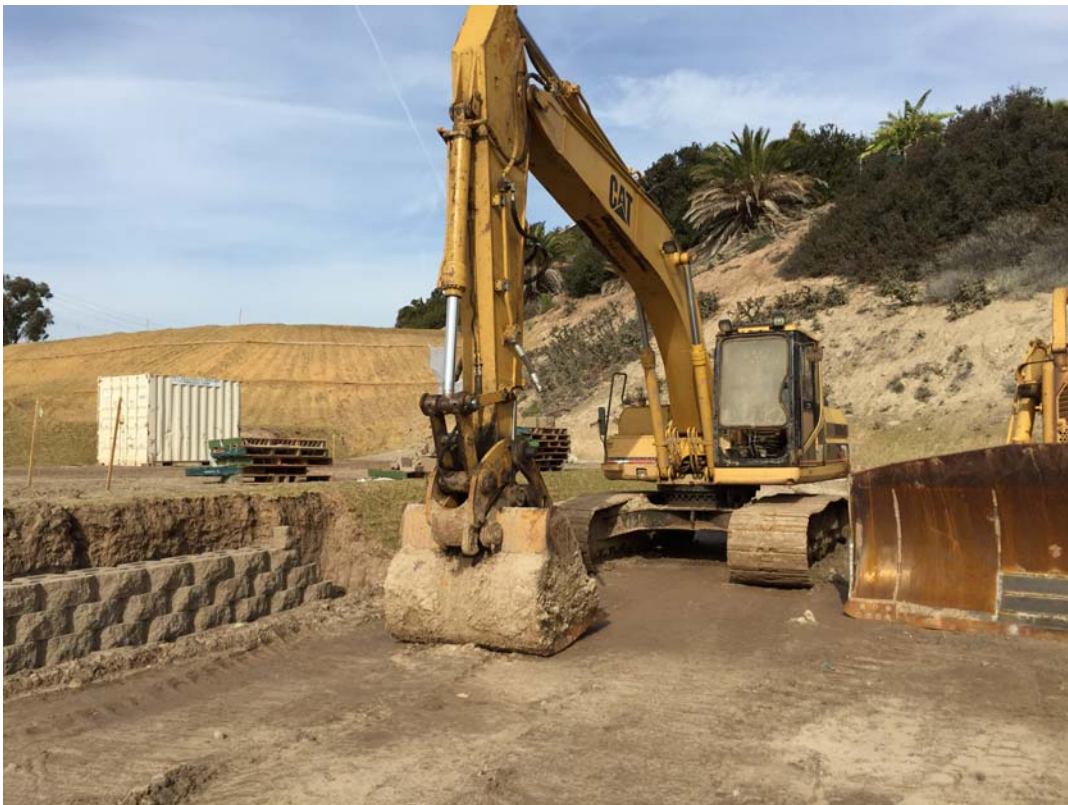
**Figure 4. Failure to have vehicle fluid leak protection.** Photograph taken by Wayne Chiu, San Diego Water Board on December 15, 2014, of heavy equipment without vehicle fluid leak protection. IMG\_5064.jpg

Pursuant to section B.3.a. in Attachment D to the Construction Storm Water Permit, dischargers are required to “[p]revent oil, grease, or fuel to leak in to the ground, storm drains or surface waters.” The Discharger was in violation of section B.3.a. for two days: December 15, 2014; and May 13, 2015. See Figure 4. Failure to have vehicle fluid leak protection. The violations were noted in the following documents:

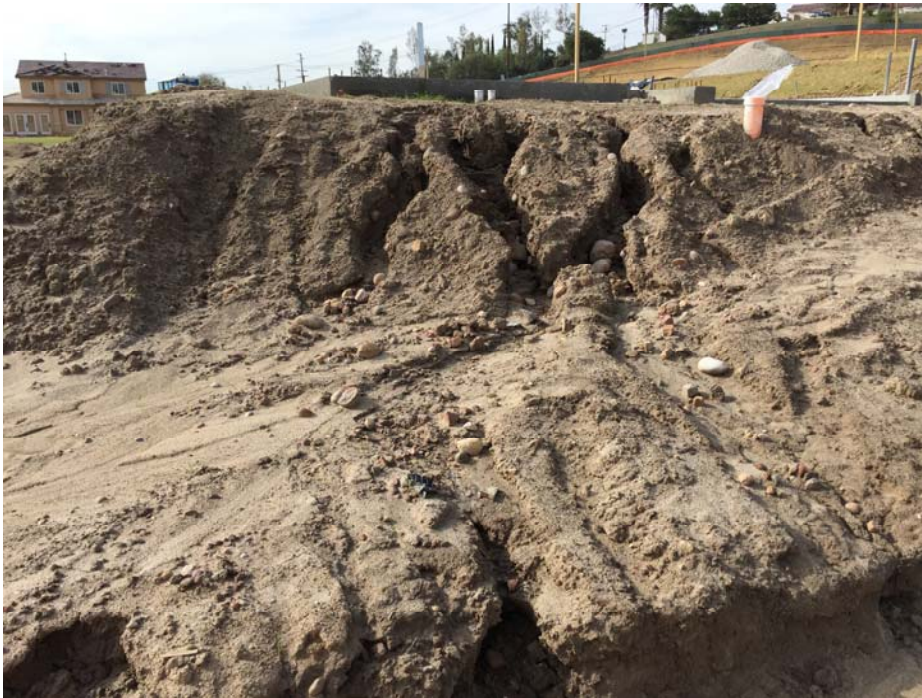
Pursuant to section D.2. in Attachment D to the Construction Storm Water Permit, dischargers are required to “*provide effective soil cover for inactive areas and all finished slopes, open space, utility backfill, and completed lots.*” The Discharger was in violation of section B.2. for 22 days: 9 days (December 1 through 9, 2014); 2 days (December 15 through 16, 2014); 1 day (January 6, 2015); 1 day (January 14, 2015); 8 days (May 8 through 15, 2015), and 1 day (September 15, 2015). See Figure 5. Failure to implement erosion control BMPs on inactive areas.

**Figure 5. Failure to implement erosion control BMPs on inactive areas.**

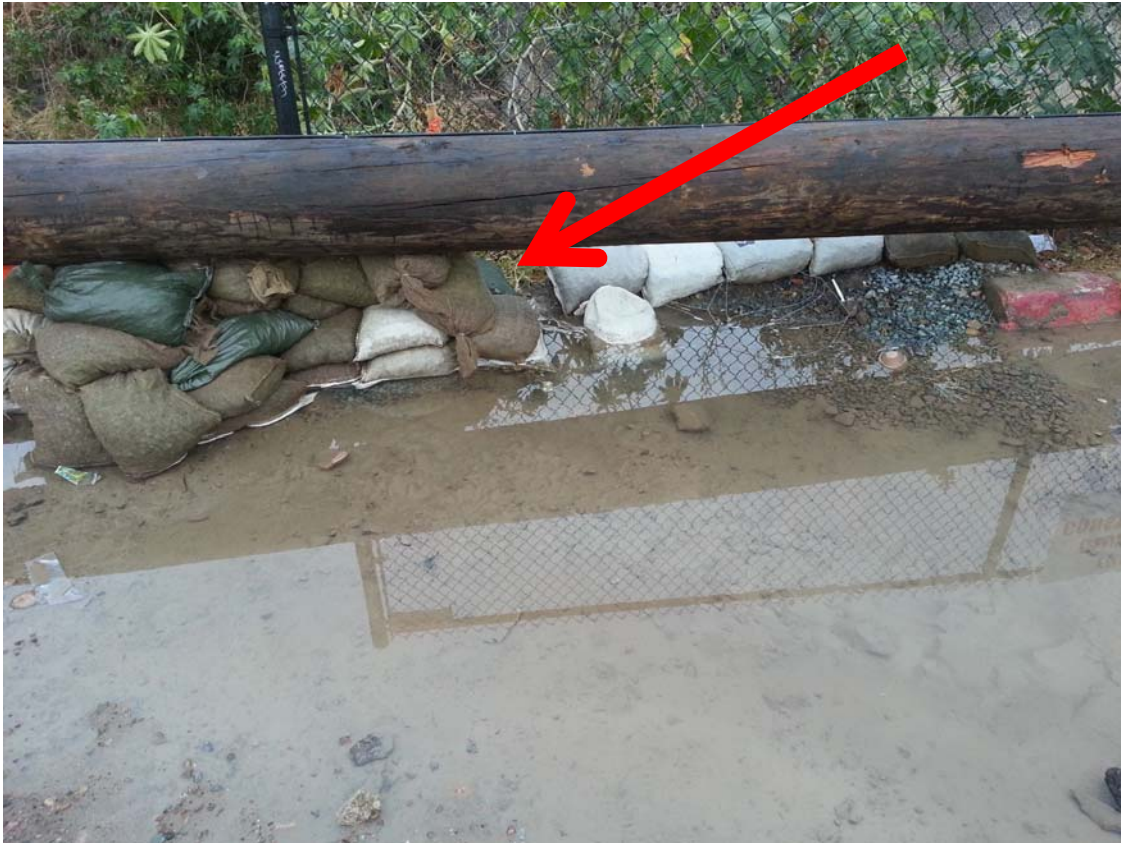
**Figure 6. Failure to implement perimeter sediment control BMPs.** Photograph taken by Frank Melbourn, San Diego Water Board on May 8, 2015, of gap (identified by red arrow) in perimeter sediment control BMPs that resulted in sediment discharge to Encanto Channel. 20150508\_192234.jpg

Pursuant to section E.1. in Attachment D to the Construction Storm Water Permit, dischargers are required to “*establish and maintain effective perimeter controls and stabilize all construction entrances and exits to sufficiently control erosion and sediment discharges from the site.*” The Discharger was in violation of section E.1. for 14 days: 5 days (December 4 through 8, 2014); 2 days (December 15 through 16, 2014); 6 days (May 8 through 13, 2015), and 1 day (September 15, 2015). See Figure 6. Failure to implement perimeter sediment control BMPs. The violations were noted in the following documents:

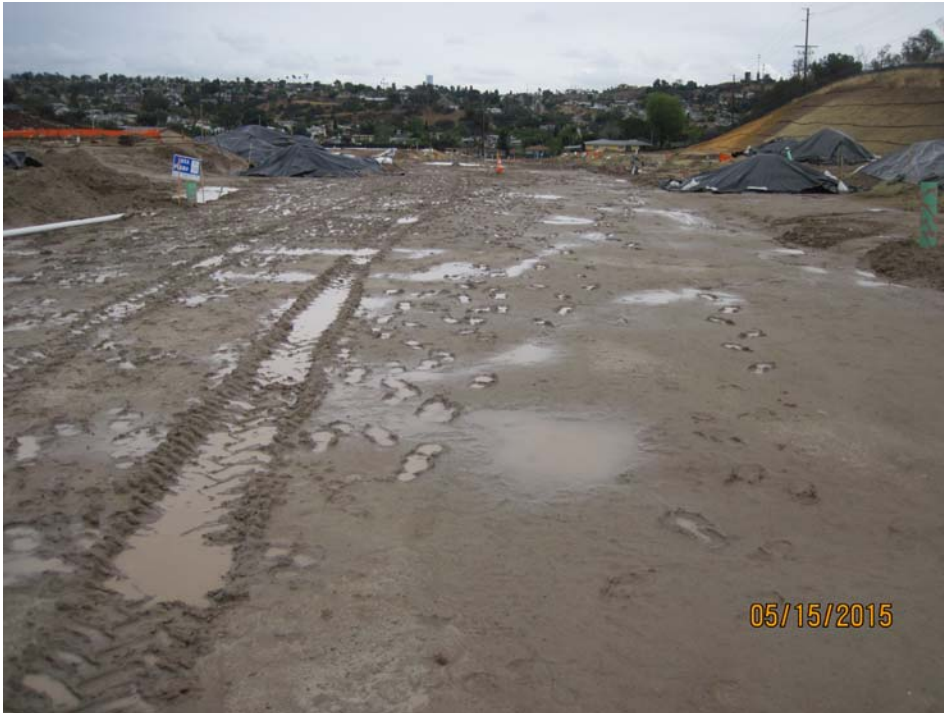
**Figure 7. Lack of erosion control BMPs in active areas.** Photograph on May 15, 2015, of muddy thoroughfare (Tangelos Place) lacking erosion control BMPs after rain event. Photograph taken by Frank Melbourn, San Diego Water Board. IMG\_0354.jpg

Pursuant to section E.3. in Attachment D to the Construction Storm Water Permit, dischargers are required to “*implement appropriate erosion control BMPs (runoff control and soil stabilization) in conjunction with sediment control BMPs for areas under active construction.*” The Discharger was in violation of section E.3. for 22 days: 8 days (December 1 through 8, 2014); 2 days (December 15 through 16, 2014); 1 day (January 6, 2015); 2 days (March 23 through 24, 2015); 8 days (May 8 through 15, 2015), and 1 day (September 15, 2015). See Figure 7. Lack of erosion control BMPs in active areas. The violations were noted in the following documents:

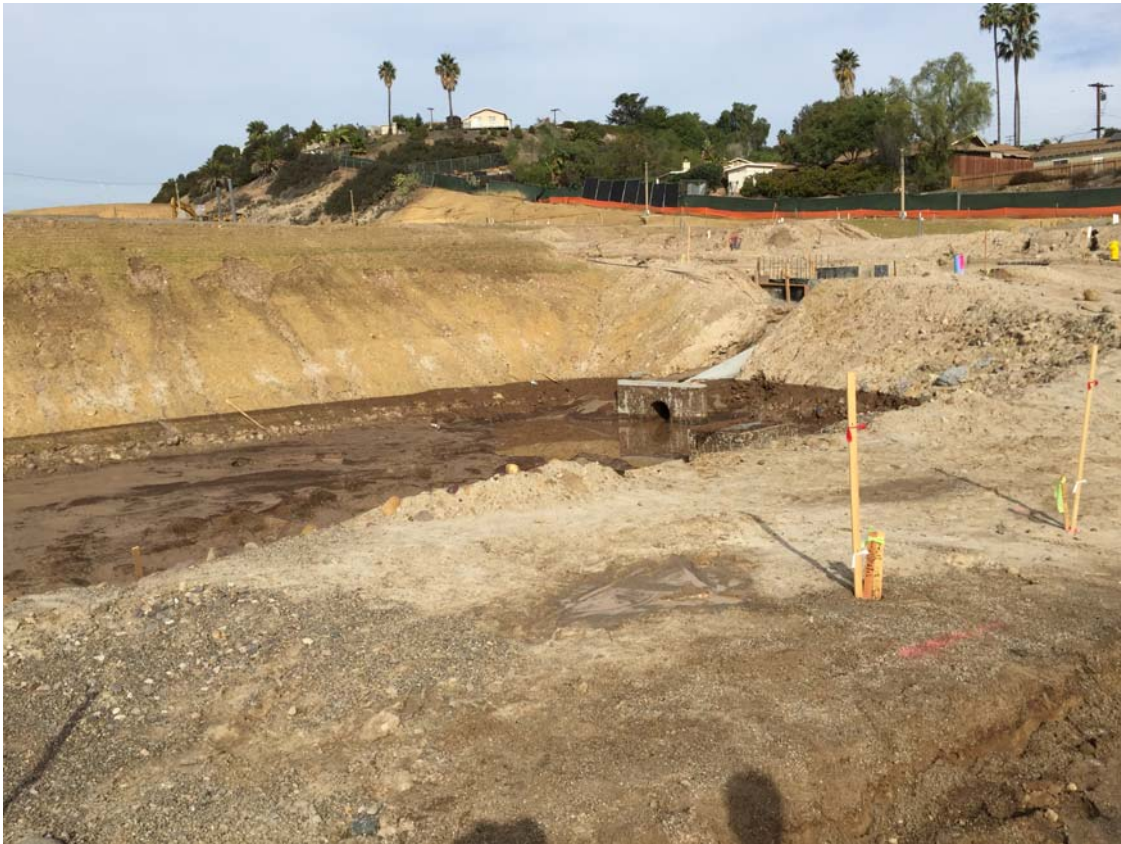
**Figure 8. Failure to apply linear sediment controls.** Photograph taken by Wayne Chiu, San Diego Water Board, on December 15, 2014, depicting the lack of linear sediment controls on a slope. IMG\_5035.jpg

Pursuant to section E.4. in Attachment D to the Construction Storm Water Permit, dischargers are required to “*apply linear sediment controls along toe of slope, face of the slope, and at the grade breaks of exposed slopes to comply with the sheet flow lengths in accordance with Table 1.*” The Discharger was in violation of section E.4. for nine days: 2 days (December 15 through 16, 2014); 6 days (May 8 through 13, 2015), and 1 day (September 15, 2015). See Figure 8. Failure to apply linear sediment controls. The violations were noted in the following documents:

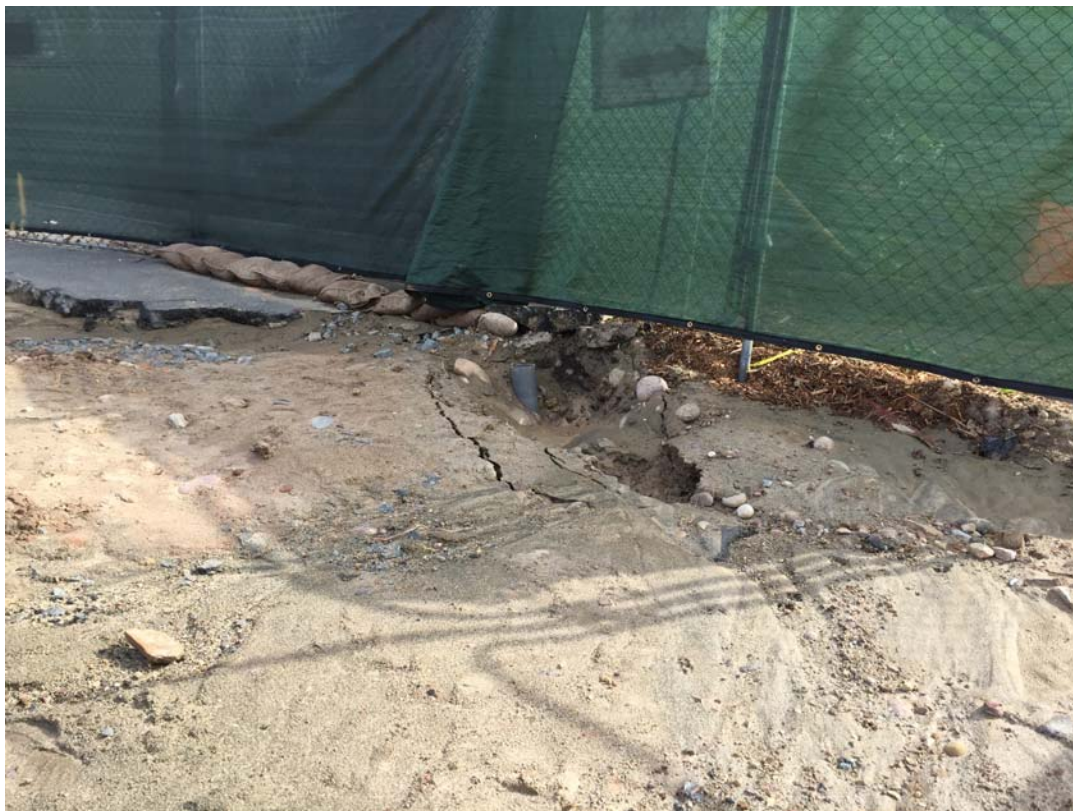
**Figure 9. Failure to manage run-on and runoff.** Photograph taken by Wayne Chiu, San Diego Water Board on December 15, 2014, displaying erosion caused by runoff flowing under fence and offsite. IMG\_5042.jpg.

Pursuant to section F. in Attachment D to the Construction Storm Water Permit, dischargers are required to “*effectively manage all run-on, all runoff within the site and all runoff that discharges off the site. Run-on from off site shall be directed away from all disturbed areas or shall be collectively be in compliance with the effluent limitations in this General Permit.*” The Discharger was in violation of section F. for seven days: 1 day (December 15, 2014); and 6 days (May 8 through 13, 2015). See Figure 9. Failure to manage run-on and runoff. The violations were noted in the following documents:

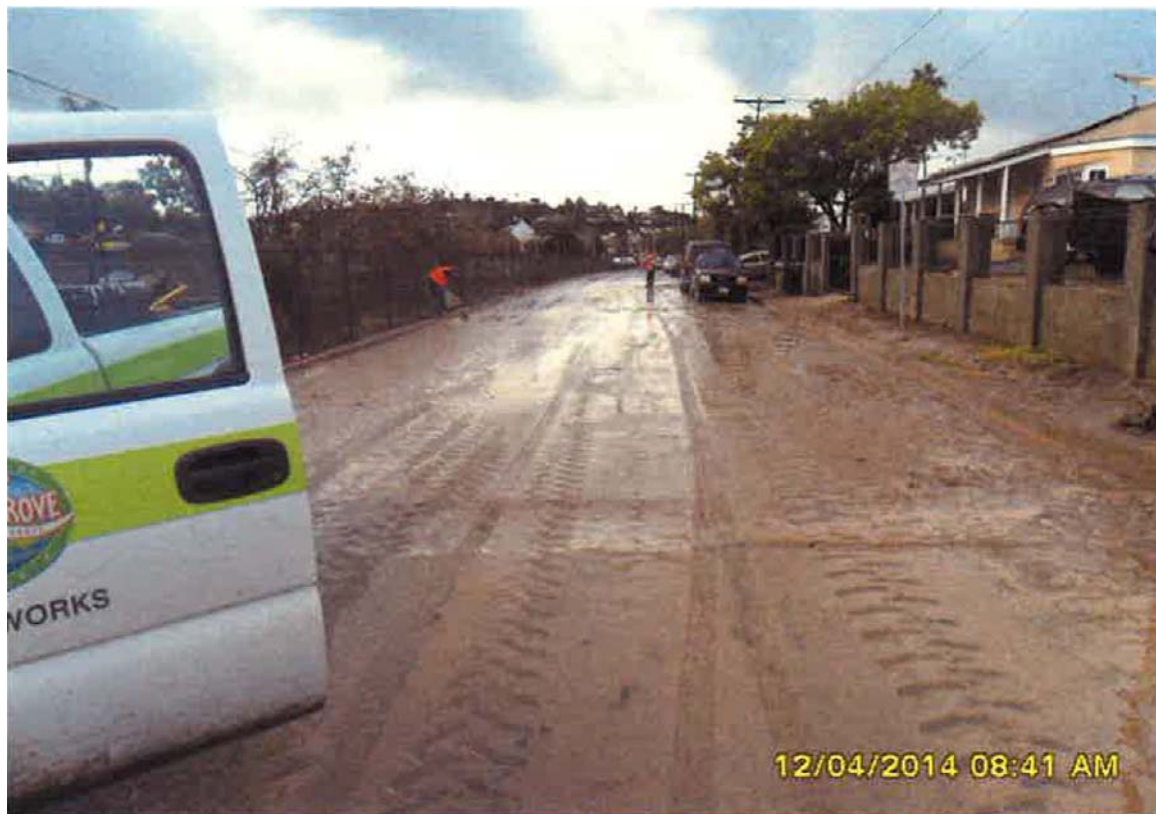
**Figure 10. Failure to remove sediment from roads.** Photograph taken by the City of Lemon Grove on December 4, 2014, depicting sediment on Akins Avenue southwest of the Site.

Pursuant to section E.7. in Attachment D to the Construction Storm Water Permit, dischargers are required “*at a minimum daily (when necessary) and prior to any rain event, the discharger shall remove any sediment or other construction activity-related materials that are deposited on the roads (by vacuuming or sweeping).*” The Discharger was in violation of section E.7. for 10 days: 8 days (December 2 through 9, 2014) December 16, 2014, and September 15, 2015. See Figure 10. Failure to remove sediment from roads. The violations were noted in the following:

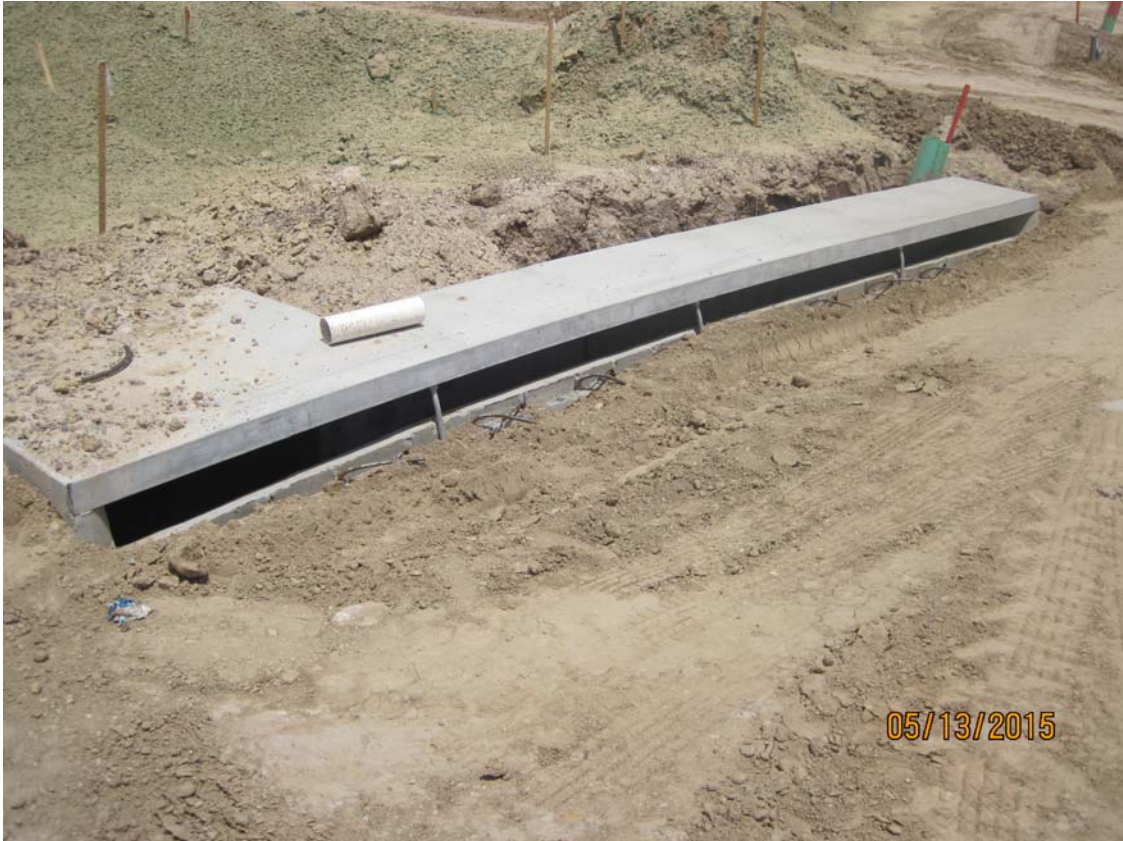
**Figure 11. Failure to protect storm drain inlets.** Photograph taken by Frank Melbourn, San Diego Water Board on May 13, 2015, displaying unprotected storm drain inlet. IMG\_0295.jpg.

Pursuant to section E.6. in Attachment D to the Construction Storm Water Permit, dischargers “*shall ensure that all storm drain inlets and perimeter controls, runoff control BMPs, and pollutant controls at entrances and exits (e.g. tire washoff locations) are maintained and protected from activities that reduce their effectiveness.*” The Discharger was in violation of section E.6. for three days: December 8, 2014; May 13, 2015, and September 15, 2015. See Figure 11. Failure to protect storm drain inlets. The violation was noted in the following:

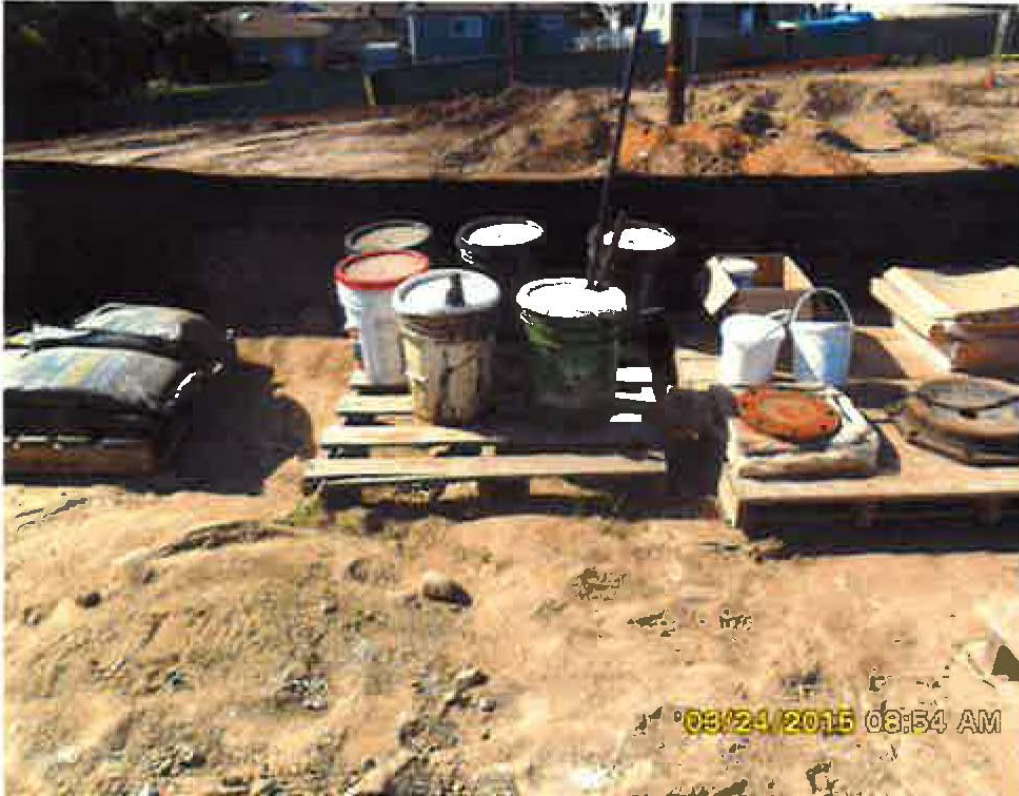
**Figure 12. Failure to properly store chemicals.** Photograph taken by the City of Lemon Grove on March 24, 2015, depicting chemicals and vehicle lubricants stored on pallets without protection from the elements and without secondary containment.

Pursuant to section B.1.c. in Attachment D to the Construction Storm Water Permit, dischargers are required to “[s]tore chemicals in watertight containers (with appropriate secondary containment to prevent any spillage or leakage) or in a storage shed (completely enclosed).” The Discharger was in violation of section B.1.c. for seven days (March 18 through 24, 2015). See Figure 12. Failure to properly store chemicals. The violations were noted in the following documents: City Inspection Report March 18, 2015 (Exhibit No. 13); and photograph IMG 6155.jpg (Exhibit No. 40) taken on March 18, 2015; and City Correct Work Notice March 24, 2015 (Exhibit No. 15).

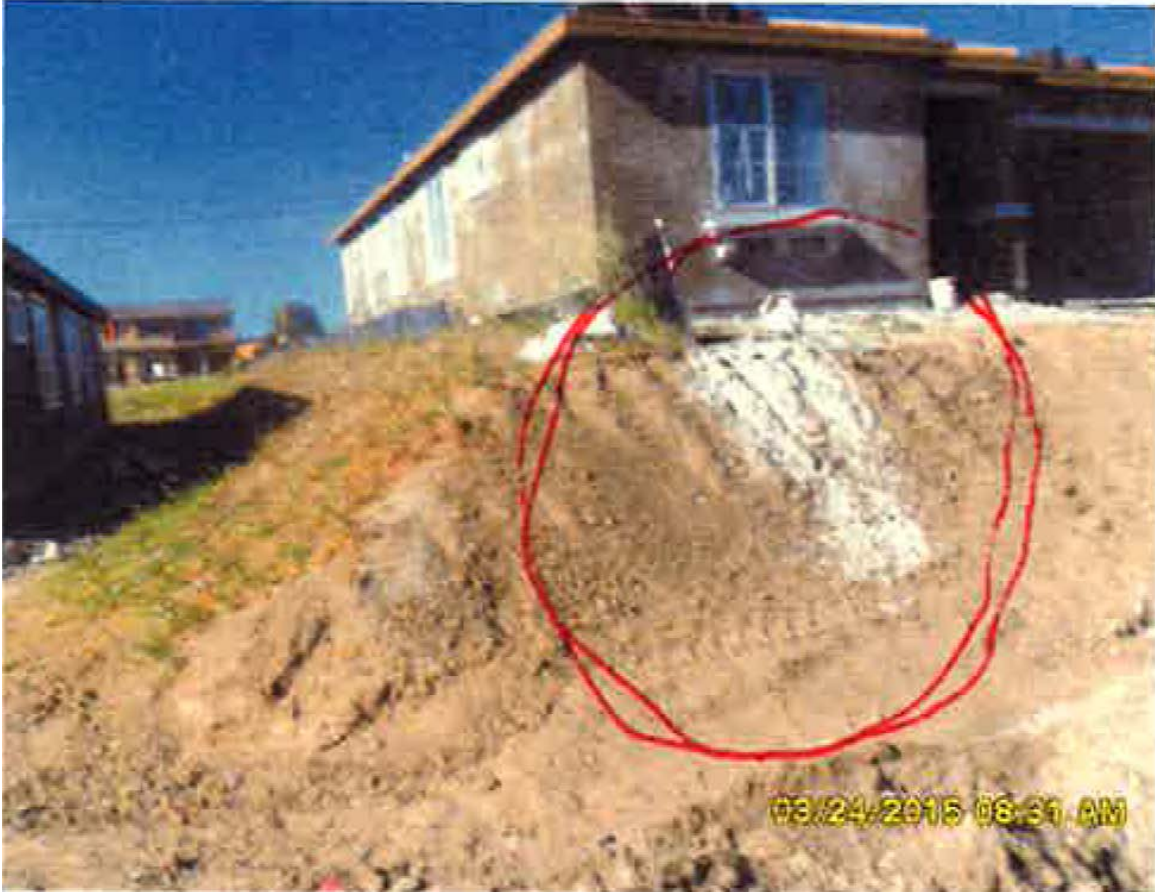
The Discharger was in violation of section B.2.i. for 15 days (March 18 through April 1, 2015). See Figure 13. Failure to prevent discharge of concrete waste to the ground. The violations were noted in the following documents:

**Figure 13. Failure to prevent the discharge of concrete waste to the ground.**  
Photograph taken by the City of Lemon Grove on March 24, 2015, depicting  
discharge of concrete waste on slope (identified by red circle).
