December 8, 2010
File: 175650032

Reference: Arroyo Mocho Planting Effects on Roughness Study

PROJECT BACKGROUND AND GOALS

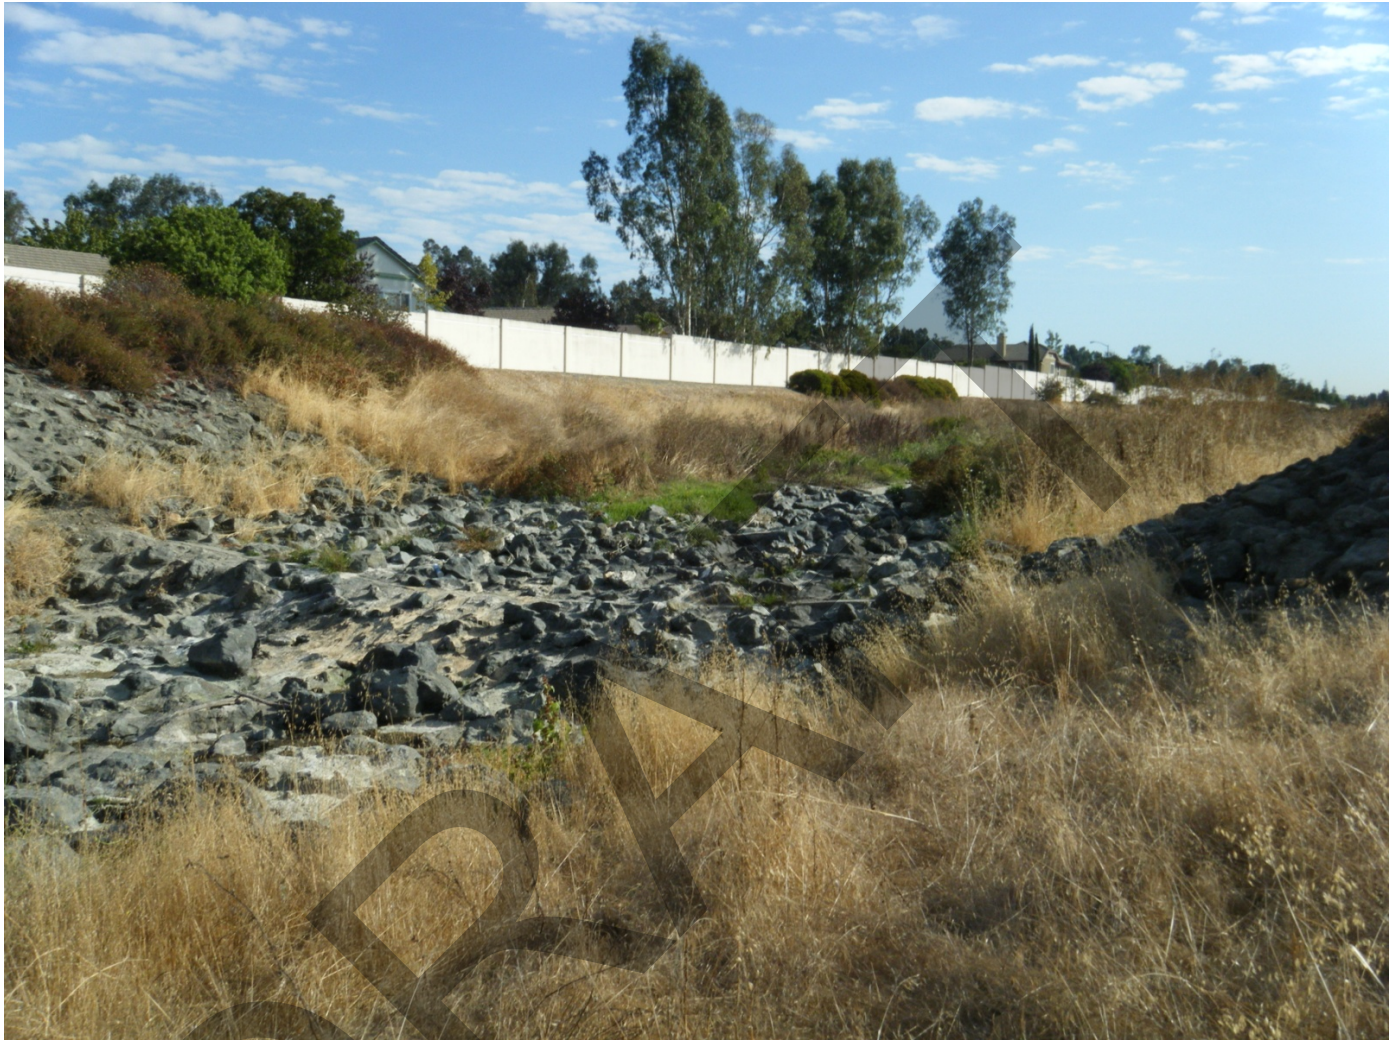
Figure 1

View of Rip Rap Grade Control Structure

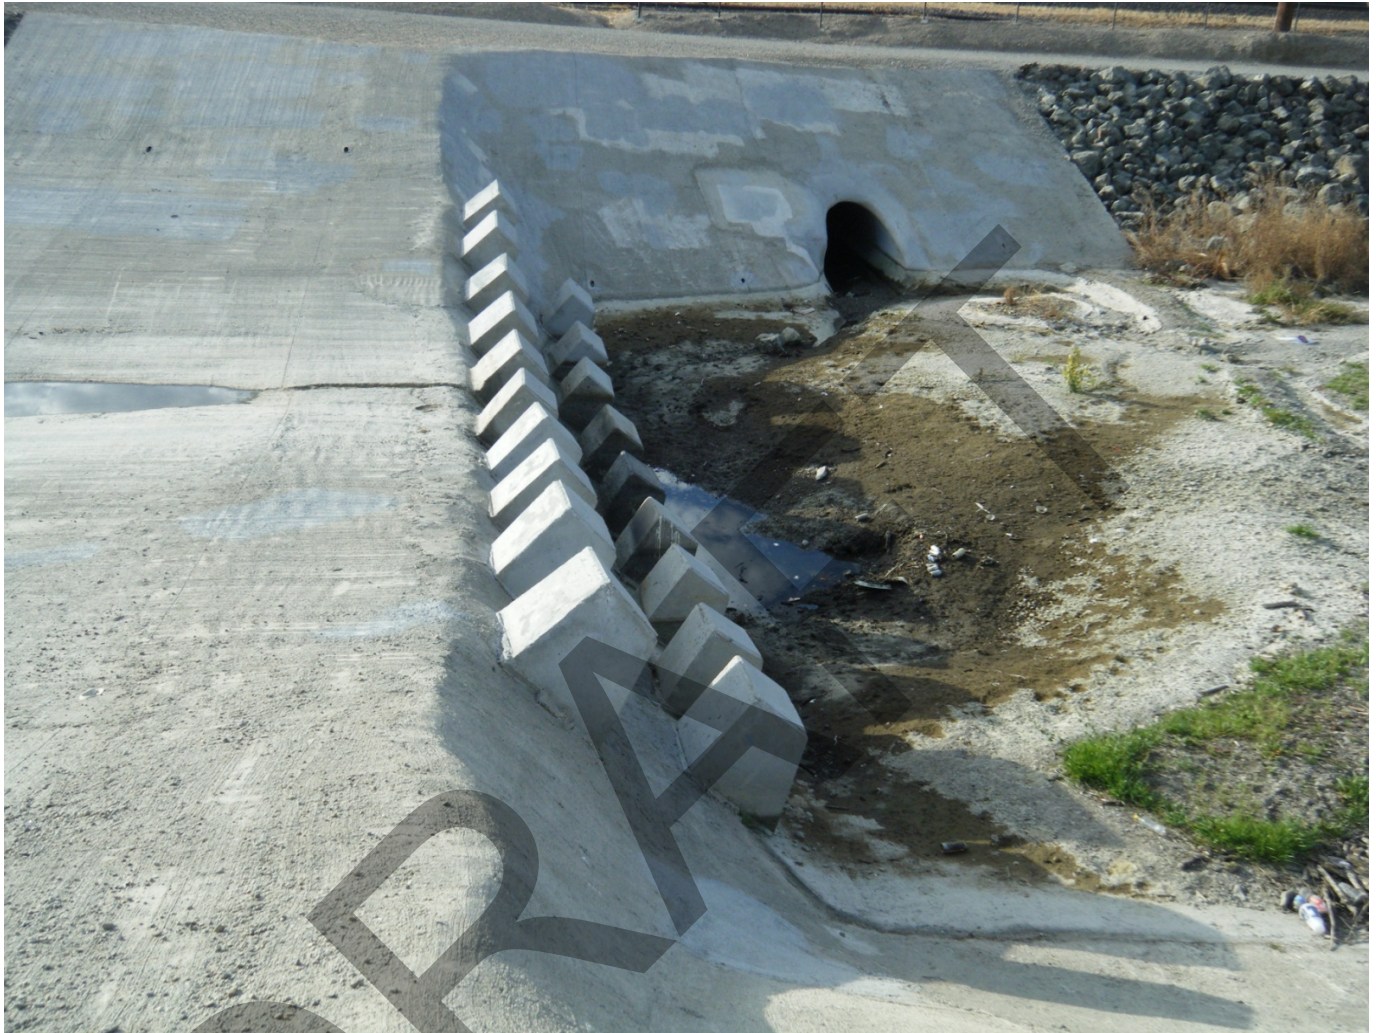
Figure 2

Dragon's Tooth Grade Control Structure

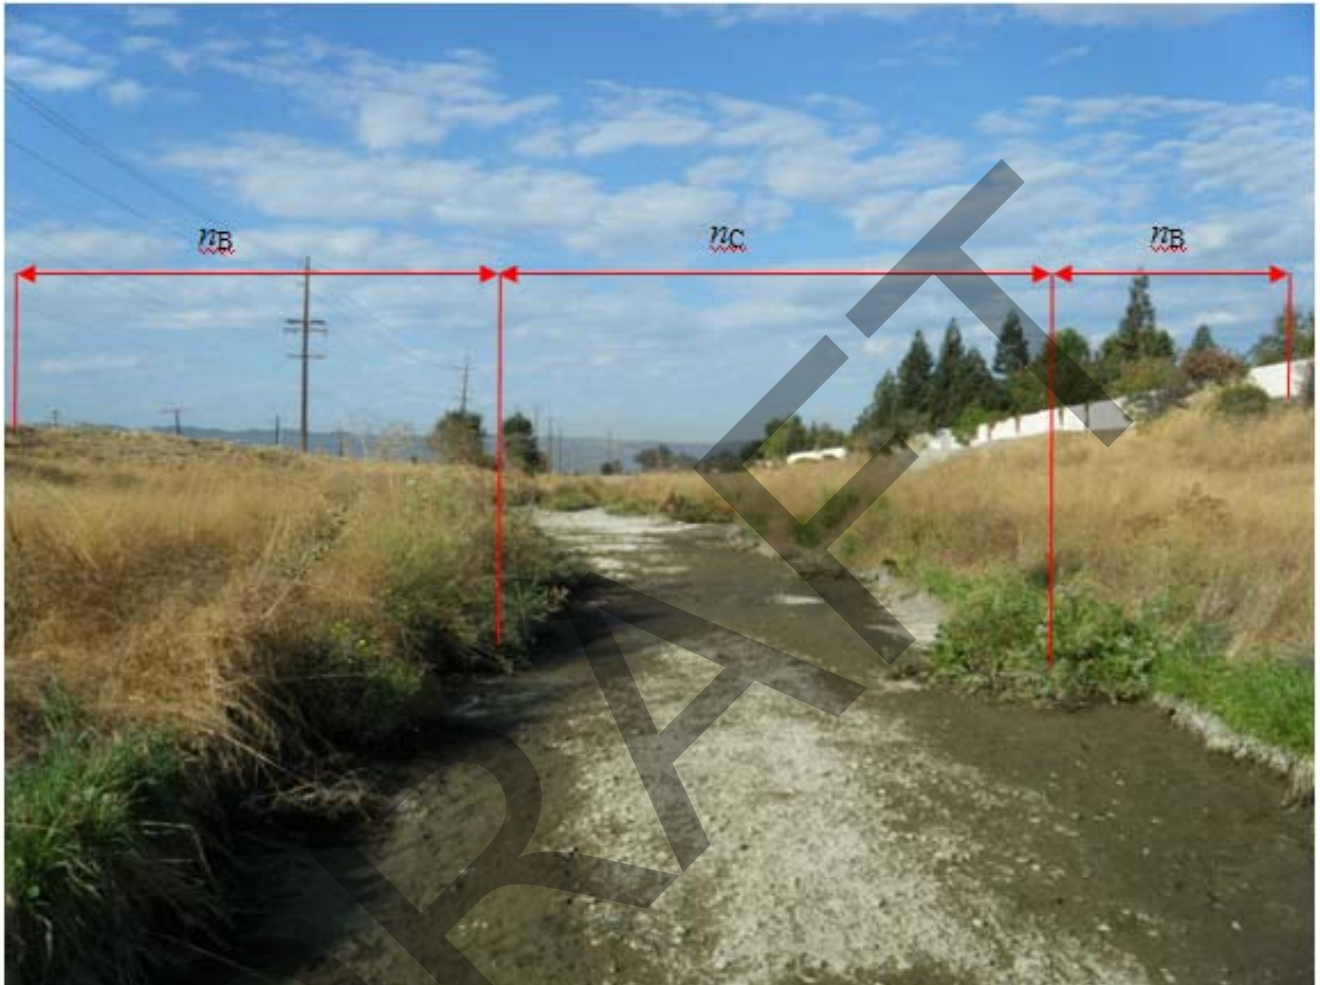
Figure 3 Cross Section of Model Showing Limits of n_c and n_b

To perform the analysis, the Manning's roughness coefficient (Manning's n) of the channel was altered in the model both laterally and longitudinally to determine where riparian planting could be administered without overtopping the channel. Specifically, the Manning's n values were increased until the channel overtopped. Overtopping was defined as flow exiting the channel. One value for Manning's n was used to represent main channel (n_C) roughness while another value was used to represent bank roughness (n_B). Figure 3 illustrates the boundaries of lateral roughness variation applied in the model. The bank roughness was altered for two scenarios, including:

- Option 1) planting down to the existing water edge; and
- Option 2) planting only the upper half of the banks.

A value of 0.035 was used for n_C for Options 1 and 2 based on sediment data collected on-site (see "Geomorphic Results" section). A third option (Option 3) was considered whereby the main channel roughness was increased until the channel overtopped. A combination of Options 1 and 2 was also investigated by varying the planting pattern longitudinally along the reach to evaluate if areas that overtopped in a higher roughness condition would ultimately remain in the channel if a less aggressive planting approach was implemented in areas where conveyance was limited by channel geometry.

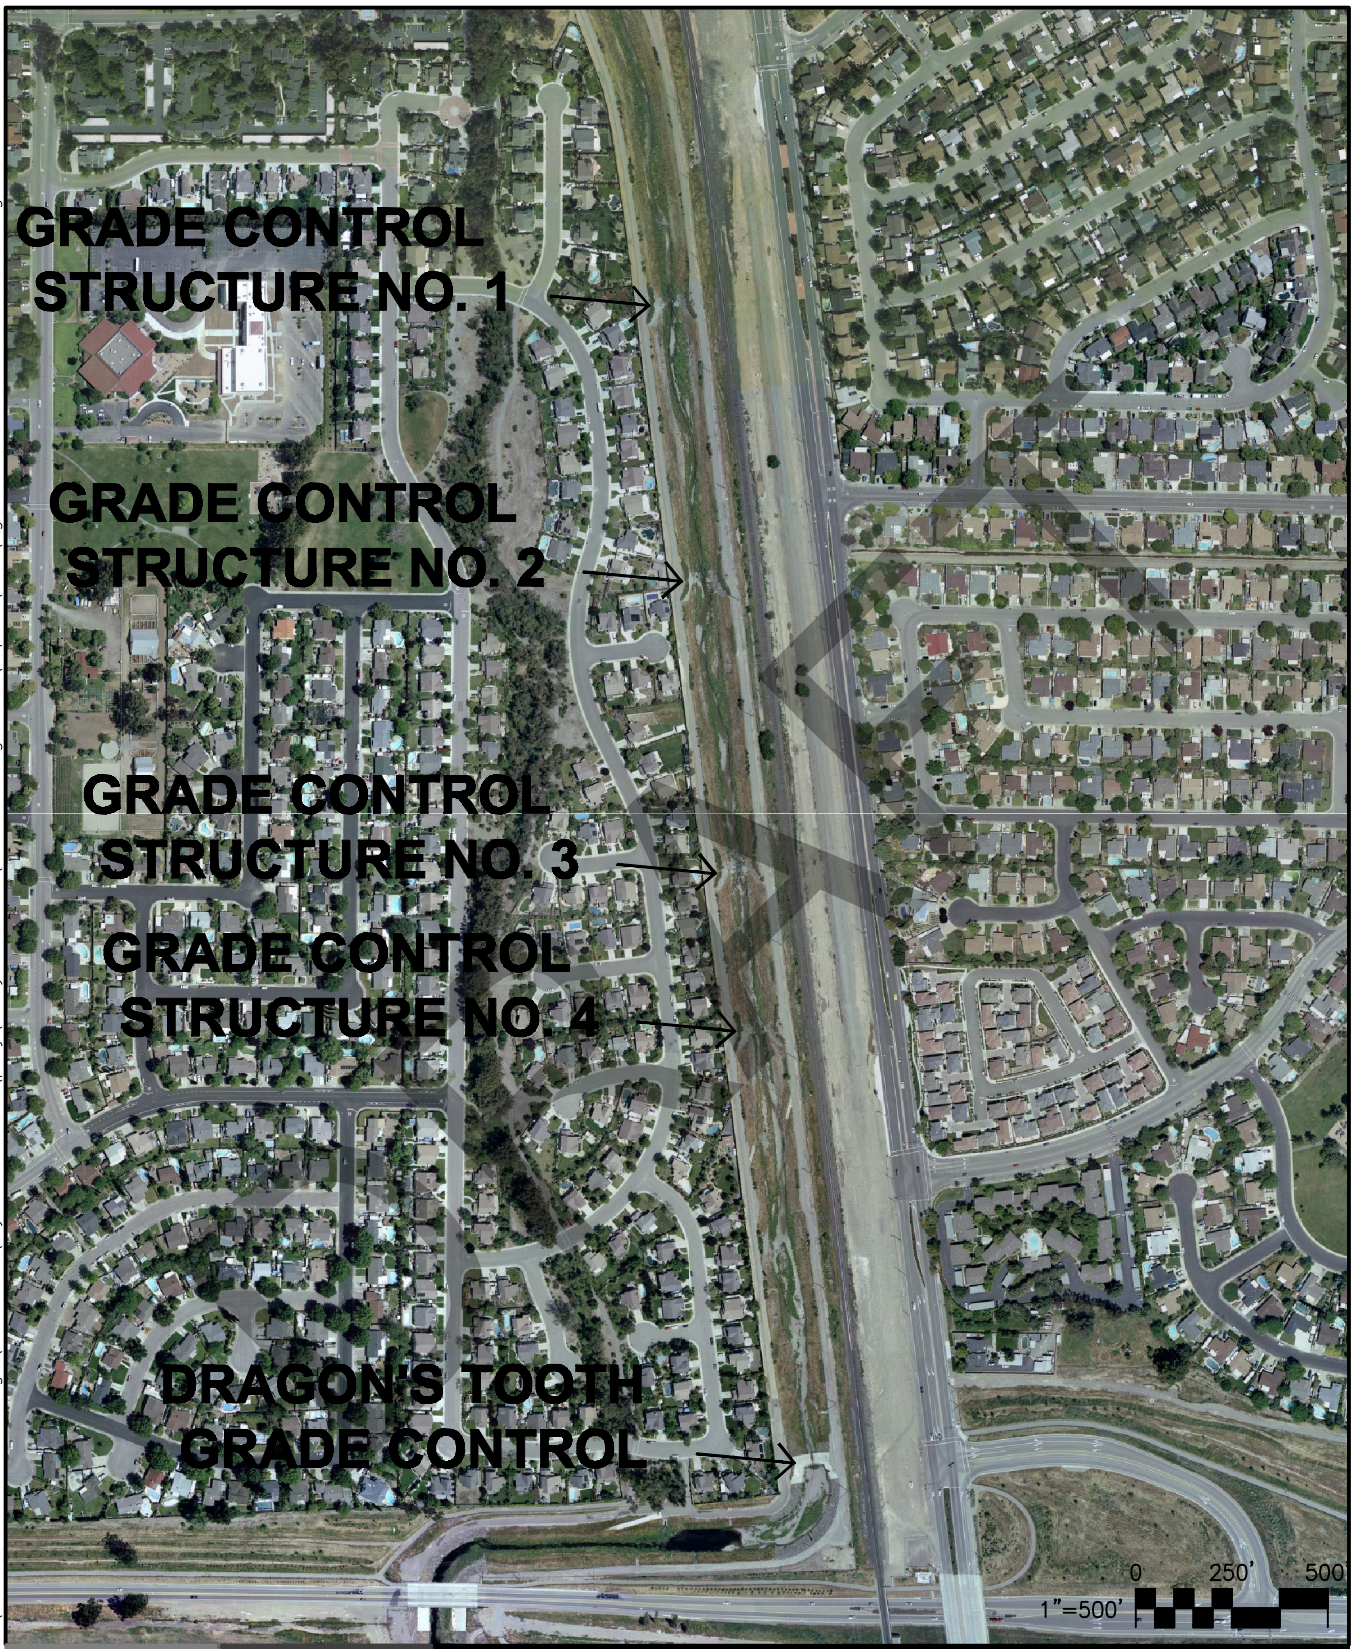
Client/Project
ZONE 7
ARROYO MOCHO
SEDIMENT STUDY
Figure No.
1.0
Title
PLAN VIEW

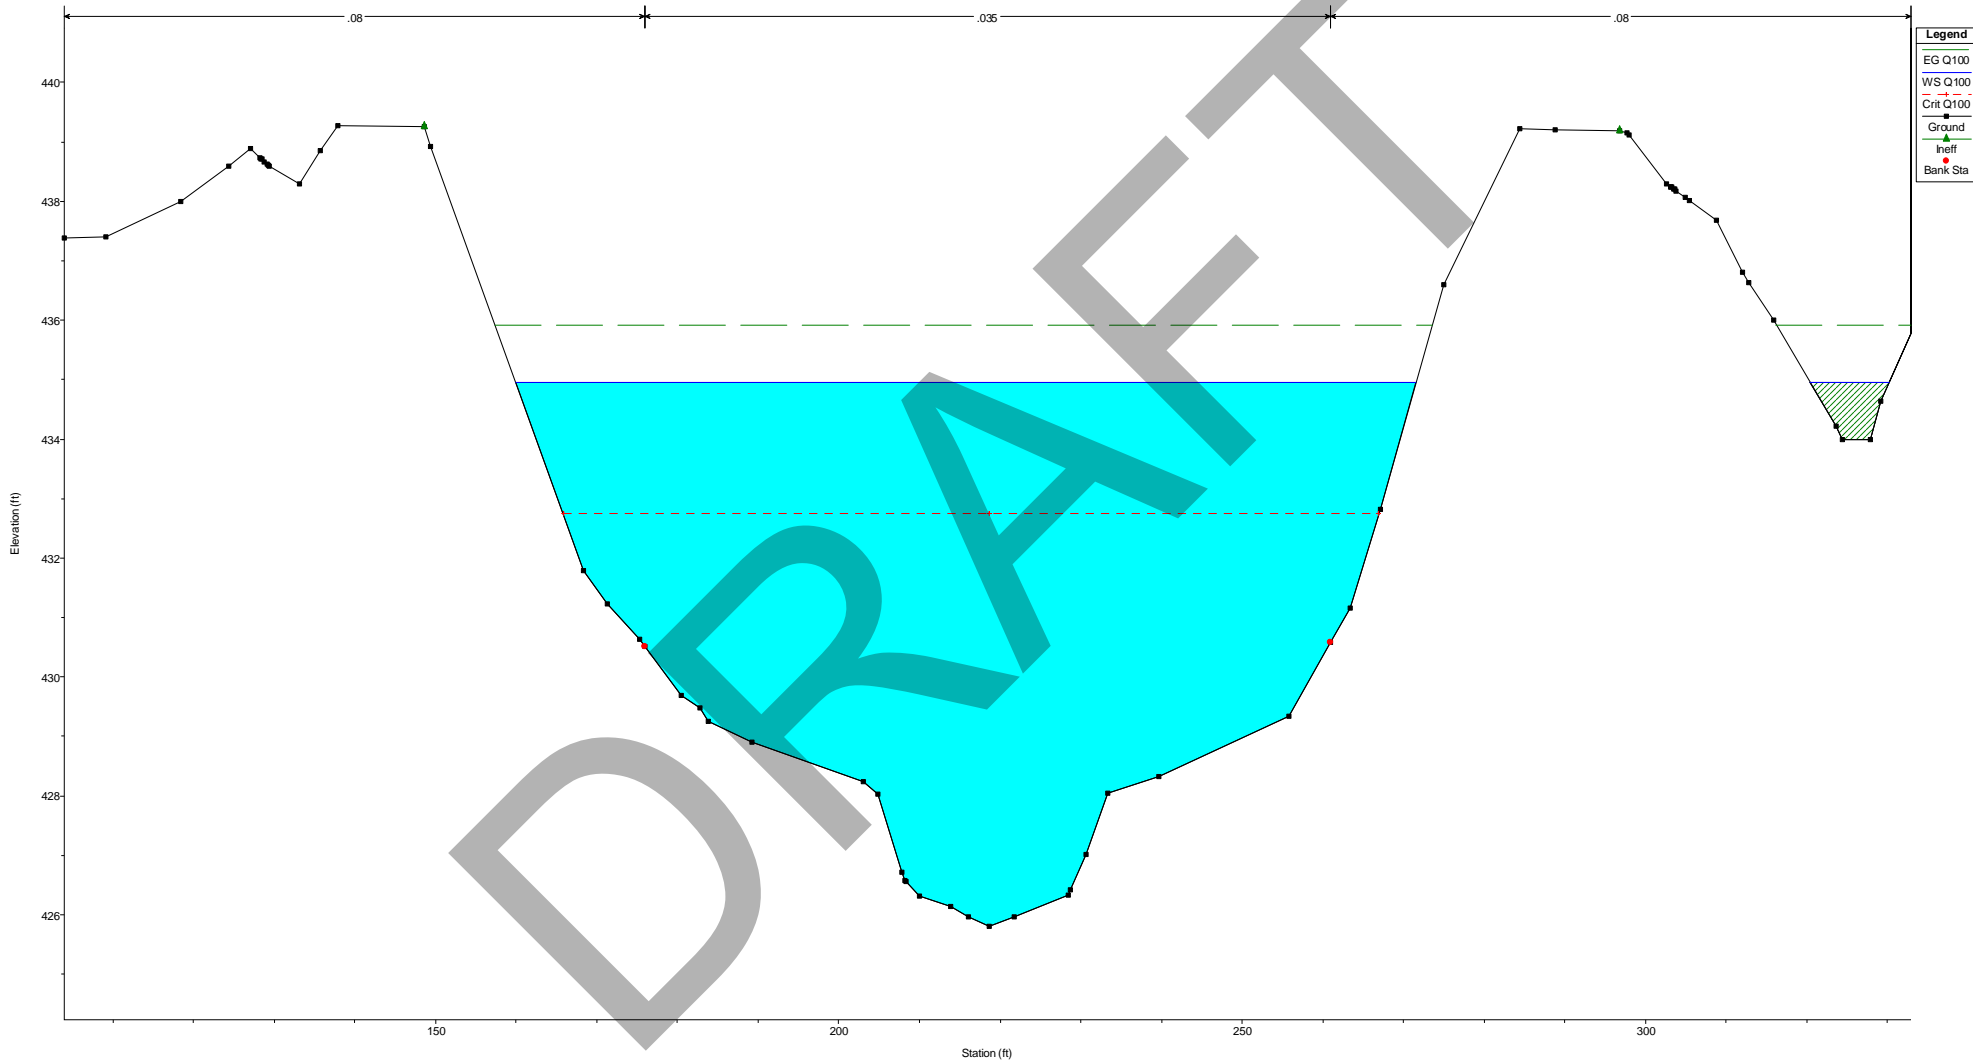
Sample HEC-RAS Cross-Section Option 2

For Option 2, the extent of the vegetation was limited to the upper half of the banks only. A Manning's n value of 0.035 was utilized for the channel bottom and lower half of the banks. The upper half of the banks was assigned a Manning's n of 0.08 (per the results of Option 1) for area of new planting. Planting only the upper half of the banks increases the channel capacity and results in a lower water surface than Option 1. Water surface elevations throughout the entire reach were reduced significantly by planting on only the upper half of the banks. A second model was run to evaluate the maximum Manning's n value that can be assigned to the banks if only the upper half is planted before overtopping. The results suggest the Manning's n value can be increased to 0.11 without overtopping the banks for Option 2 (only upper half of banks are planted).

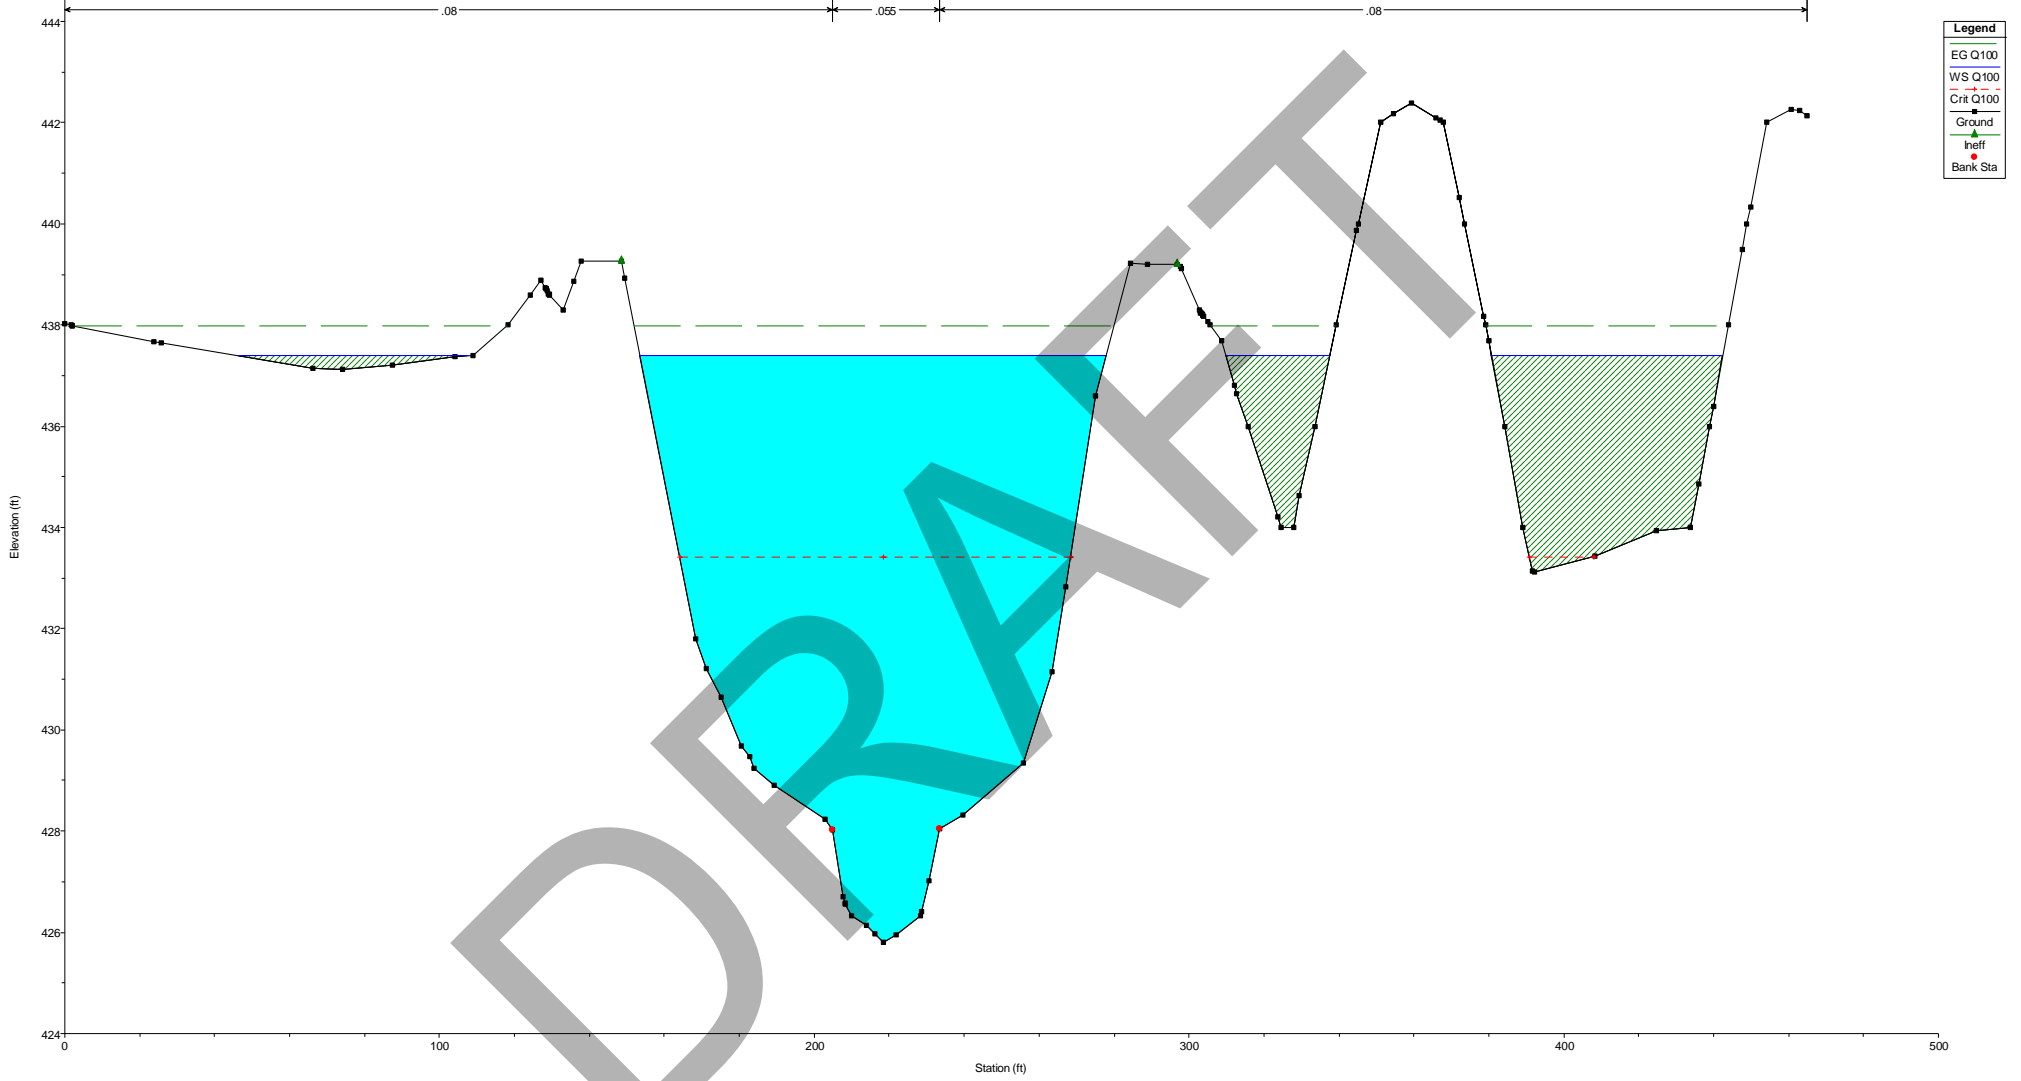
Sample HEC-RAS Cross-Section Option 3

Option 3 evaluated the maximum n_c for Option 1 outside of Stations 24+15 to 33+88 given a n_b of 0.08. The result of this analysis indicated that n_c could not exceed 0.055 without overtopping.

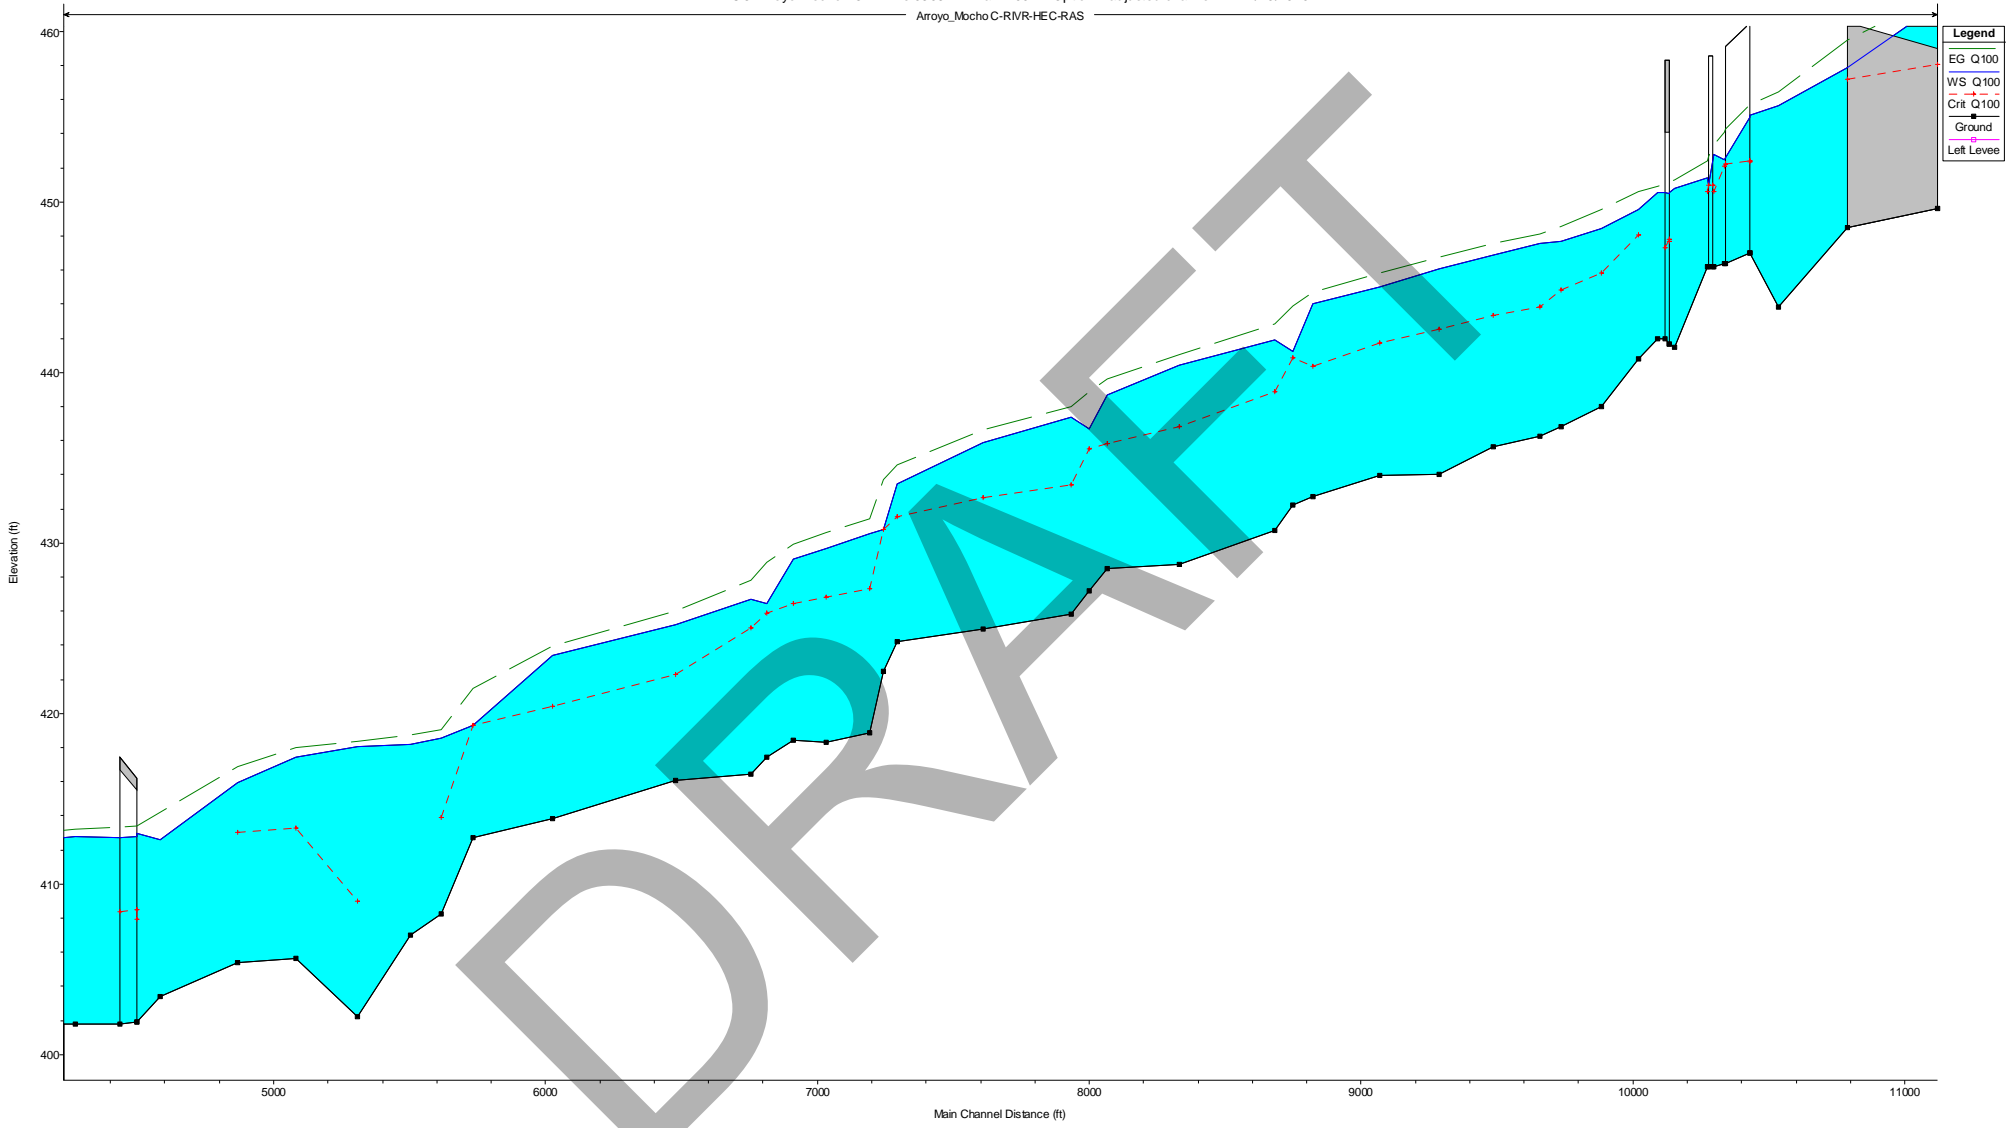
Profile Option 3

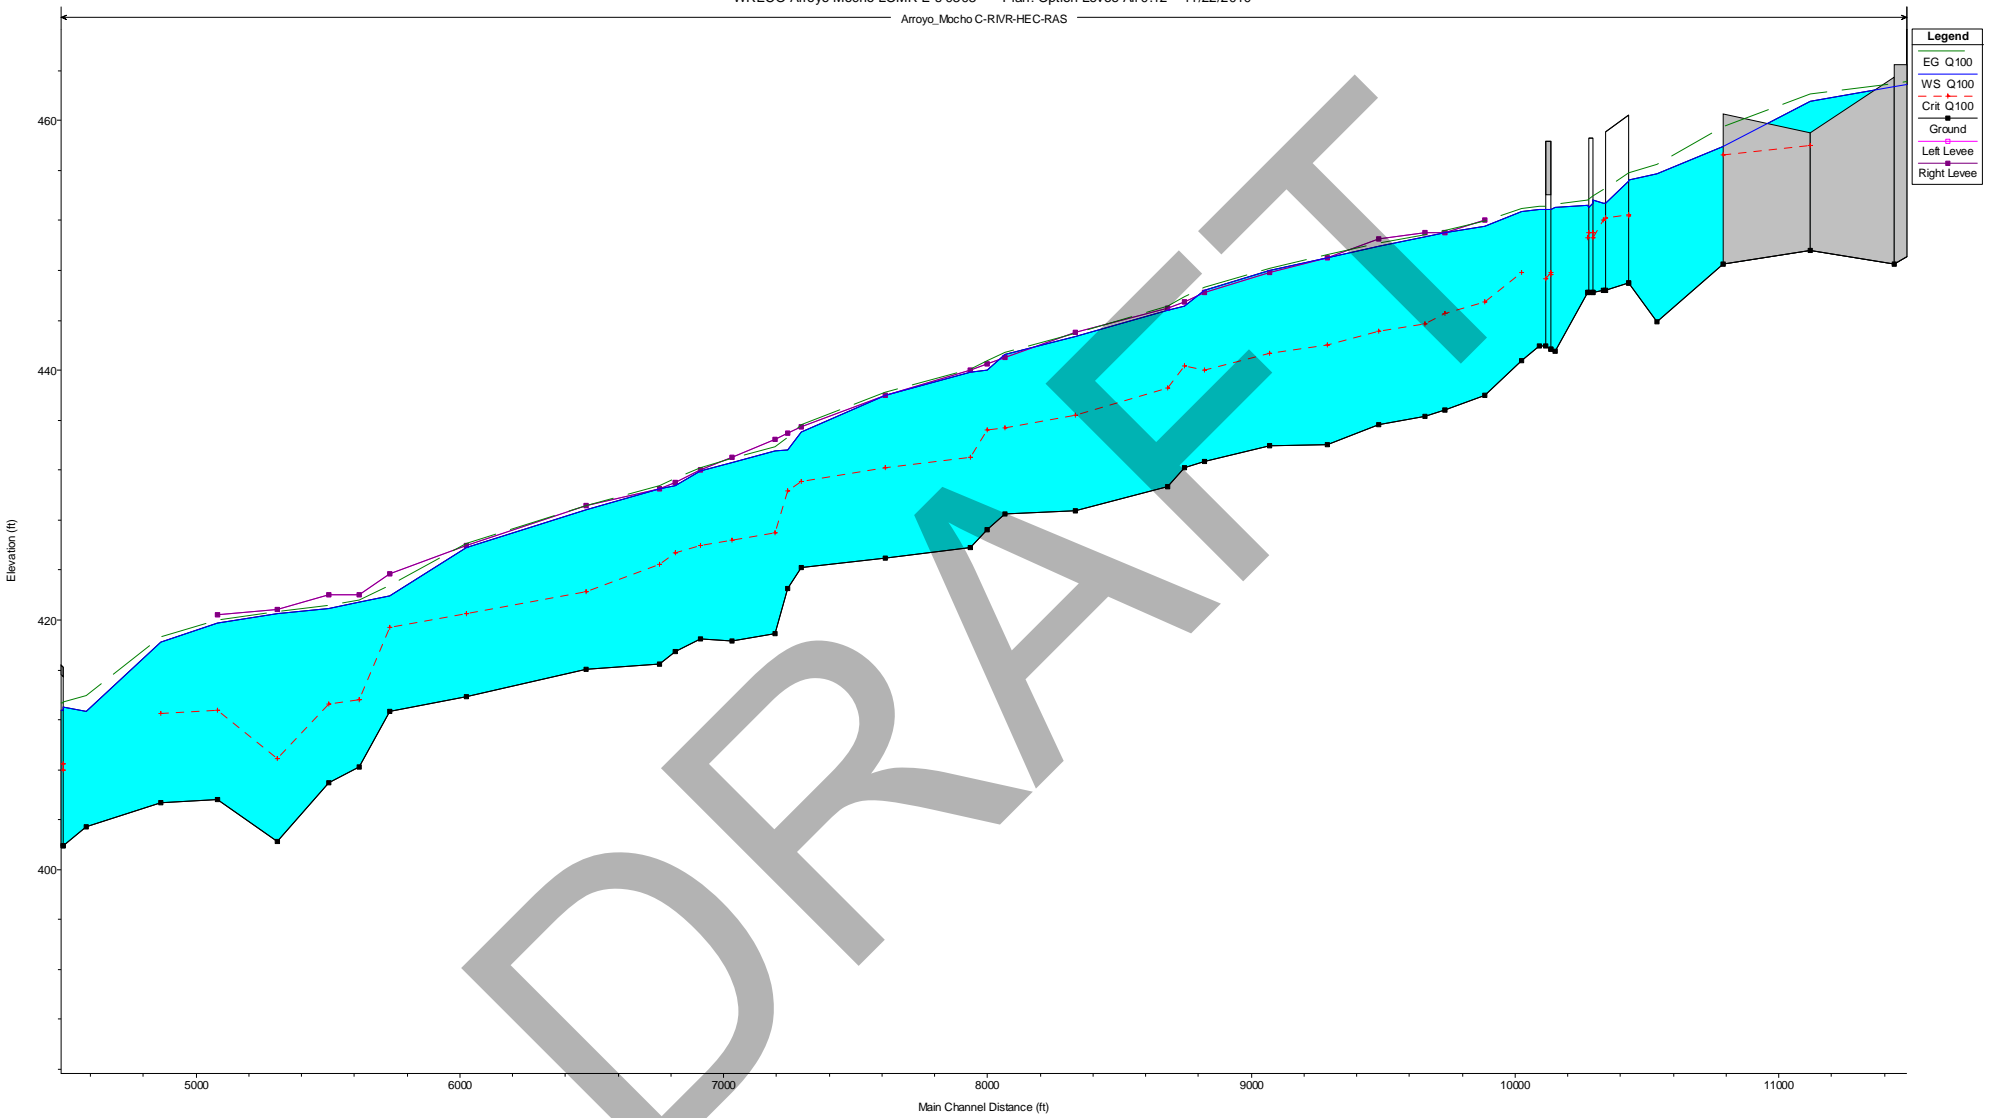
Profile with Levees

- The maintenance road would need to be raised approximately one foot to accommodate a vegetation community with a Manning's roughness coefficient of 0.09.

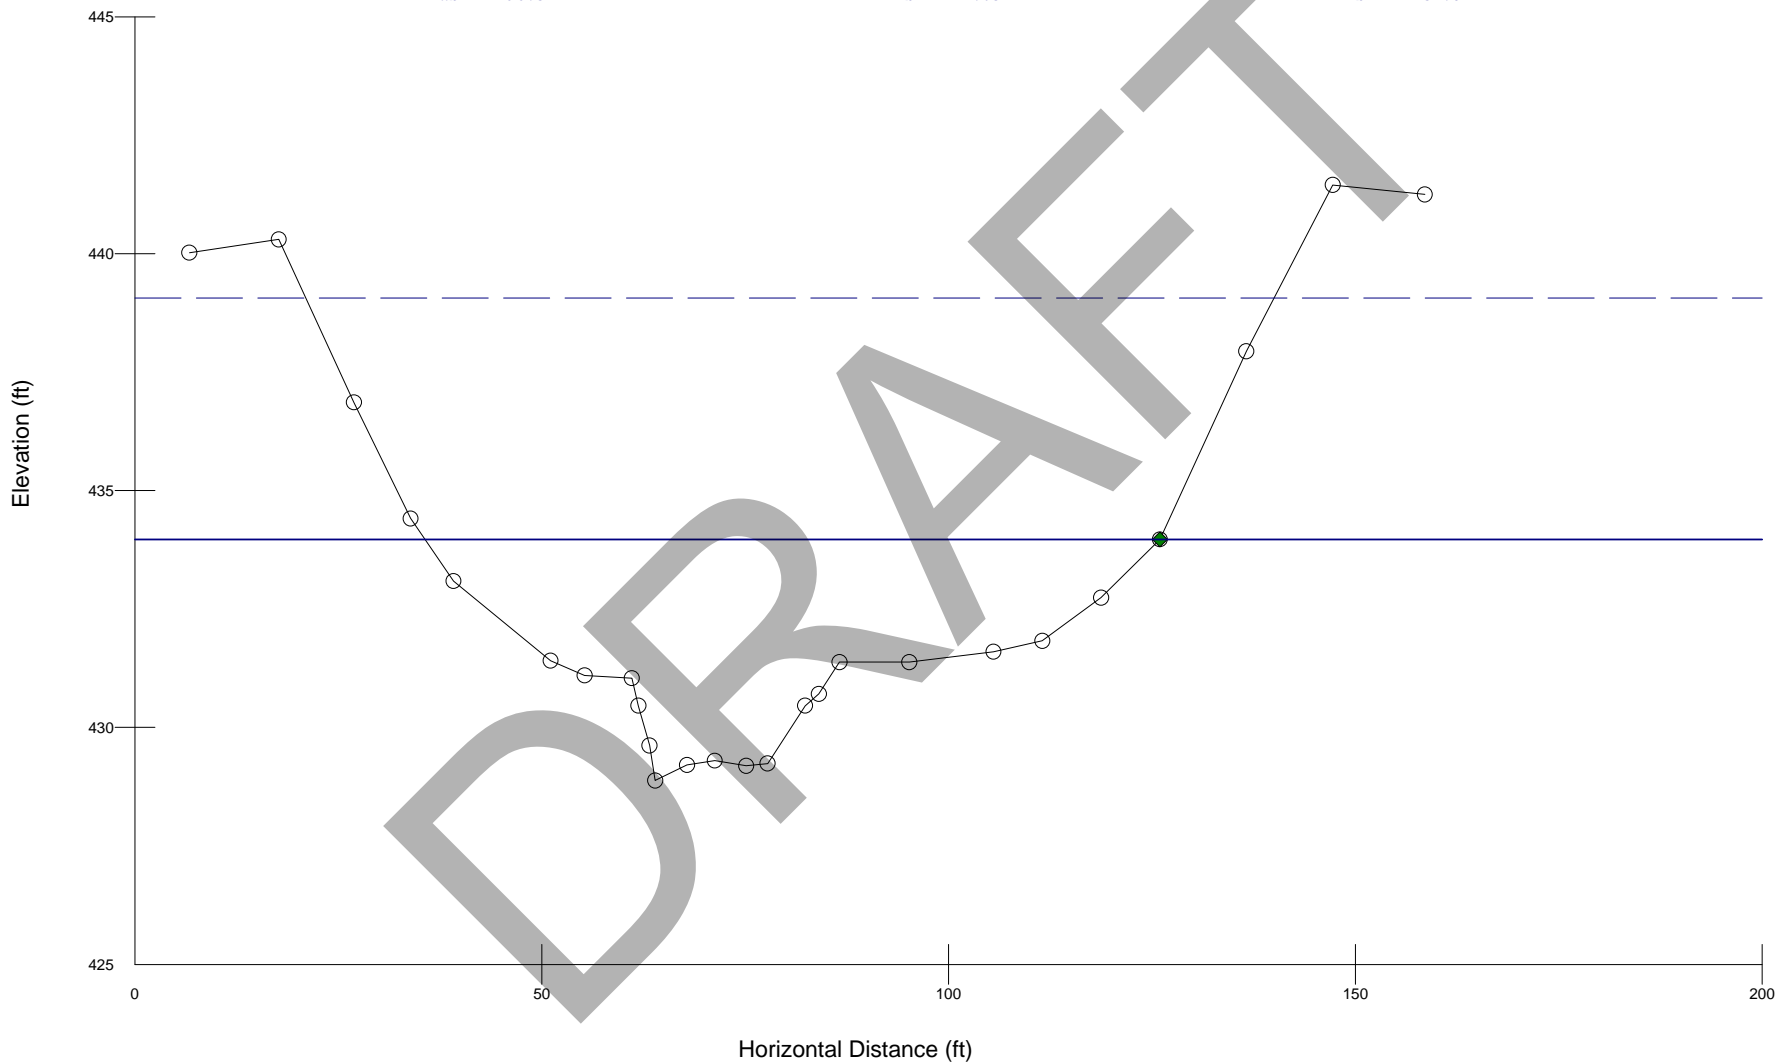
XS4 28+21

wbkf = 90.3

Dbkf = 2.63

Abkf = 237.8

Attachment 3 shows the classification, cross sections and longitudinal profile for the studied existing conditions reach and survey. The channel classification (Rosgen, 1996)² for the studied reach of Arroyo Mocho was determined to be an F4. The mean particle size of the channel bottom is 8.4mm, which is a medium gravel.

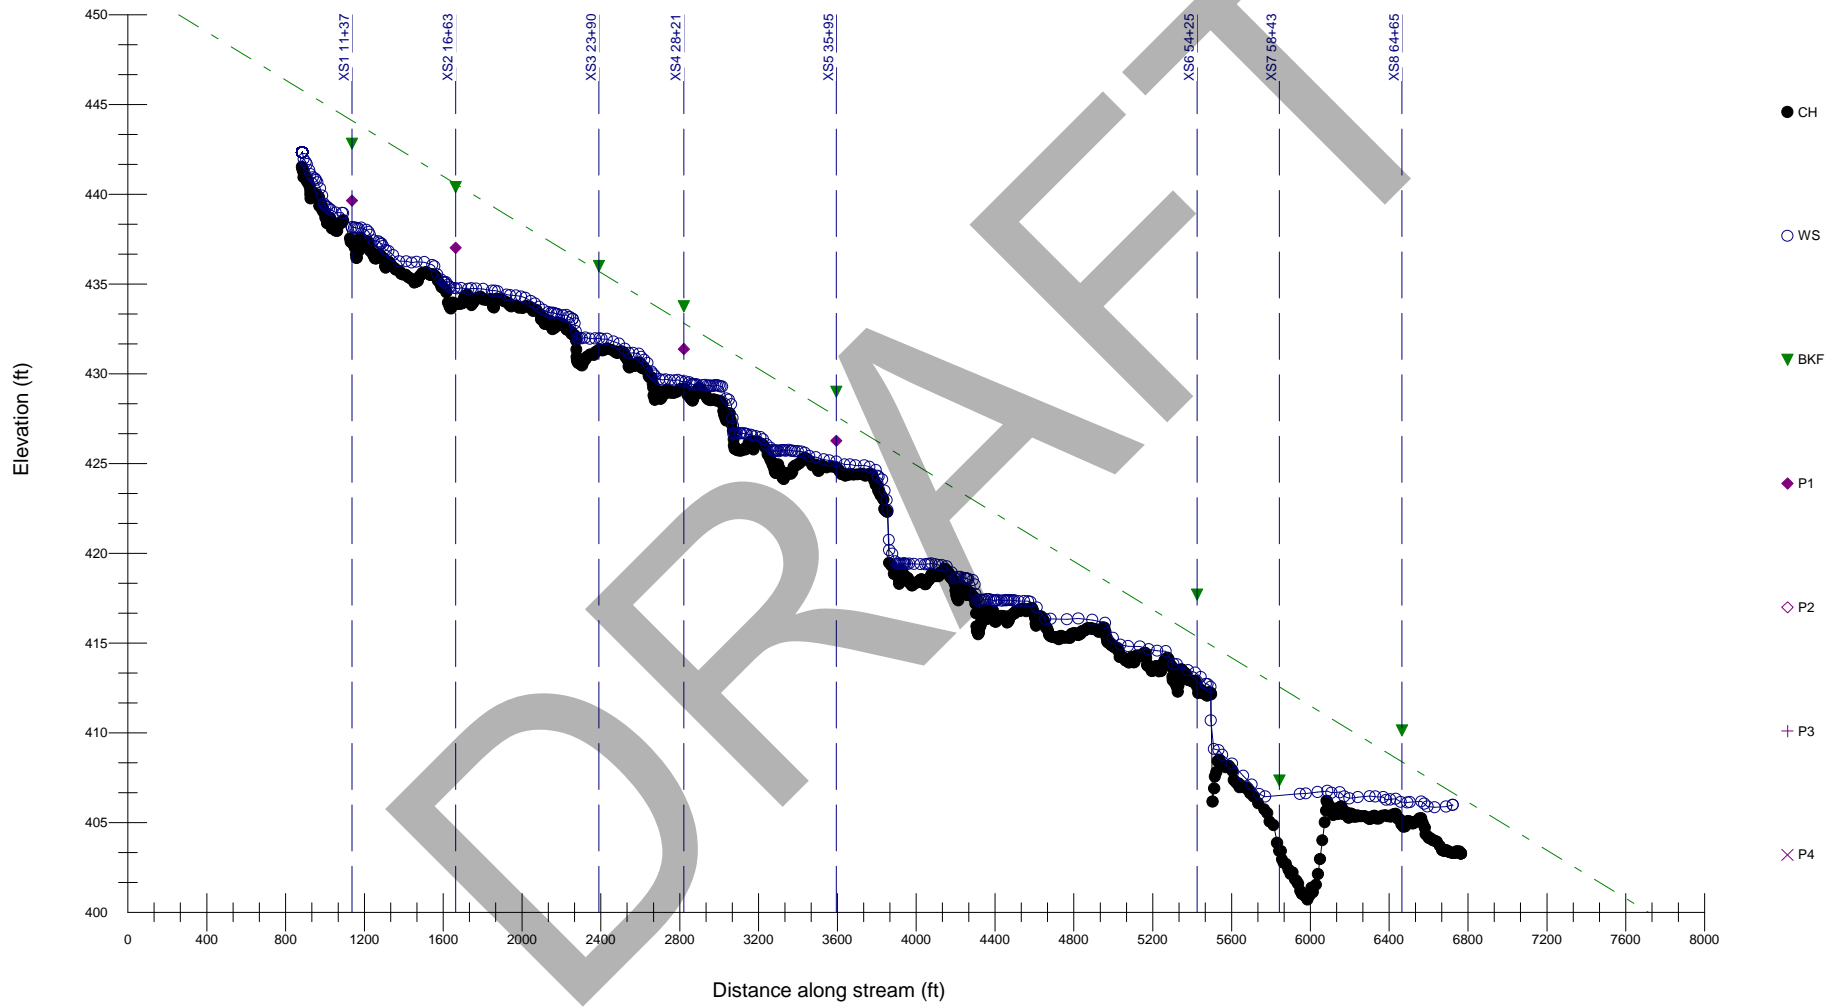
Longitudinal Profile
