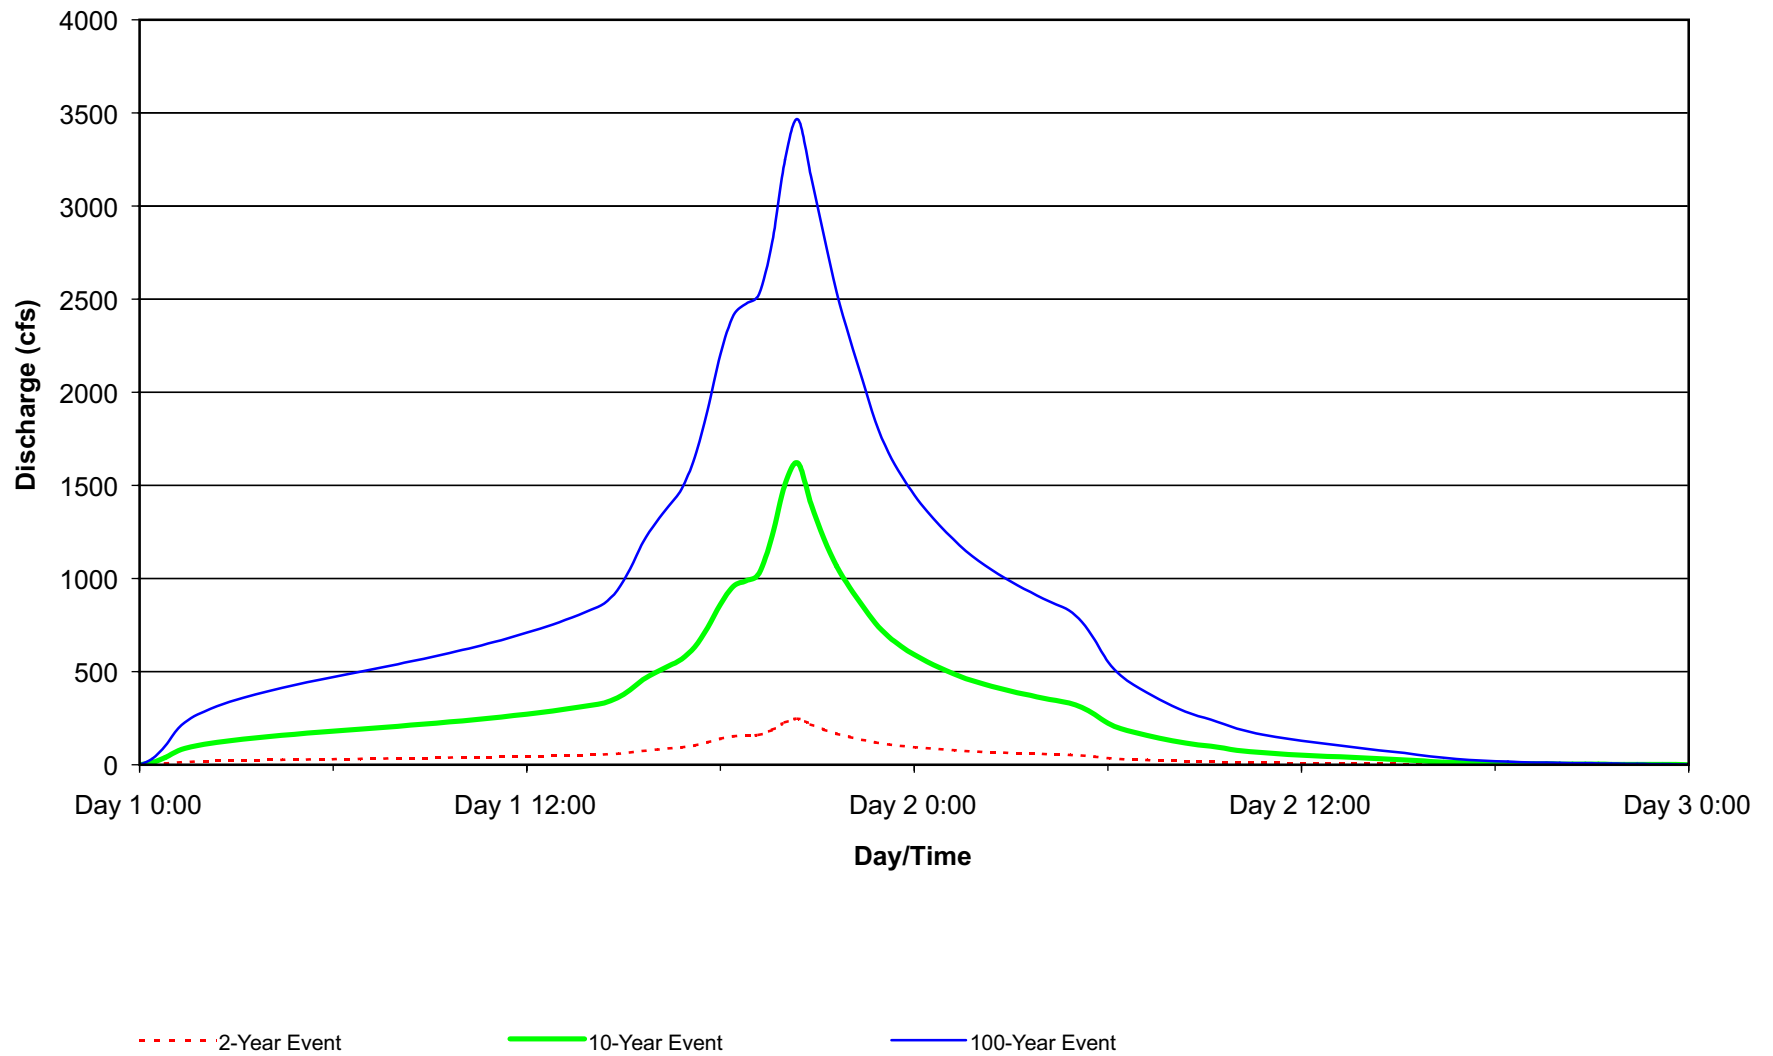
Figure 42
 Baseline Conditions Report
 2-Year, 10-Year, and 100-Year Event Hydrographs for
 Talega Canyon at Confluence with Cristianitos Creek
