# Appendix C

Aquatic Resources Delineation

September 30, 2024  
Project Number: 21-12210

**Subject: Aquatic Resources Delineation for the Kernville Raw Water Intake Upgrade Project, Kernville, Kern County, California**

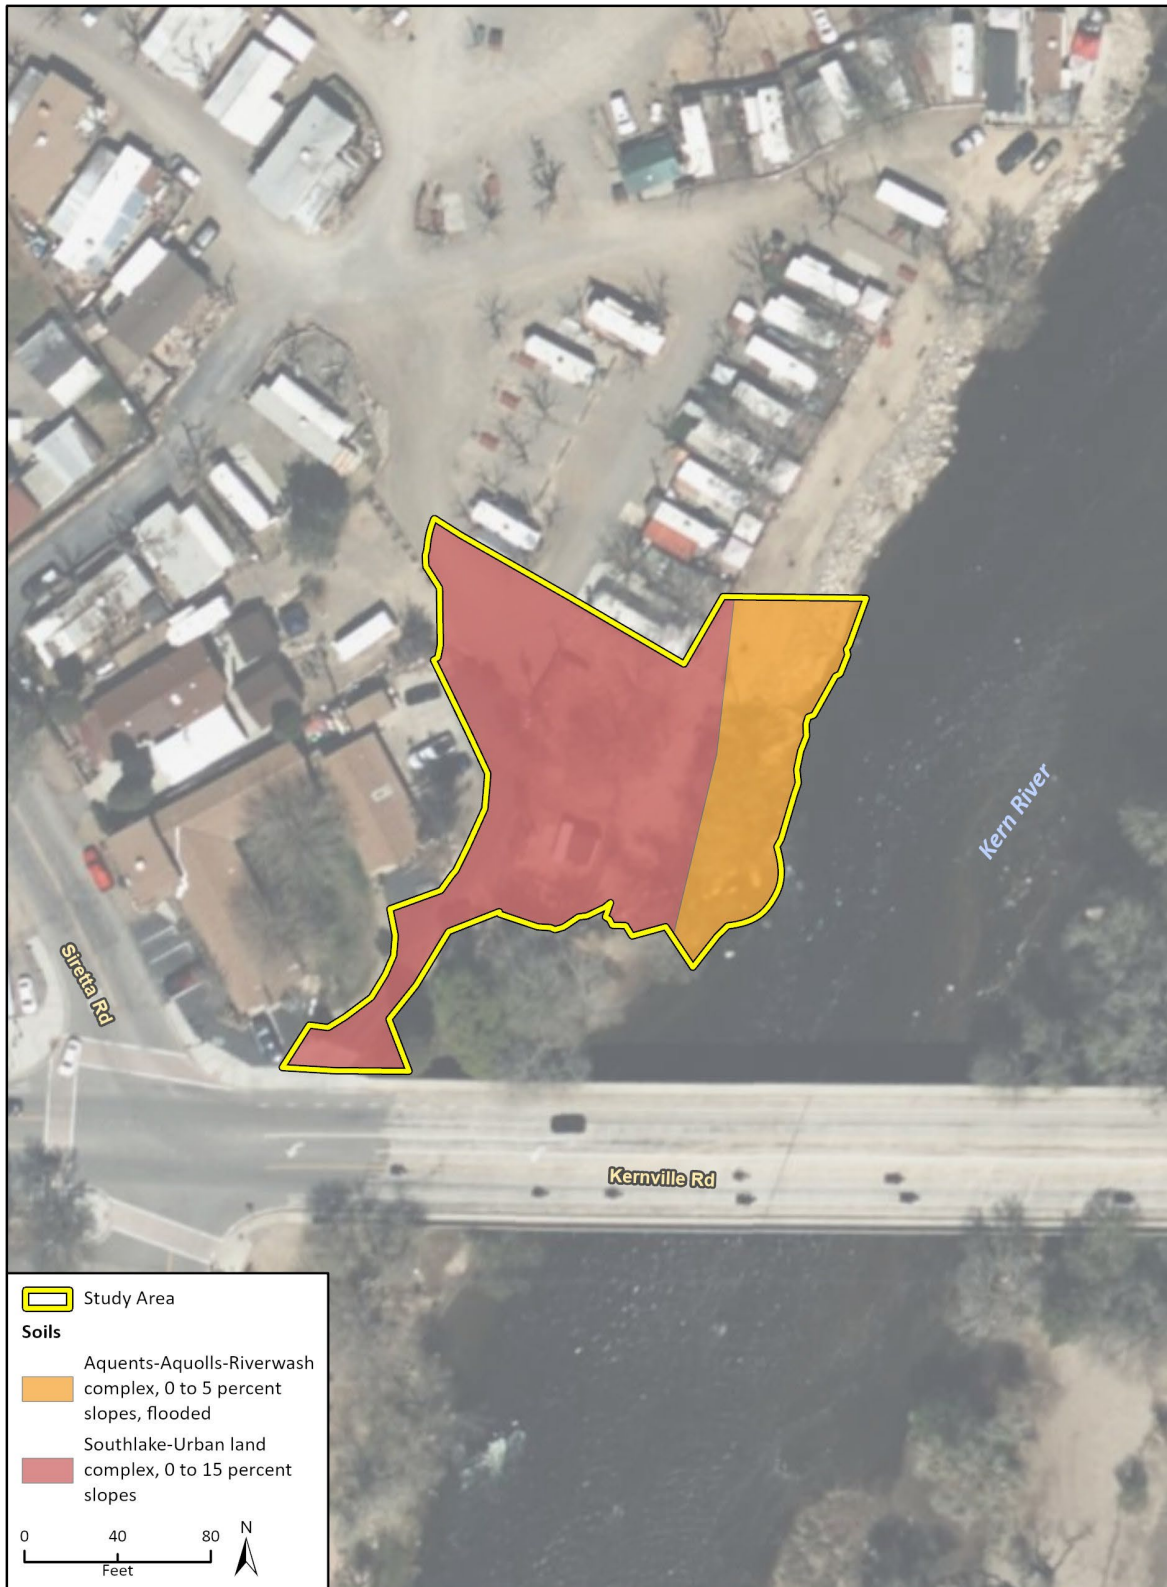
**Figure 4 Mapped Soil Units within the Study Area**

The USDA, NRCS Web Soil Survey identifies two soil types present in the Study Area: Southlake-Urban land complex, 0 to 15 percent slopes and Aquents-Aquolls-Riverwash complex, 0 to 5 percent slopes, flooded. The description of each soil map unit is presented below (USDA, NRCS 2024a). Site-specific soil observations are consistent with those mapped by the Web Soil Survey. Figure 4 in Attachment 1 provides a map of these soil types within the Study Area.

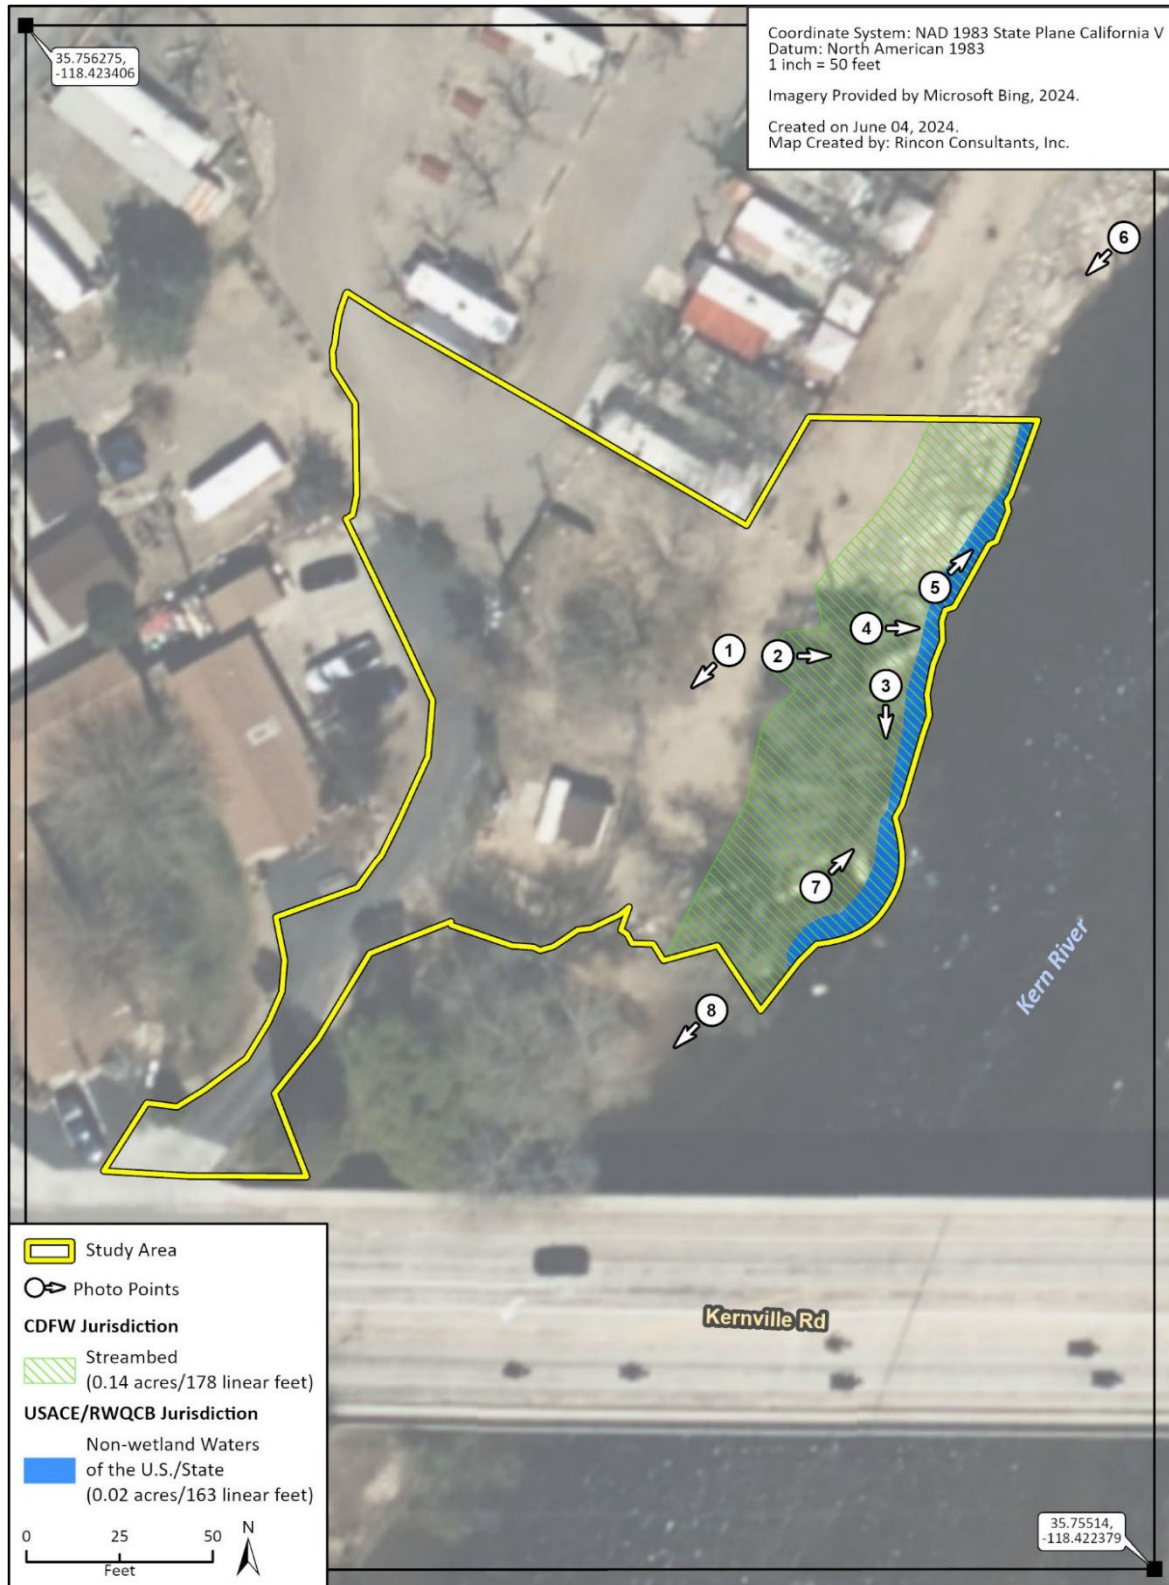
**Figure 6 Aquatic Resources Delineated within the Study Area**

Based upon the findings of Rincon's field delineation and subsequent desktop review, the Study Area contains a portion of the north fork of the Kern River. The Kern River within the Study Area is likely subject to USACE, CDFW, and SWRCB jurisdictions, as discussed below, and is illustrated graphically on Figure 6 in Attachment 1. Representative photographs can be found in Attachment 2.

Potentially aquatic resources within the Study Area are identified below in Table 1 and shown on Figure 6 in Attachment 1.

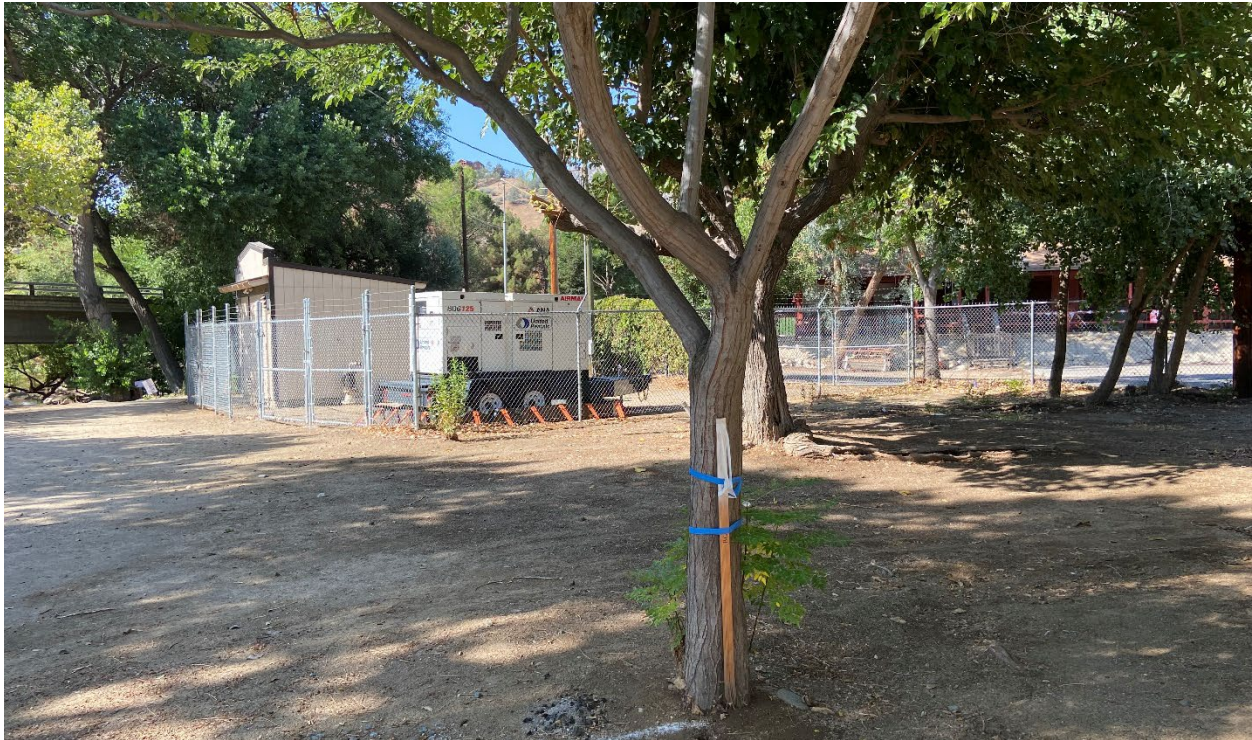
**Photograph 1.** Barren land cover with landscaped trees and the existing Cal Water station, facing southwest. September 13, 2022.

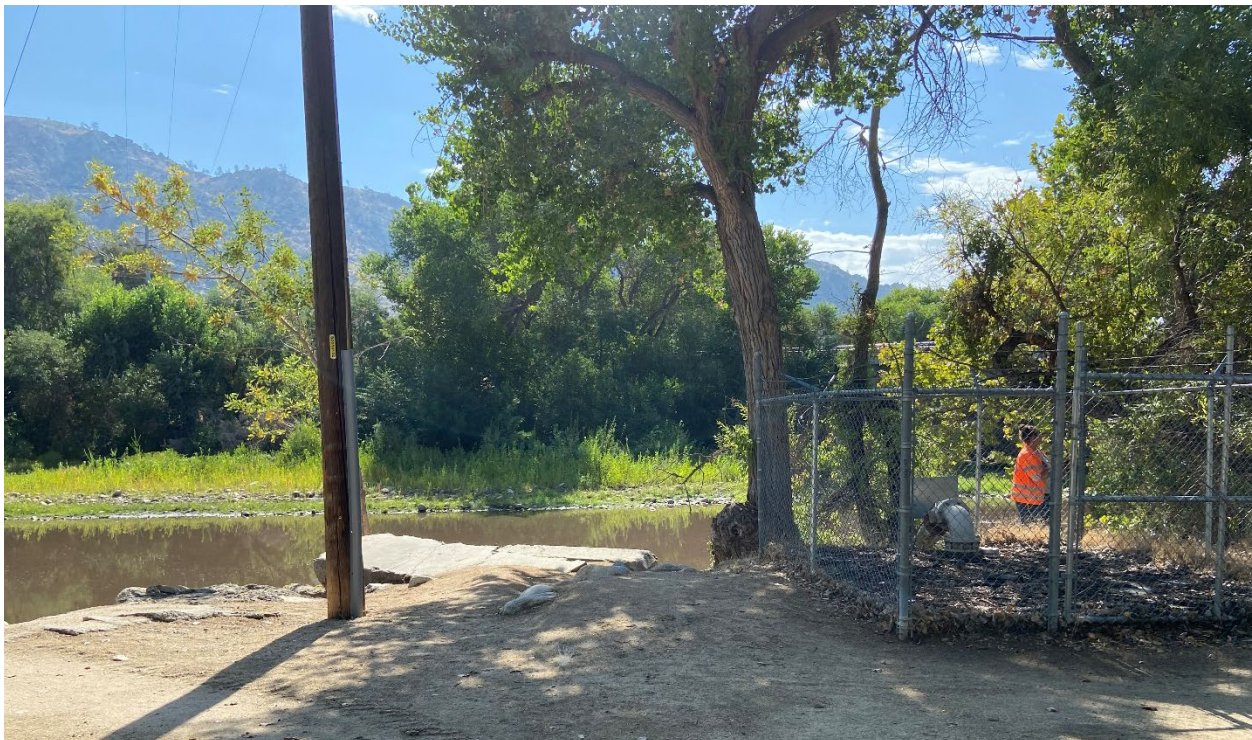
**Photograph 2.** Existing raw water intake with disturbed Fremont cottonwood woodland at the top of bank of the Kern River in the background, facing east. September 13, 2022.

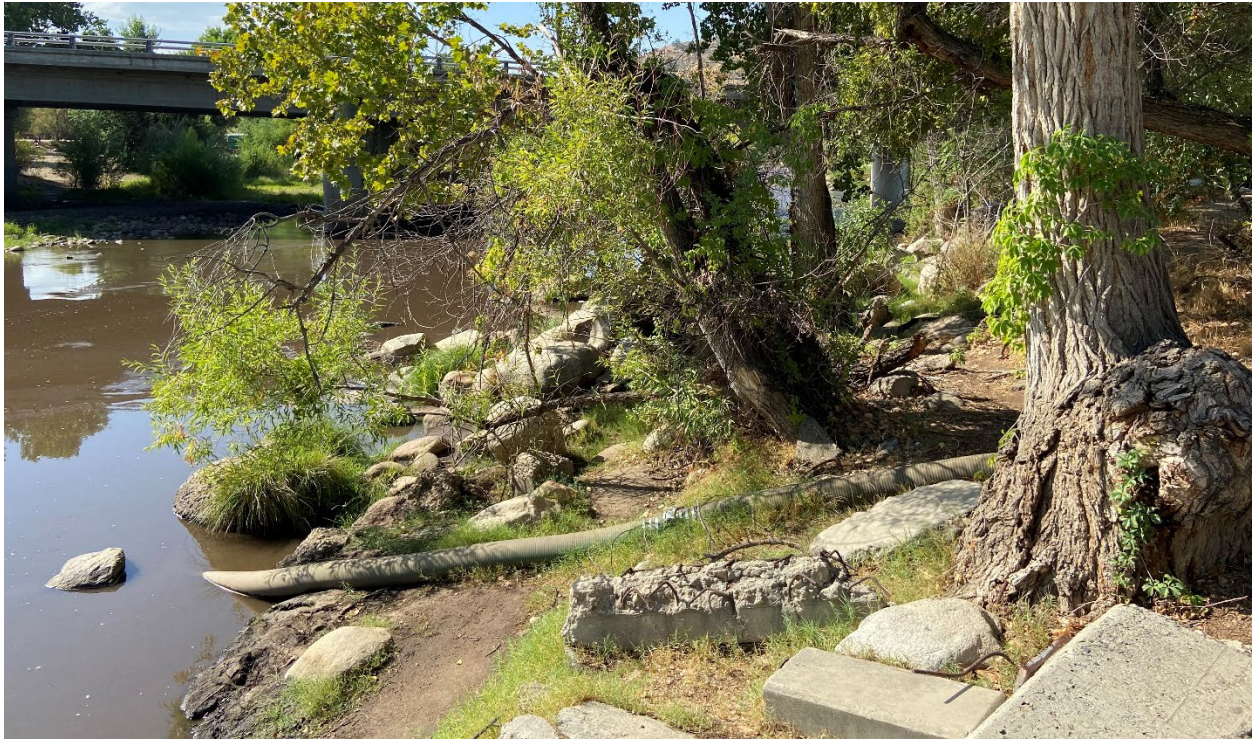
**Photograph 3.** The existing raw water intake pipe exiting the Kern River and traveling up the bank. Broken concrete and disturbed Fremont cottonwood woodland along the bank slope, facing south. September 13, 2022.

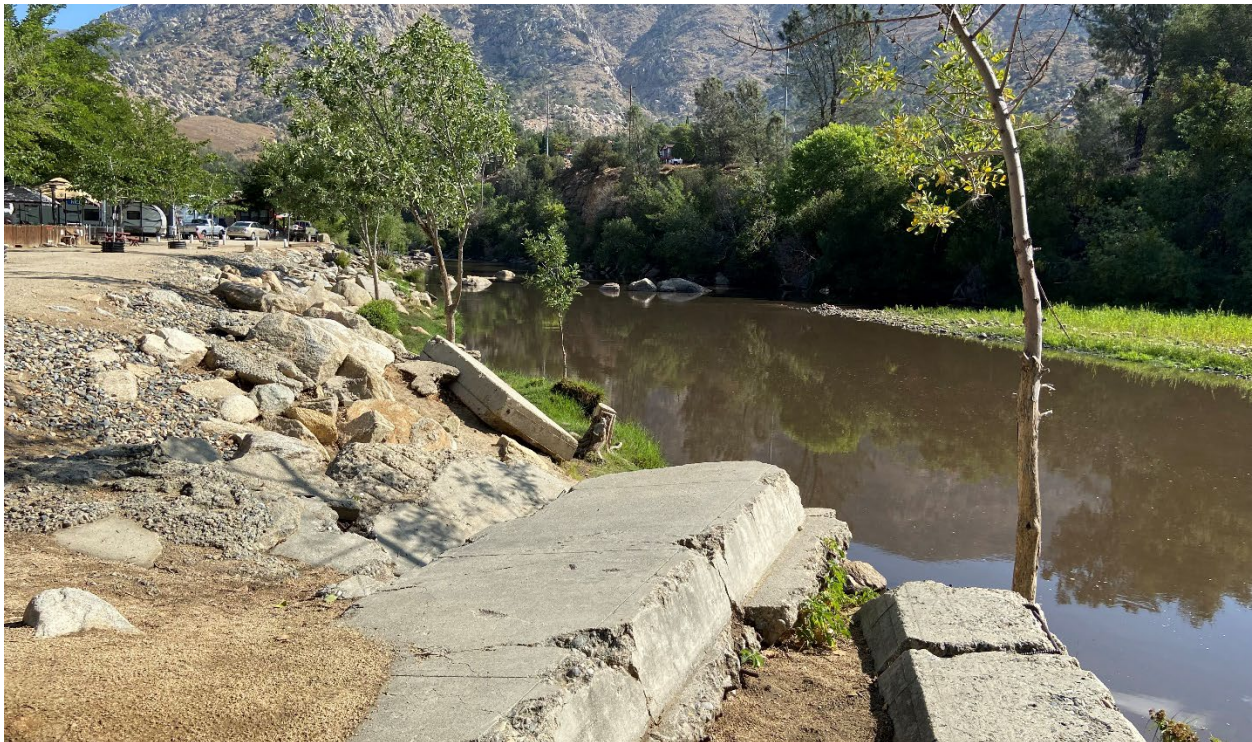
**Photograph 4.** Broken concrete and imported rocks with landscaped trees for scour protection along the Kern River bank slope, facing northeast. September 13, 2022.

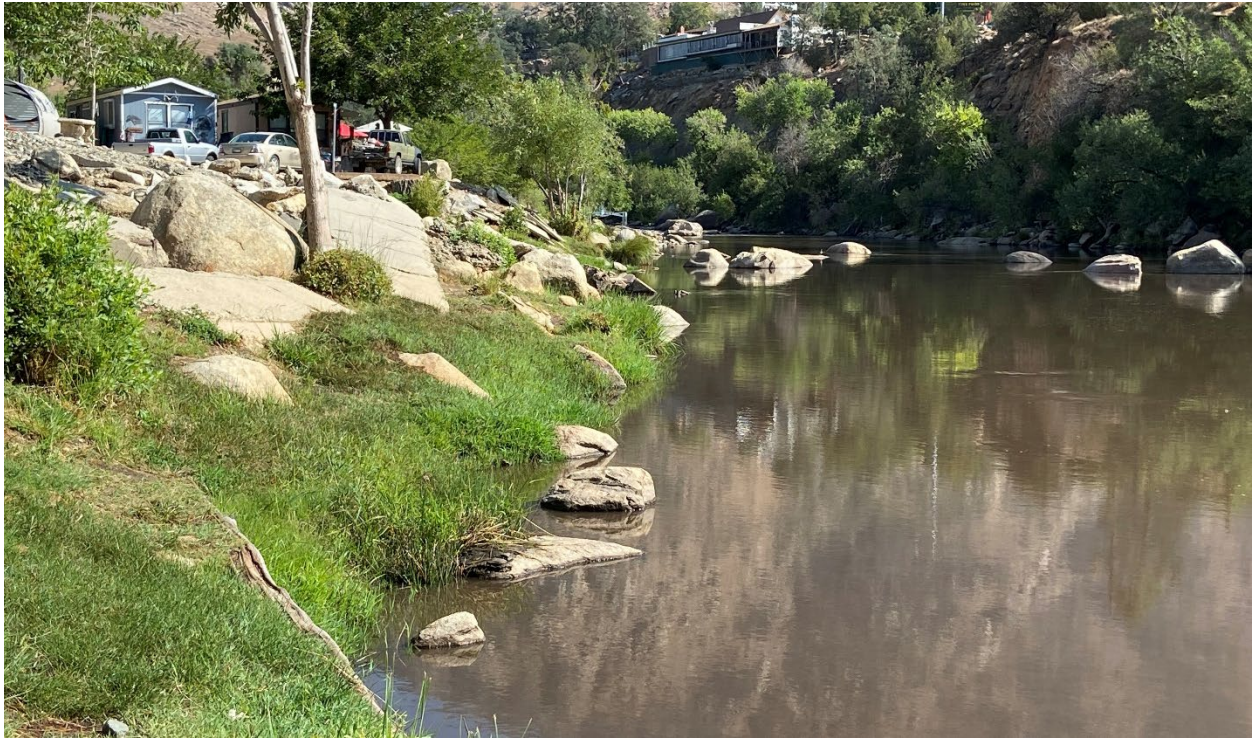
The OHWM of the Kern River is defined by a moderate break in slope, exposed roots from bank undercutting, and a change in vegetation coverage. The OHWM was determined at the edge of the flowing water. The top of bank was clearly defined by the surface relief and maintained access roadways. In the southern extent of the Study Area, the Fremont cottonwood woodland canopy extends beyond the top of bank to the west.

**Photograph 5.** Defined OHWM along the Kern River north of the existing raw water intake, facing north. September 13, 2022.

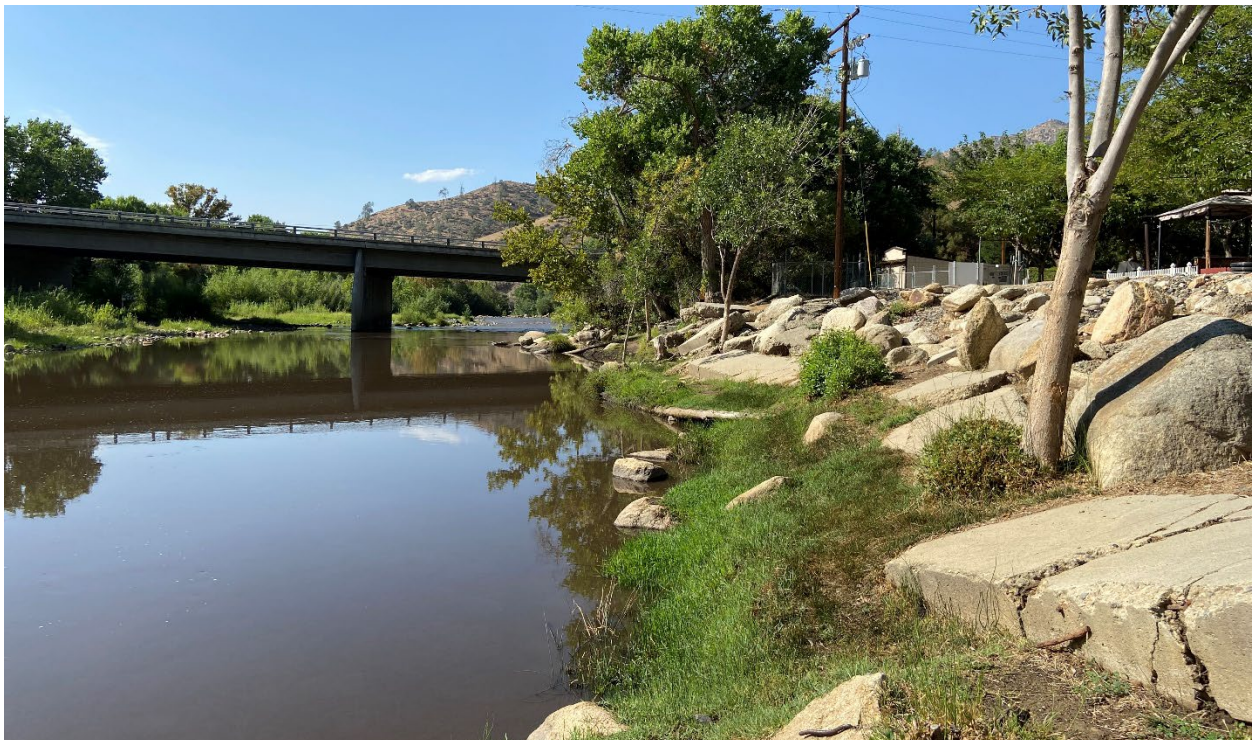
**Photograph 6.** The Kern River with in-channel vegetation and Bermudagrass turf along the Kern River bank, and broken concrete and imported rock for scour protection, facing south. September 13, 2022.

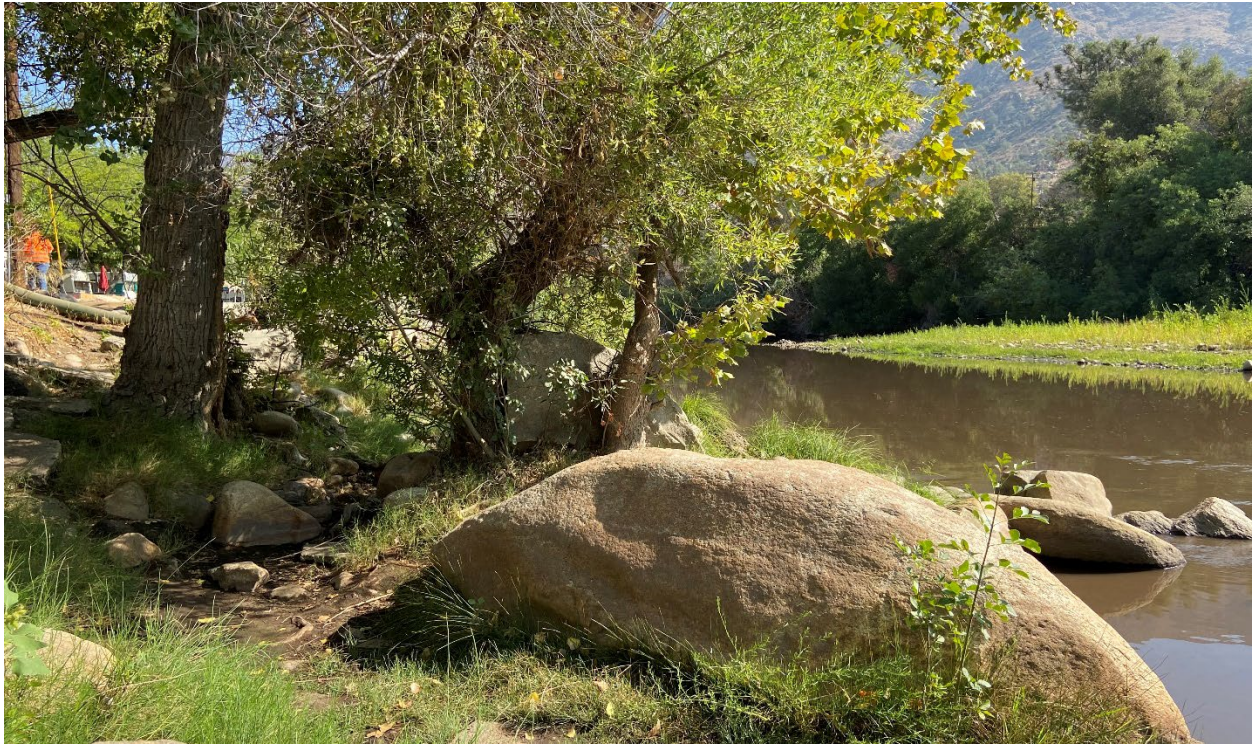
**Photograph 7.** Disturbed Fremont cottonwood woodland adjacent to the Kern River with natural in-channel boulders, facing northeast. September 13, 2022.

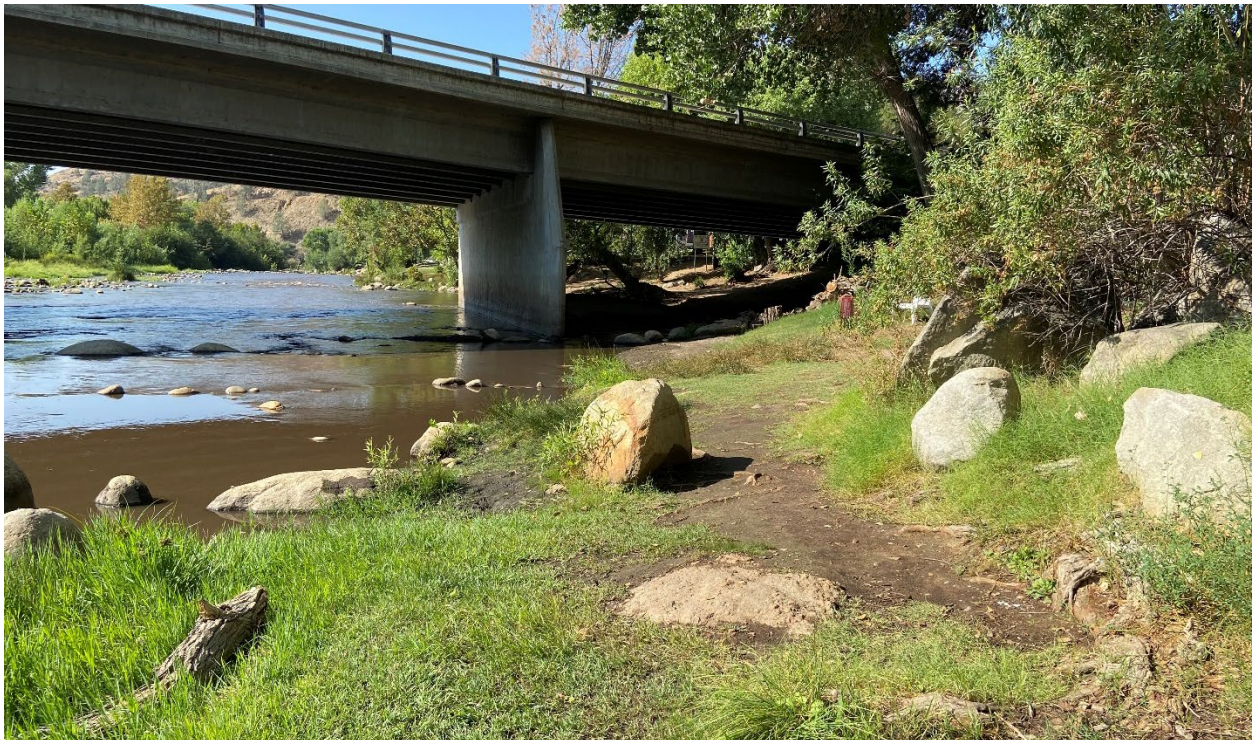
**Photograph 8.** Kern River and bank south and east of the Study Area, facing south. September 13, 2022.
