Area of Special Biological Significance 24 Draft Compliance Plan For The County of Los Angeles and City of Malibu

September 20, 2014

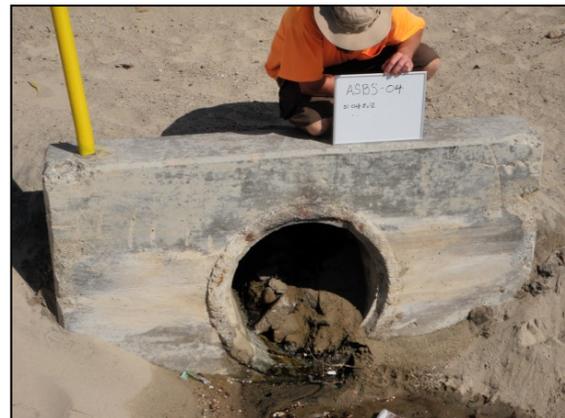
Figure 2-5. ASBS-004 Outfall

ASBS-004 is a 24-inch outfall located at the northern end of Zuma Beach, adjacent to the northernmost parking lot along Zuma Beach Access Road (Figure 2-5). This outfall is accessible during all tides and was sampled during three monitored storm events (February 19 and March 8, 2013 and February 28, 2014). The watershed draining to ASBS-004 is 9.8 acres in size and the surrounding landscape at ASBS-004 consists of a gradually sloping, broad sandy beach.

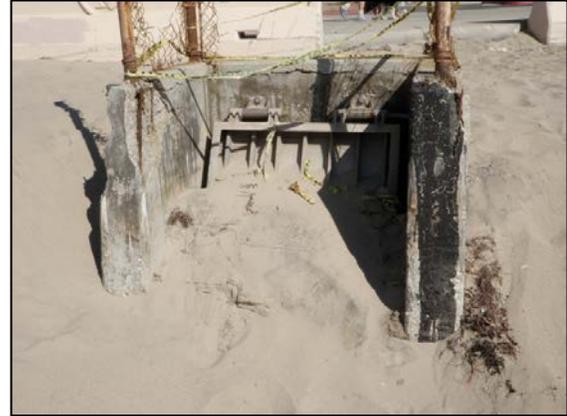
Figure 2-6. ASBS-005 Outfall

ASBS-005 is a 36-inch outfall located at the northern end of Zuma Beach, adjacent to the northernmost parking lot along Zuma Beach Access Road, and directly across from the intersection of Guernsey Avenue with PCH (Figure 2-6). This outfall is accessible during all tides and was sampled during the February 19, March 8, 2013, and February 28, 2014, storm events. The watershed draining to ASBS-005 is 65.8 acres in size and the surrounding landscape at ASBS-005 consists of a gradually sloping, broad sandy beach.

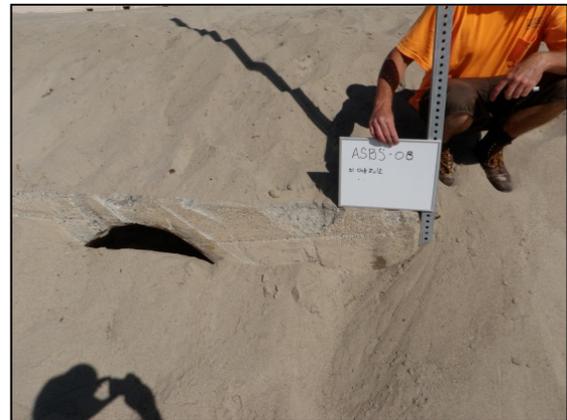
Figure 2-7. ASBS-008 Outfall

ASBS-008 is a 24-inch outfall located at the northern end of Zuma Beach, near a parking lot along Zuma Beach Access Road (Figure 2-7). This outfall is accessible during all tides and was sampled during the March 8, 2013, storm event (it was added to the list of monitored sites following the February 19, 2013, storm event). The watershed draining to ASBS-008 is 114.8 acres in size and the surrounding landscape at ASBS-008 consists of a gradually sloping, broad sandy beach.

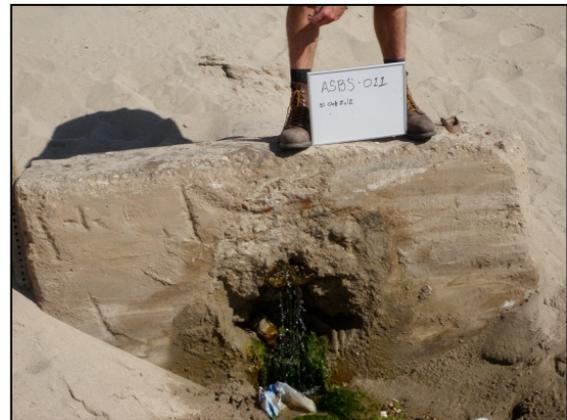
Figure 2-8. ASBS-011 Outfall

ASBS-011 is a 24-inch outfall located in middle portion of Zuma Beach, adjacent to a parking lot along Zuma Beach Access Road (Figure 2-8). This outfall is accessible during all tides and was sampled during three monitored storm events (February 19 and March 8, 2013, and February 28, 2014). The watershed draining to ASBS-011 is 7.0 acres in size and the surrounding landscape at ASBS-011 consists of a gradually sloping, broad sandy beach.

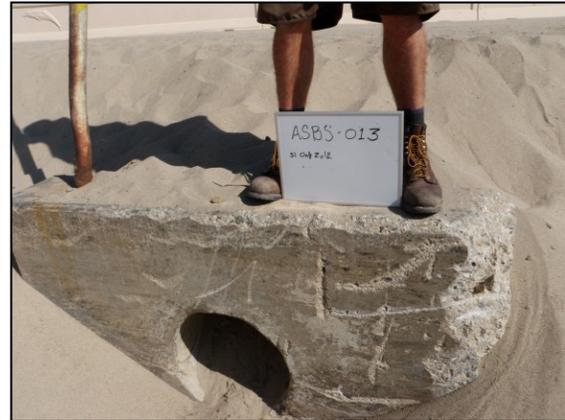
Figure 2-9. ASBS-013 Outfall

ASBS-013 is an 18-inch outfall located in middle portion of Zuma Beach, adjacent to a parking lot along Zuma Beach Access Road (Figure 2-9). This outfall is accessible during all tides and was sampled during only the March 8, 2013, and February 28, 2014, storm events, as it did not flow during the February 19, 2013, storm event. The watershed draining to ASBS-013 is 10.4 acres in size and the surrounding landscape at ASBS-013 consists of a gradually sloping, broad sandy beach.

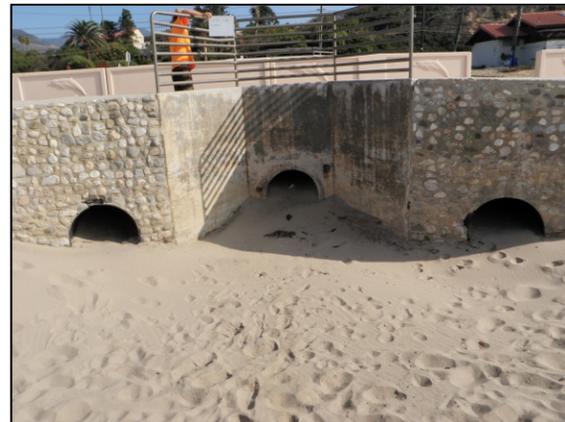
Figure 2-10. ASBS-016 Outfall

ASBS-016 is a 60-inch outfall located in middle portion of Zuma Beach, adjacent to a parking lot along Zuma Beach Access Road (Figure 2-10). This box culvert outfall is accessible during all tides and was sampled during only the March 8, 2013, and February 28, 2014, storm events, as it did not flow during the February 19, 2013, storm event. Flow monitoring equipment was installed in this outfall. The watershed draining to ASBS-016 is 115.1 acres in size and the surrounding landscape at ASBS-016 consists of a gradually sloping, broad sandy beach.

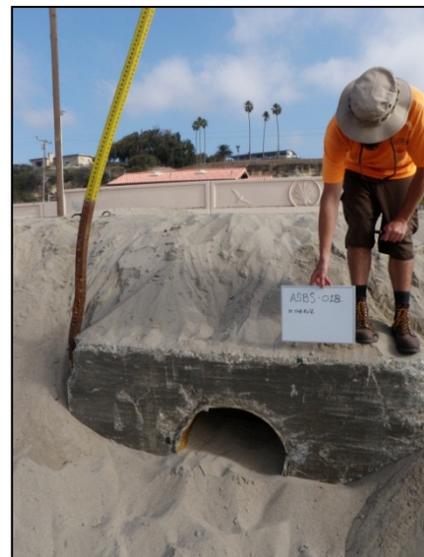
Figure 2-11. ASBS-018 Outfall

ASBS-018 is a 24-inch outfall located at the southern end of Zuma Beach, adjacent to a lifeguard station in the middle of the beach off Zuma Beach Access Road (Figure 2-11). This outfall is accessible during all tides and was sampled during three monitored storm events (February 19 and March 8, 2013, and February 28, 2014). The watershed draining to ASBS-018 is 10.0 acres in size and the surrounding landscape consists of a gradually sloping, broad sandy beach.

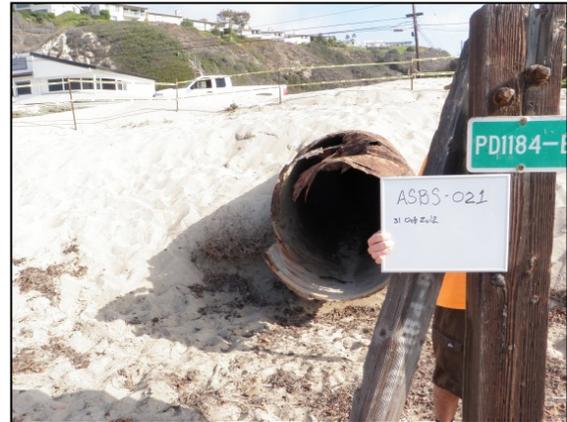
Figure 2-12. ASBS-021 Outfall

ASBS-021 is a 48-inch outfall located at the northern end of Westward Beach, adjacent to an entrance gate near the intersection of Birdview Ave. and Westward Beach Road (Figure 2-12). This outfall is accessible during all tides and was sampled during three monitored storm events (February 19 and March 8, 2013, and February 28, 2014). The watershed draining to ASBS-021 is 170 acres in size and the surrounding landscape at ASBS-021 consists of a gradually sloping, broad sandy beach.

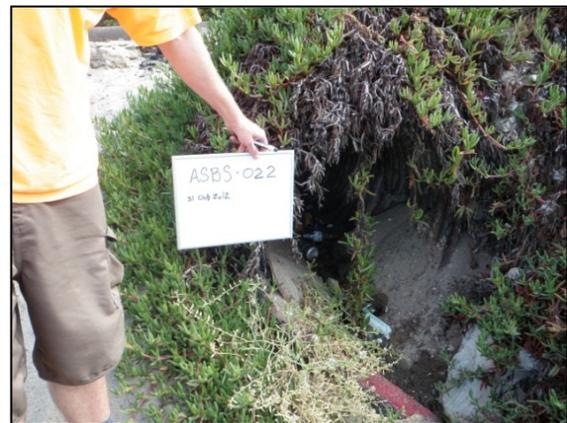
Figure 2-13. ASBS-022 Outfall

ASBS-022 is a 36-inch outfall located at the northern end of Westward Beach, midway between the entrance gate and the edge of the parking lot on Westward Beach Road (Figure 2-13). This outfall is accessible during all tides and was sampled during three monitored storm events (February 19 and March 8, 2013, and February 28, 2014).. The watershed draining to ASBS-022 is 18.4 acres in size and the surrounding landscape at ASBS-022 consists of a gradually sloping, broad sandy beach.

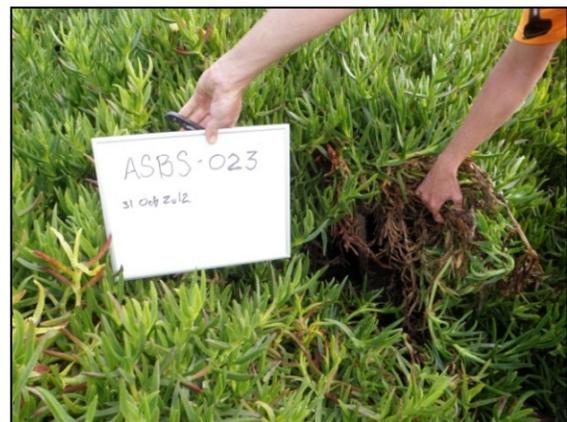
Figure 2-14. ASBS-023 Outfall

ASBS-023 is a 42-inch outfall located in the middle portion of Westward Beach, approximately 100 meters (m) north of the parking lot on Westward Beach Road (Figure 2-14). This outfall is difficult to find since it is hidden by ice plant. ASBS-023 is accessible during all tides and was sampled during three monitored storm events (February 19 and March 8, 2013, and February 28, 2014). The watershed draining to ASBS-023 is 18.4 acres in size and the surrounding landscape at ASBS-023 consists of a gradually sloping, broad sandy beach.

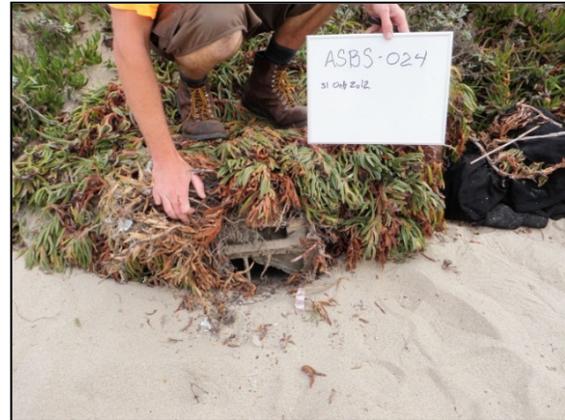
Figure 2-15. ASBS-024 Outfall

ASBS-024 is a 24-inch outfall located in the middle portion of Westward Beach, approximately 100 m south of the edge of the parking lot on Westward Beach Road (Figure 2-15). This outfall is accessible during all tides and was sampled during three monitored storm events (February 19 and March 8, 2013, and February 28, 2014). The watershed draining to ASBS-024 is 34.9 acres in size and the surrounding landscape at ASBS-024 consists of a gradually sloping, broad sandy beach.

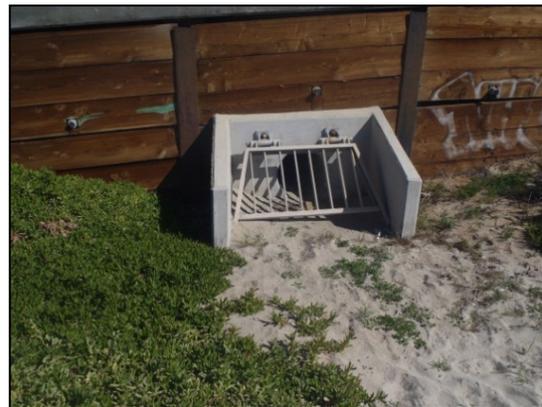
Figure 2-16. ASBS-031 Outfall

ASBS-031 is a 22-inch outfall located in the middle portion of Nicholas Beach, at the base of Nicholas Beach Road (Figure 2-16). This outfall is accessible during all tides; however, no flow was observed during either of the monitored storm events. The watershed draining to ASBS-031 is 30.1 acres in size and the surrounding landscape at ASBS-031 consists of a gradually sloping, broad sandy beach.

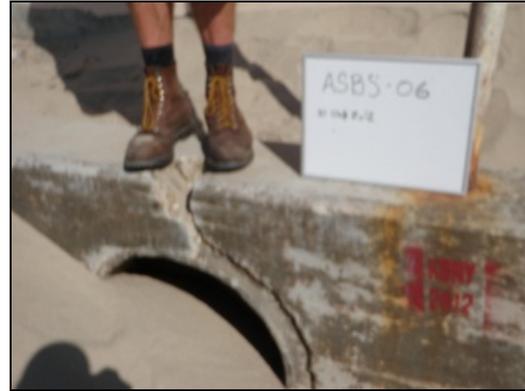
Figure 2-18. ASBS-006 Outfall

ASBS-006 is a 24-inch outfall located in the northern portion of Zuma Beach, adjacent to a parking lot along Zuma Beach Access Road (Figure 2-18). The watershed draining to ASBS-006 is 10.2 acres in size and the surrounding landscape at ASBS-006 consists of a gradually sloping, broad sandy beach.

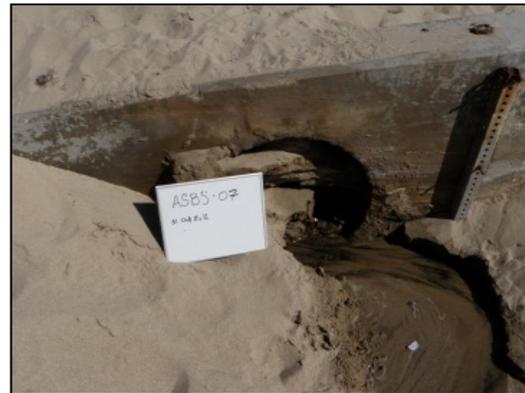
Figure 2-19. ASBS-007 Outfall

ASBS-007 is a 24-inch outfall located in the northern portion of Zuma Beach, adjacent to a parking lot along Zuma Beach Access Road (Figure 2-19). The watershed draining to ASBS-007 is 7.8 acres in size and the surrounding landscape at the outfall consists of a gradually sloping, broad sandy beach.

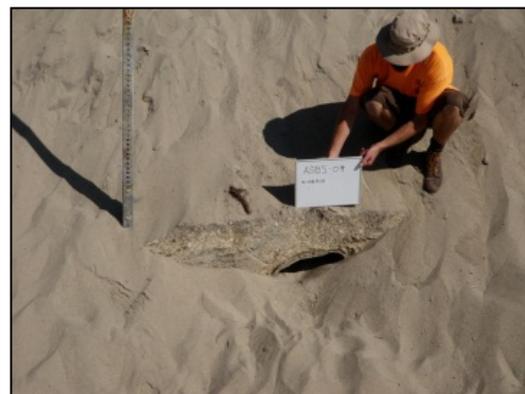
Figure 2-20. ASBS-009 Outfall

ASBS-009 is a 24-inch outfall located in the middle portion of Zuma Beach, adjacent to a parking lot along Zuma Beach Access Road, approximately 90 m south of Seadrift Cove (Figure 2-20). The watershed draining to ASBS-009 is 78.6 acres in size and the surrounding landscape at ASBS-009 consists of a gradually sloping, broad sandy beach.

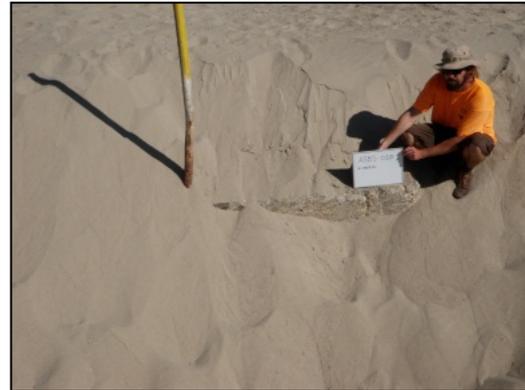
Figure 2-21. ASBS-010 Outfall

ASBS-010 is an 18-inch outfall located in the middle portion of Zuma Beach, adjacent to a parking lot along Zuma Beach Access Road, approximately 170 m south of Seadrift Cove (Figure 2-21). The watershed draining to ASBS-010 is 2.4 acres in size and the surrounding landscape at ASBS-010 consists of a gradually sloping, broad sandy beach.

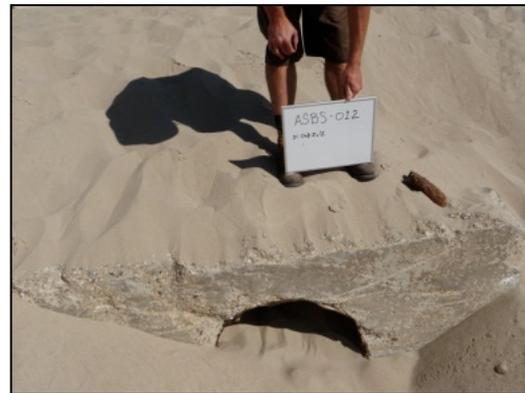
Figure 2-22. ASBS-012 Outfall

ASBS-012 is a 24-inch outfall located in the middle portion of Zuma Beach, adjacent to a parking lot along Zuma Beach Access Road, approximately 400 m south of Seadrift Cove (Figure 2-22). The watershed draining to ASBS-012 is 7.0 acres in size and the surrounding landscape at ASBS-012 consists of a gradually sloping, broad sandy beach.

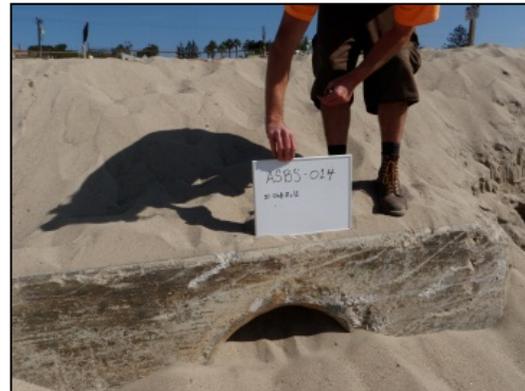
Figure 2-23. ASBS-014 Outfall

ASBS-014 is a 24-inch outfall located in the middle portion of Zuma Beach, adjacent to a parking lot along Zuma Beach Access Road, directly in front of the Beaches and Harbors maintenance yard (Figure 2-23). The watershed draining to ASBS-014 is 12.1 acres in size and the surrounding landscape at ASBS-014 consists of a gradually sloping, broad sandy beach.

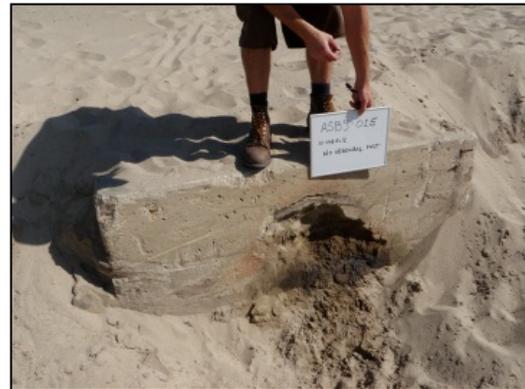
Figure 2-24. ASBS-015 Outfall

ASBS-015 is an 18-inch outfall located in the middle portion of Zuma Beach, adjacent to a parking lot along Zuma Beach Access Road, approximately 65 m south of the Beaches and Harbors maintenance yard (Figure 2-24). The watershed draining to ASBS-015 is 3.0 acres in size and the surrounding landscape at ASBS-015 consists of a gradually sloping, broad sandy beach.

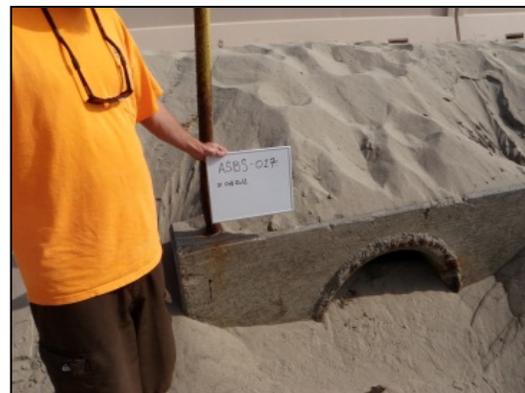
Figure 2-25. ASBS-017 Outfall

ASBS-017 is an 18-inch outfall located in the southern portion of Zuma Beach, adjacent to a parking lot along Zuma Beach Access Road, directly in front of a helicopter landing pad (Figure 2-25). The watershed draining to ASBS-017 is 8.8 acres in size and the surrounding landscape at ASBS-017 consists of a gradually sloping, broad sandy beach.

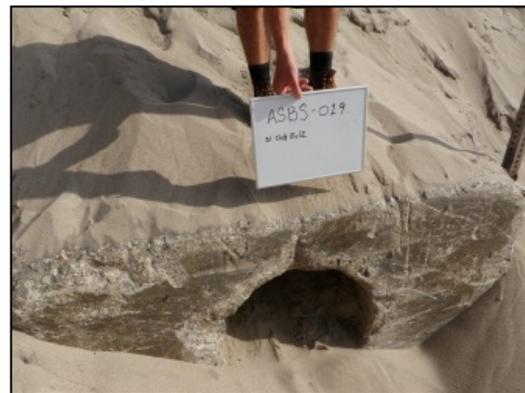
Figure 2-26. ASBS-019 Outfall

ASBS-019 is a 24-inch outfall located in the southern portion of Zuma Beach, adjacent to a parking lot along Zuma Beach Access Road, approximately 420 m north of the Zuma Beach entrance gate (Figure 2-26). The watershed draining to ASBS-019 is 20.8 acres in size and the surrounding landscape at the outfall consists of a gradually sloping, broad sandy beach.

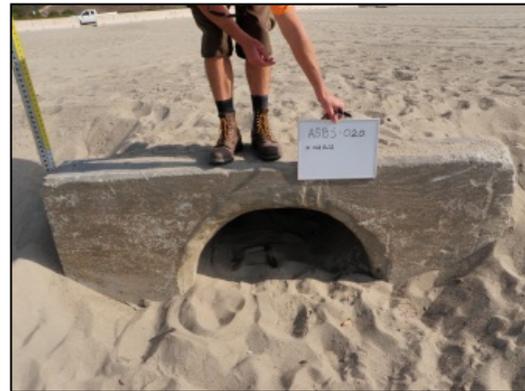
Figure 2-27. ASBS-020 Outfall

ASBS-020 is a 36-inch outfall located in the southern portion of Zuma Beach, adjacent to a parking lot along Zuma Beach Access Road, approximately 200 m north of the Zuma Beach entrance gate, in the center of the beach (Figure 2-27). The watershed draining to ASBS-020 is 12.3 acres in size and the surrounding landscape at ASBS-020 consists of a gradually sloping, broad sandy beach.

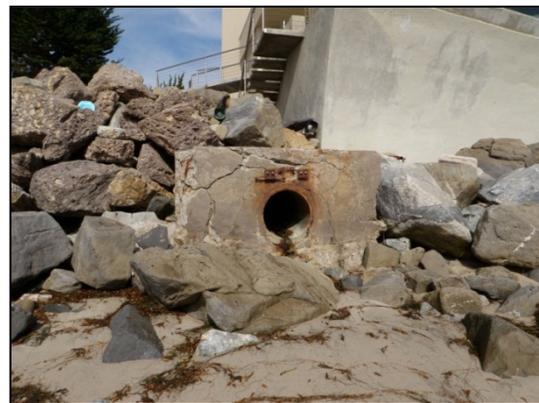
Figure 2-29. ASBS-001 Outfall

ASBS-001 is a 24-inch outfall located at the northern end of Broad Beach, along Point Lechuza, beneath a large residence (Figure 2-29). This outfall is inaccessible during high tide and was sampled during three monitored storm events (February 19 and March 8, 2013, and February 28, 2014) from a manhole located approximately 140 ft. from the beach on Point Lechuza Drive. The watershed draining to ASBS-001 is 9.4 acres in size and the area surrounding the outfall consists of a rocky intertidal area interspersed along a narrow, sandy beach.

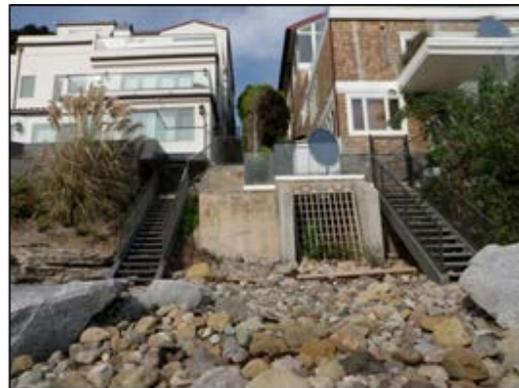
Figure 2-31. ASBS-003 Outfall

ASBS-003 is a 51-inch outfall located at the northern end of Broad Beach, south of Point Lechuza, between two residences (Figure 2-31). This outfall is inaccessible during high tide but was successfully sampled during three monitored storm events (February 19 and March 8, 2013 and February 28, 2014). The watershed draining to ASBS-003 is 253.5 acres in size and a rocky intertidal area is located directly west of the outfall.

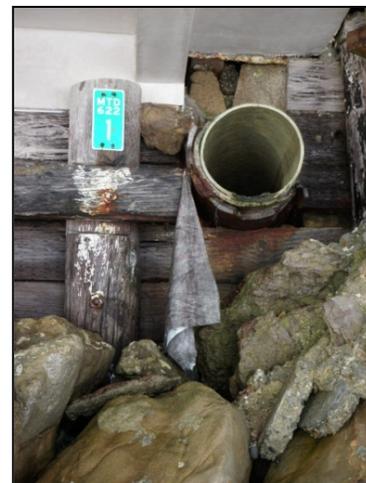
Figure 2-32. ASBS-025 Outfall

ASBS-025 is an 18-inch outfall located at the southern end of Escondido Beach, south of the Malibu Cove Colony Drive entrance off PCH (Figure 2-32). The outfall is integrated with the foundation of a residence and discharges directly onto the sand between two residences. This outfall is inaccessible during high tide but was successfully sampled during three monitored storm events (February 19 and March 8, 2013, and February 28, 2014). The watershed draining to ASBS-025 is 0.8 acres in size and the landscape surrounding the outfall is composed of a steep, sandy beach.

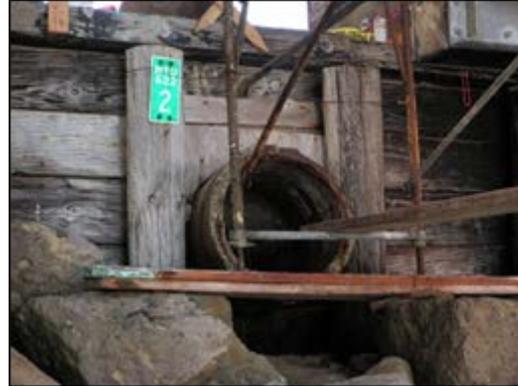
Figure 2-33. ASBS-026 Outfall

ASBS-026 is a 24-inch outfall located at the southern end of Escondido Beach, south of the Malibu Cove Colony Drive entrance off PCH (approximately 30 m southeast of ASBS-025). The outfall is integrated with the foundation of a residence and discharges directly onto the sand beneath the residence (Figure 2-33). This outfall is inaccessible during high tide but was successfully sampled during three monitored storm events (February 19 and March 8, 2013, and February 28, 2014). The watershed draining to ASBS-026 is 2.5 acres in size and the landscape surrounding the outfall is composed of a steep, sandy beach.

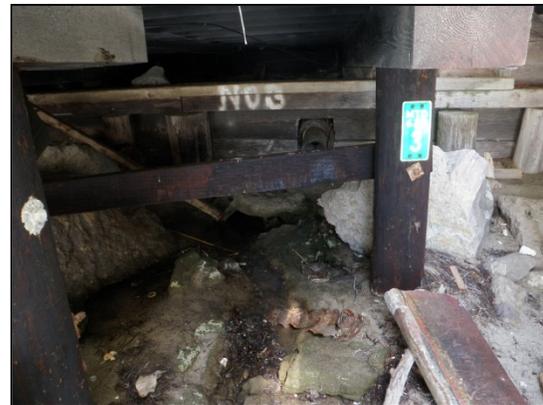
Figure 2-34. ASBS-027 Outfall

ASBS-027 is a 24-inch outfall located at the southern end of Escondido Beach, approximately 300 m east of the Malibu Cove Colony Drive entrance off PCH (Figure 2-34). The outfall is integrated with the foundation of a residence and discharges directly onto the sand beneath the residence. This outfall is inaccessible during high tide but was successfully sampled during three monitored storm events (February 19 and March 8, 2013, and February 28, 2014). The watershed draining to ASBS-027 is 18.9 acres in size and the landscape surrounding the outfall is composed of a steep, sandy beach.

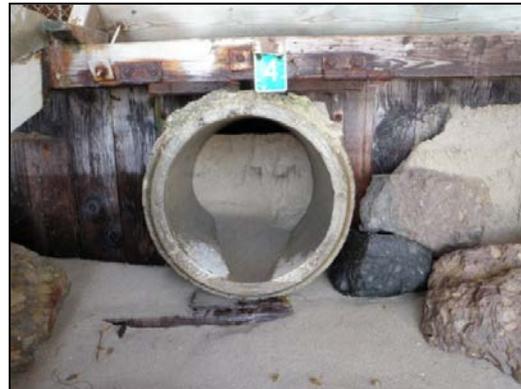
Figure 2-35. ASBS-028 Outfall

ASBS-028 is a 36-inch outfall located at the southern end of Escondido Beach, approximately 500 m east of the Malibu Cove Colony Drive entrance off PCH (Figure 2-35). The outfall is integrated with the foundation of a residence and discharges directly onto the sand beneath the residence. Flow monitoring equipment was installed in this outfall near the inlet on Malibu Cove Colony Drive. This outfall is inaccessible during high tide but was successfully sampled during three monitored storm events (February 19 and March 8, 2013, and February 28, 2014). The watershed draining to ASBS-028 is 36.0 acres in size and the landscape surrounding the outfall is composed of a steep, sandy beach.

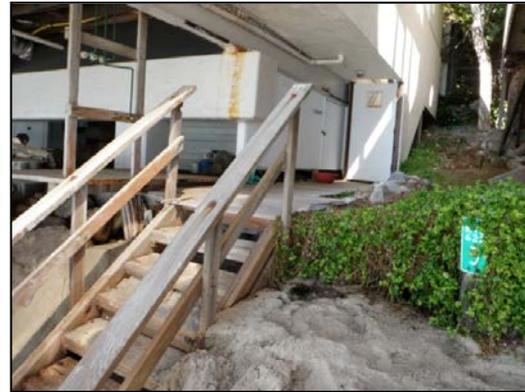
Figure 2-36. ASBS-029 Outfall

ASBS-029 is an 18-inch outfall located at the southern end of Escondido Beach, near the end of Malibu Cove Colony Drive (Figure 2-36). The outfall lies between two residences and discharges directly onto the sand. This outfall is inaccessible during high tide but was successfully sampled three monitored storm events (February 19 and March 8, 2013, and February 28, 2014). The watershed draining to ASBS-029 is 3.8 acres in size and the landscape surrounding the outfall is composed of a steep, sandy beach.

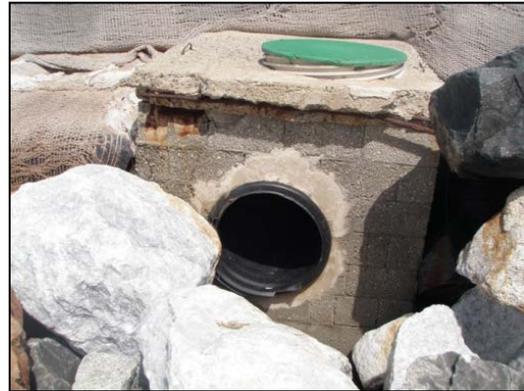
Figure 2-39. 24-BB-01Z Outfall

Site 24-BB-01Z is a 24-inch outfall located at the southern end of Broad Beach, near the intersection of Trancas Canyon Road and PCH (Figure 2-39). The outfall is located behind rock revetment and is inaccessible during high tide or dangerous surf conditions. This outfall was successfully sampled during the February 28, 2014, storm event. The monitoring program will continue into the 2014-2015 wet season and thus, sampling may be performed prior to the submittal of the final Plan. The watershed draining to 24-BB-01Z is 19.9 acres in size and consists primarily of single family residences, commercial, transportation right-of-way (ROW), and PCH ROW land uses. The landscape surrounding the outfall is composed of a rock revetment and narrow, sandy beach with near-shore reef and kelp.

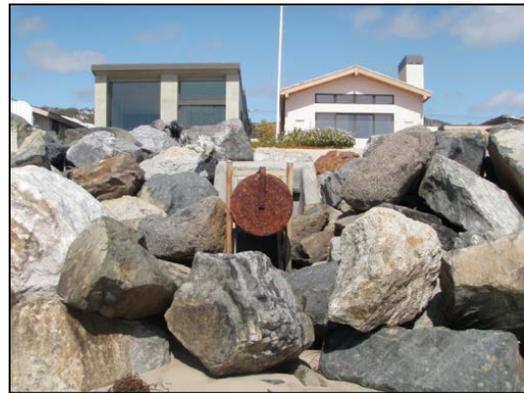
Figure 2-40. 24-BB-02Z Outfall

Site 24-BB-02Z is an 18-inch outfall located at the southern end of Broad Beach, approximately 200 m south of the intersection of Lunita Road and PCH (Figure 2-40). This outfall was successfully sampled during the February 28, 2014, storm event. The monitoring program will continue into the 2014-2015 wet season and thus, sampling may be performed prior to the submittal of the final Plan. The outfall is located among the shoreline rock revetment and is inaccessible during high tide or dangerous surf conditions. The watershed draining to 24-BB-02Z is 13.9 acres in size and consists primarily of single family residences, vacant, transportation ROW, and PCH ROW land uses. The landscape surrounding the outfall is composed of rock revetment a narrow, sandy beach.

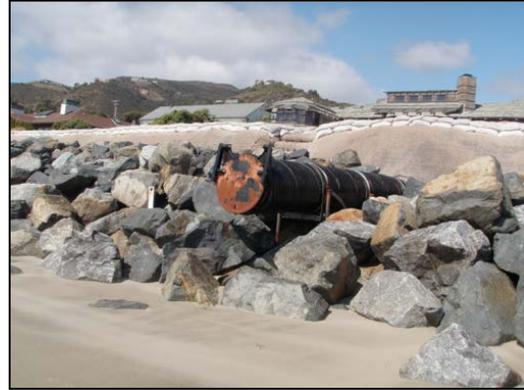
Figure 2-41. 24-BB-03Z Outfall

Site 24-BB-03Z is a 30-inch outfall located at the southern end of Broad Beach, approximately 100 m south of the intersection of Lunita Road and PCH (Figure 2-41). This outfall was successfully sampled during the February 28, 2014, storm event. The monitoring program continues into the 2013-2014 wet season and thus, sampling may be performed prior to the submittal of the Final Plan. The outfall is located among the shoreline rock revetment and is inaccessible during high tide or dangerous surf conditions. The watershed draining to 24-BB-03Z is 127.6 acres in size and consists primarily of rural residential, vacant, single family residences, transportation ROW, and PCH ROW land uses. The landscape surrounding the outfall is composed of rock revetment and a narrow, sandy beach.

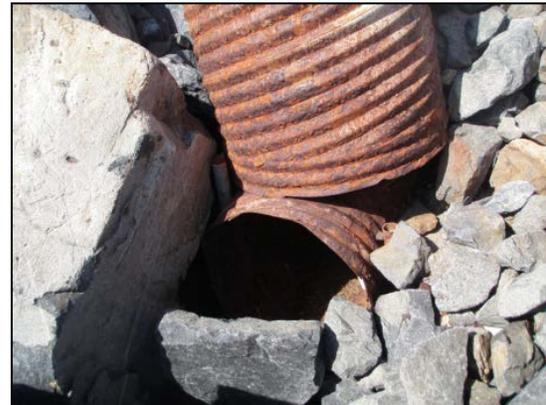
Figure 2-42. ASBS-C Outfall

Site ASBS-C-Z is a 30-inch outfall located at the northern end of Broad Beach, approximately 30 m south of the intersection of La Herran Road and PCH (Figure 2-42). While the City owns the inlet to this outfall, the outfall is considered private. The outfall is located behind and partially buried by the rock revetment and is inaccessible at all times due to the steep rock revetment that surrounds the outfall. No sampling has been performed at this site. The watershed draining to ASBS-C is 66.8 acres in size and consists primarily of single family residences, vacant, transportation ROW, and PCH ROW land uses. The landscape surrounding the outfall is composed of rock revetment and a narrow, sandy beach with some near-shore reef.

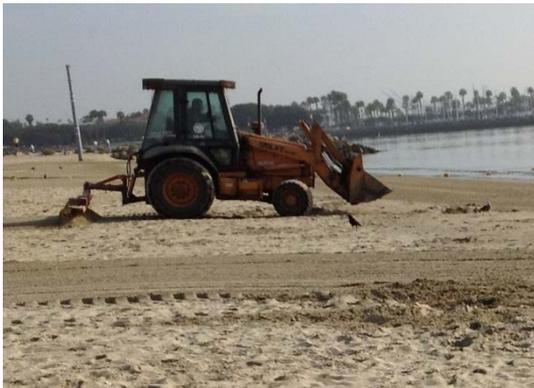
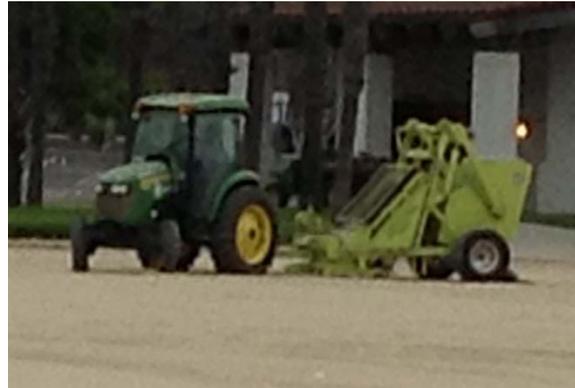
The County's waste management program includes a regional beach sand "sanitation" program that is implemented at the three County Beaches located within ASBS 24. The beach sanitation program involves collecting beach debris in a screened hopper pulled by a tractor and properly disposing of the material. A rake system attached to the back of the tractor turns over the sand and allows solar radiation to "sanitize" the beach sand. Beach sand sanitation activities are implemented three times per week, provided that the beach sand is not wet. The implementation is scheduled during the morning hours to allow for maximal day-light exposure.

Figure 3-4. County Beach Sand Sanitation Program Equipment at Work

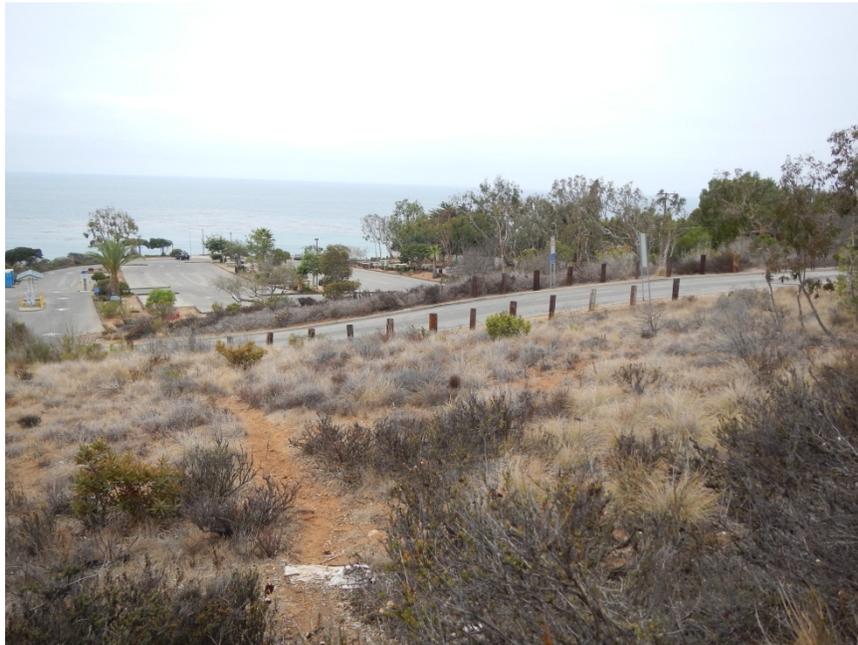
Figure 7-5. Nicholas Canyon County Beach Parking Lot

The photograph depicted in Figure 7-5 was taken looking west and downward towards the Nicholas Canyon County Beach parking lot. The up-gradient area between PCH and the parking lot is shown to have fairly good vegetation cover. A narrow foot/animal path leads down the sloped area. Signs of erosion were not observed in the area. Compared to natural cover, a parking lot with an impervious surface located on a mesa, such as the case here, increases storm water runoff quantity and velocity resulting in the potential to erode soils if not properly designed. The parking lot was observed to have several storm drain inlets with associated piping to convey collected storm water down to the ocean without the potential to increase erosion of the bluffs (i.e., outfall located at sea level along rocky shoreline).

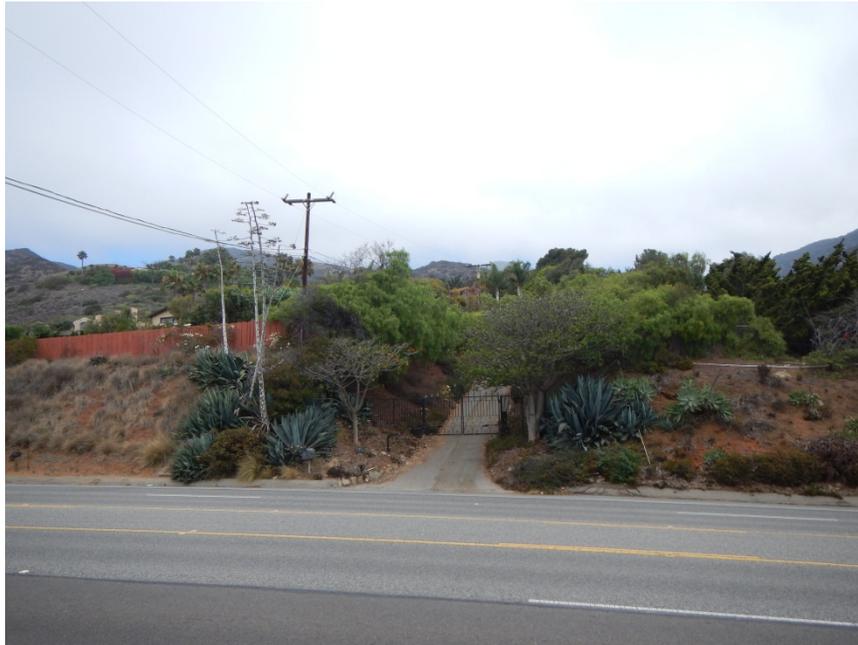
Figure 7-6. Nicholas Canyon Beach Upper Watershed Area

Figure 7-6 shows the area east of the PCH up-gradient from Nicholas Canyon County Beach. PCH and a residence occupy the area, where it appears that the highway and residential access driveway were constructed by cutting away (excavating) some the native materials and creating 2:1 (horizontal: vertical) slopes. These slopes are shown with vegetation cover and without evidence of active erosion.

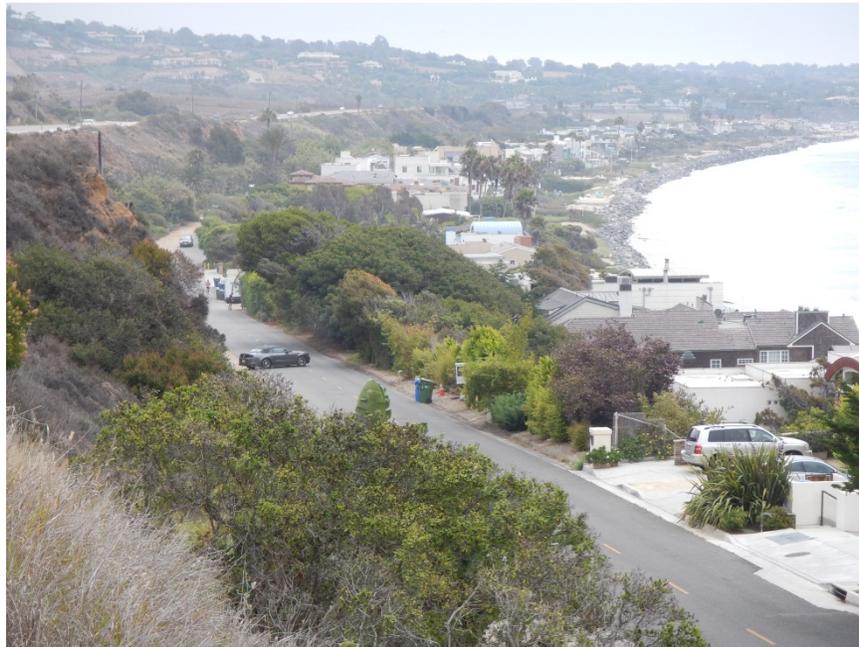
Figure 7-7. Bluff Area Above Broad Beach

The photograph depicted in Figure 7-7 was taken above Broad Beach and shows the bluff area located between PCH and the residences that are situated along the shoreline. During the field reconnaissance, the majority of the bluff appeared to have vegetation cover. Some steep portions were exposed, resembling natural bluffs observed in the area where development has been restricted (e.g., the nearby El Matador State Beach). Signs of erosion from these bare areas were not observed in the bluff along Broad Beach Road.

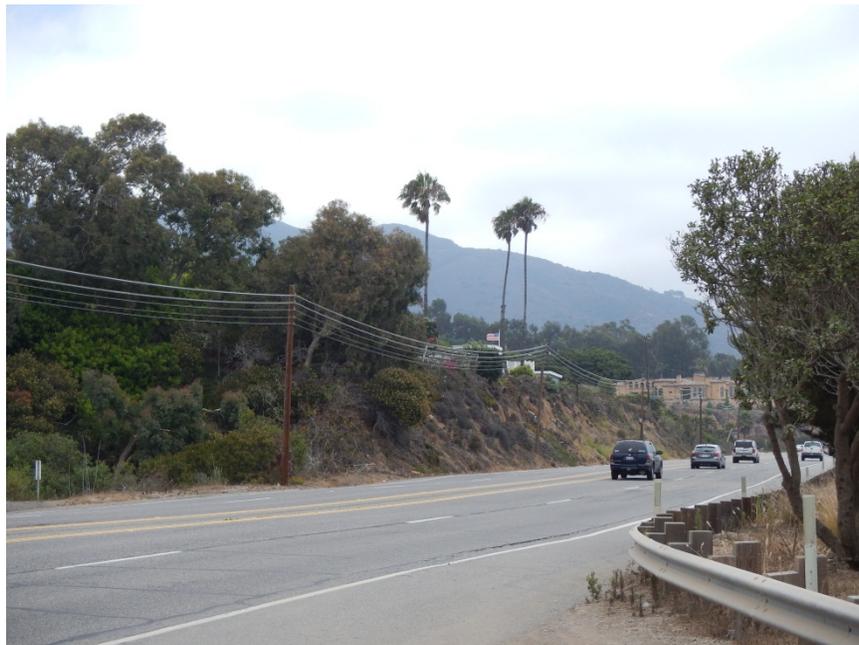
Figure 7-8. Directly Above Broad Beach Area

The photograph depicted in Figure 7-8 shows the area along PCH and directly above Broad Beach. Similar bluff materials, but having lower height, were observed at this location with similar vegetation cover as the bluffs located along Broad Beach. Thick vegetation was observed at the bottom of the bluff material adjacent to the roadway.

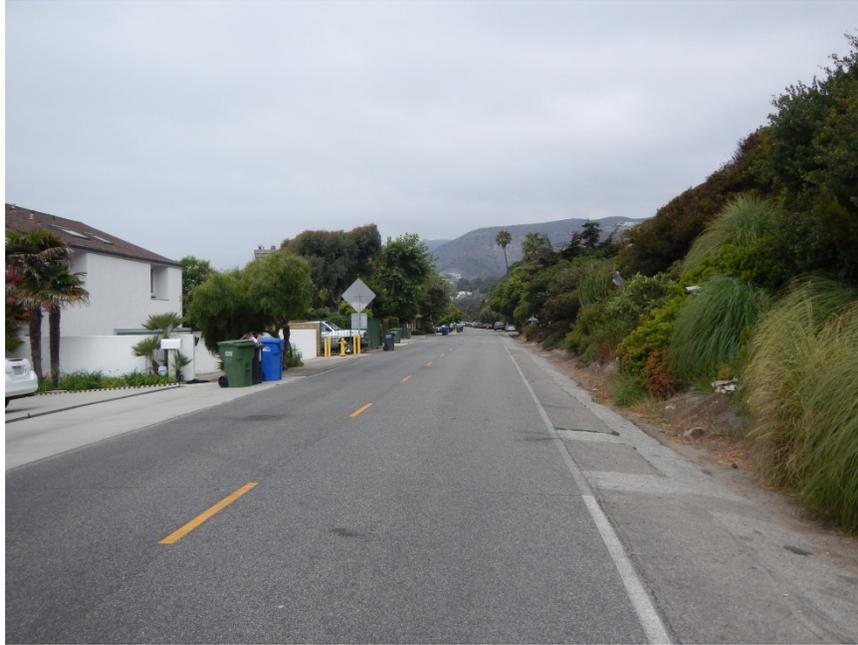
Figure 7-9. East Portion of Broad Beach

The east end of Broad Beach Road has thicker vegetation cover and a lower bluff height compared to the west area. Figure 7-9 shows the typical street composition of residences and associated improvements along the south (seaward) side and off-street parking area along the north side followed by a vegetated sloped area.

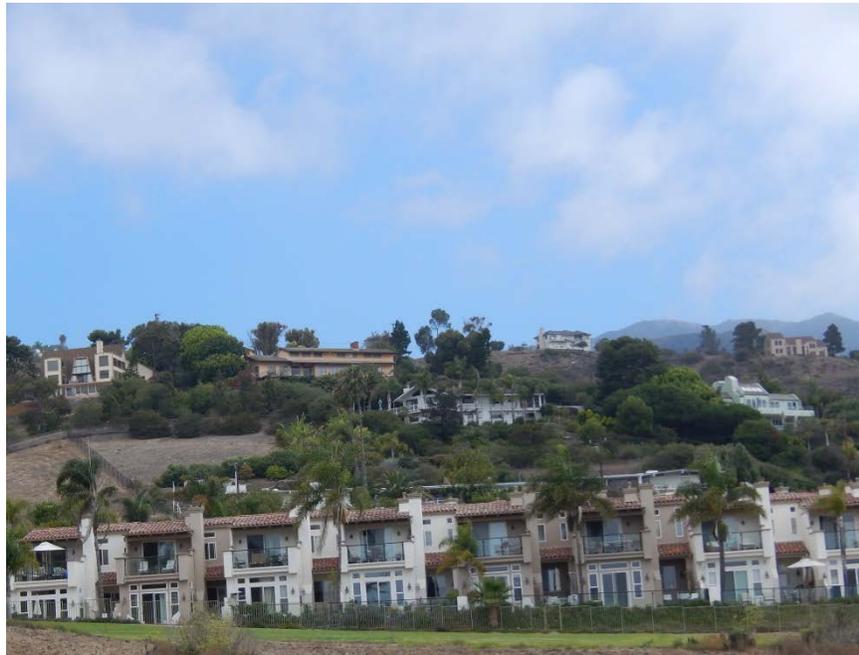
Figure 7-10. Area Up-Gradient of Broad Beach

Further up the watershed to Broad Beach the geology changes to that of the Santa Monica Mountains with hills and valleys. Figure 7-10 shows the residential development and associated landscaping in this area.

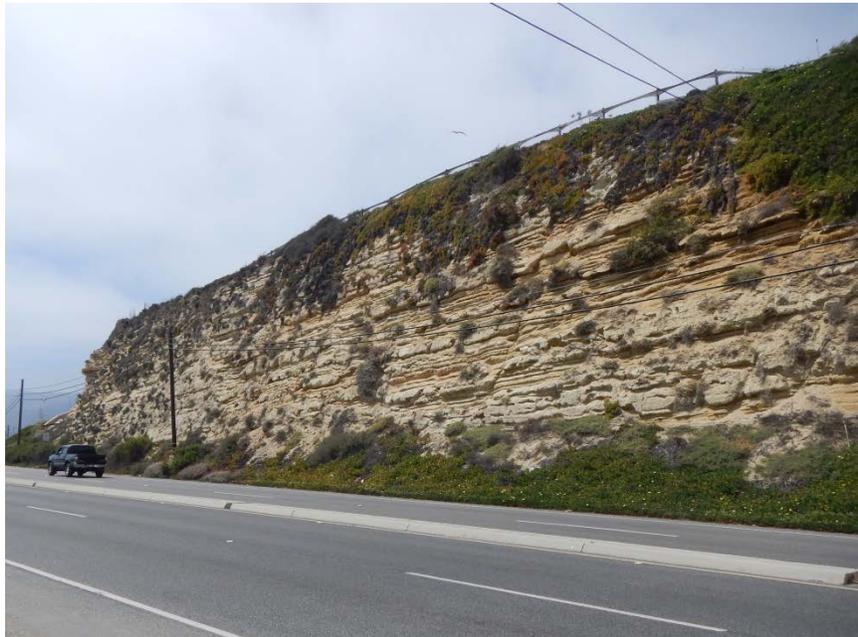
Figure 7-11. Vertical Bluff Across from Zuma Beach

The photograph depicted in Figure 7-11 shows the area across from the southeast side of Zuma County Beach, north of PCH. Field reconnaissance observed a large vertical bluff. This bluff appears to be Miocene age Modelo Formation that may have been a naturally formed vertical wall or a result of grading associated with the construction of PCH. Evidence of erosion was not observed during the reconnaissance. The materials appeared to be very hard and resistant to erosive forces of nature.

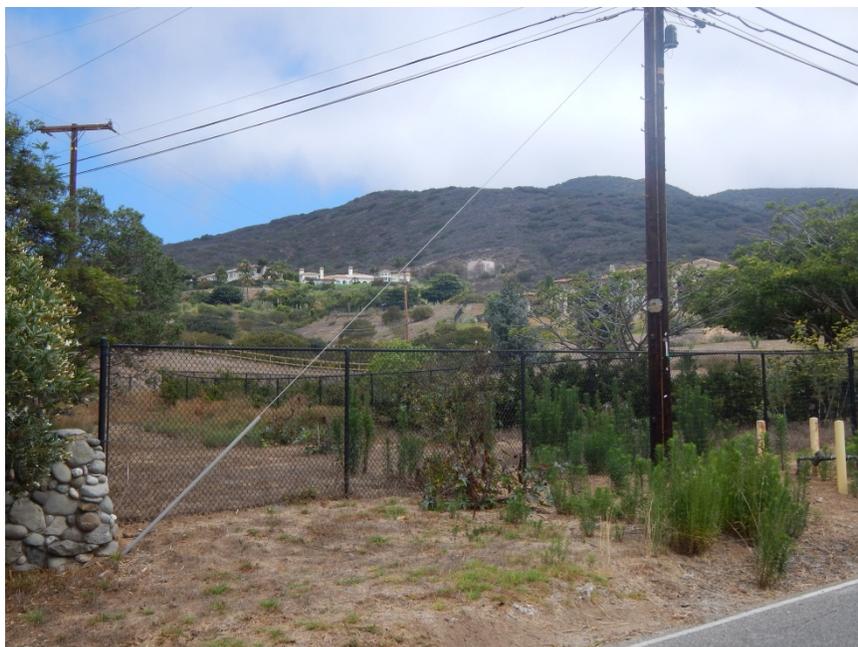
Figure 7-12. Up-Gradient of Zuma Beach Area

As with the other areas evaluated, away from the coast the geology was observed to be Santa Monica Mountains in the watersheds upstream of the Zuma County Beach shoreline. Good vegetation cover was observed in the sloped areas around the existing improvements, which included residences and a water tank (Figure 7-12). Thick native vegetation was observed above the developed areas.

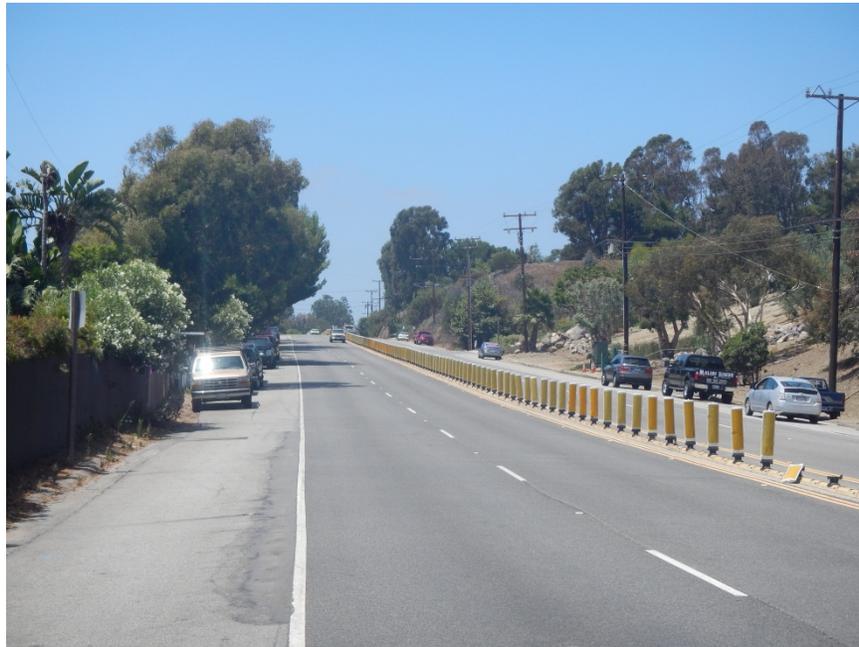
Figure 7-14. Pacific Coast Highway Near Escondido Beach

The photograph depicted in Figure 7-14 shows the area above Escondido Beach. This area was observed to have more gentle slopes of approximately 4:1 (horizontal: vertical) compared to the bluff areas observed near Zuma County Beach and Broad Beach. East of Escondido Creek and north of PCH, thick vegetation cover was observed, consisting primarily of ice plant, palm trees, and eucalyptus trees.

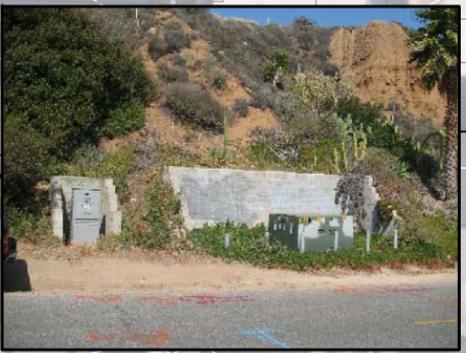
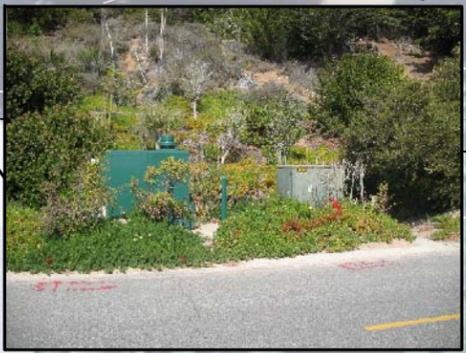
BIOFILTER REQUIRED FOR ALTERNATIVE 1 ONLY. REPLACE BIOFILTER WITH VEGETATED SWALE FOR ALTERNATIVE 2.

ALTERNATIVE 2
NO BIOFILTER REQUIRED. STORAGE TANK WITH PUMP TO IRRIGATION SYSTEM AND/OR EASTERN BIOFILTER.

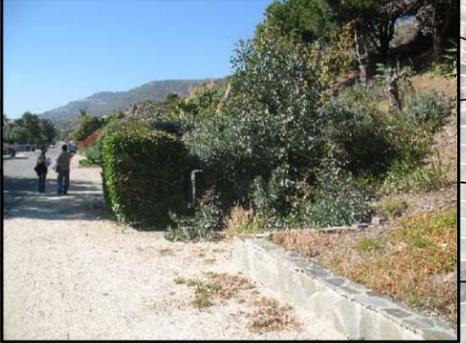
REMOVE EXISTING WALL AND SELECTIVE VEGETATION (TYP.)

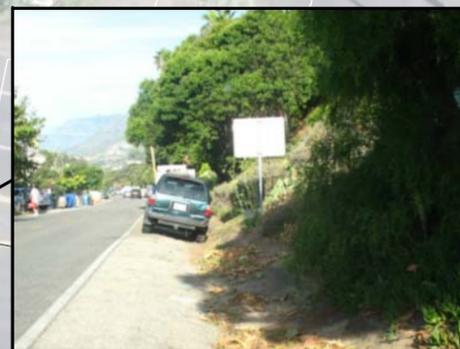
NARROW SHOULDER, PARKING ONLY.
FUTURE CONSTRUCTION
IMPROVEMENTS INCLUDE A 10' WIDE
CONCRETE PAVER PARKING AREA
WITH A CENTER CONCRETE SWALE
