NOTICE OF VIOLATION FOR UNAUTHORIZED DIVERSION AND FAILURE TO FILE  
A STATEMENT OF WATER DIVERSION AND USE FOR TEHAMA COUNTY  
ASSESSOR PARCEL NUMBER (APN) 013-220-002-000.

**Subject: Notice of Violation of Fish and Game Code Section 1602, 5650 and 5652 in Conjunction with Cannabis Cultivation**

Enclosure: Photographs

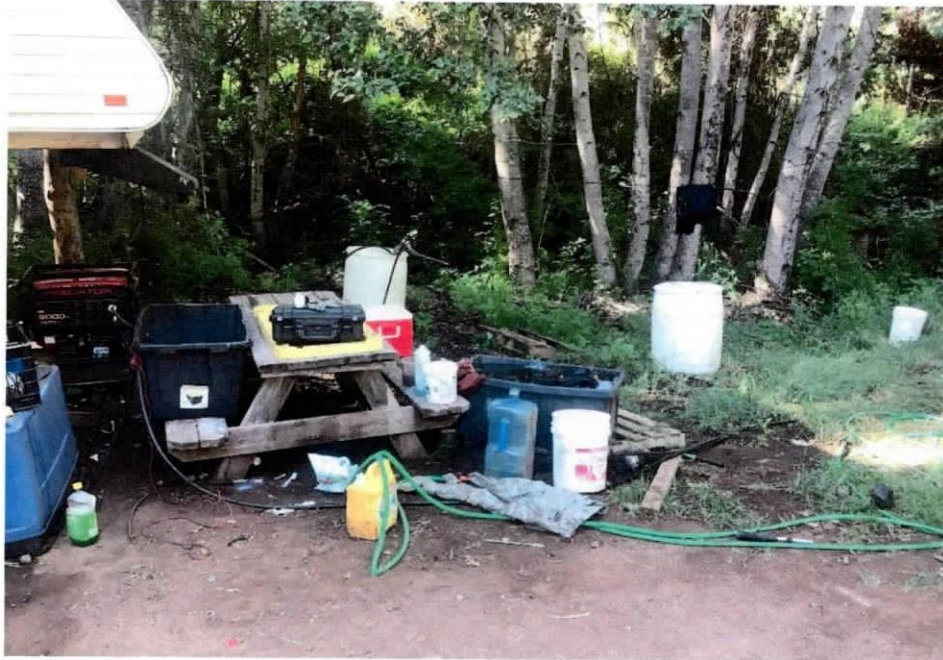
**Photo 1:** Encampment area / Pollution Polygon 1 (PPG-1) to the north of Stream Crossing 1 (SC-1). Photo shows 55-gallon drums with fuels, laundry area, leaky generator, and wastes in the foreground and the riparian area of Paynes Creek in the background.

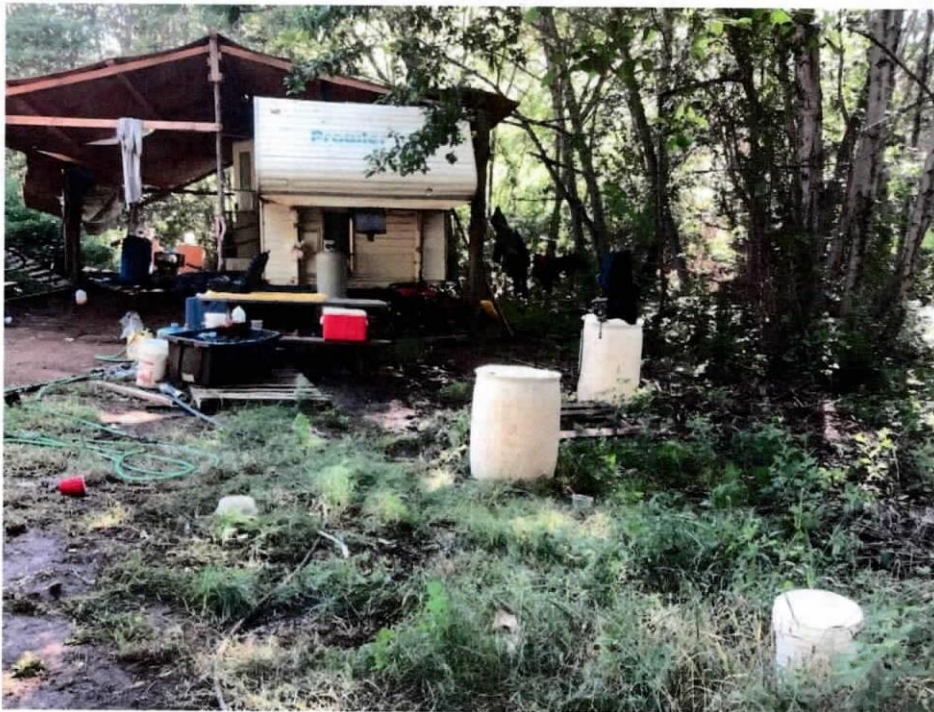
**Photo 2:** View of encampment area / Pollution Polygon 1 (PPG-1) from Stream Crossing 1 (SC-1).

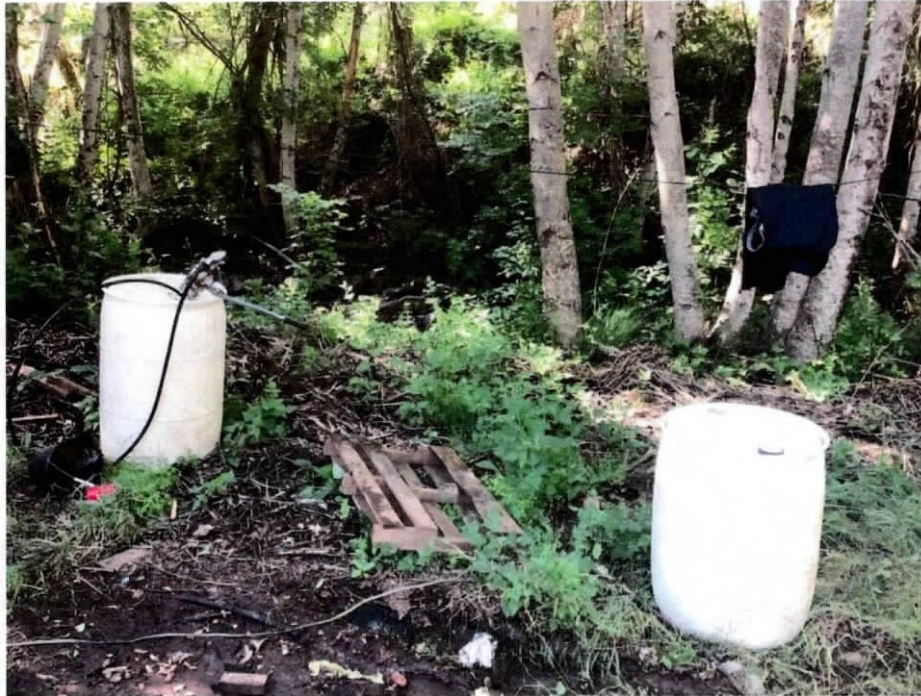
**Photo 3:** Cannabis trim waste and two 55-gallon drums, one with a fueling nozzle and petroleum fuel within the high-flow portion of the Paynes Creek. The actively flowing portion of the stream channel is observable in the background.

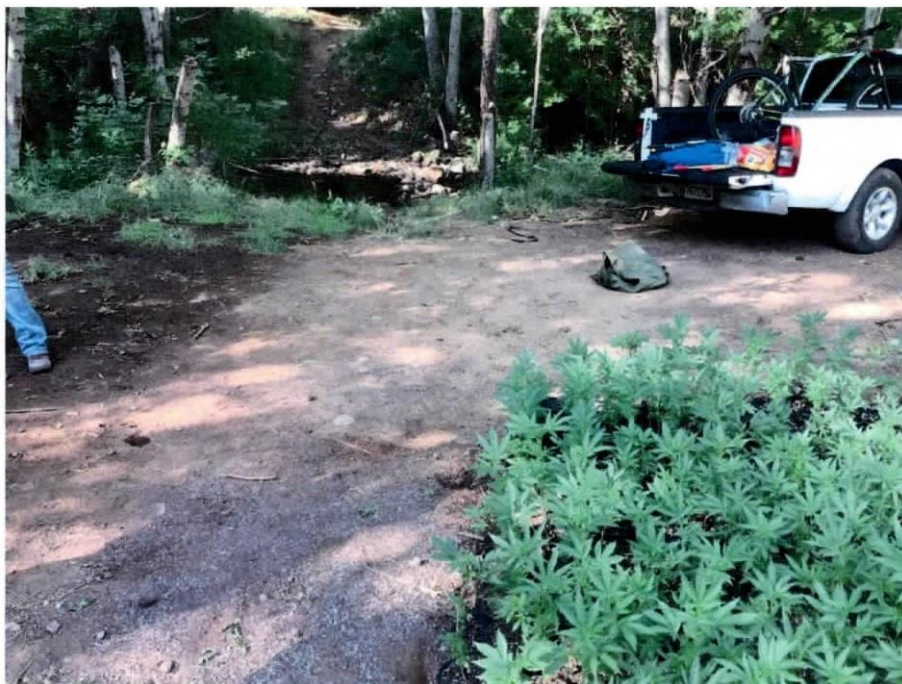
Site ID	Fish & G. Code Section	Approximate GPS Location (Latitude, Longitude)	Violation Description
PPG-1	5652(a)	40.333890°, -121.791560°	Abandonment, placement, or disposal of waste, trash, or refuse within 150 feet of, or where it can pass into waters of the state. Waste in and around the encampment and Cultivation Site 1 (CS-1) including cannabis plant waste, buckets, plant containers, gas cans, cardboard waste, and encampment refuse were observed in and within 150 feet of Paynes Creek. <b>Photos 1 - 3.</b>
PP-1/CS-1 & SC-1	5650(a)(6)	40.333920°, -121.791683° & 40.333773°, -121.791704°	Permitting a deleterious material (sediment) to pass into, or be placed where it can pass into, waters of the state. Fine sediment from scattered and uncontained potting soil at CS-1 / Pollution Point 1 (PP-1) and from hydrologically connected and unarmored road approaches to Stream Crossing 1 (SC-1) is left in a condition where it can pass into Paynes Creek, waters of the state. <b>Photo 4.</b>

**Photo 4:** View looking south towards Stream Crossing 1 (SC-1). Sediment from scattered potting soil at Cultivation Site 1 (CS-1) as well as from the unarmored and hydrologically connected approaches has placed sediment where it can enter waters of the state. Uncontrolled nutrient dense potting soil additionally places nutrients where they can enter waters of the state.

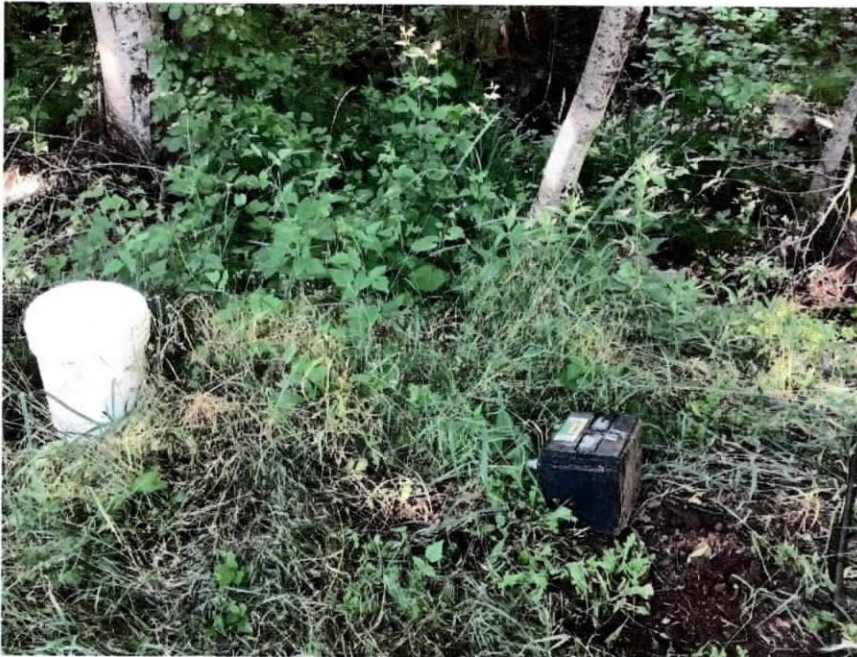
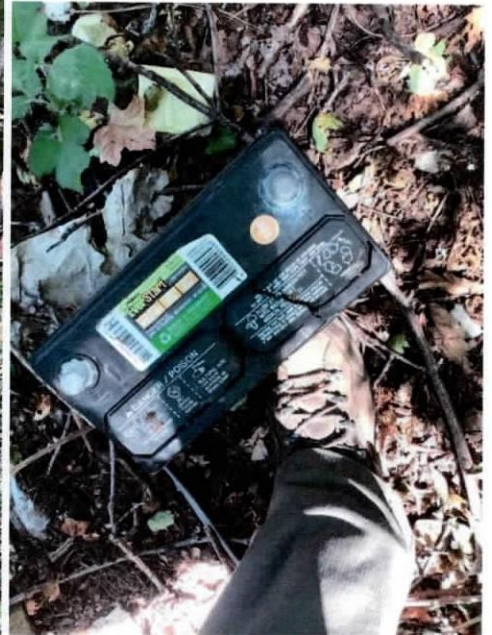
PP-1/CS-1	5650(a)(6)	40.333920°, -121.791683°	Permitting deleterious materials (nutrients) to pass into, or be placed where they can pass into, waters of the state. Nutrients from scattered and uncontained potting soils at CS-1/PP-1 are left in close proximity and in a condition where they can pass into Paynes Creek, waters of the state. <b>Photo 4.</b>
PP-2 & PP-6	5650(a)(1)	40.333822°, -121.791555° & 40.333756°, -121.791816°	Permitting acid materials to pass into, or be placed where they can pass into, waters of the state. Abandoned/wasted lead acid batteries were observed adjacent to and within the dry portion of the stream channel of Paynes Creek. <b>Photos 5 and 6.</b>

**Photos 5 and 6:** Pollution Point 2 (PP-2) and Pollution Point 6 (PP-6) showing discarded lead acid batteries adjacent to Paynes Creek.

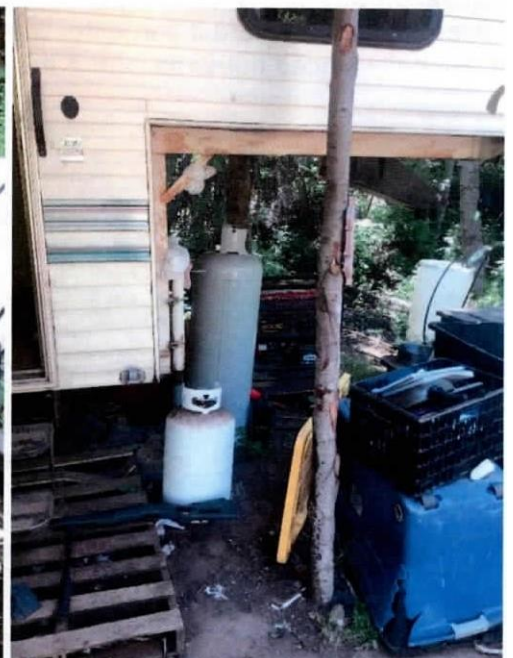
**Photo 7 and 8:** Leaky gasoline-powered generator lacking containment adjacent to Paynes Creek. Use, refueling, and placement of this generator places petroleum products where they can enter waters of the state.

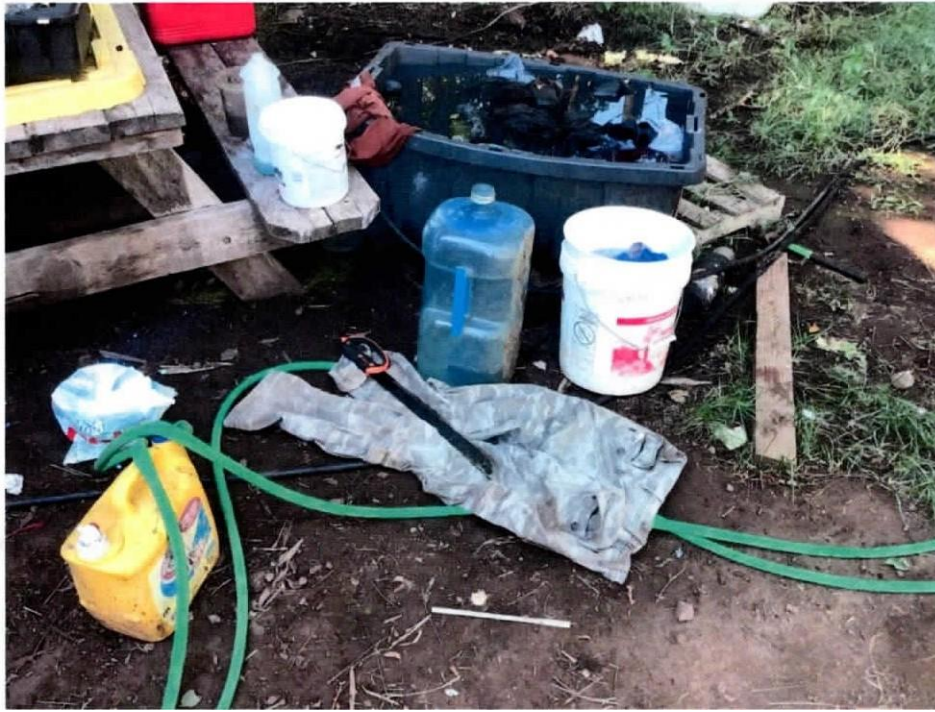
Site ID	Fish & G. Code Section	Approximate GPS Location (Latitude, Longitude)	Violation Description
PP-3 & PP-5	5650(a)(1)	40.333851° -121.791557° & 40.333663° -121.791936°	Permitting petroleum products to pass into, or be placed where they can pass into, waters of the state. Petroleum products including fuel storage containers, motor oil, propane tanks, and a leaky gas generator with no containment, were observed along the top of bank of Paynes Creek and within 15 feet of the active stream channel. <b>Photos 3, 7, and 8.</b>
PP-4	5650(a)(6)	40.333904° -121.791600°	Permitting deleterious materials (surfactants) to pass into, or be placed where they can pass into, waters of the state. Surfactants relating to a make-shift laundry facility including open containers of laundry detergent and overflowing containers full of clothes, water, and detergent were observed within 6 feet of the top of bank of Paynes Creek and within 15 feet from the active channel. <b>Photo 9.</b>

**Photo 9:** Wash area with overflowing wash bin within the encampment area. Surfactants from detergents and cleaning materials are placed where they can enter waters of the state.

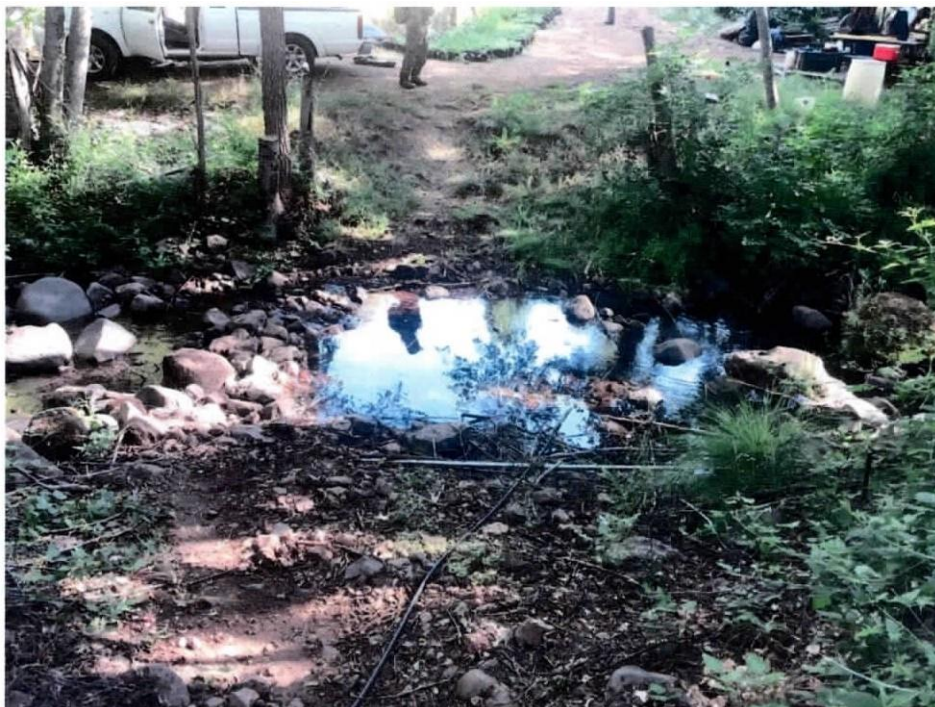
**Photo 10:** A rock cobble dam constructed on the downstream side (photo left) of Stream Crossing 1 (SC-1) has used and/or changed materials from the bed, bank, and channel of Paynes Creek and substantially obstructs the natural flow of the stream.

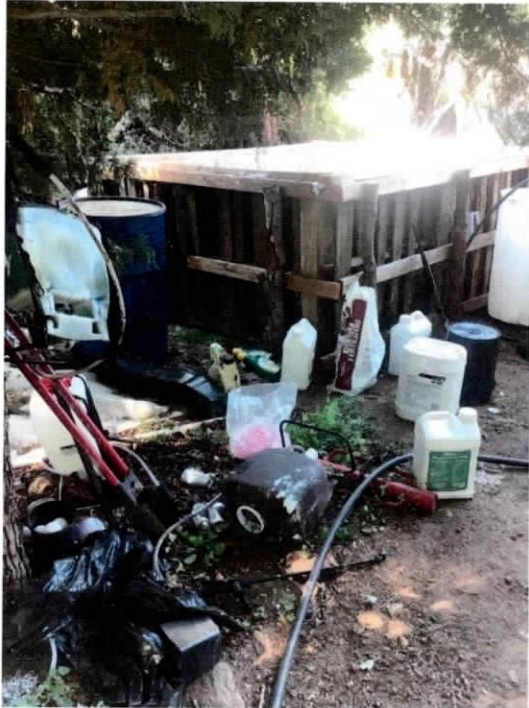
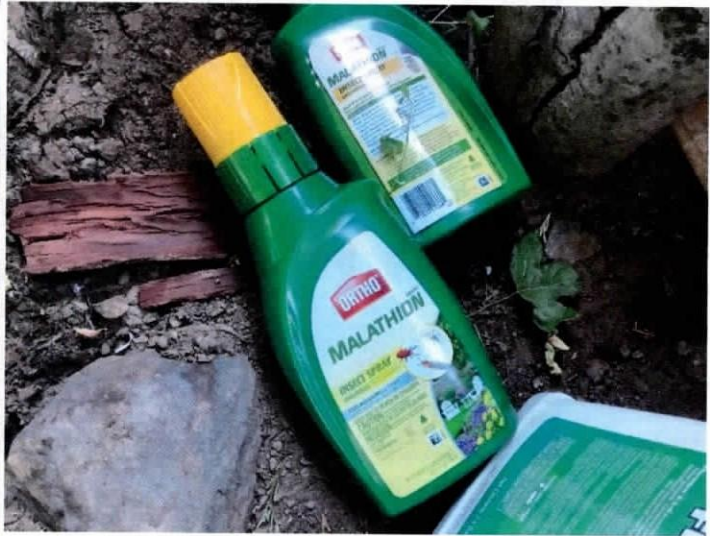
SC-1	1602(a)	40.333773° -121.791704°	Substantial obstruction and alteration of a stream without notification. A rock cobble dam constructed at downstream side of ford all-terrain-vehicle (ATV)-crossing has used and/or changed materials from the bed, bank, and channel of Paynes Creek and substantially obstructs the natural flow of the stream. <b>Photo 10.</b>
PP-5	5650(a)(6)	40.333663° -121.791936°	Permitting deleterious materials (pesticides) to pass into, or be placed where they can pass into, waters of the state. Malathion, an organophosphate pesticide, was observed approximately 35 feet from the active channel, where it can pass into waters of the state. Additionally, application of this pesticide to cannabis plants within cultivation areas abutting the stream corridor creates a high likelihood of these pesticides <u>leaching</u> into surface waters. <b>Photos 11 and 12.</b>
PPG-2	5650(a)(6)	40.333786° -121.792233°	Permitting deleterious materials (nutrients) to pass into, or be placed where they can pass into, waters of the state. Cultivation occurring in close proximity to Paynes Creek places nutrients where they can pass into waters of the state via <u>irrigation</u> tailwater and runoff. <b>Photos 11-14.</b>

**Photos 11 and 12:** Mixing area containing nutrients and pesticides. Structure in background served as a mixing reservoir and is upslope and approximately 35-40 feet from Paynes Creek. Malathion concentrate (50% malathion mixture), an organophosphate systemic pesticide, was observed in this area along with backpack applicators.

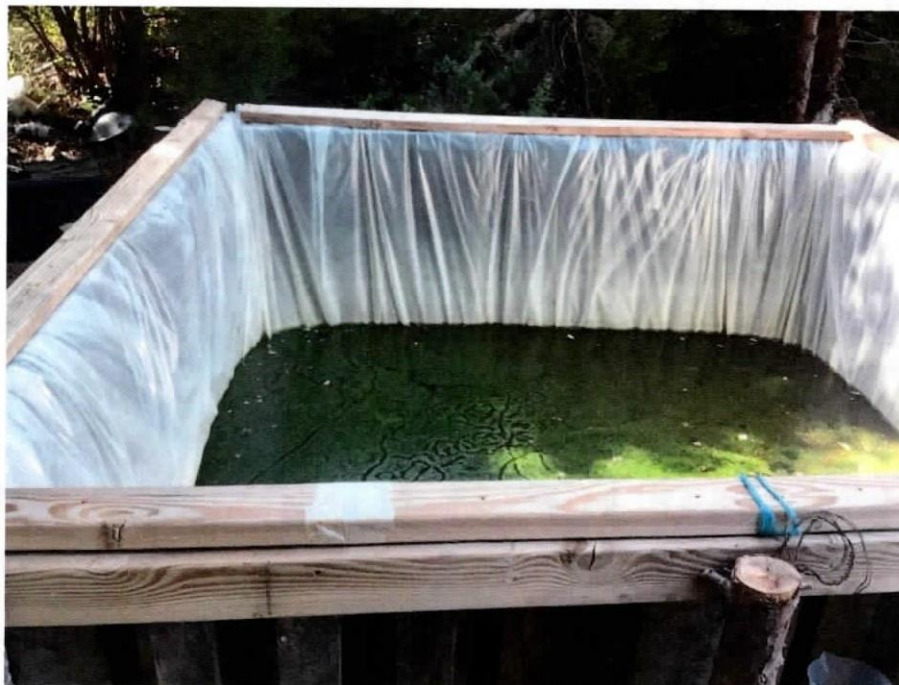
**Photo 13:** View of the mixing reservoir's contents. This solution likely contains high concentrations of nutrients based on the observable green color and evident algal growth. Measuring cups and open nutrient containers were observed adjacent to this structure.

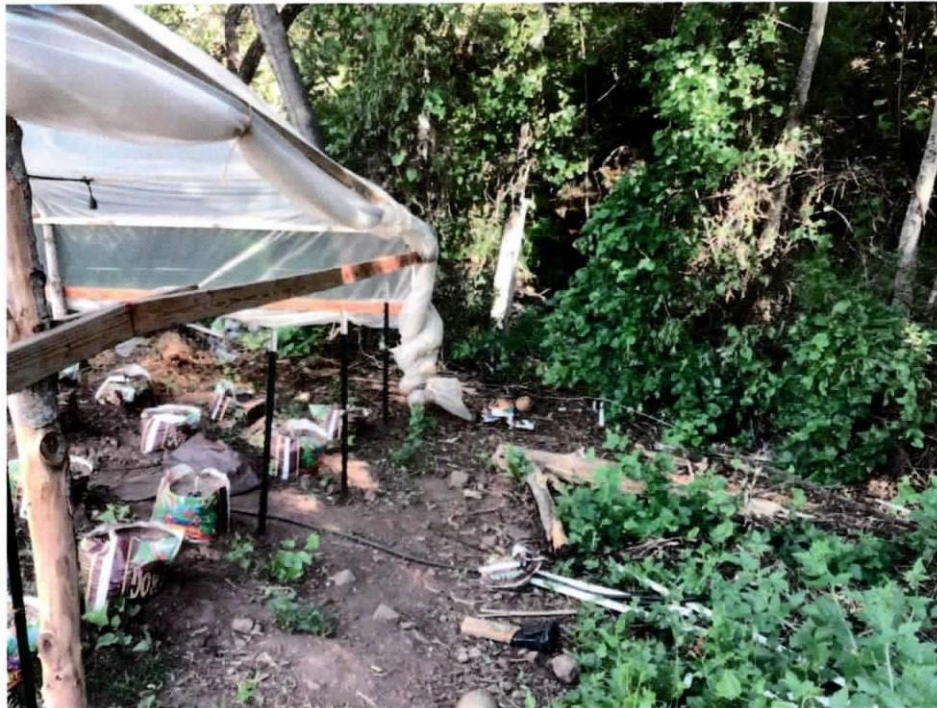
**Photo 14:** Photo looking towards Paynes Creek from the corner of Cultivation Site 2 (CS-2). The cultivation area is built immediately adjacent to the actively flowing portion of the stream channel where nutrients from irrigation tailwater and stormwater runoff through the greenhouse can enter waters of the state. Photo also shows cultivation wastes and cut riparian vegetation, used in greenhouse construction.

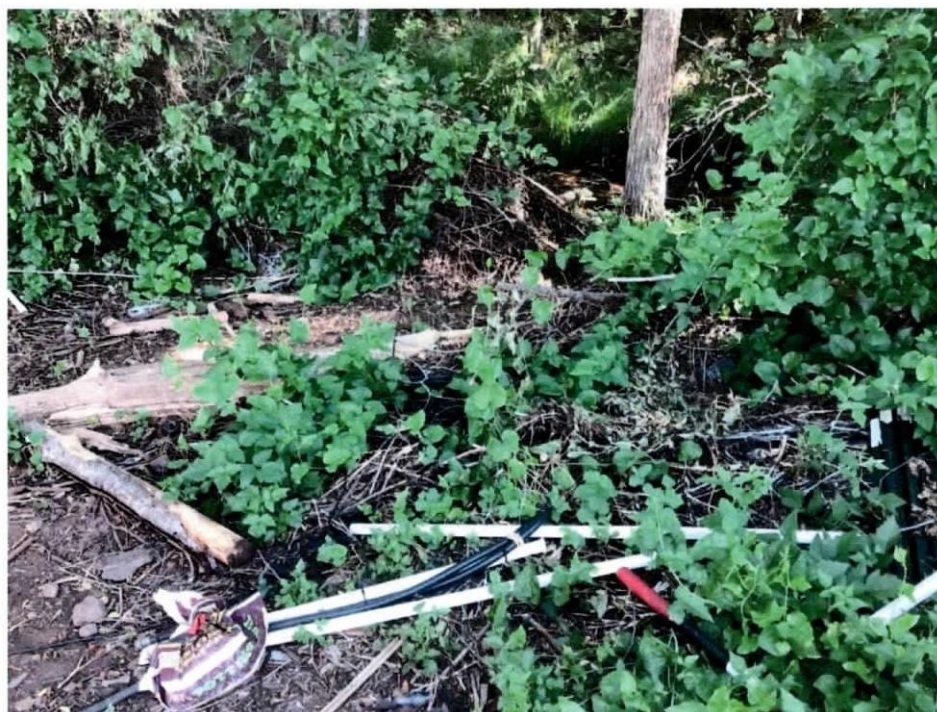
**Photo 15:** Pollution Polygon 2 (PPG-2) showing cultivation waste materials including irrigation line, plastic pipe, soil bags, plant trim waste, and other debris with Paynes Creek in the background.

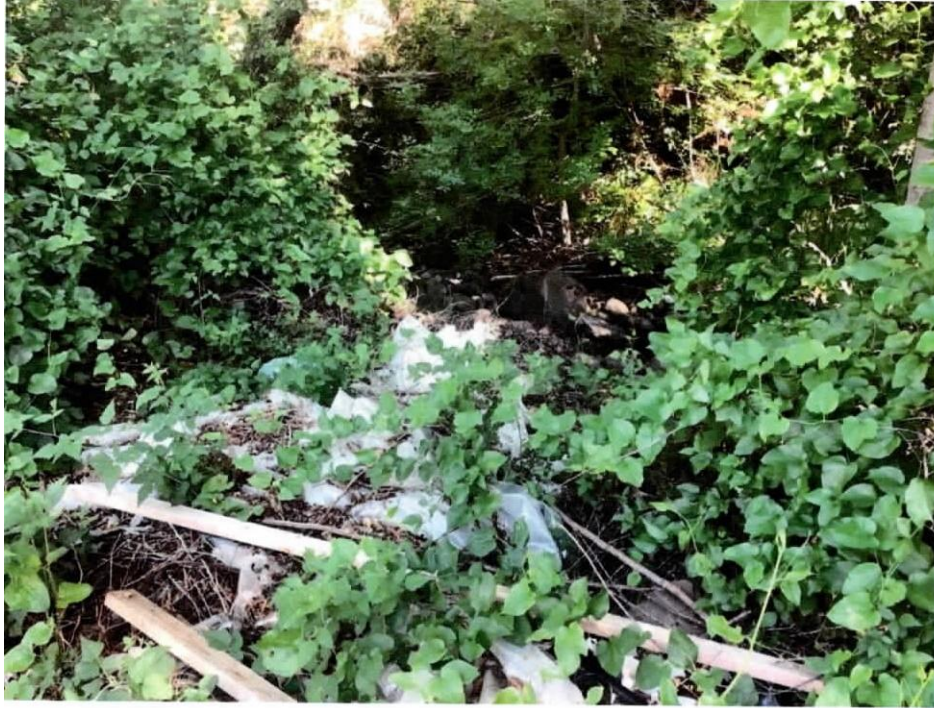
**Photo 16:** Pollution Polygon 2 (PPG-2) showing cultivation waste materials including lumber, plastic tarp material, and other debris with Paynes Creek in the background.

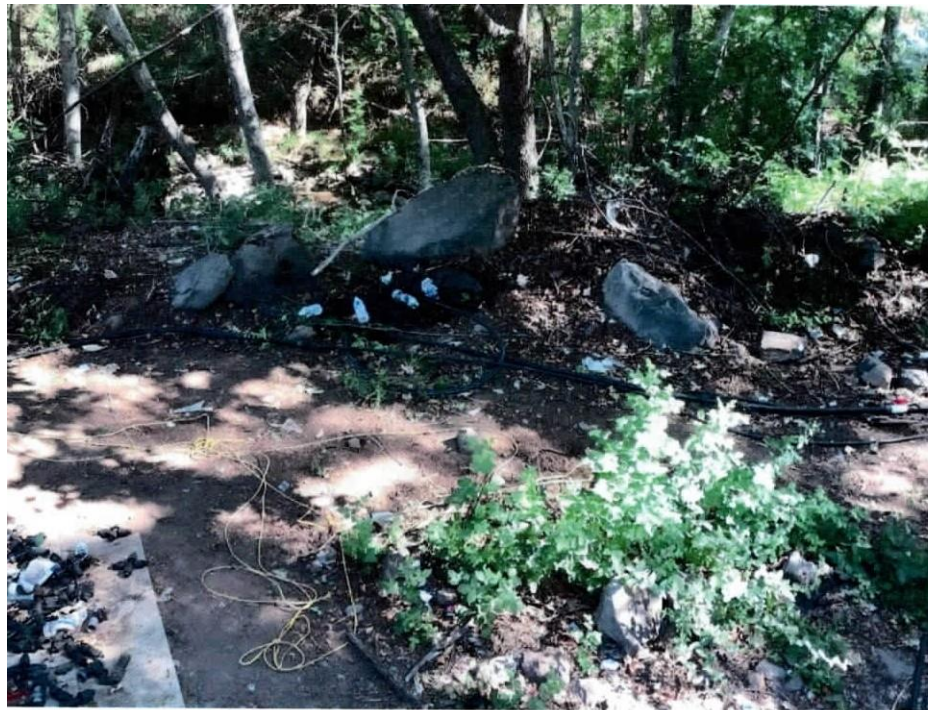
**Photo 17:** Pollution Polygon 2 (PPG-2) including cut irrigation line, plastic bottles, and other waste approximately 35-40 feet from Paynes Creek.

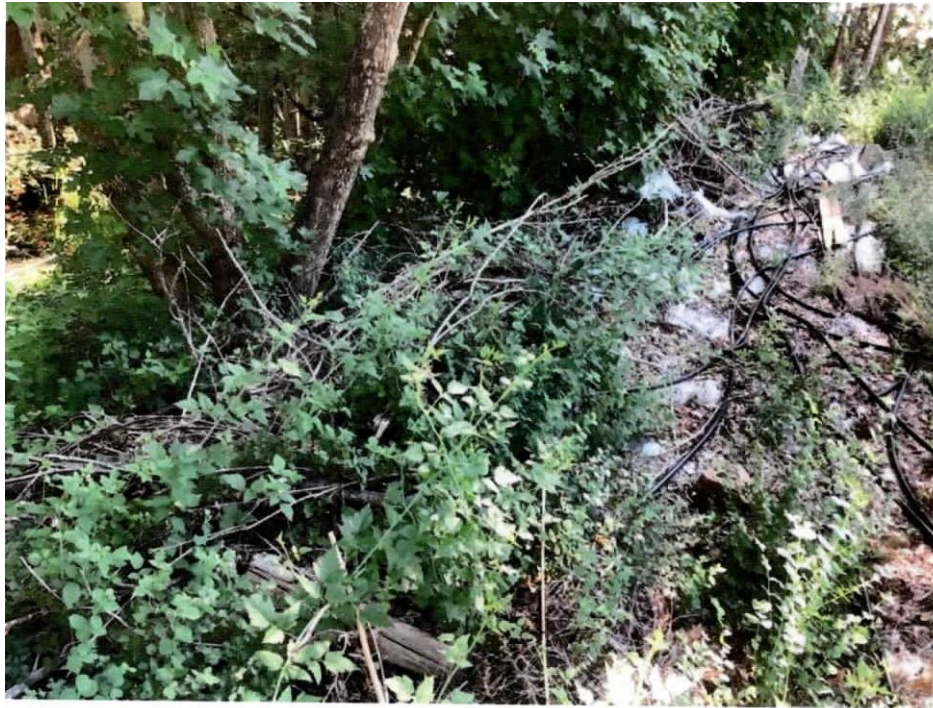
**Photo 20:** Cultivation wastes associated with Pollution Polygon 3 (PPG-3) including black irrigation line, broken down tarp material and other wastes adjacent to the actively flowing portion of Paynes Creek.

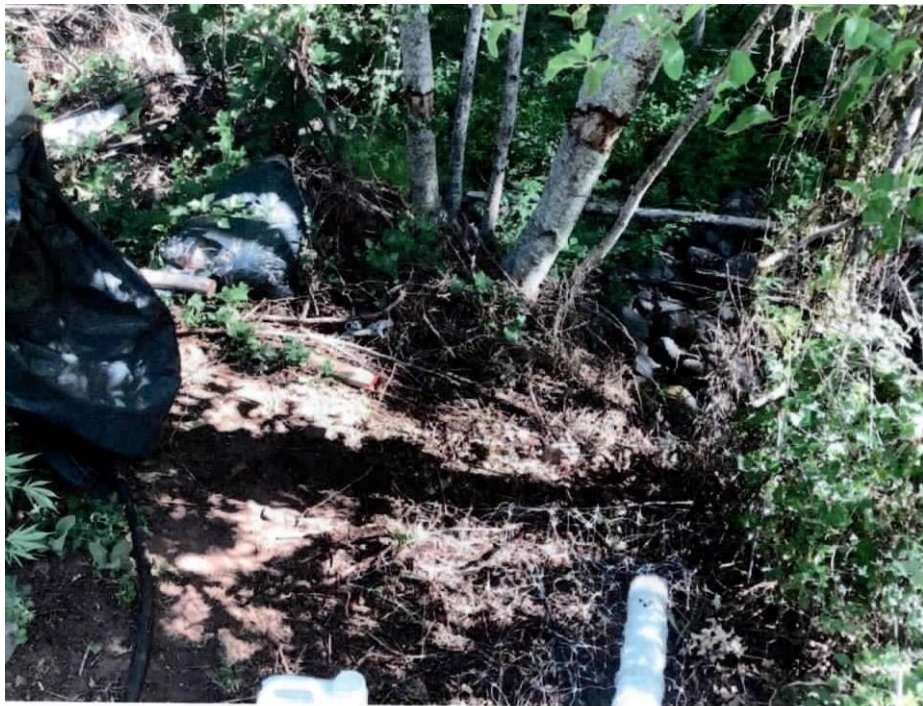
**Photo 21:** Cultivation wastes associated with Pollution Polygon 3 (PPG-3) including tarps, plastic trash bags, plant waste, and monofilament plastic netting adjacent to the actively flowing portion of Paynes Creek.

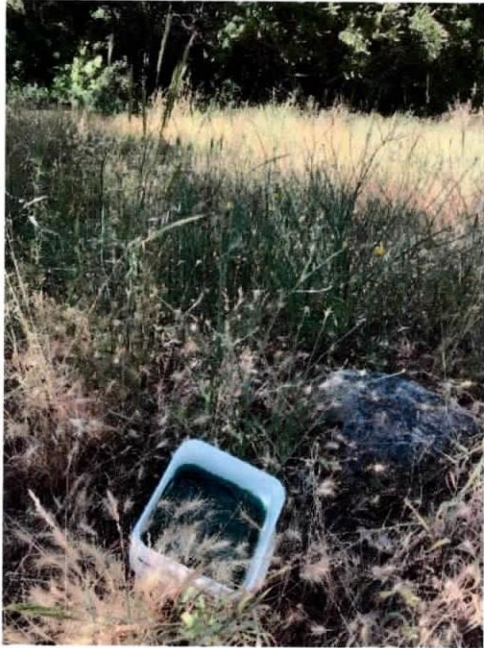
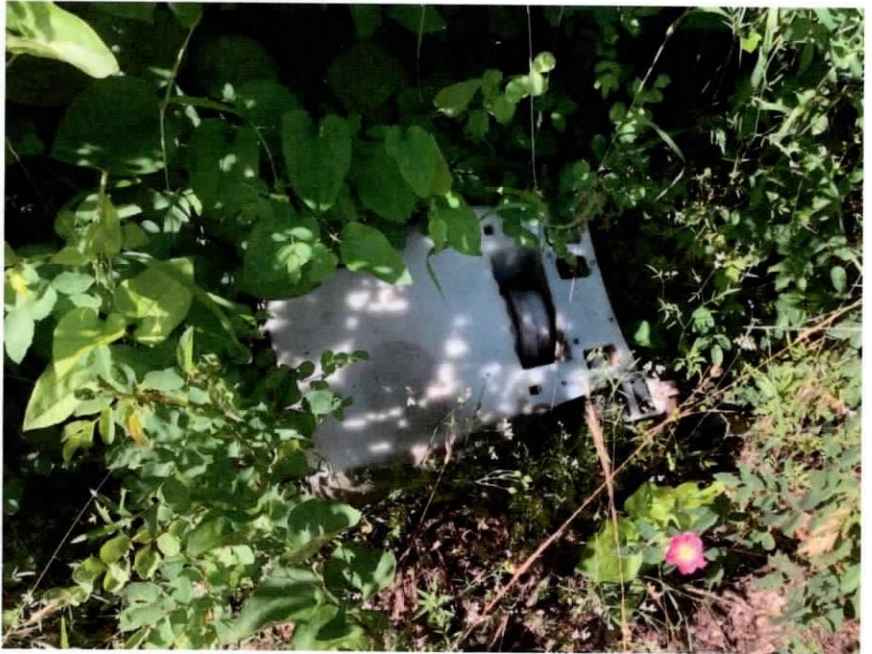
**Photos 24 and 25:** Former outdoor cultivation plot with remnants of abandoned cultivation activities. Wastes included abandoned fertilizers, netting, plastic tarps, and a backpack sprayer within 150 feet of Paynes Creek.

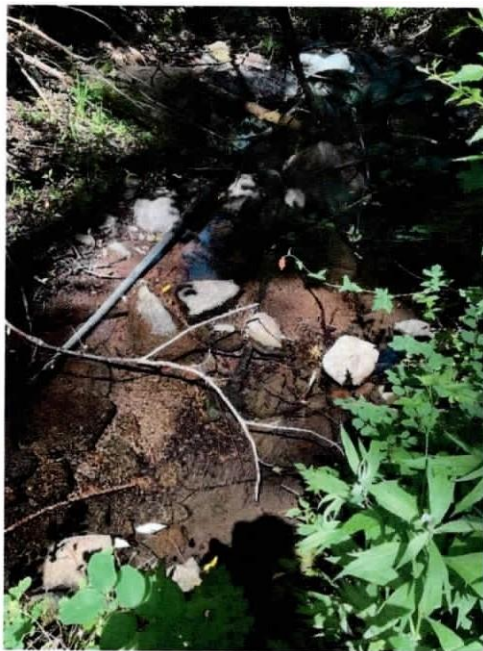
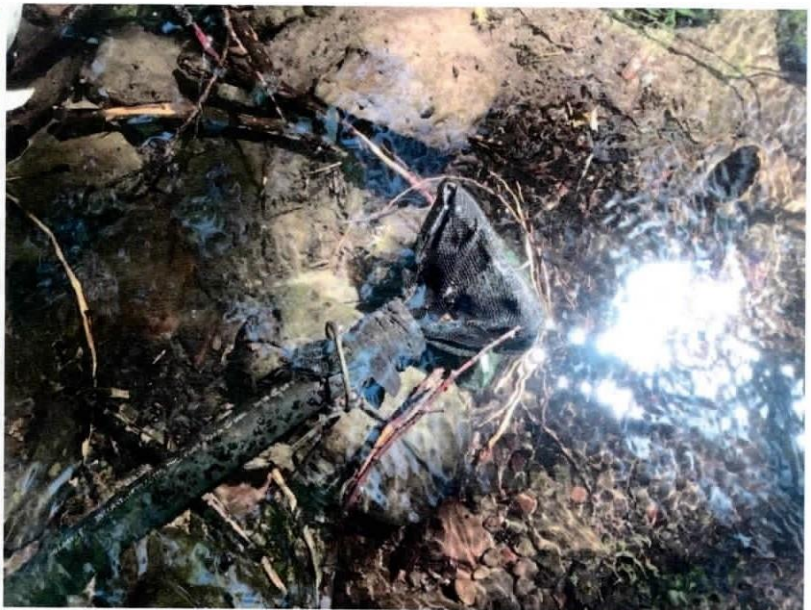
**Photo 26 and 27:** Water diversion and screened 1 ¼ inch intake at Water Source 1 (WS-1) on Chapman Gulch.

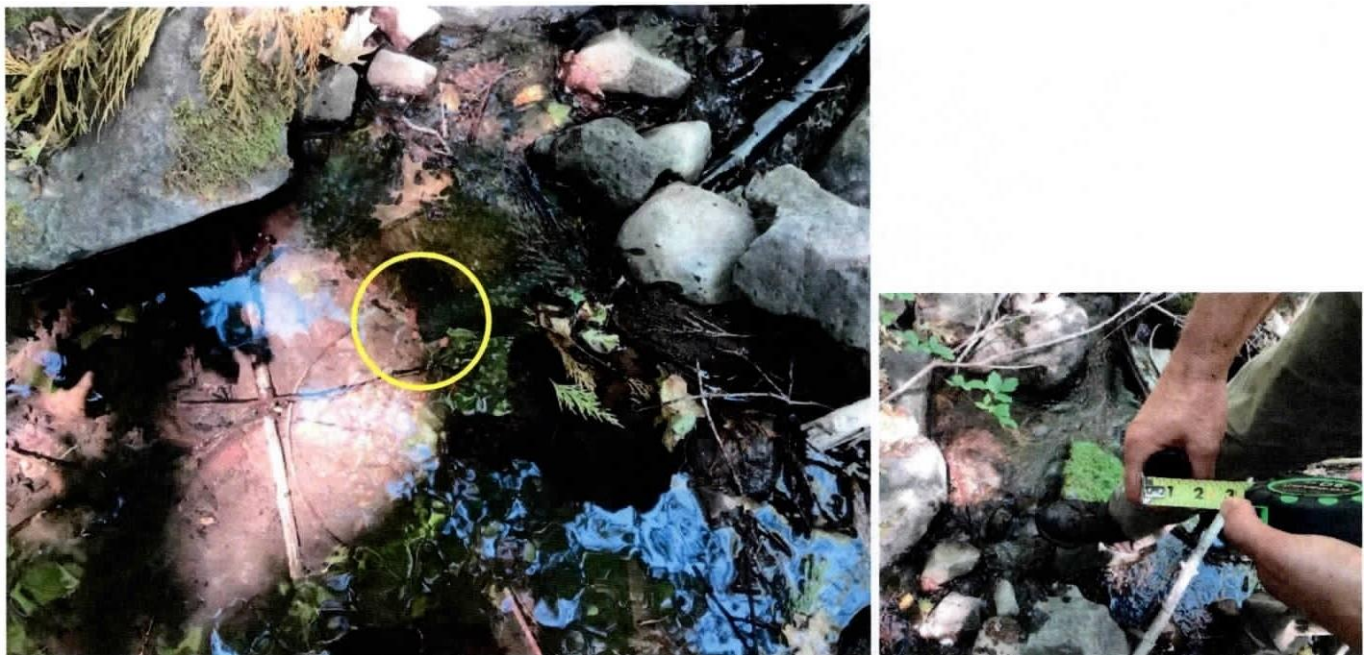
**Photos 28 and 29:** Unscreened 1 ¼ inch intake at Water Source 2 (WS-2) on Chapman Gulch.

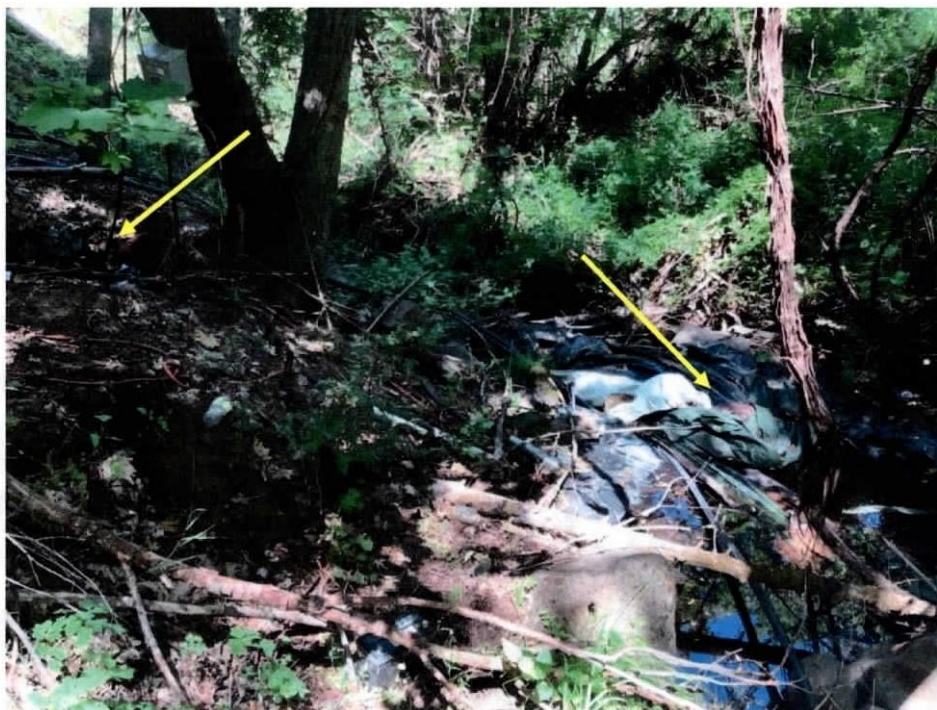
PP-7	5652(a)	40.334039', -121.795595°	Abandonment, placement, or disposal of waste, trash, or refuse within 150 feet of, or where it can pass into waters of the state. Cultivation wastes including nutrient bags/containers, plastic tarp material and backpack sprayer abandoned in former outdoor cultivation area approximately 30 to 150 feet from <u>Paynes</u> Creek. <b>Photos 24 and 25.</b>
WS-1 & WS-2	1602(a)	40.332727°, -121.789073' & 40.332436', -121.788556'	Substantial diversion of a stream without notification. Two water diversions were observed on Chapman Gulch with water lines supplying water tanks adjacent to and serving both the active cultivation and encampment areas. <b>Photos 26 - 29.</b>
HAPt-1	1602(a)	40.332725°, -121.789121°	Substantial alteration of the streambank and obstruction of a stream without notification. A nine-foot long by five-and-a-half-foot wide rock, sandbag, and tarp darn were observed spanning the active channel within Chapman Gulch to obstruct stream flow and pool surface water for the diversion of water. In addition, two pits dug into the bank of Chapman Gulch, one five-foot by five-foot by two-and-a-half-foot deep and the other five-foot by four-foot by two-and-a-half-foot deep, filled with trash and debris, have substantially changed the streambank, and have placed debris where it can pass into the stream. <b>Photos 30 and 31.</b>

**Photo 30:** Habitat Alteration Point 1 (HAPt-1) at Water Source 1 (WS-1). A sandbag, rock, and tarp impoundment (photo right) placed downstream of WS-1, substantially obstructs the natural flow of Chapman Gulch to create a pool for the placement of the diversion line at WS-1. Additionally, two large pits excavated into the southern streambank and filled with trash and debris (one visible photo left) have substantially altered the bank of Chapman Gulch and have placed waste and debris where they can enter waters of the state.

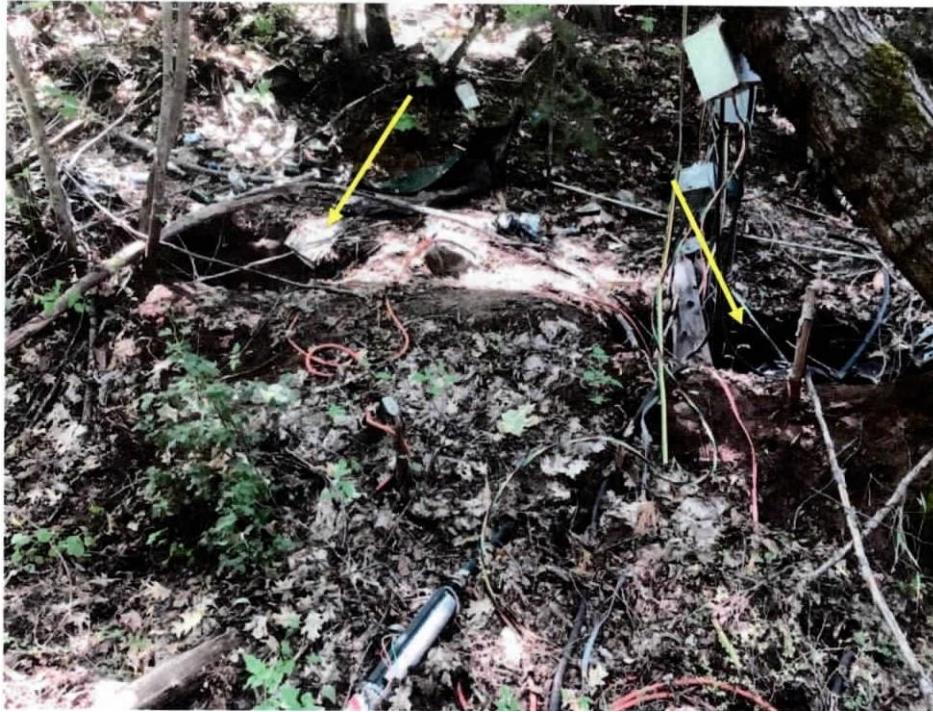
**Photo 31:** Pits excavated into the streambank of Chapman Gulch filled with waste and debris at Pollution Point 8 (PP-8).

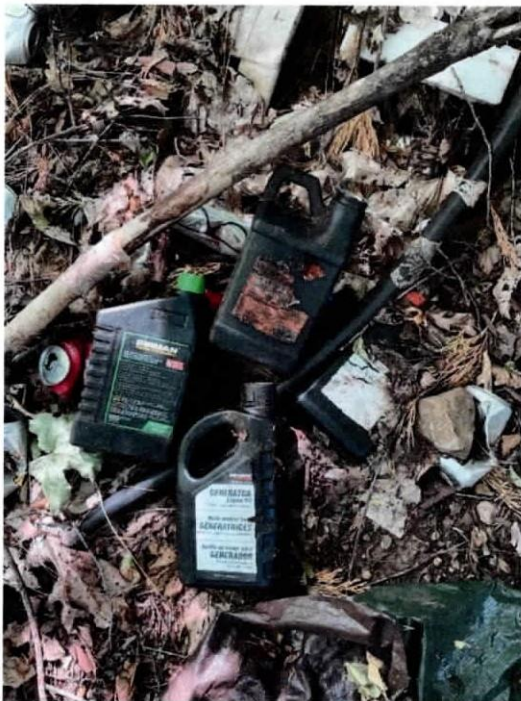
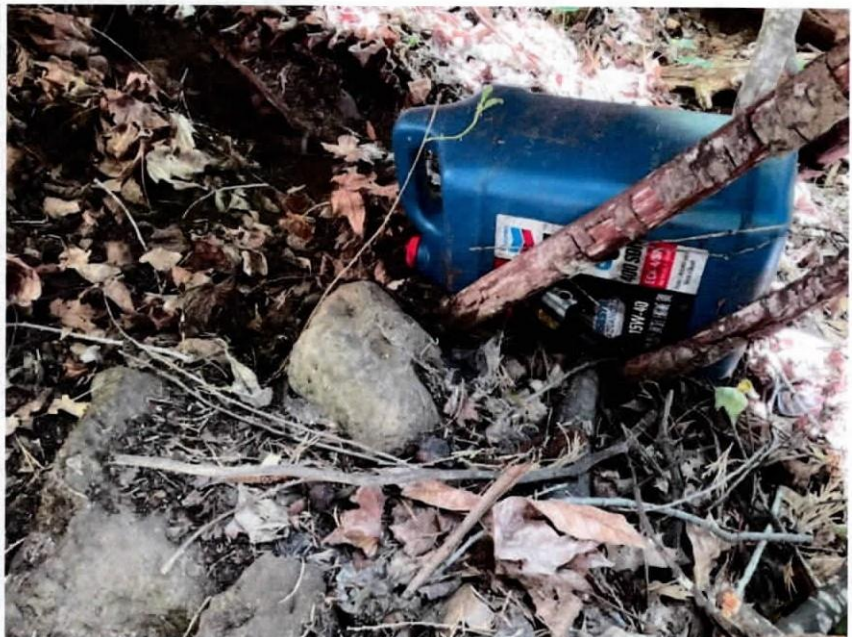
Site ID	Fish & G Code Section	Approximate GPS Location (Latitude, Longitude)	Violation Description
PP-8	5650(a)(1)	40.332704°, -121.789113°	Permitting petroleum products to pass into, or be placed where they can pass into, waters of the state. Petroleum products including discarded motor oil containers were observed within the dry portion of the stream channel of <u>Chapman</u> Gulch. <b>Photos 32 and 33.</b>
PP-8	5650(a)(1)	40.332704°, -121.789113°	Permitting acid materials to pass into, or be placed where they can pass into, waters of the state. Abandoned/wasted lead acid batteries were observed adjacent to and within the dry portion of the stream channel of Chapman Gulch. <b>Photos 34 and 35.</b>
PP-8	5652(a)	40.332704°, -121.789113°	Abandonment, placement, or disposal of waste, trash, or refuse within 150 feet of, or where it can pass into waters of the state. Abandoned wastes including irrigation line, tarps, bottles, old pumps, batteries, and other debris was found in and within 150 feet of Chapman Gulch adjacent to the water diversion at WS-1. Pits filled with trash and other waste materials had been dug into the bank and were observed within the <u>high-flow</u> channel of the stream. <b>Photos 30-35.</b>

**Photo 32 and 33:** Multiple discarded oil containers found adjacent to excavated pits adjacent to Chapman Gulch at Pollution Point 8 (PP-8).

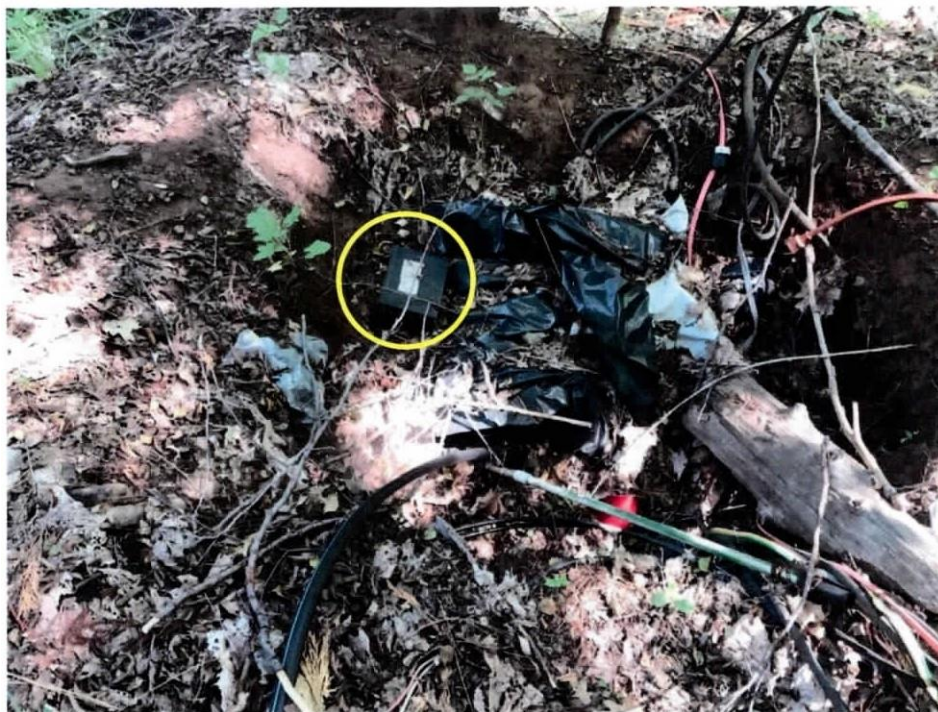
**Photo 34:** Lead acid battery discarded into excavated pit into the streambank of Chapman Gulch at Point 8 (PP-8).

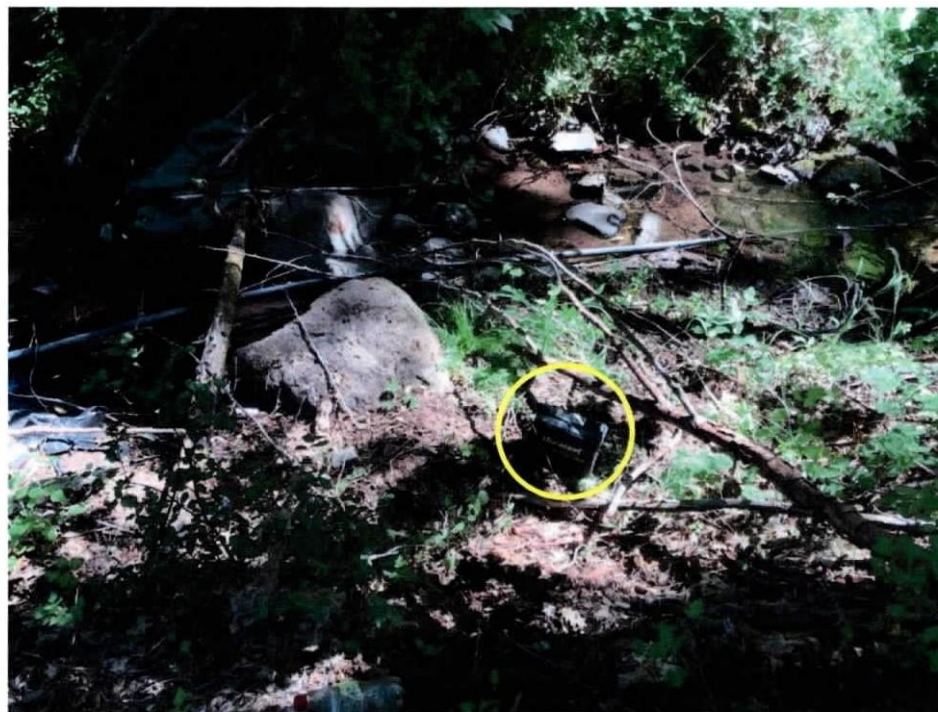
**Photo 35:** Lead acid battery discarded on the streambank (and within the high-flow portion of the channel) of Chapman Gulch at Point 8 (PP-8).

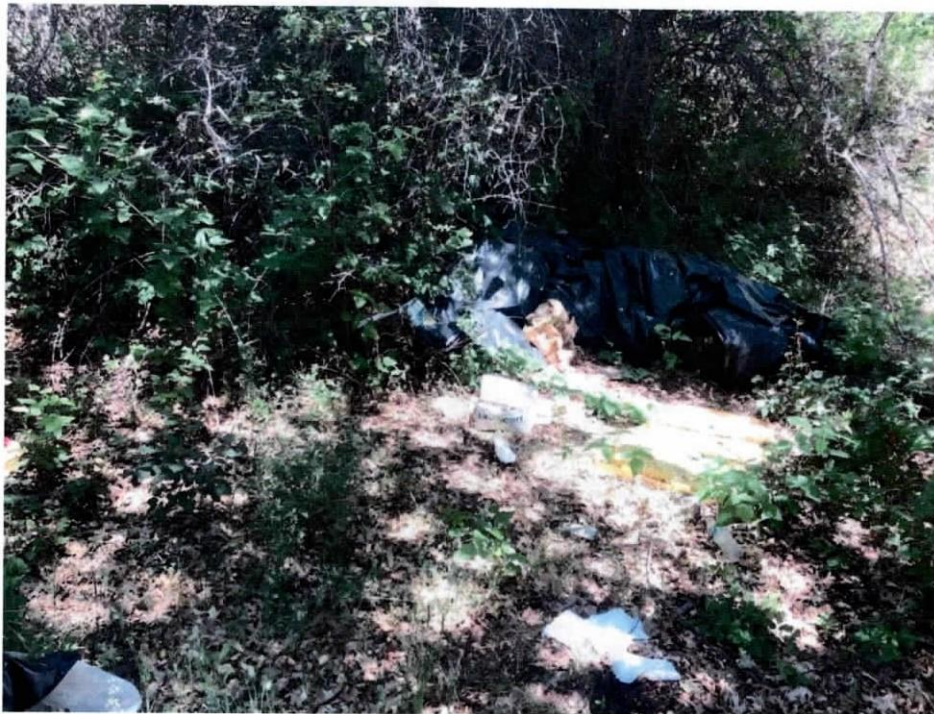
**Photo 36:** Bags of trash, tarps, cans and other debris approximately 25 feet from Paynes Creek at Pollution Point 9 (PP-9). Staff also observed irrigation line and other cultivation wastes along the western bank of Paynes Creek at this location.

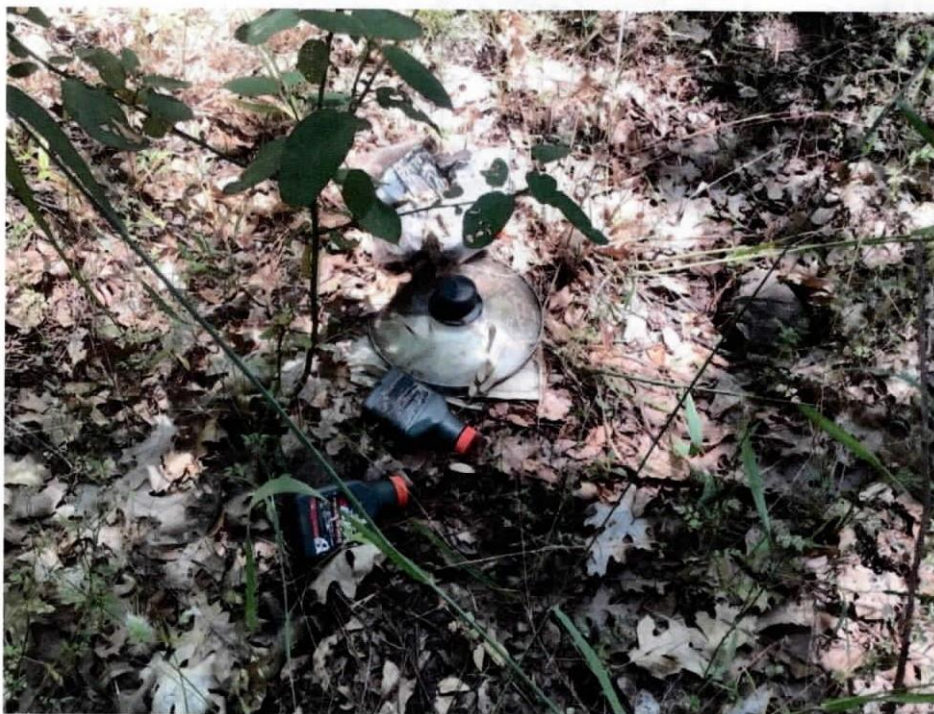
**Photo 36:** Bottles of 2-stroke oil, a petroleum product, observed abandoned adjacent to Paynes Creek along with wastes observed in photo 35 above.

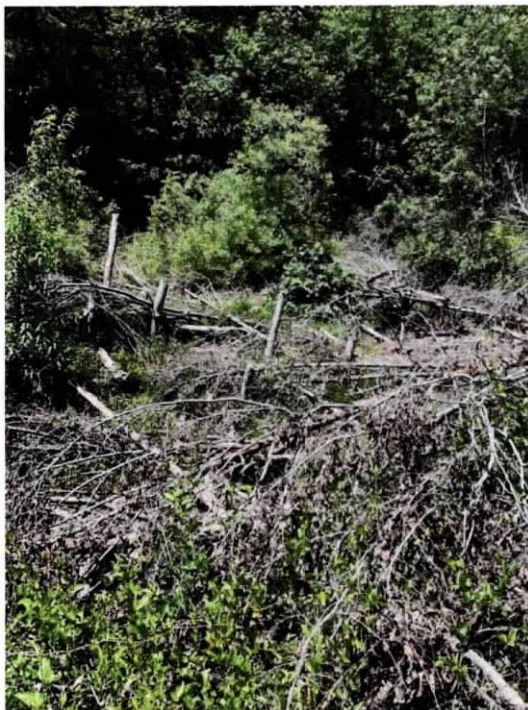
PP-9	5652(a)	40.334576° -121.790928°	Abandonment, placement, or disposal of waste, trash, or refuse within 150 feet of, or where it can pass into waters of the state. Abandoned bags of trash and other uncontained wastes were scattered along the bank of and approximately 25 feet from <u>Paynes</u> Creek. <b>Photo 36.</b>
PP-10	5650(a)(1)	40.334697°, -121.790938°	Permitting petroleum products to pass into, or be placed where they can pass into, waters of the state. Petroleum products including multiple containers of 2-stroke oil were observed abandoned adjacent to Paynes Creek. <b>Photos 37.</b>
HAP-4 & HAPt-2	1602(a)	40.336070°, -121.790055°	Substantial alteration of the streambank and obstruction of a stream without notification. Removal of riparian habitat for former cultivation activities has substantially altered approximately 8,763 square feet of the stream corridor. Placement of cleared materials and vegetative debris within the channel of Paynes Creek has resulted in the obstruction of natural flow of the stream. <b>Photos 37 and 38.</b>

**Photo 37:** Habitat Alteration Polygon 4 (HAP-4). Former cultivation activities have led to substantial clearing of riparian vegetation along Paynes Creek and the removal of mature trees.

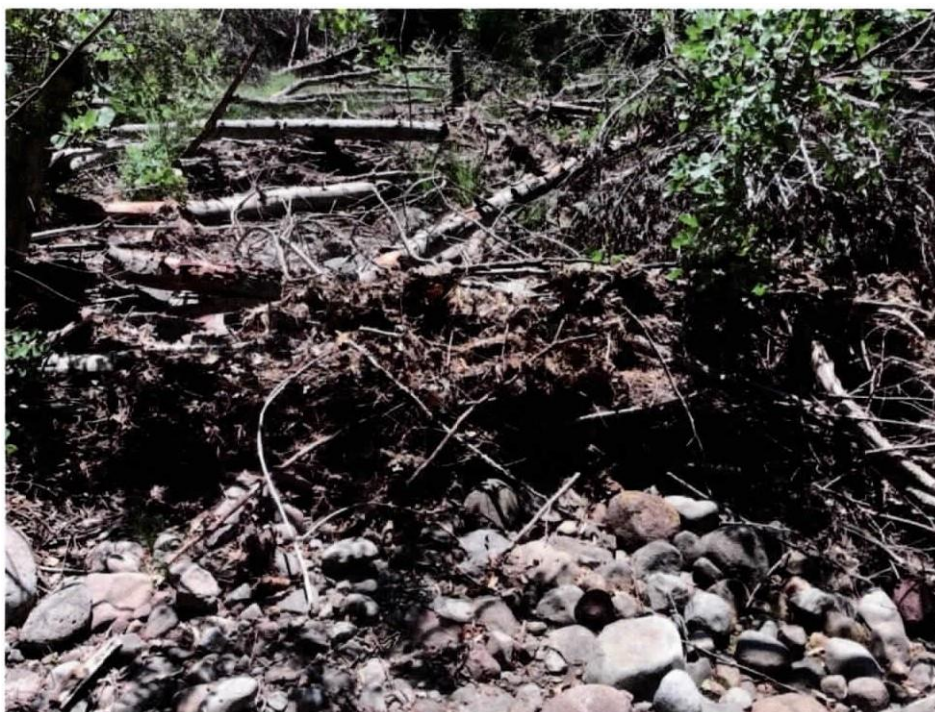
**Photo 38:** Removal of trees and other riparian vegetation within Habitat Alteration Polygon 4 (HAP-4) and placement of these debris directly in Paynes Creek has led to the substantial obstruction of natural flow within the channel. The photo below shows a cross section within Paynes Creek of the vegetative obstruction from downed vegetation and debris racking from obstructed streamflow.
