NOTICE OF VIOLATION FOR UNAUTHORIZED DIVERSION AND FAILURE TO FILE  
A STATEMENT OF WATER DIVERSION AND USE FOR TEHAMA COUNTY  
ASSESSOR PARCEL NUMBER (APN) 013-220-002-000.

**Subject: Notice of Violation of Fish and Game Code Section 1602, 5650 and 5652 in Conjunction with Cannabis Cultivation**

Enclosure: Photographs

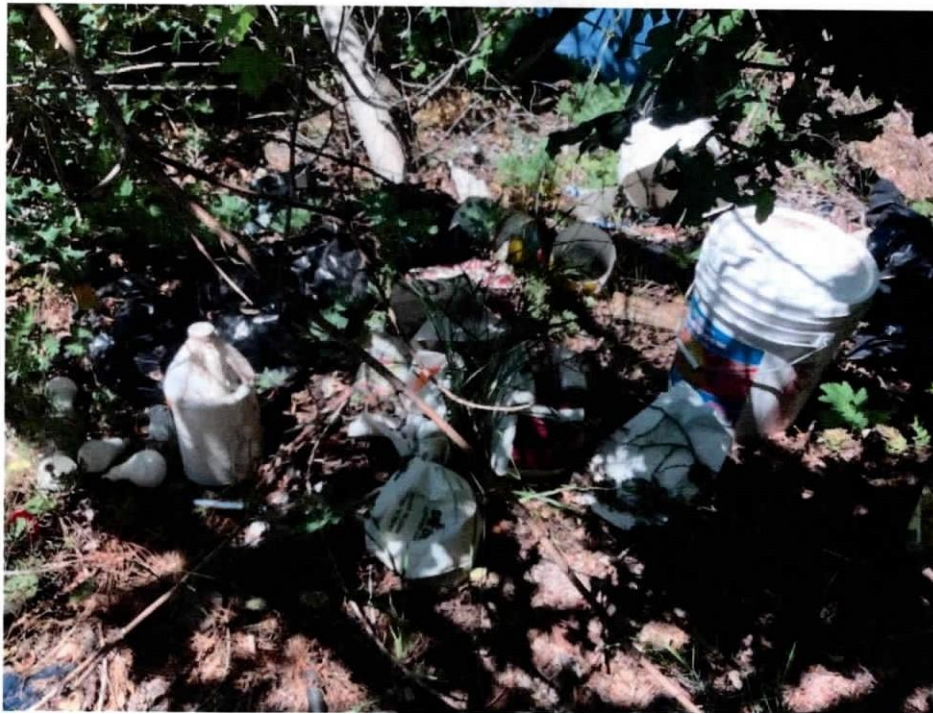
PP-11	5650(a)(6)	40.336124°, -121.790103°	Permitting deleterious materials (nutrients) to pass into, or be placed where they can pass into, waters of the state. Abandoned nutrient containers found on bank of, and where contents can pass into, Paynes Creek. Substantial algal growth, immediately downstream from the nutrient location, indicates these nutrients have likely leached into the stream channel. <b>Photos 39 and 40.</b>

**Photo 39:** Chemical fertilizers and waste on the top of bank of Paynes Creek at Pollution Point 11 (PP-11).

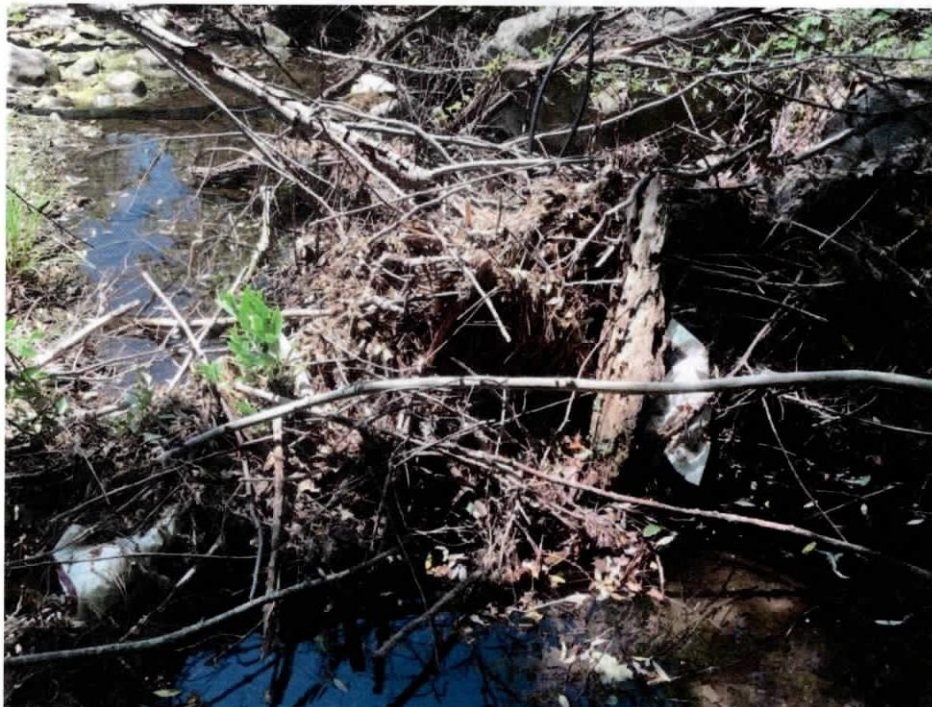
**Photo 40:** Debris rack with abandoned nutrient bags within Paynes creek, immediately downstream from the abandoned nutrient pile depicted in Photo 39 above. Algae mats observable in photo top left, likely due to nutrient inputs from abandoned stockpile at Pollution Point 11 (PP-11) and sun exposure from riparian clearing associated with Habitat Alteration Polygon 4 (HAP-4).

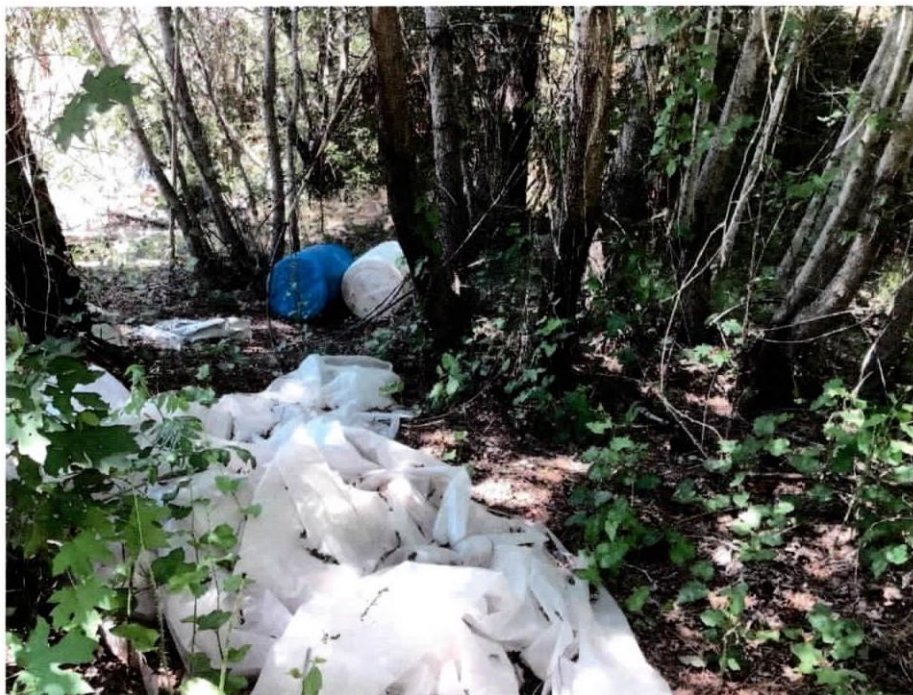
**Photo 41:** Other wastes observed along the eastern bank of Paynes Creek adjacent to the historic cultivation area at Habitat Alteration Polygon 4 (HAP-4).

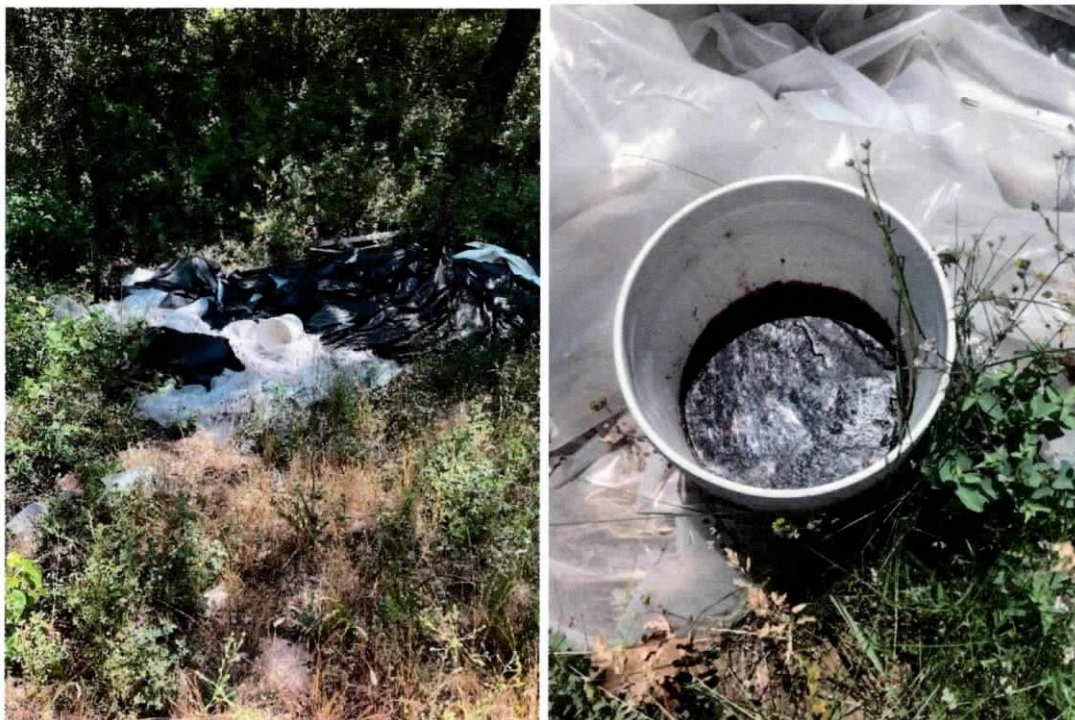
Site ID	Fish & G. Code Section	Approximate GPS Location (Latitude, Longitude)	Violation Description
PP-11	5652(a)	40.336124°, -121.790103°	Abandonment, placement, or disposal of waste, trash, or refuse within 150 feet of, or where it can pass into waters of the state. Chemical nutrient containers, fertilizer bags, buckets, tarps, and other wastes were observed on the top of bank and within approximately 6 feet of the active flow of Paynes Creek. <b>Photos 39-41.</b>
PP-12	5652(a)	40.336390°, -121.789324°	Abandonment, placement, or disposal of waste, trash, or refuse within 150 feet of, or where it can pass into waters of the state. Abandoned cultivation wastes including trash, tarps, water lines, soil bags, open buckets with unknown contents were observed approximately 47 feet from the active channel of Paynes Creek. <b>Photos 42 and 43.</b>

**Photo 42 and 43:** Pollution Point 12 (PP-12). Wastes associated with a historic cultivation site within Habitat Alteration Polygon 5 (HAP-5).
