**DECLARATION OF SCOTT
STEPHENS, P.E. IN SUPPORT OF
OPPOSITION TO PLAINTIFFS'
MOTION FOR PRELIMINARY
INJUNCTION**
[C.C.P. §2015.5]

22 **HLE EXHIBIT 19**

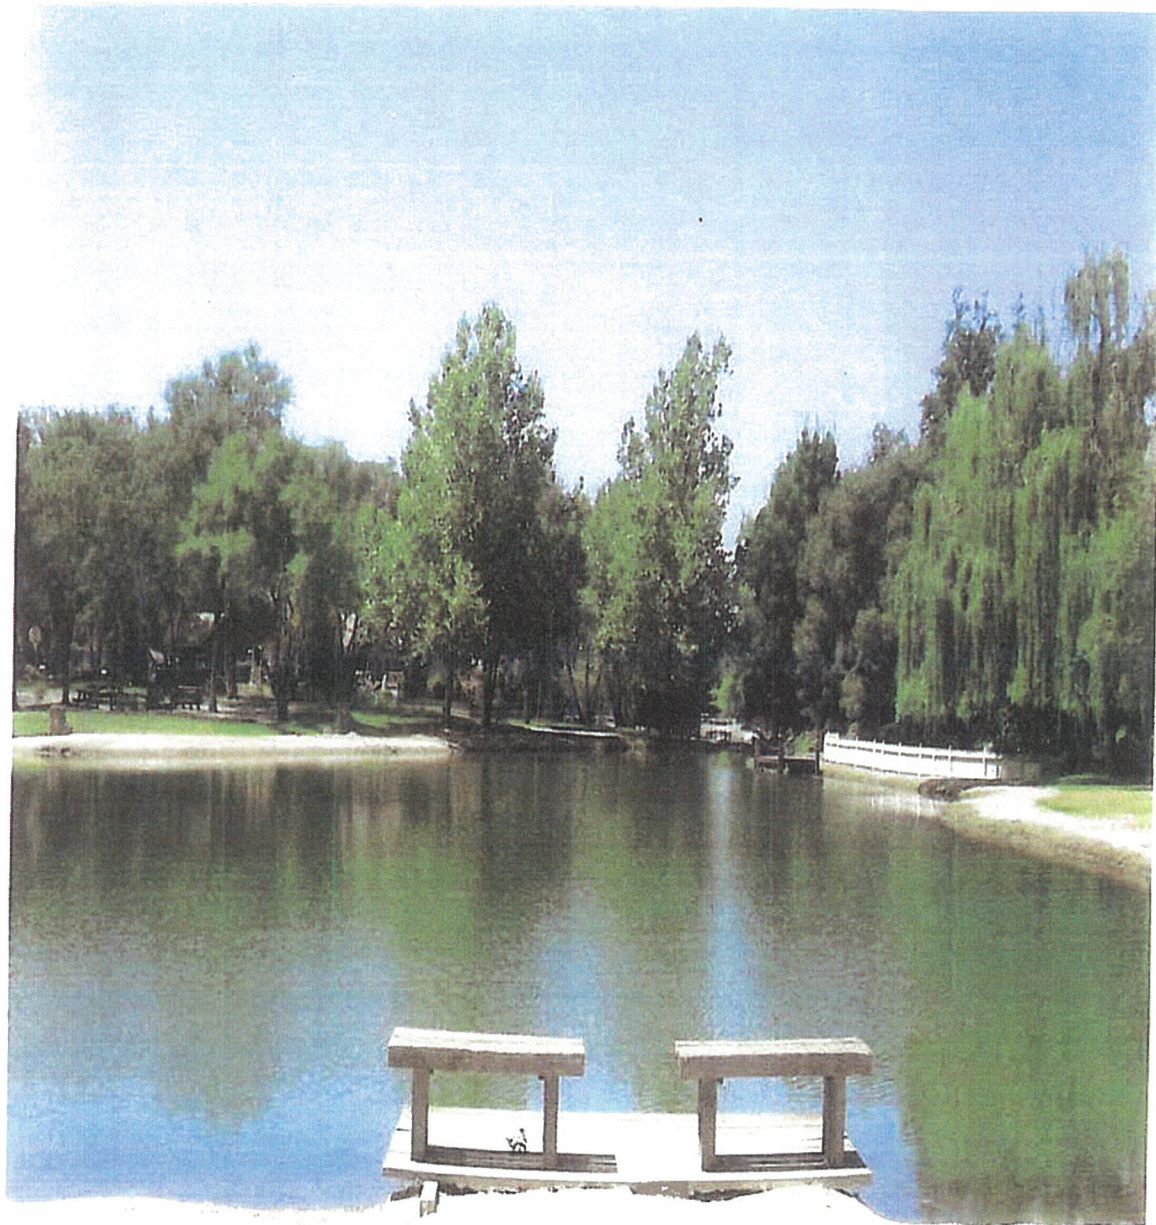
EXHIBIT A

20 A. View southwest from top of embankment at Lots 71 and 72.

21 Depicts lower lake and banks.

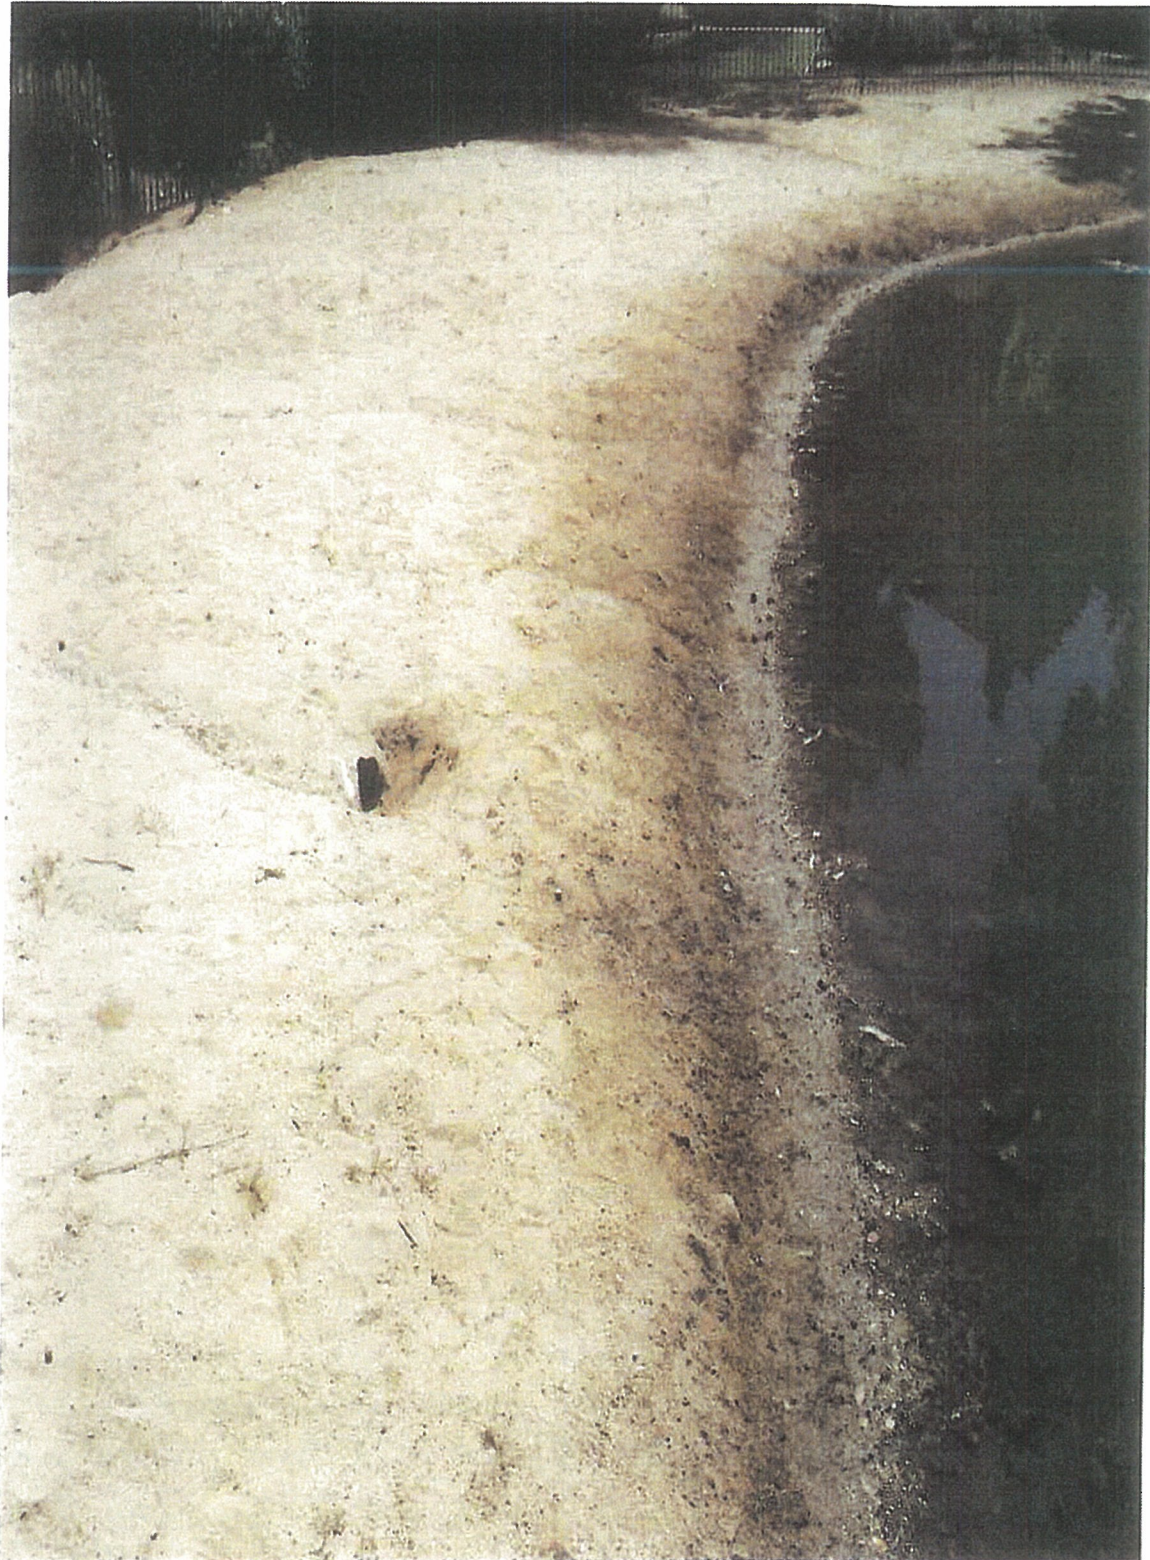
EXHIBIT B

22 B. View easterly on top of embankment on Association
23 property. Drainage culvert (Corrogated Metal Pipe)
24 embedded in embankment at extension of property line
25 between Lots 71 and 72. Fencing beginning on left upper
26 side of photo is on Lot 72. Lake level is approximately 5
27 feet higher than level of rear, southerly portions of, Lots 71
28 and 72.

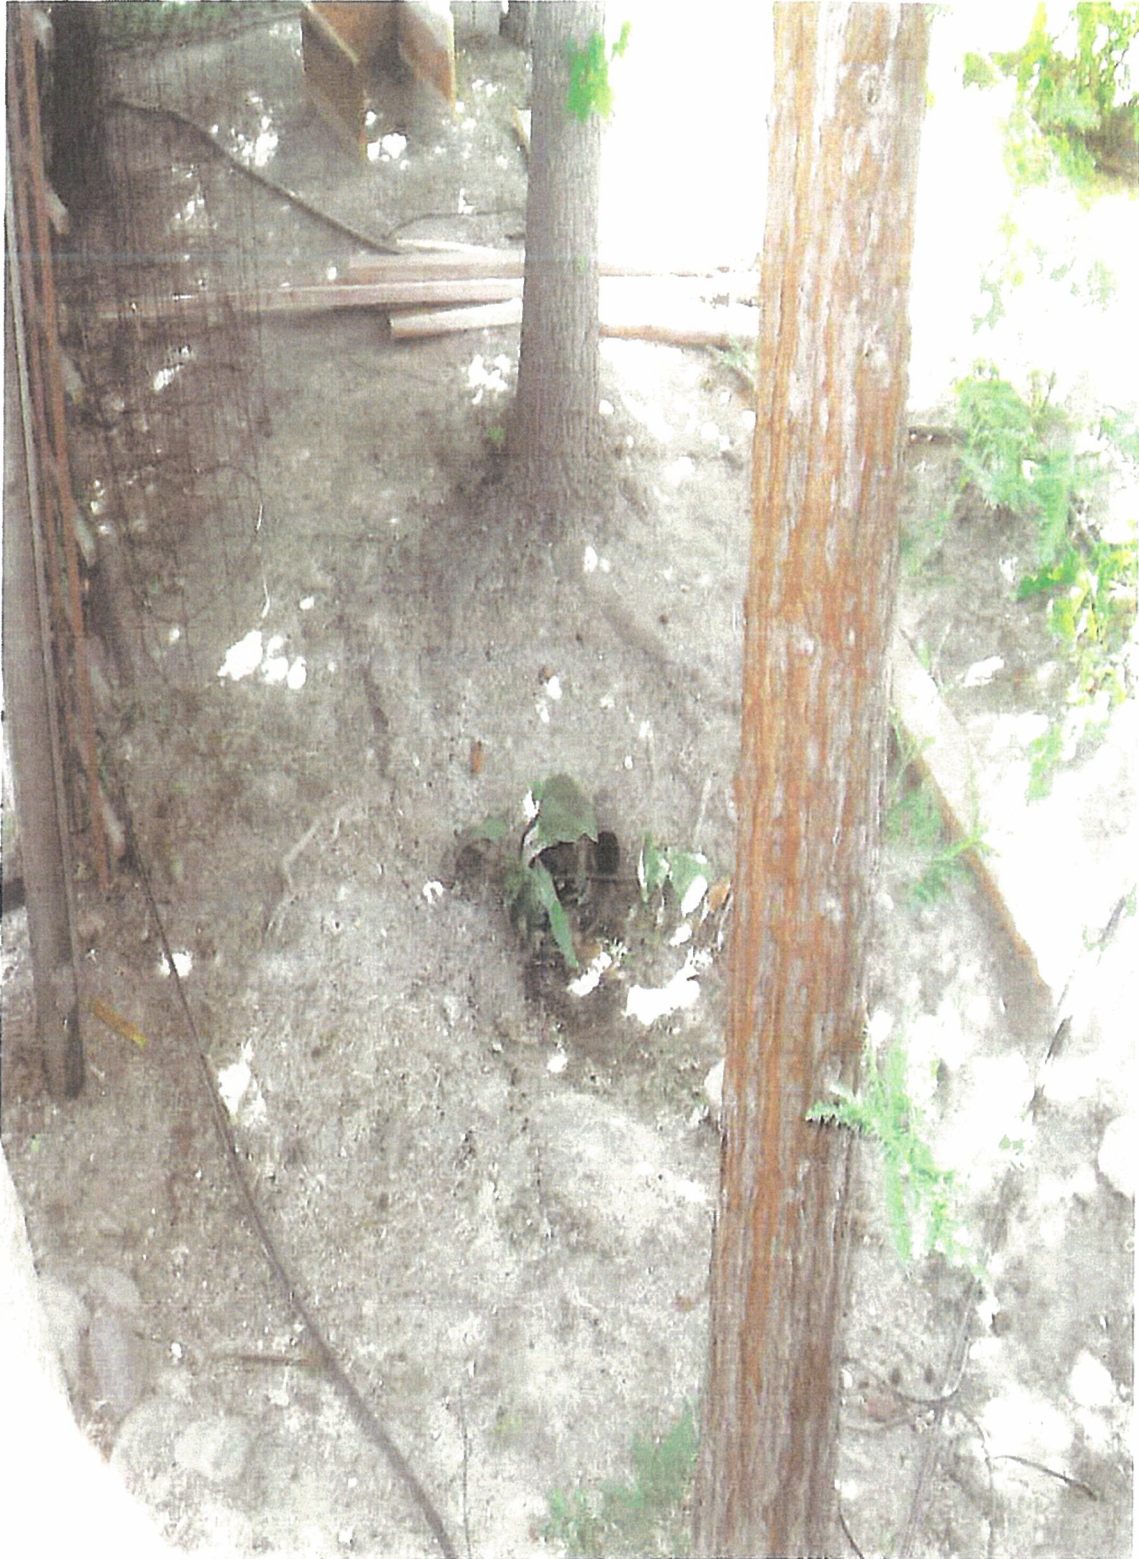
- E. View northeasterly in Meandering Drainage Easement on Lot 72 depicting damaged embedded drainage culvert in mid photo. Fence at left is on property line. All soil on Lot 72 was firm though water droplets were visible at many locations evidencing very recent surface watering. All soil was hardened dry except where the darkened soil area at the culvert inlet appeared slightly moist, but was firm. This soil is fill over a natural, historic streambed. The grade appears raised, and does not appear to slope to drain.

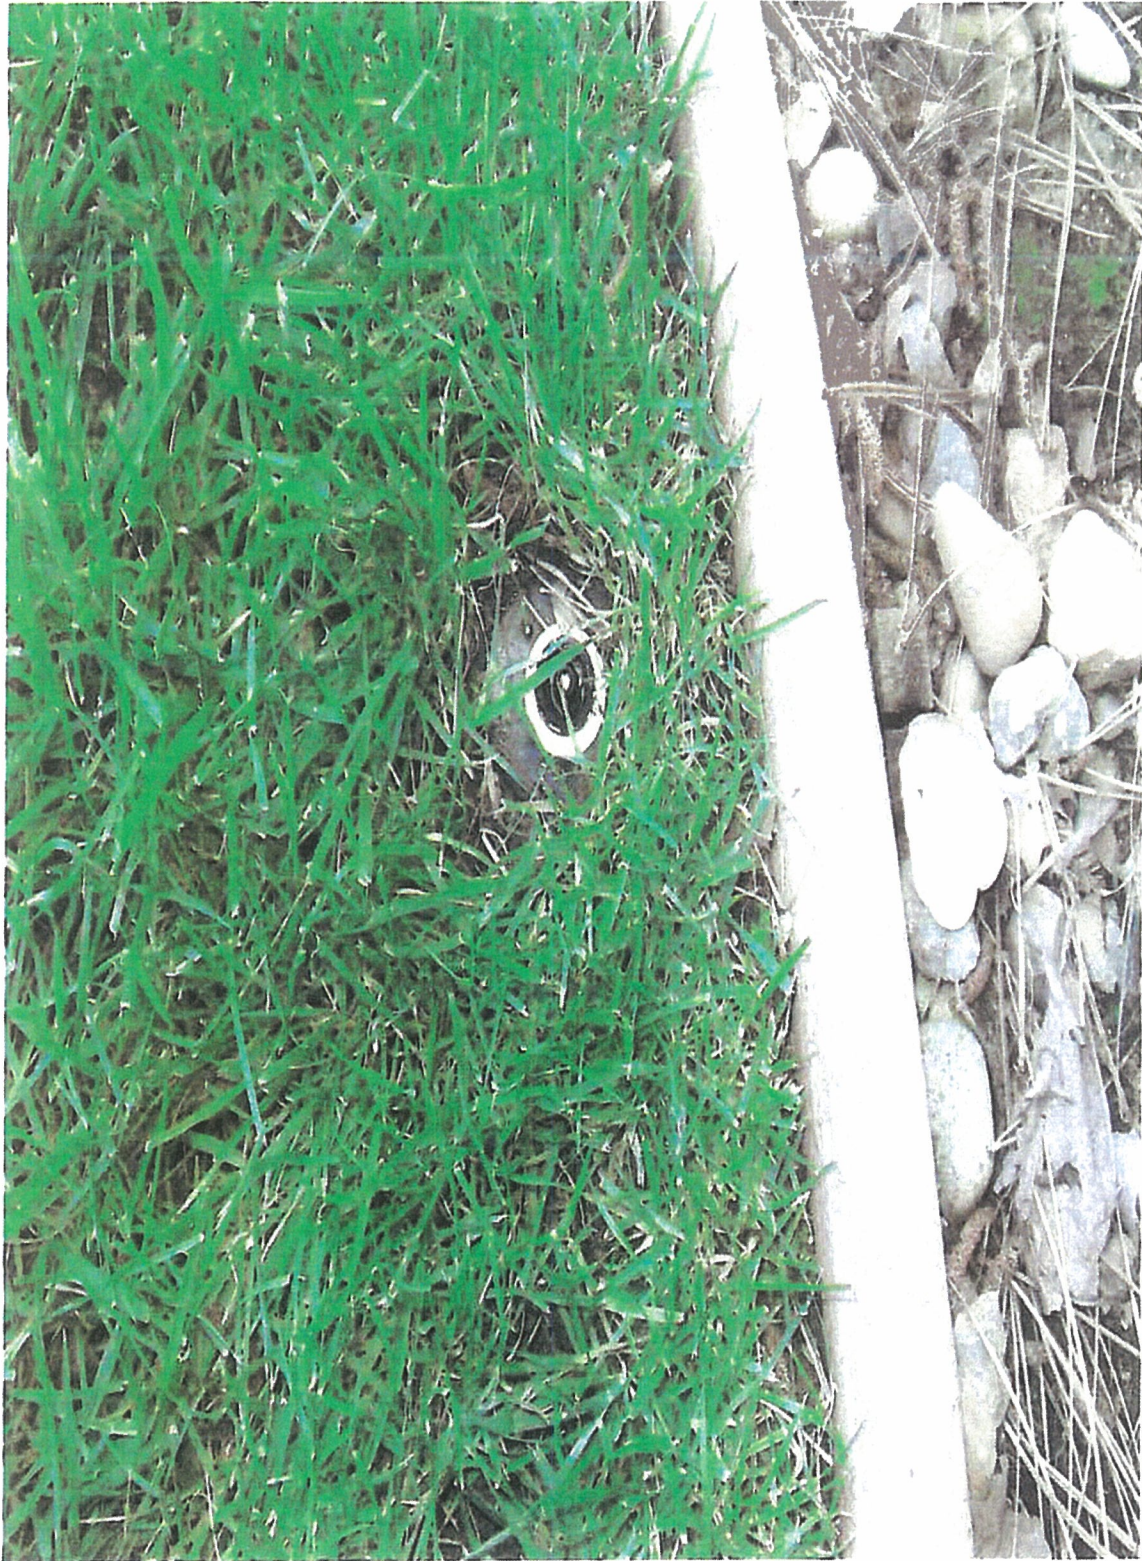
EXHIBIT G

- F. View of sprinkler head in lawn of Lot 71 depicting water at head of sprinkler shortly after 11:00 a.m. on June 18, 2004. Though attorney Thomas stated that the lot had not been watered recently, the presence of water droplets on the sprinkler head and grass blades long after all dew and nighttime moisture had evaporated proves that the lawn was

watered very recently.

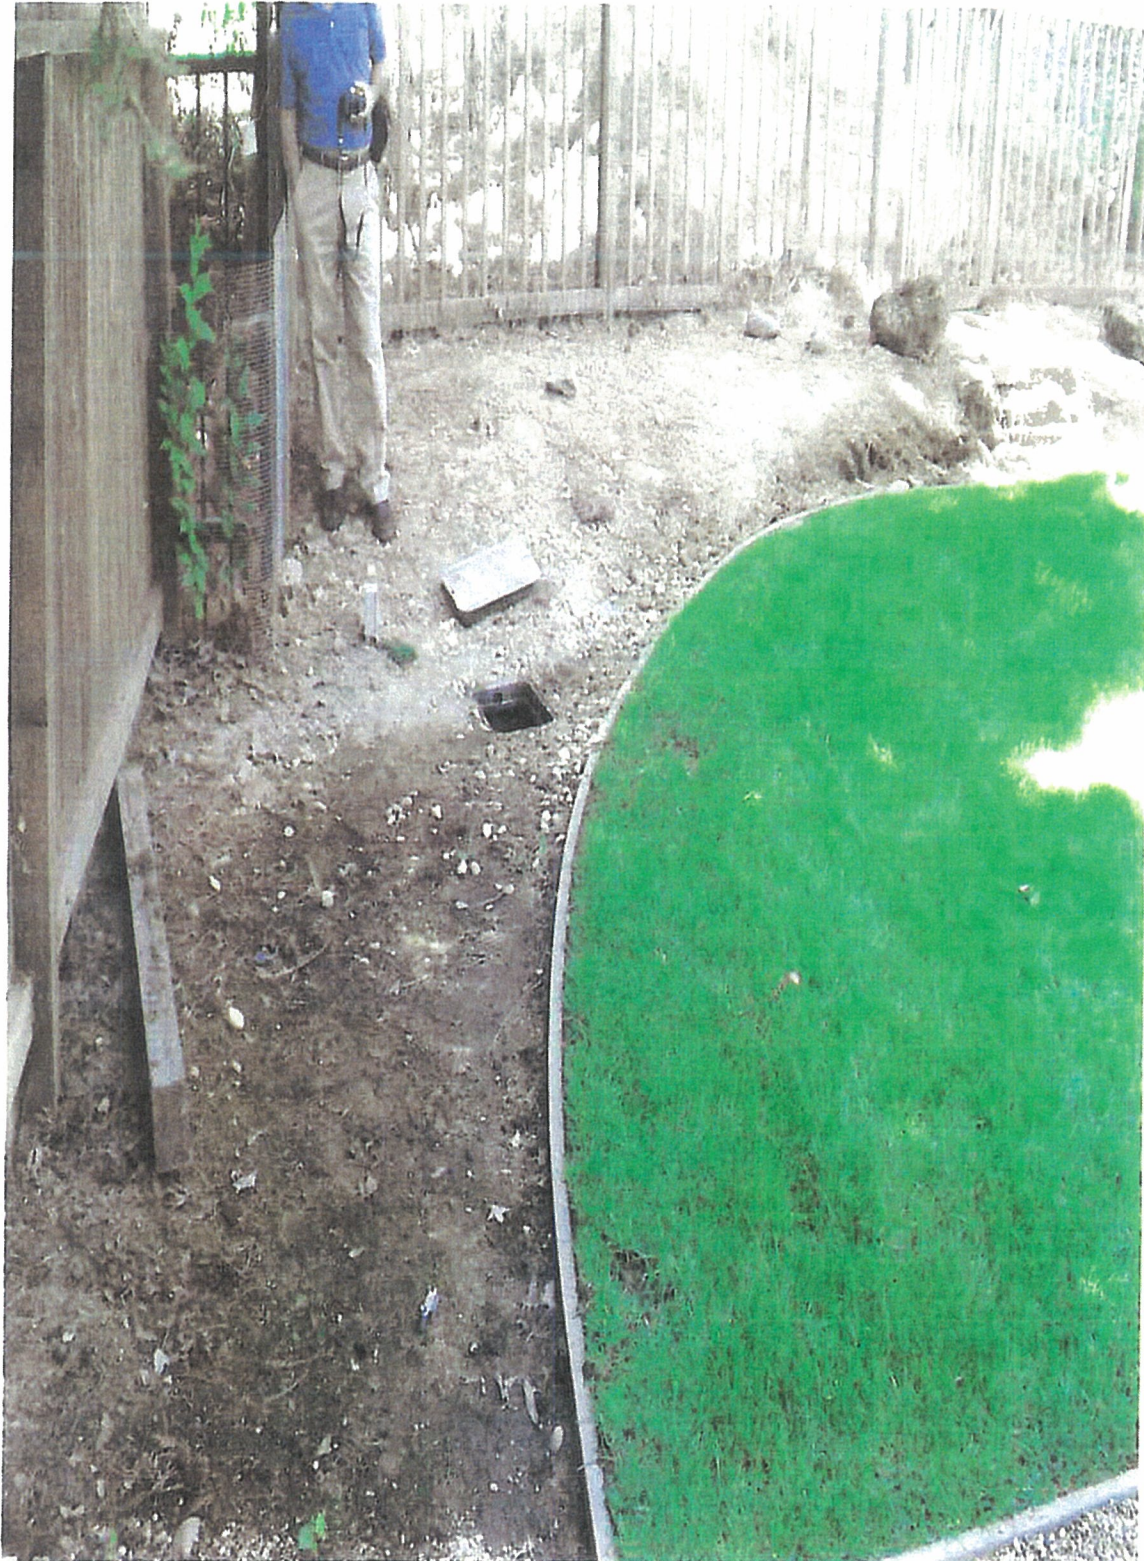
EXHIBIT H

G. View southwesterly on Lot 71 depicting sprinkler spray patter evidencing recent deep watering at Meandering Drainage Easement. Fence at left is property line, and toe of embankment at lake in background. At upper right of photo, old concrete steps are visible. Adjacent to the left of the steps is recent excavation apparently part of recent lawn and sod installation. At mid photo is embedded sump pump. Attorney Thomas stated that interceptor drain was installed from the box towards the right of the photo. All visible surfaces were firm and dry except for sprinkler water residue.

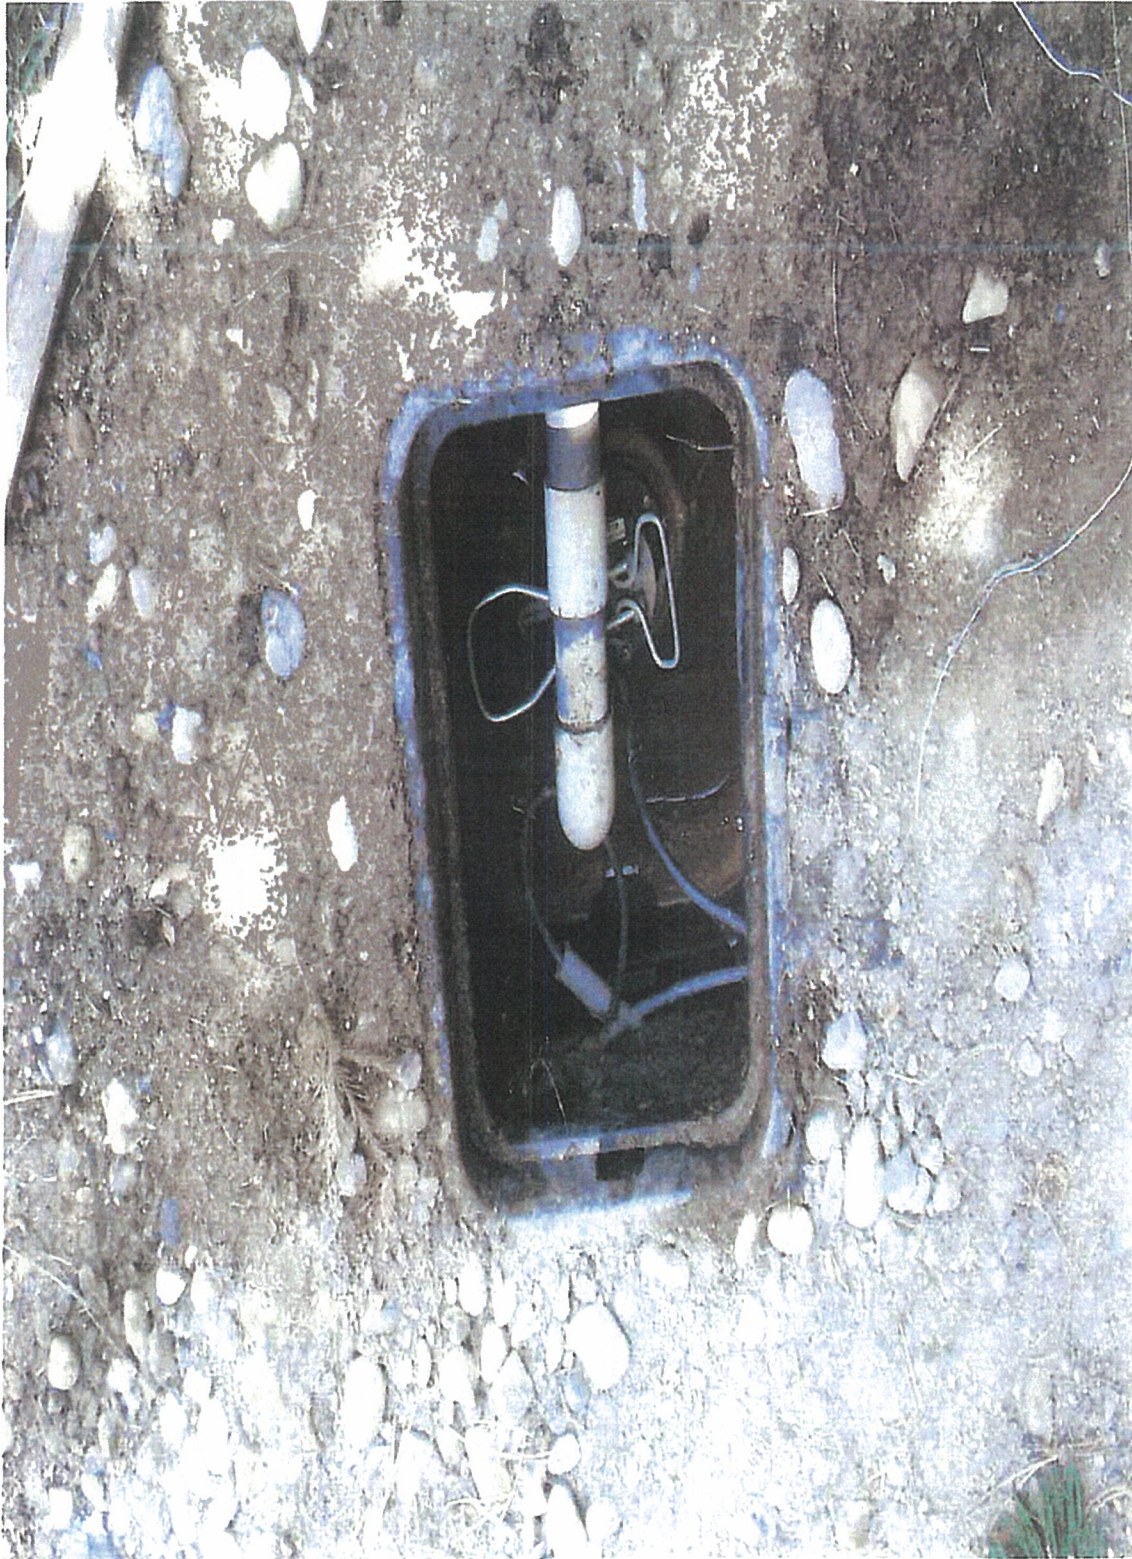
EXHIBIT I

H. View of sump pump box recessed in Meandering Drainage Easement. I observed the pump operate through several cycles. There was no evidence of soil saturation.

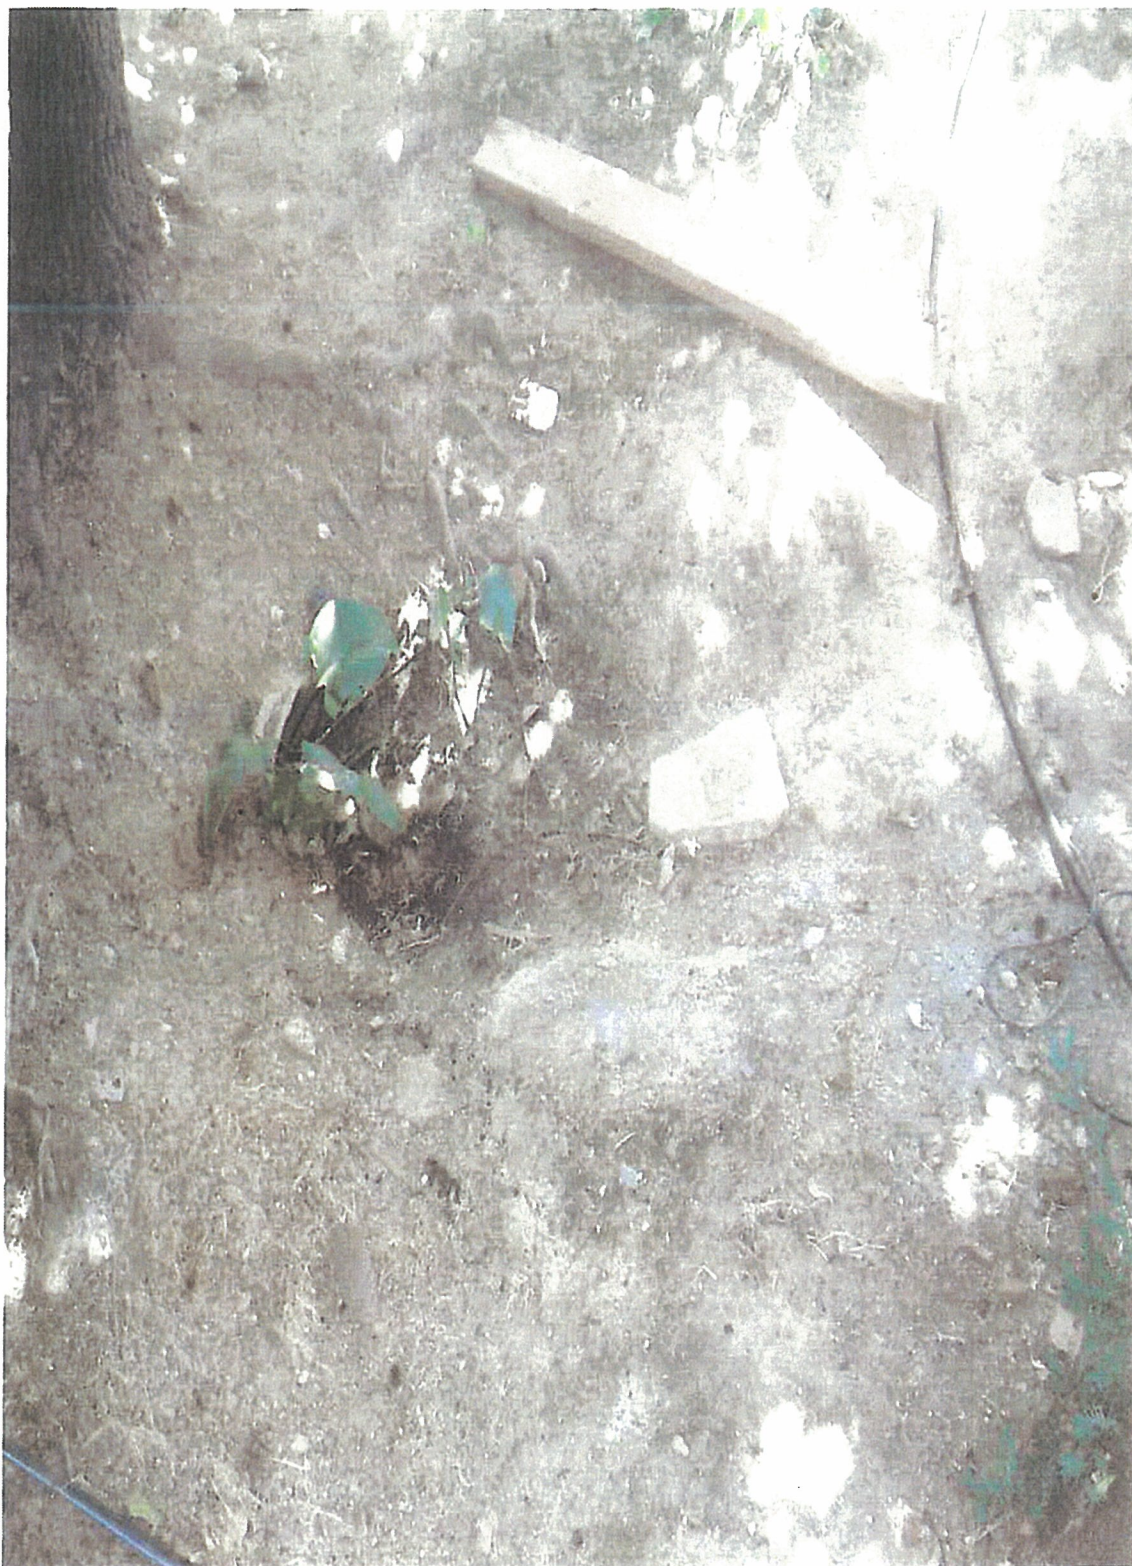
I. View of culvert in Meandering Drainage Easement on Lot 72 embedded in fill and near tree.

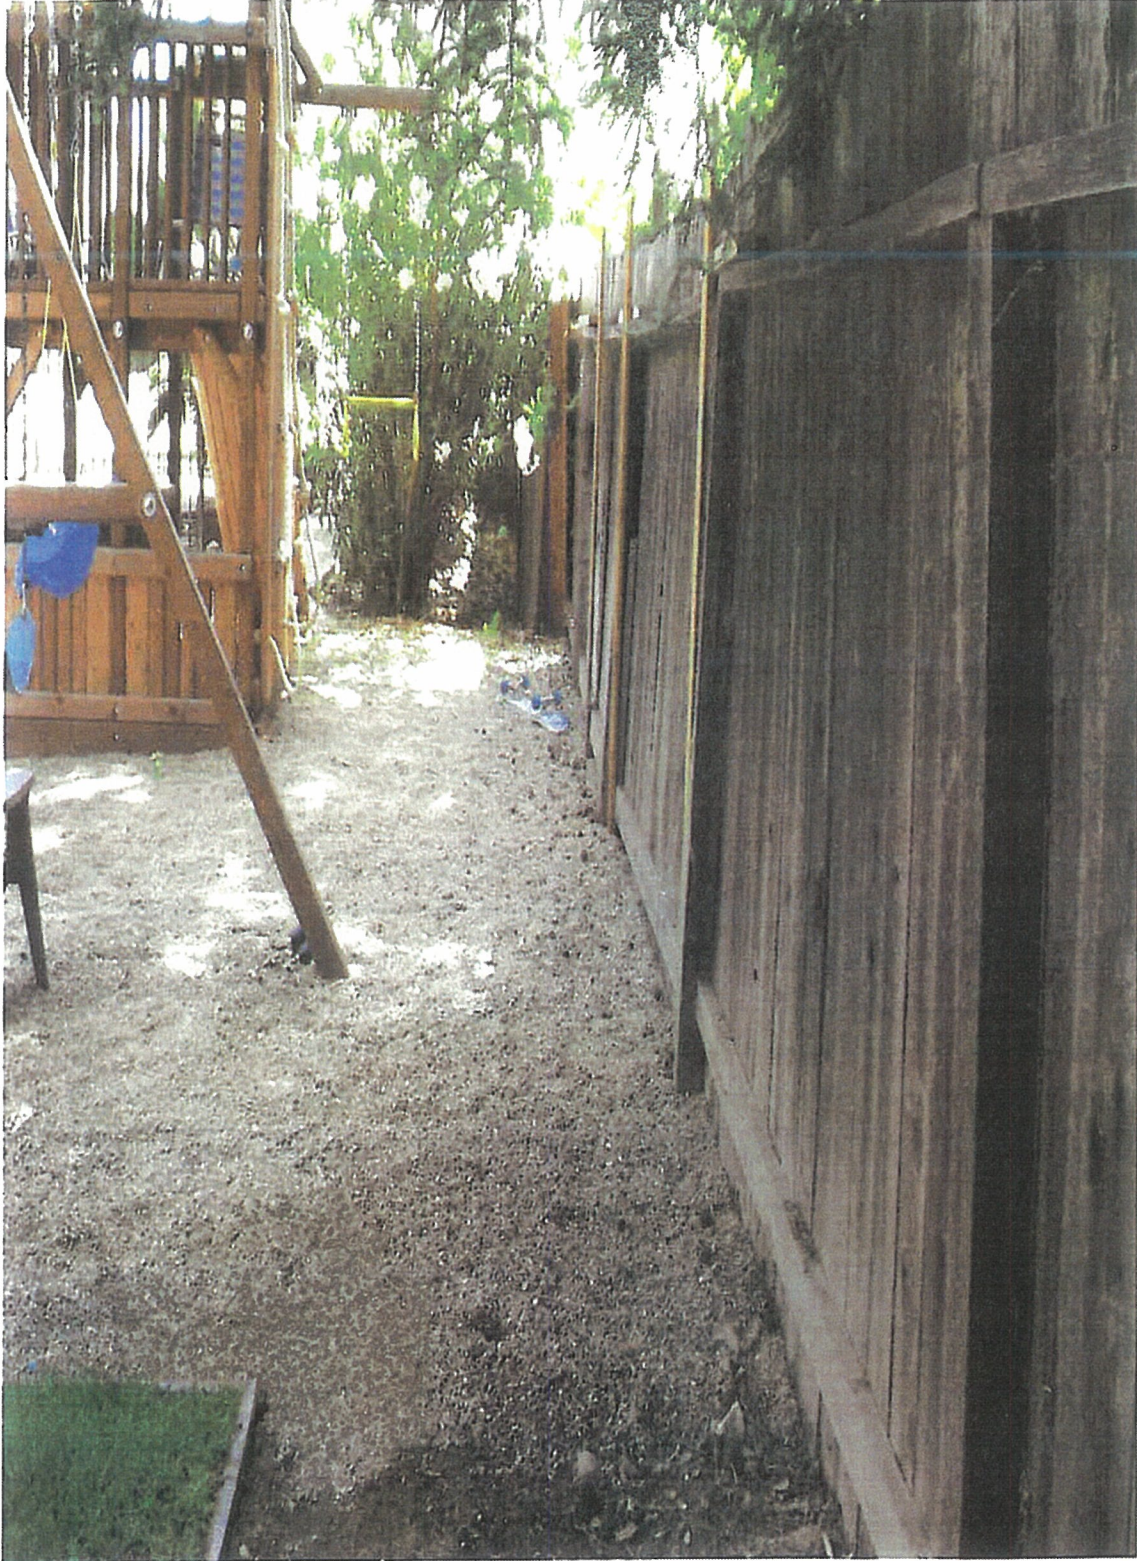
EXHIBIT K

J. View northeasterly on Lot 71 at recent gravel fill in Meandering Drainage Easement. Gravel appears to be placed on top of raised earth fill, and does not slope to drain. Play structure and fence in Meandering Drainage Easement.

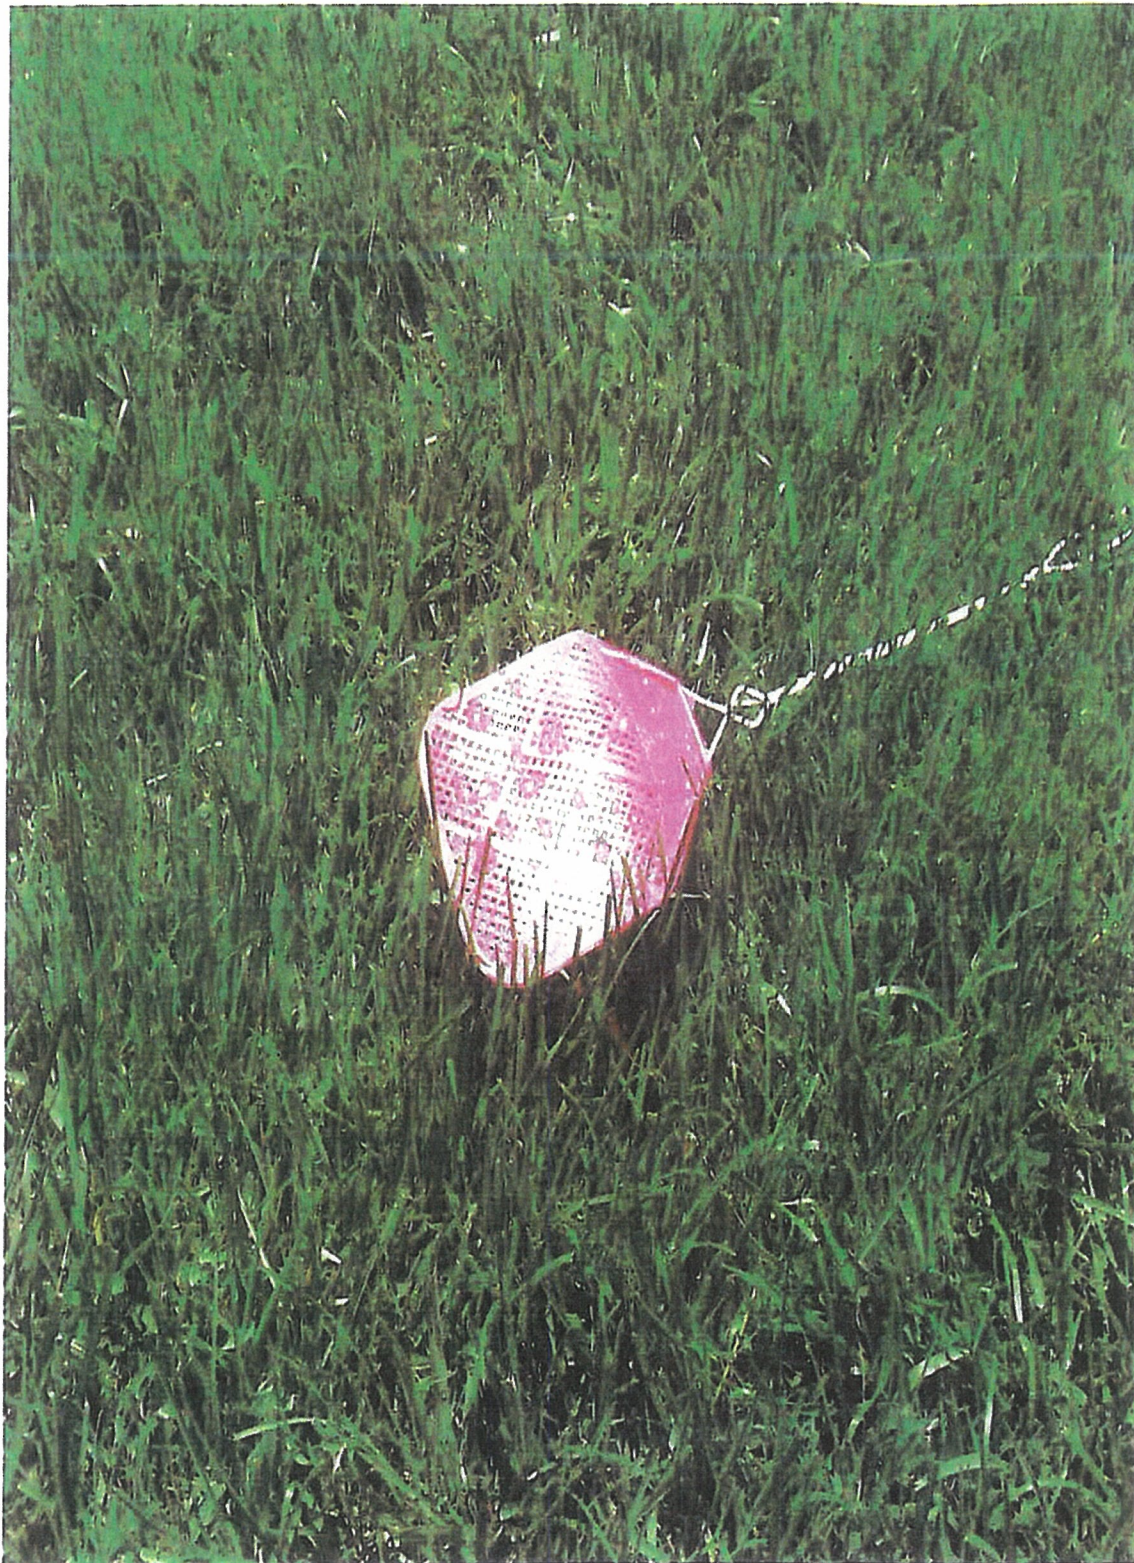
- M. View depicting plastic fly swatter found *in situ* on lawn at Lot 71 with residual water droplets from watering before inspection.
- N View northeasterly on Lot 71 depicting fill area in Meandering Drainage Easement and apparently recently installed concrete walk. The nature and extent of excavation and fill is unknown. A green monitoring well is present in mid photo.

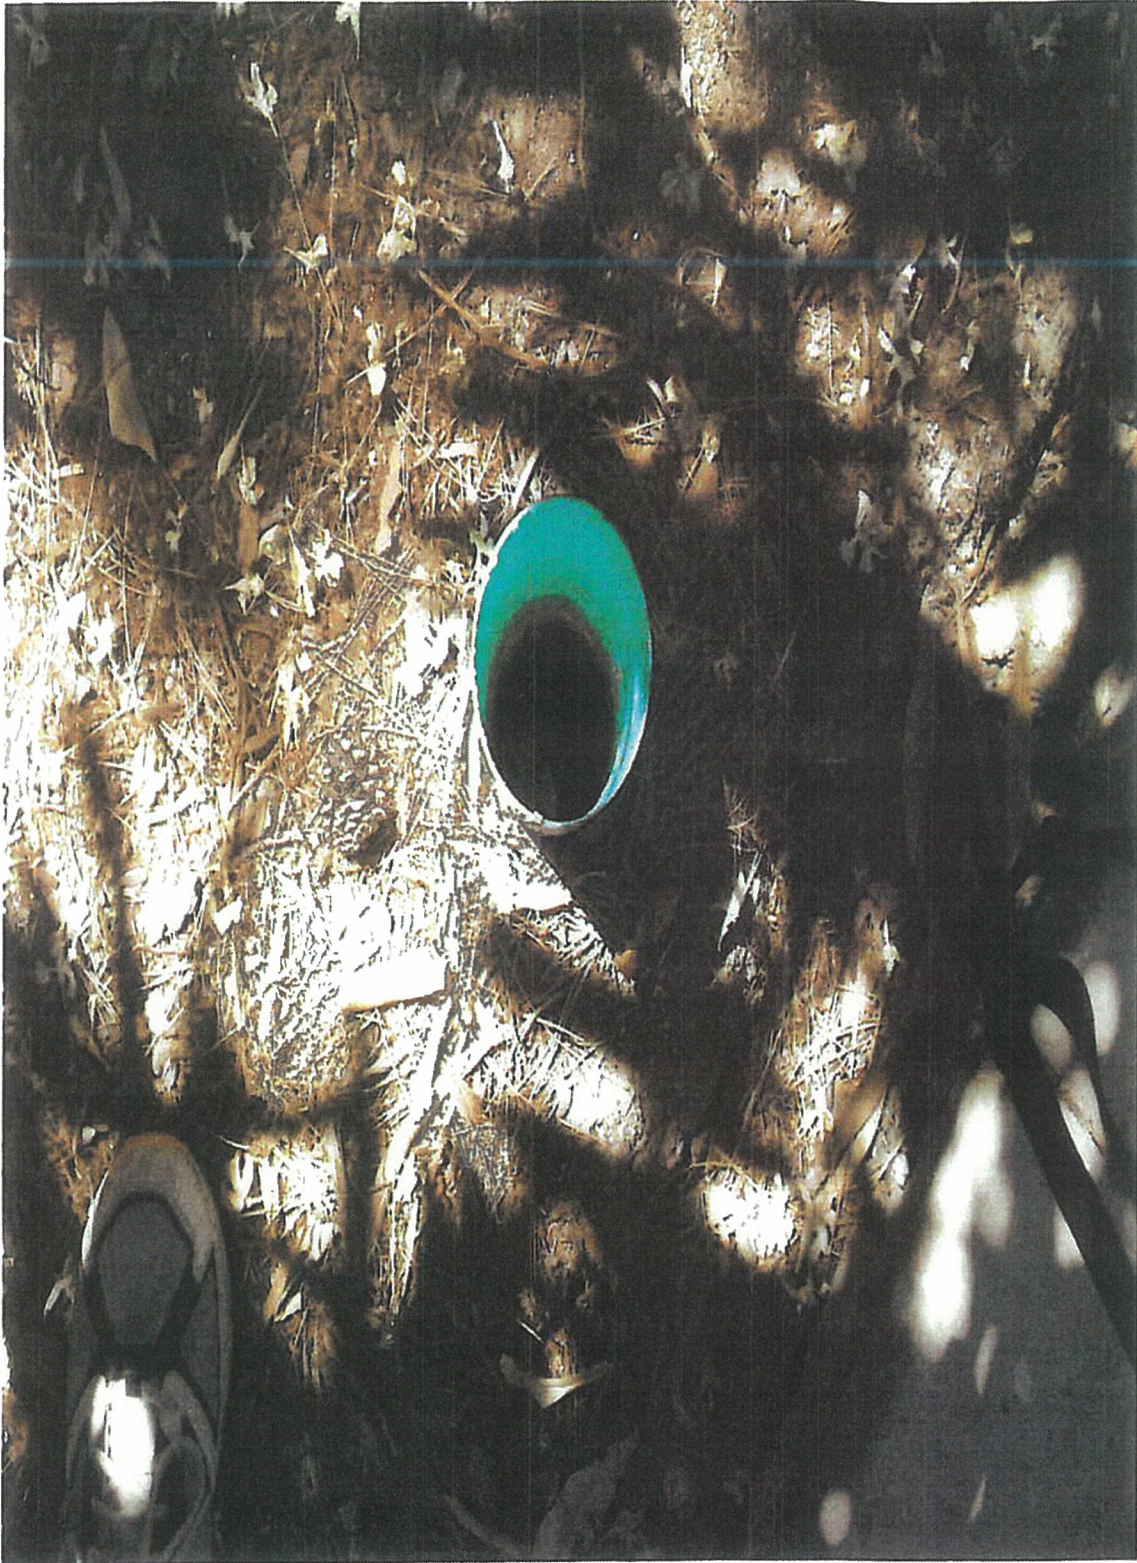
- O. View depicting monitoring well and high ground water level that is expected in the historical stream bed.
- P. View northeasterly at Lot 71 showing concrete apron poured up to property fence line and into Meandering Drainage Easement.

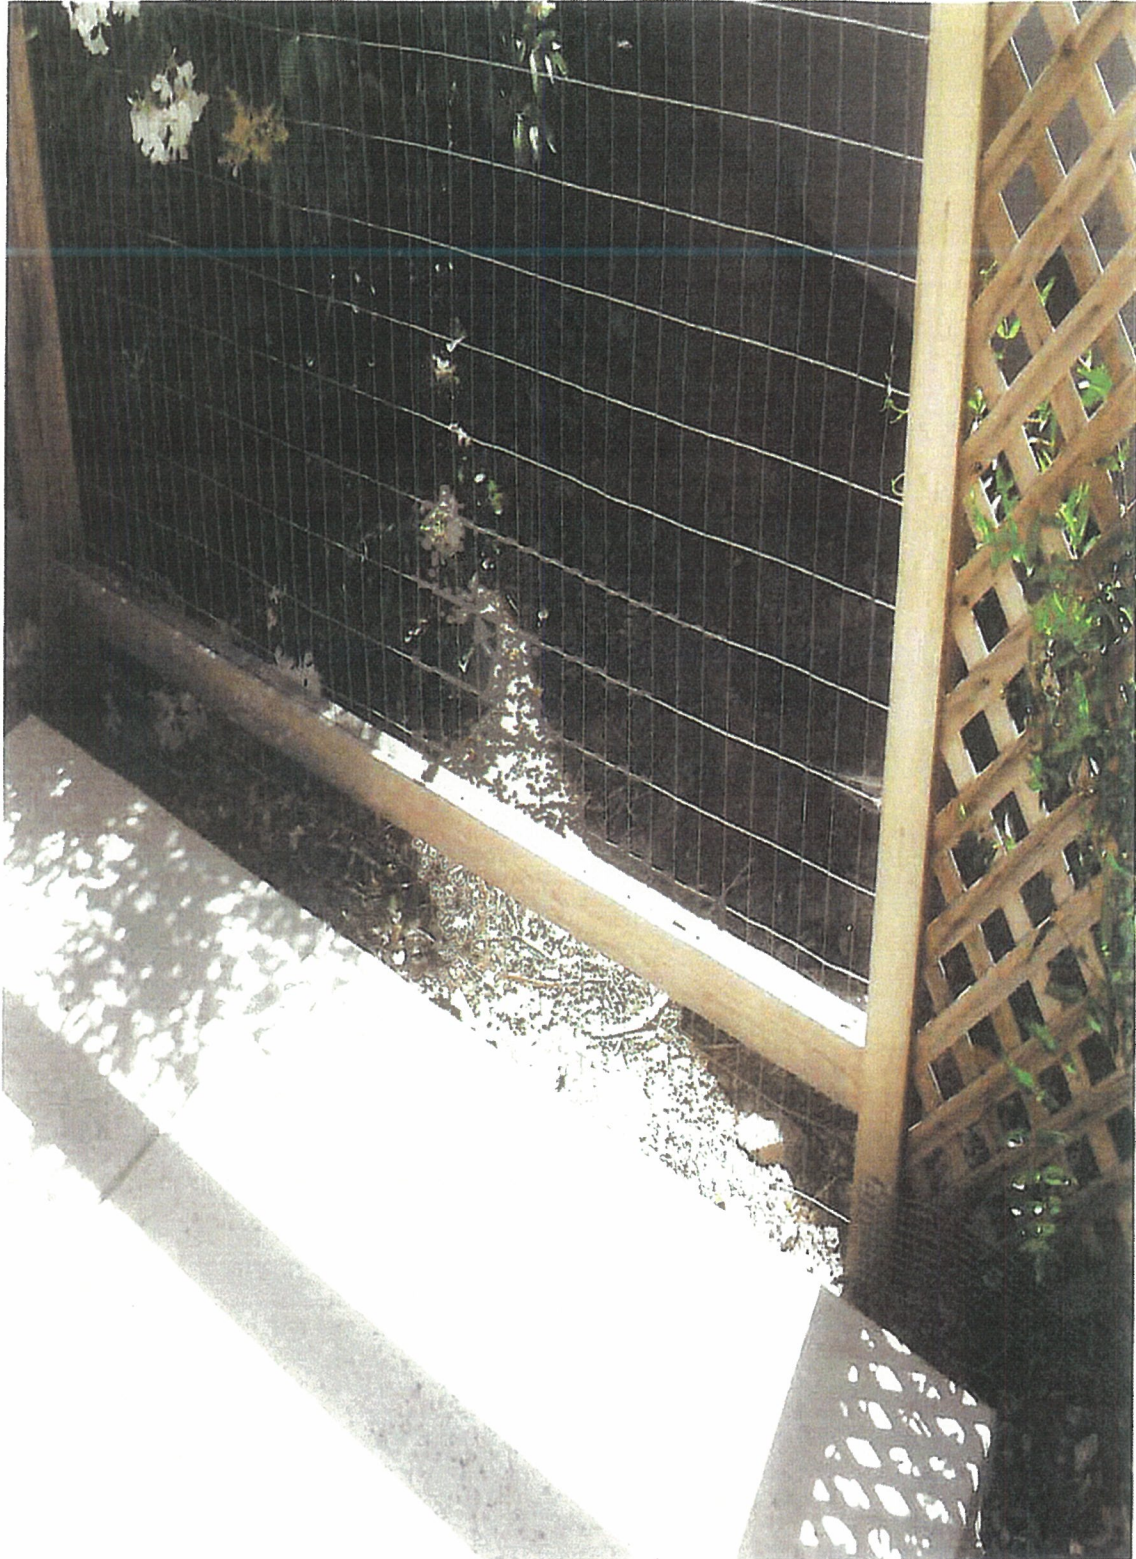
- Q. View easterly from Lot 71 into Lot 72 where concrete apron extends to property fence line and completely over Meandering Drainage Easement. Visible through wire is concrete pad used for boat storage on Lot 72, completely disrupting surface drainage.

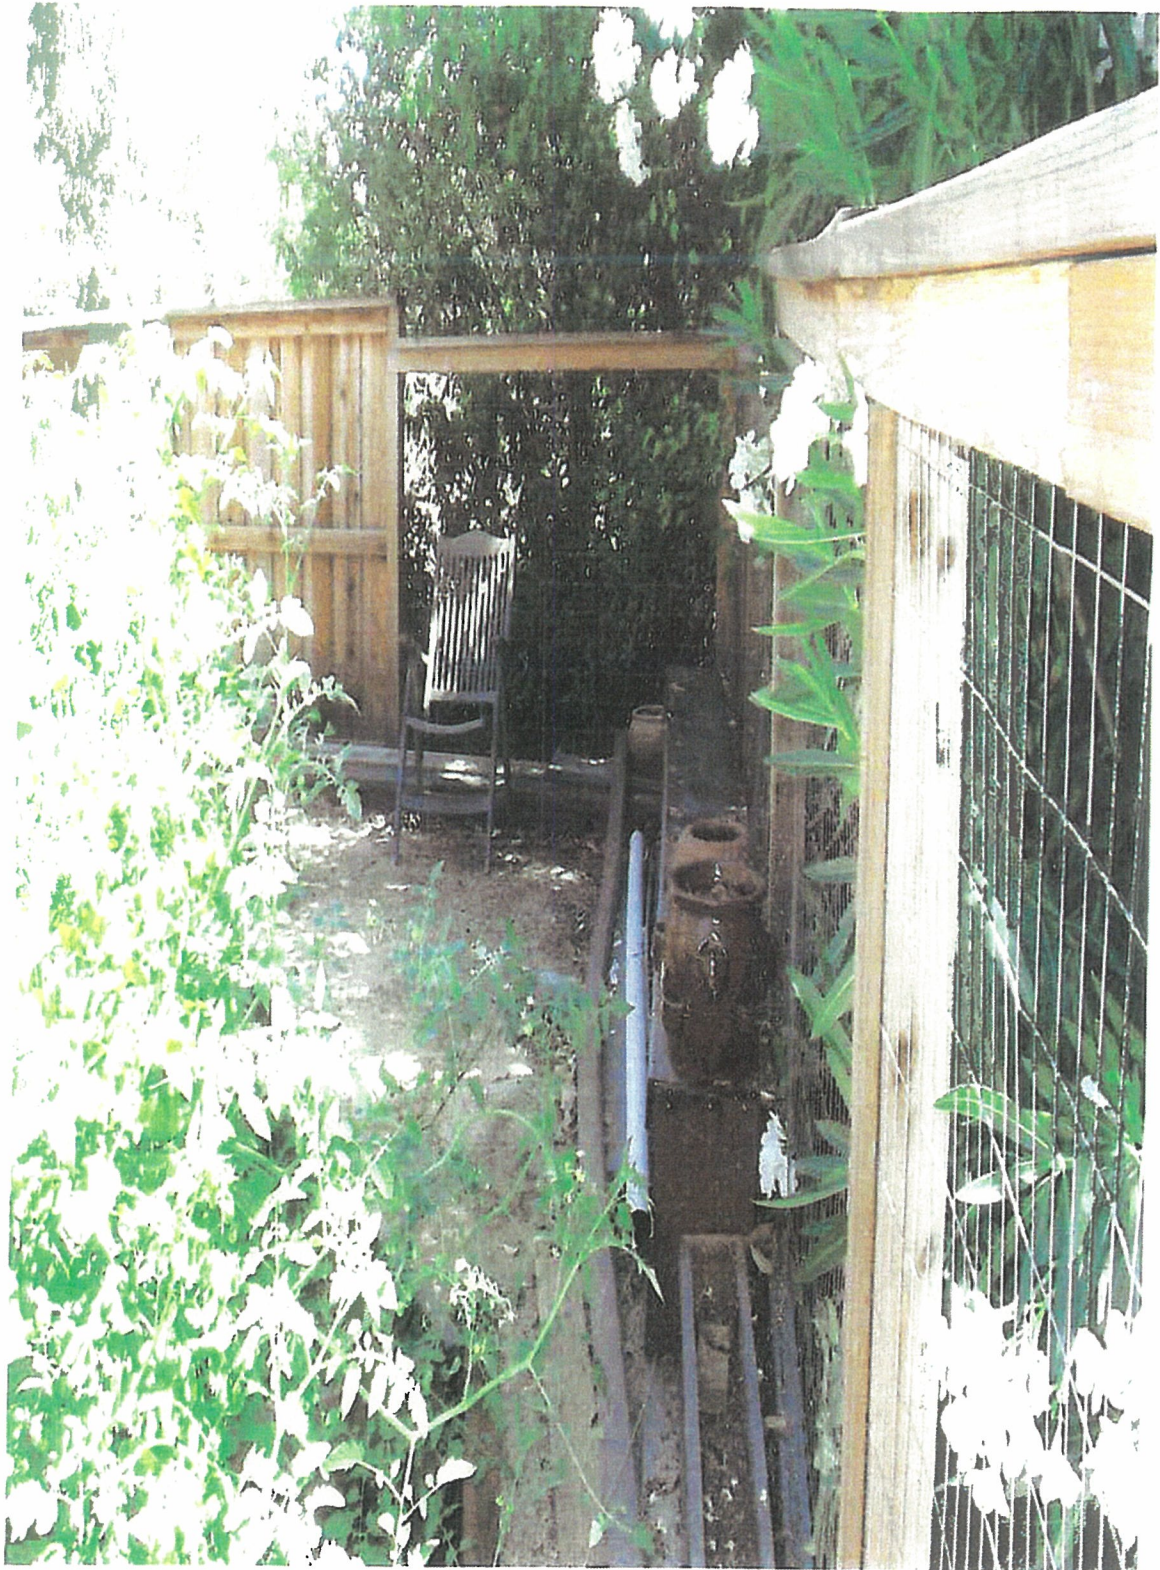
- R. View northeasterly on Lot 71 at property line showing raised bed garden that is filled approximately 2 feet above grade and into Meandering Drainage Easement. The corner of the

garden drops 2 feet to grade.
