**DECLARATION OF SCOTT
STEPHENS, P.E. IN SUPPORT OF
OPPOSITION TO PLAINTIFFS'
MOTION FOR PRELIMINARY
INJUNCTION**
[C.C.P. §2015.5]

22 **HLE EXHIBIT 19**

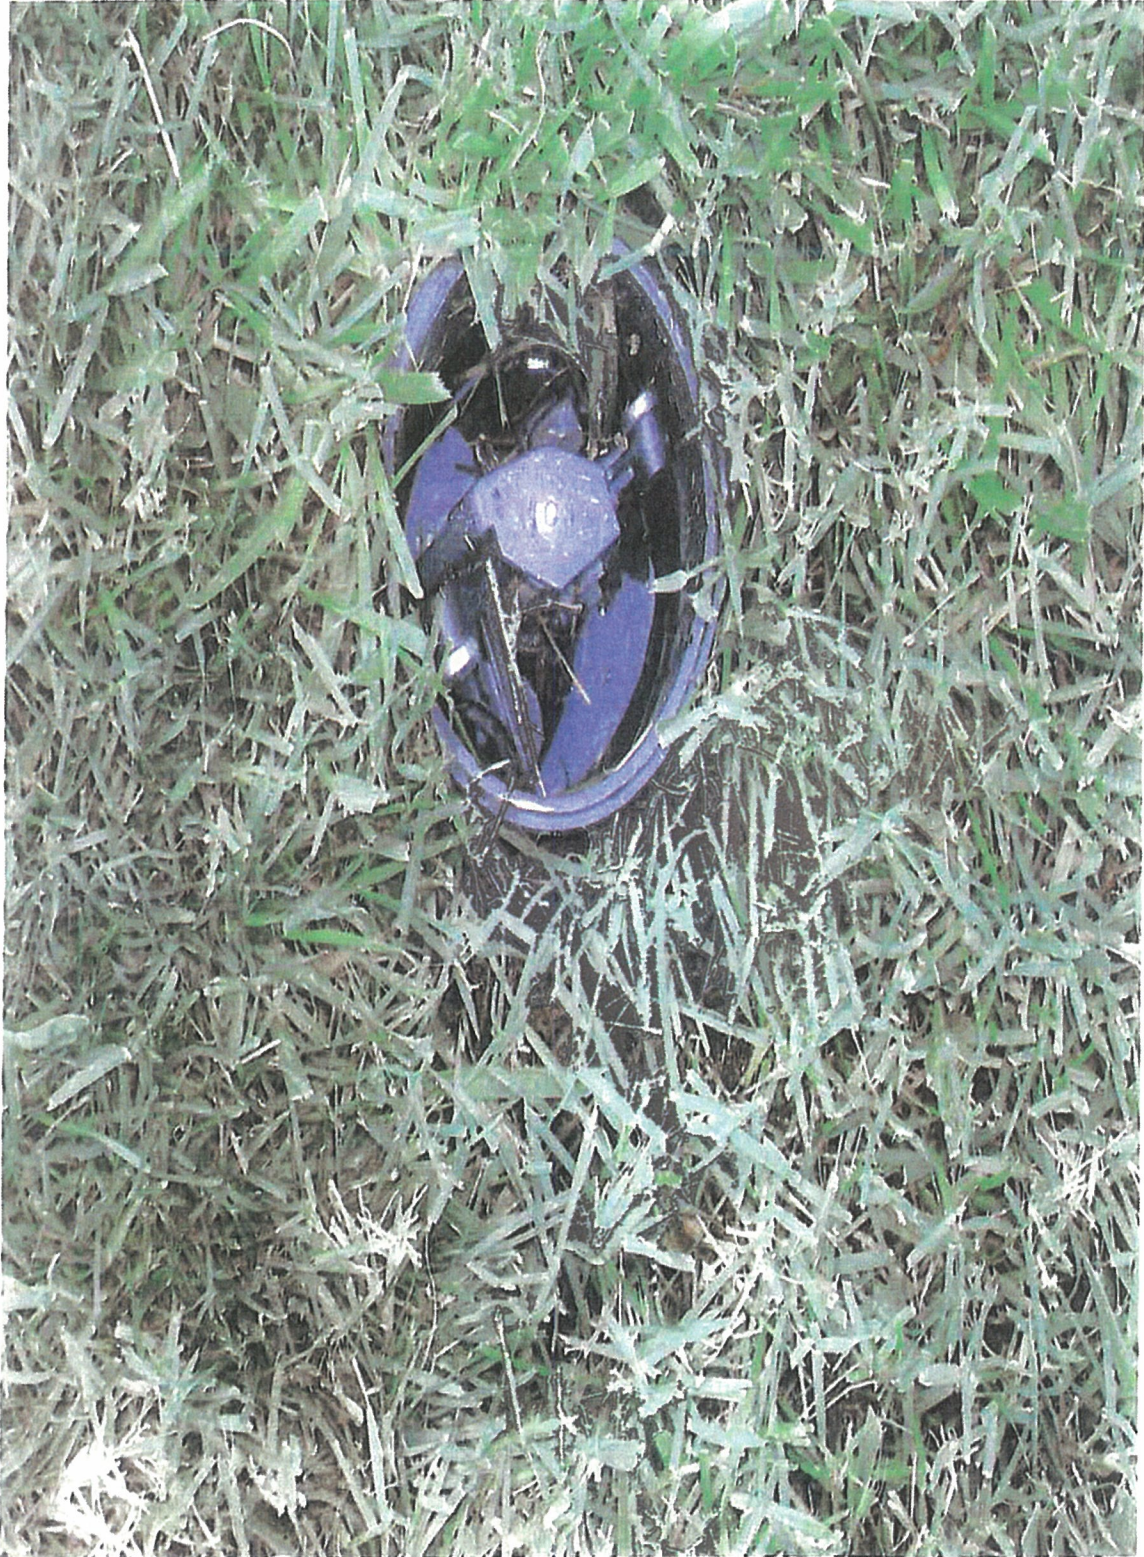
U. View of sprinkler at Lot 72 showing ponded water in sprinkler from recent use. Water droplets were present on grass blades on Lot 72 lawn areas notwithstanding attorney Thomas' representation that the Allegras' had not watered for over one year.

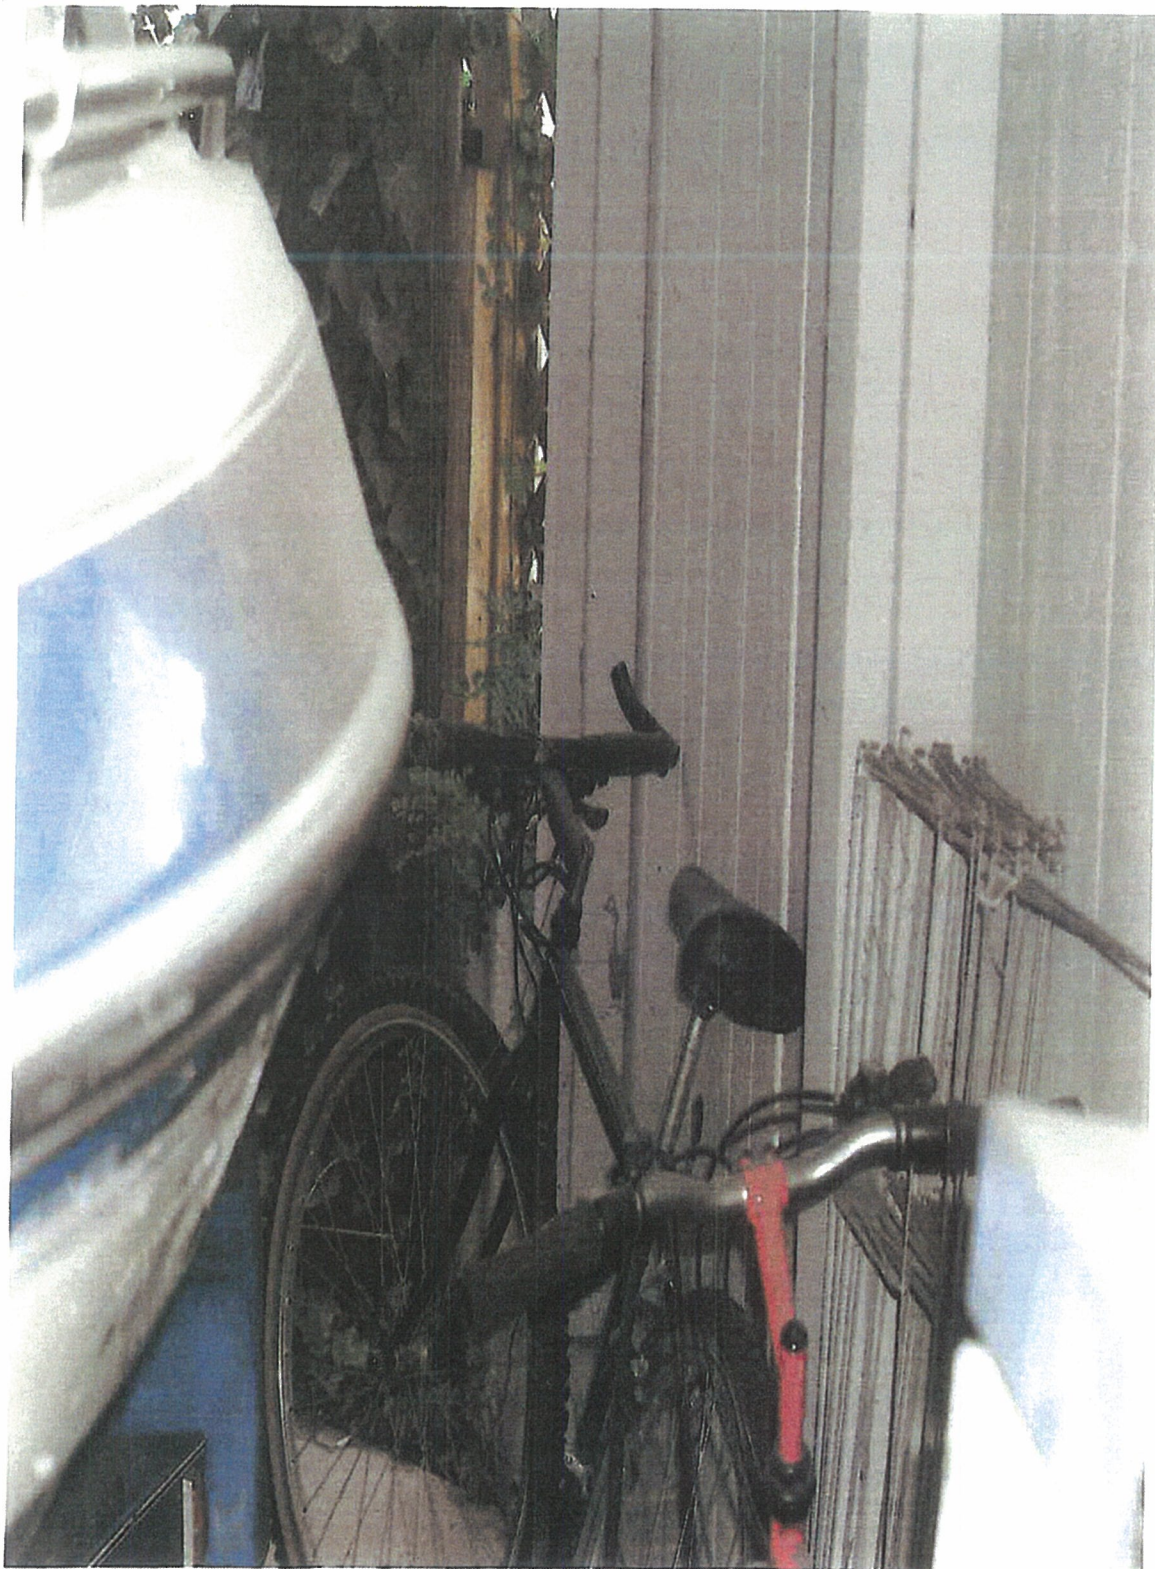
V. View of boat and concrete apron poured close to property line and into Meandering Drainage Easement at northerly portion of Lot 72.
