RECREATIONAL USE RE-EVALUATION OF THE ENGINEERED CHANNELS OF THE LOS ANGELES RIVER WATERSHED

**FIELD RECONNAISSANCE REPORT
NOVEMBER 2010- MARCH 2011**

**LOS ANGELES REGIONAL WATER QUALITY CONTROL BOARD
MARCH, 2011**

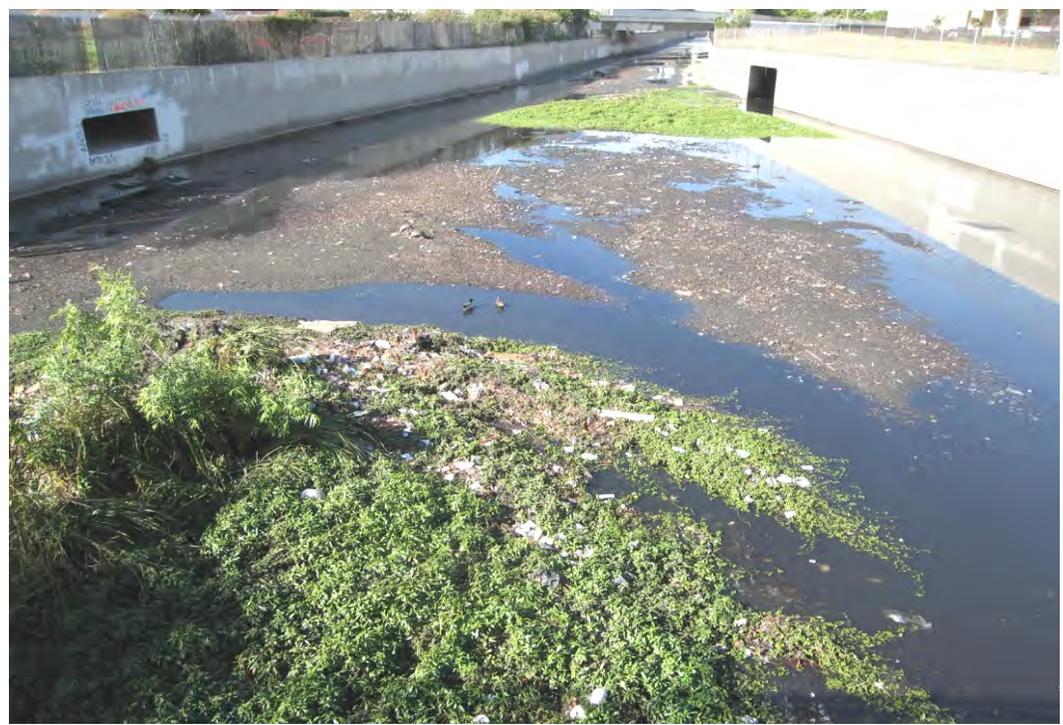
Time: 12:48p m	Photo No. 1
-----------------------------	------------------------------

Additional Comments:
Massive culvert b/w up- and down-stream. channel widens at this point. Earthen bottom begins downstream

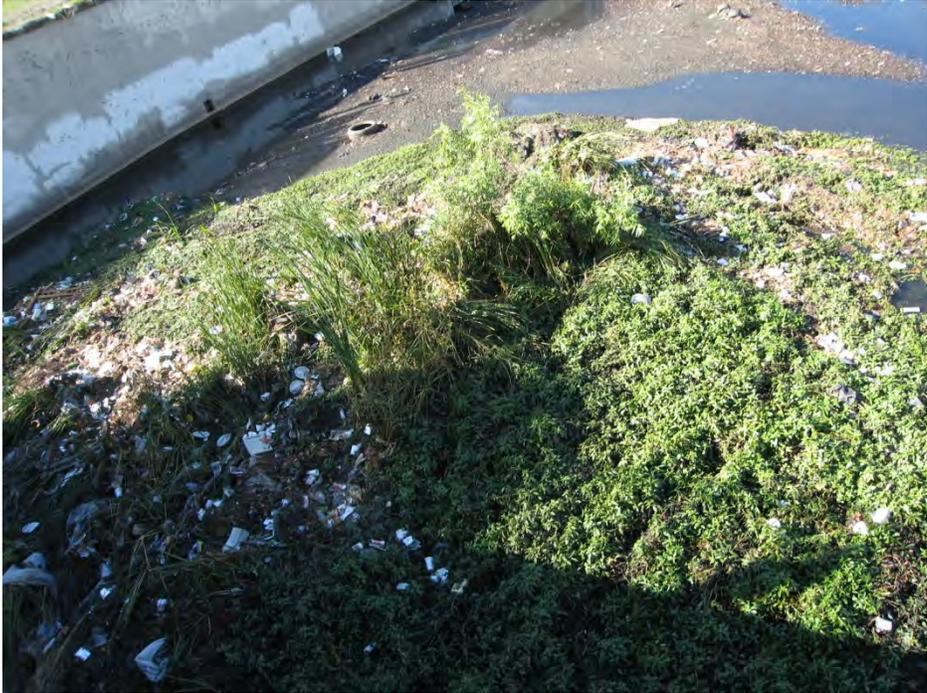
Date: 11/30/2010		Latitude/Longitude: 33° 52' 40.5" / 118° 13' 19.0"	Cross Streets: Alameda & 91 Fwy (TG 735 A7)
Time: 12:48pm	Photo No. 3

Direction Photo Taken: Trash along stream			
<i>** Creek details refer to preceding page</i>			
Time: 12:48pm	Photo No. 4

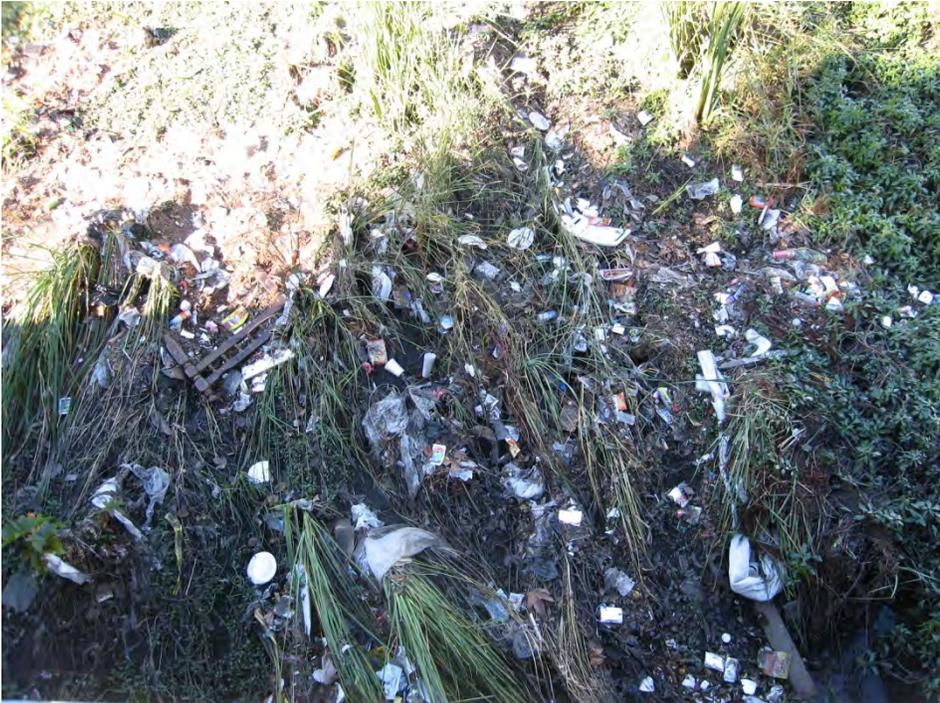
Direction Photo Taken: Trash along stream			
<i>** Creek details refer to preceding page</i>

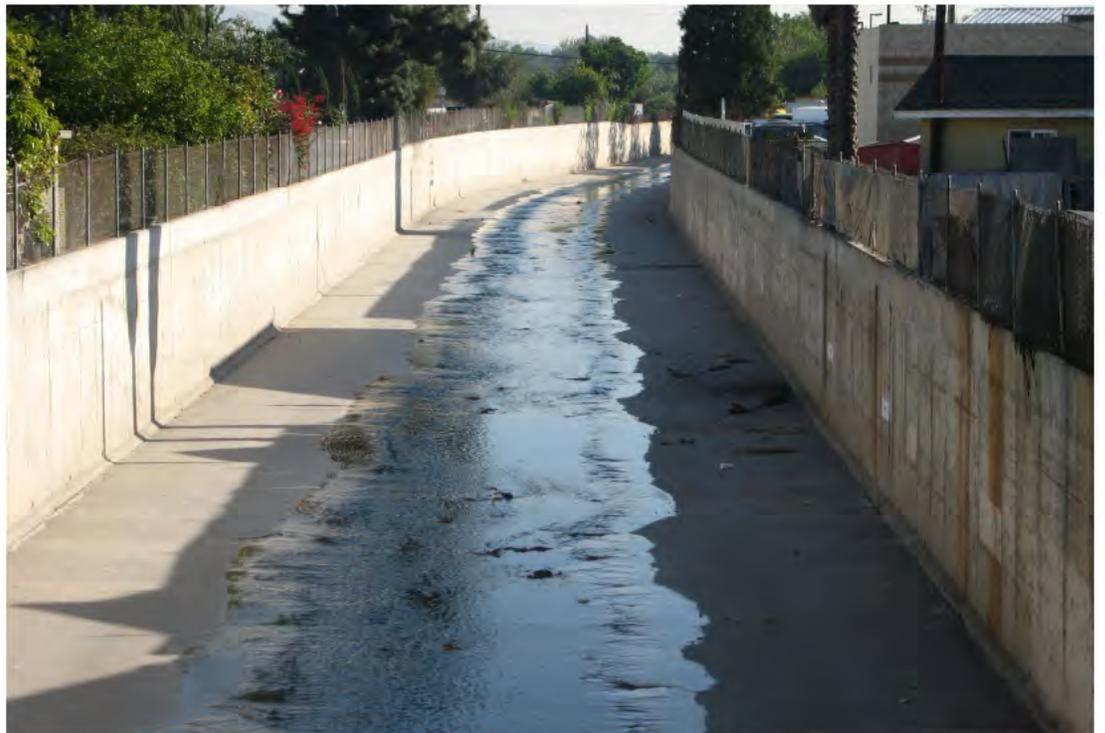
Date: 11/18/2010		Latitude/Longitude: 34° 5' 8.34" / 118° 6' 32.07"	Cross Streets: New Ave. & Adams Ave. (TG 596-D6)
Time: 2:24pm	Photo No. 1		
Direction Photo Taken: Upstream			
<p>Mode of Access: Un-gated Maintenance Rd b/w Golf Course & HS</p> <p>Potential Access Points: Fenced (both sides of wall), Maintenance Ramp</p> <p>Adj. Rec Facility: Golf Course</p> <p>Adj. Land Uses: Rec & Educational HS</p> <p>Low Flow Channel: None</p> <p>Bike Path: Absent</p> <p>Other Signs of Access: Covered up graffiti</p>

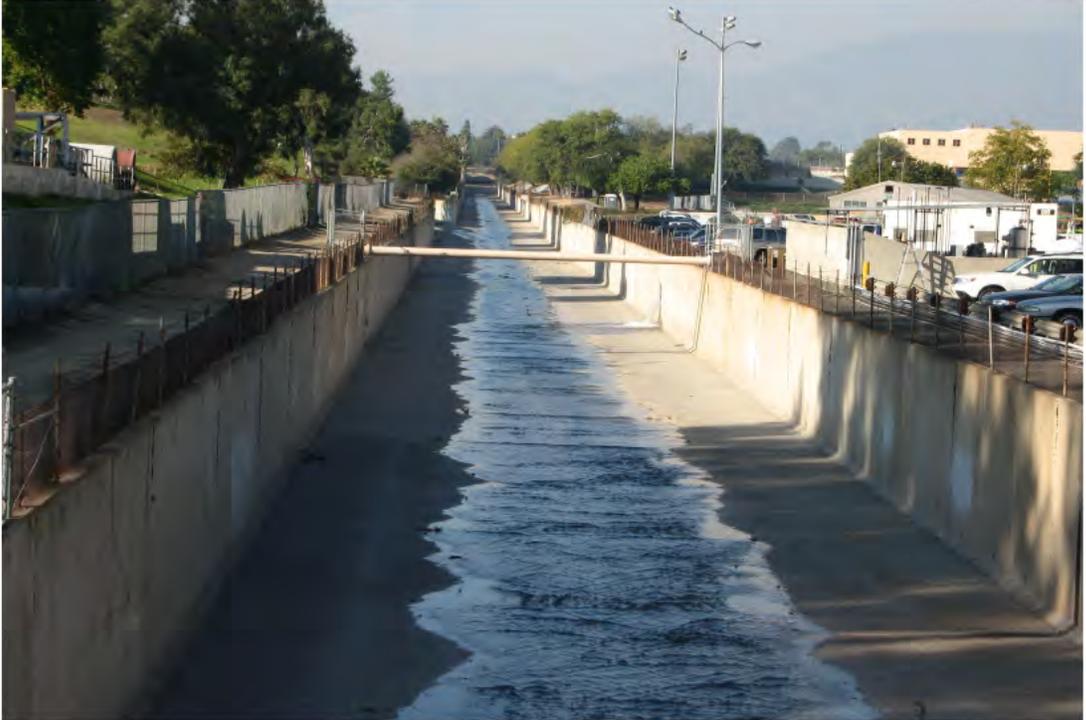
Time: 11:58am		Photo No. 2	
Direction Photo Taken: Downstream			
Ext. Surveyed: 1000 ft			
<p>Channel Characteristics: - Concrete bottom - Vertical box</p> <p>Water Characteristics: - Presence of flow - Presence of algae</p> <p>Field Team: RB: Ginachi Amah, Michael Morales, Thomas Siebels</p>

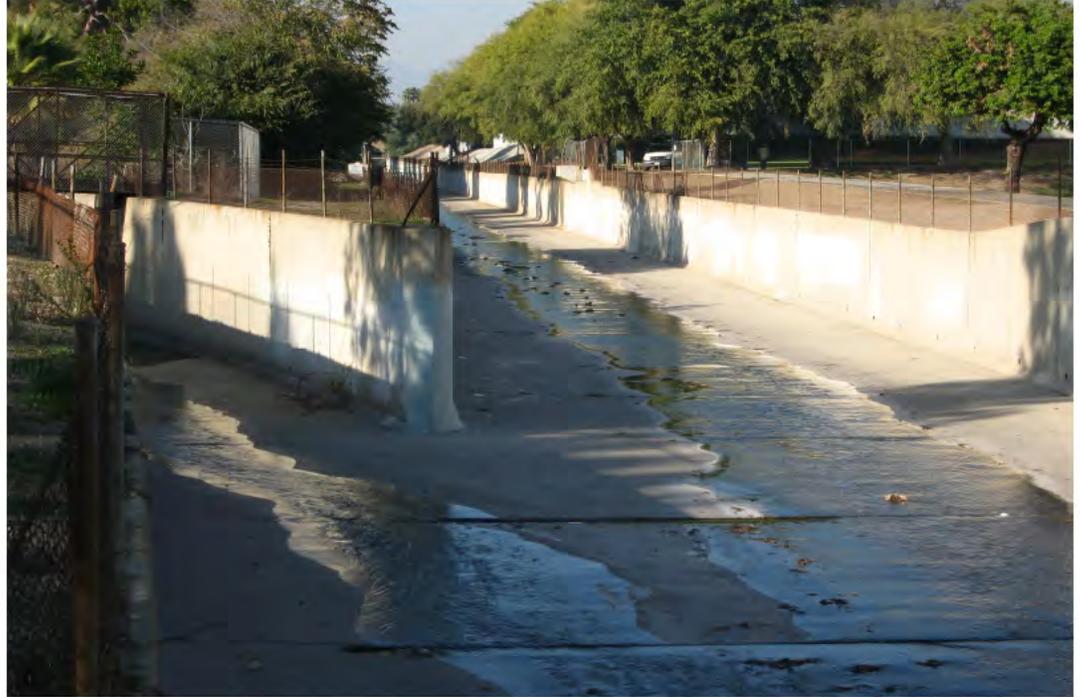
Photo No.
4

Direction Photo Taken:
Downstream @confluence with un-named channel

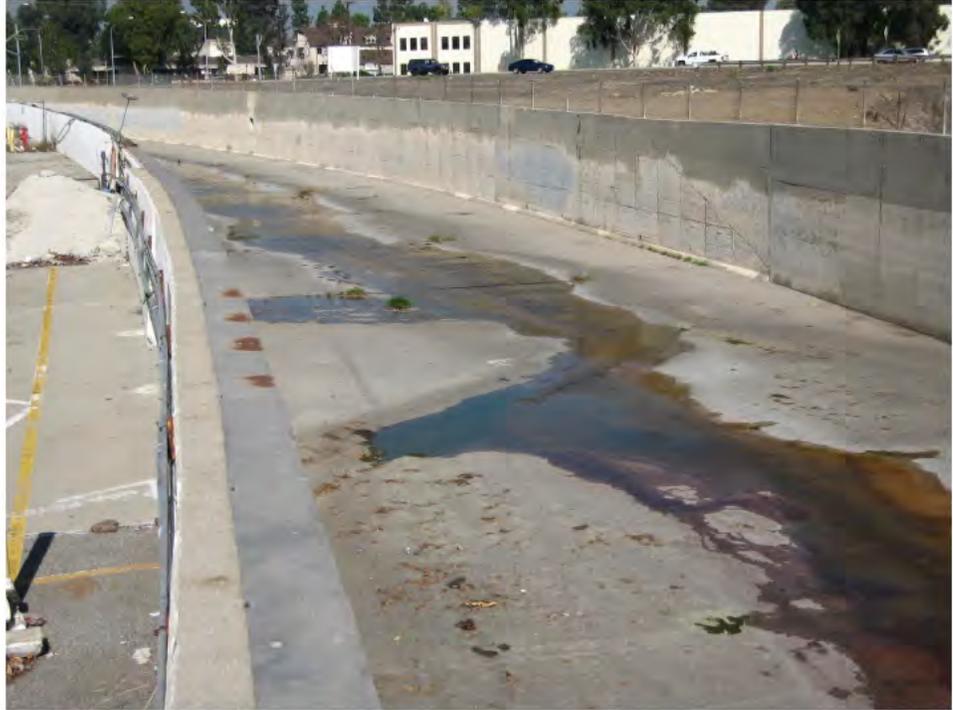
Time: 12:16pm		Photo No. 2	
Direction Photo Taken: Downstream toward confluence with Los Angeles River			
Other Signs of Access: Homeless Encampment			
Channel Characteristics: - Concrete bottom - Vertical box, but becomes trapezoidal @ confluence			
Water Characteristics: - Presence of flow			
Field Team: RB: Ginachi Amah, Michael Morales, Thomas Siebels

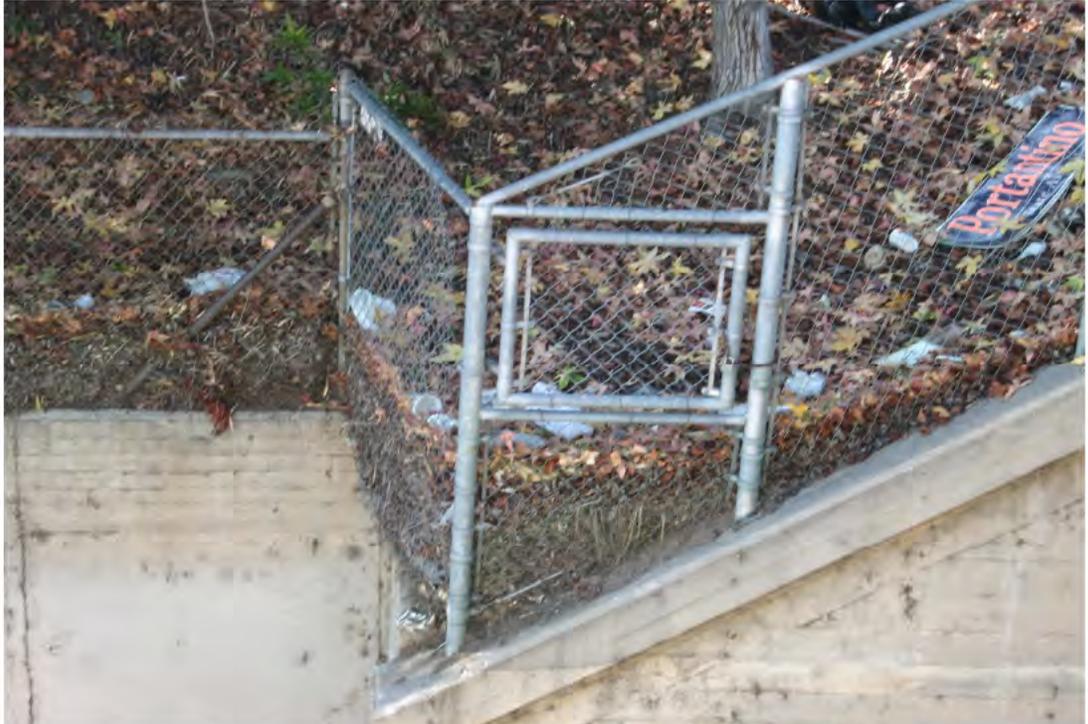
Time: 12:00pm	Photo No. 2

Direction Photo Taken:					
Other Signs of Access: None					
Channel Characteristics: - Concrete bottom - Vertical box					
Water Characteristics: - Presence of flow - Presence of algae - Presence of trash in-stream and surroundings					
Field Team: RB: Ginachi Amah, Michael Morales, Thomas Siebels

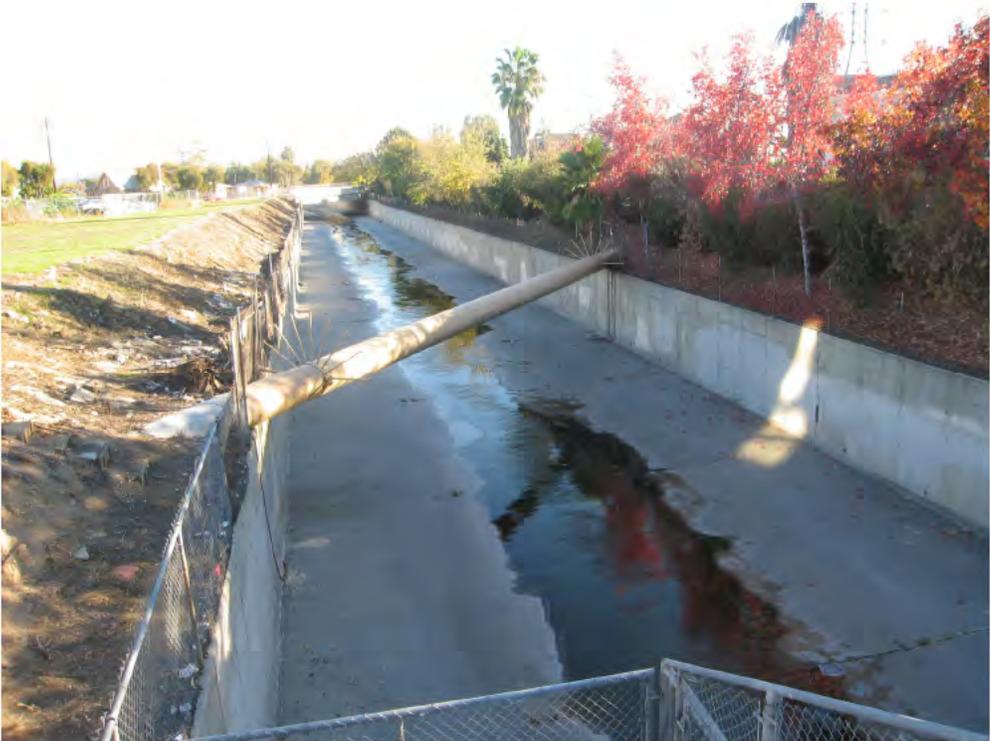
Direction Photo Taken: Downstream			
Mode of Access: Overpass			
Potential Access Points: Fenced (both sides of channel wall)			
Adj. Rec Facility: None			
Adj. Land Uses: Commercial			
Low Flow Channel: None			
Bike Path: Absent			
Ext. Surveyed: 300ft ↓			
Other Signs of Access: None

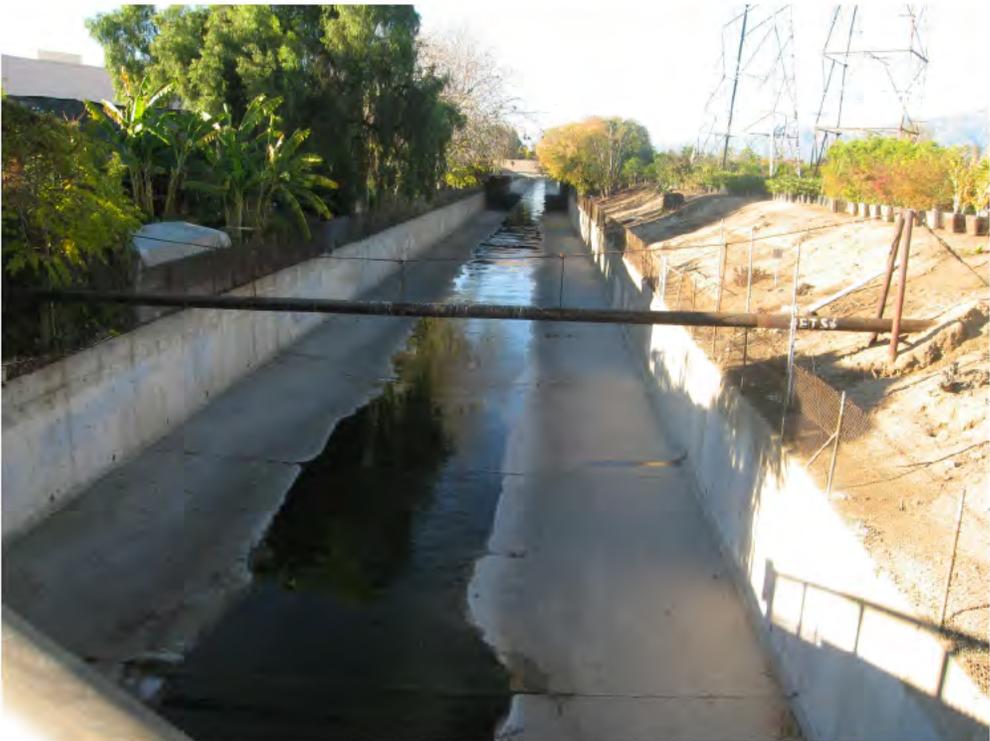
Time: 3:06pm		Photo No. 2

Direction Photo Taken: Upstream			
Channel Characteristics: - Concrete bottom, inverted channel bottom - Vertical box			
Water Characteristics: - Presence of flow - Presence of algae			
Other Signs of Access: None			
Field Team: RB Ginachi Amah, Michael Morales County: Emiko K. Innes, Elaine Kunitake, Ryan Romo

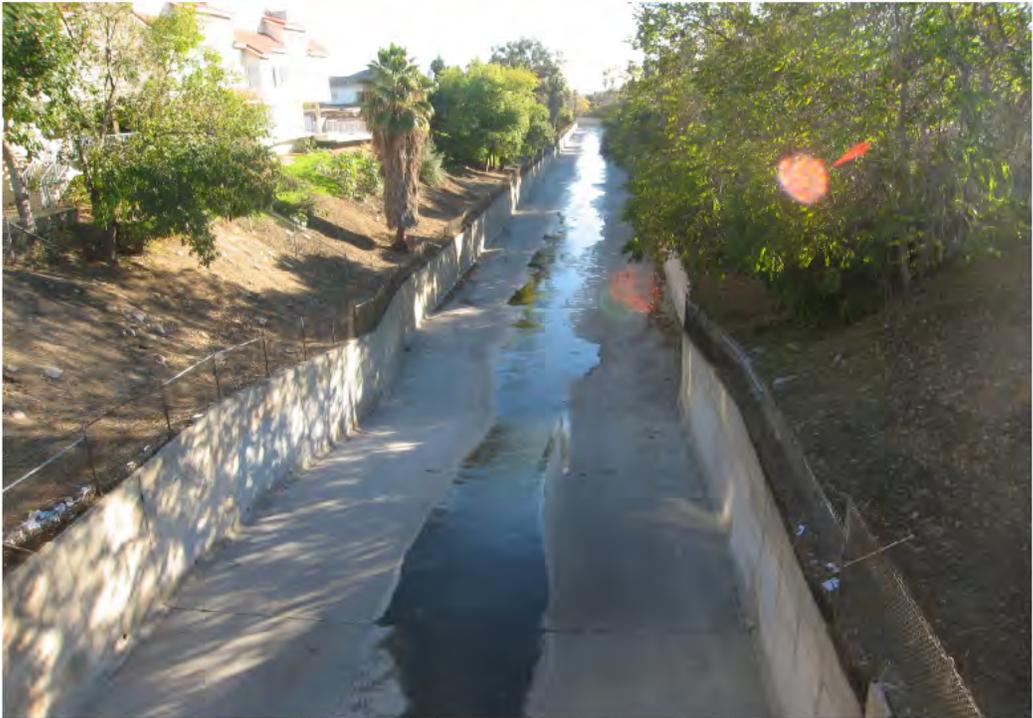
Time: 2:42pm		Photo No. 2

Direction Photo Taken: Upstream			
Channel Characteristics: - Concrete bottom, inverted channel bottom - Vertical box			
Water Characteristics: - Presence of flow - Presence of algae			
Other Signs of Access: None			
Field Team: RB: Ginachi Amah County: Emiko K. Innes, Elaine Kunitake, Ryan Romo

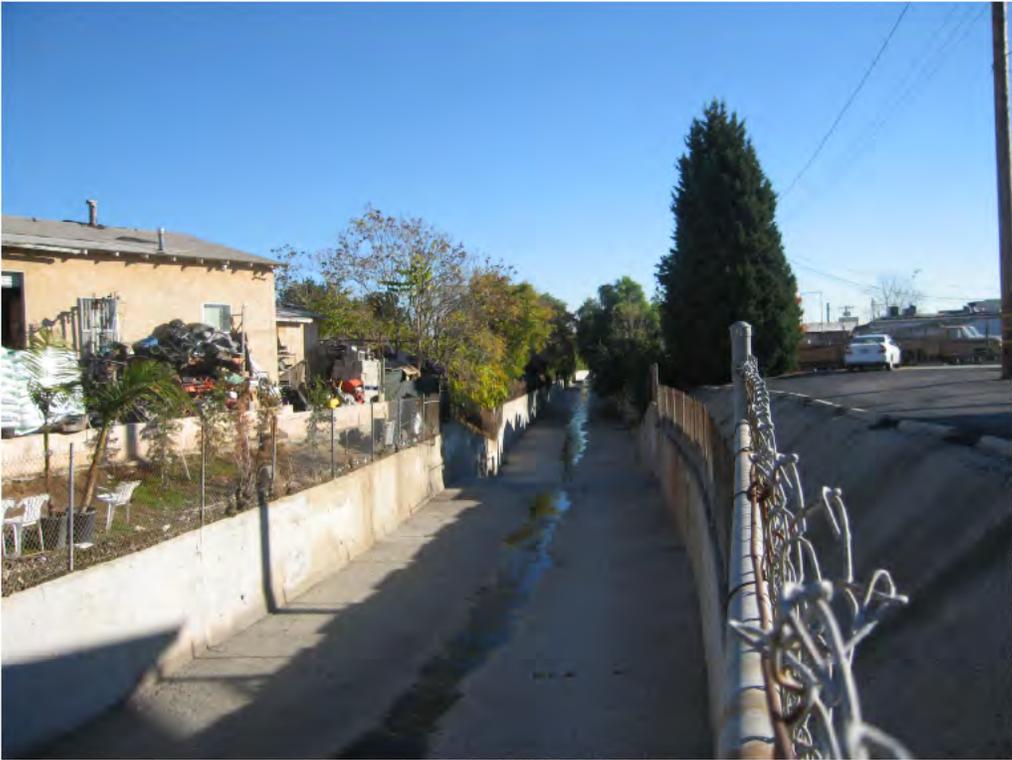
Time: 2:30pm	Photo No. 2
Direction Photo Taken: Upstream	
Channel Characteristics: - Concrete bottom - Vertical box, but sloped towards middle	
Water Characteristics: - Presence of flow - Presence of algae	
Team Members: RB: Ginachi Amah County: Emiko K. Innes, Elaine Kunitake, Ryan Romo

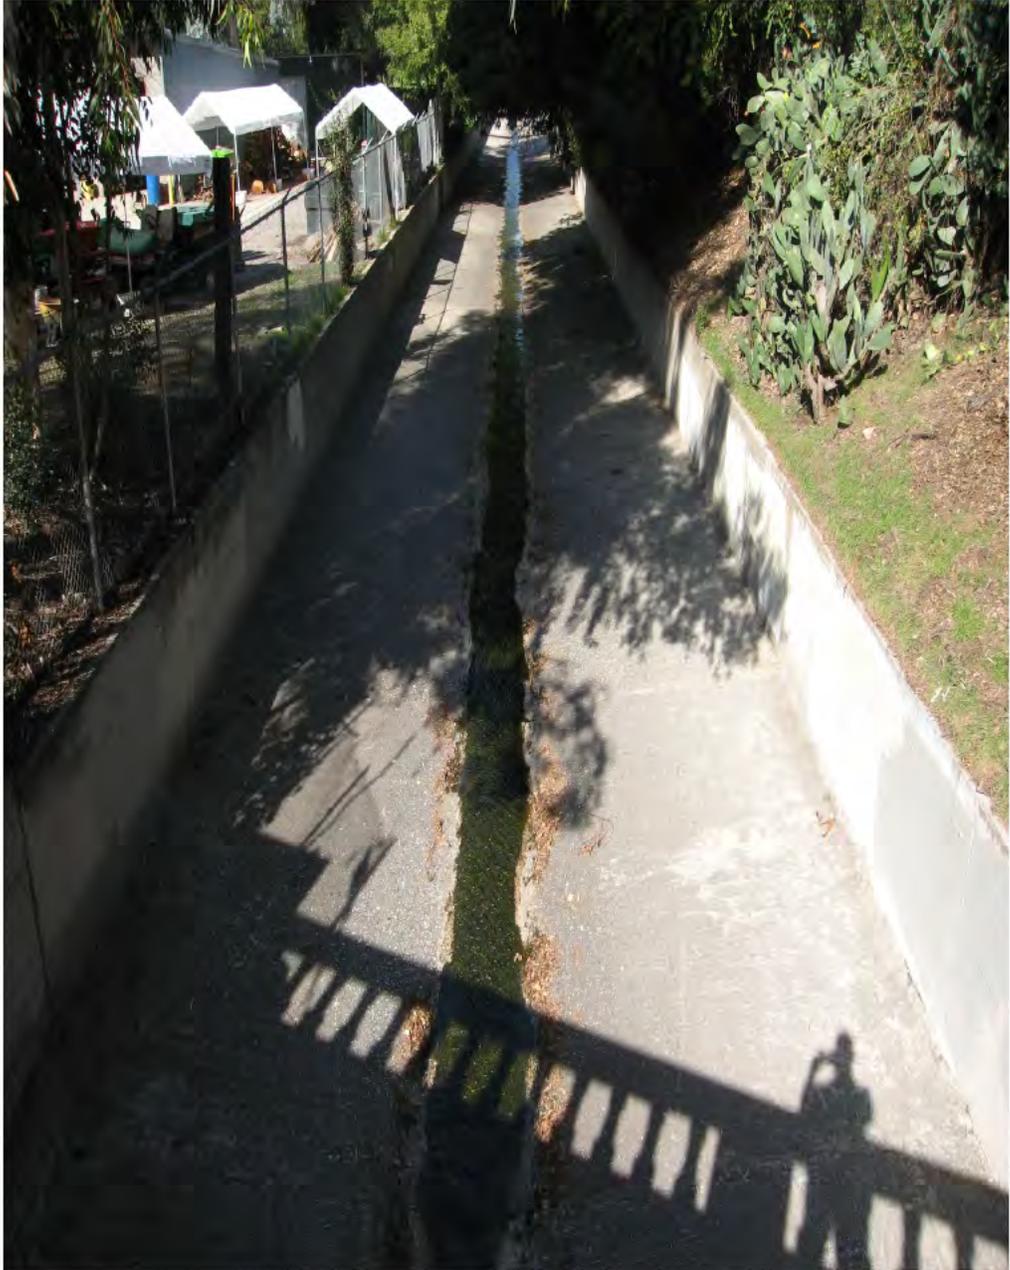
Direction Photo Taken: Upstream		
Mode of Access: Over Pass		
Potential Access Points: Gates (absent), fenced (both sides of channel wall)		
Adj. Rec Facility: Golf Course		
Adj. Land Uses: Residential		
Low Flow Channel: Present		
Bike Path: Absent		
Ext. Surveyed: 100 ft ↓ & ↑ approx. - At Las Tunas and California St Culvert		
Other Signs of Access: None		
Channel Characteristics: - Concrete bottom - Vertical box		
Water Characteristics: - Presence of flow - Presence of algae		
Additional Comments: - Channel bottom sloped towards center causing low flow		
Field Team: RB: Ginachi Amah, Michael Morales, Thomas Siebels

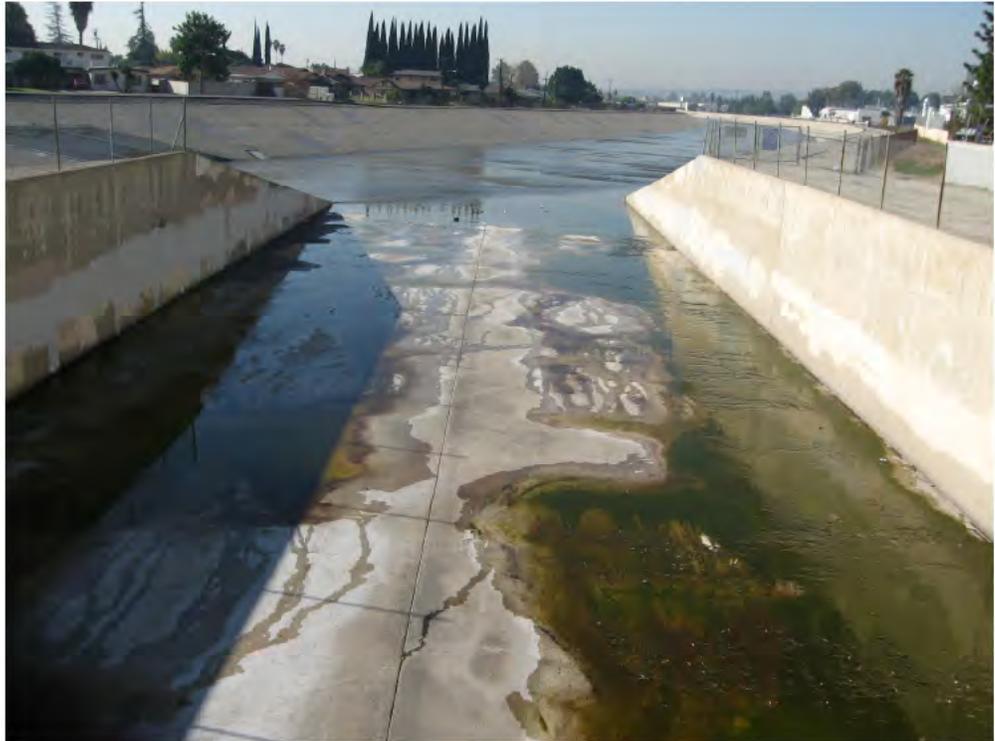
Time: 10:00am	Photo No. 2
Direction Photo Taken: at confluence with Los Angeles River –Eaton at left	
Ext. Surveyed: 300 ft	
Other Signs of Access: Trash. Covered patches, possible graffiti	
Channel Characteristics: - Concrete bottom - Vertical box	
Water Characteristics: - Presence of flow	
Field Team: RB: Ginachi Amah, Michael Morales, Thomas Siebels

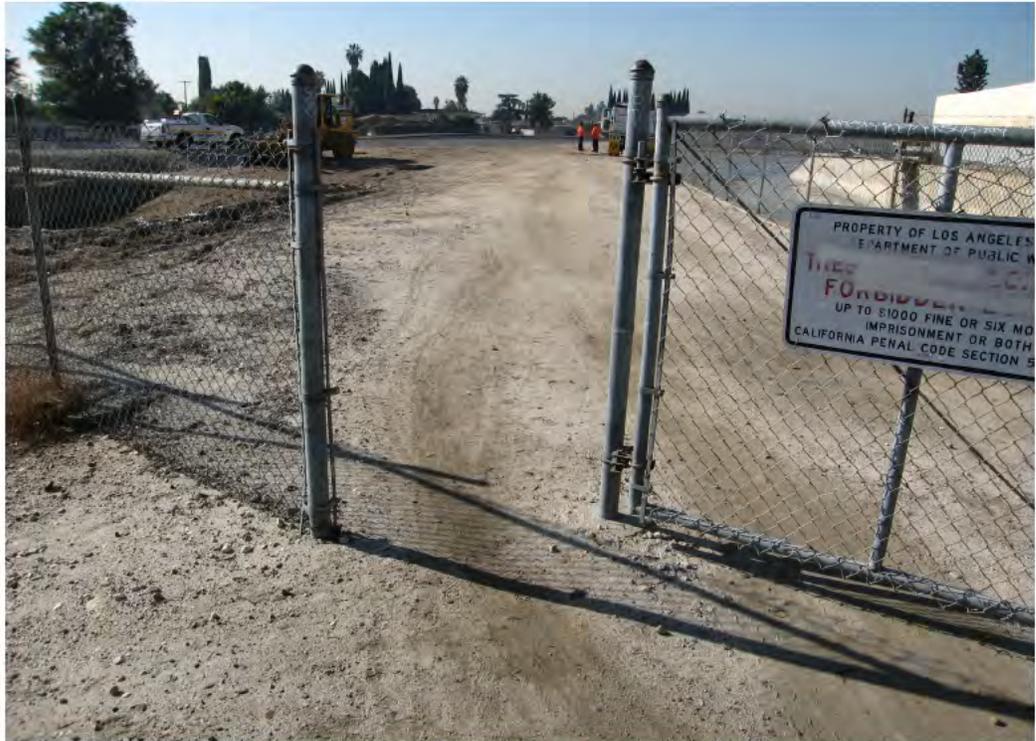
Photo No.
3

Direction Photo Taken: Break in fence

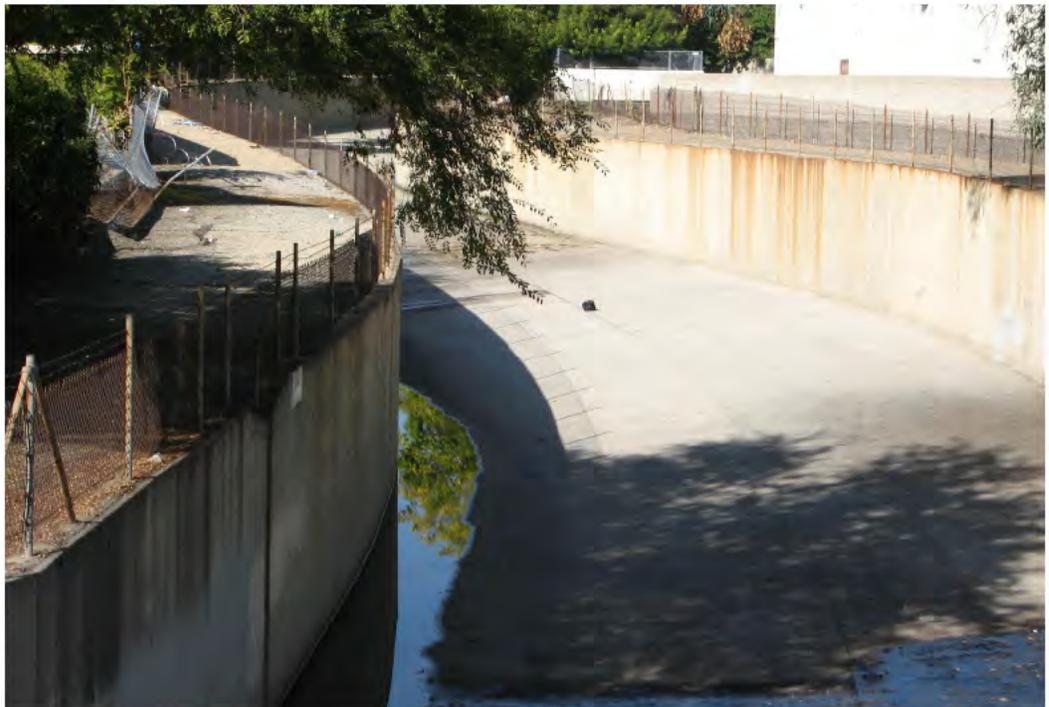
Photo No.
3

Direction Photo Taken:
Downstream – Furniture adjacent to fenced channel

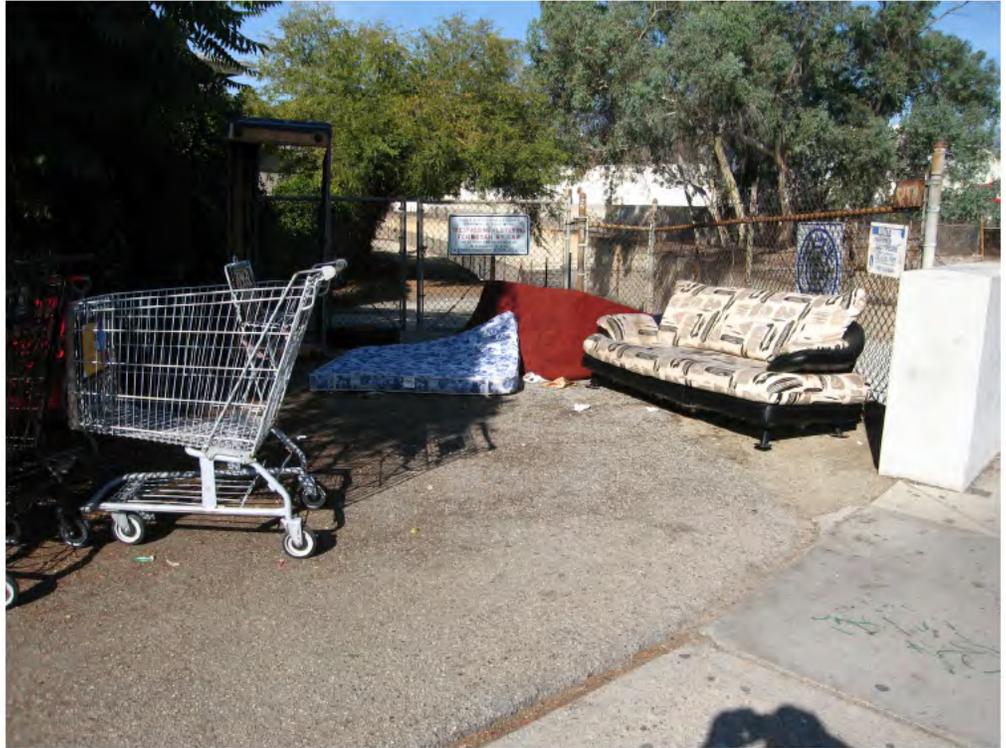
Photo No.
4

Direction Photo Taken:
Upstream -Trash

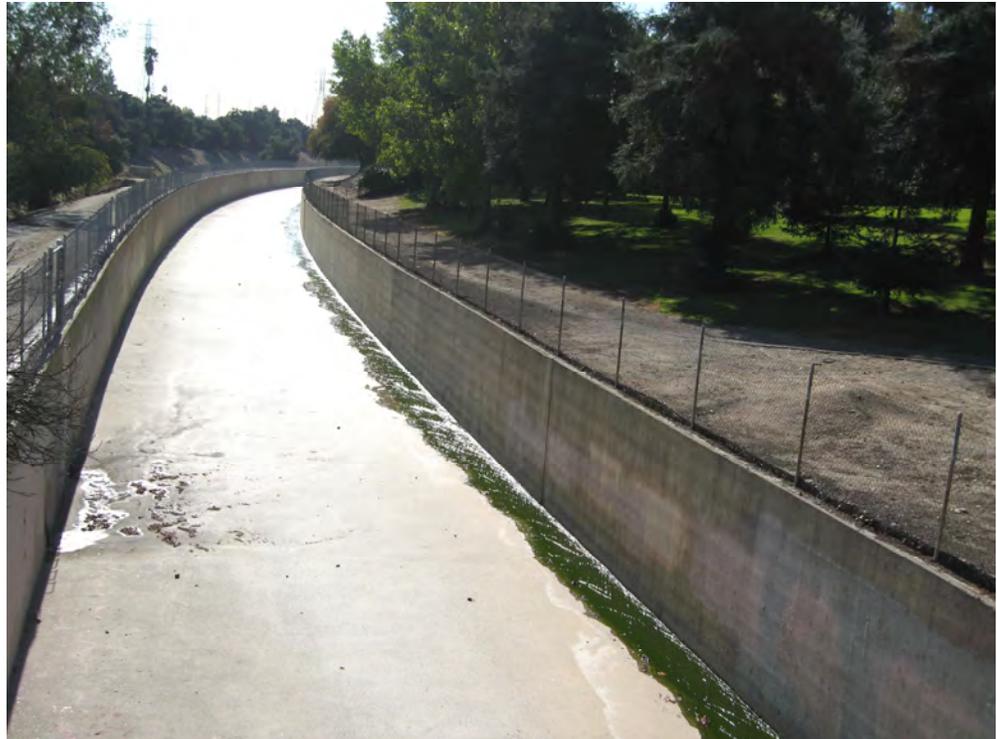
Time: 10:50am	Photo No. 2
Direction Photo Taken: Upstream	
Other Signs of Access: Covered Graffiti	
Channel Characteristics: - Concrete bottom - Vertical box	
Water Characteristics: - Presence of flow - Presence of algae	
Field Team: RB: Ginachi Amah, Michael Morales, Thomas Siebels

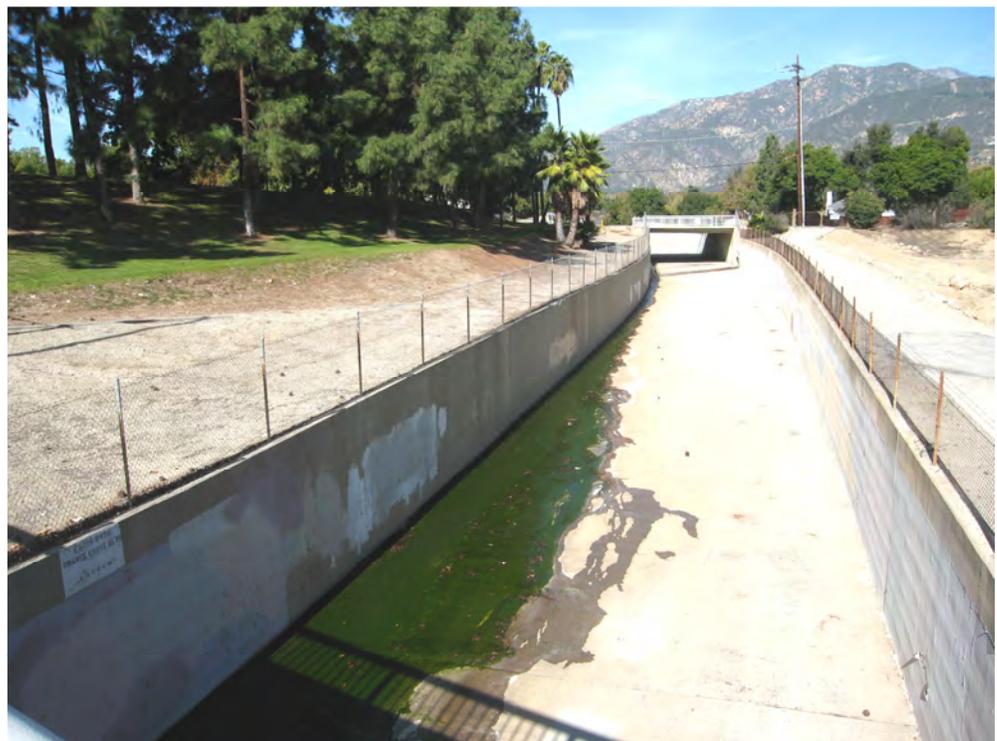
Date: 11/18/2010		Latitude/Longitude: 34° 10' 3.97' / 118° 5' 35.58'		Cross Streets: (TG: 566-F1) E Washington Blvd/ Woodlyn Rd	
Time: 11:10am	Photo No. 1				
Direction Photo Taken: Downstream					
<p>Mode of Access: Gates (Secured) LACDPW Maint Yard</p> <p>Potential Access Points: Gates, Maintenance Ramp, fenced (both sides of channel wall)</p> <p>Adj. Rec Facility: None</p> <p>Adj. Land Uses: LADPW maintenance yard/ Public Facility</p> <p>Bike Path: Absent</p> <p>Ext. Surveyed: 1000 ft</p>

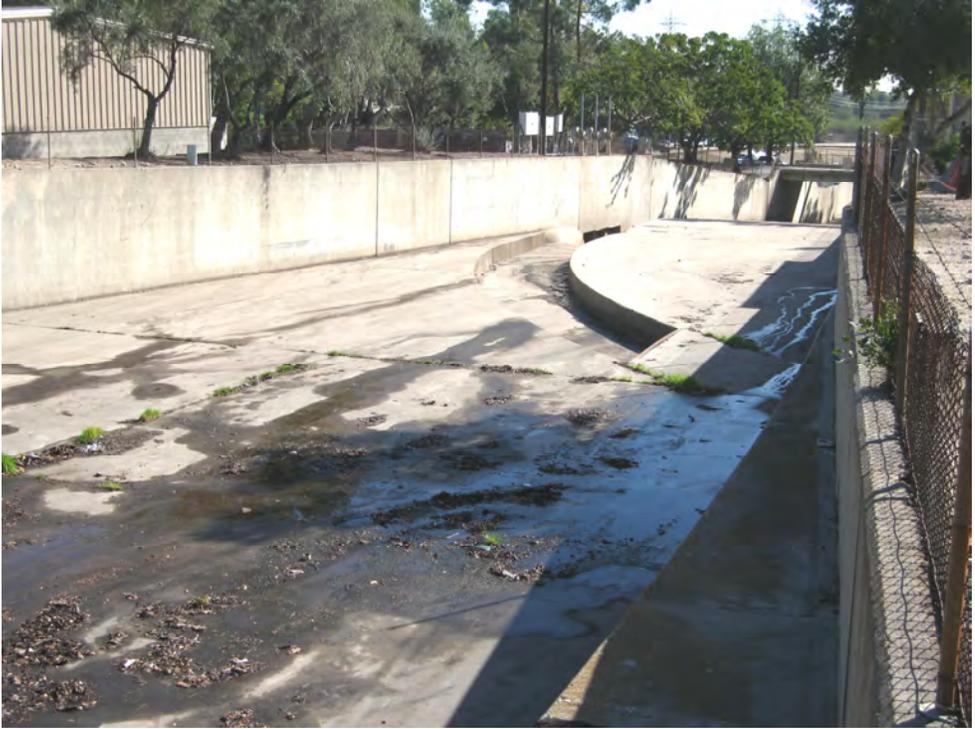
Time: 11:10am		Photo No. 2			
Direction Photo Taken: Upstream					
<p>Low Flow Channel: No</p> <p>Other Signs of Access: None</p> <p>Channel Characteristics: - Concrete bottom - Vertical box (low walls split downstream)</p> <p>Water Characteristics: - Dry at dam and wetted bottom channel downstream</p> <p>Field Team: RB: Ginachi Amah, Michael Morales, Thomas Siebels</p> <p>Also on 12/7/2010 with Field Team: RB: Ginachi Amah County: Emiko K. Innes, Elaine Kunitake, Ryan Romo</p>

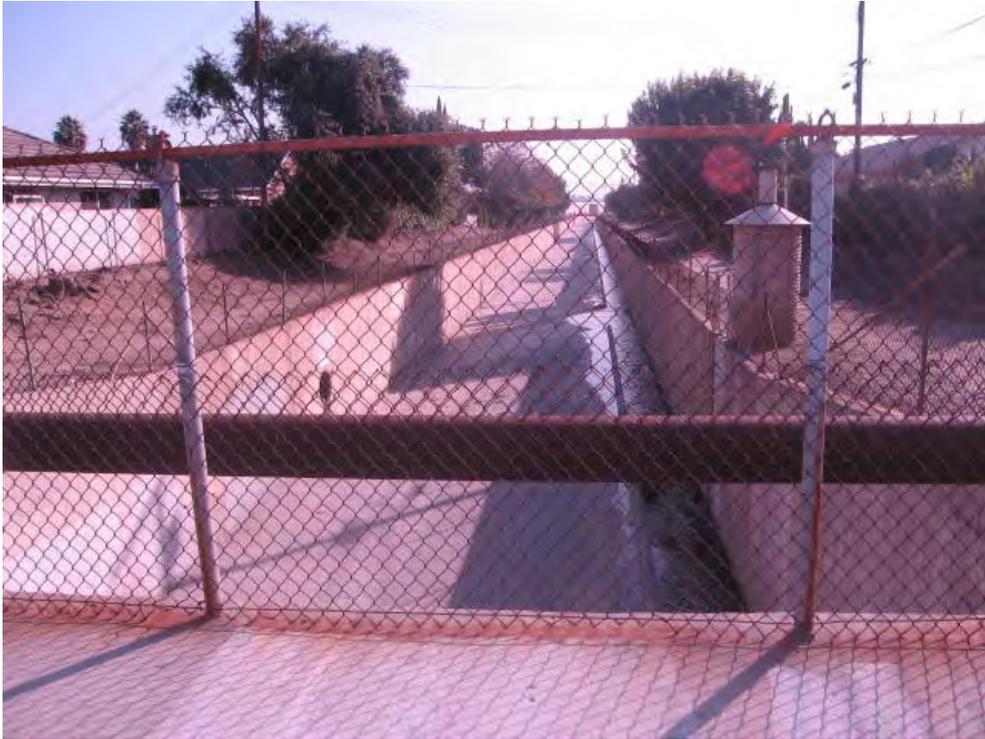
Direction Photo Taken: Downstream					
Mode of Access: Over Bridge					
Potential Access Points: Maintenance Ramp, Gates (secured), fenced (both sides of channel wall)					
Adj. Rec Facility: None					
Adj. Land Uses: Residential					
Low Flow Channel: Yes					
Bike Path: Absent					
Ext. Surveyed: 400ft ↓1000ft ↑					
Time: 1:44pm	Photo No. 2

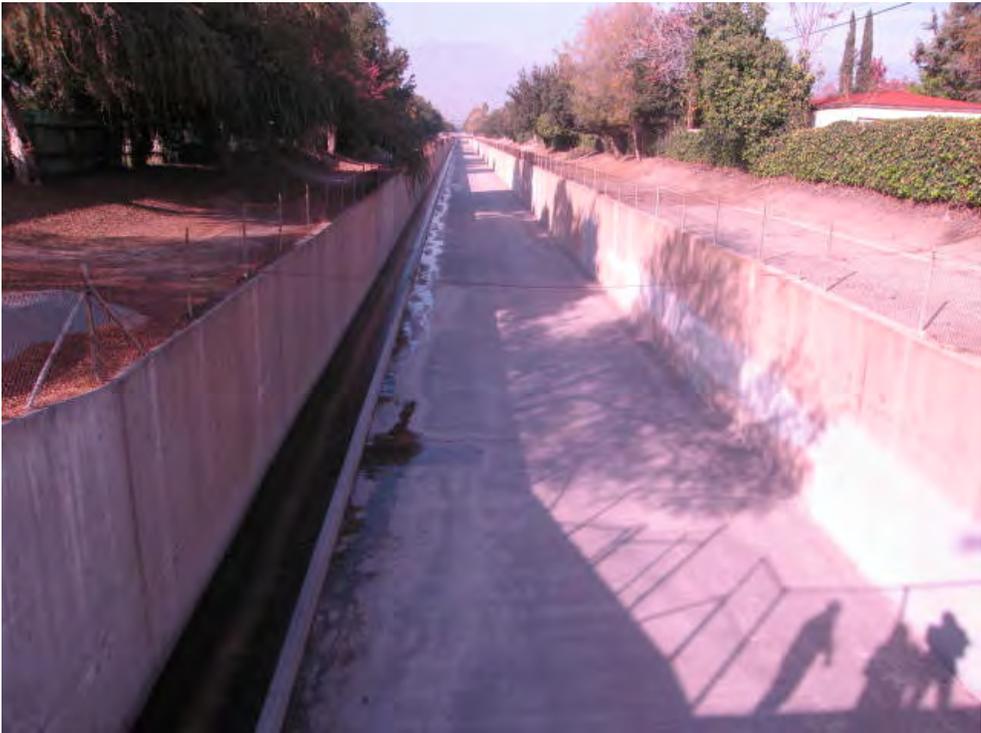
Direction Photo Taken: Upstream					
Other Signs of Access: None					
Channel Characteristics: - Concrete bottom - Vertical box					
Water Characteristics: - Presence of flow					
Field Team: RB: Ginachi Amah, Michael Morales, County: Emiko K. Innes, Ryan Romo, Geremew Amenu, Dan Sharp

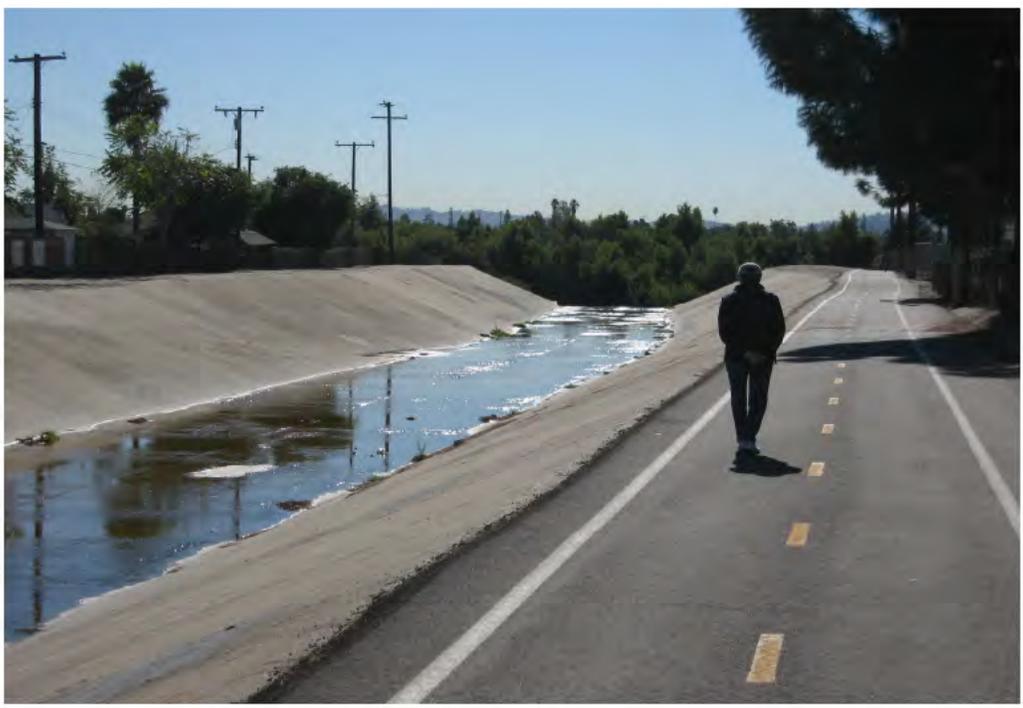
Direction Photo Taken:
Downstream – no fencing between bike path and channel

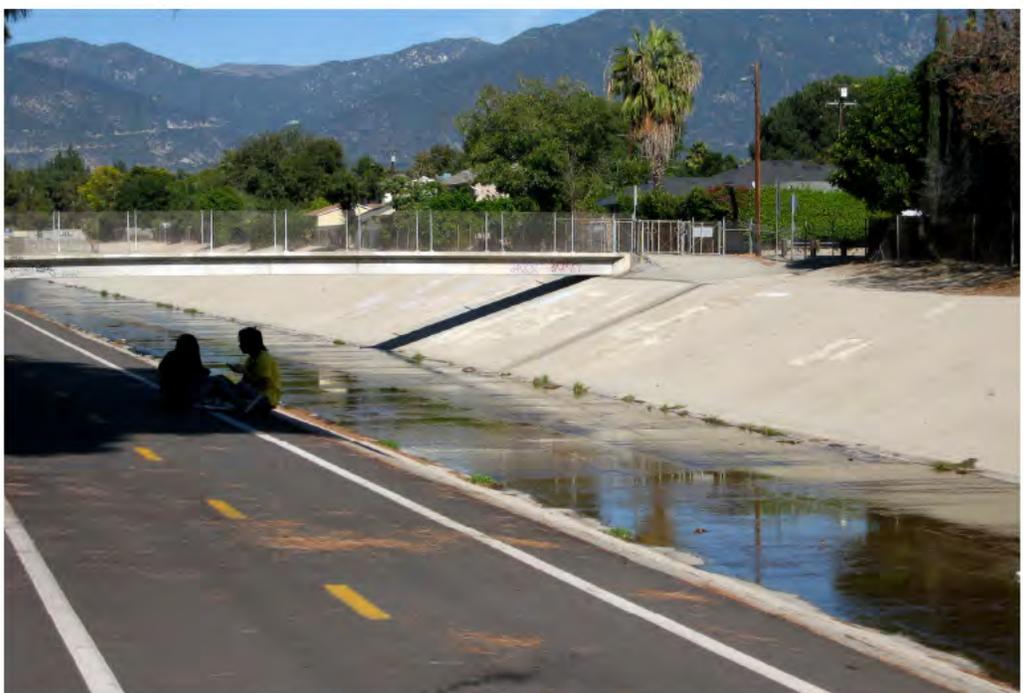
Other Signs of Access:
Trash, plastic bottles, etc.

Channel Characteristics:
- Concrete bottom
- Trapezoidal bank slopes
Transitions to vertical walls shortly after pedestrian over pass.

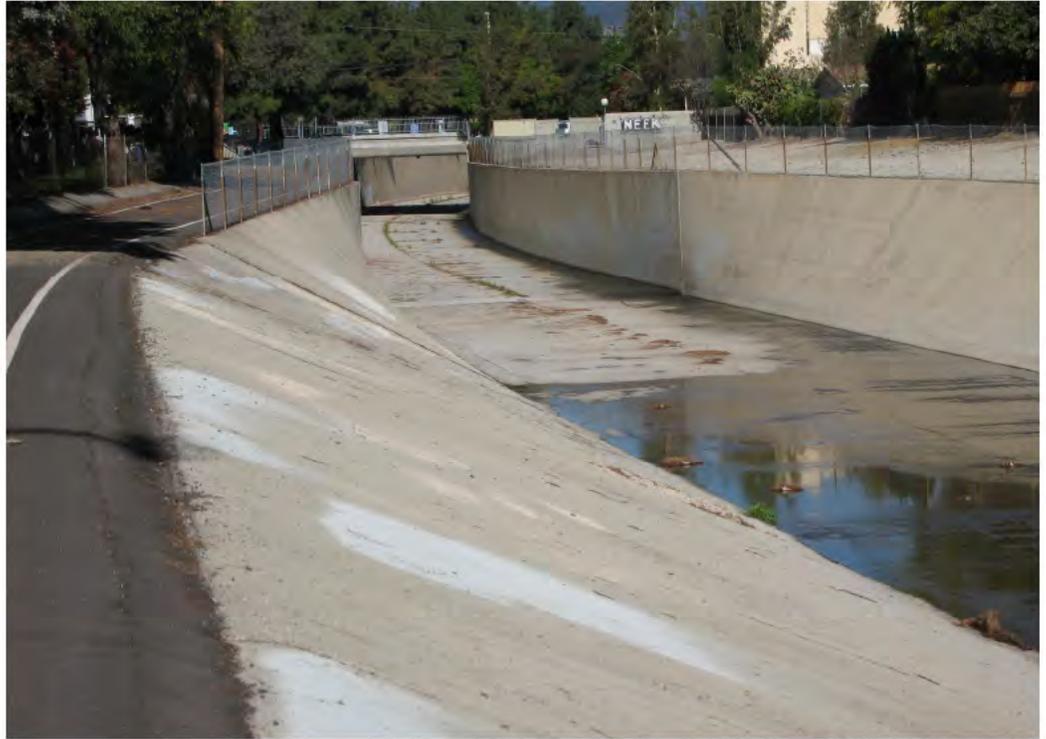
Other Signs of Access:
Trash, plastic bottles, etc.

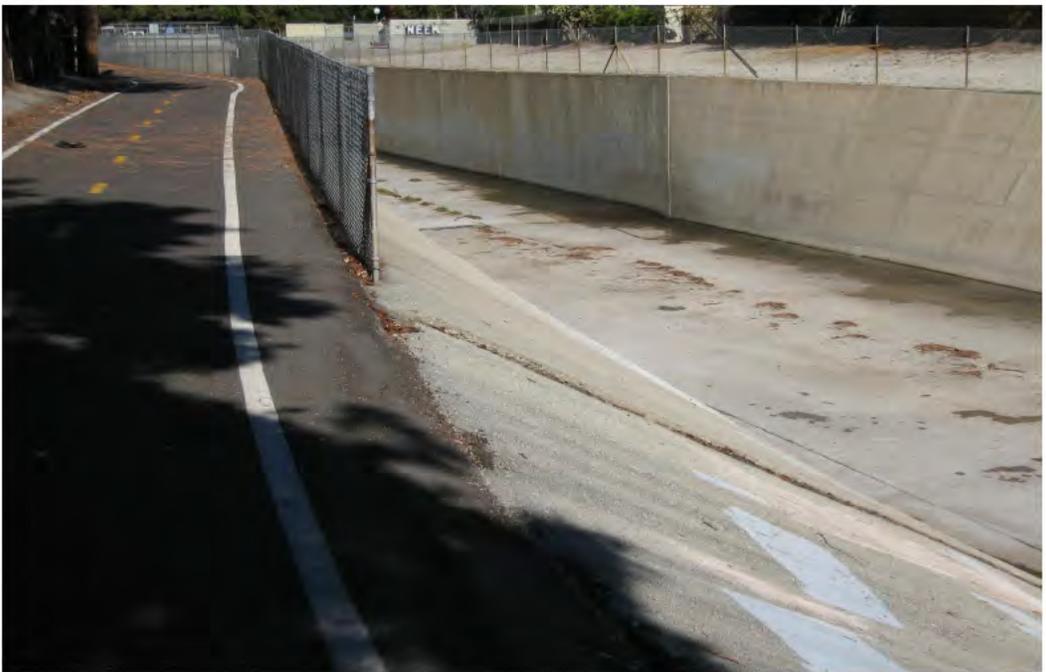
Channel Characteristics:
- Transition to vertical channel (U/S)
- Concrete bottom

Water Characteristics:
- Absence of flow
- Presence of algae

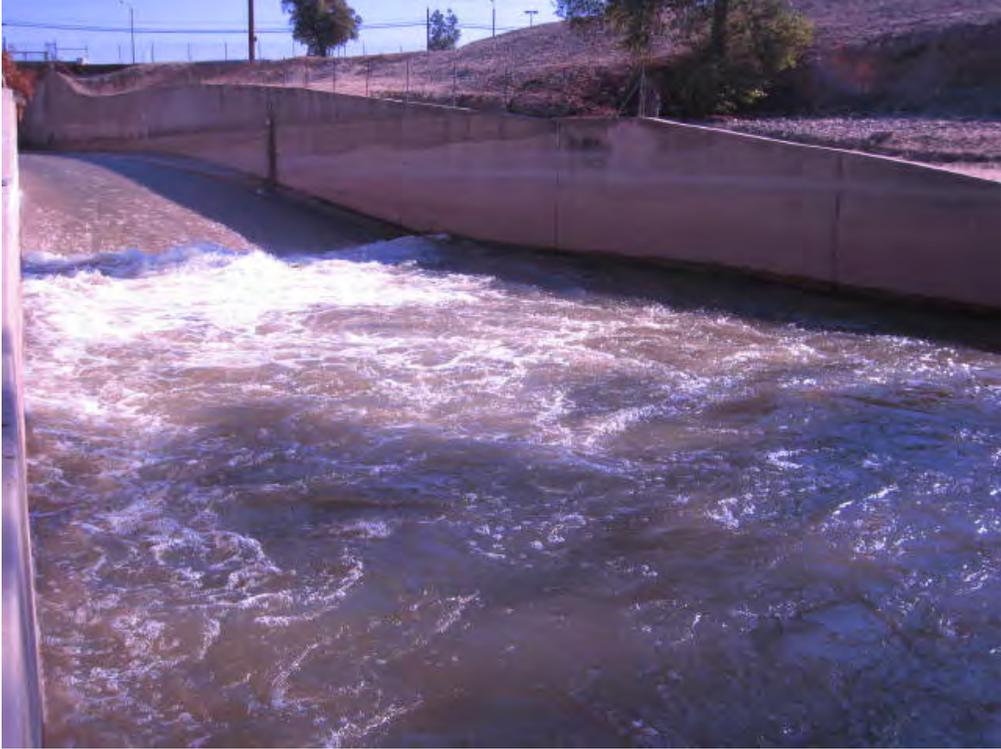
Date: 11/16/2010		Latitude/Longitude: 34° 6' 20.31' / 118° 0' 30.45'		Cross Streets: (TG 597-H1) Peck Road & Foothill Transit Driveway	
Time: 10:30am	Photo No. 1				
Direction Photo Taken: Upstream					
Mode of Access: Unsecured Gate					
Potential Access Points: Gates (unsecured), Break in Fence.					
Adj. Rec Facility: Peck Road Park Lake					
Adj. Land Uses: Industrial					
Low Flow Channel: None					
Bike Path: Absent					
Ext. Surveyed: 100 Ft					
Other Signs of Access: Trash Present
