RECREATIONAL USE RE-EVALUATION OF THE ENGINEERED CHANNELS OF THE LOS ANGELES RIVER WATERSHED

**FIELD RECONNAISSANCE REPORT
NOVEMBER 2010- MARCH 2011**

**LOS ANGELES REGIONAL WATER QUALITY CONTROL BOARD
MARCH, 2011**

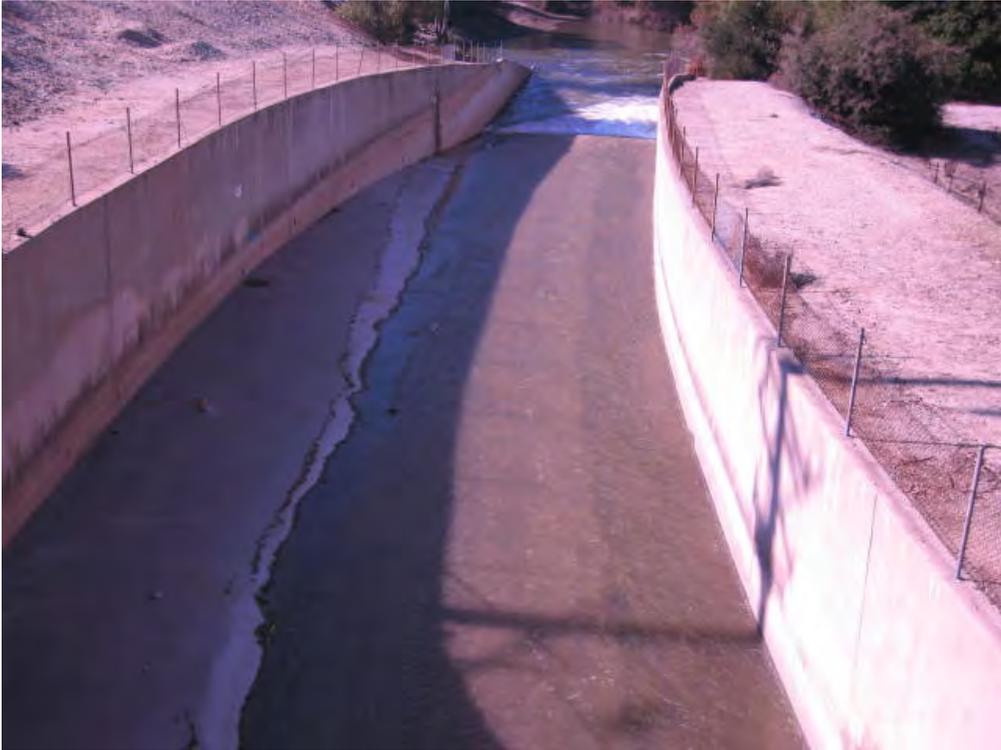
Time: 10:30am		Photo No. 2			
Direction Photo Taken: Downstream towards confluence					
Other Signs of Access: Trash Present					
Channel Characteristics: - Concrete bottom - Vertical box					
Water Characteristics: - Presence of turbulent flow - Presence of algae					
Field Team: RB: Ginachi Amah, Michael Morales, Thomas Siebels

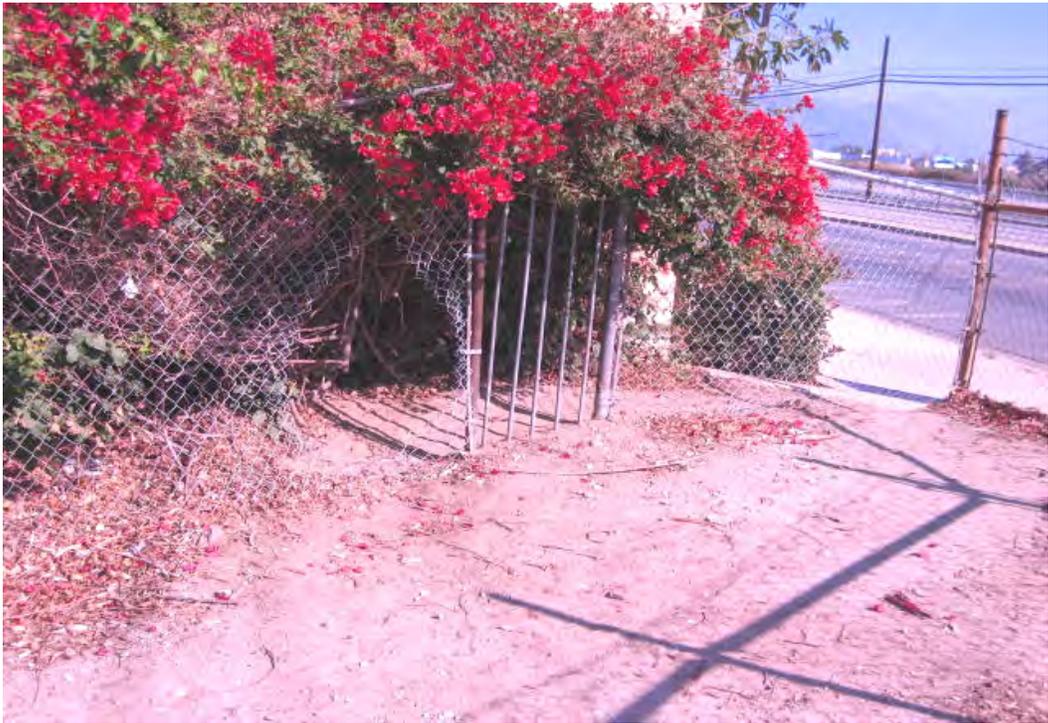
Direction Photo Taken: Break in fence		
<i>*** Creek details refer to preceding page</i>

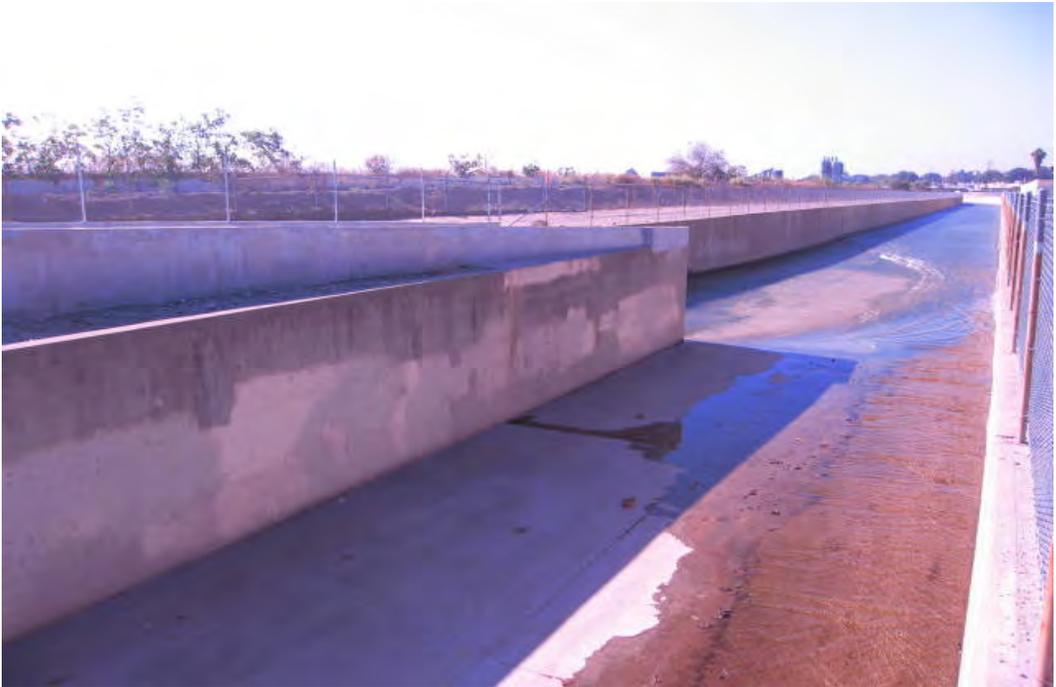
Direction Photo Taken: Downstream		
Other Signs of Access: Graffiti		
Channel Characteristics: - Concrete bottom - Vertical box		
Water Characteristics: - Low flow at edges upstream of splits		
Field Team: RB: Ginachi Amah, Michael Morales, Thomas Siebels

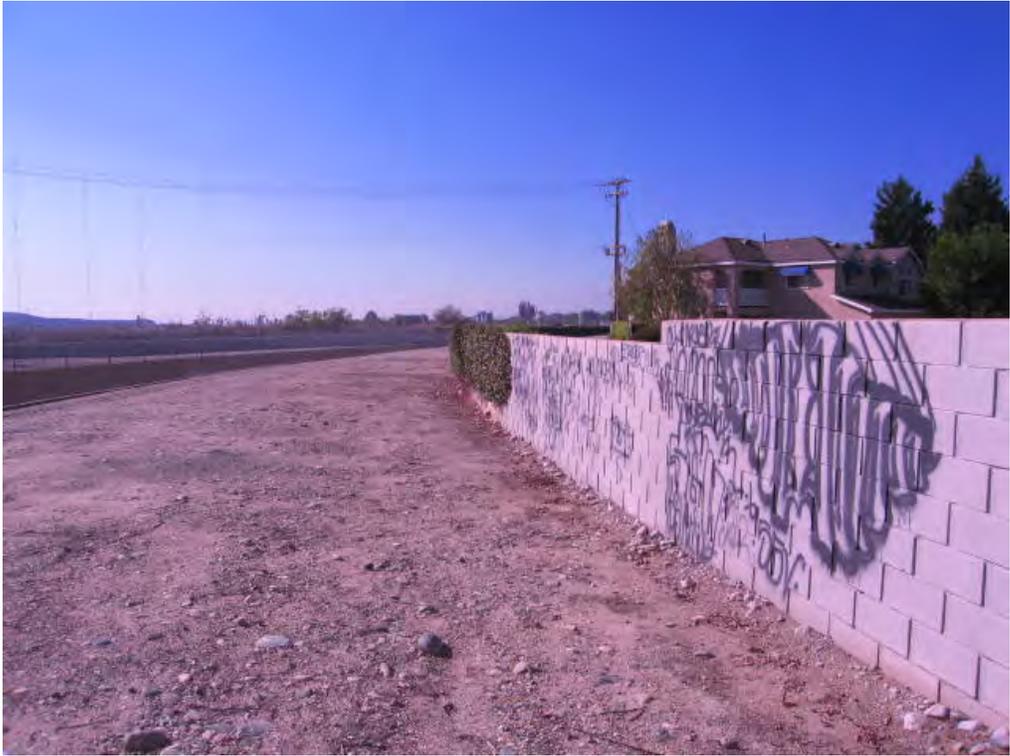
Direction Photo Taken: Graffiti on walls of maintenance ramp			
<i>** Creek details refer to preceding page</i>

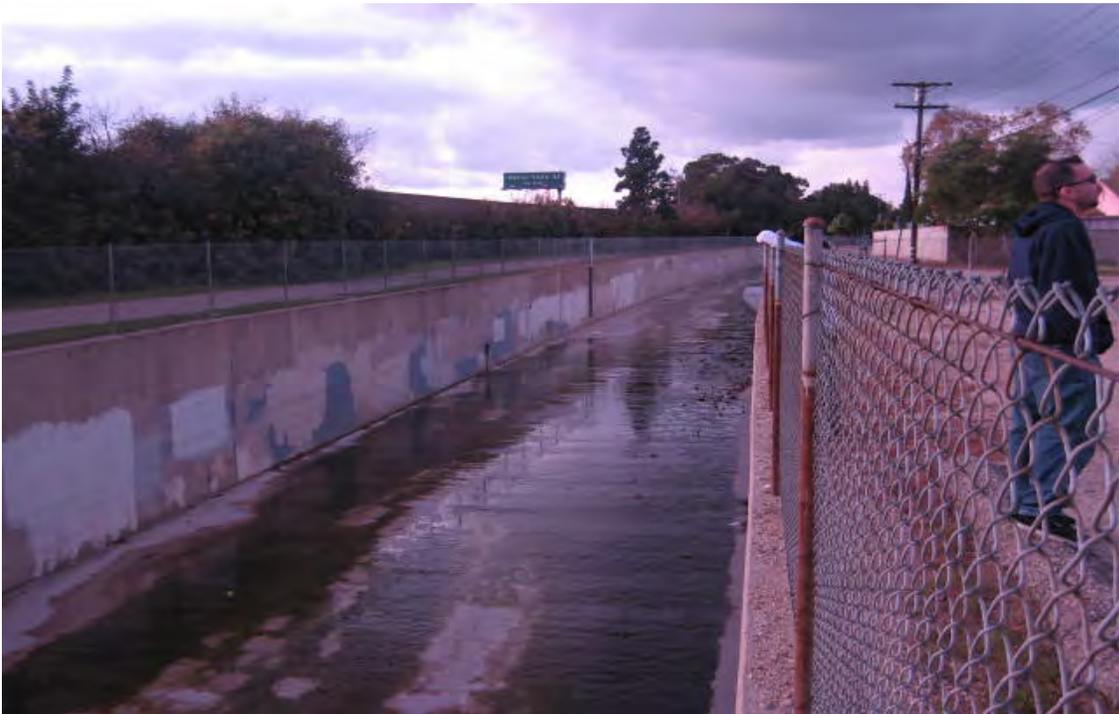
Direction Photo Taken: Downstream		
Mode of Access: Bike path		
Potential Access Points: Maintenance Ramp, Gates (secured), fenced (both sides of channel wall)		
Adj. Rec Facility: None		
Adj. Land Uses: Residential, Transportation		
Low Flow Channel: None		
Bike Path: Present		
Other Signs of Access: Painted-over graffiti		
Time: 3:07pm	Photo No. 2

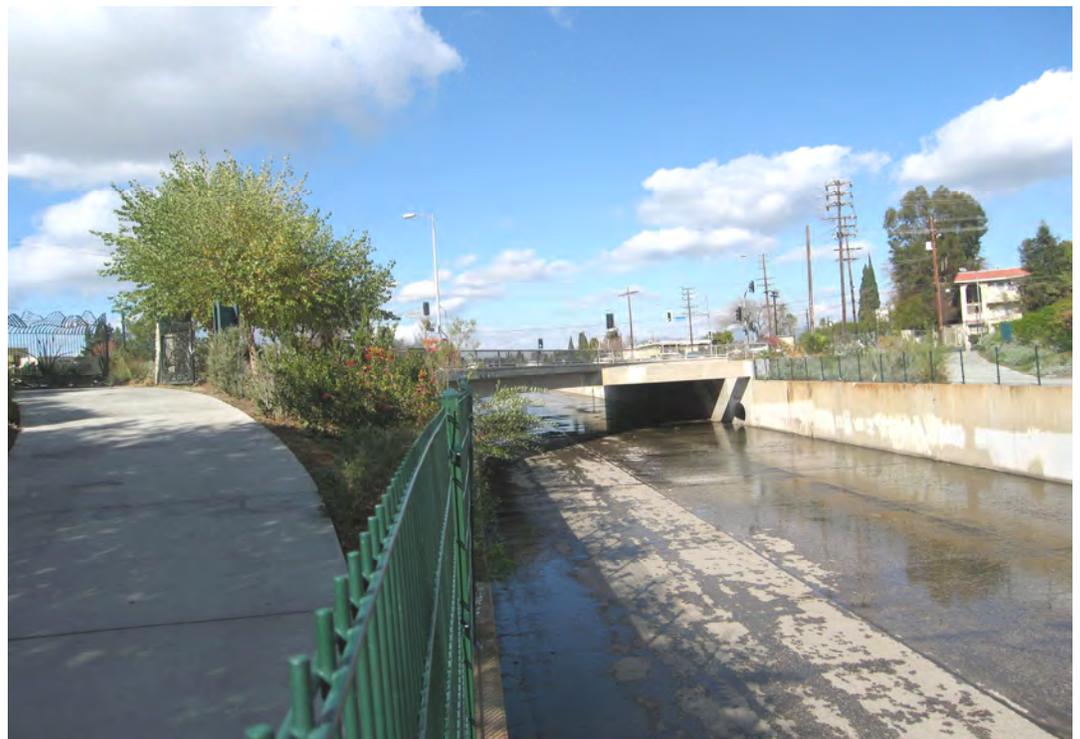
Time: 11:54am	Photo No. 2
Direction Photo Taken: Upstream	
Other Signs of Access: Covered up graffiti	
Channel Characteristics: - Concrete bottom - Vertical box	
Water Characteristics: - Presence of flow	
Field Team: RB: Ginachi Amah, Michael Morales County: Emiko K. Innes, Kenneth Rickard, Richard Gomez	
Additional Comments: Greenway is 1 mile long; clove adjacent to great mural of the Los Angeles. Burbank Blvd. / Coldwater Ave

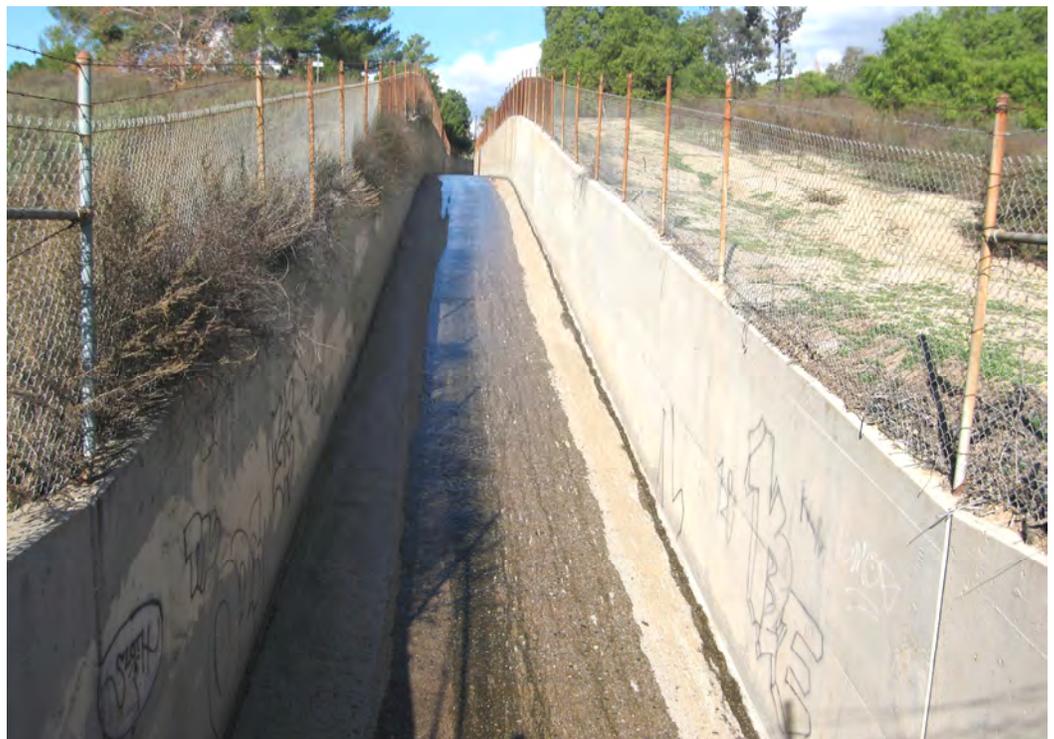
Other Signs of Access:
Graffiti on channel walls

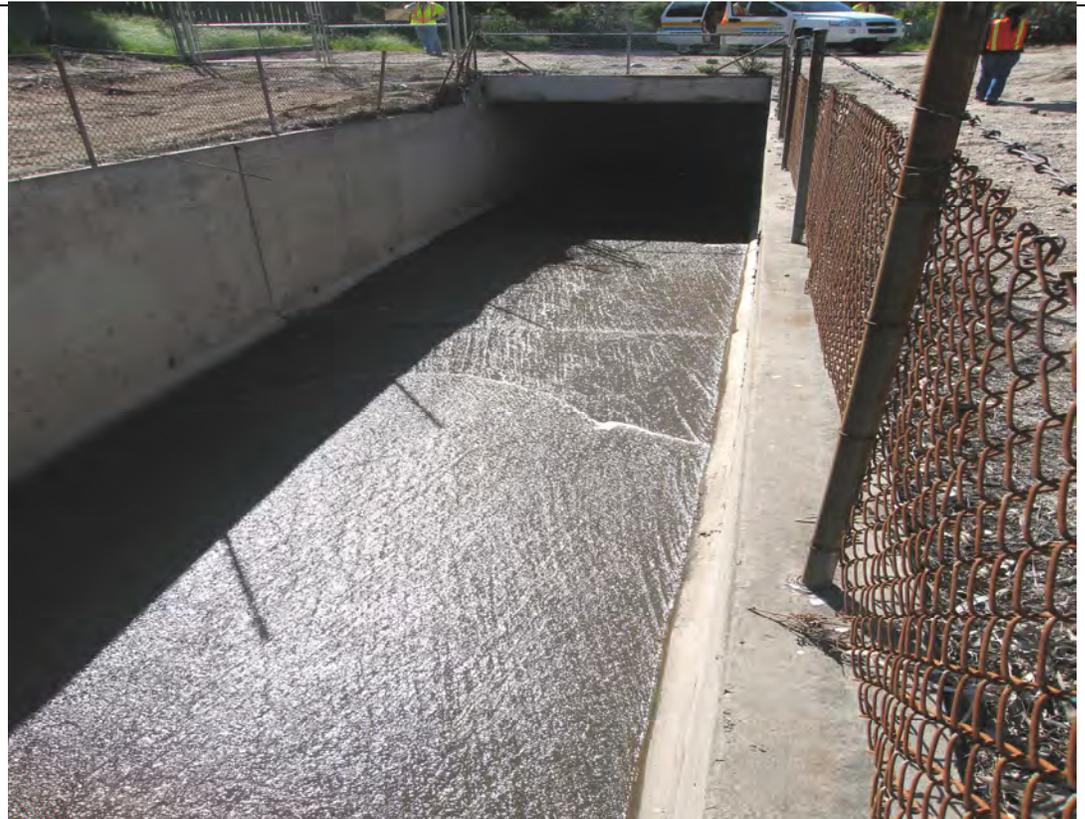
Additional Comments:
Channel goes underground downstream

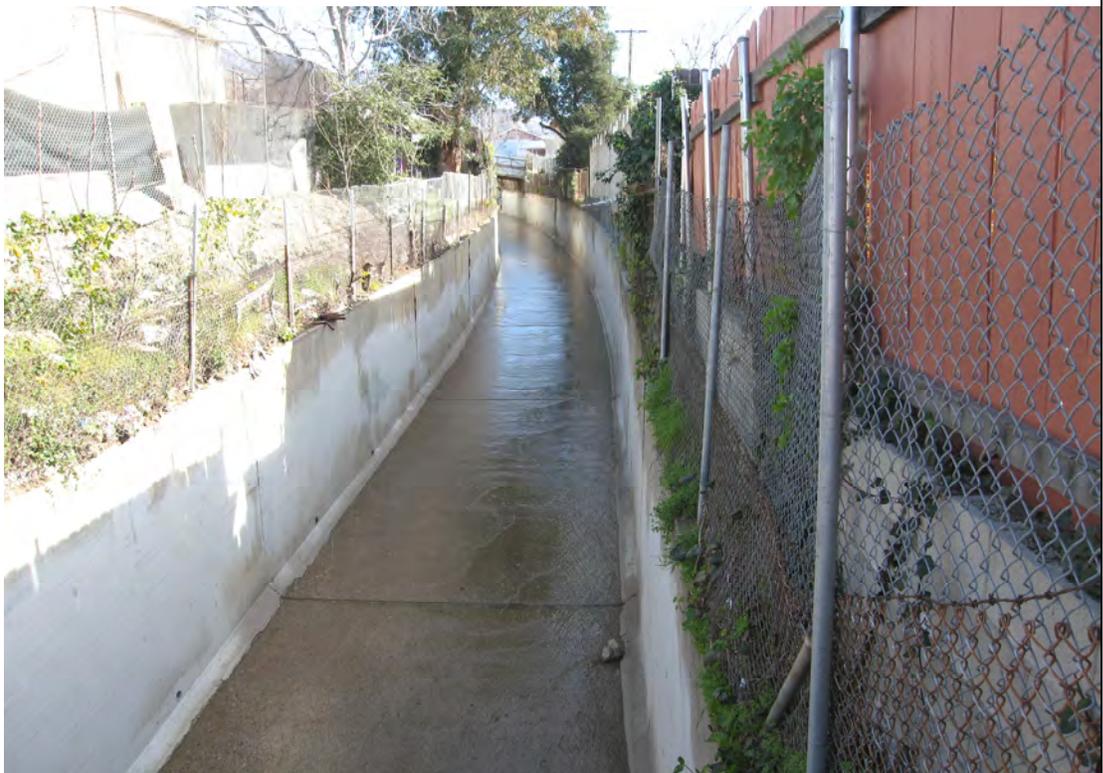
Time: 10:52 am	Photo No. 2
Direction Photo Taken: Upstream	
Low Flow Channel: Absent	
Other Signs of Access: None	
Channel Characteristics: - Concrete bottom - Vertical box	
Water Characteristics: -Presence of flow -Presence of trash	
Field Team: RB: Ginachi Amah, Shruthi Bala County: Emiko Innes, Geremew Amenu, Chien-Hao Chen

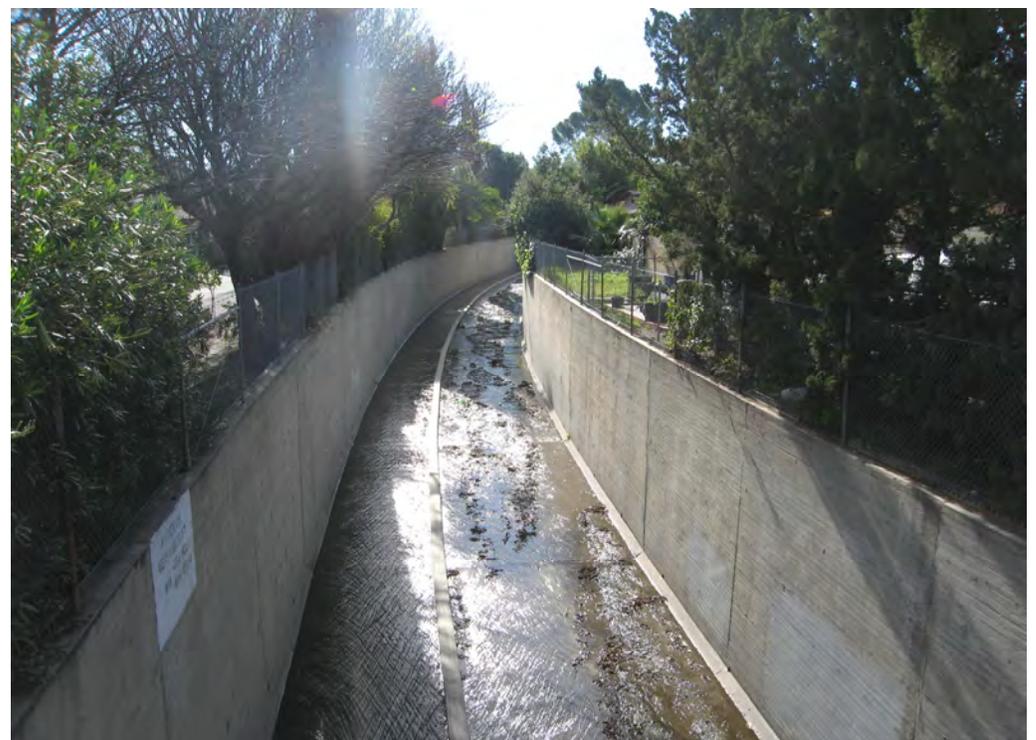
Water Characteristics:
- Presence of flow in both low flow and channel
- Presence of Trash especially large and small pieces of trash.

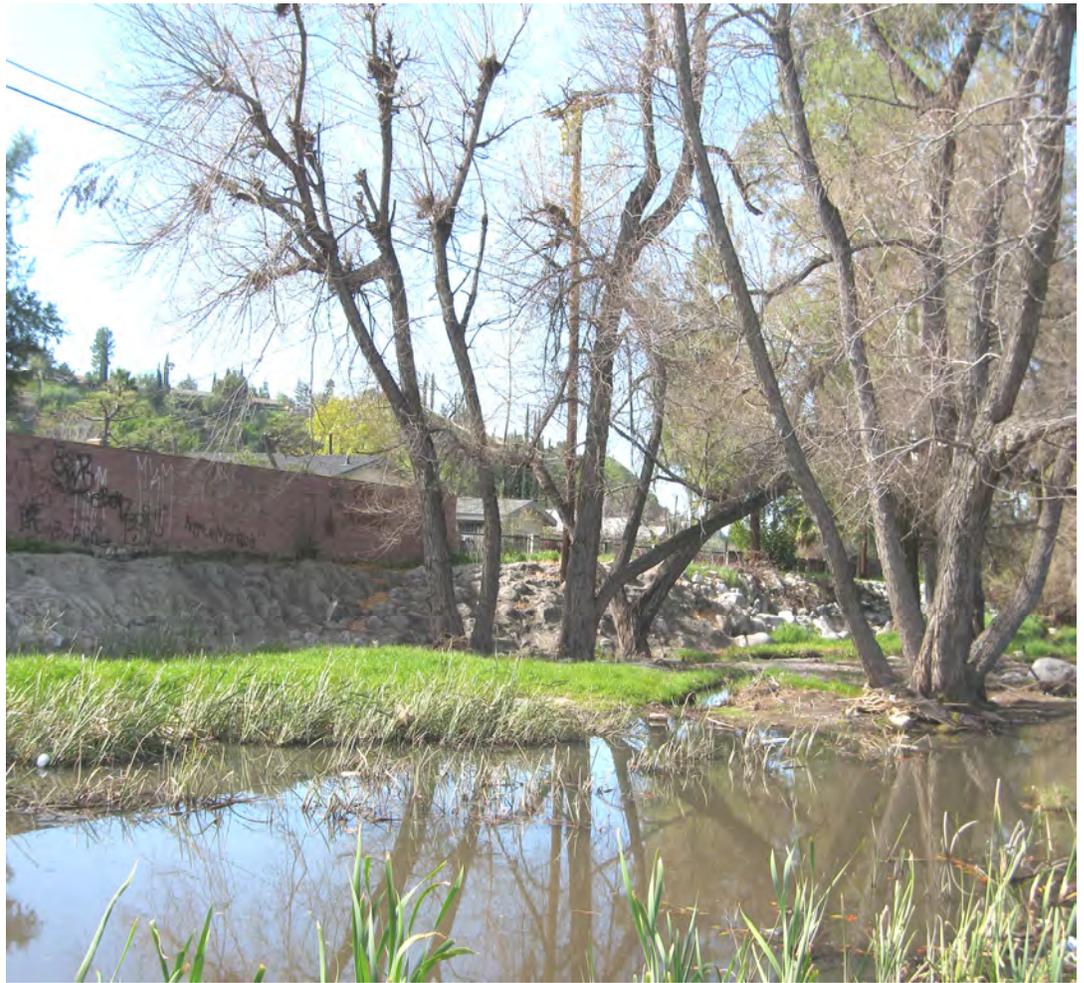
**Photo
No.**
1

**Direction Photo
Taken:**
Downstream (Graffiti on
left wall)

Graffiti at the natural
section. Houses back
onto creek on one side

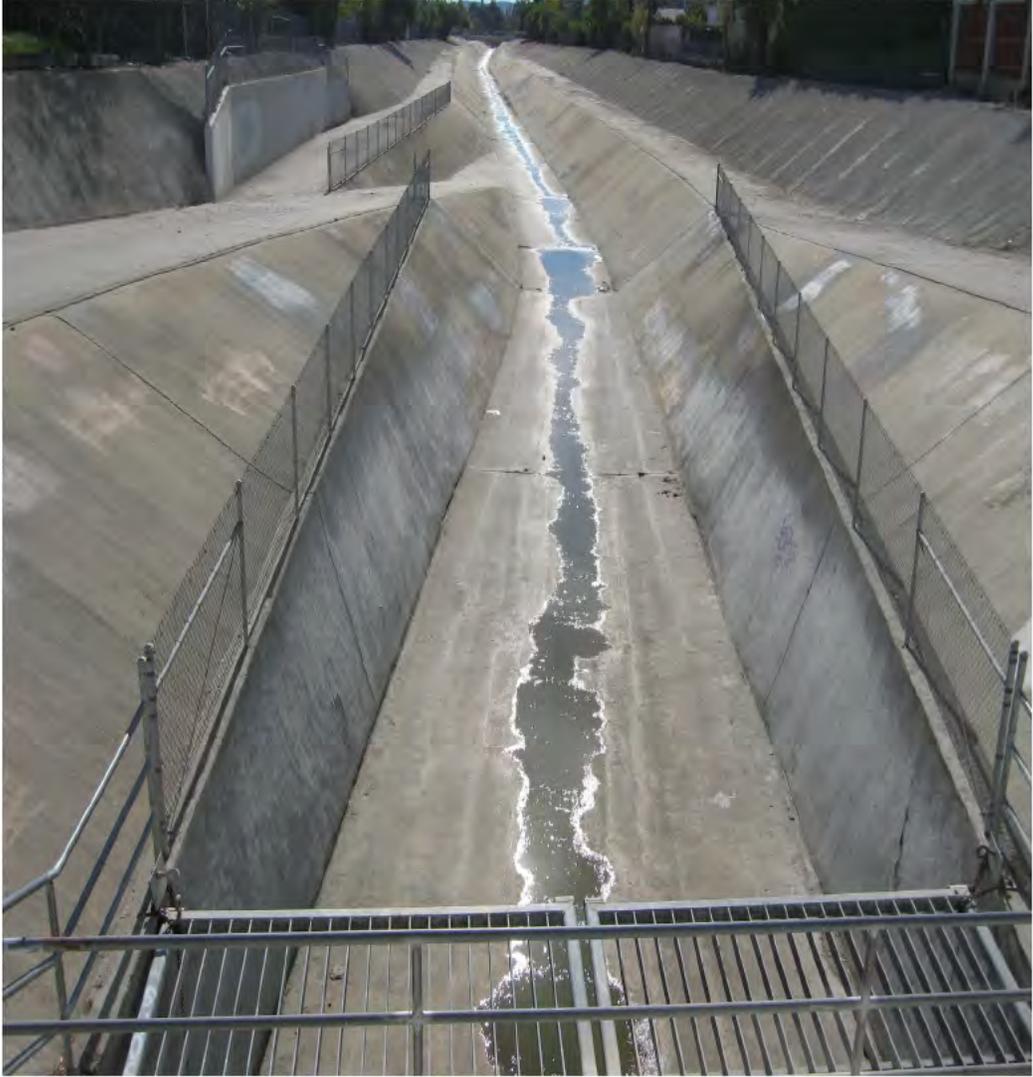
Direction Photo Taken: Downstream		
Mode of Access: Over Pass		
Potential Access Points: Gates (secured), fenced (both sides of channel wall), ramped		
Adj. Rec Facility: None		
Adj. Land Uses: Residential		
Low Flow Channel: No		
Bike Path: Absent		
Ext. Surveyed: 350ft ↓		
Other Signs of Access: Painted over Graffiti		
Channel Characteristics: - Concrete bottom - Trapezoidal bank slopes		
Water Characteristics: - Presence of Flow		
Field Team: RB: Ginachi Amah, Shruthi Bala, Michael Morales County: Emiko K. Innes, Chien-Hao Chen, Giles Coon

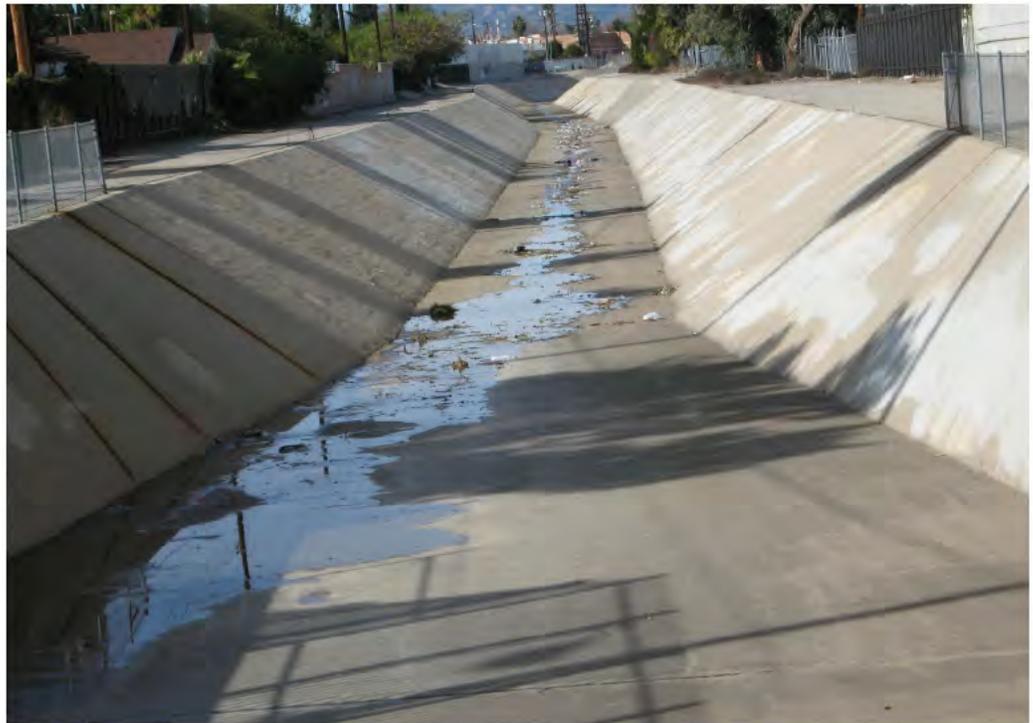
Time: 12:40pm	Photo No. 2
Direction Photo Taken: Upstream	
Other Signs of Access: None	
Channel Characteristics: - Concrete bottom - Trapezoidal bank slopes	
Water Characteristics: - Presence of flow - Presence of trash	
Additional Comments: Goes under-ground as a storm drain till confluence w/ LA river reach 5	
Field Team: RB: Ginachi Amah, Shruthi Bala, Michael Morales County: Emiko K. Innes, Chien-Hao Chen, Giles Coon

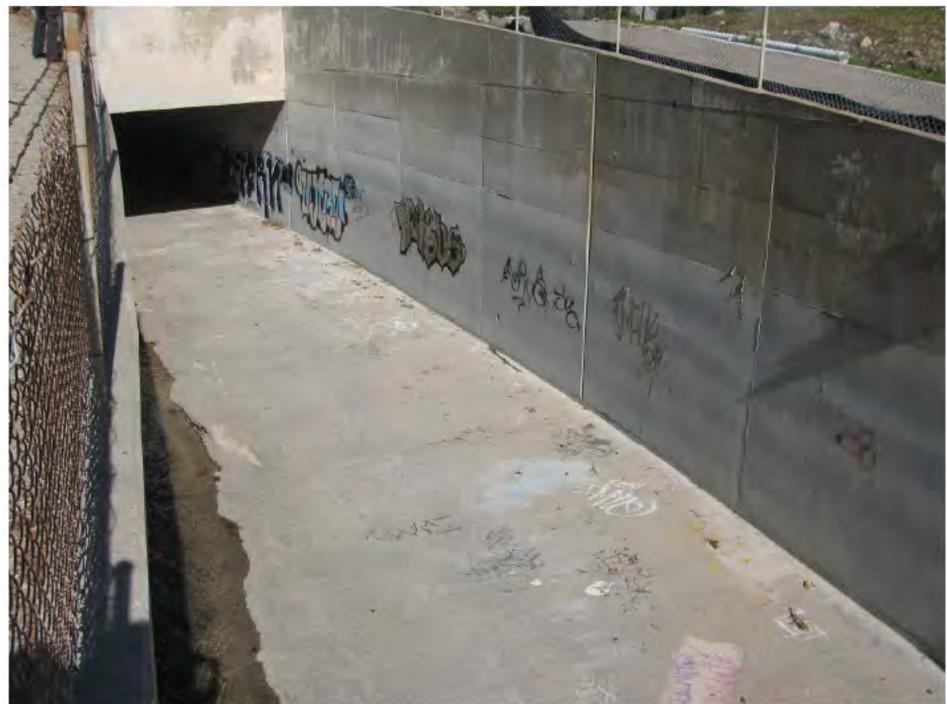
Time: 11:57am	Photo No. 2
Direction Photo Taken: Upstream	
Other Signs of Access: Graffiti	
Channel Characteristics: - Concrete bottom - Vertical box	
Water Characteristics: - Presence of flow	
Field Team: RB: Ginachi Amah, Shruthi Bala, Michael Morales County: Emiko K. Innes, Chien-Hao Chen, Giles Coon

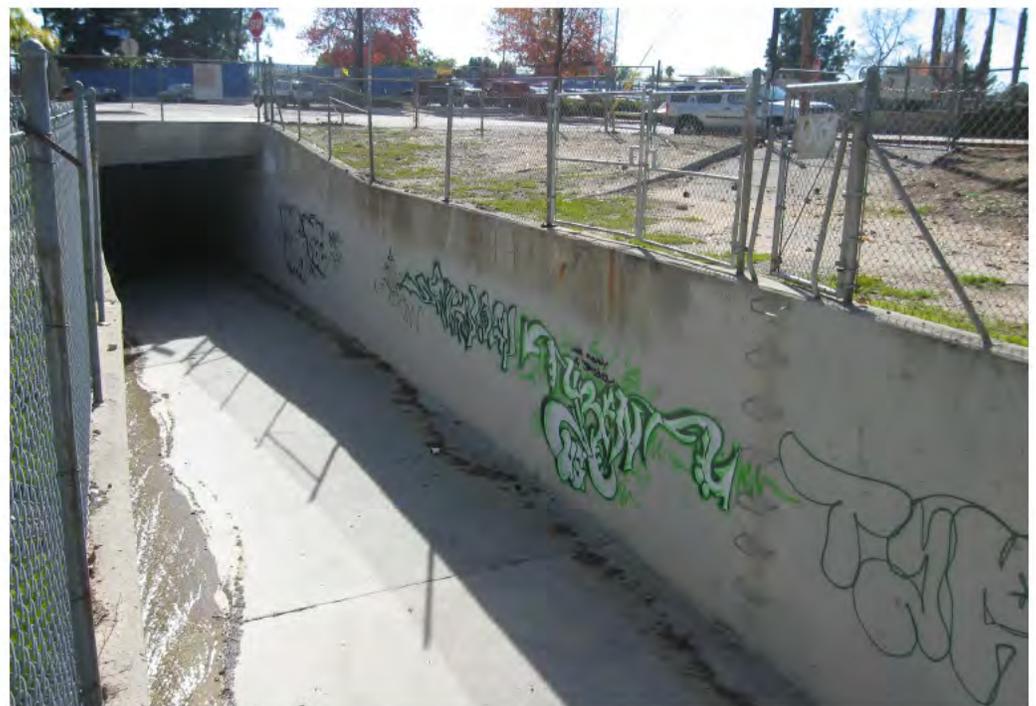
Time: 11:40am	Photo No. 2
Direction Photo Taken: Upstream	
Other Signs of Access: Graffiti	
Channel Characteristics: - Concrete bottom - Vertical box	
Water Characteristics: - Presence of flow @ edge of channel	
Field Team: RB: Ginachi Amah, Shruthi Bala, Michael Morales County: Emiko K. Innes, Chien-Hao Chen, Giles Coon

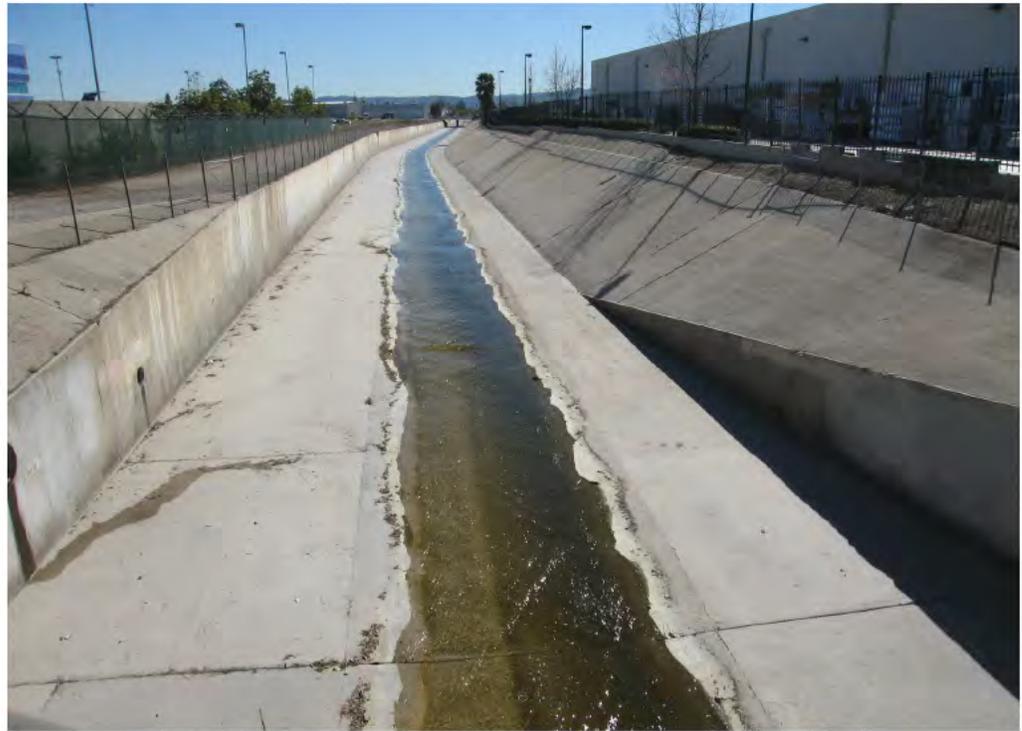
Photo No.
1

Other Signs of Access:
Graffiti

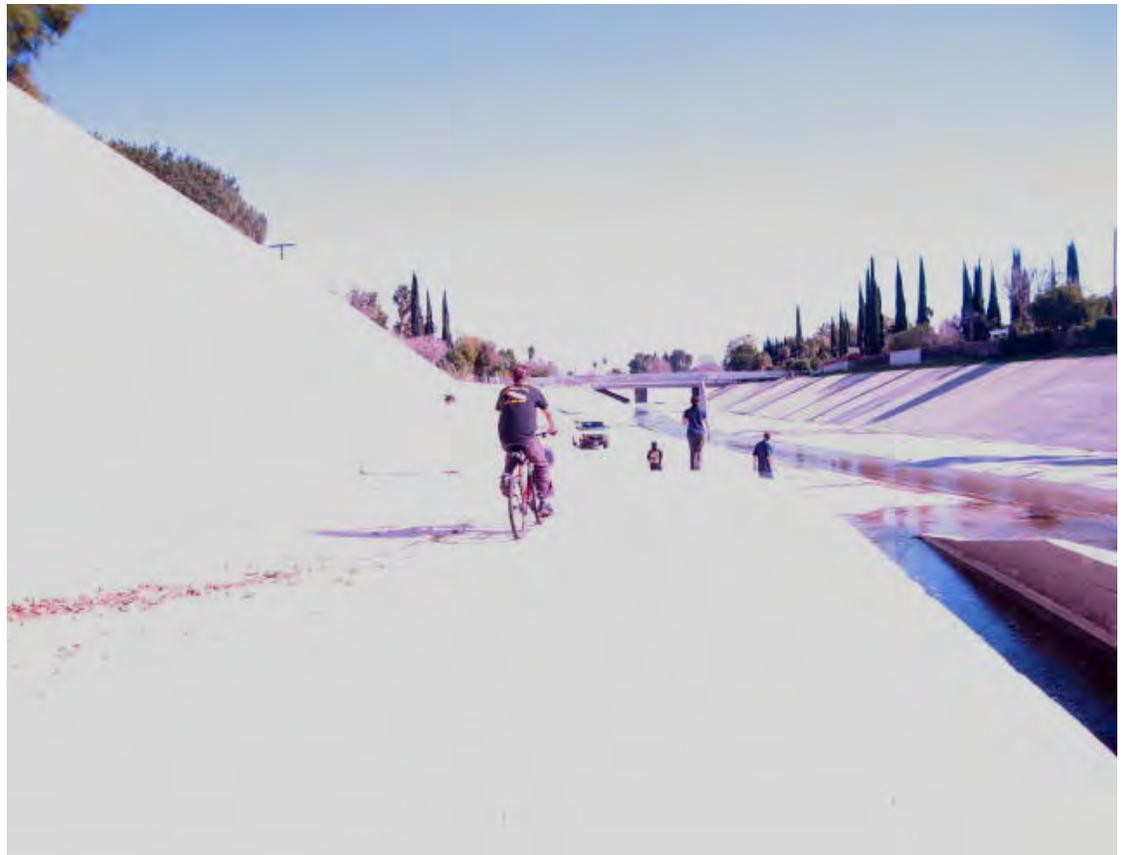
Photo No.
3

Bikers in Channel coming from Aliso Creek into LA river Channel . Gained access through maintenance gate left open by field team during site visit

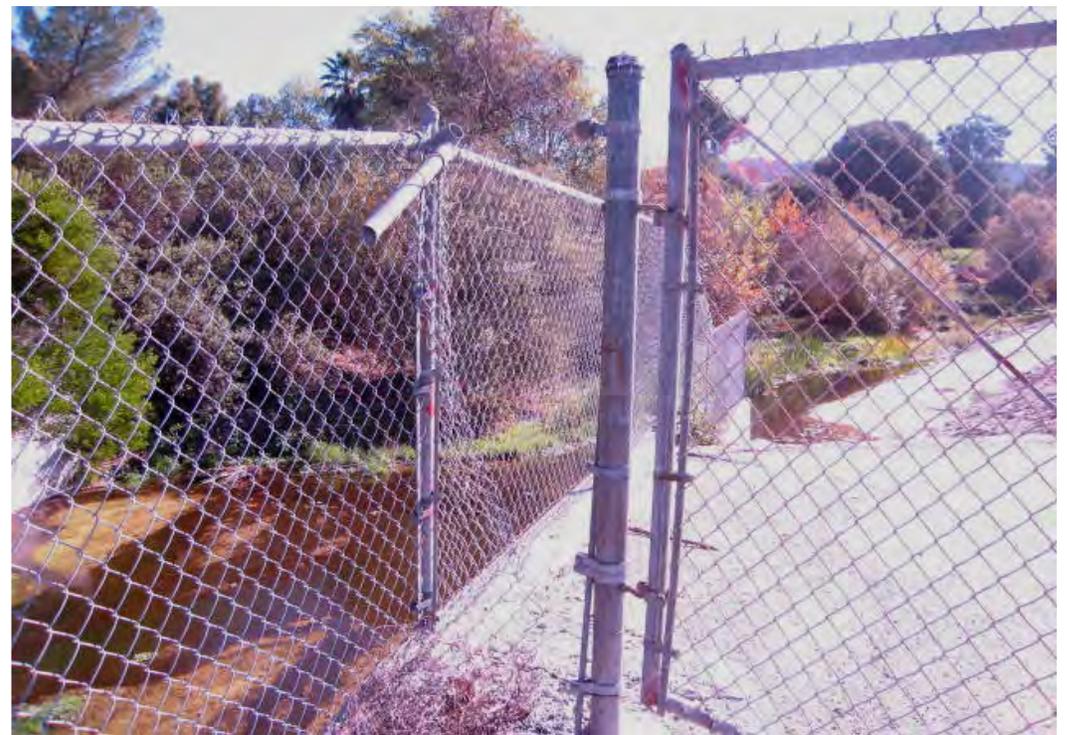
Time: 12:52pm	Photo No. 4
-------------------------	------------------------------

Photo details:
Fence break

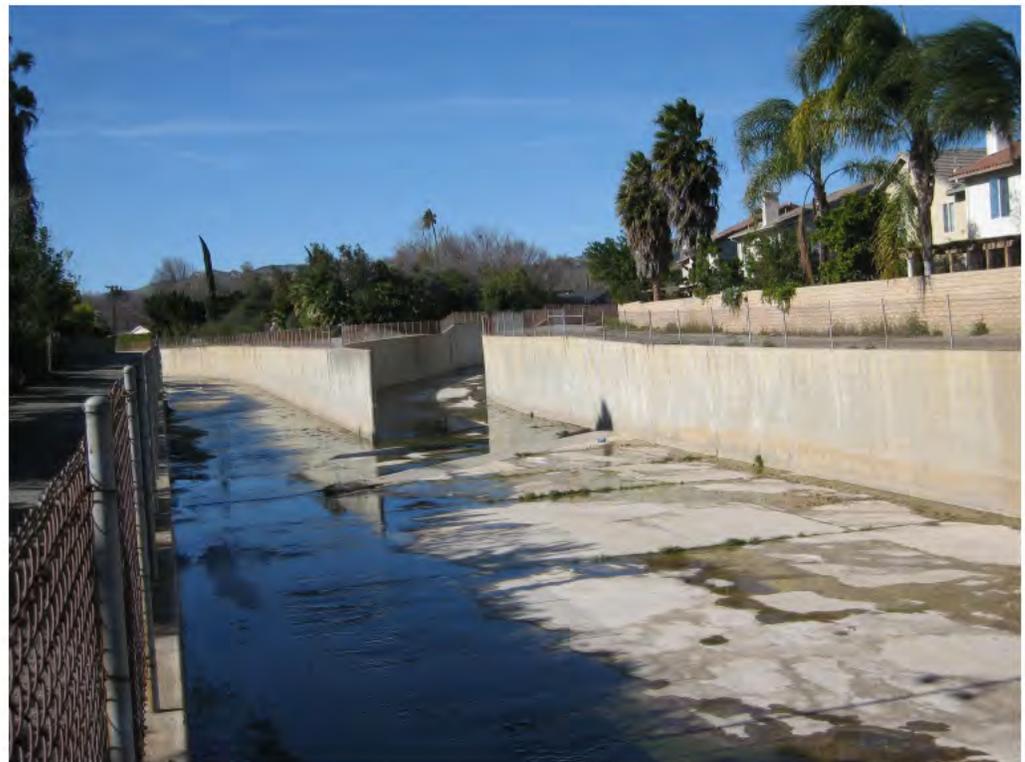
Time: 11:58am	Photo No. 3
-------------------------	------------------------------

Direction Photo Taken:
Downstream of Bell Creek

Channel Bank slope:
Vertical Box

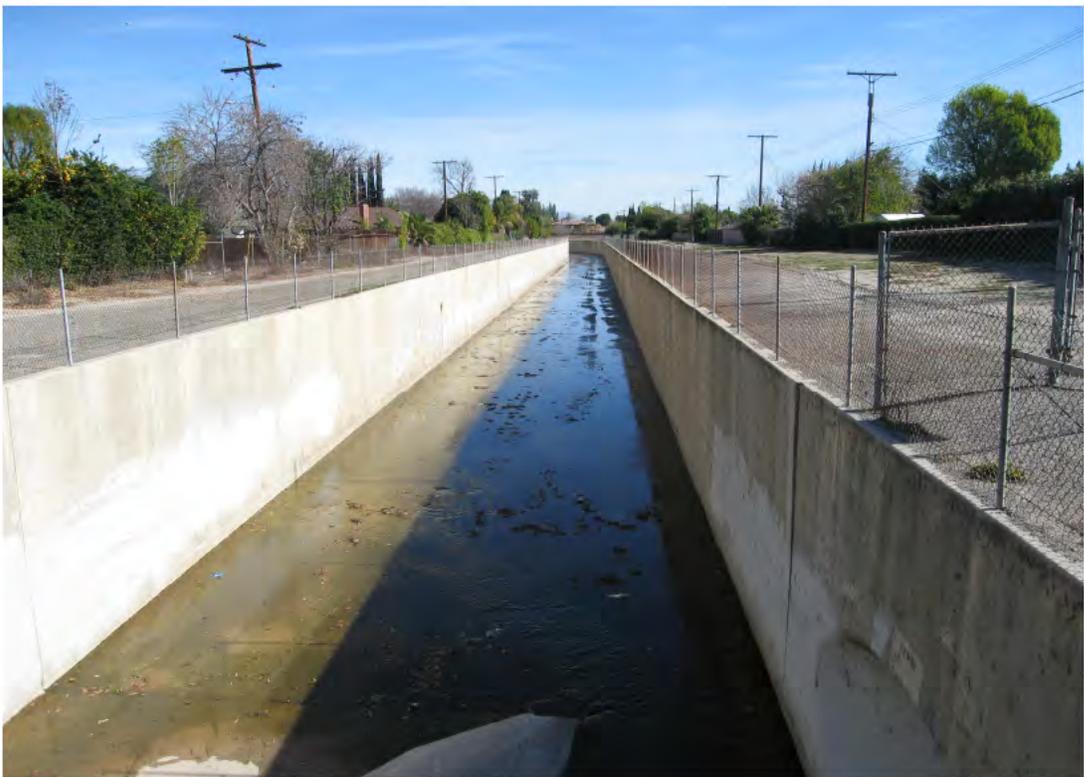
Time: 11:58am	Photo No. 4
-------------------------	------------------------------

Photo details:
Upstream transition to Trapezoidal

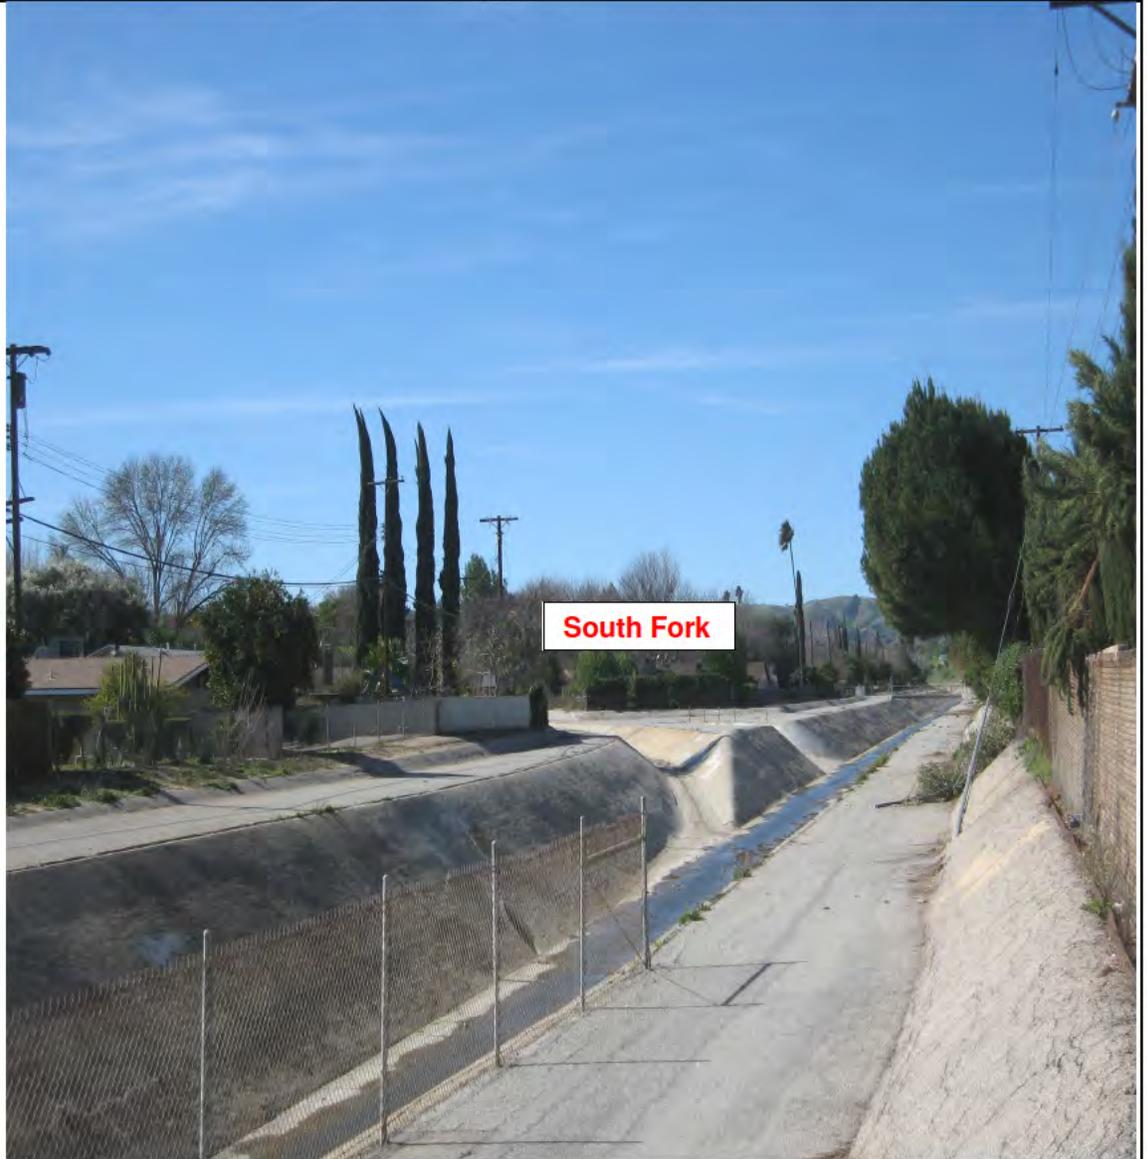
Photo No.
1

Direction Photo Taken:
Upstream

Fencing: Present (both sides of channel walls), gates secured. Ramp present

Water Characteristics:
-Presence of flow
-Presence of algae and trash

Channel Characteristics:
- Concrete bottom
- Trapezoidal bank slope

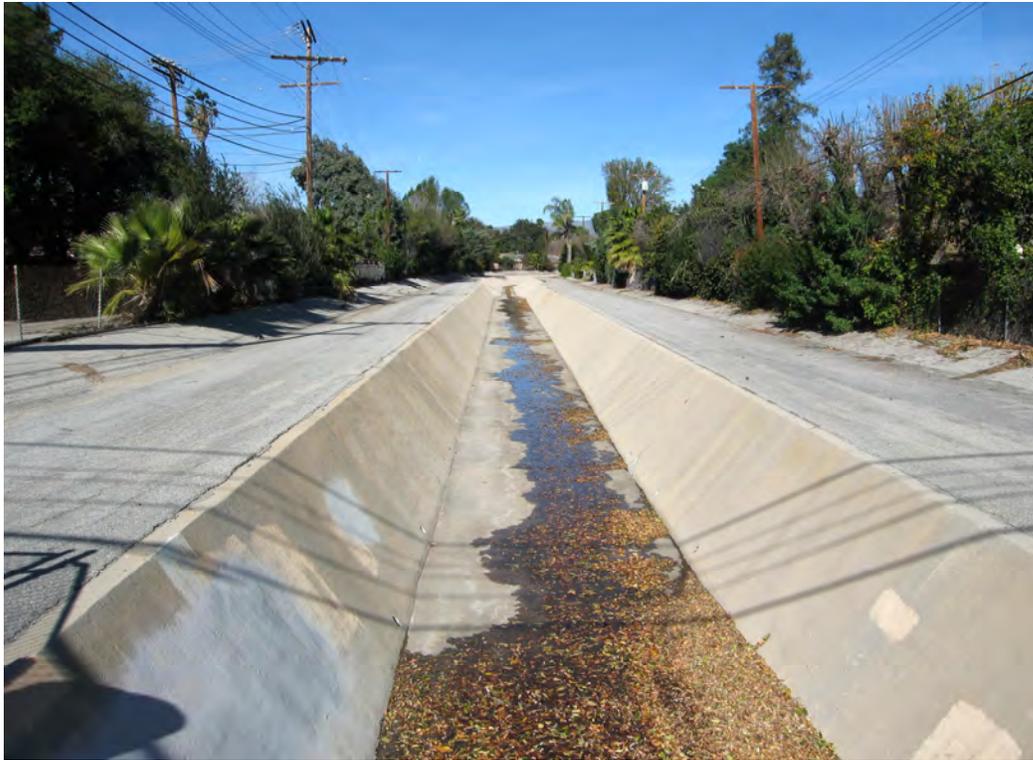
Direction Photo Taken: Downstream		
Mode of Access: Overpass		
Potential Access Points: Gates (secured), fenced (along maintenance road) and ramped.		
Adj. Rec Facility: None		
Adj. Land Uses: Residential and Commercial		
Bike Path: Absent		
Ext. Surveyed: 300 ft (D/S) and 400 ft (U/S)		
Low Flow Channel: Absent		
Time: 12:51 pm	Photo No. 2

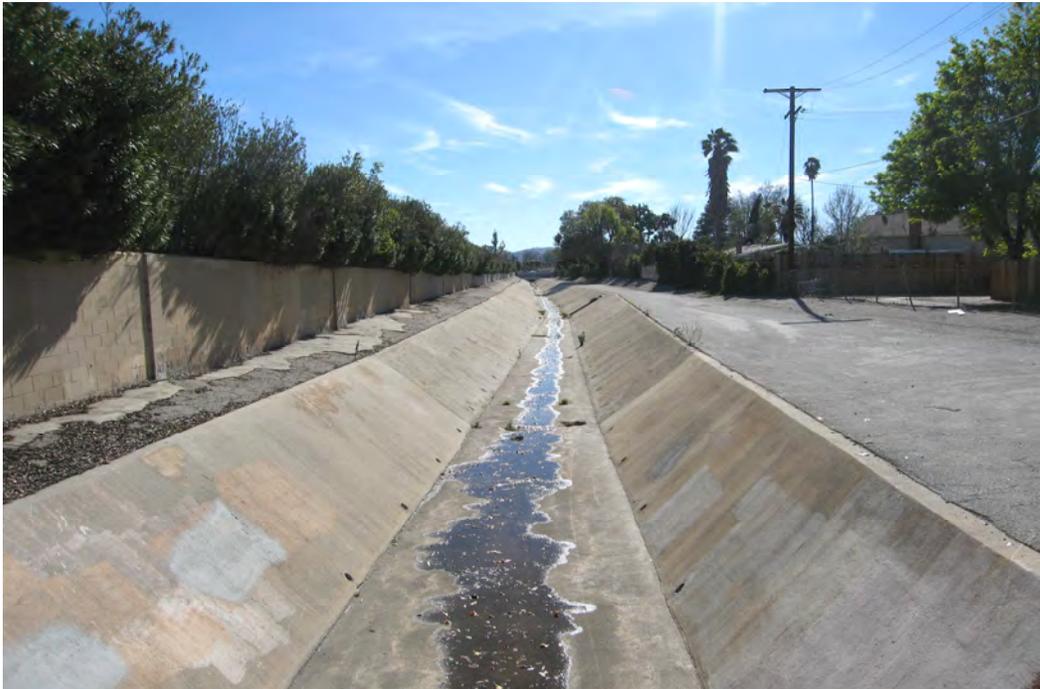
Direction Photo Taken: Upstream		
Other Signs of Access: None		
Channel Characteristics: - Concrete bottom - Trapezoidal bank slopes		
Water Characteristics: - Presence of flow - Presence of Trash		
Additional Comments: Residence back onto creek on both sides D/S end and one side U/S end		
Field Team: RB: Ginachi Amah, Shruthi Bala, County: Emiko Innes, Chien-Hao Chen and Dan Sharp

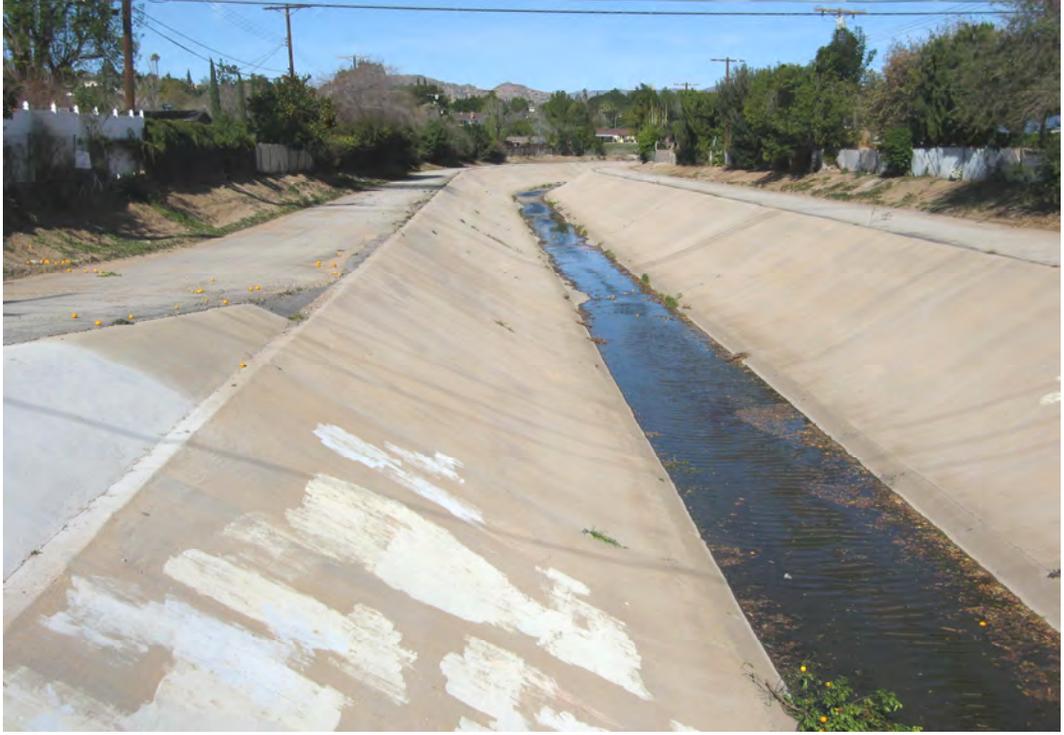
Direction Photo Taken: Downstream		
Mode of Access: Overpass		
Potential Access Points: Gates (secured), fenced (along maintenance road) and ramped. Adj. Rec Facility: None Adj. Land Uses: Residential and Commercial Bike Path: Absent Ext. Surveyed: 150 ft (D/S) and 300 ft (U/S)		
Time: 1:02 pm	Photo No. 2

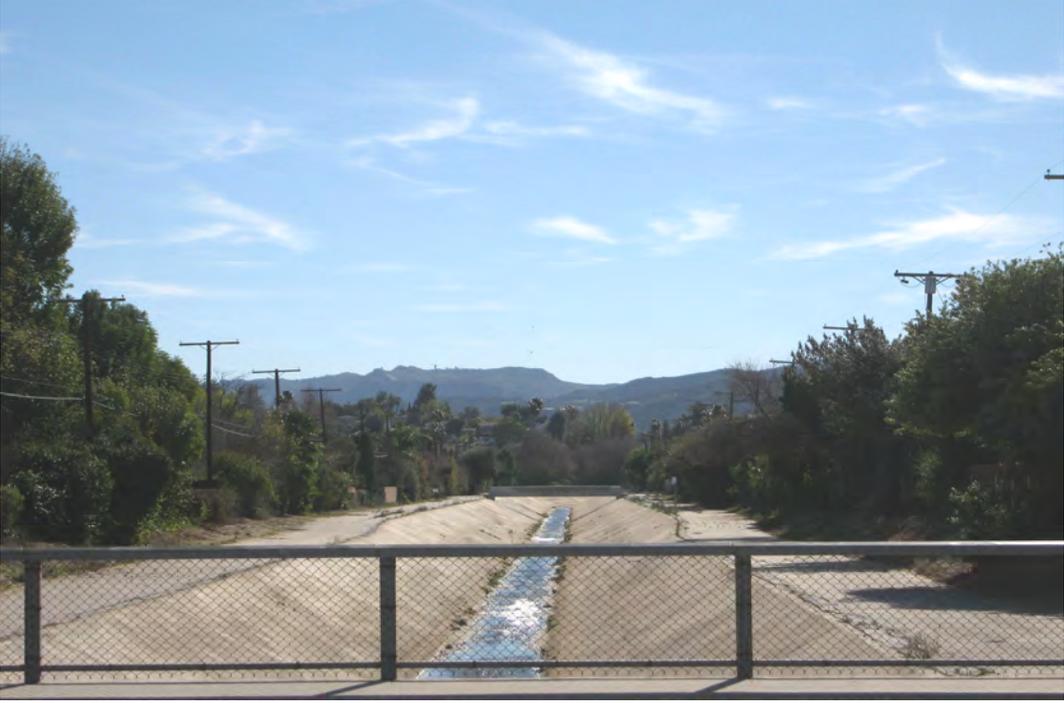
Direction Photo Taken: Upstream		
Low Flow Channel: Absent		
Other Signs of Access: None Channel Characteristics: - Concrete bottom - Trapezoidal bank slopes Water Characteristics: -Presence of flow Field Team: RB: Ginachi Amah, Shruthi Bala, County: Emiko Innes, Chien-Hao Chen and Dan Sharp

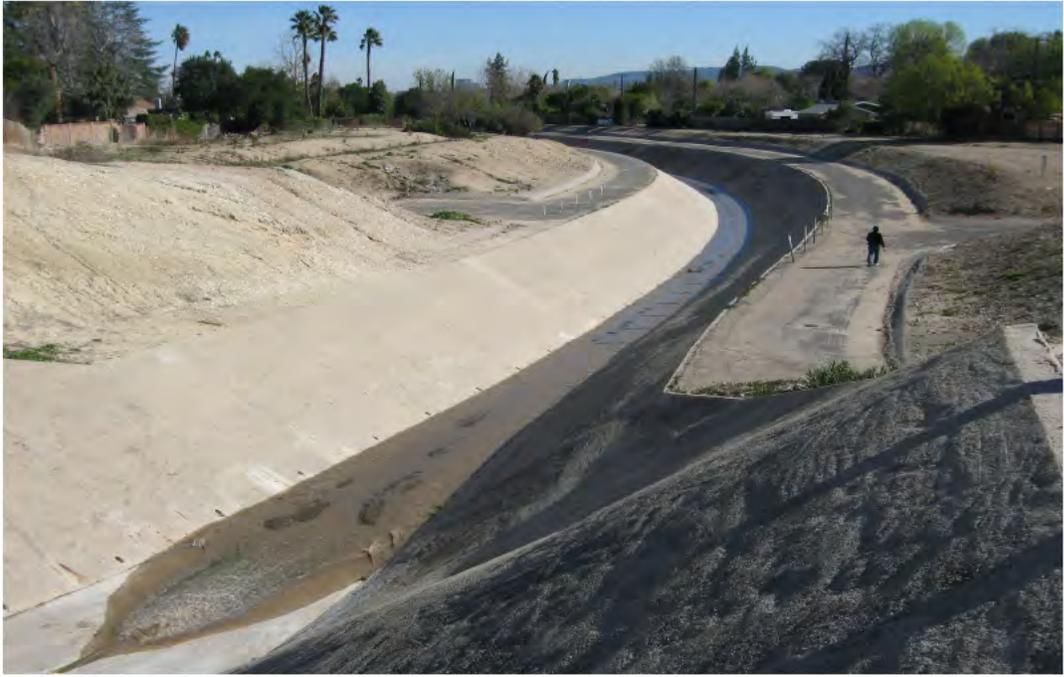
Direction Photo Taken: Downstream					
Mode of Access: Debris Dam facility gates and Maintenance Road					
Potential Access Points: Gates (secured), fenced (Along Maintenance Rd.) and Ramped Adj. Rec Facility: None Adj. Land Uses: Residential Bike Path: Absent Extent Surveyed: 500 Ft ↓
