RECREATIONAL USE RE-EVALUATION OF THE ENGINEERED CHANNELS OF THE LOS ANGELES RIVER WATERSHED

**FIELD RECONNAISSANCE REPORT
NOVEMBER 2010- MARCH 2011**

**LOS ANGELES REGIONAL WATER QUALITY CONTROL BOARD
MARCH, 2011**

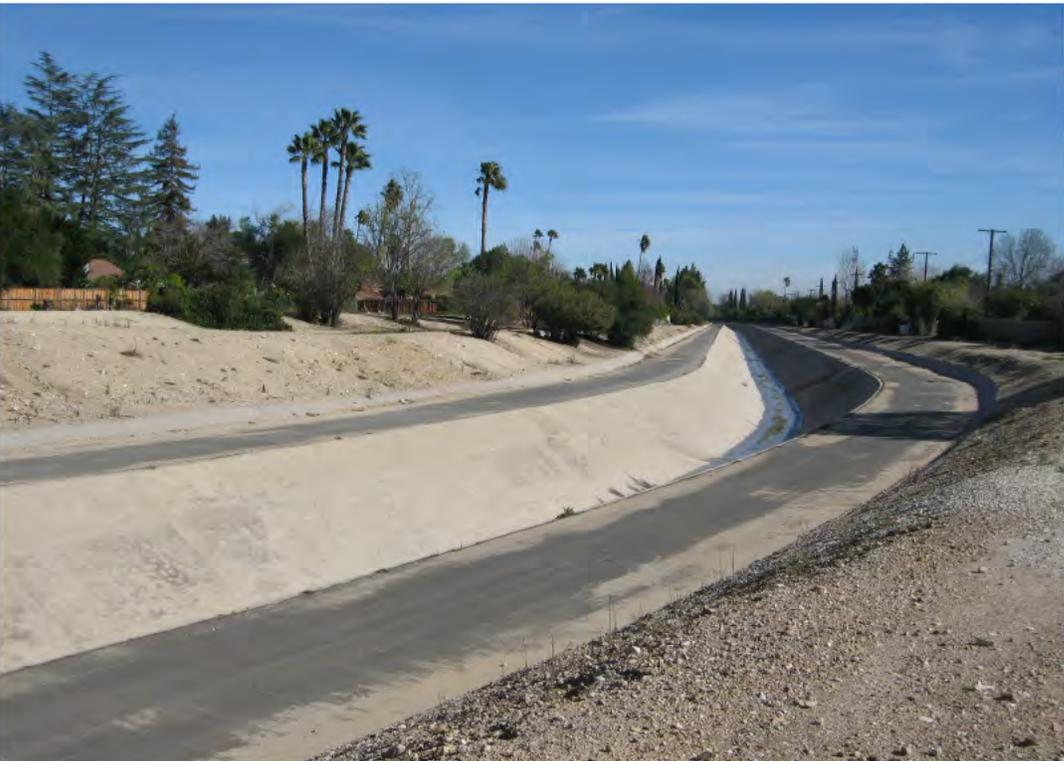
Time: 1:20 pm		Photo No. 2

Direction Photo Taken: Downstream					
Water Characteristics: -Presence of flow					
Low Flow Channel: Absent Channel Characteristics: - Concrete bottom - Trapezoidal bank slopes Other Signs of Access: None Field Team: RB: Ginachi Amah, Shruthi Bala, County: Emiko Innes, Chien-Hao Chen and Dan Sharp
